CASE STUDY – MONOLITHIC

COMPOSITE PLATE

TFM – ASA: Non-Destructive Testing

GROUP 1:

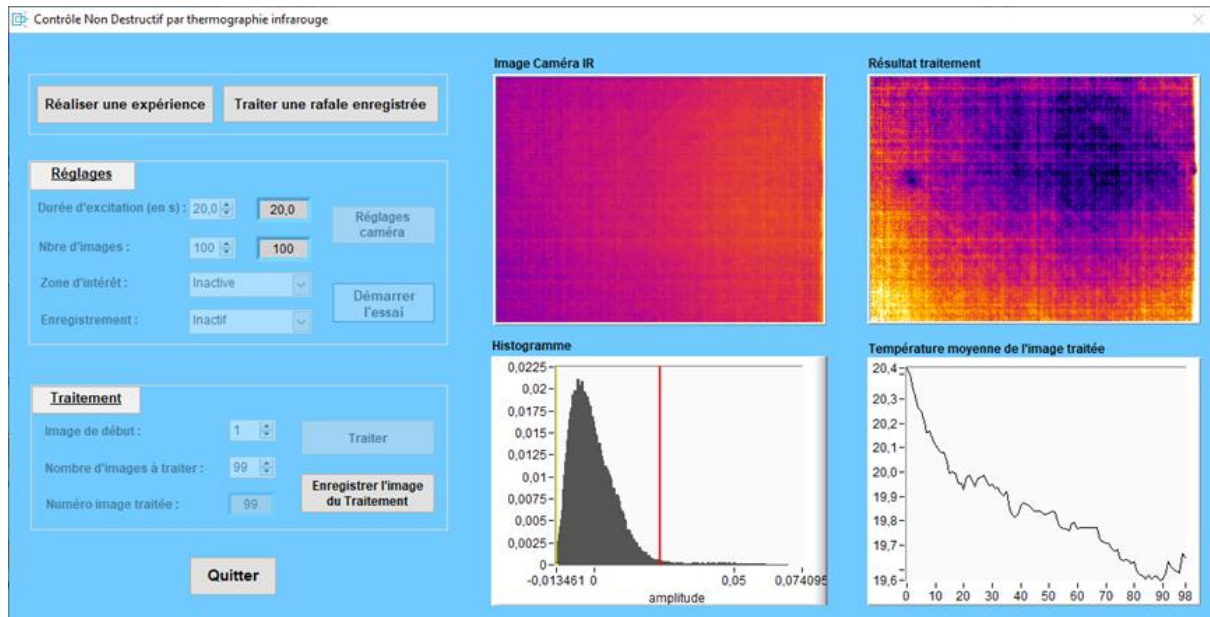
Fig. 3: Image of defect for Time excitation of 20s and 100 number of images

From Fig. 3 we observe that, at excitement duration of 20 seconds and number of images at 100, the above defects were found, but from the obtained results we can see that the cooldown time was very high. Fig. 4 represents the excitation time was reduced to 15 seconds and number of images to 80, we obtained a result where, a better visibility of defect was found.

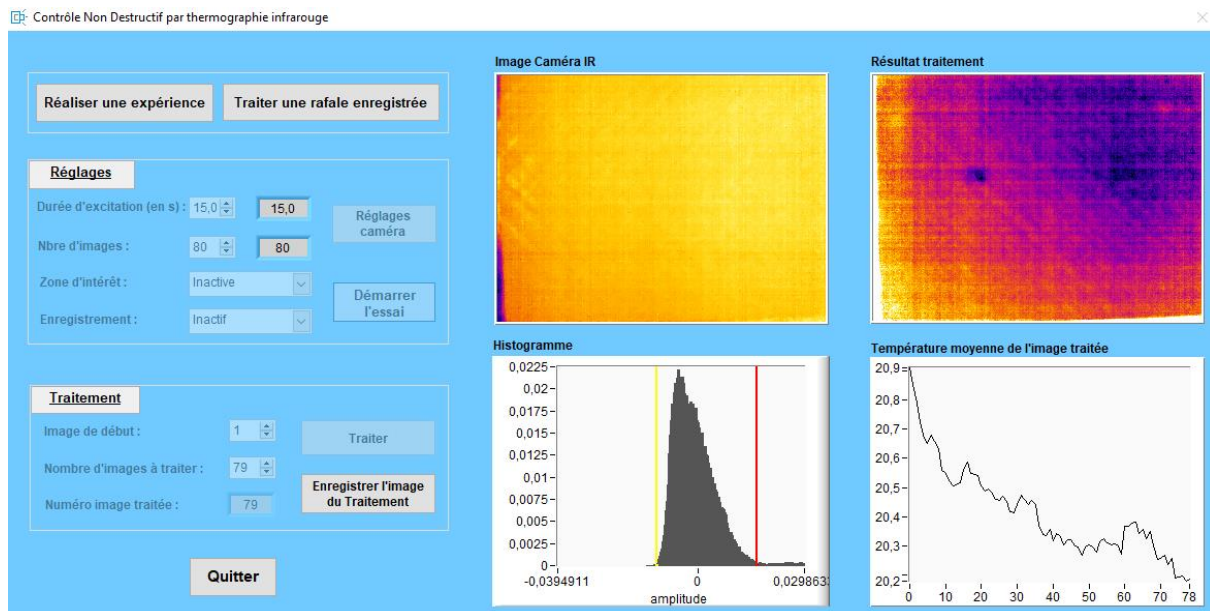
Fig. 4: Image of defect for Time excitation of 15s and 80 number of images

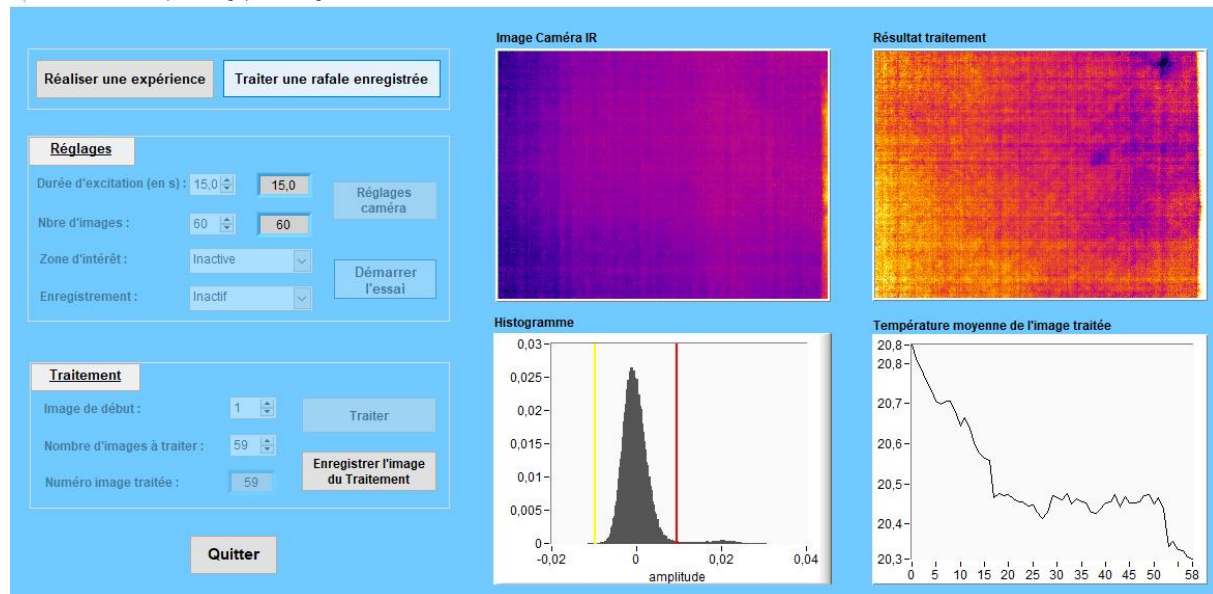
Fig. 5: Image of defect for Time excitation of 15s and 60 number of images

Similar to the above case, number of images were further reduced to 60 and the defect was visible more clearly than previous case, and we could confirm the presence of defect from this face of the composite plate which could be observed in Fig. 5.

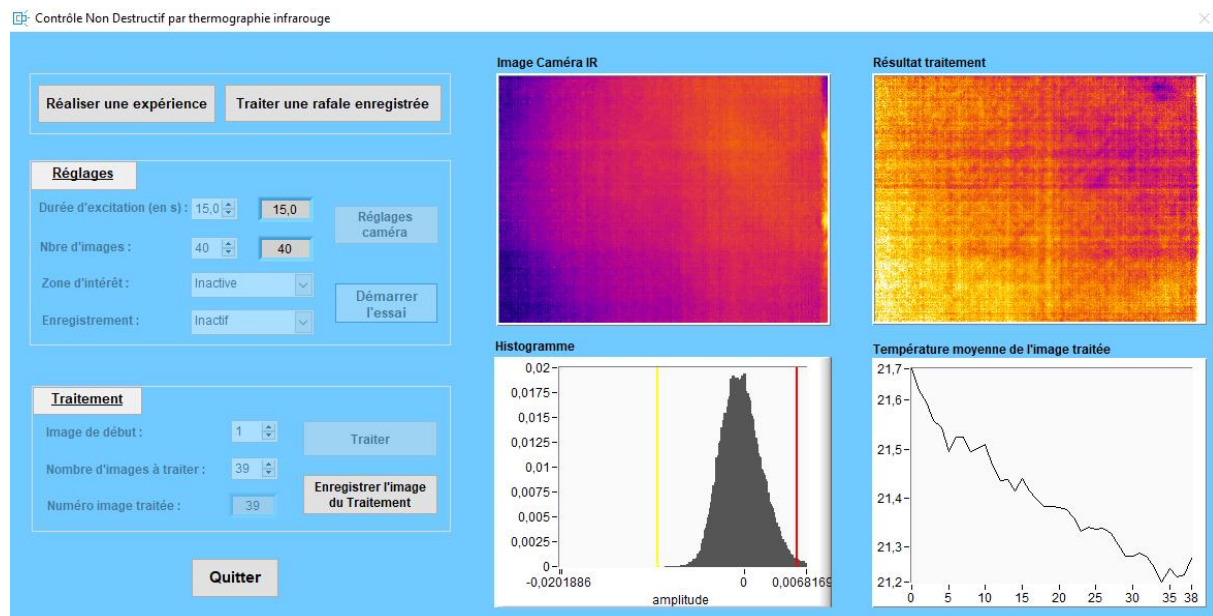
Fig. 6: Image of defect for Time excitation of 15s and 40 number of images

Further, the composite plate is moved to check for defect at different location on composite plate and then the excitation and number of images were further reduced and the above results were obtained, where the defect was visible at the top right corner on the screen and no other defects were detected in the Fig. 6.

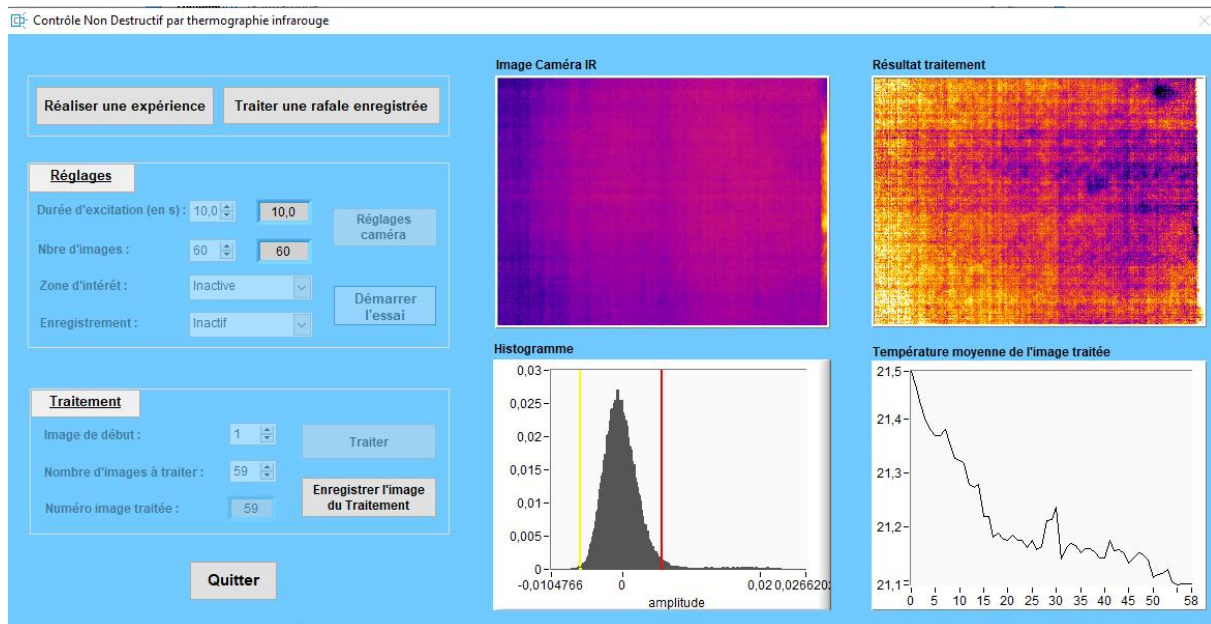
Fig. 7: Image of defect for Time excitation of 10s and 60 number of images

In the above case, the composite plate was flipped and with excitation time of 10 seconds and number of images at 60, we can confirm that the defect is present at the same place after flipping the composite plate which is observed in Fig. 7. Similar to the above case, the flipped composite plate was adjusted to check for other errors and then the excitement time and number of images were given as 10 seconds and 60 images respectively, and we could observe that no other defects were found shown in Fig. 8.

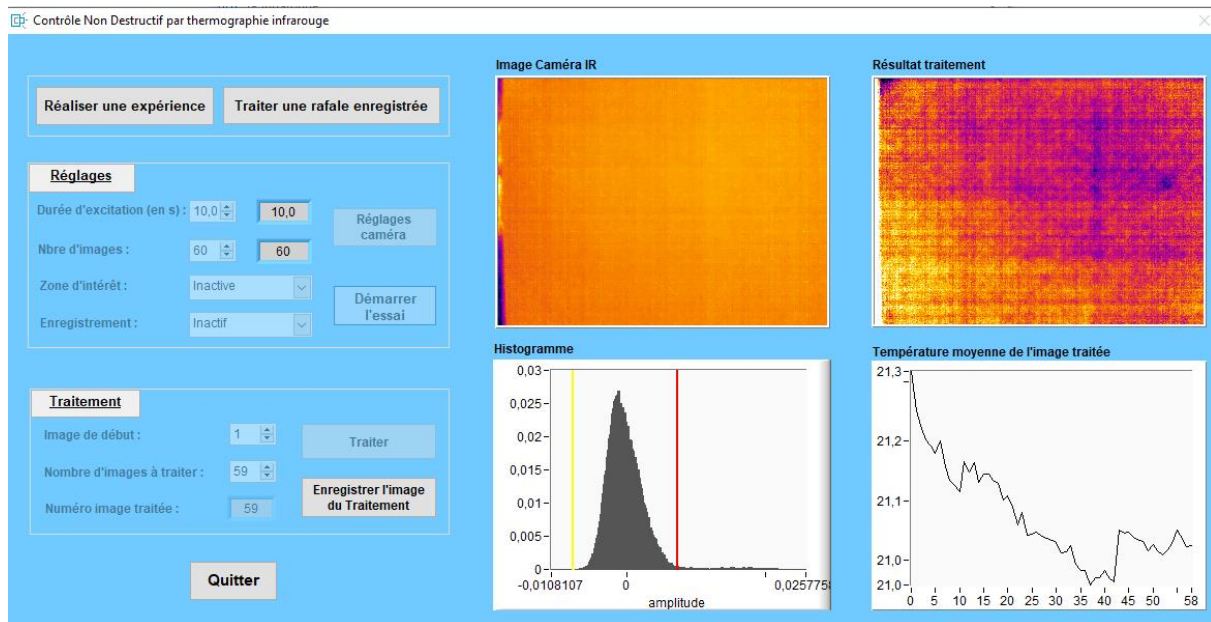
Fig. 8: Image of defect for Time excitation of 15s and 40 number of images

And there was another minor defect detected at one corner of the composite plane which is evenly spread out, and we are assuming that this defect might have evolved from continuous usage of the component and might be because of the water entering the inner parts of the composite plate, which can be further confirmed by using the ultrasound testing method.

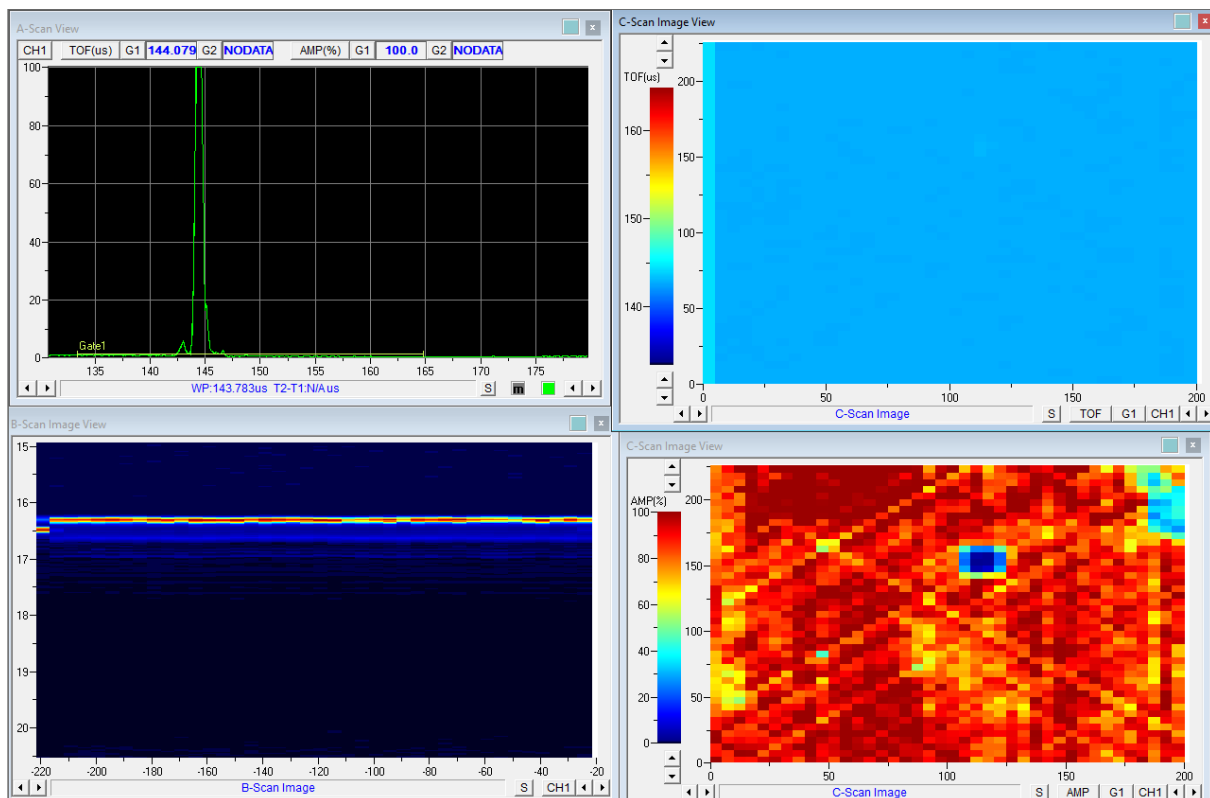
Ultrasound can be performed in 2 ways either transmission or reflection. Starting with transmission the position of defect could be found and through this area with dimensions of defect could be found easily. The plate was fully scanned using partial resolution so that the approximate location of the defect in the plate can be found. After full scan it was found that the plate has a defect at the upper right section of the plate observed in Fig. 10. The schematic of the defect location is shown Fig. 9.

Fig. 10: A-, B- and C-Scan for entire composite plate

From Fig. 10 of the entire scan we get the co-ordinates of the major and minor defect as

Major Defect : x-start: 124 & 103.5 mm & y: 127.25 & 149.5 mm

Minor Defect : x: 181 & 200 mm & y: 124 & 180 mm

Area of Major defect : $(124 - 103.5) \times (149.5 - 127.25) = 456.125 \text{ mm}^2$

Area of Minor defect : $(200 - 181) \times (180 - 124) = 1064 \text{ mm}^2$

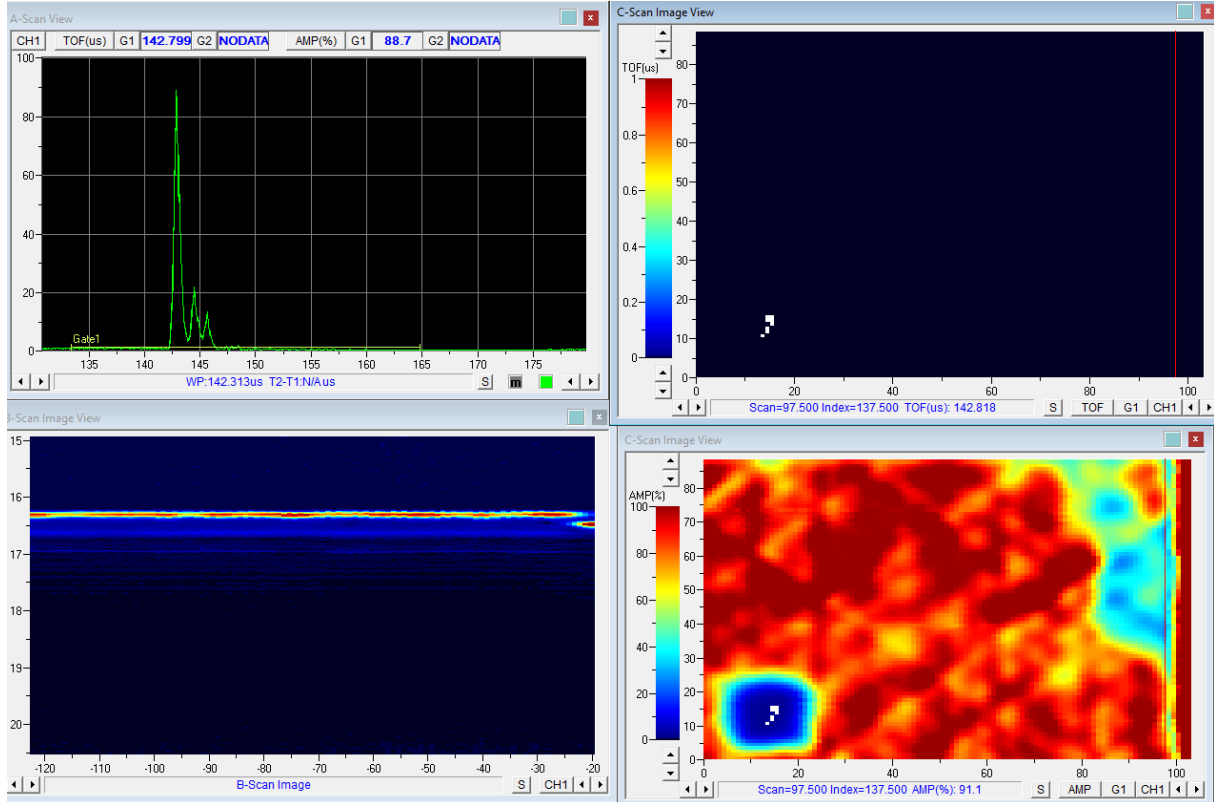
After this step a small parameter is taken for consideration for setting up the coordinates in the Ultrasound machine. The upper part is then scanned with high resolution of the scan so that more precision in A, B and C scan data can be extracted which can be observed in Fig. 11. This gives a high-resolution image in C-Scan with colour legend of dark blue depicting the area of defect and colour legend of orange/ yellow areas depicting no defects. And as can be seen the new section of the part used with new coordinated shows defect at left bottom corner. Apart from this, there has been another minor defect on the top right corner with light blue

scale of the colour legend. This gives an inference that due to immersion of the part in the fluid medium multiple times during the test due to water insertion in the part layers this defect has been generated on a minor scale.

Fig. 11: Focussed A-, B- and C-Scan of the composite plate

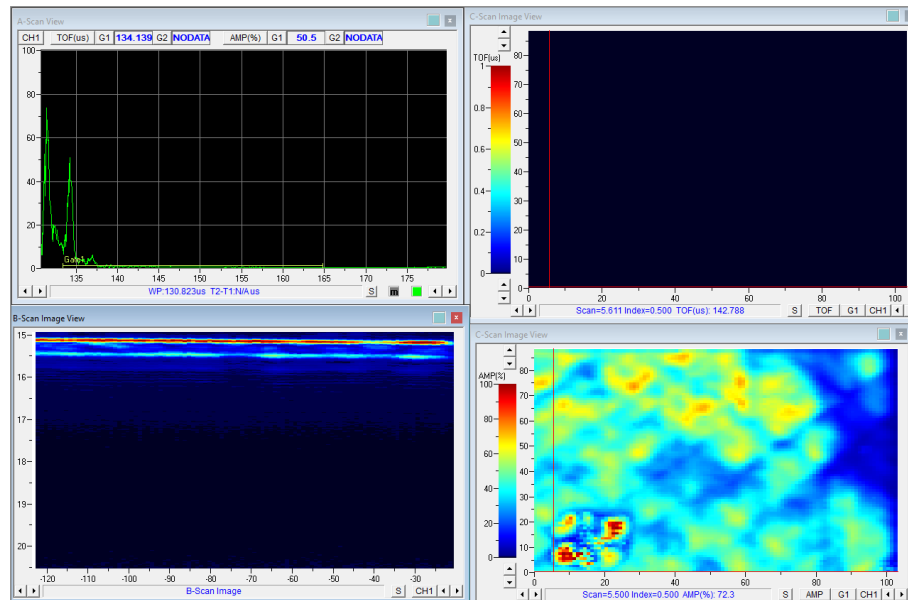
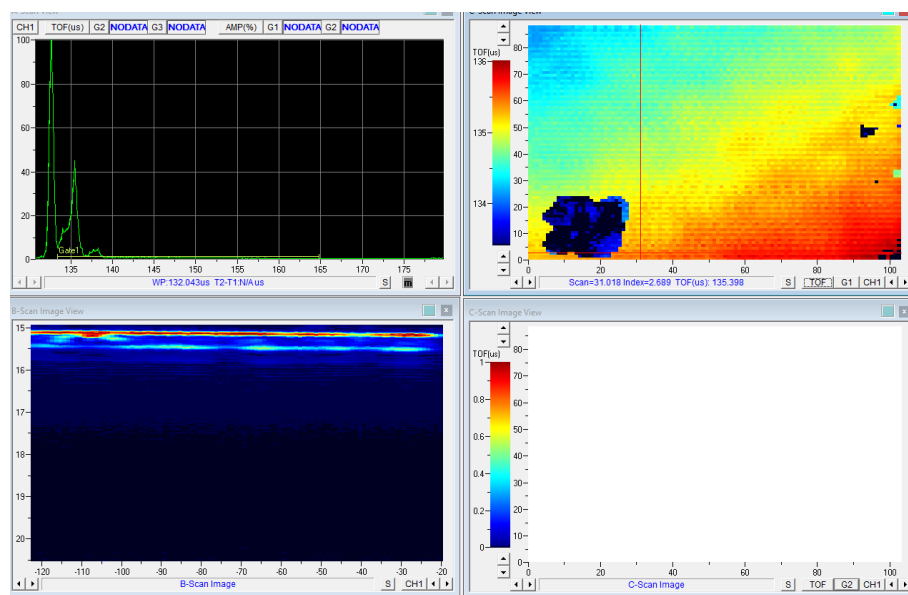
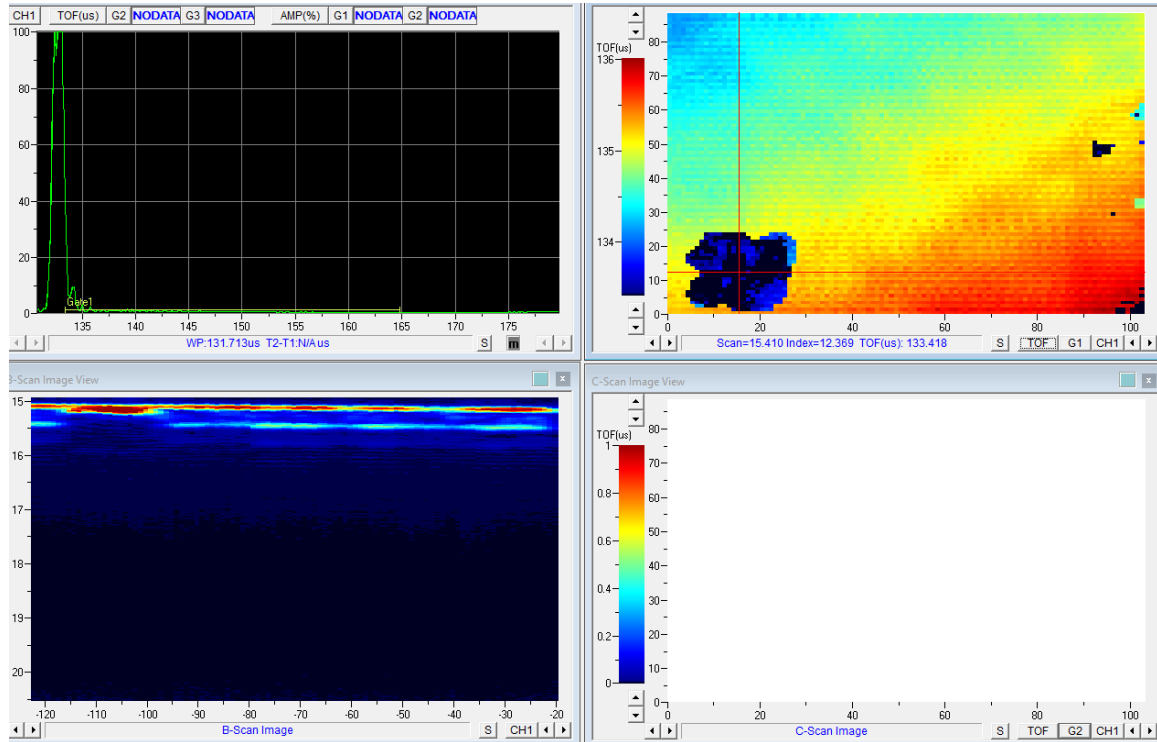
Reflection of the ultrasounds has been performed, where in the major defect has been detected. But in this case the minor defect is not be seen precisely. From the available images we find that the depth of defect can be found approximately from 0.1 mm to 0.4 mm, which

represent depth as 0.3mm and 0.1 mm from the surface of the plate as observed in Fig. 12, Fig. 13 and Fig. 14. Due to time constraint the position of gates to detect the depth using time of flight is not considered. But, using B-scan the depth calculation has been performed.

Fig. 12 A-, B- and C-Scan using reflection at focussed are of the plate (weak resolution)

Fig. 12 A-, B- and C-Scan using reflection at focussed are of the plate (medium resolution)

Fig. 12 A-, B- and C-Scan using reflection at focussed are of the plate (good resolution)

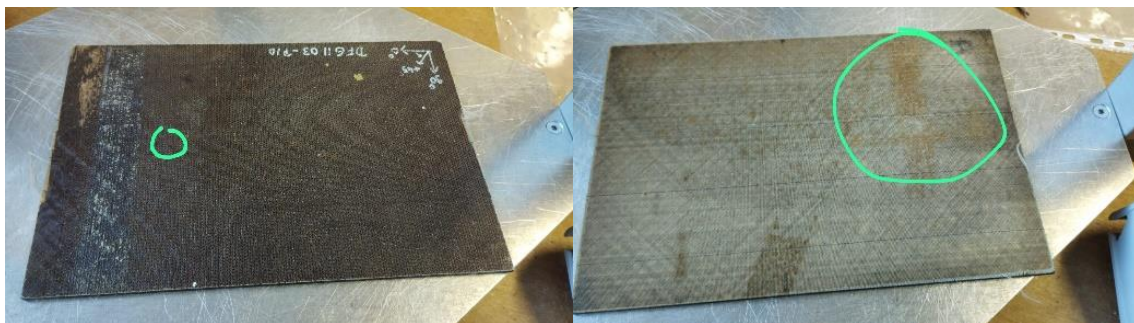
Fig. 13 and Fig. 14 are showing the original plate with defects been highlighted and also the placement of the composite plate in the ultrasonic machine inside water.

Fig. 13: The composite plate with defects highlighted in the front and back end of the plate respectively
