## Insufficient refrigeration

**Fault profile:** Insufficient refrigeration – temperature alarm is activated.

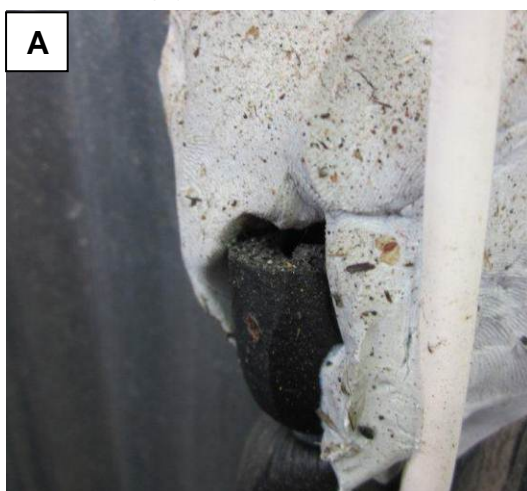
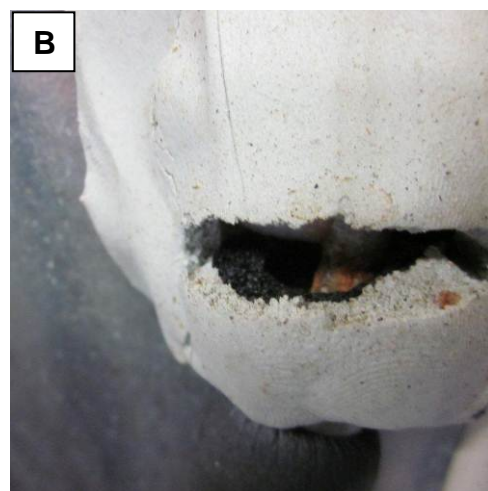
**Cause:** Condensation can form on the suction pipeline in the feed-through area of the housing, if the putty does not fully seal the end of the insulation hose (A) or the putty is cracked (B).

**To correct:** Order evaporator via Liparts and exchange.

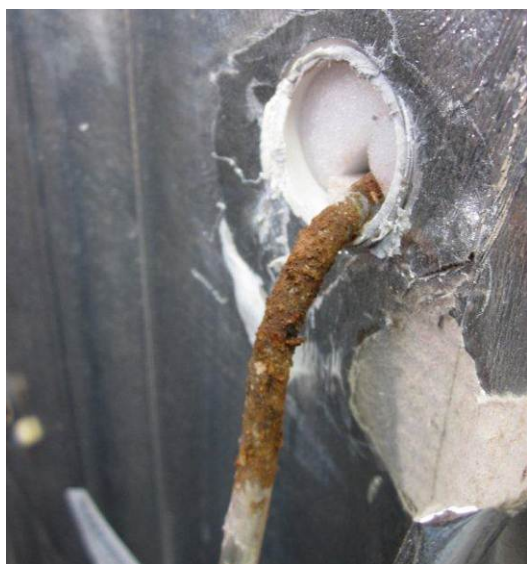
The suction pipeline can also corrode around the area of the bend and become leaky.

Please note: The refrigeration circuit may become blocked as a consequence. If a blockage is discovered, the area mentioned above must therefore be checked in order to find the actual cause.
