Service Bulletin

Subject: Drainage Correction

SOTTO - UG18/UG20/UG30/UG40/UG50/UG65/UG80 MODELS

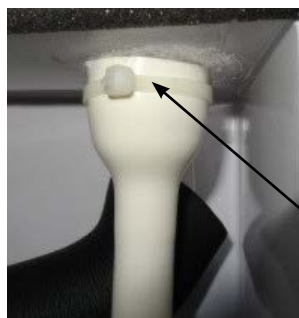
Remove
Plastic Tie

- Step 1** Disconnect power and water supply.
- Step 2** Remove back panel.
- Step 3** Remove plastic tie and remove vinyl drain tube.

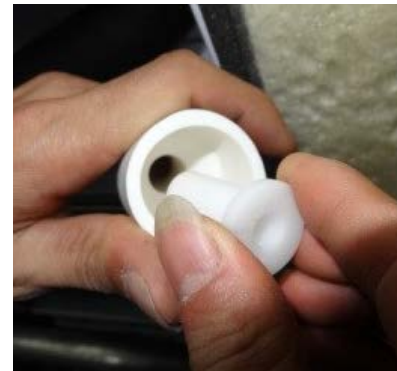
Units with **Serial Numbers from 310247716 to 310280909** shipped without the proper water flow restrictor causing water back-up and overflow. This will result in internal damage to the electrical components of the unit.

Step 4 Insert Water Flow Restrictor

- UG18 - 040004659
- UG20/UG30/UG40/UG50/UG65/UG80 - 040002833
