Gopuram Status Report

January 17, 2015

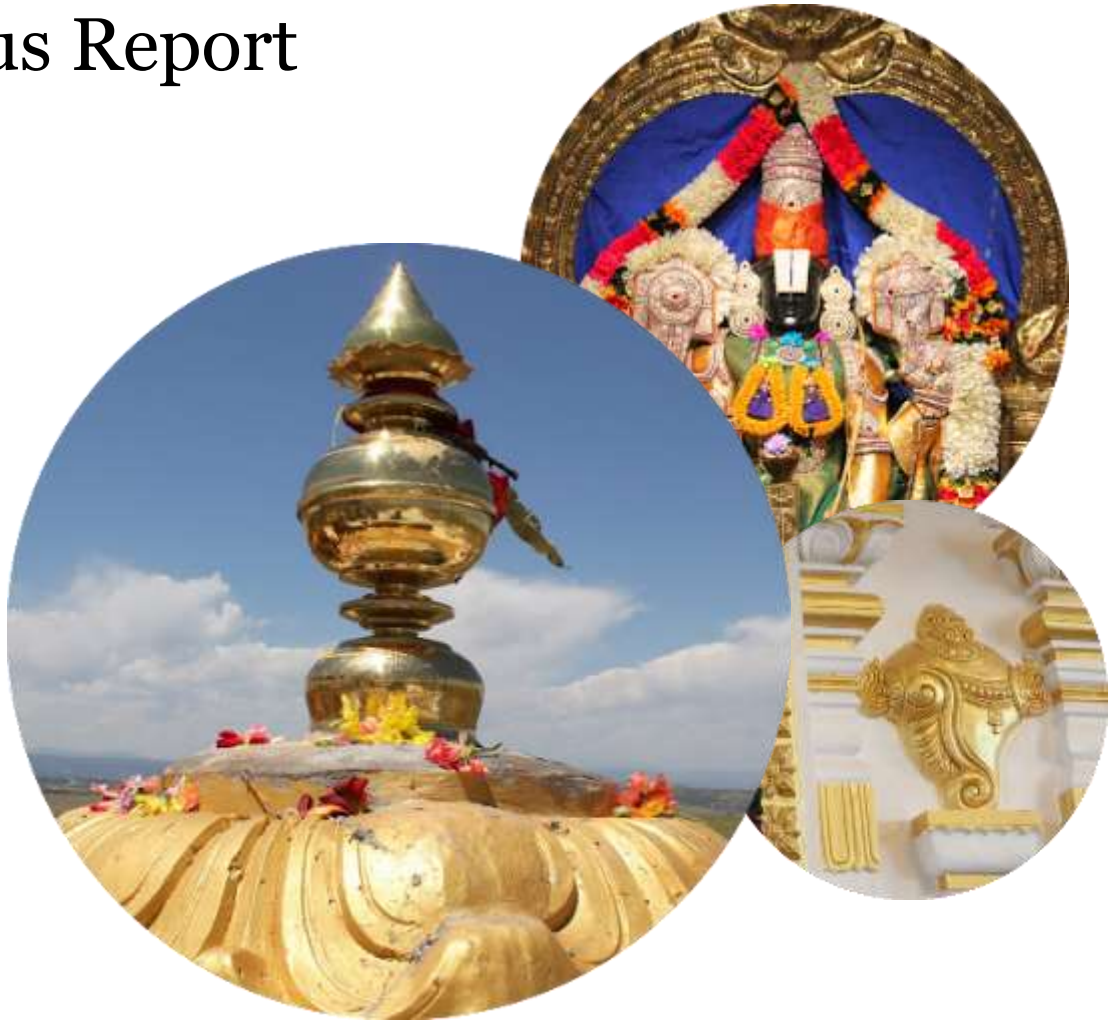
- Ornate Indian Decoration (Medallions) coming apart
 - Material Disintegration
 - Big Pieces Getting Unglued
- Material used
 - GFRC (Glass Fiber Reinforced Concrete)
 - Strength, Durability, Load Bearing Capacity, *Light Weight*
 - *Maybe not moldable easily?*
 - Mortar (Cement + Sand)
 - Cement
 - Gold Paint
- Noticed May 2014

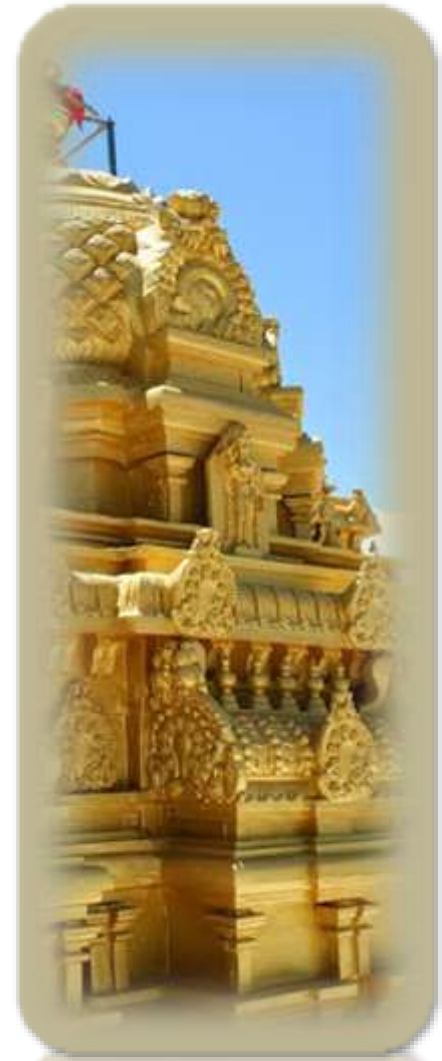
- No Structural Issues
- Gopuram Construction
 - Steel Frame
 - Plywood Interior
 - Bulk Construction using GFRC
 - Big & Small Medallions attached*
- Roof Floor is Thick Membrane (Falling debris could puncture it)

- Material not suitable for exterior
- Improper Curing
- Ratio
- Improper Installation
 - Bonding Agent
 - Screw Anchor Not Secure
 - No Caulking
- Water Damage (Freeze/Expand)
- Interior Paint
- Staphis Lack Technical Knowledge
- Exterior Elements Unique to The Rocky Mountain Region
 - Lack of Humidity, UV, Hail

- Remove all loosely attached pieces
- Create new forms
- Create new medallions
 - Use Correct material
 - Proper Curing
 - Attach Correctly
- Strip and Repaint
- Spring/Summer 2015 Timeframe
