Drainage Report

Site: St Catherines
New North Road
Exeter
EX4 4AG

Date: Friday, December 6, 2019

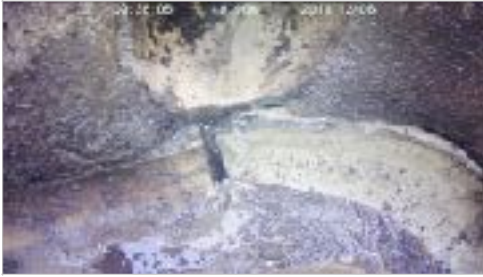
Photo 1

Manhole 1	Depth	360mm	Channel cracked, Benching defective. Photos 1&2
Manhole 2	Depth	900mm	Ok.
Manhole 3	Depth	730mm	Root ingress, Manhole cover warped. Photos 3&4

- 1.1 General Remedy the defects noted in the General Observations on page 3
- 1.2 Run 2 Renew or line
- 1.3 Run 3 Renew
- 1.4 Run 4 Patch line the circumferential crack at .28m or renew
- 1.5 Run 5 Renew or line
- 1.6 Run 6 Confirm disused & if so seal off at the manhole
- 1.7 Run 7 Confirm disused & if so seal off at the manhole
- 1.8 Run 8 Patch line the crack & end of the liner
- 1.9 Run 9 Renew
- 1.10 Run 11 Renew
- 1.11 Run 12 Renew
- 1.12 Run 13 Knock out the interceptor fitting and replace with a straight through piece of pipe

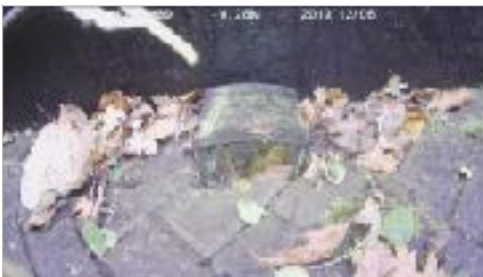
There is an open vent at ground level. Photo 10

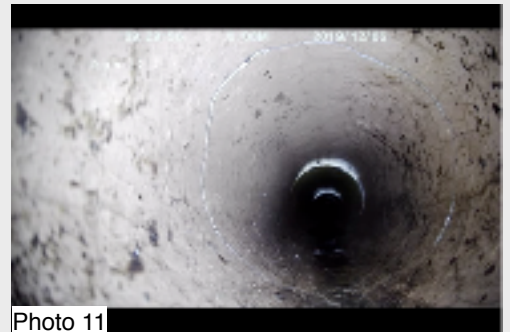
Photo 11

1	0.00	Start at manhole		
	0.08	Crack	3	11
	0.17	Slight displacement. Holding water.	2	12
	0.75	Damaged and cracked joint	3	13
	2.57	Root ingress	4	14
	3.05	Finish at the back of the gully. Crack & Root ingress	4	15

Recommendations: Remedy defects.

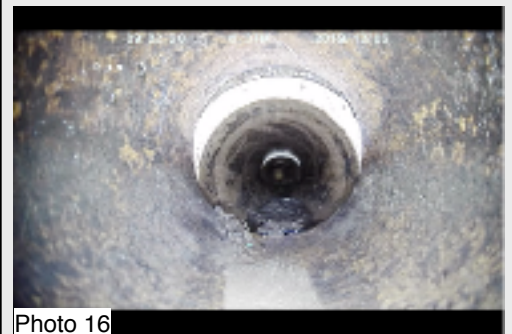
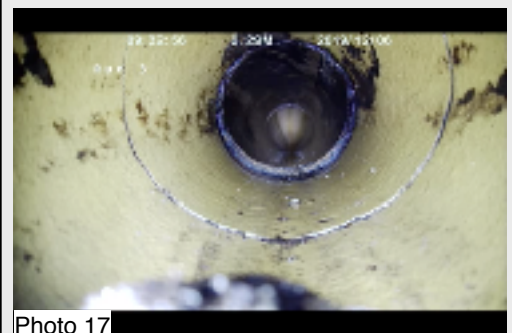
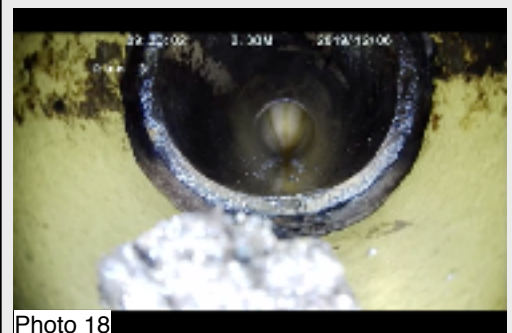
Metres	Observations	Ratin	Photo
1	0.00 Start at manhole		
	0.37 Displaced joint	3	16
	2.29 Circumferential crack	3	17
	2.38 Open joint	2	18
	3.34 End of run at bend to vertical		
<div style="display: flex; align-items: center;"> <div style="margin-right: 20px;"> <p style="color: red; text-align: center;">Direction of survey</p> <p style="color: blue; text-align: center;">Direction of flow</p> </div> <div> </div> </div>			
Recommendations:		Remedy defects.

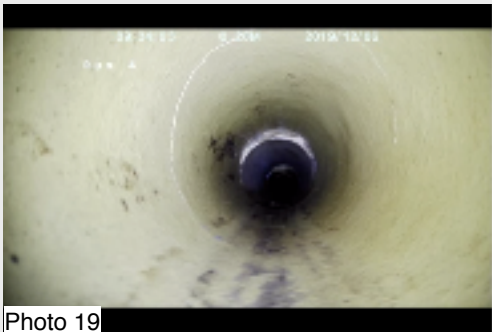
Metres	Observations	Rating	Photo
1 0.00	Start at manhole		
0.28	Circumferential crack	2	19
2.40	Finish at the back of the gully		
<div> <div>Direction of survey</div> <div>Direction of flow</div> </div>			
<div> <div>Photo 19</div>

</div>			
<div>Recommendations: Remedy defect.</div>

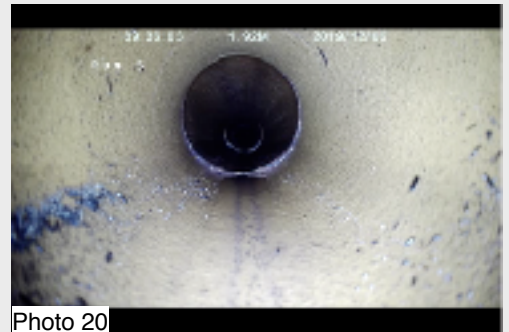
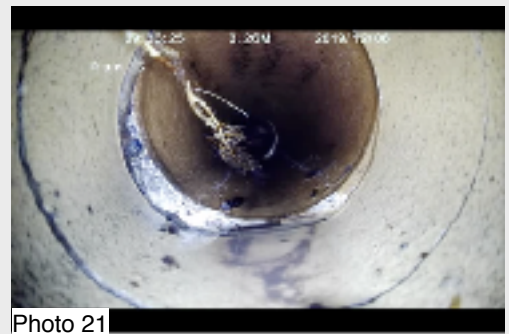
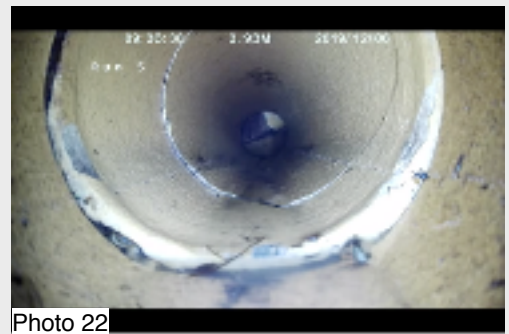
Metres	Observations	Rating	Photo
1 0.00	Start at manhole		
1.92	Circumferential crack	2	20
3.26	Circumferential crack & Root ingress	3	21
3.93	Crack	3	22
2 4.51	Manhole 2		
<div> <div>Direction of survey</div> <div>Direction of flow</div> </div>			
<div> <div>Recommendations: Remedy defects.</div> </div>

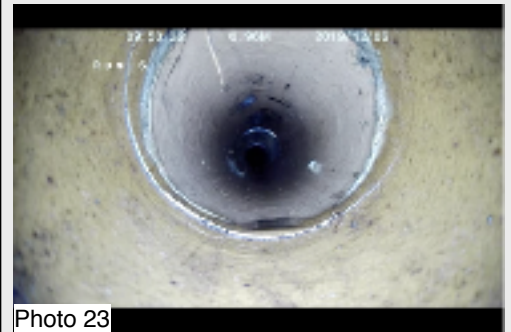
Photo 23

0.96 Circumferential crack & Root ingress

Recommendations: Drain presumed disused. Seal off drain at manhole.

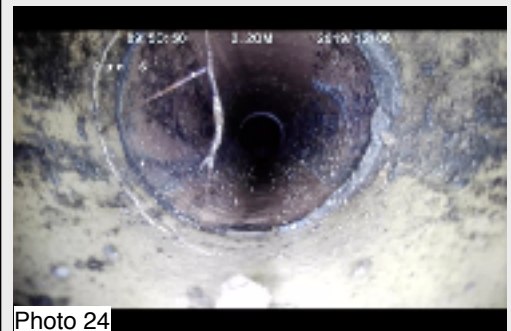
Photo 24

2.20 Circumferential crack & Root ingress

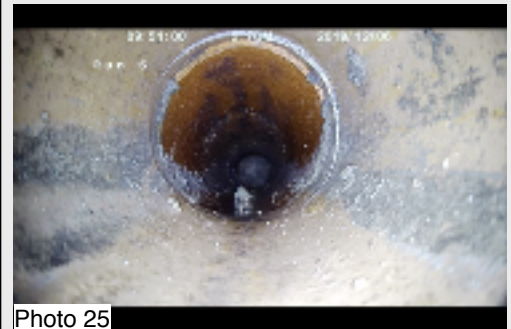
Photo 25

2.78 Circumferential crack

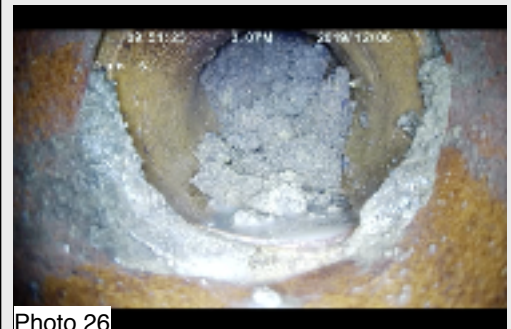
Photo 26

3.07 Drain filled with concrete. End of run

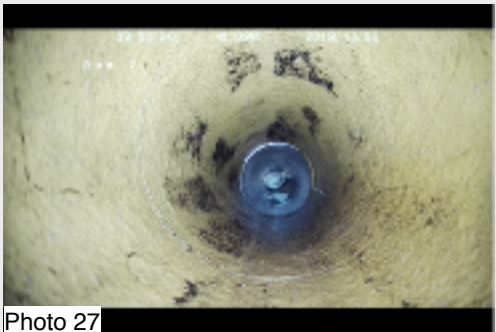
Photo 27

Metres	Observations	Rating	Photo
2	0.00 Start at manhole		
	0.09 Circumferential crack	2	27
	0.38 Longitudinal cracks at 3&6 o'clock	1	28
	1.34 Debris in pipe. End of run	-	29

Recommendations: Drain presumed disused. Seal off drain at manhole.

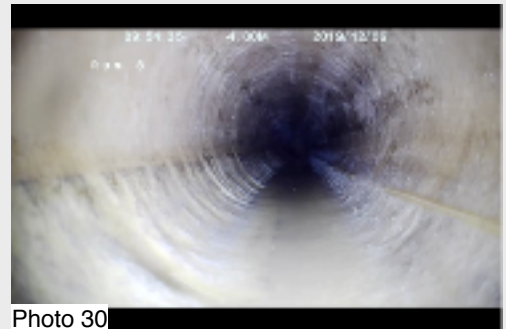
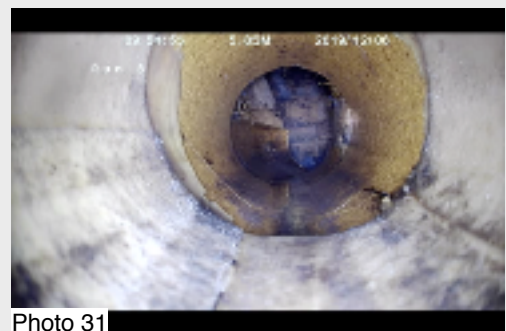
Metres	Observations	Rating	Photo
2	0.0 Start at manhole		
<div> <div>Direction of survey</div> <div>Direction of flow</div> </div>			
4.8	Holding water	1	30
5.9	End of liner. Crack	2	31
6.3	Manhole 3		
<div> <div>3</div> </div>			
<div> <div>Recommendations: Remedy defects.</div> </div>

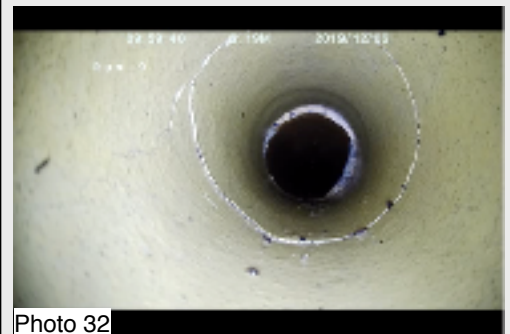
Photo 32

Metres	Observations	Rating	Photo
3	0.00 Start at manhole		
	0.19 Cracks	3	32
	1.24 Root ingress	2	33
	1.34 Root ingress & finish at the back of the	3	34
	Roots removed - damaged and cracked joint	3	34a

Recommendations: Remedy defects.

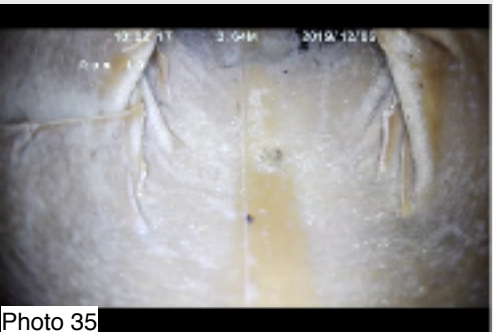
Metres	Observations	Rating	Photo
3 0.0	Start at manhole		
3.6	Unable to go past bend due to liner. End	-	35
<div> <div>Direction of survey</div> <div>Direction of flow</div> </div>			
<div> <div>Photo 35</div>

</div>			
<div>Recommendations: Note wrinkled liner.</div>

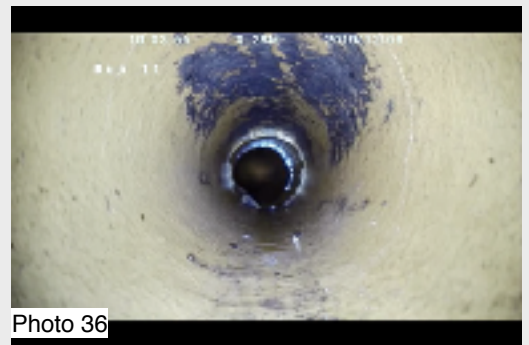
Photo 36

Metres	Observations	Rating	Photo
3	0.00 Start at manhole		
0.28	Circumferential crack	2	36
0.57	Hard deposit & crack	2	37
1.15	Displaced. End of run at back of gully	2	38

Recommendations: Remedy defects.

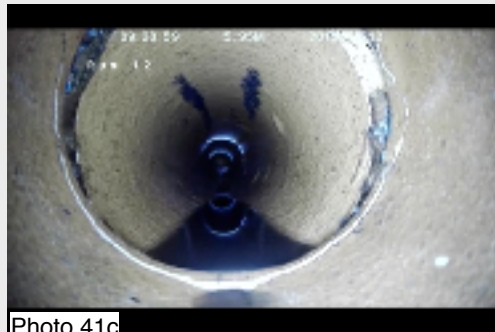
Photo 41c

Metres	Observations	Rating	Photo
3	0.00 Start at manhole		
	0.09 Circumferential crack	2	39
	0.76 Circumferential crack	3	40
	1.05 Root ingress. As far as we could go	5	41
	1.63 Roots removed- damaged pipe	5	41a
	2.59 Circumferential crack just before joint	3	41b
	5.95 Circumferential crack just before joint	3	41c
	7.68 Finish at the back of the gully		
<div> <div>Direction of survey</div> <div>Direction of flow</div> </div>			
<div> <div>Photo 39</div> <div>Photo 40</div> <div>Photo 41</div> <div>Photo 41a</div> <div>Photo 41b</div> </div>			
<div> <div>Recommendations: Line or renew</div> </div>

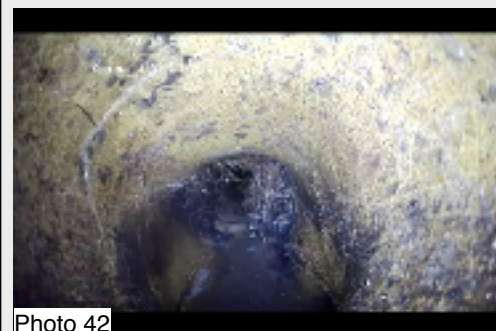
Photo 42

Metres	Observations	Rating	Photo
3	0.00 Start at manhole. Cracks & Root ingress	3	42 & 42a
0.57	Start of liner		
	Holding water & debris throughout	2	43
6.62	End of liner		
11.30	Joins sewer in road

Recommendations: Note defects.
