Grating Efficiency Analysis

REIXS Spectrometer, CLS

Mark Boots
December 2007

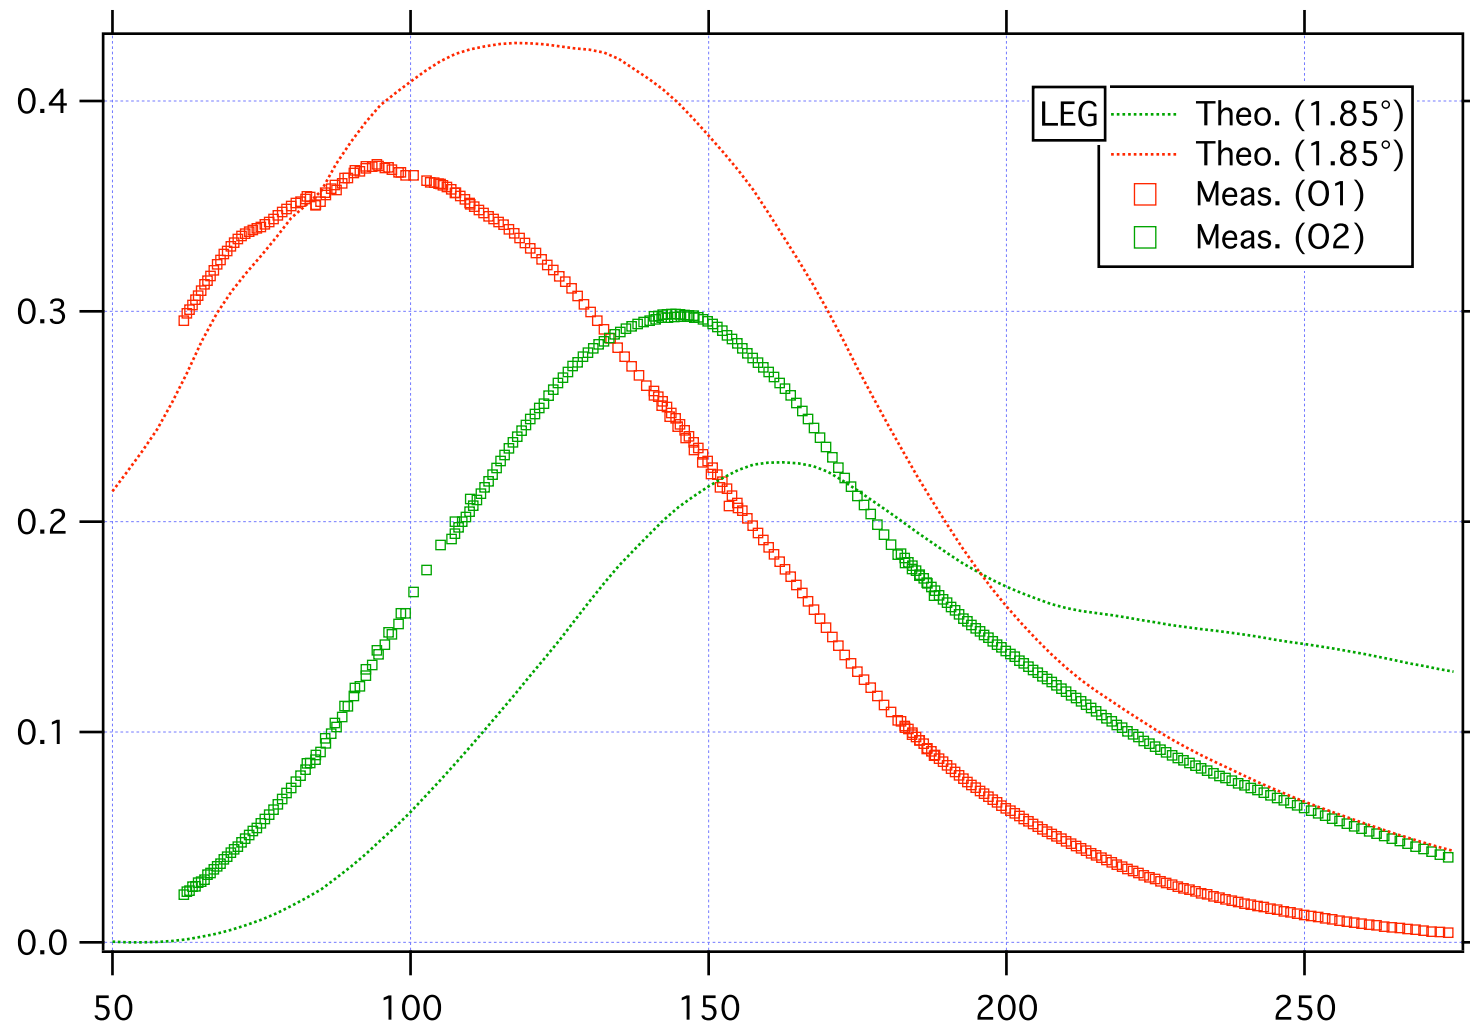
LEG: Measured

- What happened? Peaks shifted, 2nd order messed

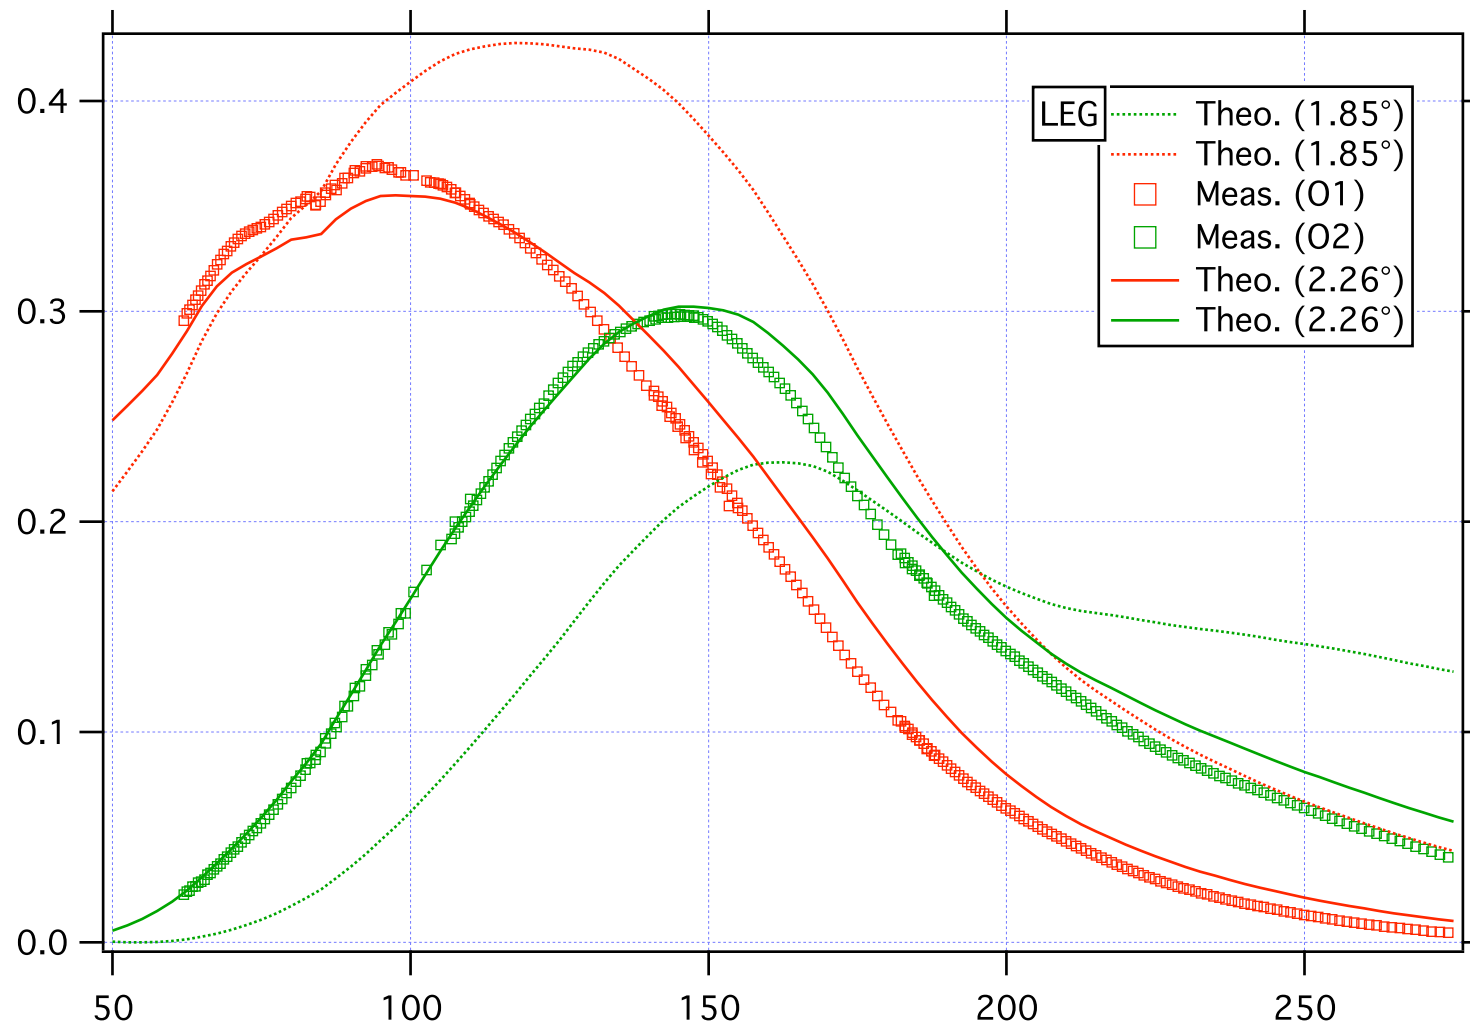
LEG: Hypothesis

- Hypothesis: manufacturer missed blaze angle target of 1.85 degrees. Closer to 2.26 (estimated).

- Conduct AFM scans of all gratings to actually measure the groove profile / blaze angle
- Fitting estimates show *all blaze angles* are 0.3deg to 0.4deg too large.
- If so, gratings are off-spec ($\pm 10\%$) and should be fixed by Bernie and co.
- Find a chemical that will dissolve nickelous oxides but not nickel...
- Find out what happened with HEG.

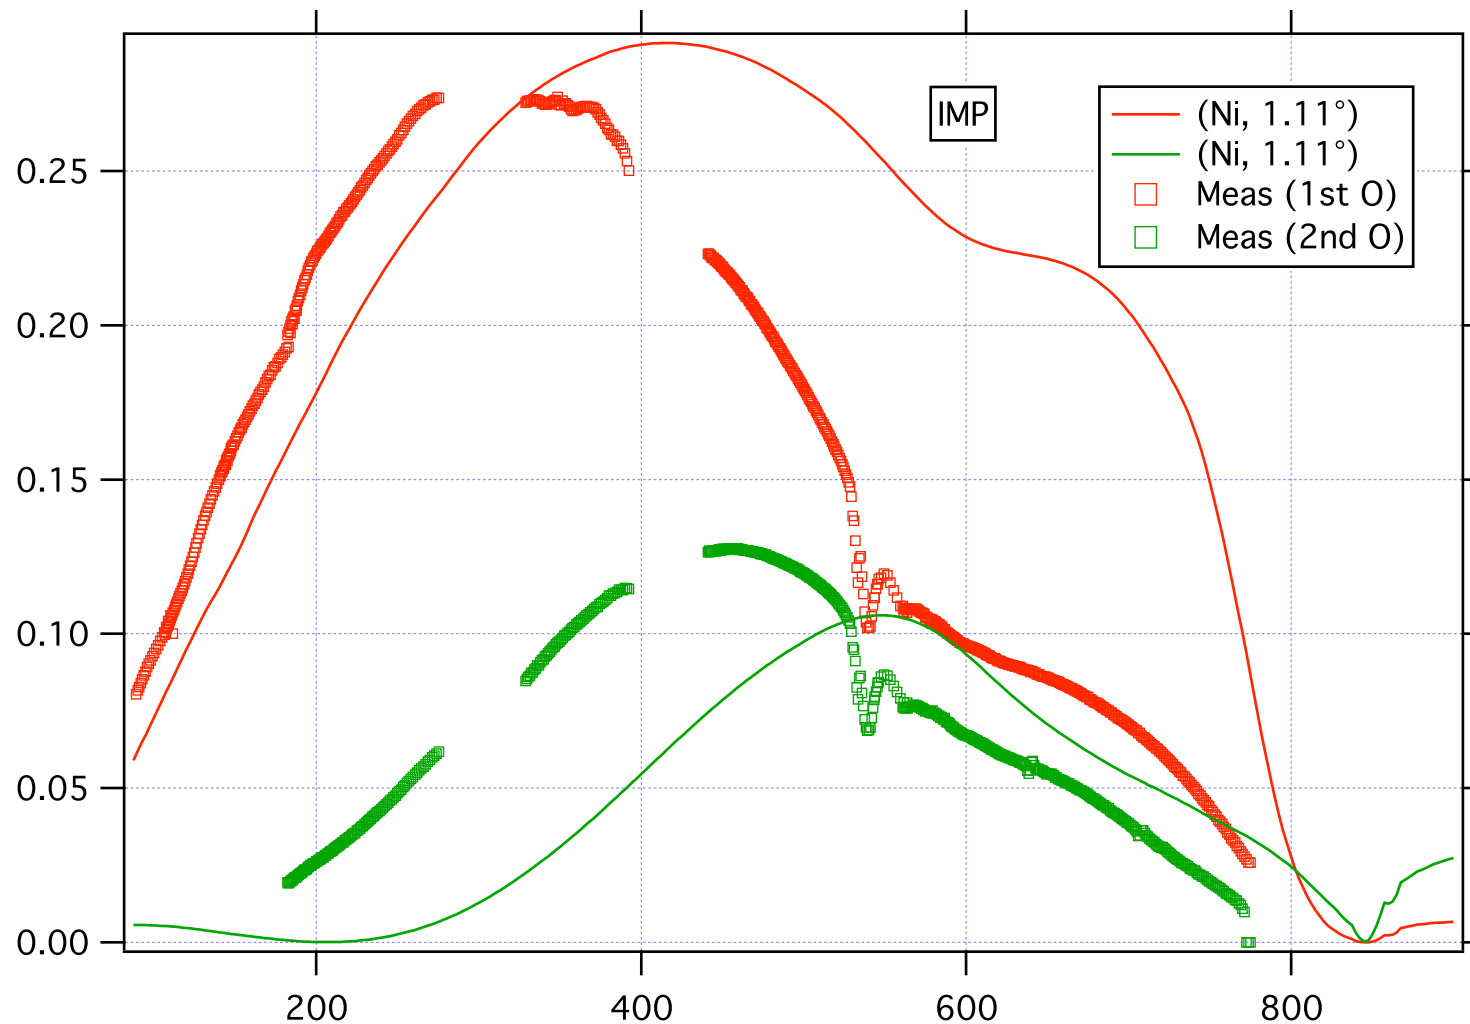
IMP: Measured

- What happened? Shifted again, but also... Drop-off near 520eV... Hmm... O-edge?

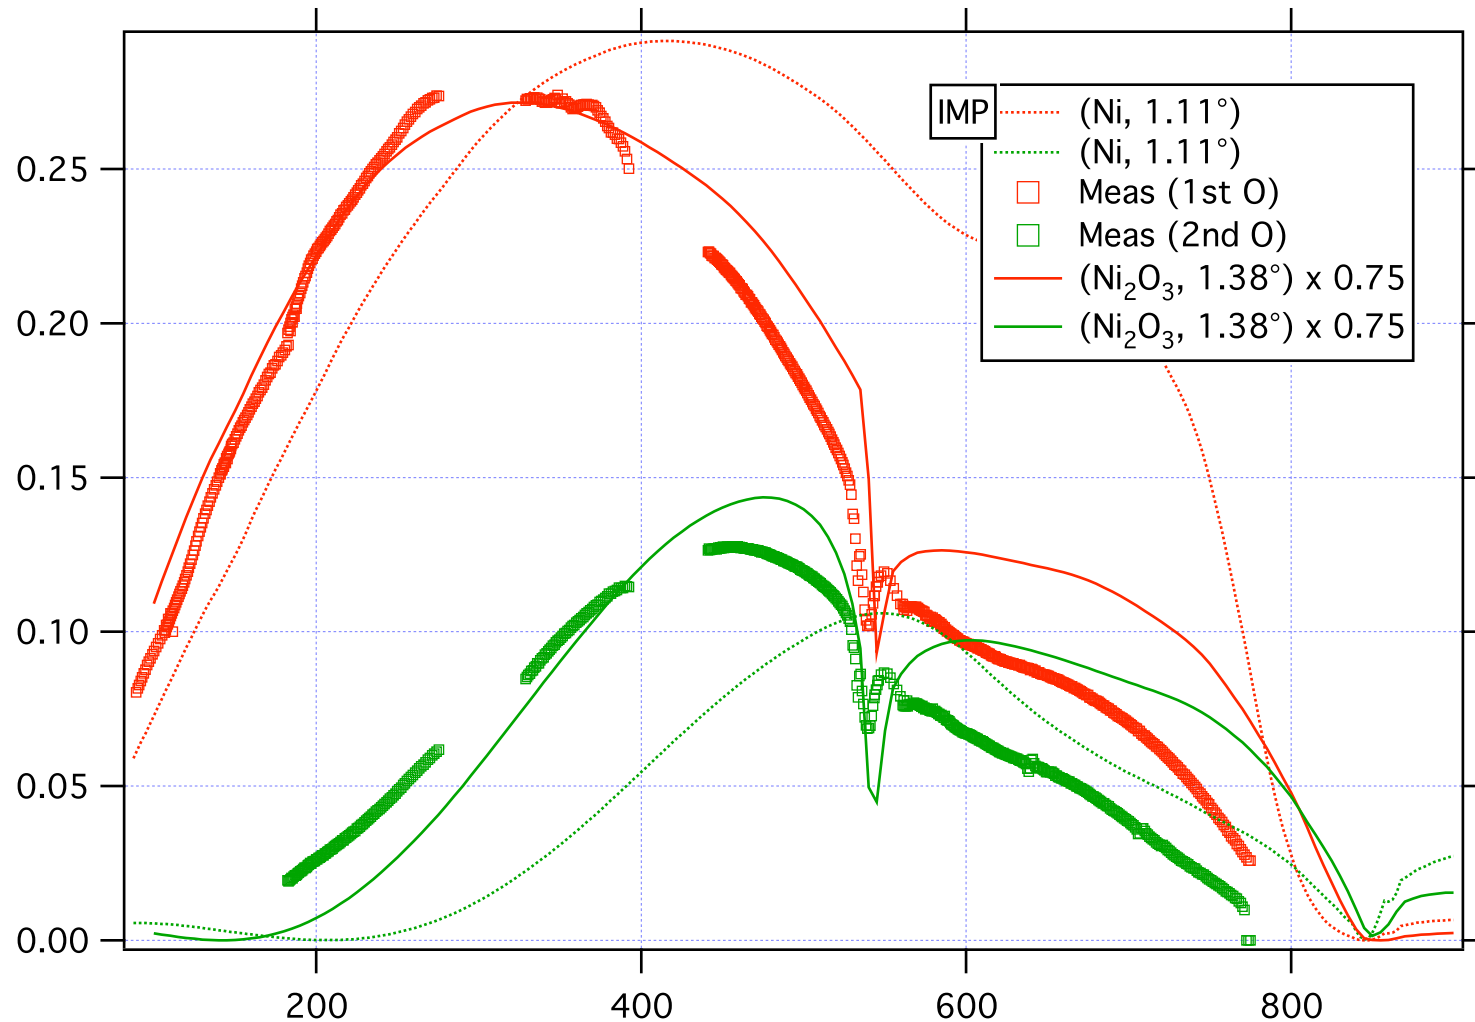
IMP: Hypothesis

- Fitted: modeled as Nickel Oxide, 1.38deg blaze angle.
- Conclusion: Missed target blaze; Grating is oxidized.

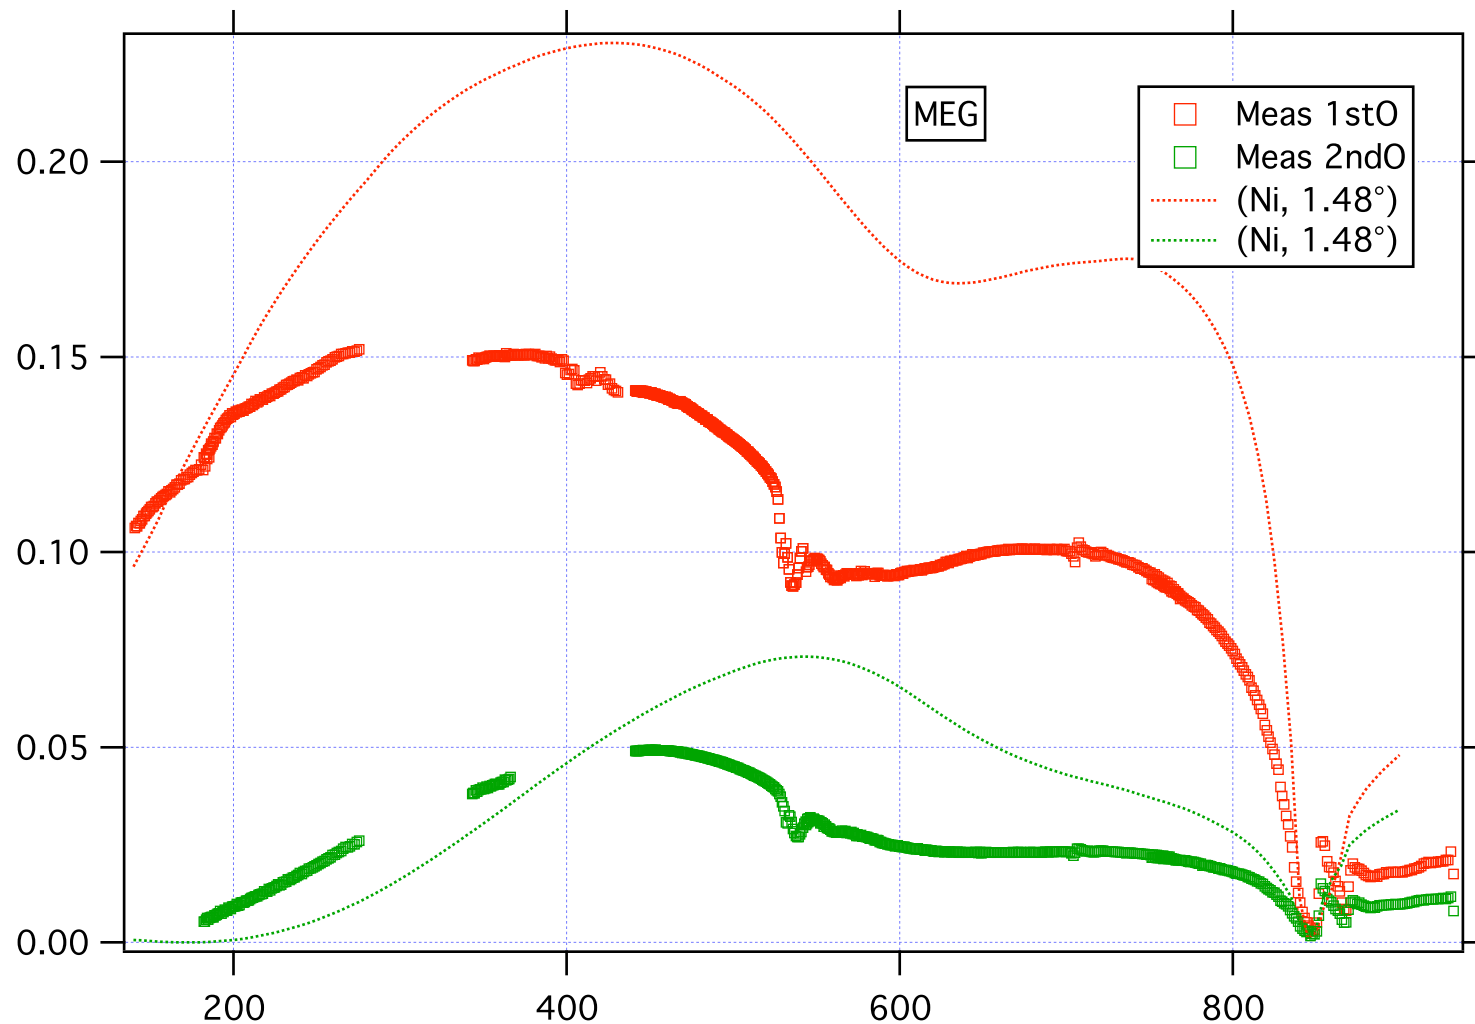
MEG: Measured

- What happened? Drop-off near 520eV... Hmm... O-edge?

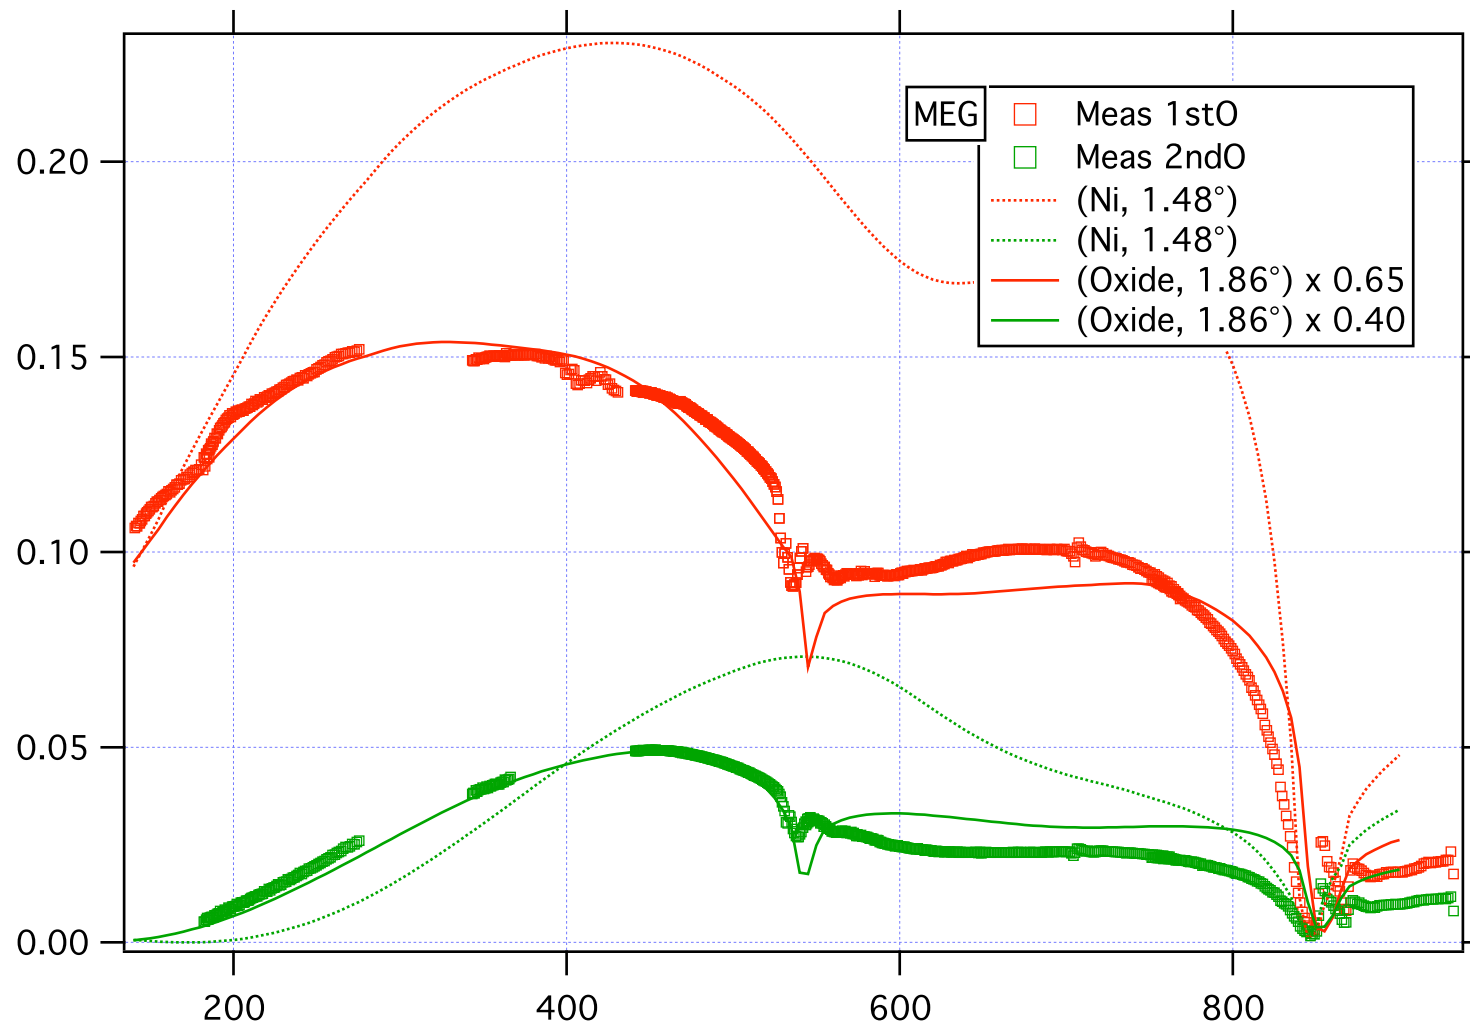
MEG: Hypothesis

- Fitted: modeled as Nickel Oxide, 1.86deg blaze angle.
- Conclusion: Missed target blaze; Grating is oxidized.

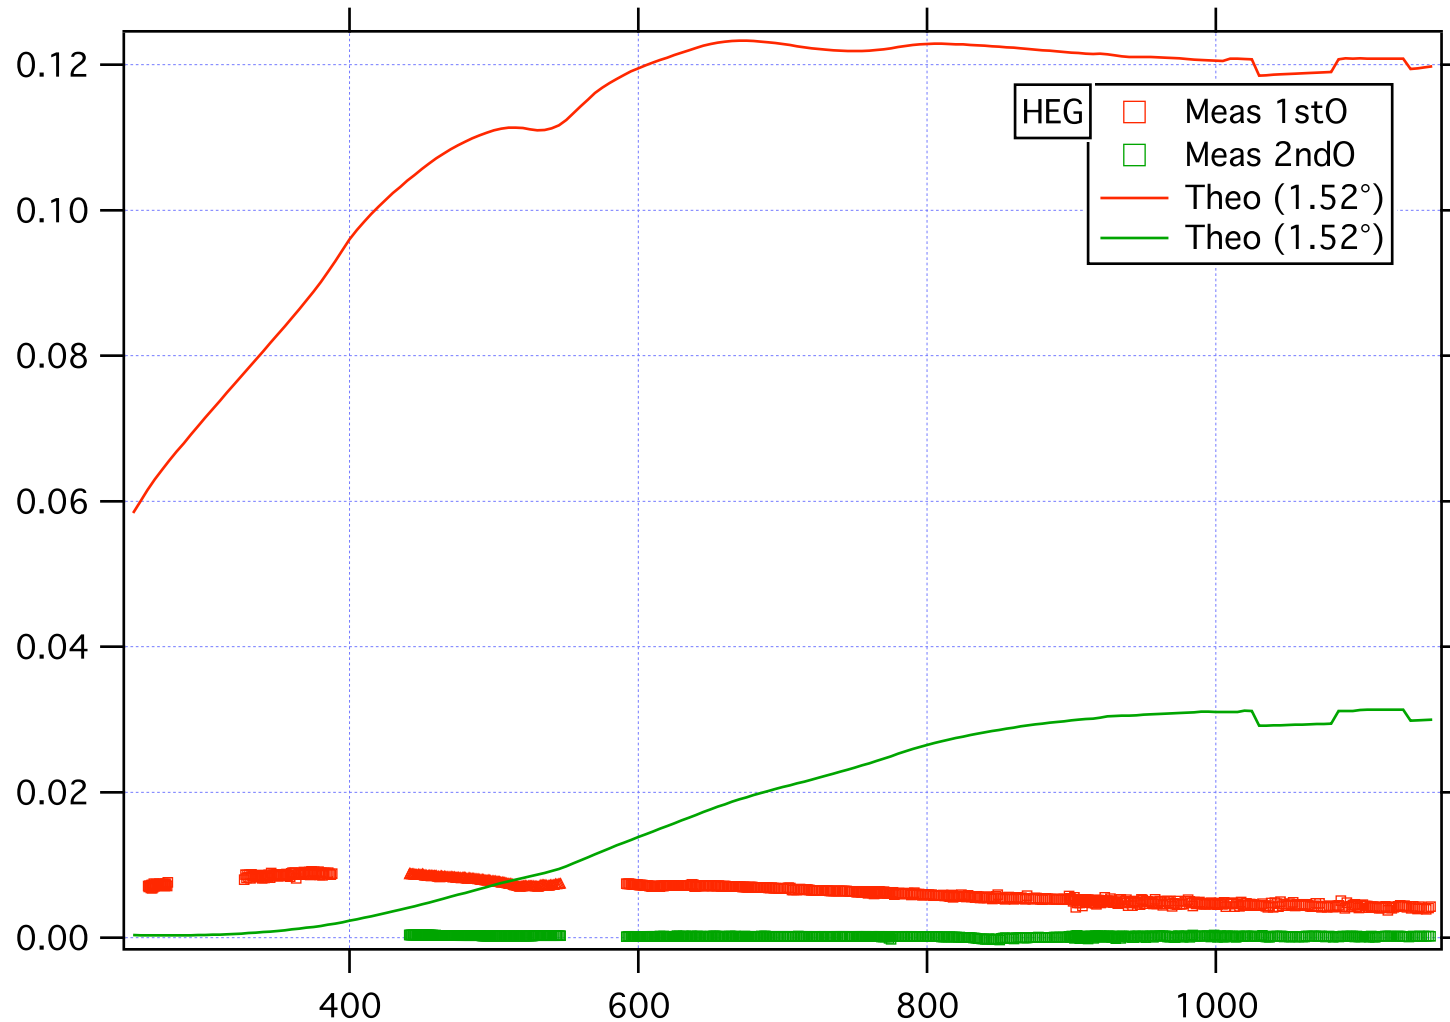
HEG: a total dud...

- Hypothesis: ???
(Did they mark the blaze direction backwards?)
- Even high-res gratings in 3rd order get better efficiency

- Very disappointing; HEG is a critical grating.
 - Pt-coated: crucial for measuring above Ni-edge.
 - Covers entire range from 400 - 1300eV
- Even high-res gratings in 3rd order get better efficiency
- Best scenario: Direction of blaze was marked backwards, so simply rotating the grating 180deg. will fix it.
- If not... ???
 - AFM scan will reveal if this is the case.

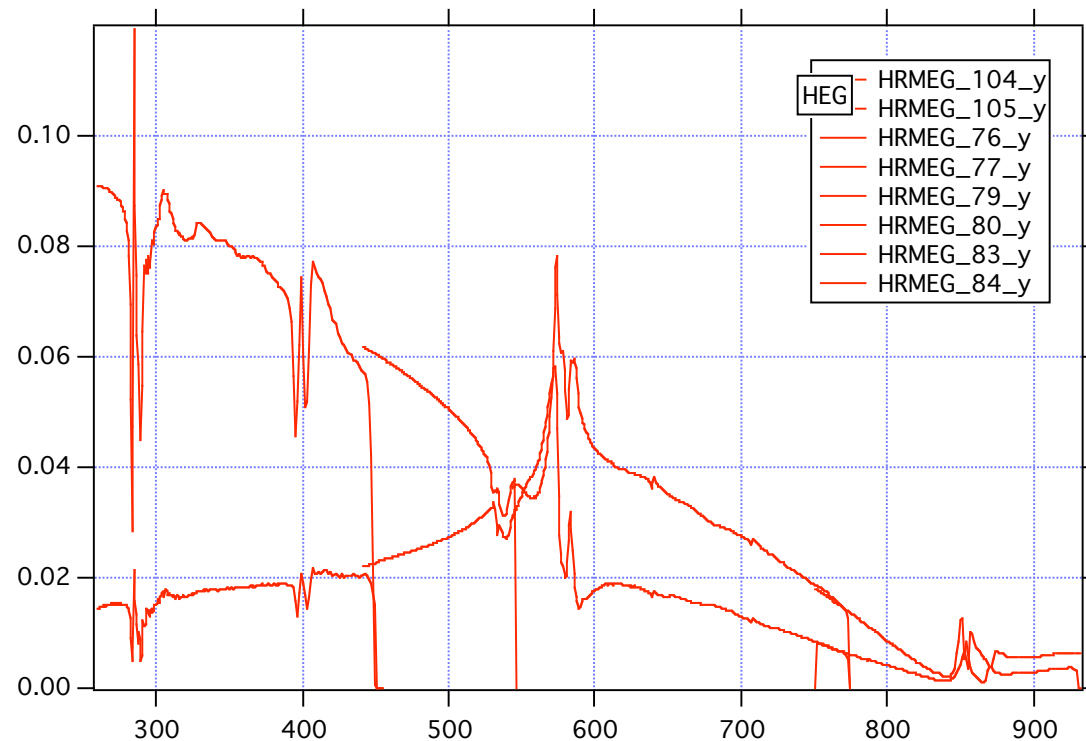
- Still working on analyzing data from HR gratings.
- Beamline 6 normalizing software had bug with offset points (apparent only near absorption edges)
- Need to normalize manually, or fix software:
