Inspection Result (Individual Data)

Lot number : 7

商品名	標準透明6-6-3	周長	
顧客名		Ex1	
CODE番号		Ex2	
基材		Ex3

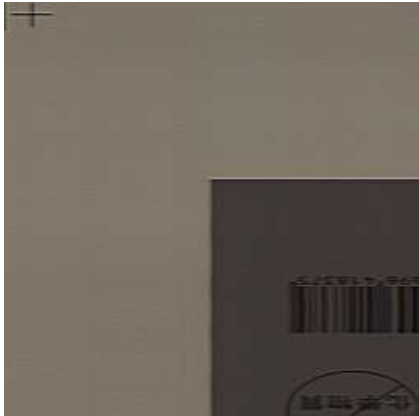
No.	#57, \$42	Date	2023/8/9 下午 04:14:14
Segment	1	Camera	1
Pattern	2107	Position[x, y]	701.5 [mm], 1593.4 [m], (77.4 [m])
Type	縱向刀絲疵點	Size	H:0.5 ,V:18.8 [mm]
Result	-	Area	5.3 [mm2]
Inspection level	5/5,5/5,5/5,5/5,5/5	Label	-
Light	6,6,3/6,6,3

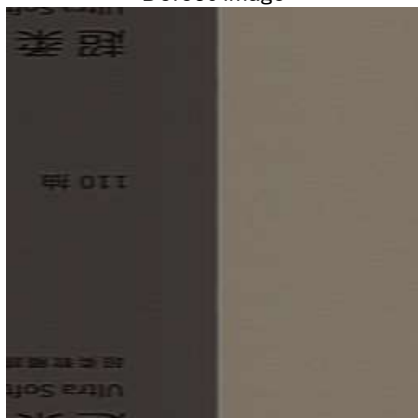
Defect image

No.	#57, \$42	Date	2023/8/9 下午 04:14:14
Segment	1	Camera	1
Pattern	2107	Position[x, y]	569.7 [mm], 1593.4 [m], (77.5 [m])
Type	縱向刀絲疵點	Size	H:0.5 ,V:31.6 [mm]
Result	-	Area	6.2 [mm2]
Inspection level	5/5,5/5,5/5,5/5,5/5	Label	-
Light	6,6,3/6,6,3

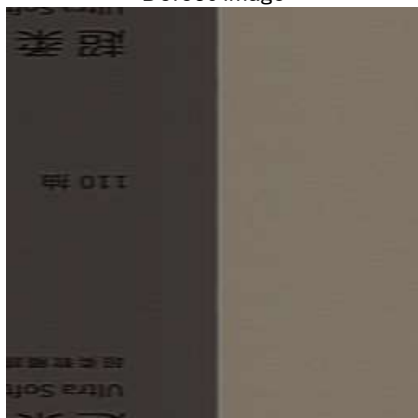
Defect image

No.	#56, \$41	Date	2023/8/9 下午 04:14:13
Segment	1	Camera	1
Pattern	2106	Position[x, y]	701.5 [mm], 1592.8 [m], (78.1 [m])
Type	縱向刀絲疵點	Size	H:0.5 ,V:12.0 [mm]
Result	-	Area	2.4 [mm2]
Inspection level	5/5,5/5,5/5,5/5,5/5	Label	-
Light	6,6,3/6,6,3

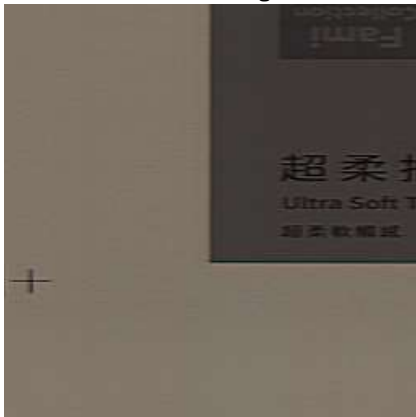
Defect image

No.	#53, \$38	Date	2023/8/9 下午 04:14:07
Segment	1	Camera	1
Pattern	2094	Position[x, y]	701.5 [mm], 1583.8 [m], (87.1 [m])
Type	縱向刀絲疵點	Size	H:0.5 ,V:9.6 [mm]
Result	-	Area	2.4 [mm2]
Inspection level	5/5,5/5,5/5,5/5,5/5	Label	-
Light	6,6,3/6,6,3

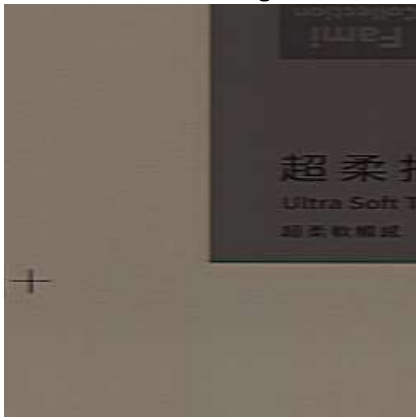
Defect image

No.	#52, \$37	Date	2023/8/9 下午 04:14:04
Segment	1	Camera	1
Pattern	2089	Position[x, y]	739.4 [mm], 1580.1 [m], (90.8 [m])
Type	縱向刀絲疵點	Size	H:4.4 ,V:8.8 [mm]
Result	-	Area	4.4 [mm2]
Inspection level	5/5,5/5,5/5,5/5,5/5	Label	-
Light	6,6,3/6,6,3

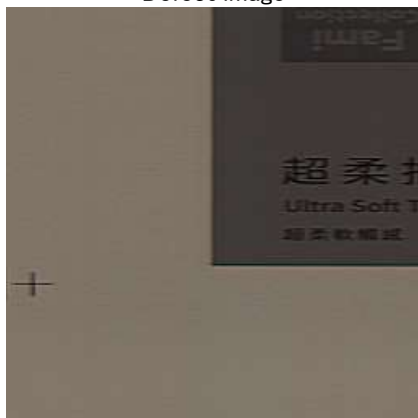
Defect image

No.	#52, \$37	Date	2023/8/9 下午 04:14:04
Segment	1	Camera	1
Pattern	2089	Position[x, y]	97.8 [mm], 1580.1 [m], (90.8 [m])
Type	縱向刀絲疵點	Size	H:0.5 ,V:9.6 [mm]
Result	-	Area	4.6 [mm2]
Inspection level	5/5,5/5,5/5,5/5,5/5	Label	-
Light	6,6,3/6,6,3

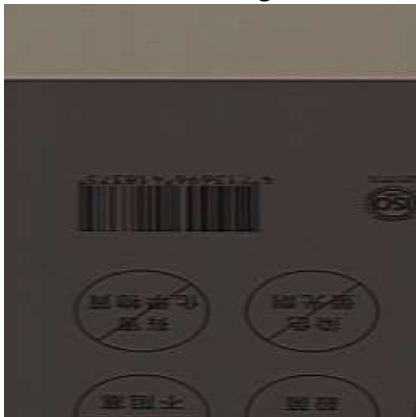
Defect image

No.	#52, \$37	Date	2023/8/9 下午 04:14:04
Segment	1	Camera	1
Pattern	2089	Position[x, y]	731.3 [mm], 1579.7 [m], (91.1 [m])
Type	縱向刀絲疵點	Size	H:15.6 ,V:9.6 [mm]
Result	-	Area	7.5 [mm2]
Inspection level	5/5,5/5,5/5,5/5,5/5	Label	-
Light	6,6,3/6,6,3

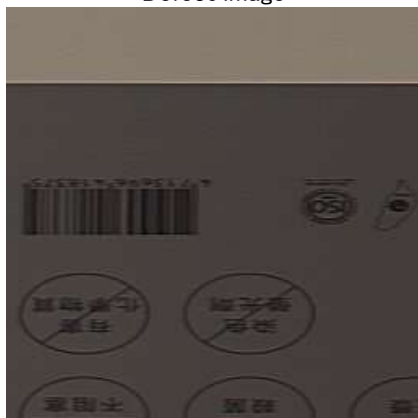
Defect image

No.	#51, \$36	Date	2023/8/9 下午 04:14:04
Segment	1	Camera	1
Pattern	2088	Position[x, y]	97.8 [mm], 1579.3 [m], (91.5 [m])
Type	縱向刀絲疵點	Size	H:0.5 ,V:9.2 [mm]
Result	-	Area	2.7 [mm2]
Inspection level	5/5,5/5,5/5,5/5,5/5	Label	-
Light	6,6,3/6,6,3

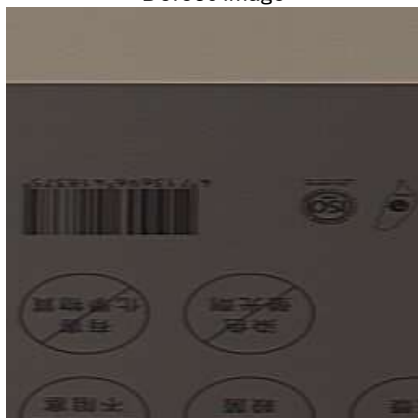
Defect image

No.	#48, \$35	Date	2023/8/9 下午 04:13:31
Segment	1	Camera	1
Pattern	2026	Position[x, y]	242.3 [mm], 1532.7 [m], (138.2 [m])
Type	点状疵点縱向刀絲疵點	Size	H:2.7 ,V:797.2 [mm]
Result	-	Area	499.8 [mm2]
Inspection level	5/5,5/5,5/5,5/5,5/5	Label	-
Light	6,6,3/6,6,3

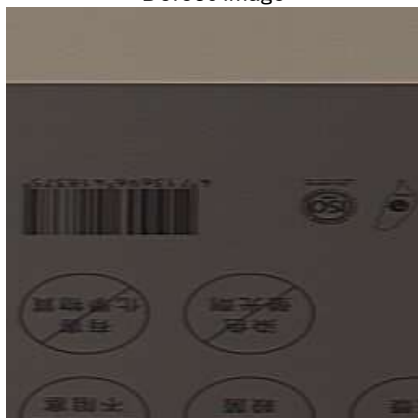
Defect image

No.	#48, \$35	Date	2023/8/9 下午 04:13:31
Segment	1	Camera	1
Pattern	2026	Position[x, y]	567.0 [mm], 1532.6 [m], (138.3 [m])
Type	点状疵点縱向刀絲疵點	Size	H:2.7 ,V:797.6 [mm]
Result	-	Area	511.9 [mm2]
Inspection level	5/5,5/5,5/5,5/5,5/5	Label	-
Light	6,6,3/6,6,3

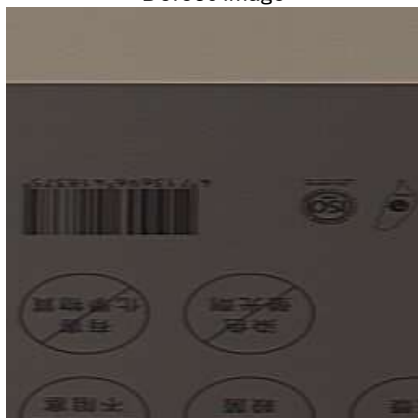
Defect image

No.	#48, \$35	Date	2023/8/9 下午 04:13:31
Segment	1	Camera	1
Pattern	2026	Position[x, y]	375.1 [mm], 1532.6 [m], (138.3 [m])
Type	点状疵点縱向刀絲疵點	Size	H:5.4 ,V:609.2 [mm]
Result	-	Area	542.1 [mm2]
Inspection level	5/5,5/5,5/5,5/5,5/5	Label	-
Light	6,6,3/6,6,3

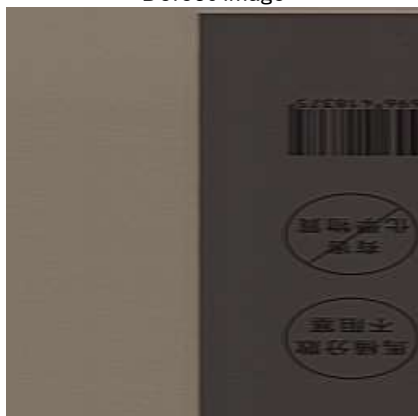
Defect image

No.	#47, \$34	Date	2023/8/9 下午 04:13:30
Segment	1	Camera	1
Pattern	2025	Position[x, y]	699.8 [mm], 1531.8 [m], (139.0 [m])
Type	点状疵点縱向刀絲疵點	Size	H:5.1 ,V:626.8 [mm]
Result	-	Area	293.1 [mm2]
Inspection level	5/5,5/5,5/5,5/5,5/5	Label	-
Light	6,6,3/6,6,3

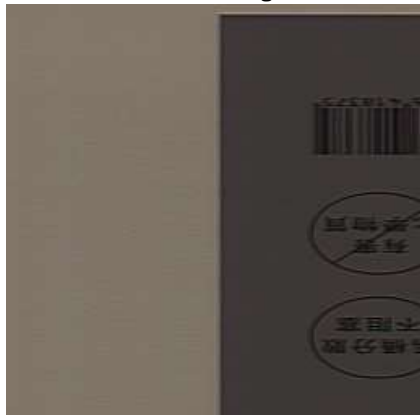
Defect image

No.	#46, \$33	Date	2023/8/9 下午 04:13:29
Segment	1	Camera	1
Pattern	2024	Position[x, y]	374.9 [mm], 1531.1 [m], (139.8 [m])
Type	点状疵点縱向刀絲疵點	Size	H:5.1 ,V:643.6 [mm]
Result	-	Area	222.0 [mm2]
Inspection level	5/5,5/5,5/5,5/5,5/5	Label	-
Light	6,6,3/6,6,3

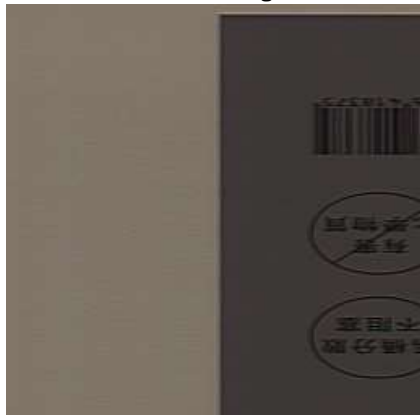
Defect image

No.	#46, \$33	Date	2023/8/9 下午 04:13:29
Segment	1	Camera	1
Pattern	2024	Position[x, y]	699.8 [mm], 1531.1 [m], (139.8 [m])
Type	点状疵点縱向刀絲疵點	Size	H:4.9 ,V:644.0 [mm]
Result	-	Area	239.6 [mm2]
Inspection level	5/5,5/5,5/5,5/5,5/5	Label	-
Light	6,6,3/6,6,3

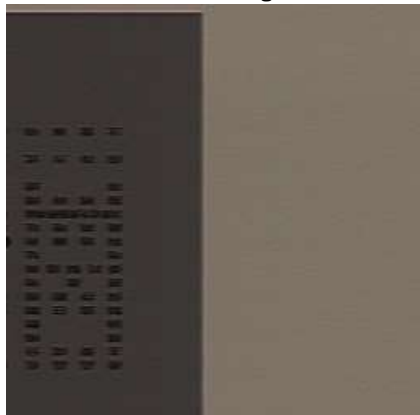
Defect image

No.	#46, \$33	Date	2023/8/9 下午 04:13:29
Segment	1	Camera	1
Pattern	2024	Position[x, y]	567.0 [mm], 1531.2 [m], (139.7 [m])
Type	点状疵点縱向刀絲疵點	Size	H:2.2 ,V:744.0 [mm]
Result	-	Area	279.2 [mm2]
Inspection level	5/5,5/5,5/5,5/5,5/5	Label	-
Light	6,6,3/6,6,3

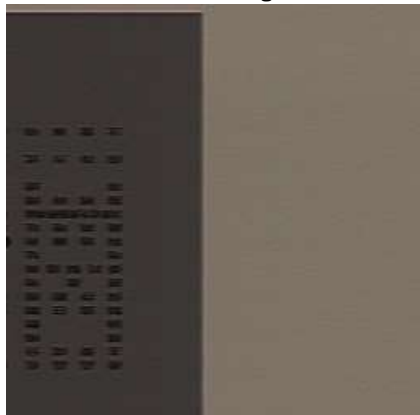
Defect image

No.	#45, \$32	Date	2023/8/9 下午 04:13:29
Segment	1	Camera	1
Pattern	2023	Position[x, y]	567.0 [mm], 1530.3 [m], (140.5 [m])
Type	点状疵点縱向刀絲疵點	Size	H:2.2 ,V:552.4 [mm]
Result	-	Area	77.0 [mm2]
Inspection level	5/5,5/5,5/5,5/5,5/5	Label	-
Light	6,6,3/6,6,3

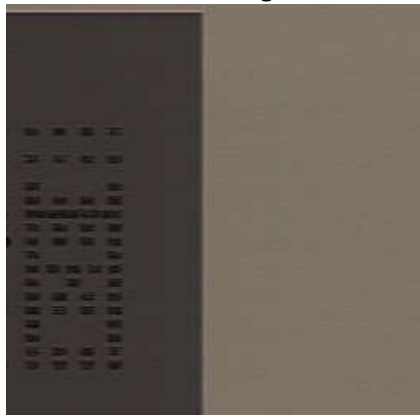
Defect image

No.	#45, \$32	Date	2023/8/9 下午 04:13:29
Segment	1	Camera	1
Pattern	2023	Position[x, y]	699.8 [mm], 1530.7 [m], (140.2 [m])
Type	点状疵点縱向刀絲疵點	Size	H:4.9 ,V:239.6 [mm]
Result	-	Area	81.9 [mm2]
Inspection level	5/5,5/5,5/5,5/5,5/5	Label	-
Light	6,6,3/6,6,3

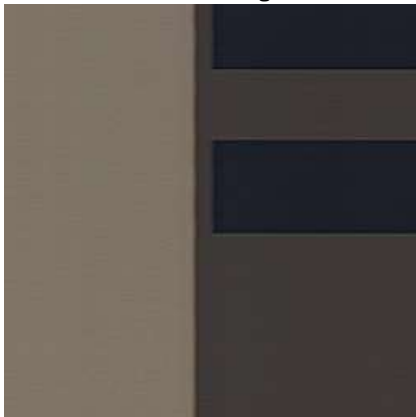
Defect image

No.	#44, \$31	Date	2023/8/9 下午 04:13:28
Segment	1	Camera	1
Pattern	2022	Position[x, y]	375.8 [mm], 1529.6 [m], (141.3 [m])
Type	縱向刀絲疵點	Size	H:2.9 ,V:169.6 [mm]
Result	-	Area	21.3 [mm2]
Inspection level	5/5,5/5,5/5,5/5,5/5	Label	-
Light	6,6,3/6,6,3

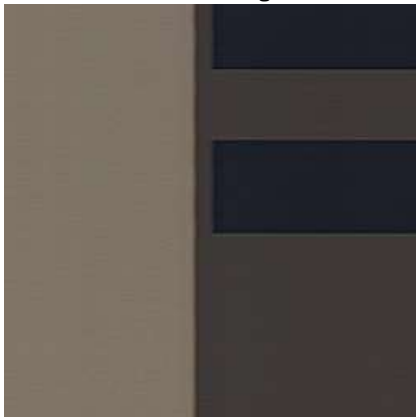
Defect image

No.	#44, \$31	Date	2023/8/9 下午 04:13:28
Segment	1	Camera	1
Pattern	2022	Position[x, y]	567.0 [mm], 1530.0 [m], (140.9 [m])
Type	縱向刀絲疵點	Size	H:0.2 ,V:147.6 [mm]
Result	-	Area	27.4 [mm2]
Inspection level	5/5,5/5,5/5,5/5,5/5	Label	-
Light	6,6,3/6,6,3

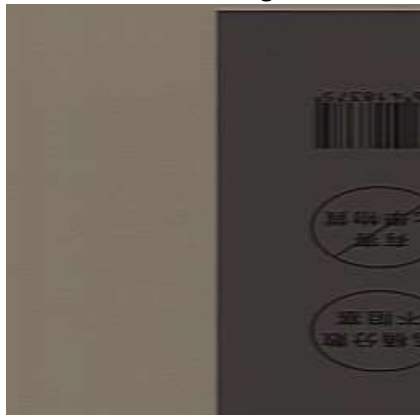
Defect image

No.	#41, \$30	Date	2023/8/9 下午 04:13:21
Segment	1	Camera	1
Pattern	2010	Position[x, y]	937.4 [mm], 1520.3 [m], (150.5 [m])
Type	面狀重疵點	Size	H:4.2 ,V:29.2 [mm]
Result	-	Area	65.7 [mm2]
Inspection level	5/5,5/5,5/5,5/5,5/5	Label	-
Light	6,6,3/6,6,3

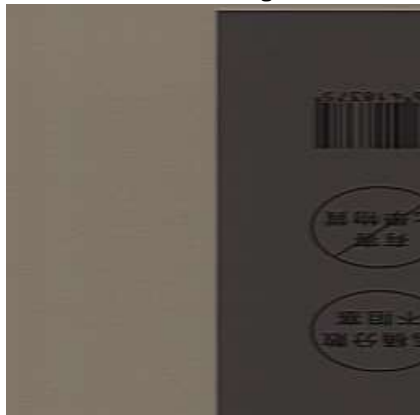
Defect image

No.	#41, \$30	Date	2023/8/9 下午 04:13:21
Segment	1	Camera	1
Pattern	2010	Position[x, y]	32.3 [mm], 1520.6 [m], (150.3 [m])
Type	面狀重疵點	Size	H:26.9 ,V:25.2 [mm]
Result	-	Area	142.5 [mm2]
Inspection level	5/5,5/5,5/5,5/5,5/5	Label	-
Light	6,6,3/6,6,3

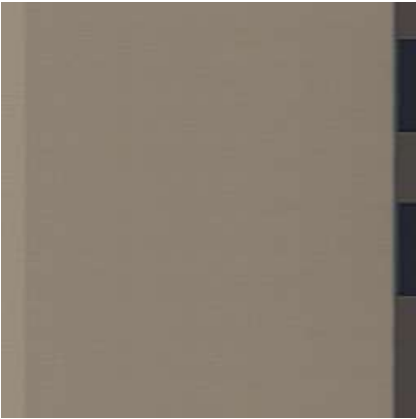
No.	#41, \$30	Date	2023/8/9 下午 04:13:21
Segment	1	Camera	1
Pattern	2010	Position[x, y]	15.0 [mm], 1520.6 [m], (150.3 [m])
Type	点状疵点	Size	H:53.5 ,V:40.0 [mm]
Result	-	Area	1447.7 [mm2]
Inspection level	5/5,5/5,5/5,5/5,5/5	Label	-
Light	6,6,3/6,6,3

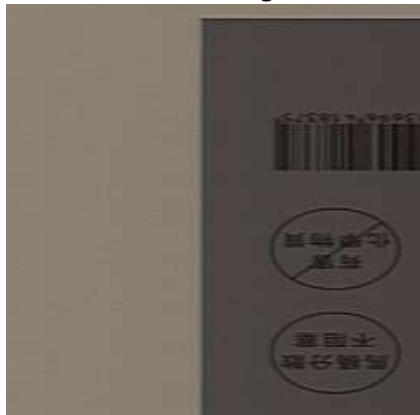
Defect image

No.	#29, \$22	Date	2023/8/9 下午 04:04:48
Segment	1	Camera	1
Pattern	1710	Position[x, y]	243.0 [mm], 1291.4 [m], (379.5 [m])
Type	点状疵点縱向刀絲疵點	Size	H:2.9 ,V:442.0 [mm]
Result	-	Area	523.5 [mm2]
Inspection level	5/5,5/5,5/5,5/5,5/5	Label	-
Light	6,6,3/6,6,3

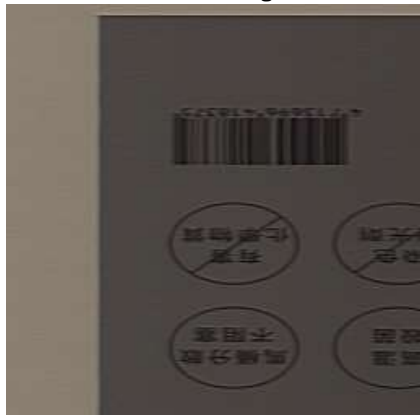
Defect image

No.	#28, \$21	Date	2023/8/9 下午 04:04:48
Segment	1	Camera	1
Pattern	1709	Position[x, y]	243.0 [mm], 1290.7 [m], (380.2 [m])
Type	点状疵点縱向刀絲疵點	Size	H:2.9 ,V:463.6 [mm]
Result	-	Area	413.2 [mm2]
Inspection level	5/5,5/5,5/5,5/5,5/5	Label	-
Light	6,6,3/6,6,3
