# Inspection Result (Individual Data)

Lot number : 2

Inspected date : 2023/8/10 上午 07:56:43 ~ 2023/8/10 上午 09:15:18

商品名	標準透明6-6-3	周長
顧客名		Ex1
CODE番号		Ex2
基材		Ex3

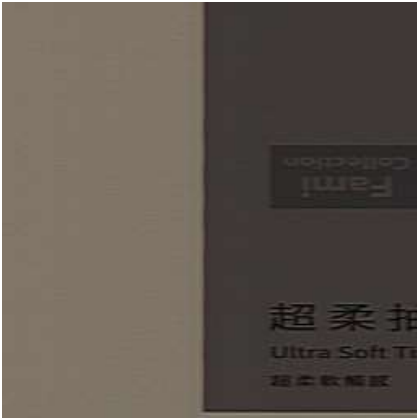
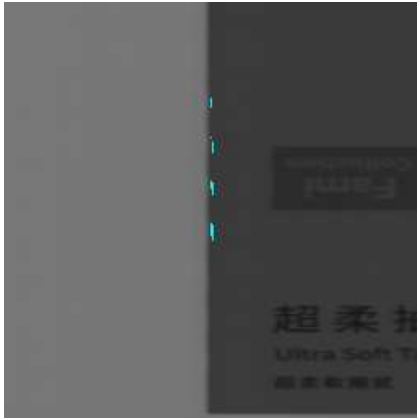
No.	#107, \$90	Date	2023/8/10 上午 09:14:54
Segment	1	Camera	1
Pattern	8009	Position[ x, y ]	698.1 [mm], 6022.9 [m], ( 23.6 [m] )
Type	縱向刀絲疵點	Size	H:0.5 ,V:14.0 [mm]
Result	-	Area	2.2 [mm2]
Inspection level	5/5,5/5,5/5,5/5,5/5	Label	-
Light	6,6,3/6,6,3

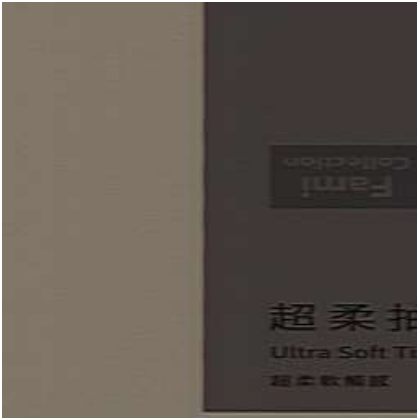
No.	#106, \$89	Date	2023/8/10 上午 09:14:53
Segment	1	Camera	1
Pattern	8007	Position[ x, y ]	698.1 [mm], 6022.0 [m], ( 24.5 [m] )
Type	縱向刀絲疵點	Size	H:0.5 ,V:36.4 [mm]
Result	-	Area	3.4 [mm2]
Inspection level	5/5,5/5,5/5,5/5,5/5	Label	-
Light	6,6,3/6,6,3

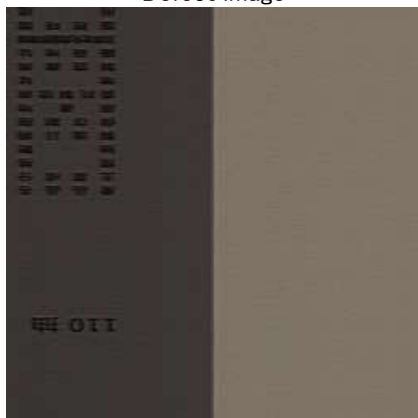
Defect image

No.	#103, \$88	Date	2023/8/10 上午 09:14:28
Segment	1	Camera	1
Pattern	7965	Position[ x, y ]	697.4 [mm], 5990.2 [m], ( 56.4 [m] )
Type	点状疵点	Size	H:0.7 ,V:326.8 [mm]
Result	-	Area	126.5 [mm2]
Inspection level	5/5,5/5,5/5,5/5,5/5	Label	-
Light	6,6,3/6,6,3

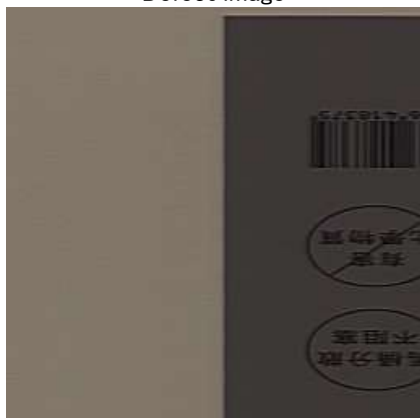
Defect image

No.	#102, \$87	Date	2023/8/10 上午 09:14:28
Segment	1	Camera	1
Pattern	7964	Position[ x, y ]	371.5 [mm], 5989.8 [m], ( 56.8 [m] )
Type	点状疵点縱向刀絲疵點	Size	H:2.2 ,V:284.4 [mm]
Result	-	Area	128.6 [mm2]
Inspection level	5/5,5/5,5/5,5/5,5/5	Label	-
Light	6,6,3/6,6,3

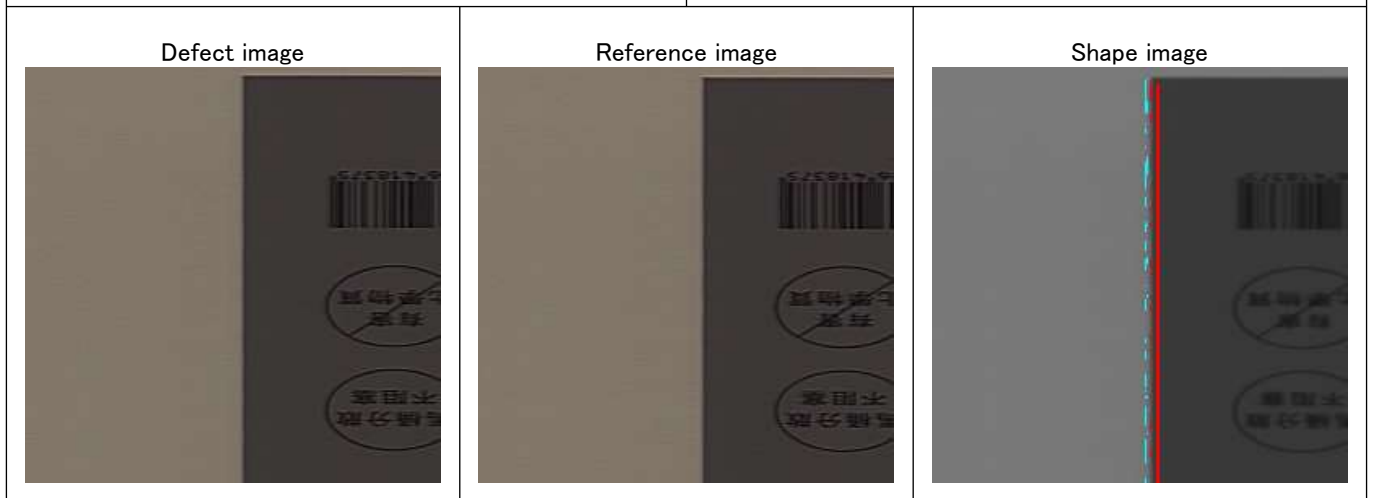
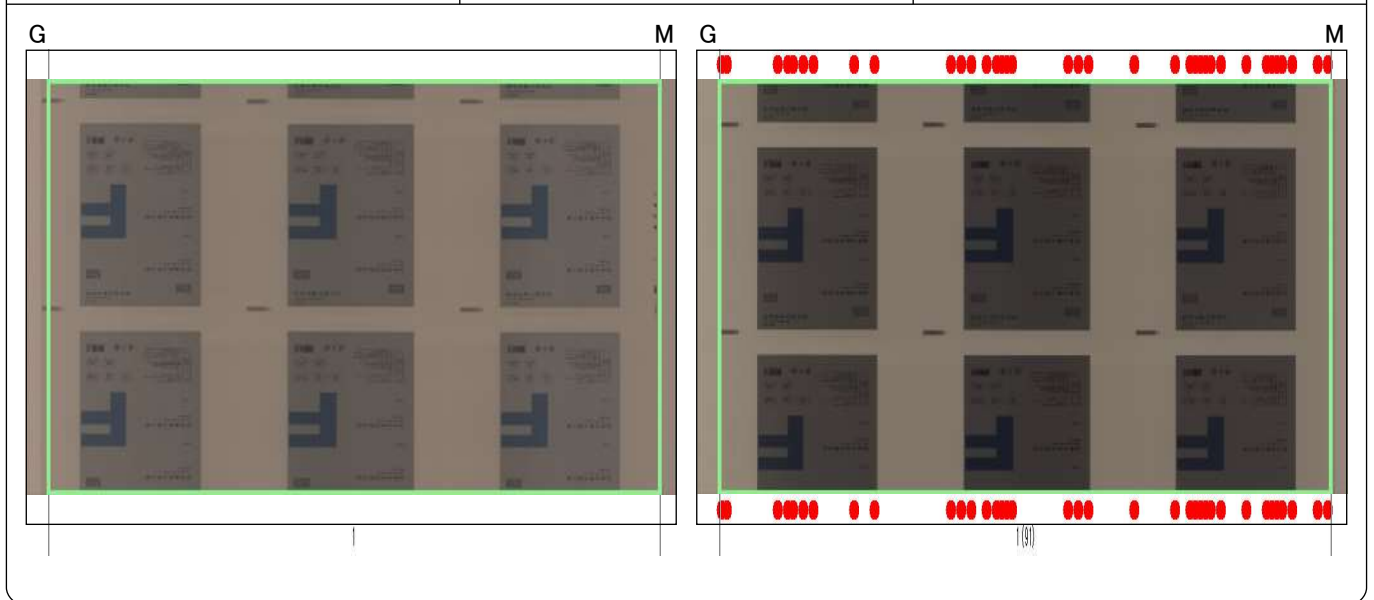
No.	#102, \$87	Date	2023/8/10 上午 09:14:28
Segment	1	Camera	1
Pattern	7964	Position[ x, y ]	696.2 [mm], 5989.8 [m], ( 56.8 [m] )
Type	点状疵点縱向刀絲疵點	Size	H:2.2 ,V:283.6 [mm]
Result	—	Area	128.8 [mm2]
Inspection level	5/5,5/5,5/5,5/5,5/5	Label	—
Light	6,6,3/6,6,3

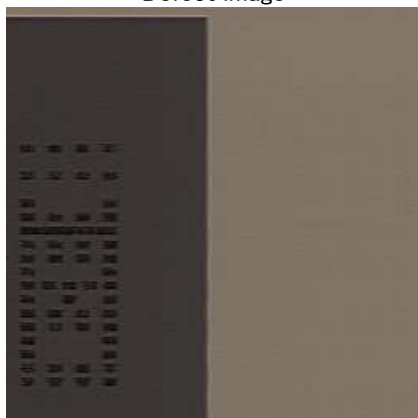
Defect image

No.	#100, \$85	Date	2023/8/10 上午 09:14:27
Segment	1	Camera	1
Pattern	7962	Position[ x, y ]	565.6 [mm], 5988.0 [m], ( 58.6 [m] )
Type	点状疵点	Size	H:0.5 ,V:180.4 [mm]
Result	-	Area	76.5 [mm2]
Inspection level	5/5,5/5,5/5,5,5/5,5/5	Label	-
Light	6,6,3/6,6,3

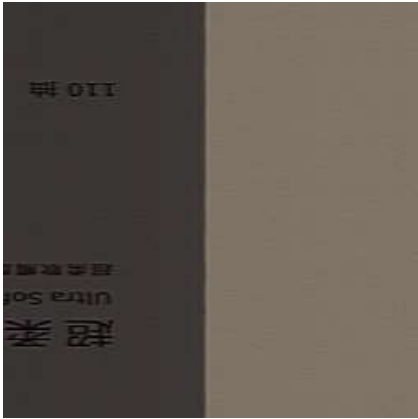
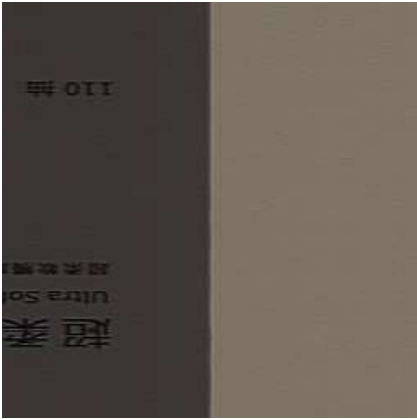
No.	#96, \$83	Date	2023/8/10 上午 09:14:18
Segment	1	Camera	1
Pattern	7947	Position[ x, y ]	565.6 [mm], 5976.9 [m], ( 69.6 [m] )
Type	点状疵点縱向刀絲疵點	Size	H:2.4 ,V:668.4 [mm]
Result	-	Area	407.1 [mm2]
Inspection level	5/5,5/5,5/5,5/5,5/5	Label	-
Light	6,6,3/6,6,3

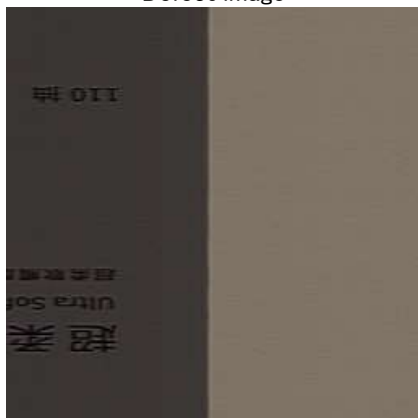
Defect image

No.	#96, \$83	Date	2023/8/10 上午 09:14:18
Segment	1	Camera	1
Pattern	7947	Position[ x, y ]	240.6 [mm], 5976.7 [m], ( 69.8 [m] )
Type	点状疵点縱向刀絲疵點	Size	H:2.4 ,V:806.4 [mm]
Result	-	Area	428.5 [mm2]
Inspection level	5/5,5/5,5/5,5/5,5/5	Label	-
Light	6,6,3/6,6,3

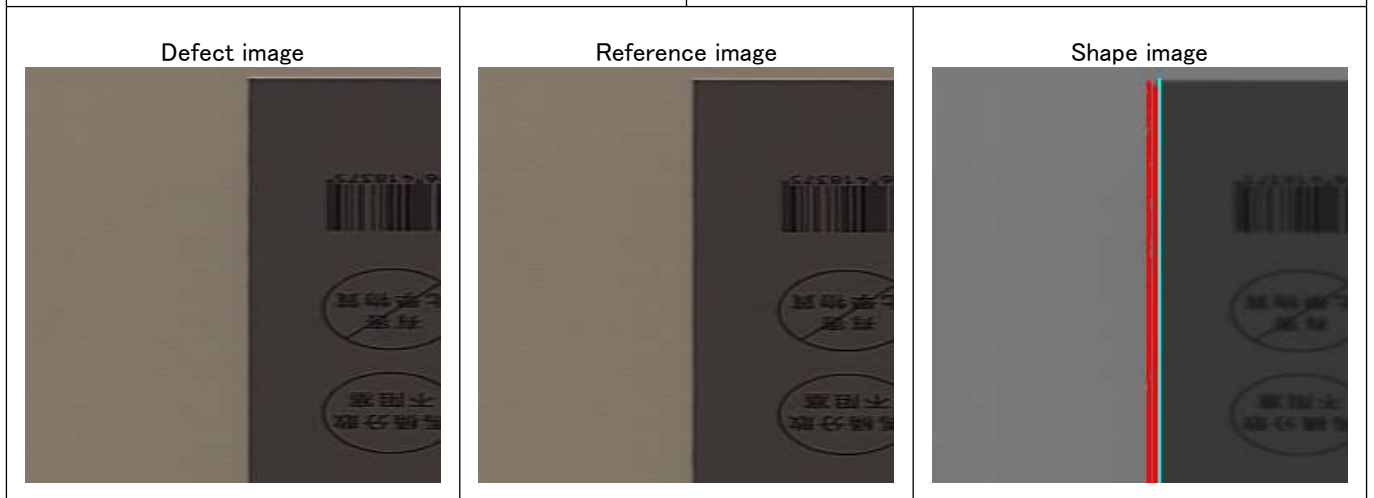
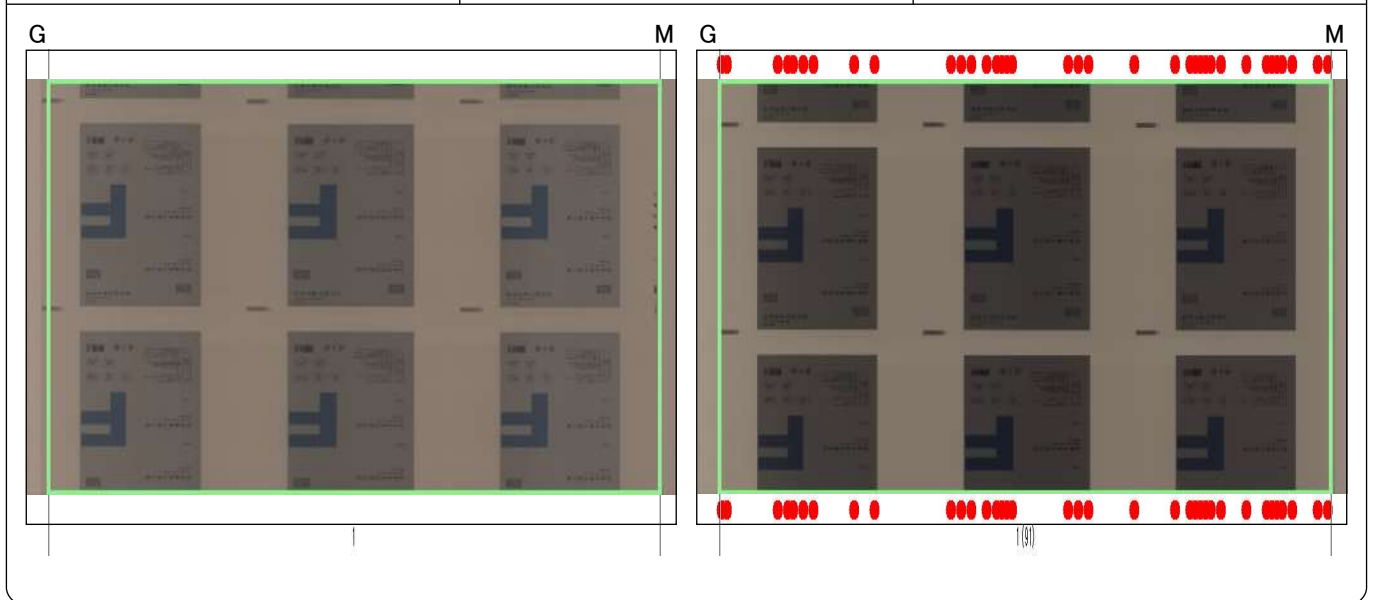
No.	#95, \$82	Date	2023/8/10 上午 09:14:17
Segment	1	Camera	1
Pattern	7946	Position[ x, y ]	565.6 [mm], 5976.0 [m], ( 70.5 [m] )
Type	点状疵点縱向刀絲疵點	Size	H:2.2 ,V:808.0 [mm]
Result	—	Area	289.4 [mm2]
Inspection level	5/5,5/5,5/5,5/5,5/5	Label	—
Light	6,6,3/6,6,3

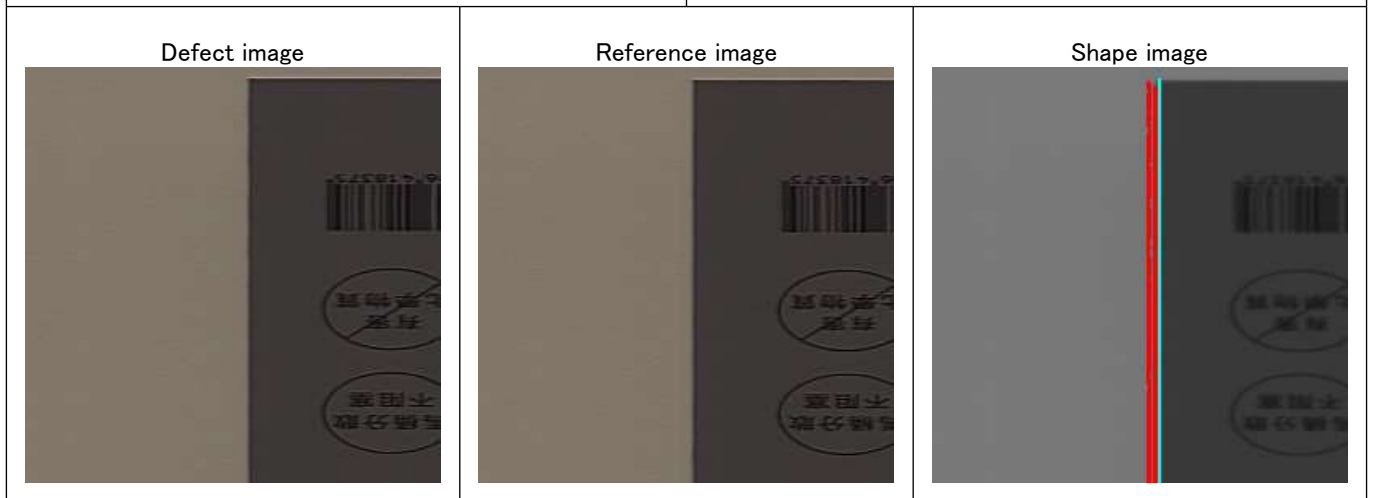
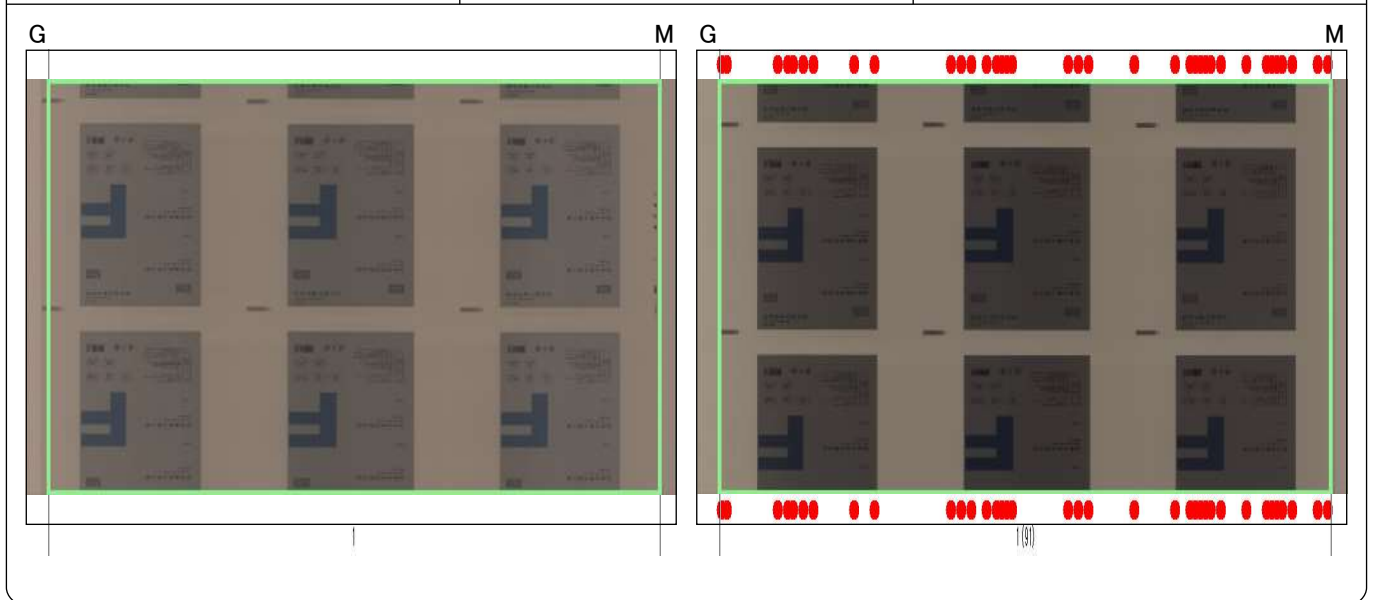
No.	#95, \$82	Date	2023/8/10 上午 09:14:17
Segment	1	Camera	1
Pattern	7946	Position[ x, y ]	373.4 [mm], 5976.1 [m], ( 70.4 [m] )
Type	点状疵点縱向刀絲疵點	Size	H:4.6 ,V:559.2 [mm]
Result	—	Area	308.5 [mm2]
Inspection level	5/5,5/5,5/5,5/5,5/5	Label	—
Light	6,6,3/6,6,3

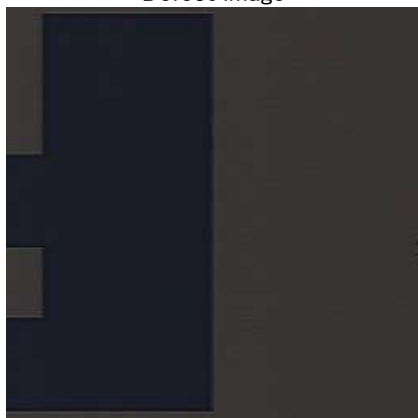
Defect image

No.	#92, \$79	Date	2023/8/10 上午 09:14:15
Segment	1	Camera	1
Pattern	7943	Position[ x, y ]	422.7 [mm], 5973.6 [m], ( 72.9 [m] )
Type	縱向刀絲疵點	Size	H:0.5 ,V:73.6 [mm]
Result	-	Area	23.6 [mm2]
Inspection level	5/5,5/5,5/5,5/5,5/5	Label	-
Light	6,6,3/6,6,3

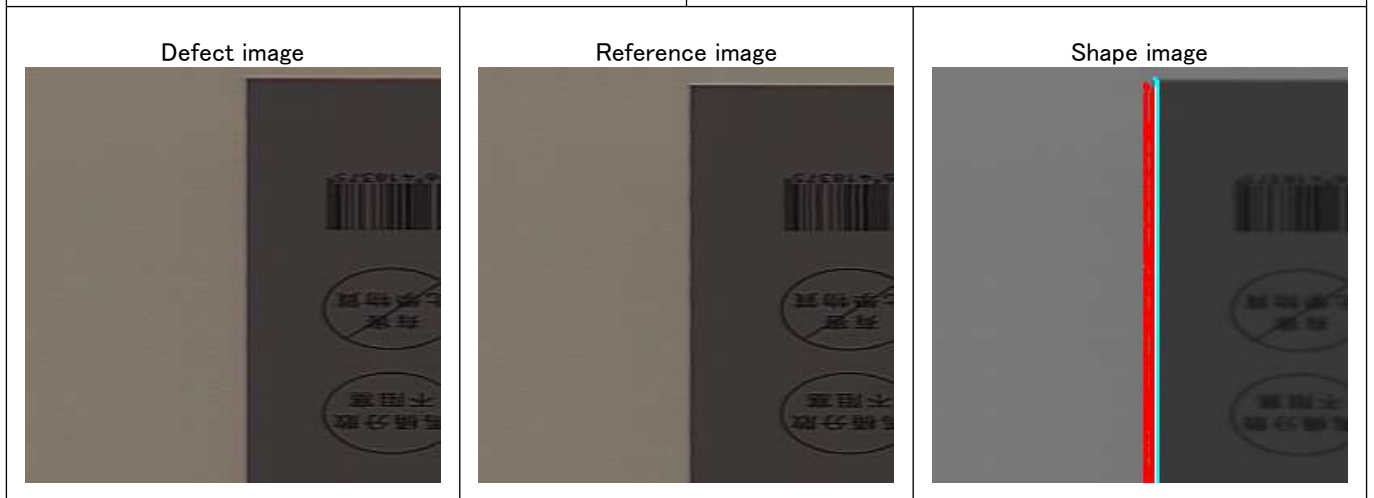
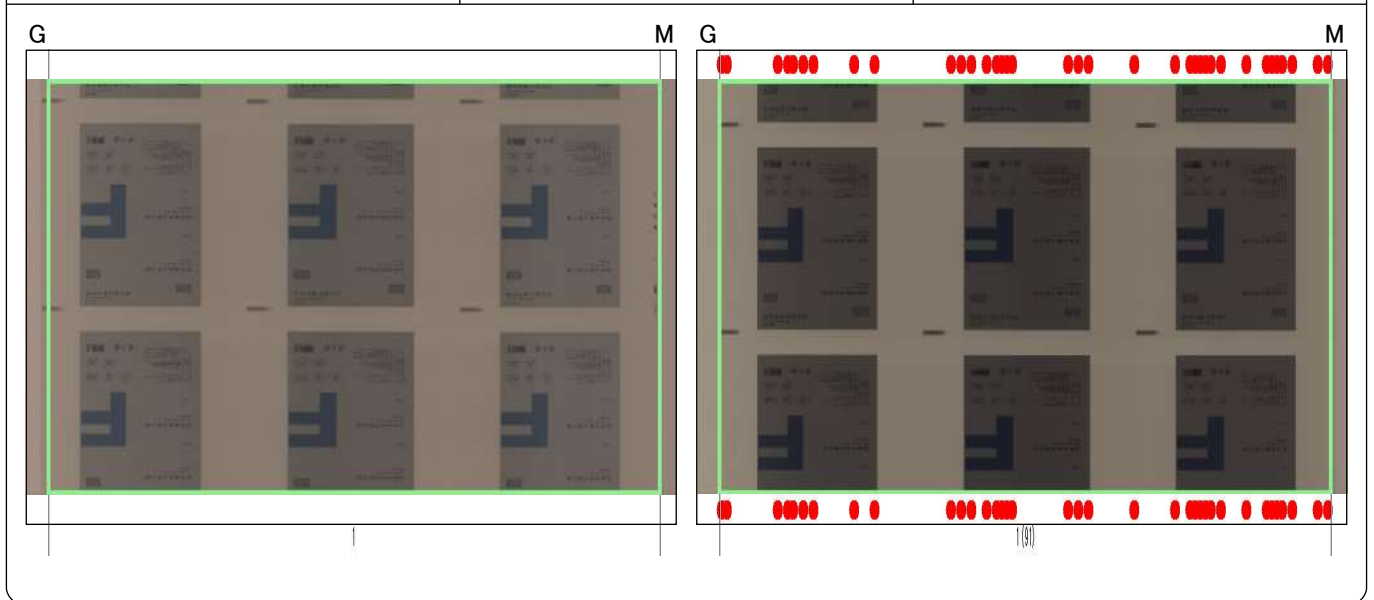
No.	#82, \$73	Date	2023/8/10 上午 09:13:57
Segment	1	Camera	1
Pattern	7912	Position[ x, y ]	372.9 [mm], 5950.7 [m], ( 95.8 [m] )
Type	点状疵点縱向刀絲疵點	Size	H:5.1 ,V:454.8 [mm]
Result	—	Area	539.3 [mm2]
Inspection level	5/5,5/5,5/5,5/5,5/5	Label	—
Light	6,6,3/6,6,3

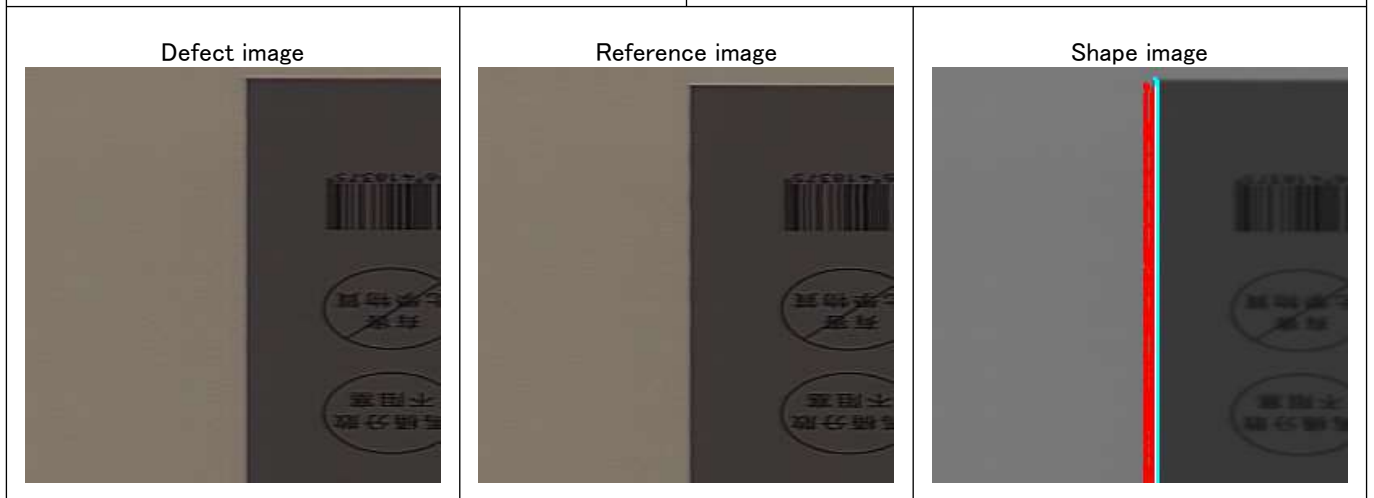
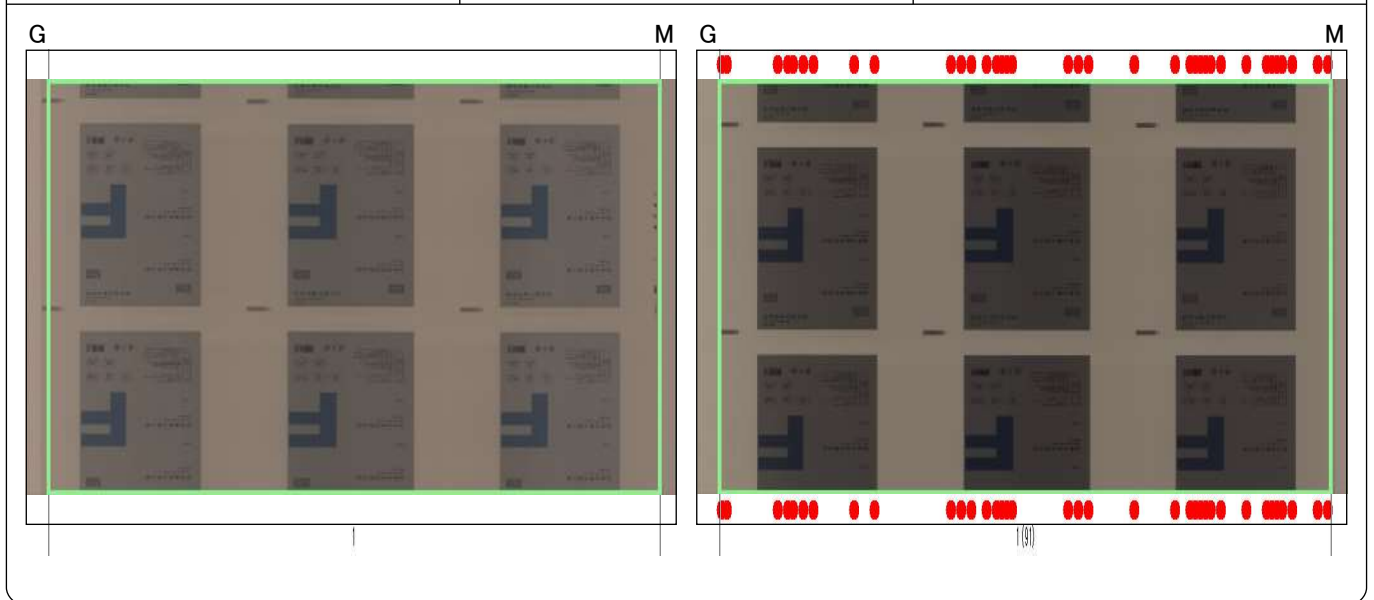
No.	#81, \$72	Date	2023/8/10 上午 09:13:57
Segment	1	Camera	1
Pattern	7911	Position[ x, y ]	565.1 [mm], 5949.9 [m], ( 96.7 [m] )
Type	点状疵点縱向刀絲疵點	Size	H:2.4 ,V:433.6 [mm]
Result	—	Area	214.0 [mm2]
Inspection level	5/5,5/5,5/5,5/5,5/5	Label	—
Light	6,6,3/6,6,3

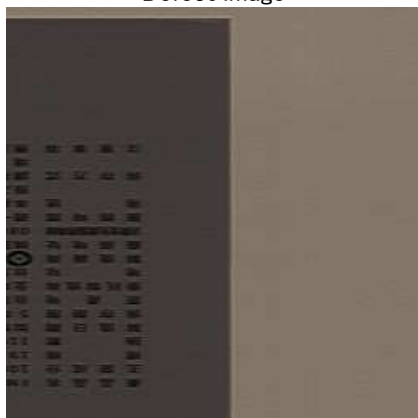
Defect image

No.	#81, \$72	Date	2023/8/10 上午 09:13:57
Segment	1	Camera	1
Pattern	7911	Position[ x, y ]	240.1 [mm], 5949.9 [m], ( 96.7 [m] )
Type	点状疵点縱向刀絲疵點	Size	H:2.4 ,V:451.2 [mm]
Result	-	Area	303.1 [mm2]
Inspection level	5/5,5/5,5/5,5/5,5/5	Label	-
Light	6,6,3/6,6,3

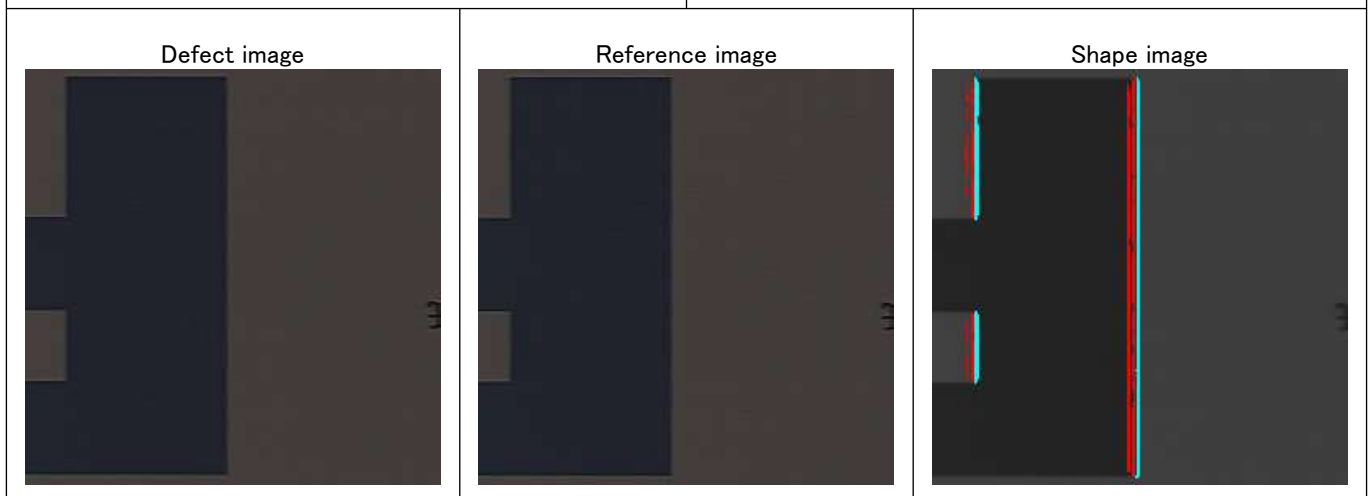
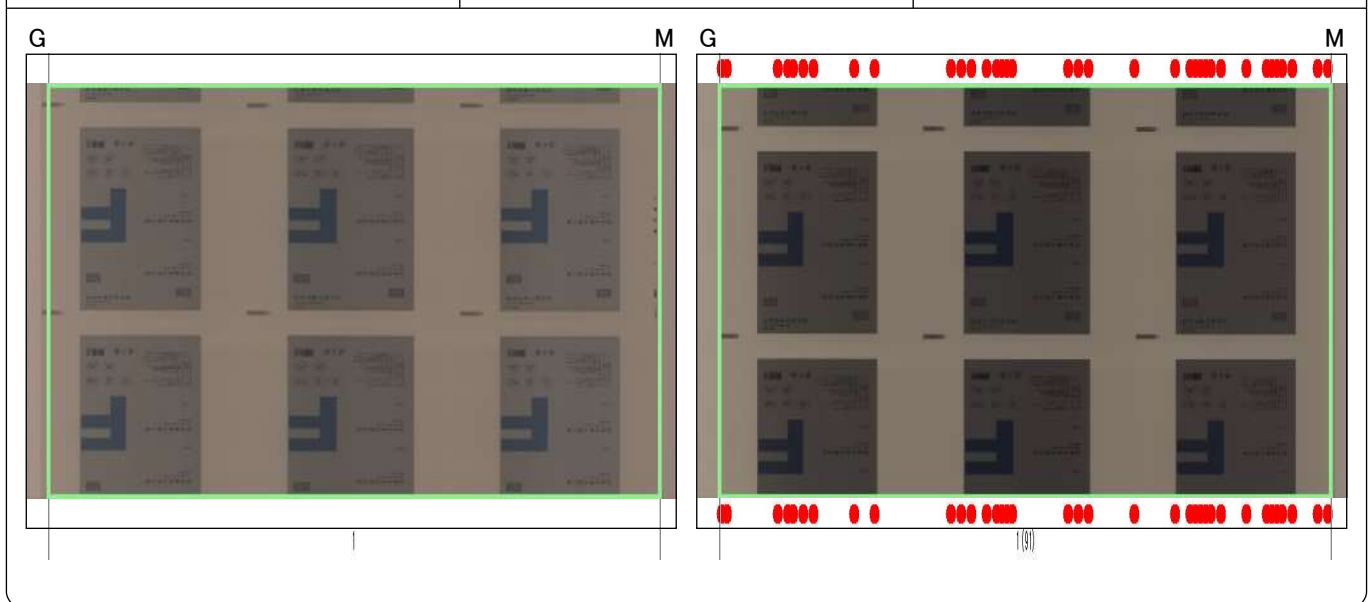
No.	#79, \$70	Date	2023/8/10 上午 09:13:56
Segment	1	Camera	1
Pattern	7909	Position[ x, y ]	770.6 [mm], 5948.5 [m], ( 98.0 [m] )
Type	縱向刀絲疵點	Size	H:0.7 ,V:97.2 [mm]
Result	-	Area	51.5 [mm2]
Inspection level	5/5,5/5,5/5,5/5,5/5	Label	-
Light	6,6,3/6,6,3

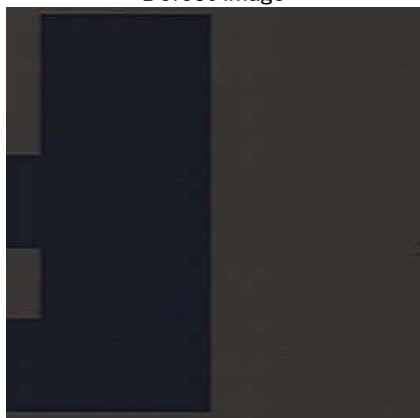
Defect image

No.	#78, \$69	Date	2023/8/10 上午 09:13:55
Segment	1	Camera	1
Pattern	7908	Position[ x, y ]	422.5 [mm], 5947.7 [m], ( 98.8 [m] )
Type	縱向刀絲疵點	Size	H:0.5 ,V:74.4 [mm]
Result	-	Area	24.2 [mm2]
Inspection level	5/5,5/5,5/5,5/5,5/5	Label	-
Light	6,6,3/6,6,3

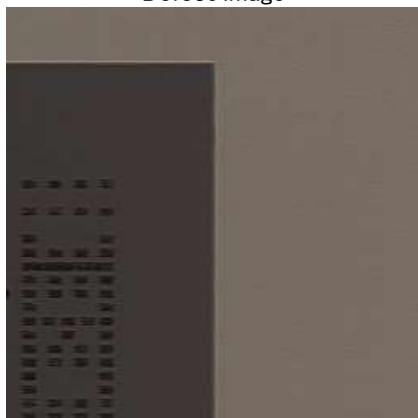
Defect image

No.	#73, \$66	Date	2023/8/10 上午 09:13:41
Segment	1	Camera	1
Pattern	7884	Position[ x, y ]	136.9 [mm], 5929.4 [m], ( 117.2 [m] )
Type	点状疵点縱向刀絲疵點橫向刀絲	Size	H:187.3 ,V:546.8 [mm]
Result	-	Area	6143.2 [mm2]
Inspection level	5/5,5/5,5/5,5/5,5/5	Label	-
Light	6,6,3/6,6,3

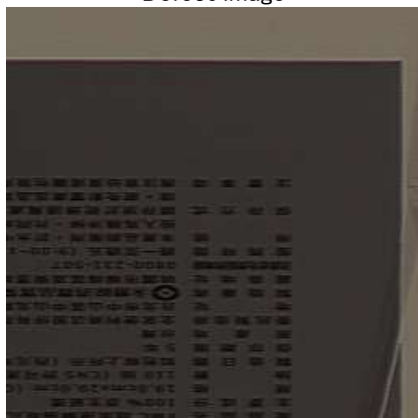
Defect image

No.	#73, \$66	Date	2023/8/10 上午 09:13:41
Segment	1	Camera	1
Pattern	7884	Position[ x, y ]	455.0 [mm], 5929.4 [m], ( 117.2 [m] )
Type	点状疵点縱向刀絲疵點橫向刀絲	Size	H:196.0 ,V:547.2 [mm]
Result	-	Area	6789.7 [mm2]
Inspection level	5/5,5/5,5/5,5/5,5/5	Label	-
Light	6,6,3/6,6,3

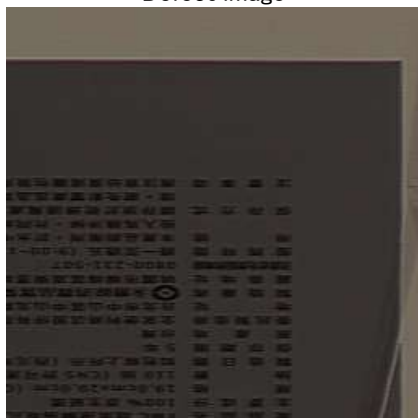
Defect image

No.	#72, \$65	Date	2023/8/10 上午 09:13:40
Segment	1	Camera	1
Pattern	7883	Position[ x, y ]	773.3 [mm], 5928.5 [m], ( 118.1 [m] )
Type	点状疵点縱向刀絲疵點	Size	H:186.0 ,V:346.0 [mm]
Result	-	Area	1968.1 [mm2]
Inspection level	5/5,5/5,5/5,5/5,5/5	Label	-
Light	6,6,3/6,6,3

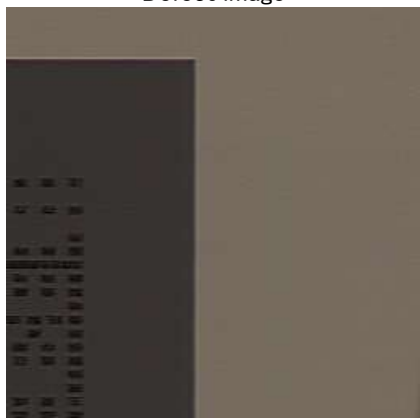
Defect image

No.	#72, \$65	Date	2023/8/10 上午 09:13:40
Segment	1	Camera	1
Pattern	7883	Position[ x, y ]	450.3 [mm], 5928.7 [m], ( 117.9 [m] )
Type	点状疵点縱向刀絲疵點橫向刀絲	Size	H:240.5 ,V:768.8 [mm]
Result	-	Area	6683.4 [mm2]
Inspection level	5/5,5/5,5/5,5/5,5/5	Label	-
Light	6,6,3/6,6,3

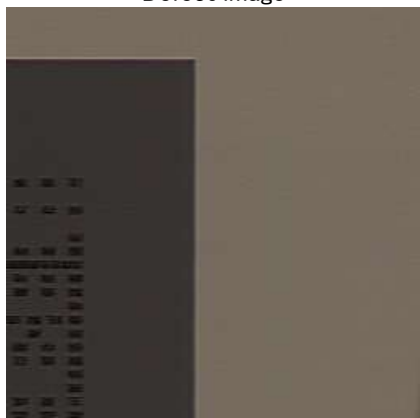
Defect image

No.	#71, \$64	Date	2023/8/10 上午 09:13:40
Segment	1	Camera	1
Pattern	7882	Position[ x, y ]	471.8 [mm], 5927.7 [m], ( 118.9 [m] )
Type	点状疵点縱向刀絲疵點	Size	H:195.1 ,V:352.0 [mm]
Result	-	Area	2505.4 [mm2]
Inspection level	5/5,5/5,5/5,5/5,5/5	Label	-
Light	6,6,3/6,6,3

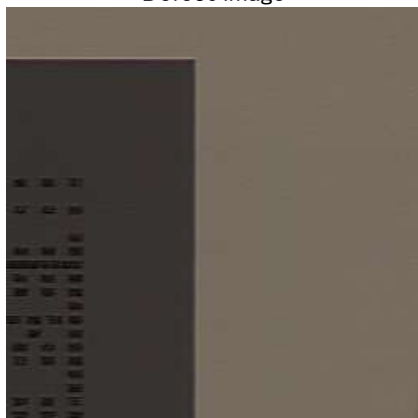
Defect image

No.	#71, \$64	Date	2023/8/10 上午 09:13:40
Segment	1	Camera	1
Pattern	7882	Position[ x, y ]	131.0 [mm], 5927.9 [m], ( 118.7 [m] )
Type	点状疵点縱向刀絲疵點橫向刀絲	Size	H:186.3 ,V:591.6 [mm]
Result	-	Area	5816.7 [mm2]
Inspection level	5/5,5/5,5/5,5/5,5/5	Label	-
Light	6,6,3/6,6,3

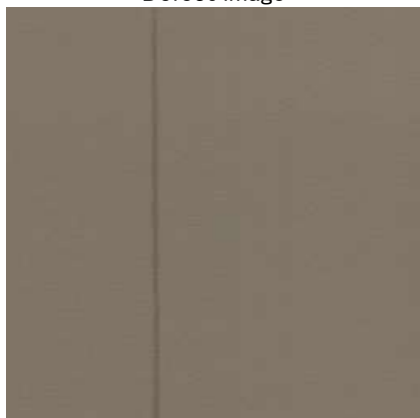
Defect image

No.	#68, \$63	Date	2023/8/10 上午 09:13:30
Segment	1	Camera	1
Pattern	7866	Position[ x, y ]	631.5 [mm], 5914.7 [m], ( 131.9 [m] )
Type	点状疵点縱向刀絲疵點	Size	H:12.0 ,V:708.4 [mm]
Result	-	Area	1047.6 [mm2]
Inspection level	5/5,5/5,5/5,5/5,5/5	Label	-
Light	6,6,3/6,6,3

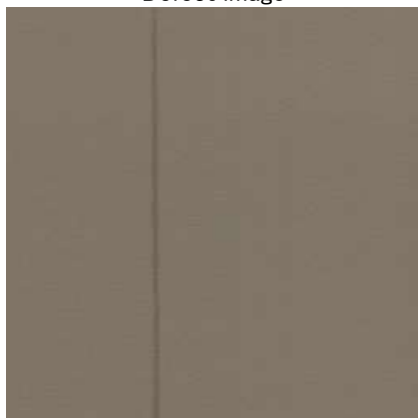
Defect image

No.	#67, \$62	Date	2023/8/10 上午 09:13:29
Segment	1	Camera	1
Pattern	7865	Position[ x, y ]	426.6 [mm], 5914.0 [m], ( 132.6 [m] )
Type	縱向刀絲疵點	Size	H:68.1 ,V:183.2 [mm]
Result	-	Area	70.3 [mm2]
Inspection level	5/5,5/5,5/5,5/5,5/5	Label	-
Light	6,6,3/6,6,3

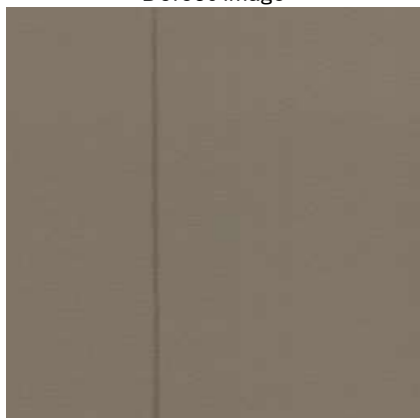
Defect image

No.	#67, \$62	Date	2023/8/10 上午 09:13:29
Segment	1	Camera	1
Pattern	7865	Position[ x, y ]	749.2 [mm], 5914.0 [m], ( 132.6 [m] )
Type	面狀重疵點縱向刀絲疵點	Size	H:65.9 ,V:180.4 [mm]
Result	-	Area	81.9 [mm2]
Inspection level	5/5,5/5,5/5,5/5,5/5	Label	-
Light	6,6,3/6,6,3

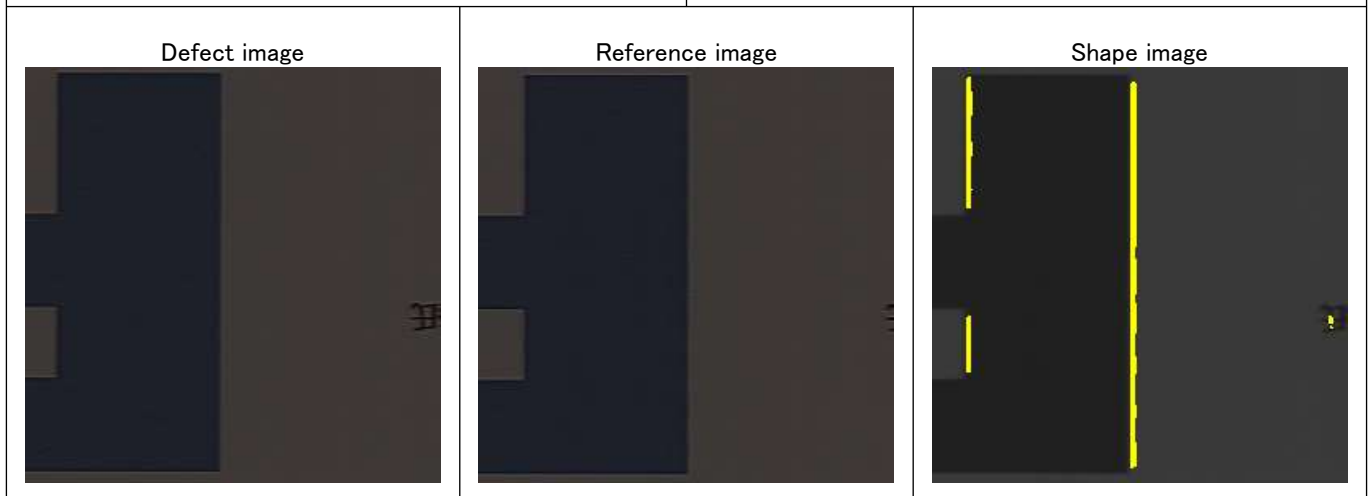
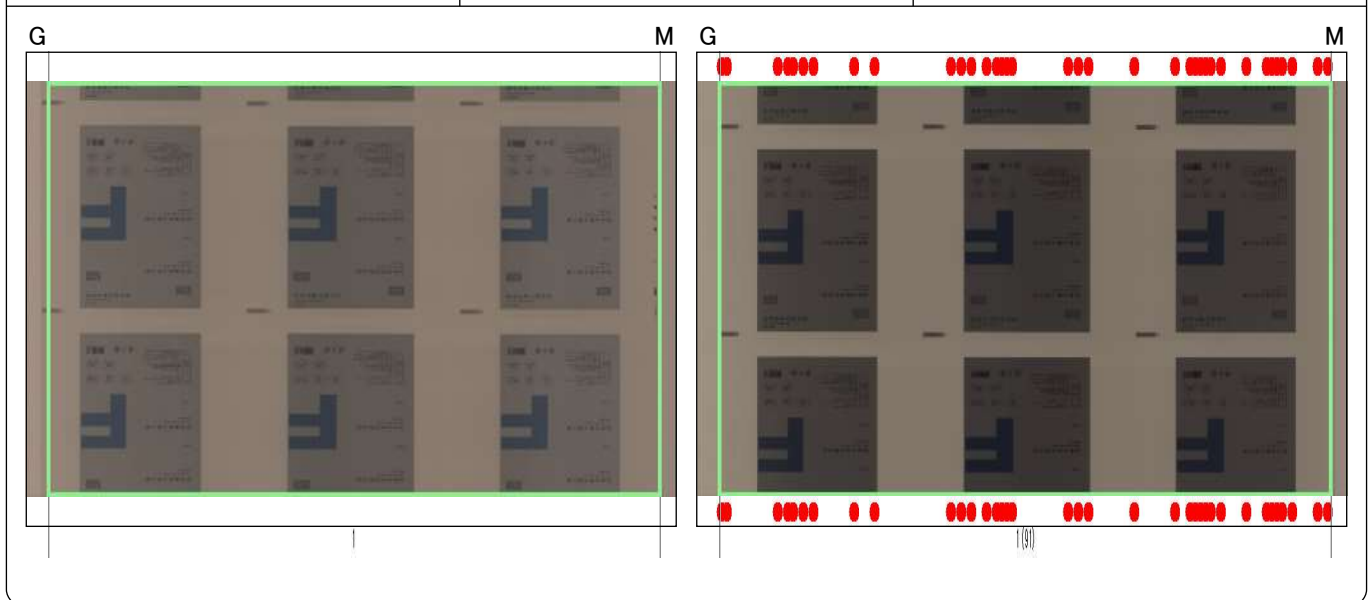
No.	#66, \$61	Date	2023/8/10 上午 09:13:28
Segment	1	Camera	1
Pattern	7864	Position[ x, y ]	115.1 [mm], 5913.2 [m], ( 133.4 [m] )
Type	縱向刀絲疵點	Size	H:38.8 ,V:180.8 [mm]
Result	-	Area	68.9 [mm2]
Inspection level	5/5,5/5,5/5,5/5,5/5	Label	-
Light	6,6,3/6,6,3

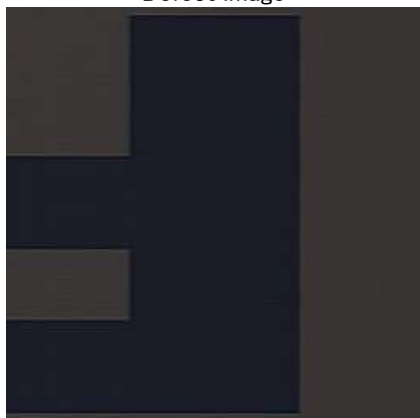
Defect image

No.	#66, \$61	Date	2023/8/10 上午 09:13:28
Segment	1	Camera	1
Pattern	7864	Position[ x, y ]	430.8 [mm], 5913.2 [m], ( 133.3 [m] )
Type	縱向刀絲疵點	Size	H:41.0 ,V:180.4 [mm]
Result	-	Area	69.5 [mm2]
Inspection level	5/5,5/5,5/5,5/5,5/5	Label	-
Light	6,6,3/6,6,3

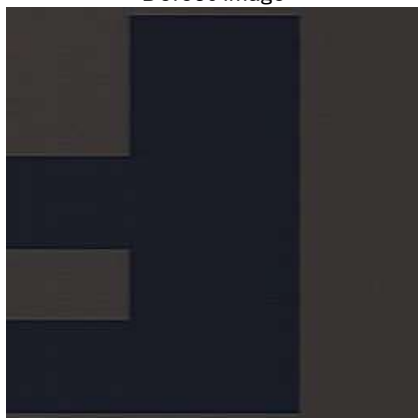
Defect image

No.	#65, \$60	Date	2023/8/10 上午 09:13:28
Segment	1	Camera	1
Pattern	7863	Position[ x, y ]	93.6 [mm], 5912.5 [m], ( 134.1 [m] )
Type	点状疵点縱向刀絲疵點	Size	H:22.5 ,V:156.4 [mm]
Result	-	Area	27.7 [mm2]
Inspection level	5/5,5/5,5/5,5/5,5/5	Label	-
Light	6,6,3/6,6,3

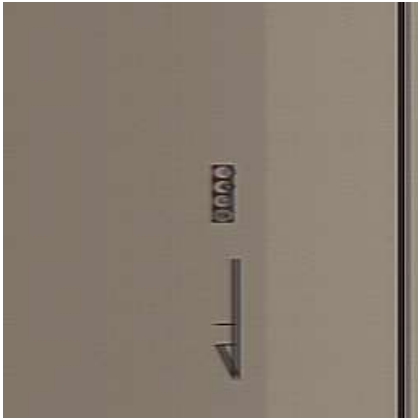
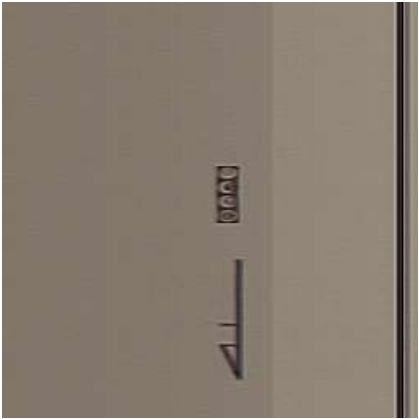
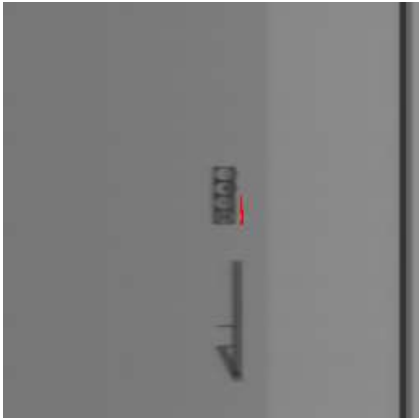
No.	#54, \$51	Date	2023/8/10 上午 09:12:53
Segment	1	Camera	1
Pattern	7804	Position[ x, y ]	937.1 [mm], 5868.0 [m], ( 178.6 [m] )
Type	点状疵点	Size	H:0.5 ,V:6.4 [mm]
Result	-	Area	1.8 [mm2]
Inspection level	5/5,5/5,5/5,5/5,5/5	Label	-
Light	6,6,3/6,6,3

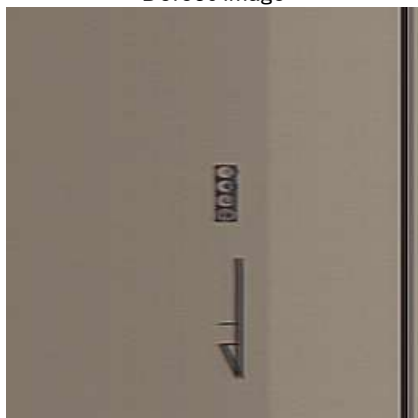
Defect image

No.	#53, \$50	Date	2023/8/10 上午 09:12:53
Segment	1	Camera	1
Pattern	7803	Position[ x, y ]	937.1 [mm], 5867.2 [m], ( 179.3 [m] )
Type	点状疵点	Size	H:0.5 ,V:3.2 [mm]
Result	-	Area	1.0 [mm2]
Inspection level	5/5,5/5,5/5,5/5,5/5	Label	-
Light	6,6,3/6,6,3

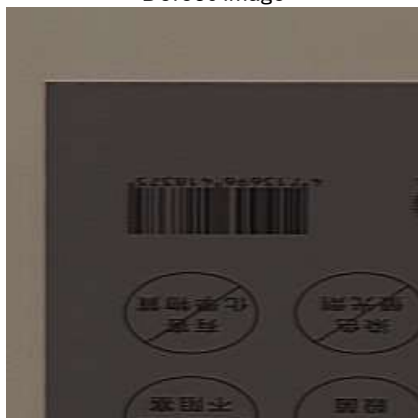
Defect image

No.	#47, \$46	Date	2023/8/10 上午 09:12:39
Segment	1	Camera	1
Pattern	7780	Position[ x, y ]	721.3 [mm], 5850.4 [m], ( 196.1 [m] )
Type	縱向刀絲疵點	Size	H:0.5 ,V:8.8 [mm]
Result	-	Area	4.2 [mm2]
Inspection level	5/5,5/5,5/5,5,5/5,5/5	Label	-
Light	6,6,3/6,6,3

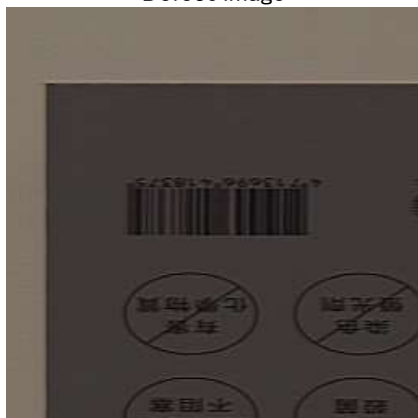
Defect image

No.	#45, \$44	Date	2023/8/10 上午 09:12:29
Segment	1	Camera	1
Pattern	7762	Position[ x, y ]	408.1 [mm], 5836.8 [m], ( 209.8 [m] )
Type	点状疵点	Size	H:0.5 ,V:2.4 [mm]
Result	-	Area	1.1 [mm2]
Inspection level	5/5,5/5,5/5,5/5,5/5	Label	-
Light	6,6,3/6,6,3

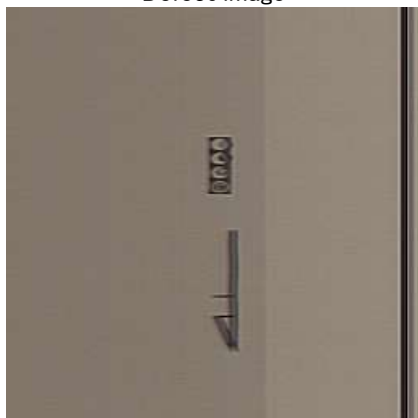
Defect image

No.	#45, \$44	Date	2023/8/10 上午 09:12:29
Segment	1	Camera	1
Pattern	7762	Position[ x, y ]	933.0 [mm], 5836.4 [m], ( 210.1 [m] )
Type	点状疵点縱向刀絲疵點	Size	H:5.9 ,V:37.6 [mm]
Result	-	Area	18.9 [mm2]
Inspection level	5/5,5/5,5/5,5/5,5/5	Label	-
Light	6,6,3/6,6,3

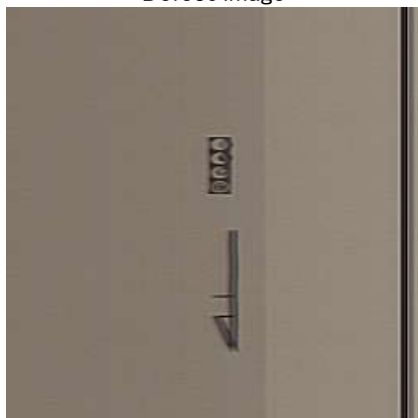
Defect image

No.	#44, \$43	Date	2023/8/10 上午 09:12:28
Segment	1	Camera	1
Pattern	7761	Position[ x, y ]	851.9 [mm], 5835.9 [m], ( 210.7 [m] )
Type	点状疵点	Size	H:5.6 ,V:133.2 [mm]
Result	-	Area	19.3 [mm2]
Inspection level	5/5,5/5,5/5,5/5,5/5	Label	-
Light	6,6,3/6,6,3

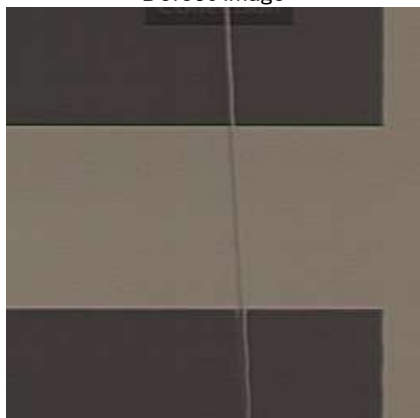
Defect image

No.	#43, \$42	Date	2023/8/10 上午 09:12:28
Segment	1	Camera	1
Pattern	7760	Position[ x, y ]	856.1 [mm], 5835.5 [m], ( 211.1 [m] )
Type	点状疵点縱向刀絲疵點	Size	H:22.9 ,V:78.8 [mm]
Result	-	Area	7.2 [mm2]
Inspection level	5/5,5/5,5/5,5/5,5/5	Label	-
Light	6,6,3/6,6,3

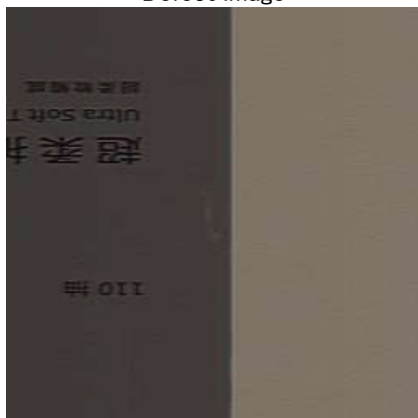
Defect image

No.	#38, \$37	Date	2023/8/10 上午 08:06:59
Segment	1	Camera	1
Pattern	1044	Position[ x, y ]	877.1 [mm], 790.6 [mm], ( 5256.0 [m] )
Type	縱向刀絲疵點	Size	H:1.7 ,V:2.4 [mm]
Result	-	Area	2.1 [mm2]
Inspection level	5/5,5/5,5/5,5/5,5/5	Label	-
Light	6,6,3/6,6,3

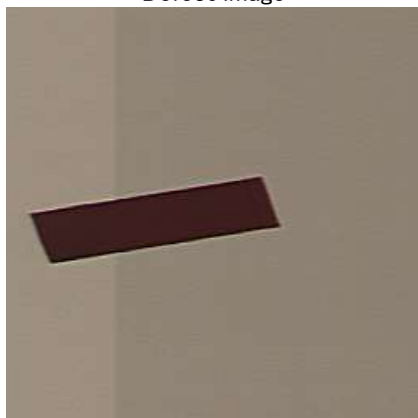
Defect image

No.	#36, \$35	Date	2023/8/10 上午 07:59:16
Segment	1	Camera	1
Pattern	260	Position[ x, y ]	10.6 [mm], 202.1 [m], ( 5844.4 [m] )
Type	点状疵点縱向刀絲疵點橫向刀絲	Size	H:21.7 ,V:19.2 [mm]
Result	-	Area	276.3 [mm2]
Inspection level	5/5,5/5,5/5,5/5,5/5	Label	-
Light	6,6,3/6,6,3

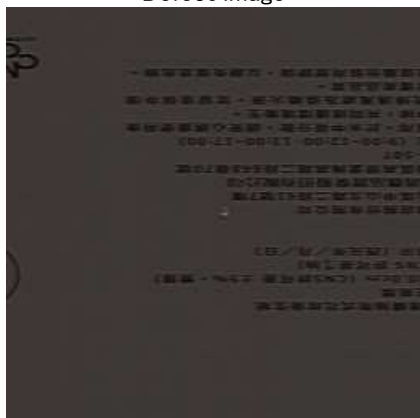
Defect image

No.	#33, \$32	Date	2023/8/10 上午 07:57:47
Segment	1	Camera	1
Pattern	109	Position[ x, y ]	809.5 [mm], 88.3 [m], ( 5958.2 [m] )
Type	縱向刀絲疵點	Size	H:2.0 ,V:1.6 [mm]
Result	-	Area	2.1 [mm2]
Inspection level	5/5,5/5,5/5,5/5,5/5	Label	-
Light	6,6,3/6,6,3

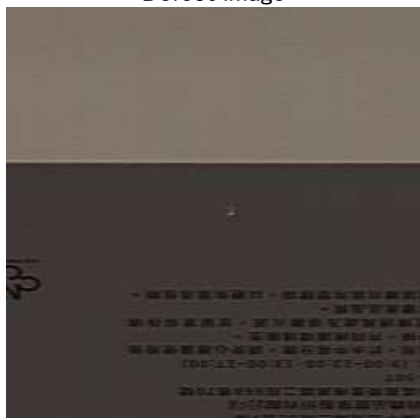
Defect image

No.	#19, \$18	Date	2023/8/10 上午 07:57:16
Segment	1	Camera	1
Pattern	57	Position[ x, y ]	810.4 [mm], 49.7 [m], ( 5996.9 [m] )
Type	縱向刀絲疵點	Size	H:2.0 ,V:1.6 [mm]
Result	-	Area	2.5 [mm2]
Inspection level	5/5,5/5,5/5,5/5,5/5	Label	-
Light	6,6,3/6,6,3

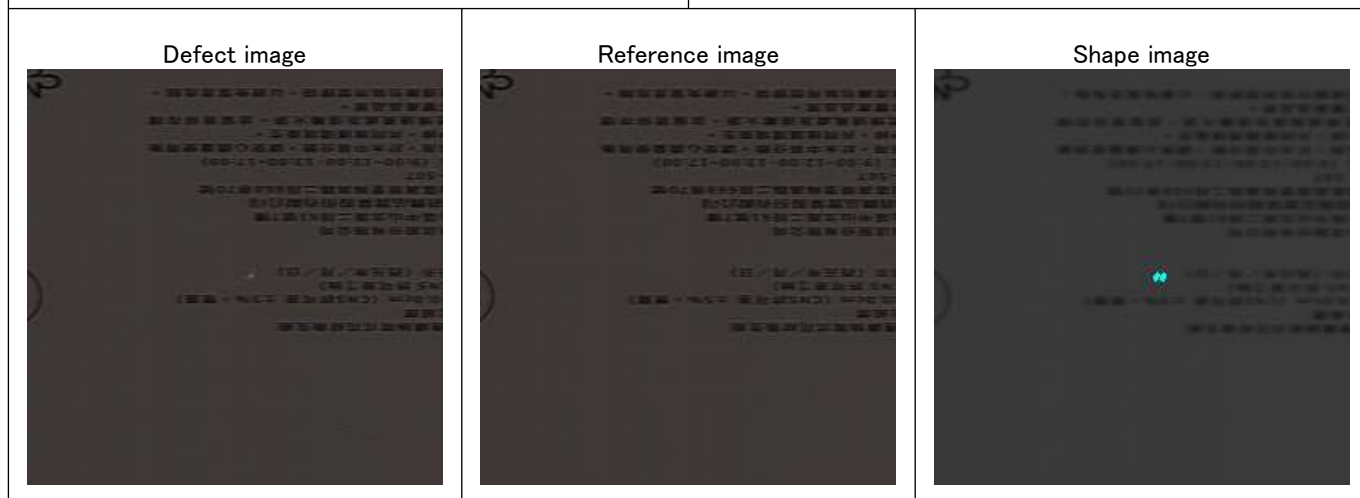
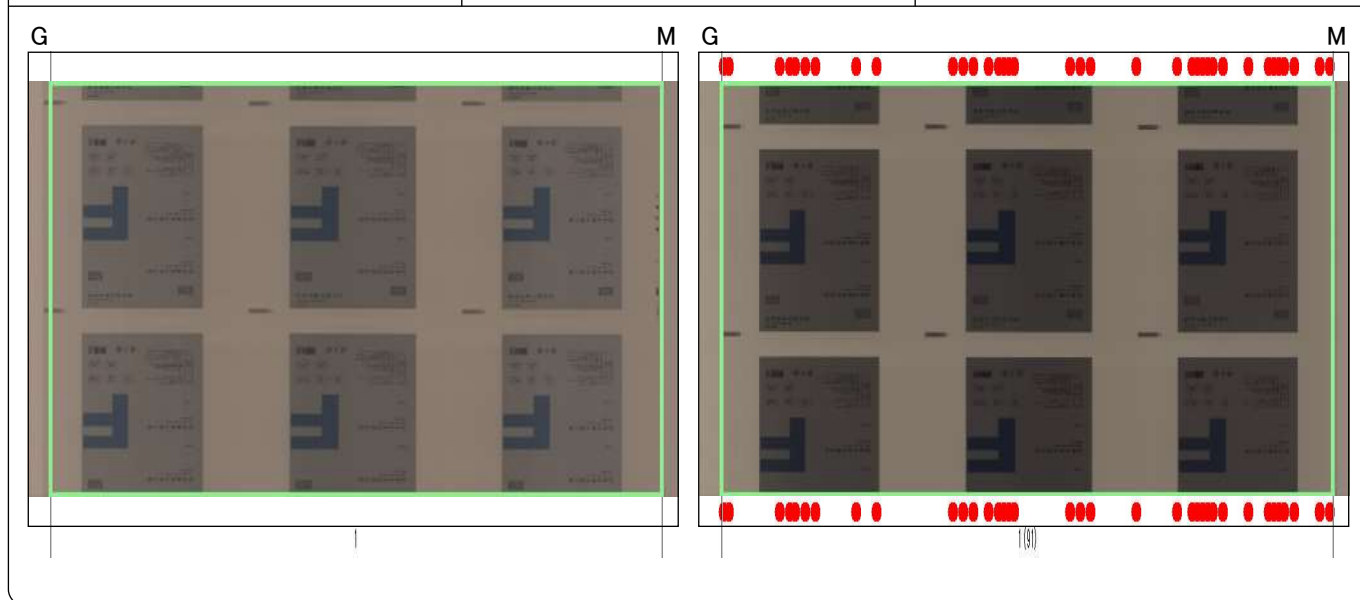
No.	#18, \$17	Date	2023/8/10 上午 07:57:15
Segment	1	Camera	1
Pattern	55	Position[ x, y ]	810.2 [mm], 48.2 [m], ( 5998.3 [m] )
Type	縱向刀絲疵點	Size	H:2.0 ,V:1.6 [mm]
Result	—	Area	2.3 [mm2]
Inspection level	5/5,5/5,5/5,5/5,5/5	Label	—
Light	6,6,3/6,6,3
