Inspection Result (Individual Data)

Lot number : 3

商品名	標準透明6-6-3	周長	
顧客名		Ex1	
CODE番号		Ex2	
基材		Ex3

Total defects	148	檢查範圍 : 83.6 ~ 1024.2 [mm]	寬度 : 940.6 [mm]
Web length	5508.4 [m]	參照更新 : 週期10<平時>/週期10<平時>	
Segments	1 (從左側)

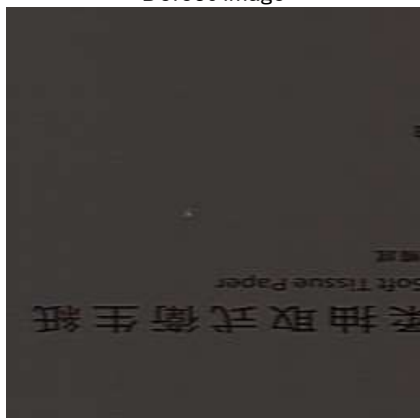
Defect image

No.	#156, \$143	Date	2023/8/9 上午 11:33:28
Segment	1	Camera	1
Pattern	7131	Position[x, y]	181.7 [mm], 5393.6 [m], (114.7 [m])
Type	縱向刀絲疵點	Size	H:2.0 ,V:1.2 [mm]
Result	-	Area	2.0 [mm2]
Inspection level	5/5,5/5,5/5,5,5/5,5/5	Label	-
Light	6,6,3/6,6,3

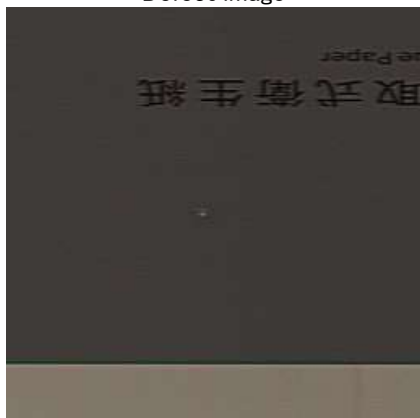
Defect image

No.	#154, \$141	Date	2023/8/9 上午 11:33:24
Segment	1	Camera	1
Pattern	7124	Position[x, y]	168.3 [mm], 5388.2 [m], (120.2 [m])
Type	縱向刀絲疵點	Size	H:2.0 ,V:1.2 [mm]
Result	-	Area	2.1 [mm2]
Inspection level	5/5,5/5,5/5,5/5,5/5	Label	-
Light	6,6,3/6,6,3

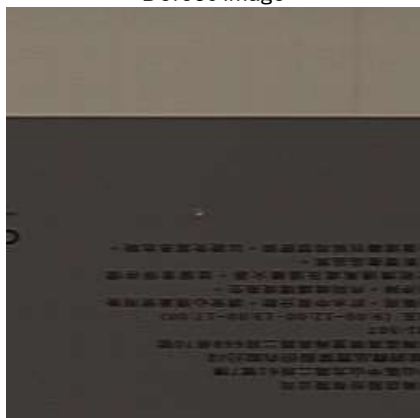
Defect image

No.	#153, \$140	Date	2023/8/9 上午 11:33:17
Segment	1	Camera	1
Pattern	7113	Position[x, y]	167.8 [mm], 5379.6 [m], (128.7 [m])
Type	縱向刀絲疵點	Size	H:2.0 ,V:1.6 [mm]
Result	-	Area	2.7 [mm2]
Inspection level	5/5,5/5,5/5,5/5,5/5	Label	-
Light	6,6,3/6,6,3

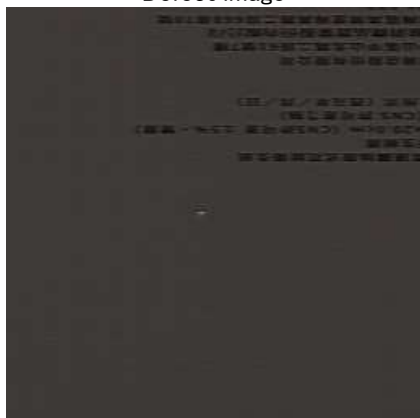
Defect image

No.	#152, \$139	Date	2023/8/9 上午 11:33:16
Segment	1	Camera	1
Pattern	7111	Position[x, y]	168.1 [mm], 5378.2 [m], (130.2 [m])
Type	縱向刀絲疵點	Size	H:2.0 ,V:1.6 [mm]
Result	-	Area	2.1 [mm2]
Inspection level	5/5,5/5,5/5,5/5,5/5	Label	-
Light	6,6,3/6,6,3

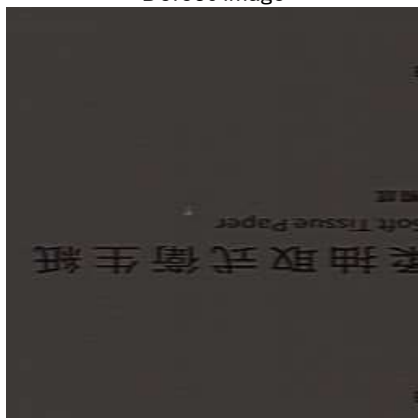
Defect image

No.	#148, \$135	Date	2023/8/9 上午 11:33:06
Segment	1	Camera	1
Pattern	7095	Position[x, y]	181.7 [mm], 5366.6 [m], (141.8 [m])
Type	縱向刀絲疵點	Size	H:2.0 ,V:1.6 [mm]
Result	-	Area	2.1 [mm2]
Inspection level	5/5,5/5,5/5,5/5,5/5	Label	-
Light	6,6,3/6,6,3

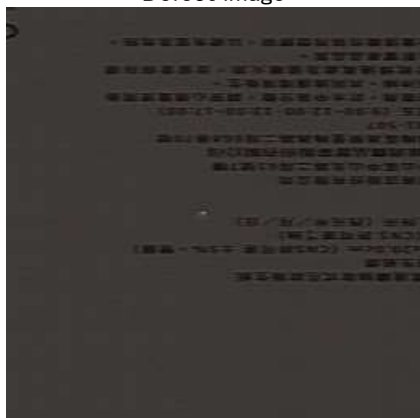
Defect image

No.	#145, \$132	Date	2023/8/9 上午 11:33:00
Segment	1	Camera	1
Pattern	7084	Position[x, y]	168.3 [mm], 5358.3 [m], (150.1 [m])
Type	縱向刀絲疵點	Size	H:2.0 ,V:1.6 [mm]
Result	-	Area	2.2 [mm2]
Inspection level	5/5,5/5,5/5,5/5,5/5	Label	-
Light	6,6,3/6,6,3

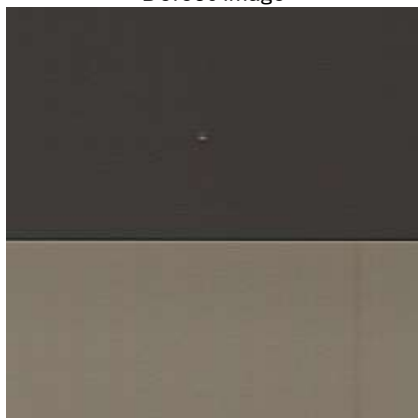
Defect image

No.	#143, \$130	Date	2023/8/9 上午 11:32:57
Segment	1	Camera	1
Pattern	7079	Position[x, y]	168.3 [mm], 5354.0 [m], (154.4 [m])
Type	縱向刀絲疵點	Size	H:2.0 ,V:1.6 [mm]
Result	-	Area	2.5 [mm2]
Inspection level	5/5,5/5,5/5,5/5,5/5	Label	-
Light	6,6,3/6,6,3

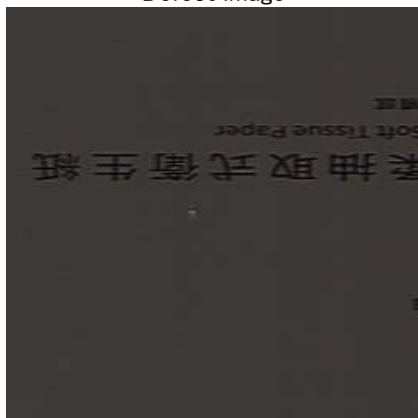
Defect image

No.	#141, \$128	Date	2023/8/9 上午 11:32:55
Segment	1	Camera	1
Pattern	7076	Position[x, y]	182.5 [mm], 5352.4 [m], (156.0 [m])
Type	縱向刀絲疵點	Size	H:2.0 ,V:1.6 [mm]
Result	-	Area	2.4 [mm2]
Inspection level	5/5,5/5,5/5,5/5,5/5	Label	-
Light	6,6,3/6,6,3

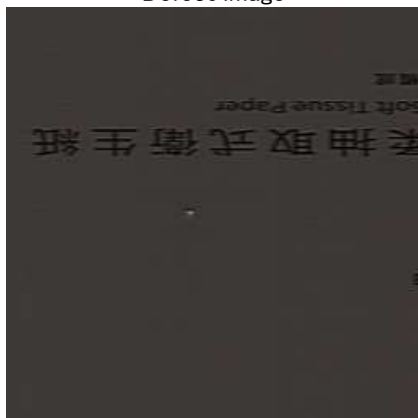
Defect image

No.	#134, \$121	Date	2023/8/9 上午 11:32:44
Segment	1	Camera	1
Pattern	7057	Position[x, y]	182.0 [mm], 5338.1 [m], (170.2 [m])
Type	縱向刀絲疵點	Size	H:2.0 ,V:1.6 [mm]
Result	-	Area	2.6 [mm2]
Inspection level	5/5,5/5,5/5,5/5,5/5	Label	-
Light	6,6,3/6,6,3

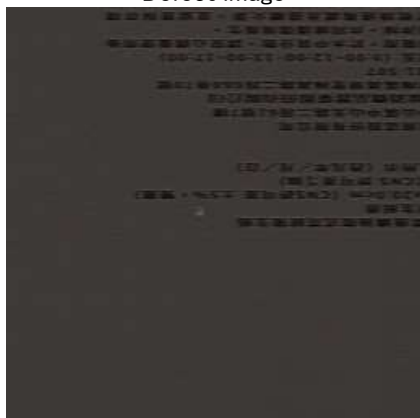
Defect image

No.	#133, \$120	Date	2023/8/9 上午 11:32:43
Segment	1	Camera	1
Pattern	7056	Position[x, y]	167.8 [mm], 5336.9 [m], (171.5 [m])
Type	縱向刀絲疵點	Size	H:2.0 ,V:1.6 [mm]
Result	-	Area	2.3 [mm2]
Inspection level	5/5,5/5,5/5,5/5,5/5	Label	-
Light	6,6,3/6,6,3

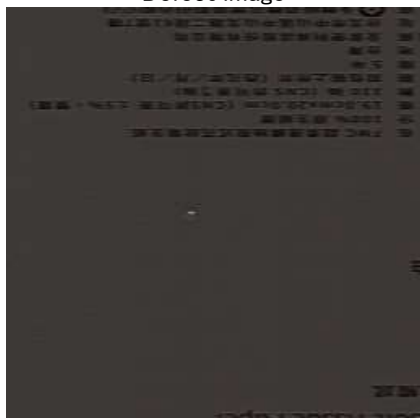
Defect image

No.	#132, \$119	Date	2023/8/9 上午 11:32:40
Segment	1	Camera	1
Pattern	7050	Position[x, y]	182.2 [mm], 5332.4 [m], (175.9 [m])
Type	縱向刀絲疵點	Size	H:2.2 ,V:1.6 [mm]
Result	-	Area	3.1 [mm2]
Inspection level	5/5,5/5,5/5,5/5,5/5	Label	-
Light	6,6,3/6,6,3

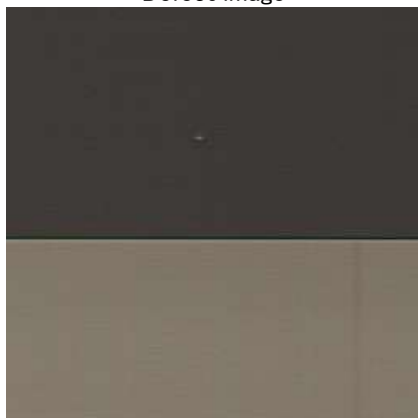
Defect image

No.	#129, \$116	Date	2023/8/9 上午 11:32:35
Segment	1	Camera	1
Pattern	7041	Position[x, y]	167.8 [mm], 5325.5 [m], (182.9 [m])
Type	縱向刀絲疵點	Size	H:2.0 ,V:1.2 [mm]
Result	-	Area	2.0 [mm2]
Inspection level	5/5,5/5,5/5,5/5,5/5	Label	-
Light	6,6,3/6,6,3

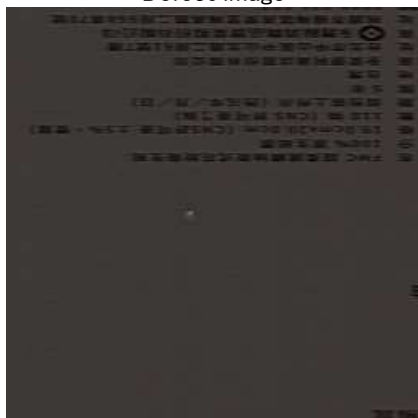
Defect image

No.	#128, \$115	Date	2023/8/9 上午 11:32:34
Segment	1	Camera	1
Pattern	7040	Position[x, y]	182.0 [mm], 5325.3 [m], (183.1 [m])
Type	縱向刀絲疵點	Size	H:2.2 ,V:2.0 [mm]
Result	-	Area	3.1 [mm2]
Inspection level	5/5,5/5,5/5,5/5,5/5	Label	-
Light	6,6,3/6,6,3

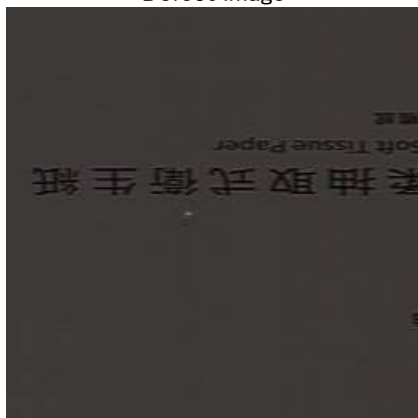
Defect image

No.	#127, \$114	Date	2023/8/9 上午 11:32:33
Segment	1	Camera	1
Pattern	7038	Position[x, y]	181.7 [mm], 5323.9 [m], (184.5 [m])
Type	縱向刀絲疵點	Size	H:2.2 ,V:1.6 [mm]
Result	-	Area	2.7 [mm2]
Inspection level	5/5,5/5,5/5,5/5,5/5	Label	-
Light	6,6,3/6,6,3

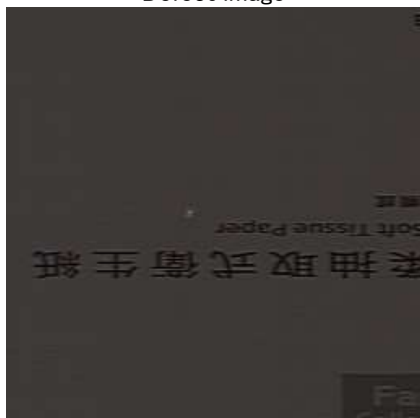
Defect image

No.	#125, \$112	Date	2023/8/9 上午 11:32:32
Segment	1	Camera	1
Pattern	7036	Position[x, y]	182.0 [mm], 5322.5 [m], (185.9 [m])
Type	縱向刀絲疵點	Size	H:2.2 ,V:1.6 [mm]
Result	-	Area	3.1 [mm2]
Inspection level	5/5,5/5,5/5,5/5,5/5	Label	-
Light	6,6,3/6,6,3

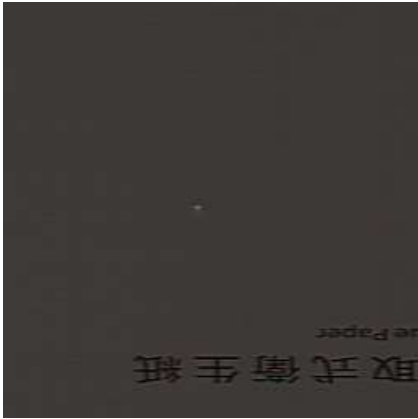
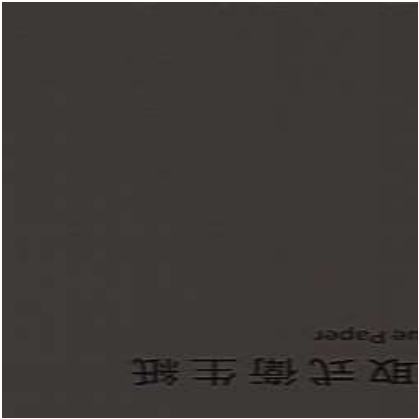
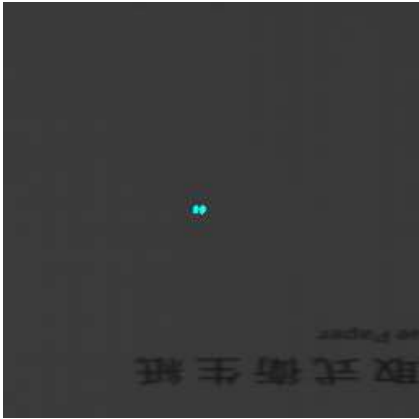
Defect image	Reference image	Shape image

No.	#122, \$109	Date	2023/8/9 上午 11:32:29
Segment	1	Camera	1
Pattern	7031	Position[x, y]	167.8 [mm], 5318.4 [m], (190.0 [m])
Type	縱向刀絲疵點	Size	H:2.0 ,V:1.6 [mm]
Result	-	Area	2.1 [mm2]
Inspection level	5/5,5/5,5/5,5/5,5/5	Label	-
Light	6,6,3/6,6,3

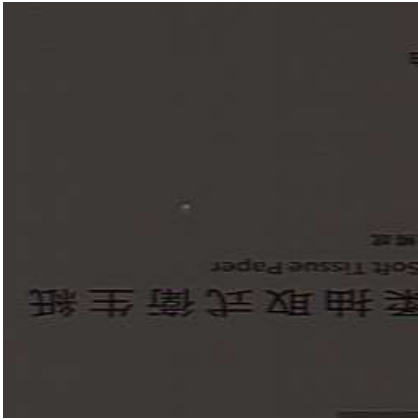
Defect image	Reference image	Shape image

No.	#121, \$108	Date	2023/8/9 上午 11:32:26
Segment	1	Camera	1
Pattern	7027	Position[x, y]	182.0 [mm], 5315.3 [m], (193.1 [m])
Type	縱向刀絲疵點	Size	H:2.2 ,V:1.6 [mm]
Result	-	Area	2.4 [mm2]
Inspection level	5/5,5/5,5/5,5/5,5/5	Label	-
Light	6,6,3/6,6,3

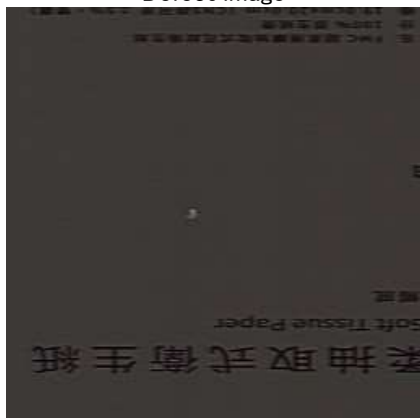
Defect image

No.	#113, \$100	Date	2023/8/9 上午 11:32:16
Segment	1	Camera	1
Pattern	7010	Position[x, y]	182.5 [mm], 5302.4 [m], (205.9 [m])
Type	点状疵点縱向刀絲疵點	Size	H:2.4 ,V:2.4 [mm]
Result	-	Area	5.4 [mm2]
Inspection level	5/5,5/5,5/5,5/5,5/5	Label	-
Light	6,6,3/6,6,3

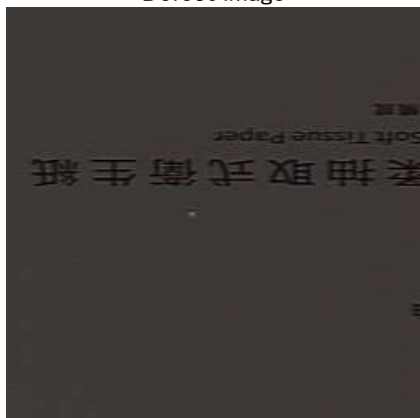
Defect image

No.	#108, \$95	Date	2023/8/9 上午 11:32:09
Segment	1	Camera	1
Pattern	6998	Position[x, y]	182.2 [mm], 5293.9 [m], (214.5 [m])
Type	縱向刀絲疵點	Size	H:2.2 ,V:1.2 [mm]
Result	-	Area	2.2 [mm2]
Inspection level	5/5,5/5,5/5,5/5,5/5	Label	-
Light	6,6,3/6,6,3

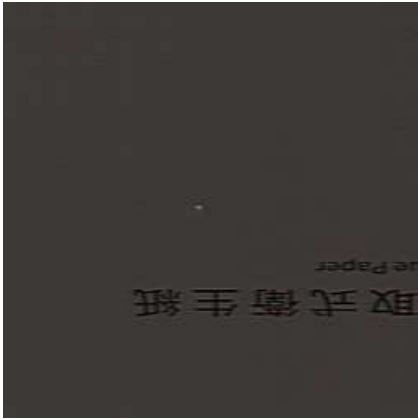
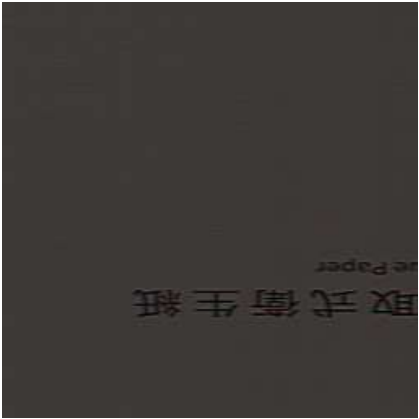
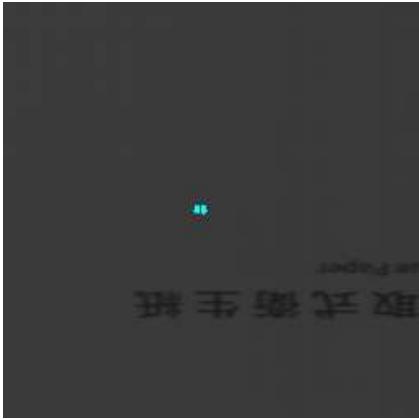
Defect image	Reference image	Shape image

No.	#106, \$93	Date	2023/8/9 上午 11:32:07
Segment	1	Camera	1
Pattern	6995	Position[x, y]	168.3 [mm], 5291.2 [m], (217.2 [m])
Type	縱向刀絲疵點	Size	H:2.2 ,V:1.6 [mm]
Result	-	Area	2.2 [mm2]
Inspection level	5/5,5/5,5/5,5/5,5/5	Label	-
Light	6,6,3/6,6,3

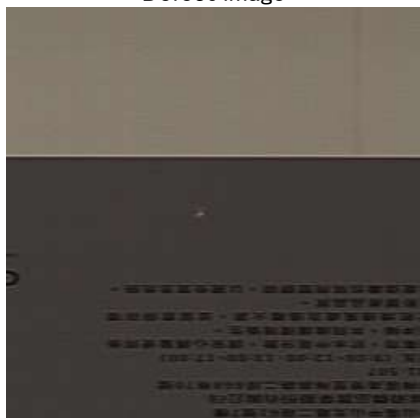
Defect image

No.	#96, \$83	Date	2023/8/9 上午 11:31:57
Segment	1	Camera	1
Pattern	6978	Position[x, y]	167.8 [mm], 5278.3 [m], (230.1 [m])
Type	縱向刀絲疵點	Size	H:2.2 ,V:1.6 [mm]
Result	-	Area	2.9 [mm2]
Inspection level	5/5,5/5,5/5,5/5,5/5	Label	-
Light	6,6,3/6,6,3

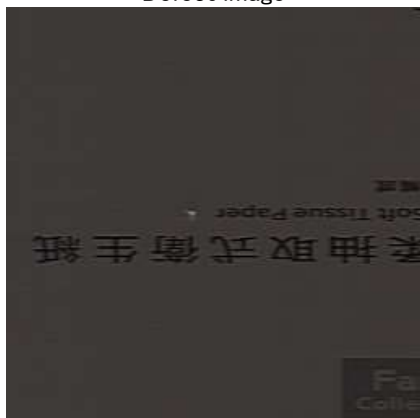
Defect image

No.	#93, \$80	Date	2023/8/9 上午 11:31:55
Segment	1	Camera	1
Pattern	6974	Position[x, y]	168.1 [mm], 5275.4 [m], (232.9 [m])
Type	縱向刀絲疵點	Size	H:1.7 ,V:1.6 [mm]
Result	-	Area	2.0 [mm2]
Inspection level	5/5,5/5,5/5,5/5,5/5	Label	-
Light	6,6,3/6,6,3

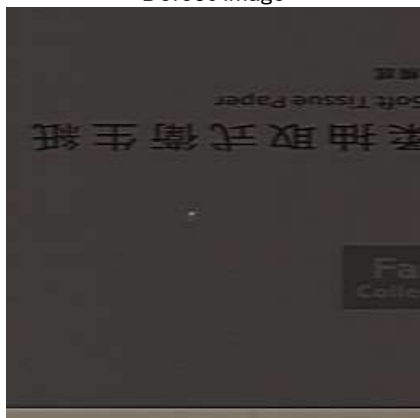
Defect image

No.	#88, \$75	Date	2023/8/9 上午 11:31:49
Segment	1	Camera	1
Pattern	6964	Position[x, y]	182.2 [mm], 5268.1 [m], (240.3 [m])
Type	縱向刀絲疵點	Size	H:2.4 ,V:2.0 [mm]
Result	-	Area	4.0 [mm2]
Inspection level	5/5,5/5,5/5,5/5,5/5	Label	-
Light	6,6,3/6,6,3

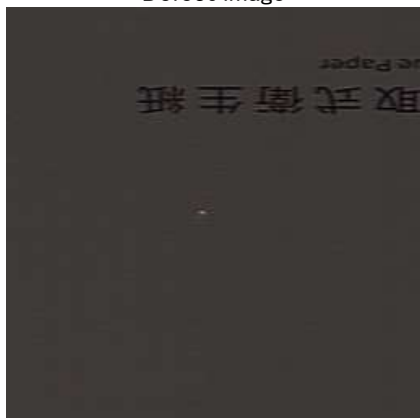
Defect image

No.	#79, \$66	Date	2023/8/9 上午 11:31:39
Segment	1	Camera	1
Pattern	6947	Position[x, y]	182.2 [mm], 5255.2 [m], (253.2 [m])
Type	縱向刀絲疵點	Size	H:2.0 ,V:1.6 [mm]
Result	-	Area	2.7 [mm2]
Inspection level	5/5,5/5,5/5,5/5,5/5	Label	-
Light	6,6,3/6,6,3

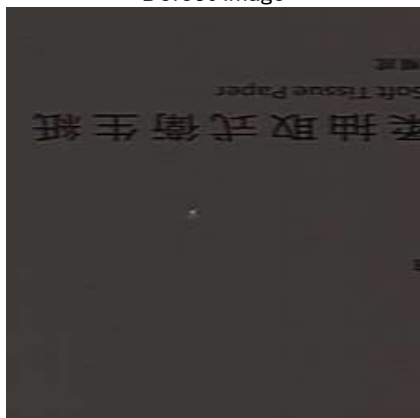
Defect image

No.	#78, \$65	Date	2023/8/9 上午 11:31:38
Segment	1	Camera	1
Pattern	6945	Position[x, y]	182.5 [mm], 5253.7 [m], (254.7 [m])
Type	縱向刀絲疵點	Size	H:2.4 ,V:1.6 [mm]
Result	-	Area	3.4 [mm2]
Inspection level	5/5,5/5,5/5,5/5,5/5	Label	-
Light	6,6,3/6,6,3

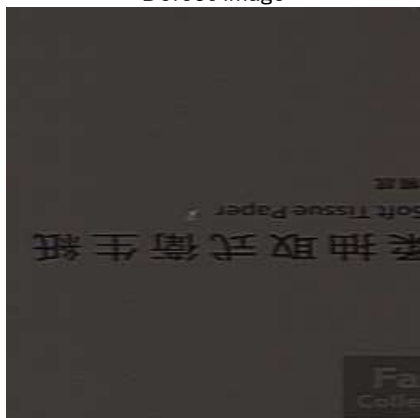
Defect image

No.	#77, \$64	Date	2023/8/9 上午 11:31:37
Segment	1	Camera	1
Pattern	6943	Position[x, y]	182.5 [mm], 5252.3 [m], (256.1 [m])
Type	縱向刀絲疵點	Size	H:2.2 ,V:2.0 [mm]
Result	-	Area	3.7 [mm2]
Inspection level	5/5,5/5,5/5,5/5,5/5	Label	-
Light	6,6,3/6,6,3

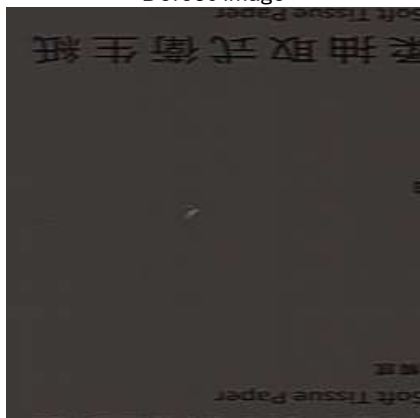
Defect image

No.	#65, \$52	Date	2023/8/9 上午 11:31:23
Segment	1	Camera	1
Pattern	6920	Position[x, y]	168.1 [mm], 5235.3 [m], (273.1 [m])
Type	縱向刀絲疵點	Size	H:2.4 ,V:1.6 [mm]
Result	-	Area	3.4 [mm2]
Inspection level	5/5,5/5,5/5,5/5,5/5	Label	-
Light	6,6,3/6,6,3

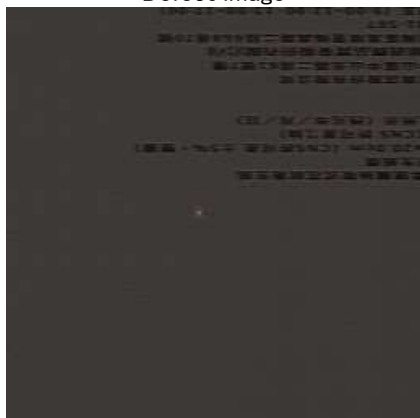
Defect image

No.	#59, \$46	Date	2023/8/9 上午 11:31:16
Segment	1	Camera	1
Pattern	6909	Position[x, y]	167.6 [mm], 5226.6 [m], (281.8 [m])
Type	縱向刀絲疵點	Size	H:2.2 ,V:1.6 [mm]
Result	-	Area	2.9 [mm2]
Inspection level	5/5,5/5,5/5,5/5,5/5	Label	-
Light	6,6,3/6,6,3

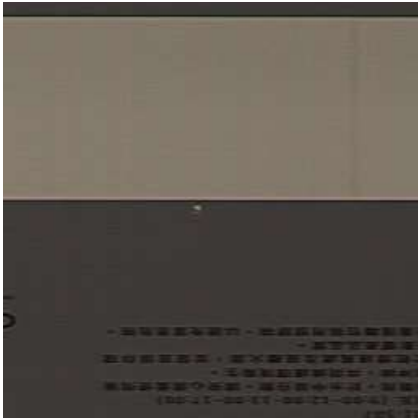
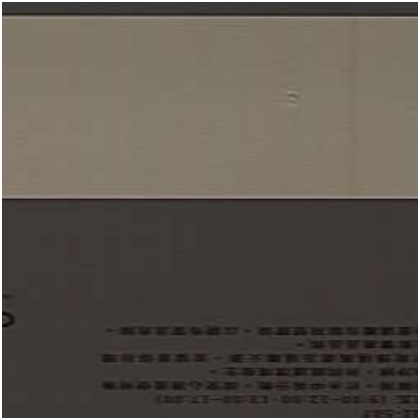
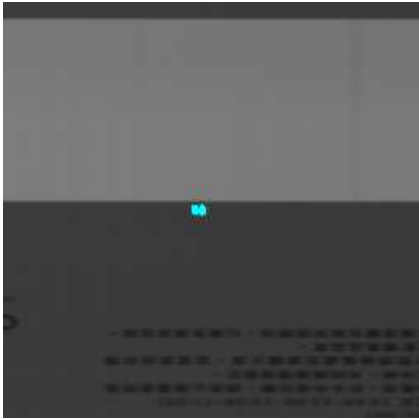
Defect image	Reference image	Shape image

No.	#36, \$27	Date	2023/8/9 上午 11:30:49
Segment	1	Camera	1
Pattern	6863	Position[x, y]	566.8 [mm], 5191.9 [m], (316.4 [m])
Type	縱向刀絲疵點	Size	H:0.5 ,V:25.2 [mm]
Result	-	Area	11.1 [mm2]
Inspection level	5/5,5/5,5/5,5/5,5/5	Label	-
Light	6,6,3/6,6,3

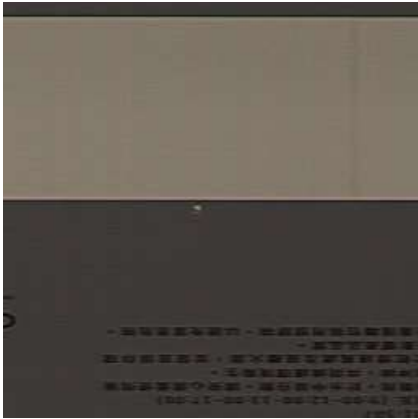
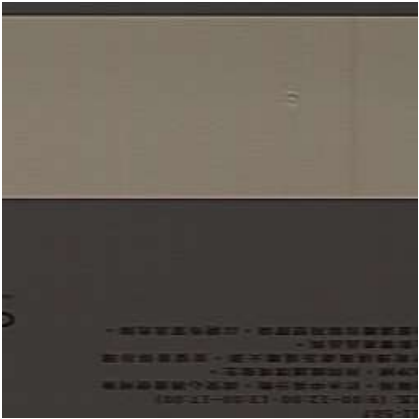
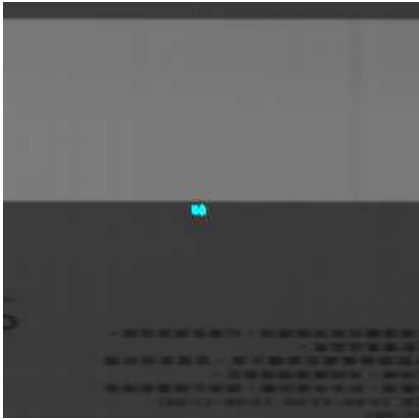
Defect image	Reference image	Shape image

No.	#36, \$27	Date	2023/8/9 上午 11:30:49
Segment	1	Camera	1
Pattern	6863	Position[x, y]	698.8 [mm], 5192.4 [m], (316.0 [m])
Type	縱向刀絲疵點	Size	H:0.5 ,V:210.0 [mm]
Result	-	Area	15.0 [mm2]
Inspection level	5/5,5/5,5/5,5/5,5/5	Label	-
Light	6,6,3/6,6,3

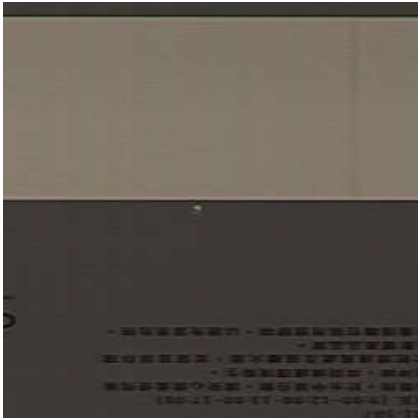
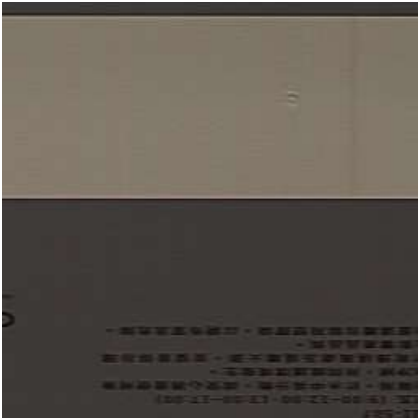
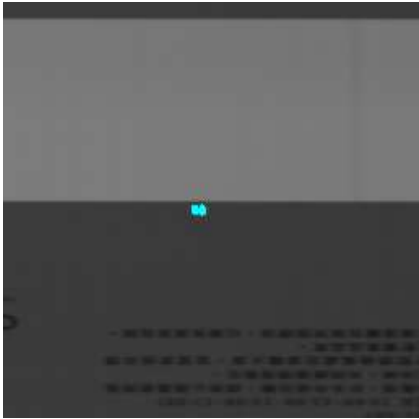
Defect image	Reference image	Shape image

No.	#36, \$27	Date	2023/8/9 上午 11:30:49
Segment	1	Camera	1
Pattern	6863	Position[x, y]	698.8 [mm], 5192.1 [m], (316.3 [m])
Type	縱向刀絲疵點	Size	H:0.5 ,V:137.2 [mm]
Result	-	Area	20.1 [mm2]
Inspection level	5/5,5/5,5/5,5/5,5/5	Label	-
Light	6,6,3/6,6,3

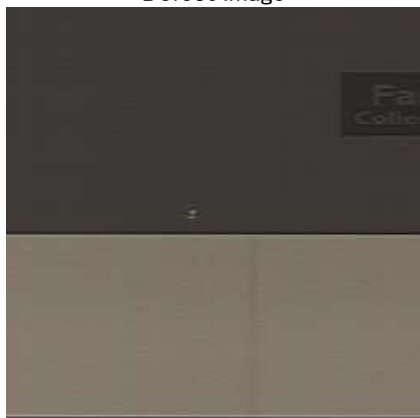
Defect image

No.	#32, \$23	Date	2023/8/9 上午 11:30:47
Segment	1	Camera	1
Pattern	6859	Position[x, y]	182.5 [mm], 5189.0 [m], (319.4 [m])
Type	縱向刀絲疵點	Size	H:2.2 ,V:2.8 [mm]
Result	-	Area	4.9 [mm2]
Inspection level	5/5,5/5,5/5,5/5,5/5	Label	-
Light	6,6,3/6,6,3

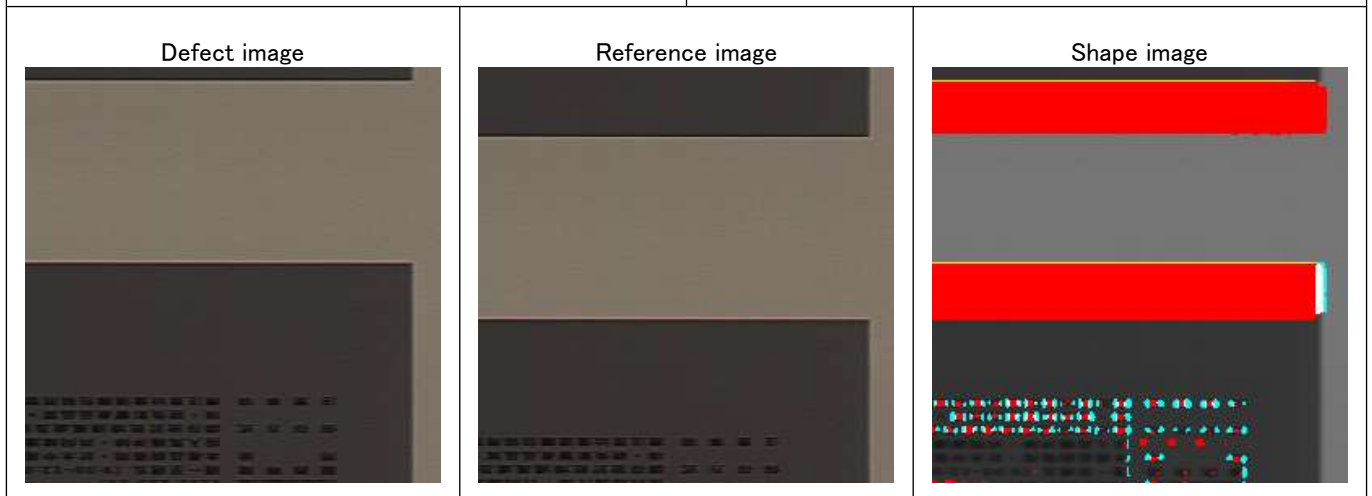
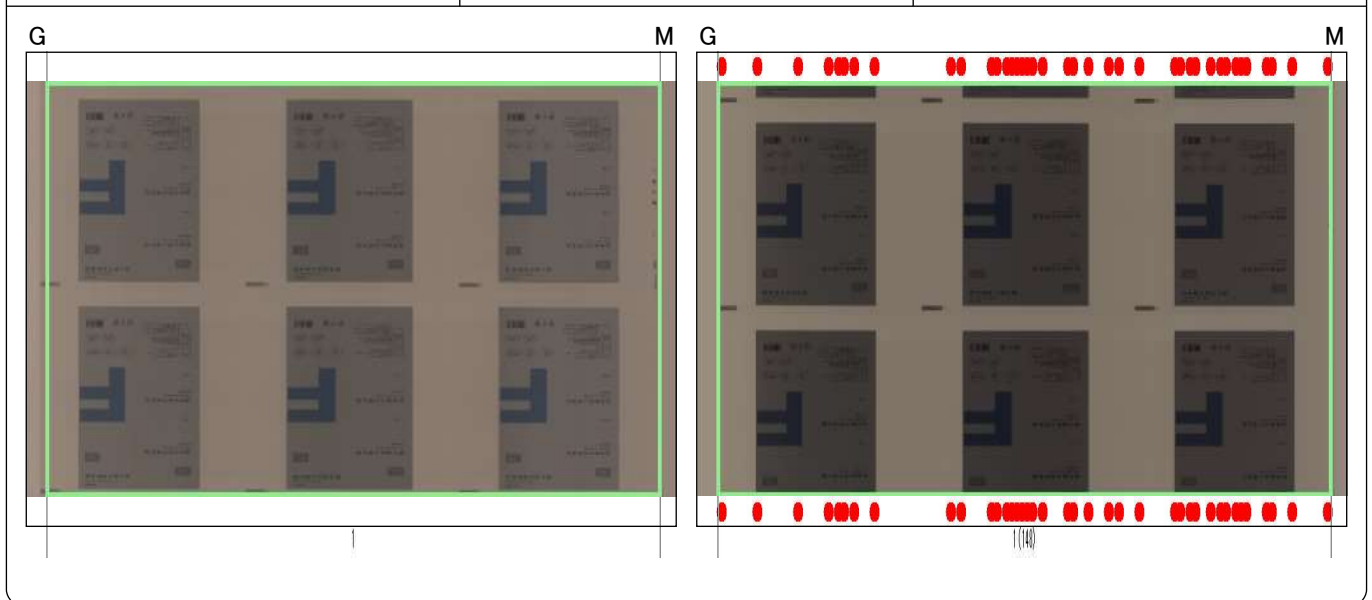
No.	#27, \$20	Date	2023/8/9 上午 11:30:37
Segment	1	Camera	1
Pattern	6842	Position[x, y]	448.3 [mm], 5176.6 [m], (331.8 [m])
Type	点状疵点縱向刀絲疵點	Size	H:193.6 ,V:167.6 [mm]
Result	-	Area	2329.0 [mm2]
Inspection level	5/5,5/5,5/5,5/5,5/5	Label	-
Light	6,6,3/6,6,3

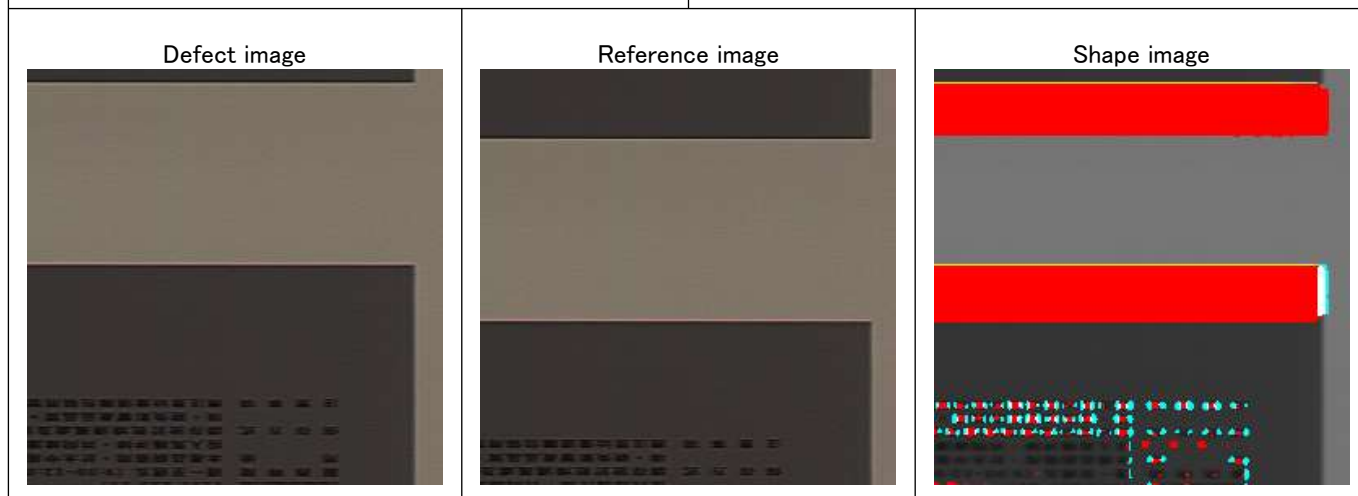
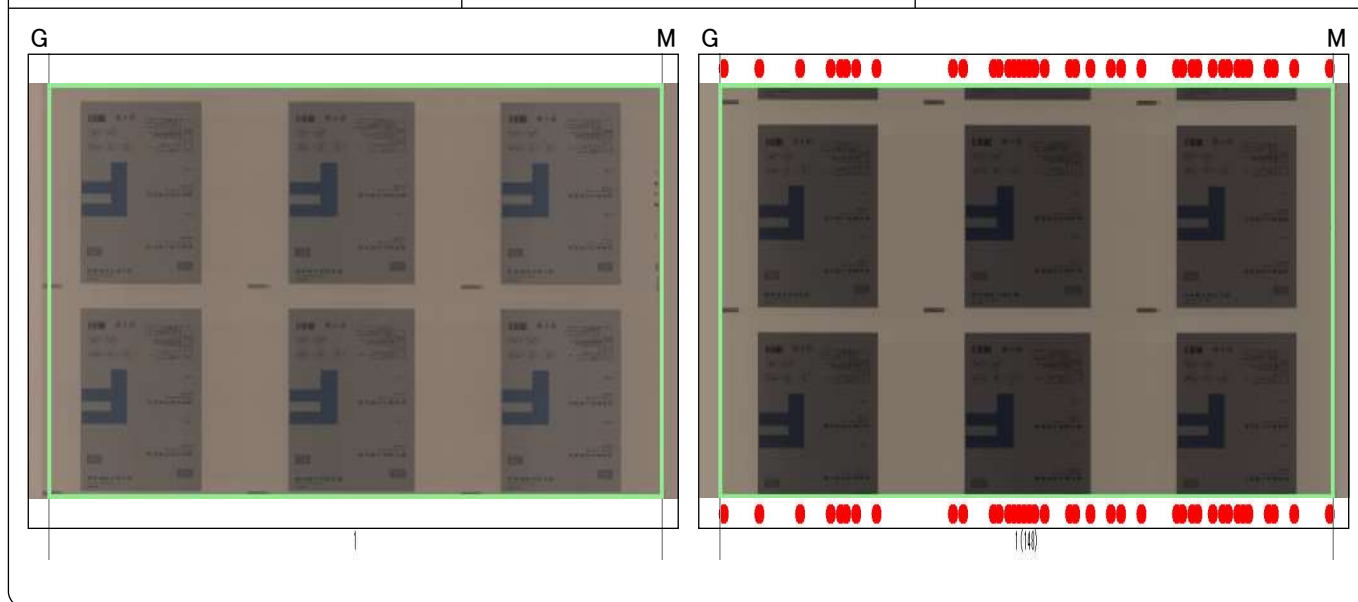
No.	#26, \$19	Date	2023/8/9 上午 11:30:36
Segment	1	Camera	1
Pattern	6841	Position[x, y]	443.0 [mm], 5175.4 [m], (333.0 [m])
Type	点状疵点縱向刀絲疵點	Size	H:193.6 ,V:50.4 [mm]
Result	-	Area	2289.6 [mm2]
Inspection level	5/5,5/5,5/5,5/5,5/5	Label	-
Light	6,6,3/6,6,3

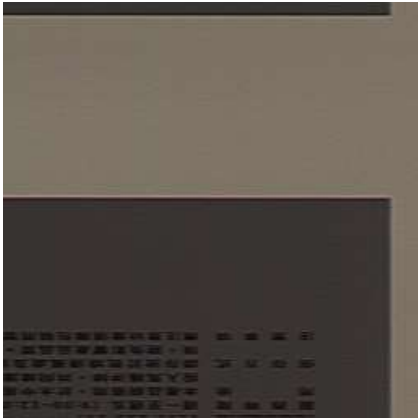
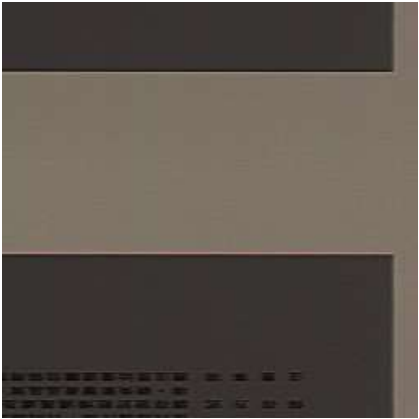
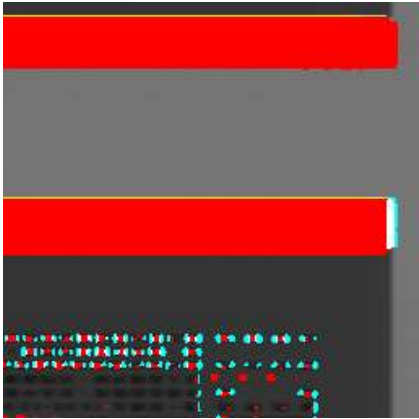
Defect image	Reference image	Shape image

No.	#26, \$19	Date	2023/8/9 上午 11:30:36
Segment	1	Camera	1
Pattern	6841	Position[x, y]	471.5 [mm], 5175.5 [m], (332.9 [m])
Type	点状疵点縱向刀絲疵點橫向刀絲	Size	H:194.8 ,V:86.8 [mm]
Result	-	Area	2363.0 [mm2]
Inspection level	5/5,5/5,5/5,5/5,5/5	Label	-
Light	6,6,3/6,6,3

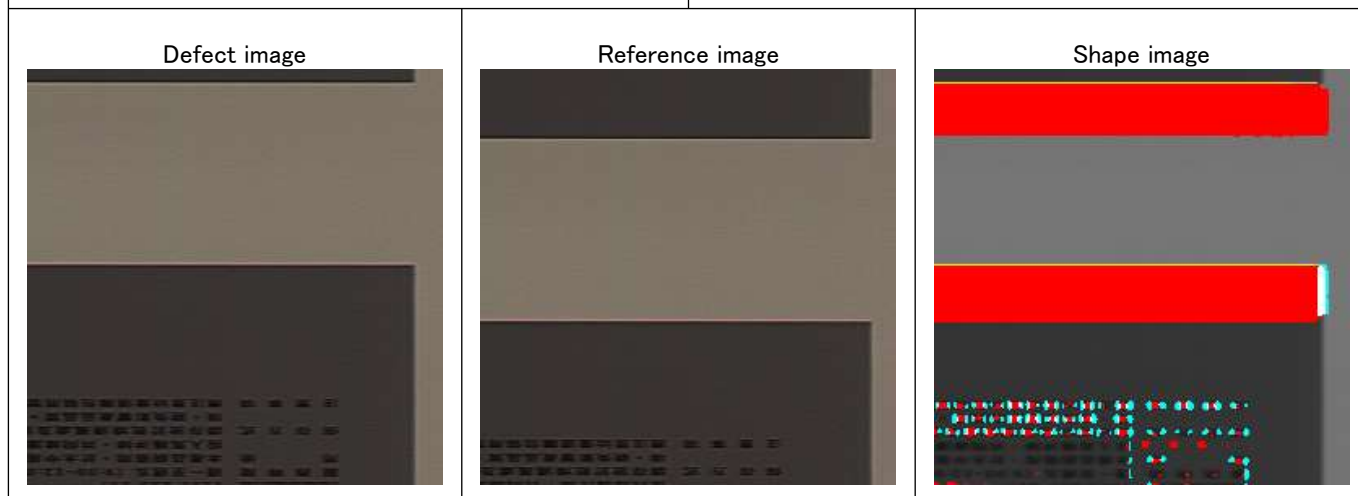
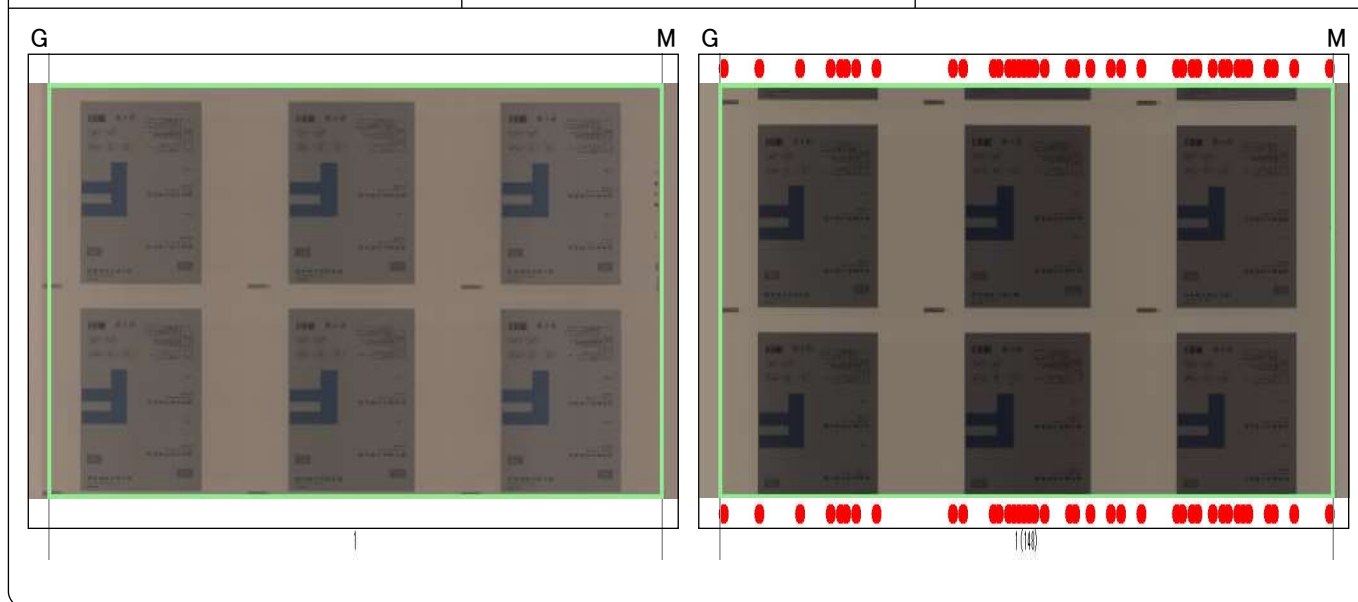
No.	#26, \$19	Date	2023/8/9 上午 11:30:36
Segment	1	Camera	1
Pattern	6841	Position[x, y]	428.3 [mm], 5175.8 [m], (332.6 [m])
Type	点状疵点縱向刀絲疵點	Size	H:193.6 ,V:38.0 [mm]
Result	-	Area	2371.8 [mm2]
Inspection level	5/5,5/5,5/5,5/5,5/5	Label	-
Light	6,6,3/6,6,3

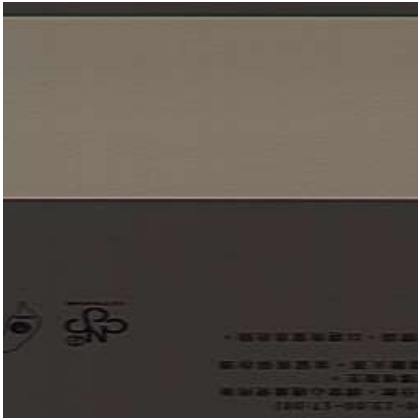
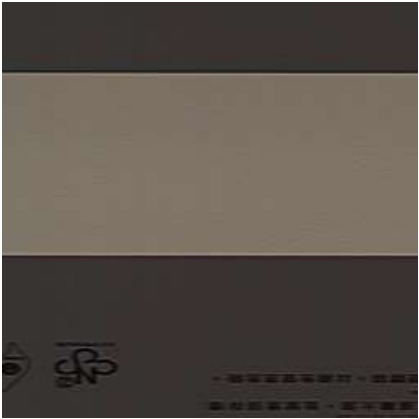
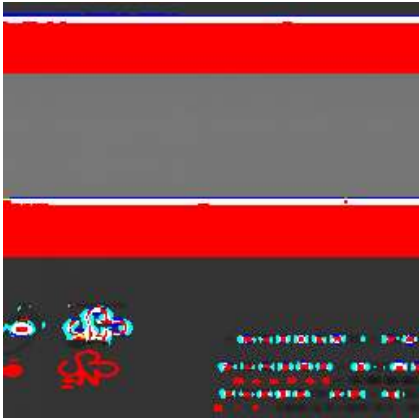
Defect image	Reference image	Shape image

No.	#24, \$17	Date	2023/8/9 上午 11:30:35
Segment	1	Camera	1
Pattern	6839	Position[x, y]	792.6 [mm], 5174.0 [m], (334.4 [m])
Type	点状疵点縱向刀絲疵點橫向刀絲	Size	H:184.3 ,V:138.0 [mm]
Result	-	Area	2184.6 [mm2]
Inspection level	5/5,5/5,5/5,5/5,5/5	Label	-
Light	6,6,3/6,6,3

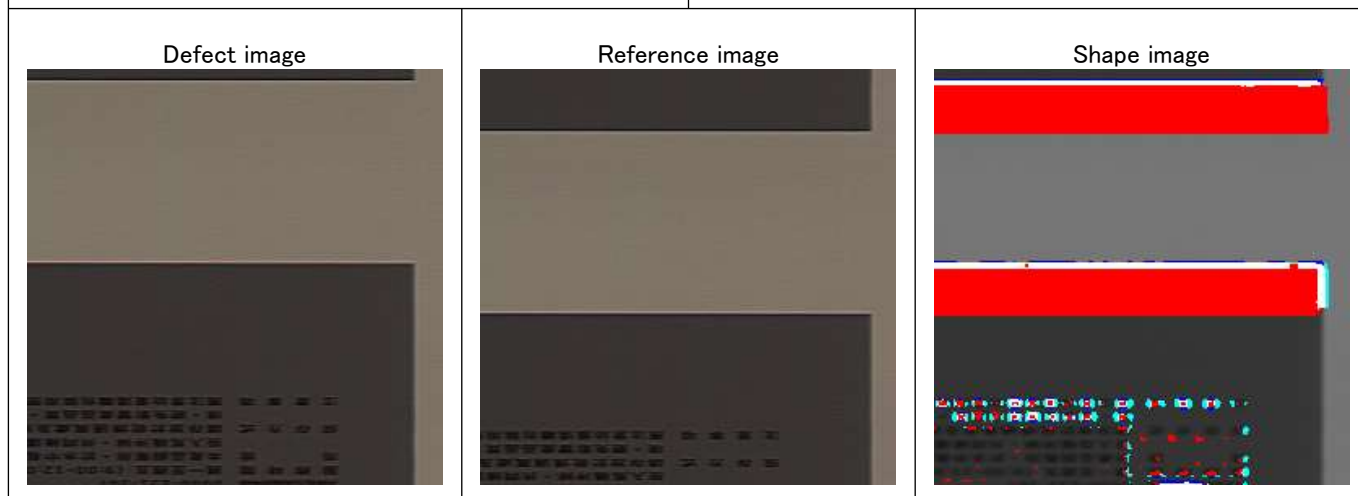
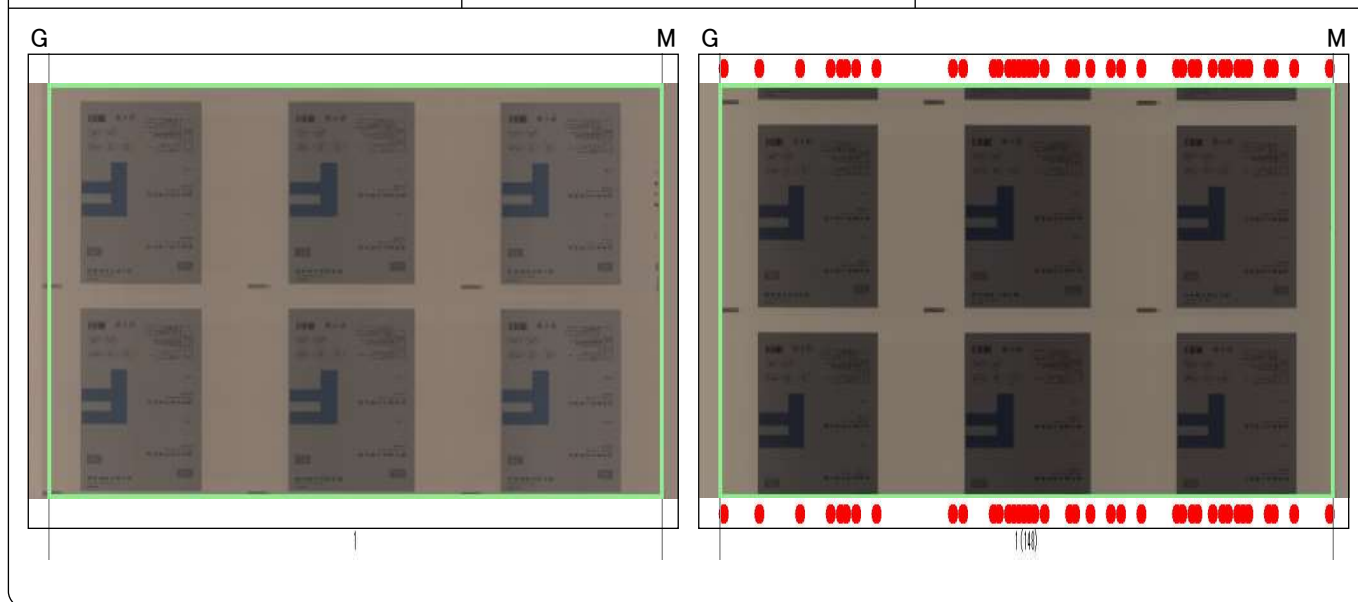
No.	#21, \$16	Date	2023/8/9 上午 11:30:18
Segment	1	Camera	1
Pattern	6810	Position[x, y]	59.7 [mm], 5152.0 [m], (356.4 [m])
Type	点状疵点縱向刀絲疵點	Size	H:11.7 ,V:424.4 [mm]
Result	-	Area	531.2 [mm2]
Inspection level	5/5,5/5,5/5,5/5,5/5	Label	-
Light	6,6,3/6,6,3

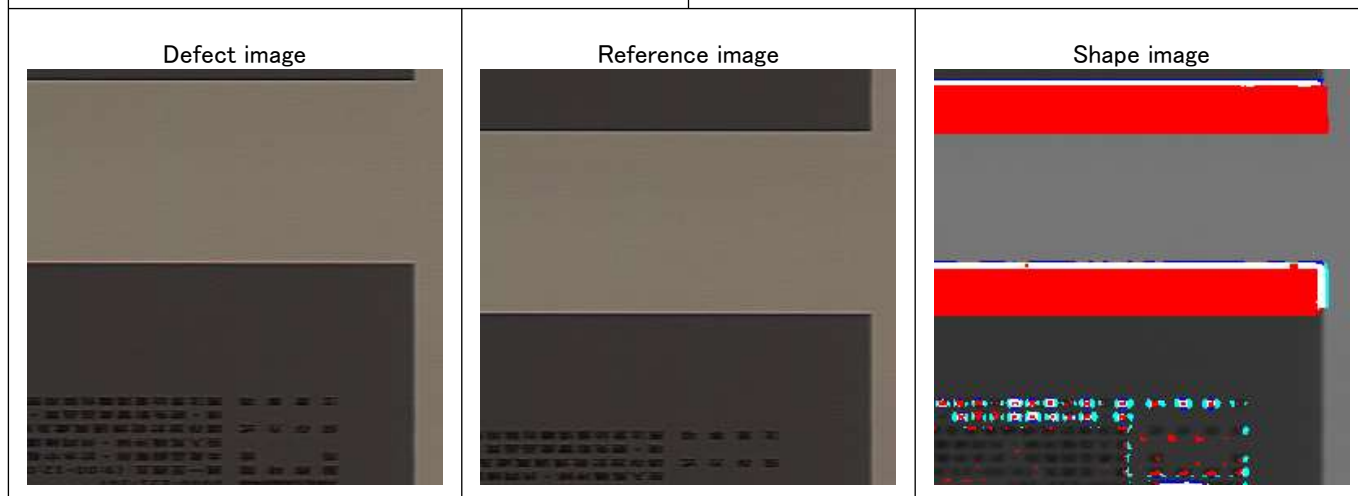
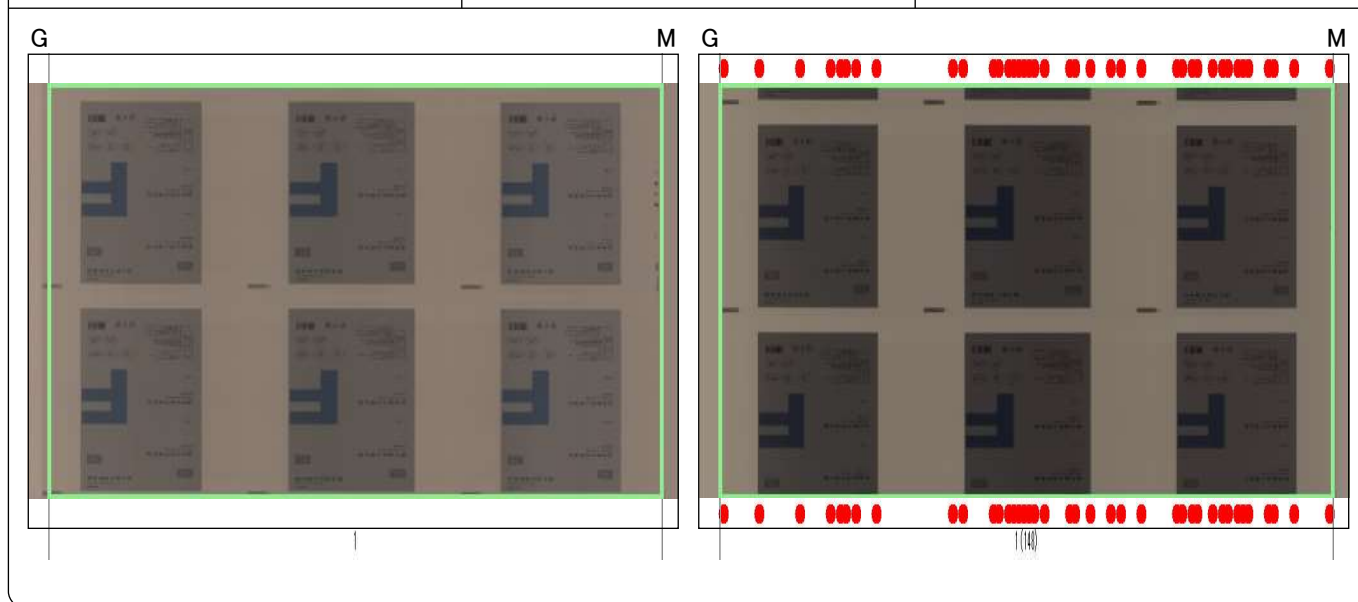
No.	#21, \$16	Date	2023/8/9 上午 11:30:18
Segment	1	Camera	1
Pattern	6810	Position[x, y]	59.4 [mm], 5152.3 [m], (356.1 [m])
Type	点状疵点縱向刀絲疵點	Size	H:11.2 ,V:606.4 [mm]
Result	-	Area	548.8 [mm2]
Inspection level	5/5,5/5,5/5,5/5,5/5	Label	-
Light	6,6,3/6,6,3

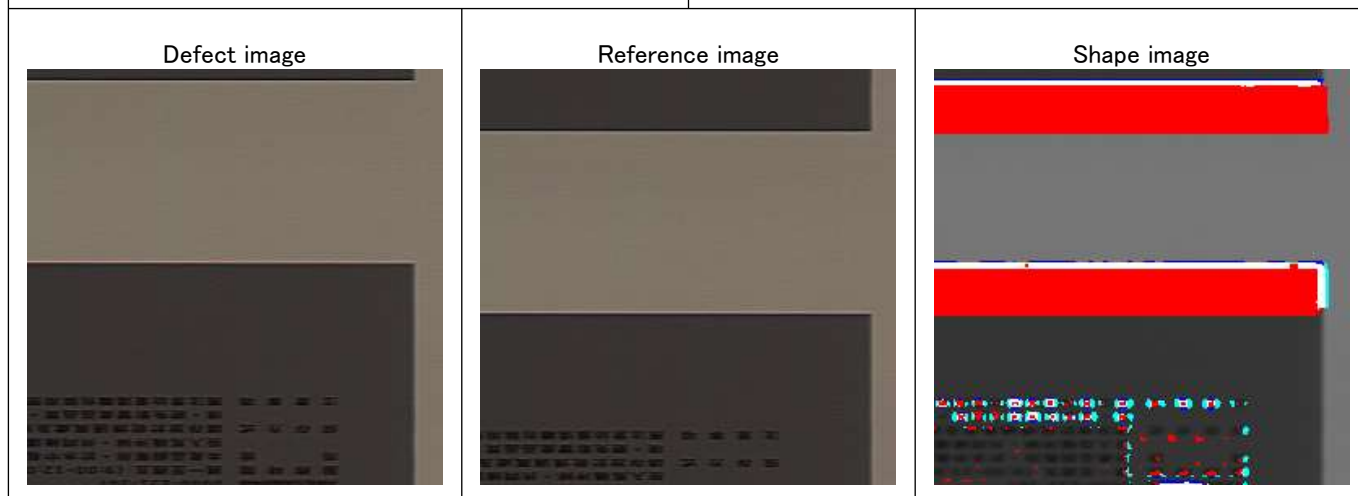
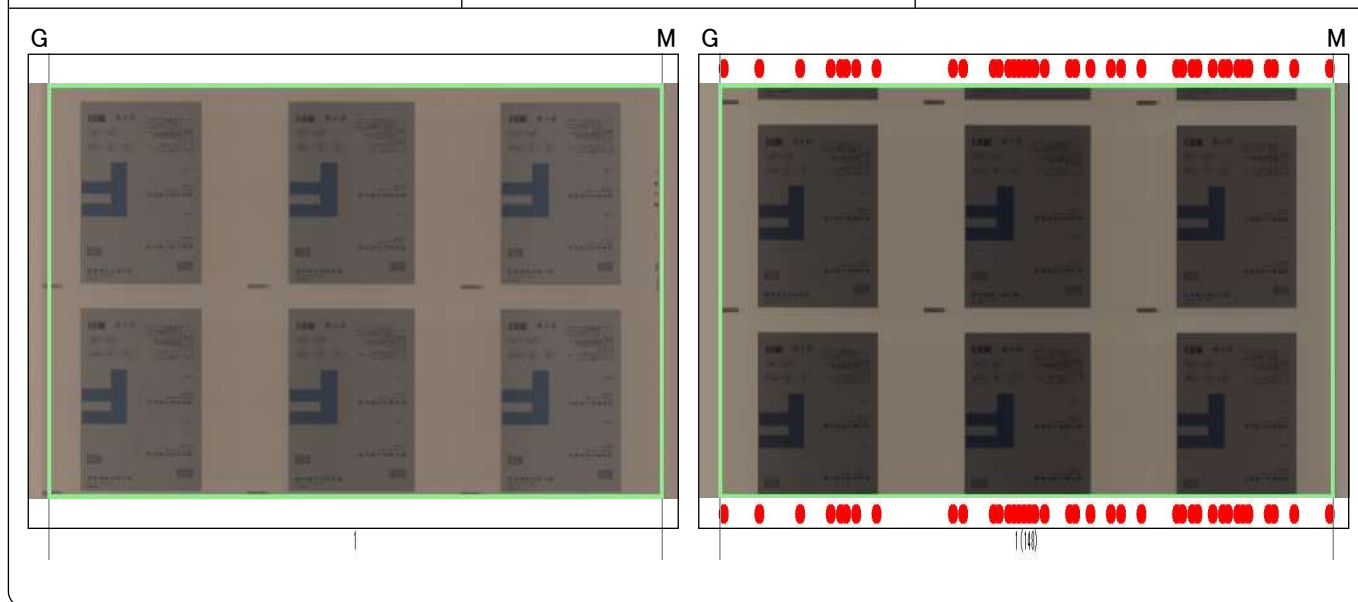
No.	#21, \$16	Date	2023/8/9 上午 11:30:18
Segment	1	Camera	1
Pattern	6810	Position[x, y]	360.9 [mm], 5152.4 [m], (356.0 [m])
Type	点状疵点縱向刀絲疵點	Size	H:89.1 ,V:382.0 [mm]
Result	-	Area	1203.0 [mm2]
Inspection level	5/5,5/5,5/5,5/5,5/5	Label	-
Light	6,6,3/6,6,3
