# Inspection Result (Individual Data)

Lot number : 6

Inspected date : 2023/8/9 下午 02:20:08 ~ 2023/8/9 下午 03:44:45

商品名	標準透明6-6-3	周長	
顧客名		Ex1	
CODE番号		Ex2	
基材		Ex3

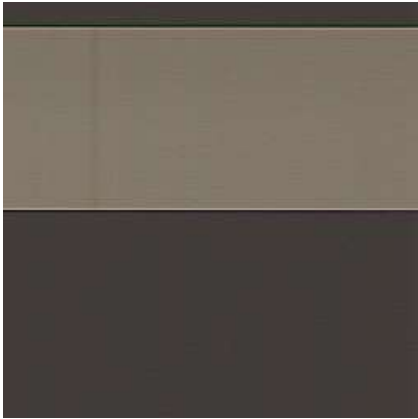
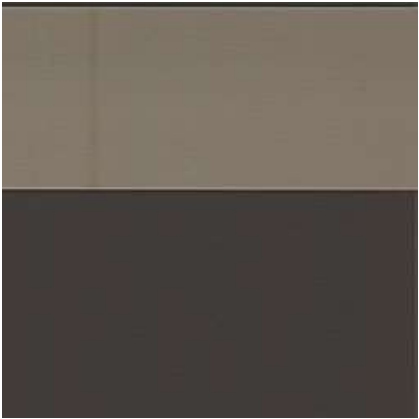
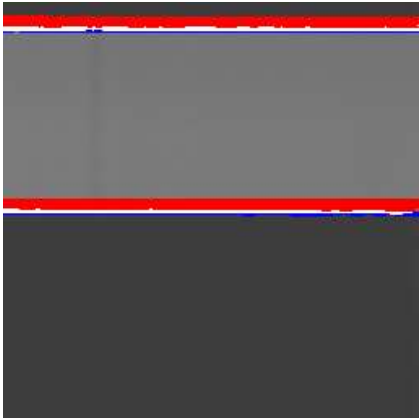
No.	#68, \$62	Date	2023/8/9 下午 03:41:41
Segment	1	Camera	1
Pattern	7880	Position[ x, y ]	126.1 [mm], 5927.3 [m], ( 213.3 [m] )
Type	点状疵点縱向刀絲疵點橫向刀絲	Size	H:185.1 ,V:108.0 [mm]
Result	-	Area	474.5 [mm2]
Inspection level	5/5,5/5,5/5,5/5,5/5	Label	-
Light	6,6,3/6,6,3

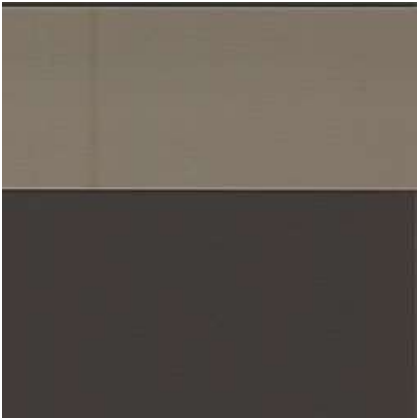
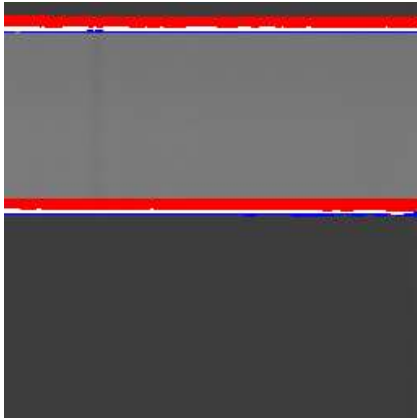
No.	#66, \$61	Date	2023/8/9 下午 03:41:24
Segment	1	Camera	1
Pattern	7879	Position[ x, y ]	469.1 [mm], 5926.3 [m], ( 214.4 [m] )
Type	点状疵点	Size	H:193.4 ,V:2.4 [mm]
Result	-	Area	364.3 [mm2]
Inspection level	5/5,5/5,5/5,5/5,5/5	Label	-
Light	6,6,3/6,6,3

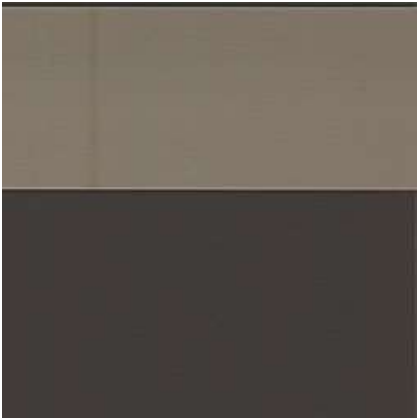
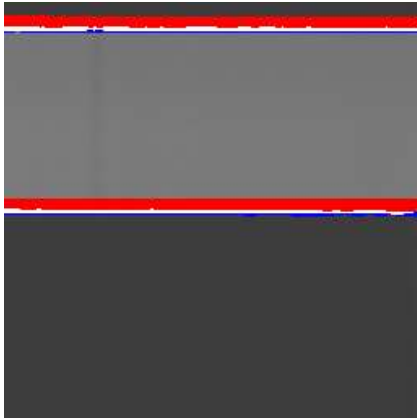
No.	#66, \$61	Date	2023/8/9 下午 03:41:24
Segment	1	Camera	1
Pattern	7879	Position[ x, y ]	783.8 [mm], 5926.2 [m], ( 214.4 [m] )
Type	点状疵点	Size	H:184.1 ,V:2.4 [mm]
Result	-	Area	377.7 [mm2]
Inspection level	5/5,5/5,5/5,5/5,5/5	Label	-
Light	6,6,3/6,6,3

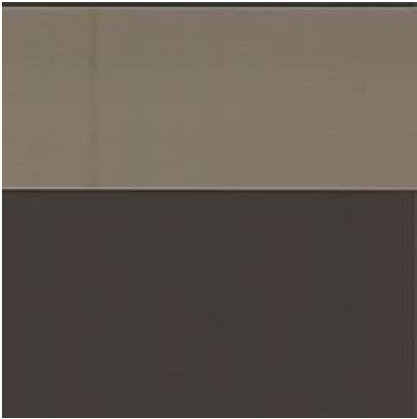
No.	#66, \$61	Date	2023/8/9 下午 03:41:24
Segment	1	Camera	1
Pattern	7879	Position[ x, y ]	460.8 [mm], 5926.2 [m], ( 214.4 [m] )
Type	点状疵点	Size	H:193.1 ,V:2.8 [mm]
Result	-	Area	405.9 [mm2]
Inspection level	5/5,5/5,5/5,5/5,5/5	Label	-
Light	6,6,3/6,6,3

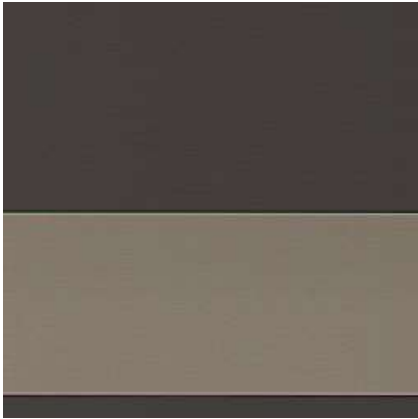
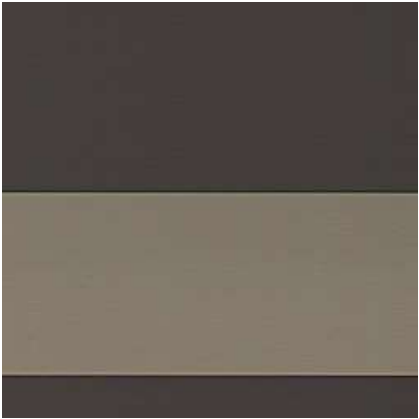
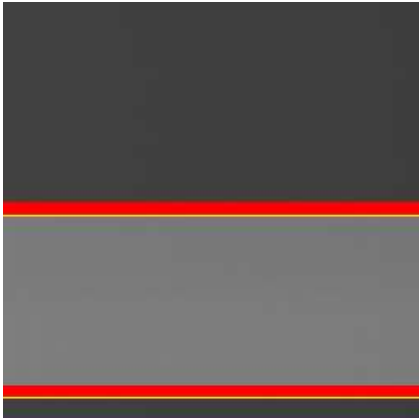
No.	#66, \$61	Date	2023/8/9 下午 03:41:24
Segment	1	Camera	1
Pattern	7879	Position[ x, y ]	149.0 [mm], 5926.2 [m], ( 214.4 [m] )
Type	点状疵点	Size	H:184.3 ,V:2.8 [mm]
Result	-	Area	439.9 [mm2]
Inspection level	5/5,5/5,5/5,5/5,5/5	Label	-
Light	6,6,3/6,6,3

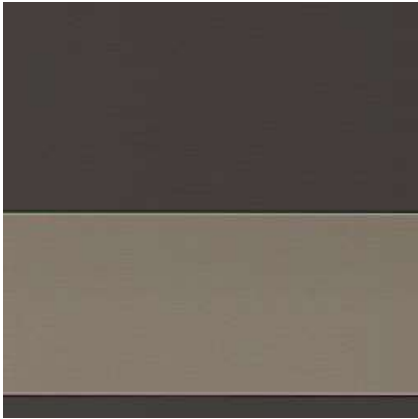
No.	#65, \$60	Date	2023/8/9 下午 03:41:22
Segment	1	Camera	1
Pattern	7878	Position[ x, y ]	464.2 [mm], 5925.9 [m], ( 214.8 [m] )
Type	点状疵点	Size	H:193.1 ,V:1.6 [mm]
Result	-	Area	275.3 [mm2]
Inspection level	5/5,5/5,5/5,5/5,5/5	Label	-
Light	6,6,3/6,6,3

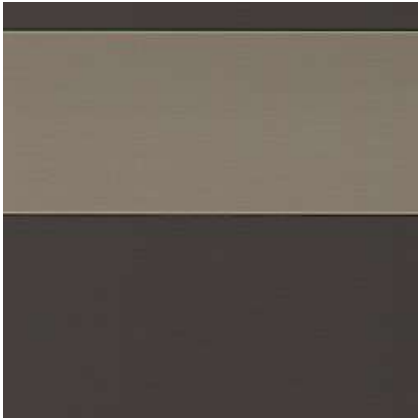
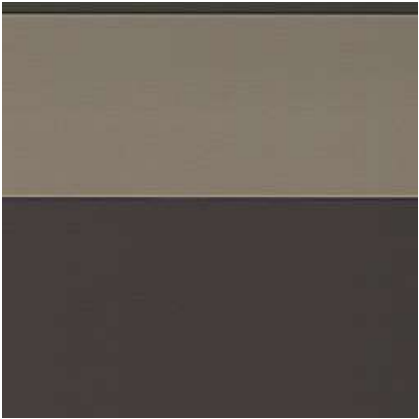
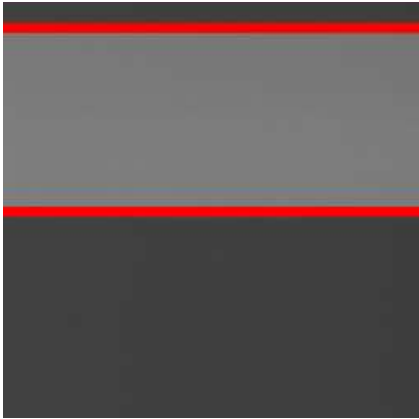
No.	#65, \$60	Date	2023/8/9 下午 03:41:22
Segment	1	Camera	1
Pattern	7878	Position[ x, y ]	148.8 [mm], 5925.9 [m], ( 214.8 [m] )
Type	点状疵点	Size	H:184.6 ,V:1.6 [mm]
Result	-	Area	292.4 [mm2]
Inspection level	5/5,5/5,5/5,5/5,5/5	Label	-
Light	6,6,3/6,6,3

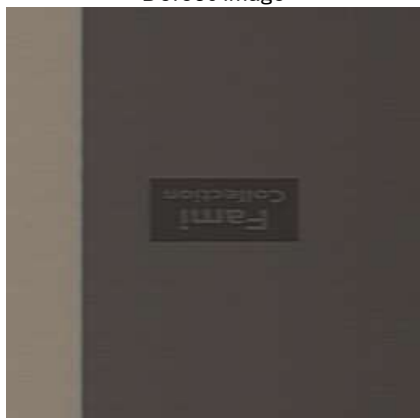
No.	#61, \$58	Date	2023/8/9 下午 03:41:07
Segment	1	Camera	1
Pattern	7854	Position[ x, y ]	403.7 [mm], 5907.6 [m], ( 233.1 [m] )
Type	点状疵点	Size	H:20.0 ,V:12.4 [mm]
Result	-	Area	184.2 [mm2]
Inspection level	5/5,5/5,5/5,5/5,5/5	Label	-
Light	6,6,3/6,6,3

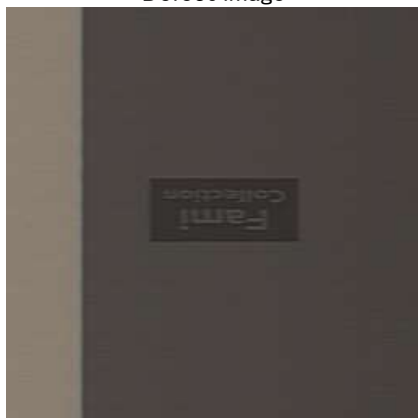
No.	#61, \$58	Date	2023/8/9 下午 03:41:07
Segment	1	Camera	1
Pattern	7854	Position[ x, y ]	727.6 [mm], 5907.9 [m], ( 232.7 [m] )
Type	点状疵点	Size	H:19.3 ,V:12.4 [mm]
Result	-	Area	185.3 [mm2]
Inspection level	5/5,5/5,5/5,5/5,5/5	Label	-
Light	6,6,3/6,6,3

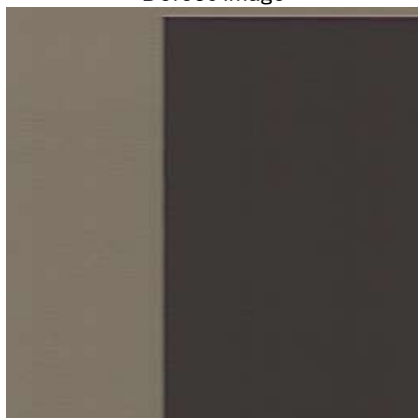
No.	#58, \$55	Date	2023/8/9 下午 03:41:05
Segment	1	Camera	1
Pattern	7851	Position[ x, y ]	118.0 [mm], 5905.5 [m], ( 235.1 [m] )
Type	点状疵点縱向刀絲疵點	Size	H:187.0 ,V:789.6 [mm]
Result	-	Area	1599.8 [mm2]
Inspection level	5/5,5/5,5/5,5/5,5/5	Label	-
Light	6,6,3/6,6,3

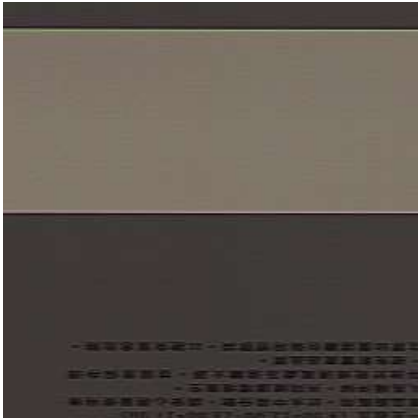
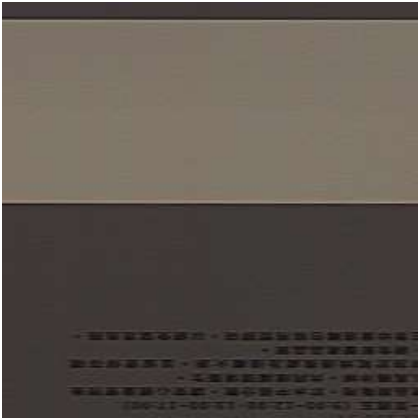
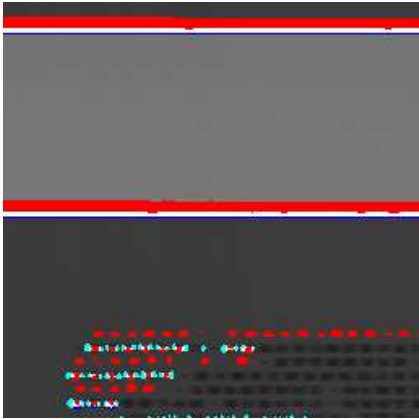
No.	#55, \$53	Date	2023/8/9 下午 03:40:14
Segment	1	Camera	1
Pattern	7782	Position[ x, y ]	767.0 [mm], 5852.6 [m], ( 288.1 [m] )
Type	点状疵点縱向刀絲疵點橫向刀絲	Size	H:183.8 ,V:130.4 [mm]
Result	-	Area	469.4 [mm2]
Inspection level	5/5,5/5,5/5,5/5,5/5	Label	-
Light	6,6,3/6,6,3

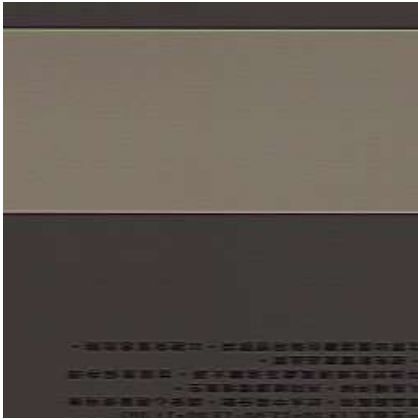
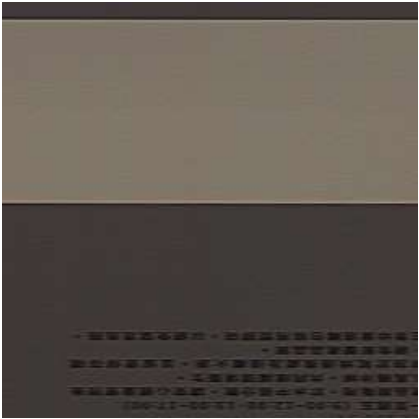
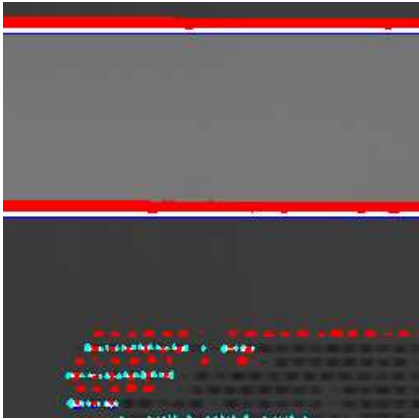
No.	#54, \$52	Date	2023/8/9 下午 03:40:10
Segment	1	Camera	1
Pattern	7781	Position[ x, y ]	442.7 [mm], 5851.5 [m], ( 289.2 [m] )
Type	点状疵点縱向刀絲疵點橫向刀絲	Size	H:193.1 ,V:50.8 [mm]
Result	-	Area	599.4 [mm2]
Inspection level	5/5,5/5,5/5,5/5,5/5	Label	-
Light	6,6,3/6,6,3

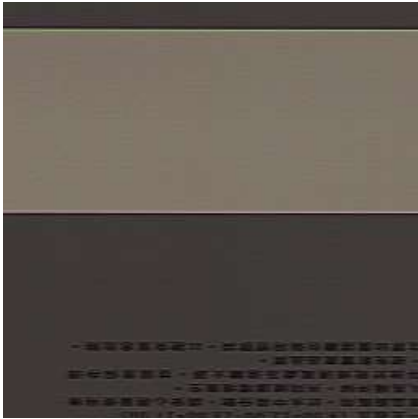
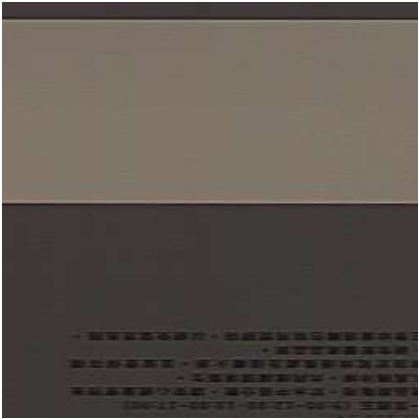
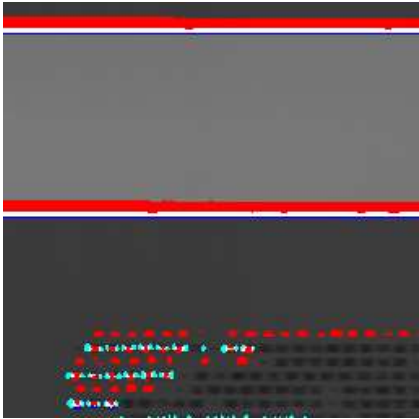
No.	#54, \$52	Date	2023/8/9 下午 03:40:10
Segment	1	Camera	1
Pattern	7781	Position[ x, y ]	468.9 [mm], 5851.4 [m], ( 289.2 [m] )
Type	点状疵点横向刀絲	Size	H:193.1 ,V:49.2 [mm]
Result	-	Area	609.4 [mm2]
Inspection level	5/5,5/5,5/5,5/5,5/5	Label	-
Light	6,6,3/6,6,3

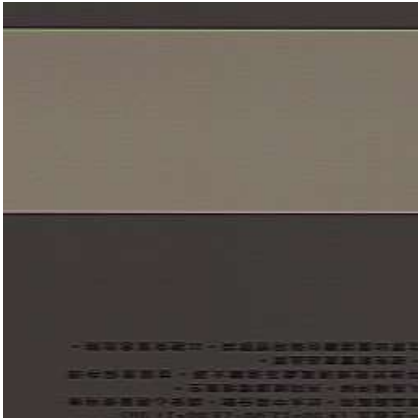
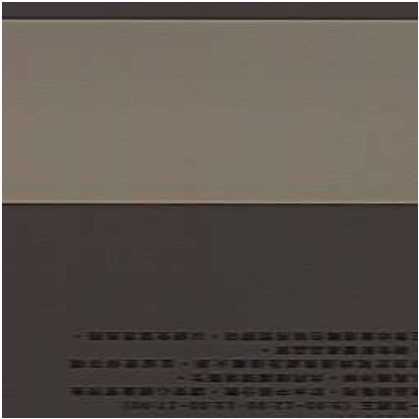
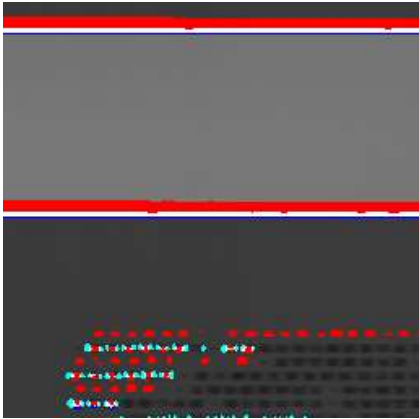
No.	#54, \$52	Date	2023/8/9 下午 03:40:10
Segment	1	Camera	1
Pattern	7781	Position[ x, y ]	131.2 [mm], 5851.5 [m], ( 289.2 [m] )
Type	点状疵点縱向刀絲疵點橫向刀絲	Size	H:184.3 ,V:60.0 [mm]
Result	-	Area	610.9 [mm2]
Inspection level	5/5,5/5,5/5,5/5,5/5	Label	-
Light	6,6,3/6,6,3

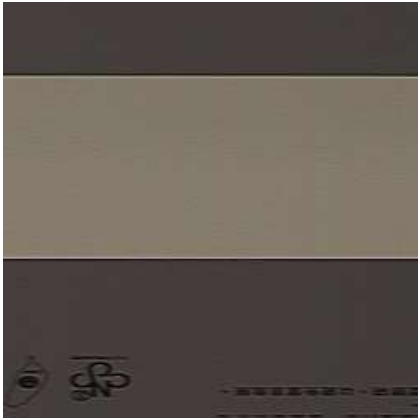
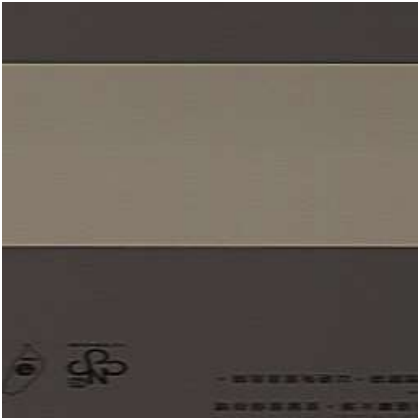
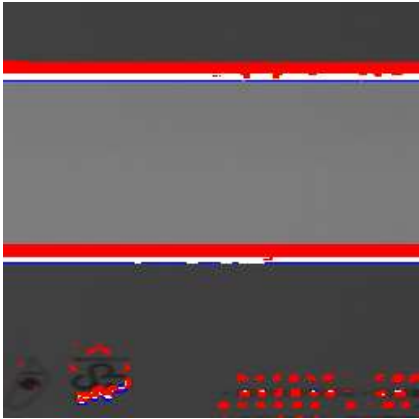
No.	#54, \$52	Date	2023/8/9 下午 03:40:10
Segment	1	Camera	1
Pattern	7781	Position[ x, y ]	153.7 [mm], 5851.4 [m], ( 289.2 [m] )
Type	点状疵点横向刀絲	Size	H:184.3 ,V:49.6 [mm]
Result	-	Area	613.1 [mm2]
Inspection level	5/5,5/5,5/5,5/5,5/5	Label	-
Light	6,6,3/6,6,3

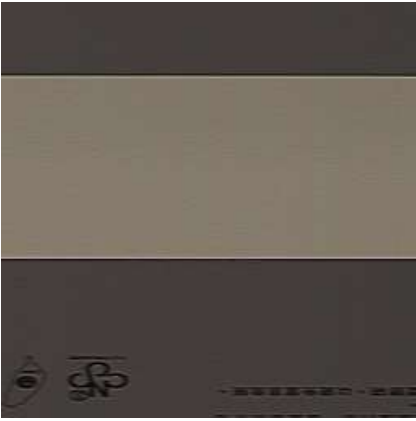
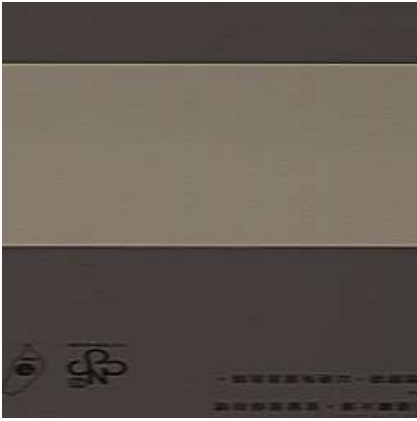
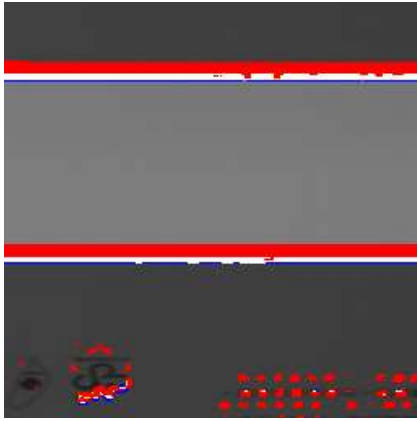
No.	#52, \$51	Date	2023/8/9 下午 03:36:31
Segment	1	Camera	1
Pattern	7780	Position[ x, y ]	468.4 [mm], 5850.7 [m], ( 290.0 [m] )
Type	点状疵点	Size	H:192.9 ,V:2.0 [mm]
Result	-	Area	319.0 [mm2]
Inspection level	5/5,5/5,5/5,5/5,5/5	Label	-
Light	6,6,3/6,6,3

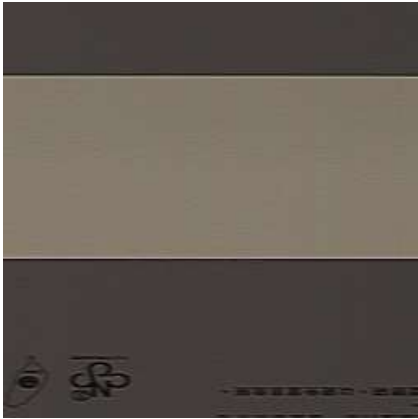
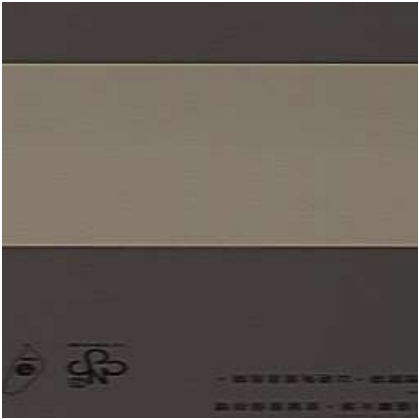
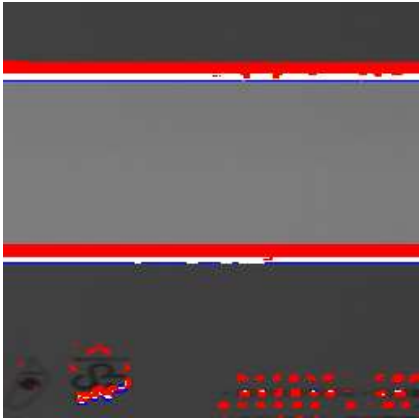
No.	#52, \$51	Date	2023/8/9 下午 03:36:31
Segment	1	Camera	1
Pattern	7780	Position[ x, y ]	146.1 [mm], 5850.7 [m], ( 290.0 [m] )
Type	点状疵点	Size	H:184.3 ,V:2.0 [mm]
Result	-	Area	319.1 [mm2]
Inspection level	5/5,5/5,5/5,5/5,5/5	Label	-
Light	6,6,3/6,6,3

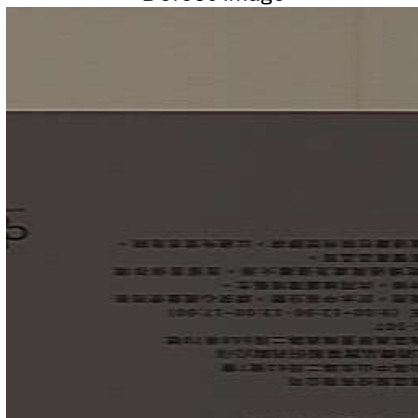
No.	#51, \$50	Date	2023/8/9 下午 03:36:29
Segment	1	Camera	1
Pattern	7779	Position[ x, y ]	134.4 [mm], 5850.0 [m], ( 290.7 [m] )
Type	点状疵点縱向刀絲疵點橫向刀絲	Size	H:173.3 ,V:88.4 [mm]
Result	-	Area	142.4 [mm2]
Inspection level	5/5,5/5,5/5,5/5,5/5	Label	-
Light	6,6,3/6,6,3

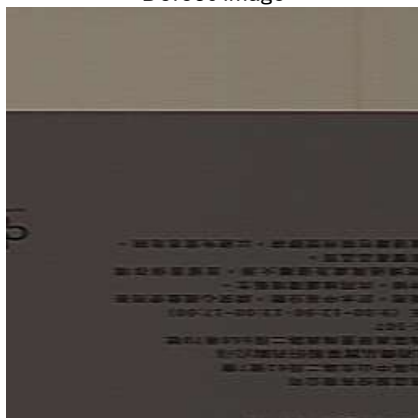
No.	#51, \$50	Date	2023/8/9 下午 03:36:29
Segment	1	Camera	1
Pattern	7779	Position[ x, y ]	793.3 [mm], 5849.9 [m], ( 290.7 [m] )
Type	点状疵点	Size	H:183.8 ,V:2.0 [mm]
Result	-	Area	272.9 [mm2]
Inspection level	5/5,5/5,5/5,5,5/5,5/5	Label	-
Light	6,6,3/6,6,3

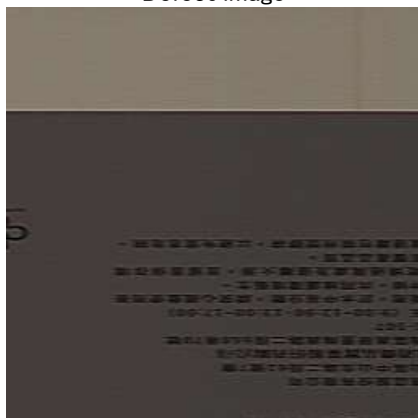
No.	#51, \$50	Date	2023/8/9 下午 03:36:29
Segment	1	Camera	1
Pattern	7779	Position[ x, y ]	155.6 [mm], 5849.9 [m], ( 290.7 [m] )
Type	点状疵点	Size	H:184.1 ,V:2.0 [mm]
Result	-	Area	318.8 [mm2]
Inspection level	5/5,5/5,5/5,5/5,5/5	Label	-
Light	6,6,3/6,6,3

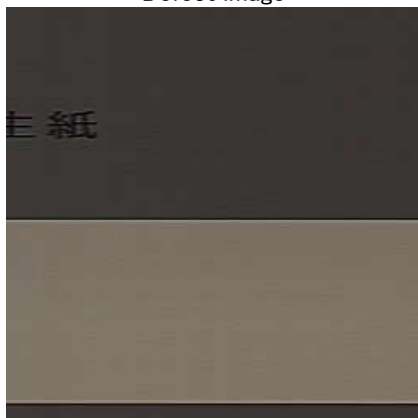
No.	#50, \$49	Date	2023/8/9 下午 03:36:28
Segment	1	Camera	1
Pattern	7778	Position[ x, y ]	729.4 [mm], 5849.8 [m], ( 290.9 [m] )
Type	点状疵点	Size	H:43.0 ,V:24.0 [mm]
Result	-	Area	18.1 [mm2]
Inspection level	5/5,5/5,5/5,5/5,5/5	Label	-
Light	6,6,3/6,6,3

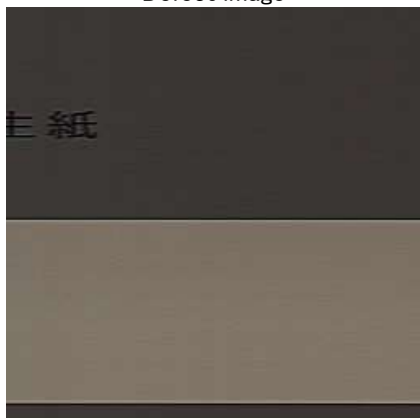
No.	#50, \$49	Date	2023/8/9 下午 03:36:28
Segment	1	Camera	1
Pattern	7778	Position[ x, y ]	84.3 [mm], 5849.8 [m], ( 290.9 [m] )
Type	点状疵点	Size	H:43.0 ,V:41.2 [mm]
Result	-	Area	21.3 [mm2]
Inspection level	5/5,5/5,5/5,5/5,5/5	Label	-
Light	6,6,3/6,6,3

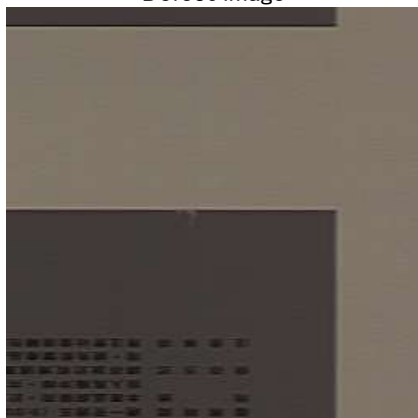
No.	#46, \$45	Date	2023/8/9 下午 03:30:21
Segment	1	Camera	1
Pattern	7154	Position[ x, y ]	862.4 [mm], 5380.8 [m], ( 759.9 [m] )
Type	縱向刀絲疵點	Size	H:2.0 ,V:2.0 [mm]
Result	-	Area	2.3 [mm2]
Inspection level	5/5,5/5,5/5,5/5,5/5	Label	-
Light	6,6,3/6,6,3

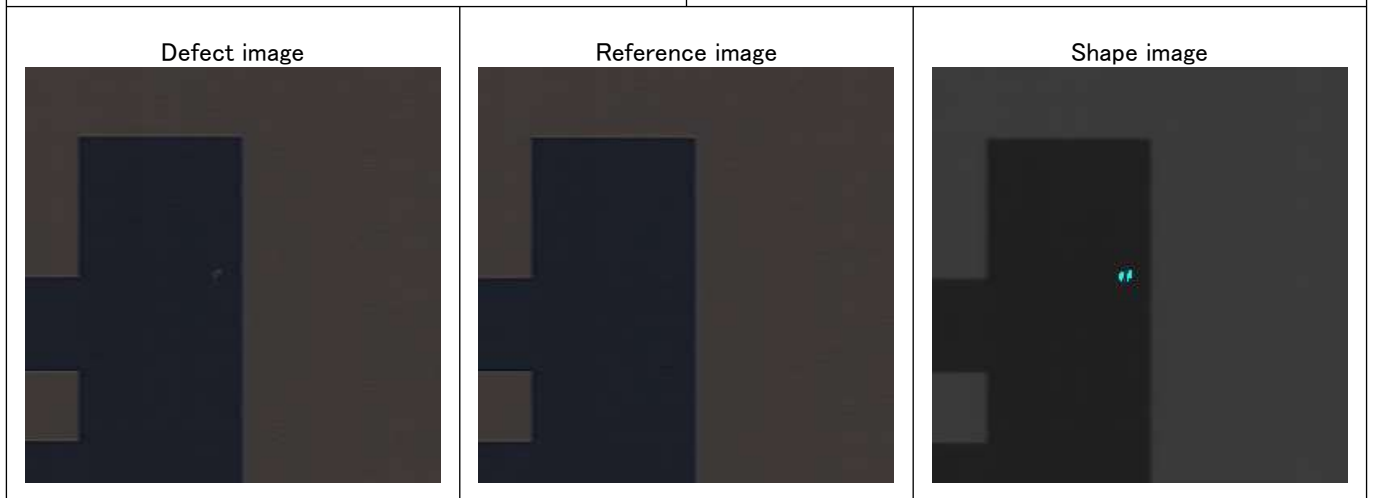
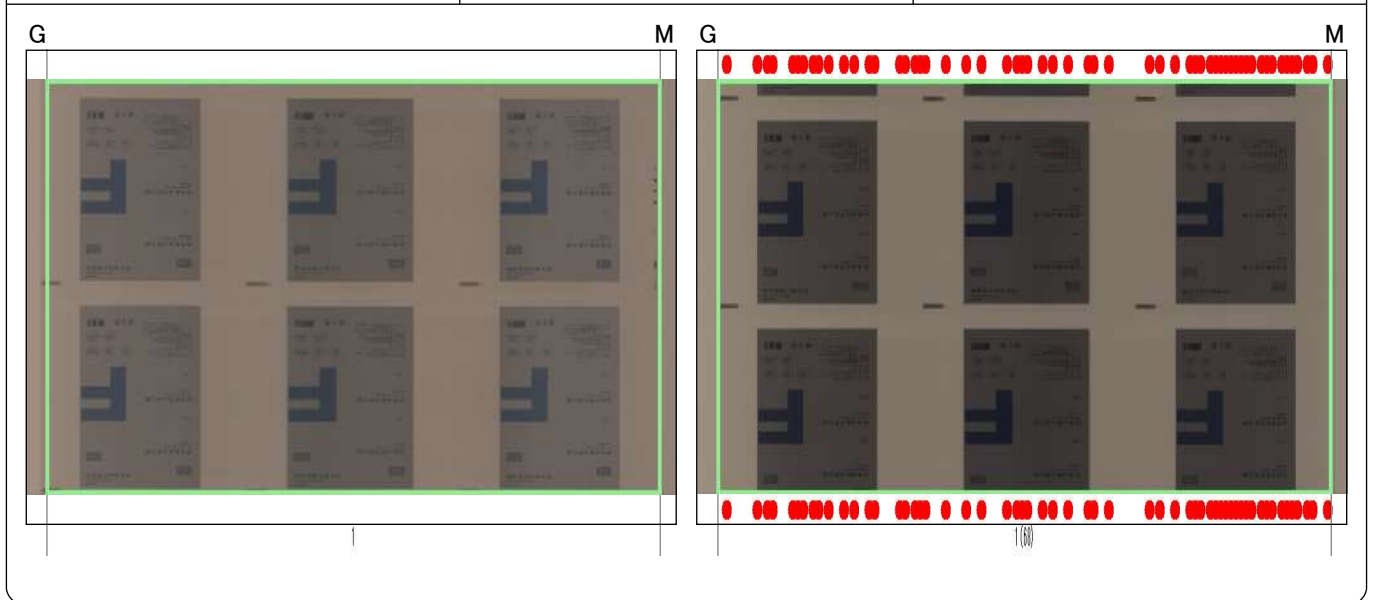
No.	#45, \$44	Date	2023/8/9 下午 03:25:09
Segment	1	Camera	1
Pattern	6623	Position[ x, y ]	769.1 [mm], 4982.0 [m], ( 1158.6 [m] )
Type	縱向刀絲疵點	Size	H:2.0 ,V:2.0 [mm]
Result	—	Area	2.1 [mm2]
Inspection level	5/5,5/5,5/5,5/5,5/5	Label	—
Light	6,6,3/6,6,3

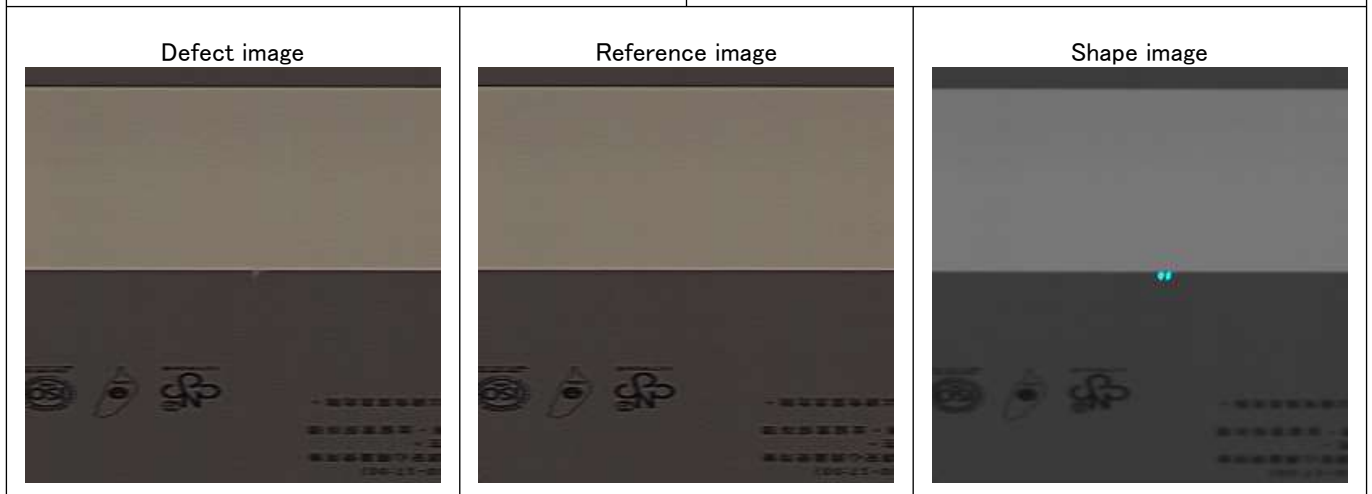
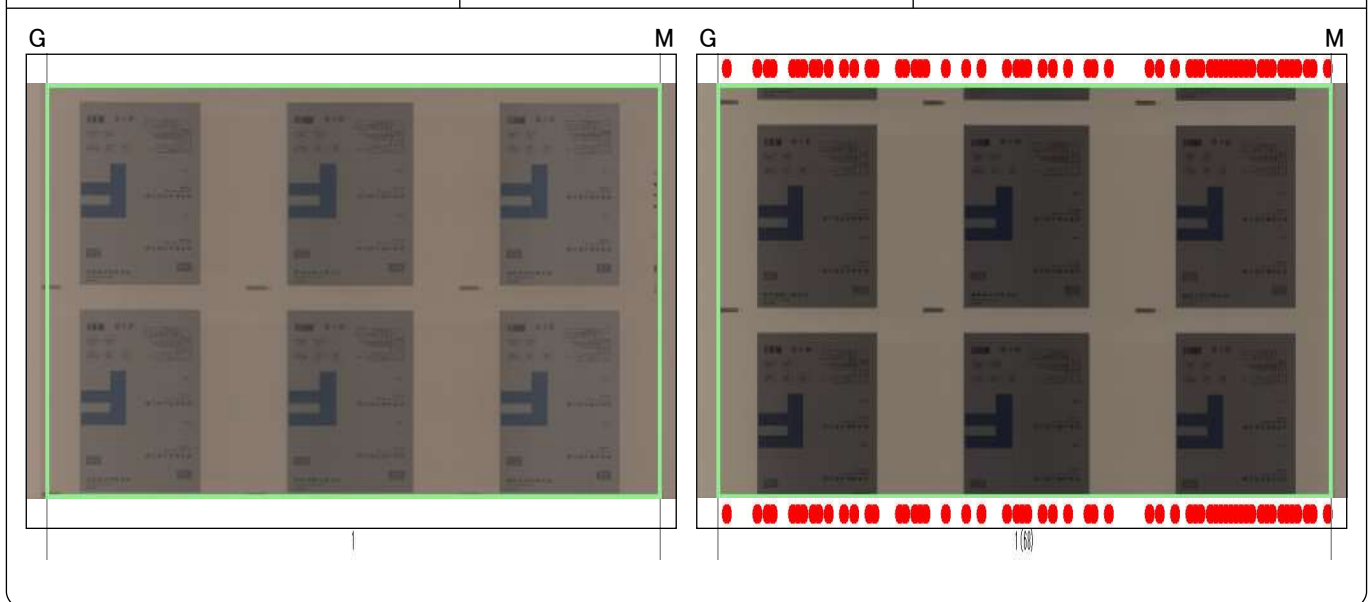
No.	#43, \$42	Date	2023/8/9 下午 03:11:35
Segment	1	Camera	1
Pattern	5237	Position[ x, y ]	790.6 [mm], 3940.8 [m], ( 2199.9 [m] )
Type	縱向刀絲疵點	Size	H:2.0 ,V:1.2 [mm]
Result	-	Area	2.0 [mm2]
Inspection level	5/5,5/5,5/5,5/5,5/5	Label	-
Light	6,6,3/6,6,3

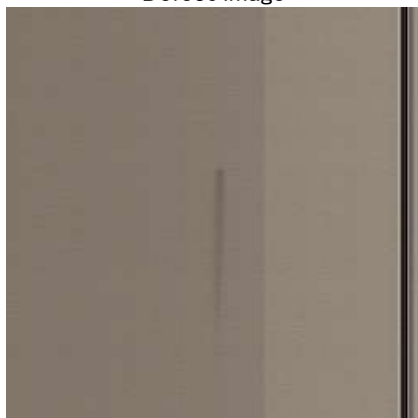
No.	#41, \$40	Date	2023/8/9 下午 03:07:45
Segment	1	Camera	1
Pattern	4846	Position[ x, y ]	936.6 [mm], 3647.0 [m], ( 2493.7 [m] )
Type	縱向刀絲疵點	Size	H:2.2 ,V:21.2 [mm]
Result	-	Area	22.2 [mm2]
Inspection level	5/5,5/5,5/5,5/5,5/5	Label	-
Light	6,6,3/6,6,3

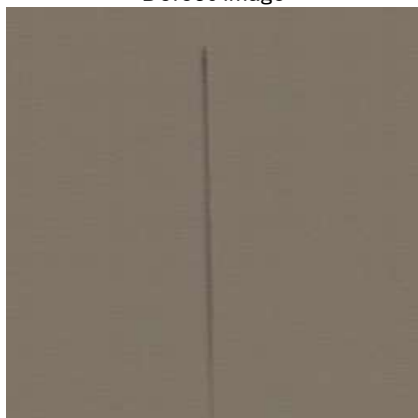
No.	#39, \$38	Date	2023/8/9 下午 02:56:20
Segment	1	Camera	1
Pattern	3680	Position[ x, y ]	317.2 [mm], 2770.8 [m], ( 3369.8 [m] )
Type	点状疵点縱向刀絲疵點	Size	H:2.9 ,V:80.8 [mm]
Result	-	Area	120.3 [mm2]
Inspection level	5/5,5/5,5/5,5/5,5/5	Label	-
Light	6,6,3/6,6,3

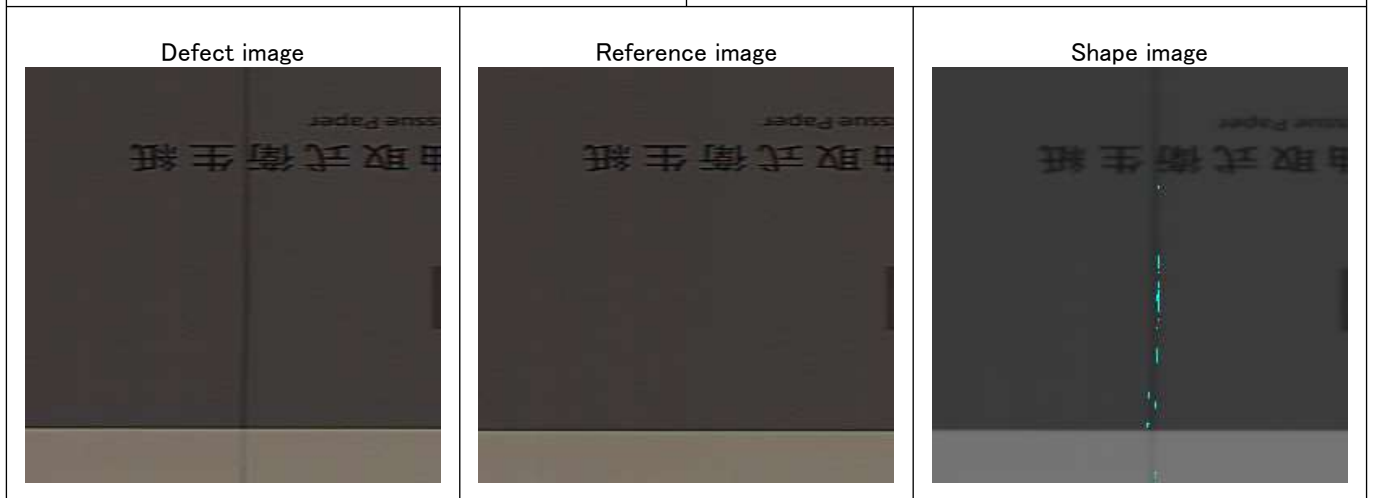
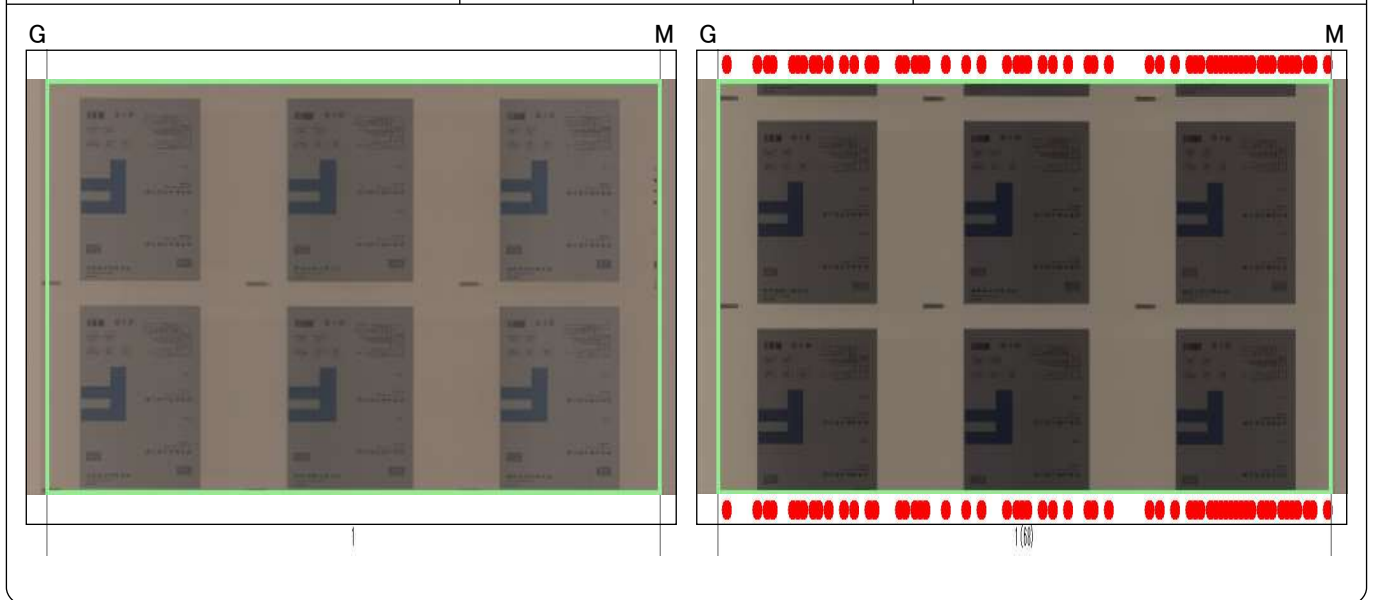
No.	#37, \$36	Date	2023/8/9 下午 02:55:56
Segment	1	Camera	1
Pattern	3640	Position[ x, y ]	820.9 [mm], 2741.3 [m], ( 3399.4 [m] )
Type	縱向刀絲疵點	Size	H:1.7 ,V:30.4 [mm]
Result	—	Area	2.0 [mm2]
Inspection level	5/5,5/5,5/5,5/5,5/5	Label	—
Light	6,6,3/6,6,3

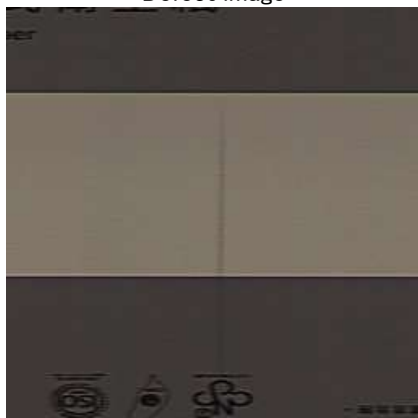
No.	#35, \$34	Date	2023/8/9 下午 02:52:38
Segment	1	Camera	1
Pattern	3303	Position[ x, y ]	780.6 [mm], 2487.4 [m], ( 3653.3 [m] )
Type	縱向刀絲疵點	Size	H:1.7 ,V:29.2 [mm]
Result	-	Area	29.1 [mm2]
Inspection level	5/5,5/5,5/5,5/5,5/5	Label	-
Light	6,6,3/6,6,3

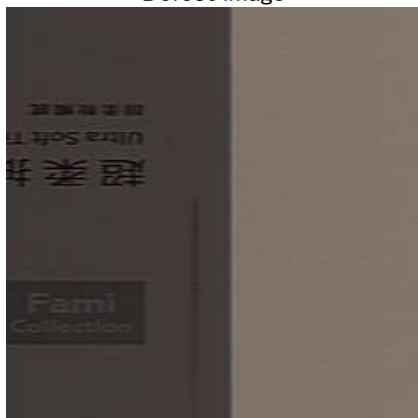
No.	#33, \$32	Date	2023/8/9 下午 02:49:55
Segment	1	Camera	1
Pattern	3026	Position[ x, y ]	878.8 [mm], 2280.0 [m], ( 3860.7 [m] )
Type	縱向刀絲疵點	Size	H:0.5 ,V:12.8 [mm]
Result	-	Area	3.2 [mm2]
Inspection level	5/5,5/5,5/5,5/5,5/5	Label	-
Light	6,6,3/6,6,3

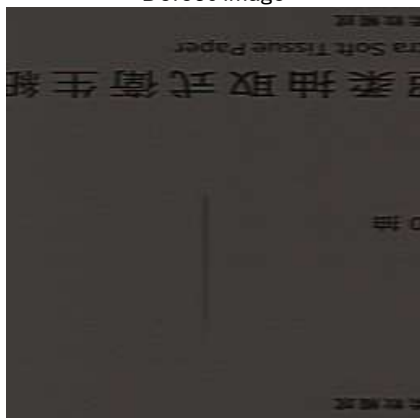
No.	#32, \$31	Date	2023/8/9 下午 02:49:02
Segment	1	Camera	1
Pattern	2936	Position[ x, y ]	192.7 [mm], 2211.9 [m], ( 3928.8 [m] )
Type	縱向刀絲疵點	Size	H:1.5 ,V:4.0 [mm]
Result	-	Area	2.0 [mm2]
Inspection level	5/5,5/5,5/5,5/5,5/5	Label	-
Light	6,6,3/6,6,3

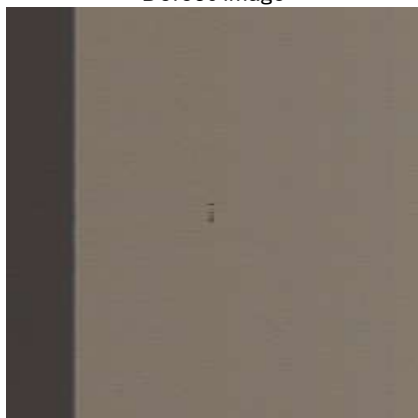
No.	#31, \$30	Date	2023/8/9 下午 02:47:17
Segment	1	Camera	1
Pattern	2759	Position[ x, y ]	904.2 [mm], 2078.9 [m], ( 4061.8 [m] )
Type	縱向刀絲疵點	Size	H:2.0 ,V:4.4 [mm]
Result	-	Area	4.2 [mm2]
Inspection level	5/5,5/5,5/5,5/5,5/5	Label	-
Light	6,6,3/6,6,3

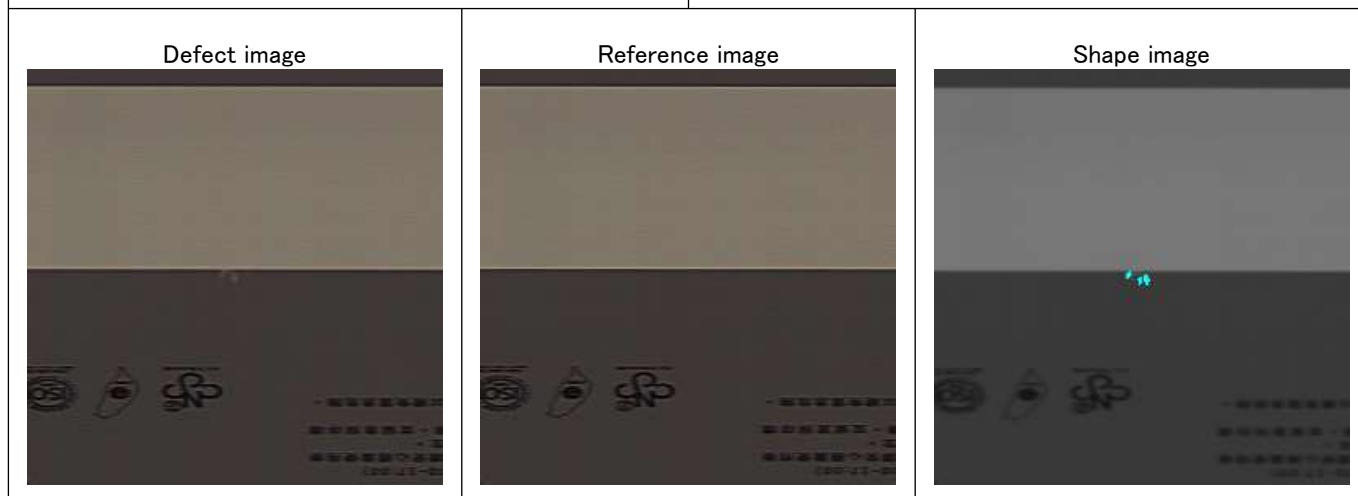
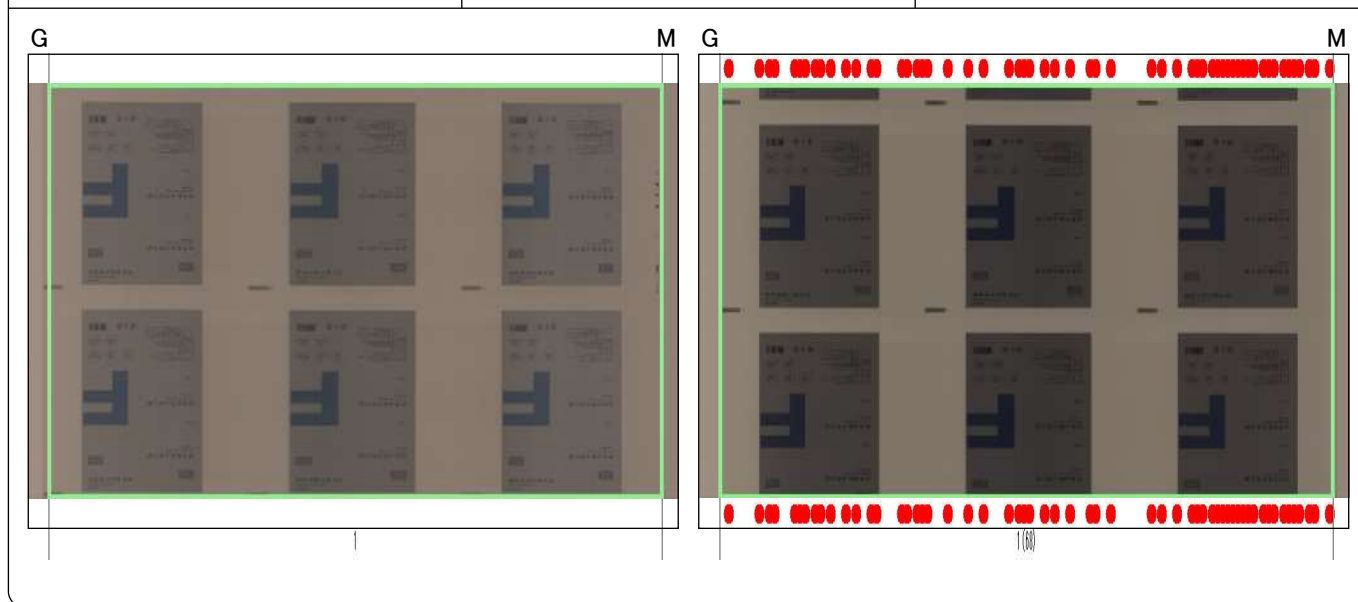
No.	#29, \$28	Date	2023/8/9 下午 02:46:11
Segment	1	Camera	1
Pattern	2647	Position[ x, y ]	786.7 [mm], 1995.0 [m], ( 4145.7 [m] )
Type	縱向刀絲疵點	Size	H:3.7 ,V:2.8 [mm]
Result	-	Area	3.1 [mm2]
Inspection level	5/5,5/5,5/5,5/5,5/5	Label	-
Light	6,6,3/6,6,3

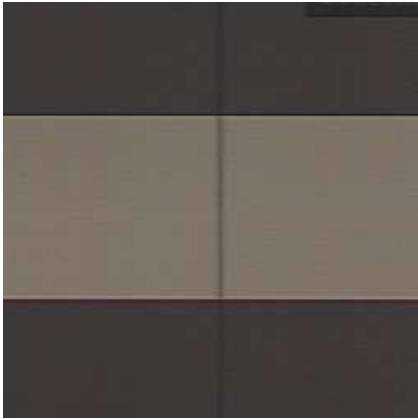
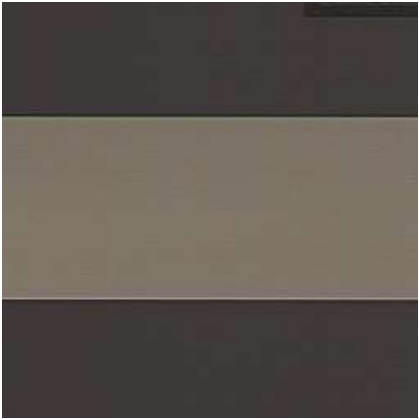
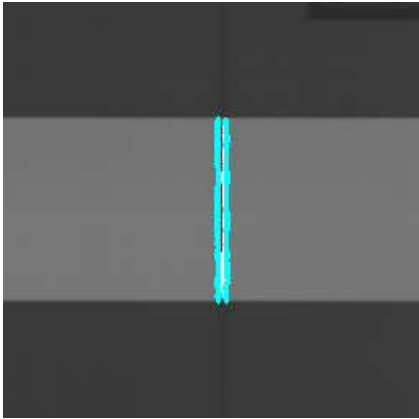
No.	#26, \$25	Date	2023/8/9 下午 02:41:02
Segment	1	Camera	1
Pattern	2122	Position[ x, y ]	835.6 [mm], 1600.5 [m], ( 4540.1 [m] )
Type	点状疵点縱向刀絲疵點	Size	H:2.4 ,V:45.6 [mm]
Result	-	Area	93.2 [mm2]
Inspection level	5/5,5/5,5/5,5/5,5/5	Label	-
Light	6,6,3/6,6,3

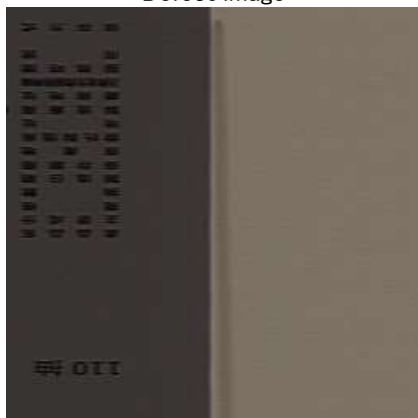
No.	#23, \$22	Date	2023/8/9 下午 02:40:13
Segment	1	Camera	1
Pattern	2038	Position[ x, y ]	571.4 [mm], 1537.6 [m], ( 4603.0 [m] )
Type	縱向刀絲疵點	Size	H:4.6 ,V:277.2 [mm]
Result	-	Area	364.7 [mm2]
Inspection level	5/5,5/5,5/5,5/5,5/5	Label	-
Light	6,6,3/6,6,3

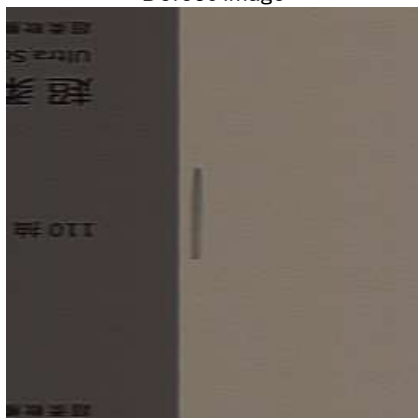
No.	#22, \$21	Date	2023/8/9 下午 02:40:04
Segment	1	Camera	1
Pattern	2023	Position[ x, y ]	886.1 [mm], 1526.0 [m], ( 4614.6 [m] )
Type	点状疵点縱向刀絲疵點	Size	H:2.9 ,V:22.4 [mm]
Result	-	Area	54.1 [mm2]
Inspection level	5/5,5/5,5/5,5/5,5/5	Label	-
Light	6,6,3/6,6,3

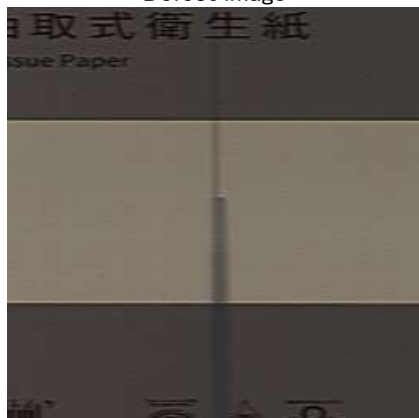
No.	#21, \$20	Date	2023/8/9 下午 02:40:01
Segment	1	Camera	1
Pattern	2019	Position[ x, y ]	123.6 [mm], 1522.8 [m], ( 4617.9 [m] )
Type	点状疵点縱向刀絲疵點	Size	H:4.4 ,V:45.2 [mm]
Result	-	Area	130.6 [mm2]
Inspection level	5/5,5/5,5/5,5/5,5/5	Label	-
Light	6,6,3/6,6,3

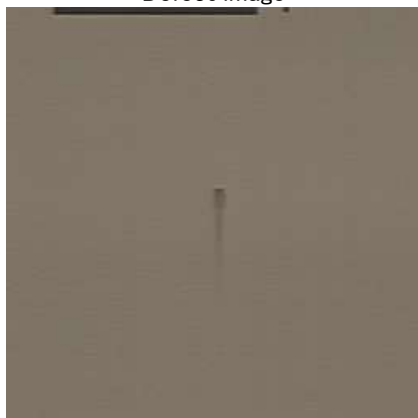
No.	#20, \$19	Date	2023/8/9 下午 02:38:28
Segment	1	Camera	1
Pattern	1860	Position[ x, y ]	662.9 [mm], 1403.4 [m], ( 4737.3 [m] )
Type	点状疵点縱向刀絲疵點	Size	H:2.9 ,V:12.4 [mm]
Result	-	Area	18.4 [mm2]
Inspection level	5/5,5/5,5/5,5/5,5/5	Label	-
Light	6,6,3/6,6,3

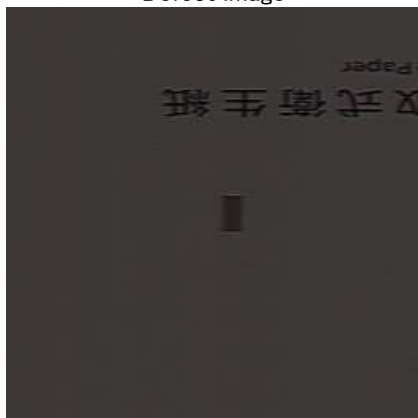
No.	#19, \$18	Date	2023/8/9 下午 02:36:54
Segment	1	Camera	1
Pattern	1701	Position[ x, y ]	813.3 [mm], 1284.5 [m], ( 4856.2 [m] )
Type	点状疵点縱向刀絲疵點	Size	H:4.2 ,V:8.0 [mm]
Result	-	Area	20.6 [mm2]
Inspection level	5/5,5/5,5/5,5/5,5/5	Label	-
Light	6,6,3/6,6,3

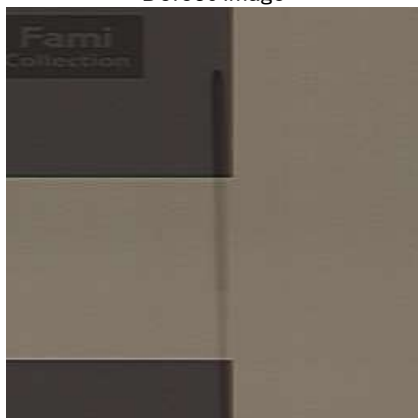
No.	#18, \$17	Date	2023/8/9 下午 02:36:07
Segment	1	Camera	1
Pattern	1621	Position[ x, y ]	240.8 [mm], 1223.7 [m], ( 4916.9 [m] )
Type	点状疵点縱向刀絲疵點	Size	H:3.7 ,V:70.4 [mm]
Result	-	Area	97.8 [mm2]
Inspection level	5/5,5/5,5/5,5/5,5/5	Label	-
Light	6,6,3/6,6,3
