# Inspection Result (Individual Data)

Lot number : 4

Inspected date : 2023/8/10 上午 10:55:13 ~ 2023/8/10 下午 12:12:08

商品名	標準透明6-6-3	周長
顧客名		Ex1
CODE番号		Ex2
基材		Ex3

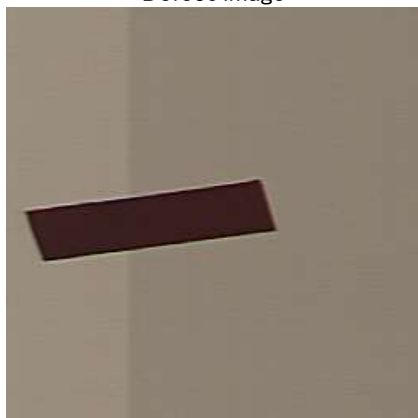
No.	#47, \$36	Date	2023/8/10 下午 12:12:01
Segment	1	Camera	1
Pattern	7872	Position[ x, y ]	10.6 [mm], 5892.5 [m], ( 1.8 [m] )
Type	点状疵点縱向刀絲疵點橫向刀絲	Size	H:21.0 ,V:18.0 [mm]
Result	-	Area	268.4 [mm2]
Inspection level	5/5,5/5,5/5,5/5,5/5	Label	-
Light	6,6,3/6,6,3

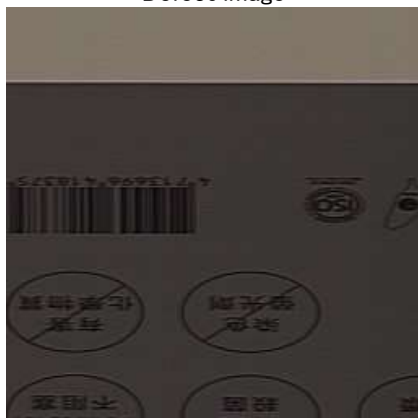
No.	#44, \$35	Date	2023/8/10 下午 12:11:39
Segment	1	Camera	1
Pattern	7835	Position[ x, y ]	414.7 [mm], 5864.4 [m], ( 29.8 [m] )
Type	縱向刀絲疵點	Size	H:0.5 ,V:9.6 [mm]
Result	-	Area	4.0 [mm2]
Inspection level	5/5,5/5,5/5,5/5,5/5	Label	-
Light	6,6,3/6,6,3

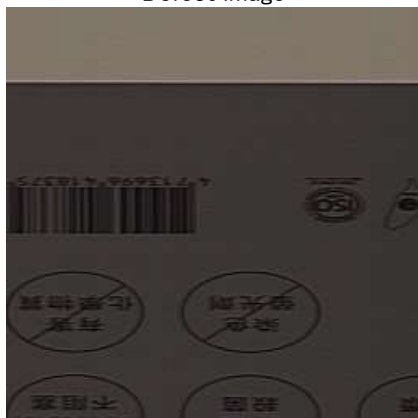
No.	#43, \$34	Date	2023/8/10 下午 12:11:38
Segment	1	Camera	1
Pattern	7834	Position[ x, y ]	739.1 [mm], 5864.1 [m], ( 30.2 [m] )
Type	縱向刀絲疵點	Size	H:0.5 ,V:8.8 [mm]
Result	-	Area	3.1 [mm2]
Inspection level	5/5,5/5,5/5,5/5,5/5	Label	-
Light	6,6,3/6,6,3

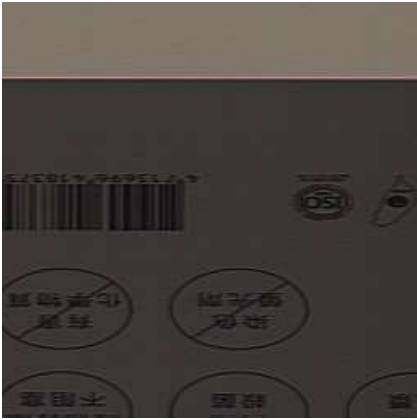
No.	#43, \$34	Date	2023/8/10 下午 12:11:38
Segment	1	Camera	1
Pattern	7834	Position[ x, y ]	412.5 [mm], 5864.1 [m], ( 30.2 [m] )
Type	縱向刀絲疵點	Size	H:4.4 ,V:9.2 [mm]
Result	-	Area	3.7 [mm2]
Inspection level	5/5,5/5,5/5,5/5,5/5	Label	-
Light	6,6,3/6,6,3

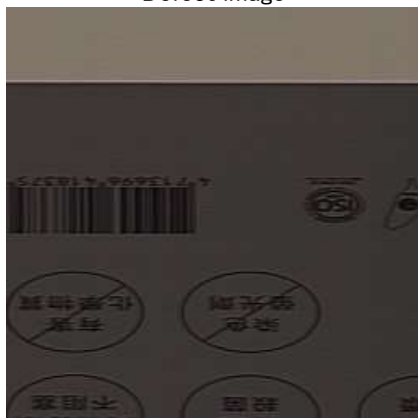
No.	#43, \$34	Date	2023/8/10 下午 12:11:38
Segment	1	Camera	1
Pattern	7834	Position[ x, y ]	414.7 [mm], 5863.7 [m], ( 30.6 [m] )
Type	縱向刀絲疵點	Size	H:0.5 ,V:9.6 [mm]
Result	-	Area	4.1 [mm2]
Inspection level	5/5,5/5,5/5,5/5,5/5	Label	-
Light	6,6,3/6,6,3

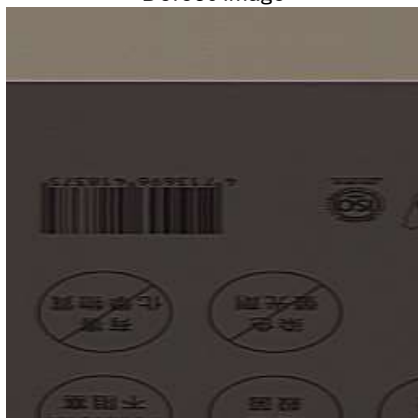
No.	#43, \$34	Date	2023/8/10 下午 12:11:38
Segment	1	Camera	1
Pattern	7834	Position[ x, y ]	738.9 [mm], 5863.7 [m], ( 30.6 [m] )
Type	縱向刀絲疵點	Size	H:0.7 ,V:9.6 [mm]
Result	-	Area	4.1 [mm2]
Inspection level	5/5,5/5,5/5,5/5,5/5	Label	-
Light	6,6,3/6,6,3

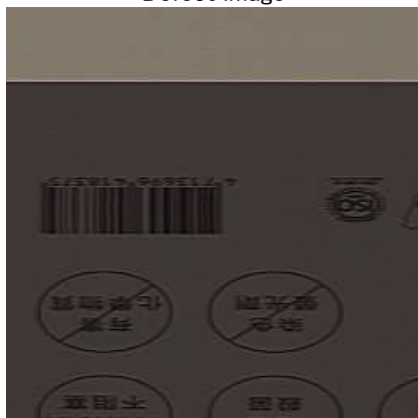
No.	#42, \$33	Date	2023/8/10 下午 12:11:38
Segment	1	Camera	1
Pattern	7833	Position[ x, y ]	399.1 [mm], 5862.9 [m], ( 31.3 [m] )
Type	縱向刀絲疵點	Size	H:0.5 ,V:8.4 [mm]
Result	-	Area	2.9 [mm2]
Inspection level	5/5,5/5,5/5,5/5,5/5	Label	-
Light	6,6,3/6,6,3

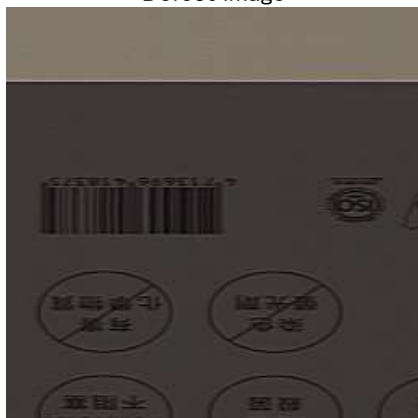
No.	#42, \$33	Date	2023/8/10 下午 12:11:38
Segment	1	Camera	1
Pattern	7833	Position[ x, y ]	414.7 [mm], 5862.9 [m], ( 31.3 [m] )
Type	縱向刀絲疵點	Size	H:0.5 ,V:9.2 [mm]
Result	-	Area	3.8 [mm2]
Inspection level	5/5,5/5,5/5,5/5,5/5	Label	-
Light	6,6,3/6,6,3

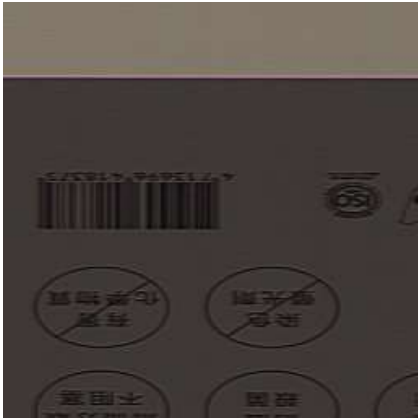
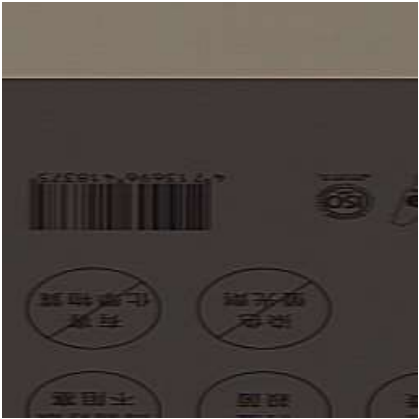
No.	#41, \$32	Date	2023/8/10 下午 12:11:37
Segment	1	Camera	1
Pattern	7832	Position[ x, y ]	95.1 [mm], 5862.6 [m], ( 31.7 [m] )
Type	縱向刀絲疵點	Size	H:0.5 ,V:8.8 [mm]
Result	-	Area	2.4 [mm2]
Inspection level	5/5,5/5,5/5,5/5,5/5	Label	-
Light	6,6,3/6,6,3

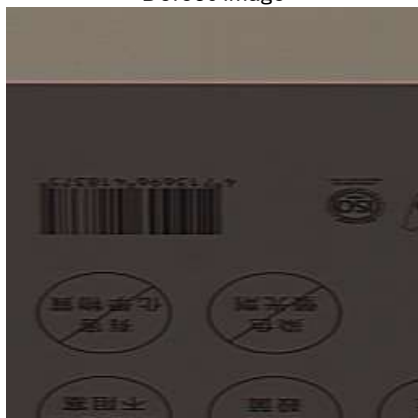
No.	#41, \$32	Date	2023/8/10 下午 12:11:37
Segment	1	Camera	1
Pattern	7832	Position[ x, y ]	738.9 [mm], 5862.2 [m], ( 32.1 [m] )
Type	縱向刀絲疵點	Size	H:0.5 ,V:9.2 [mm]
Result	-	Area	3.9 [mm2]
Inspection level	5/5,5/5,5/5,5/5,5/5	Label	-
Light	6,6,3/6,6,3

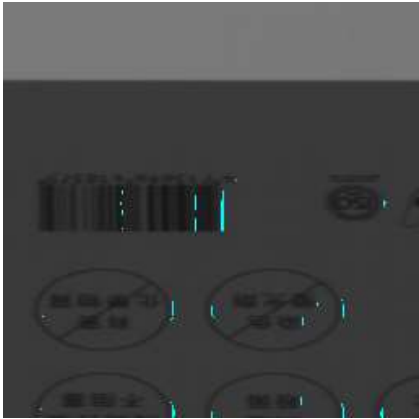
No.	#40, \$31	Date	2023/8/10 下午 12:11:37
Segment	1	Camera	1
Pattern	7831	Position[ x, y ]	401.5 [mm], 5861.8 [m], ( 32.5 [m] )
Type	縱向刀絲疵點	Size	H:8.3 ,V:28.0 [mm]
Result	-	Area	2.2 [mm2]
Inspection level	5/5,5/5,5/5,5/5,5/5	Label	-
Light	6,6,3/6,6,3

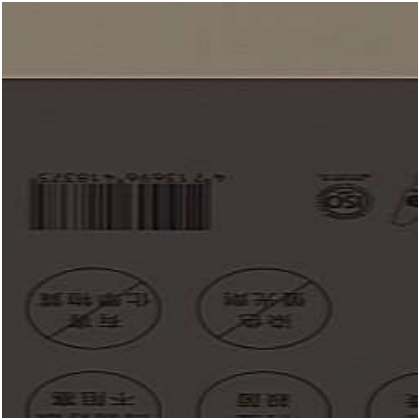
No.	#40, \$31	Date	2023/8/10 下午 12:11:37
Segment	1	Camera	1
Pattern	7831	Position[ x, y ]	95.1 [mm], 5861.8 [m], ( 32.5 [m] )
Type	縱向刀絲疵點	Size	H:0.5 ,V:8.8 [mm]
Result	-	Area	2.4 [mm2]
Inspection level	5/5,5/5,5/5,5/5,5/5	Label	-
Light	6,6,3/6,6,3

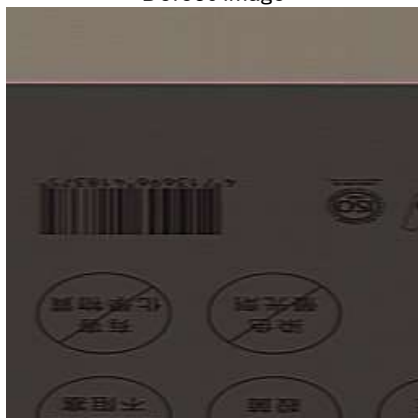
No.	#37, \$30	Date	2023/8/10 下午 12:11:21
Segment	1	Camera	1
Pattern	7805	Position[ x, y ]	241.3 [mm], 5842.4 [m], ( 51.8 [m] )
Type	点状疵点	Size	H:1.7 ,V:146.4 [mm]
Result	-	Area	158.5 [mm2]
Inspection level	5/5,5/5,5/5,5/5,5/5	Label	-
Light	6,6,3/6,6,3

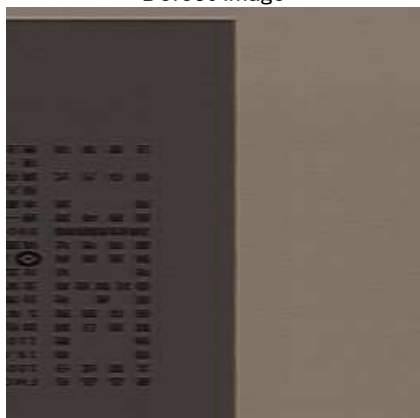
No.	#36, \$29	Date	2023/8/10 下午 12:11:21
Segment	1	Camera	1
Pattern	7804	Position[ x, y ]	240.6 [mm], 5841.6 [m], ( 52.7 [m] )
Type	点状疵点縱向刀絲疵點	Size	H:15.4 ,V:326.4 [mm]
Result	-	Area	172.5 [mm2]
Inspection level	5/5,5/5,5/5,5/5,5/5	Label	-
Light	6,6,3/6,6,3

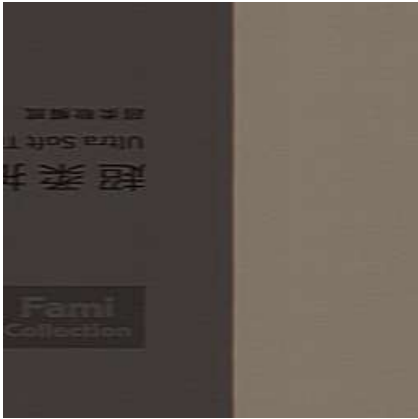
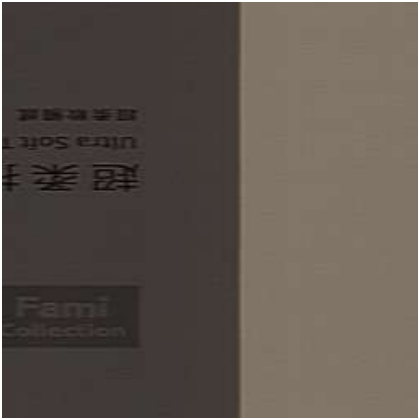
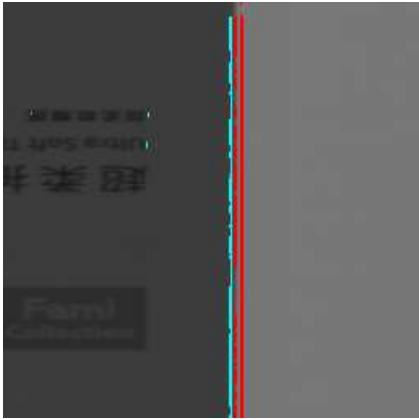
No.	#35, \$28	Date	2023/8/10 下午 12:11:20
Segment	1	Camera	1
Pattern	7803	Position[ x, y ]	240.6 [mm], 5840.8 [m], ( 53.4 [m] )
Type	点状疵点縱向刀絲疵點	Size	H:2.2 ,V:263.2 [mm]
Result	-	Area	86.5 [mm2]
Inspection level	5/5,5/5,5/5,5/5,5/5	Label	-
Light	6,6,3/6,6,3

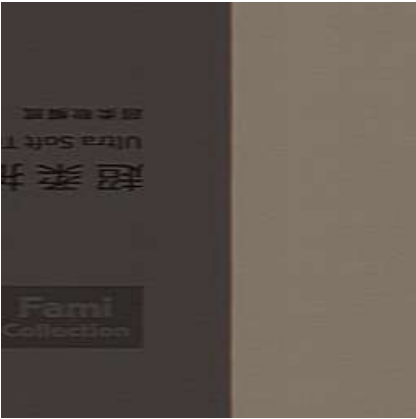
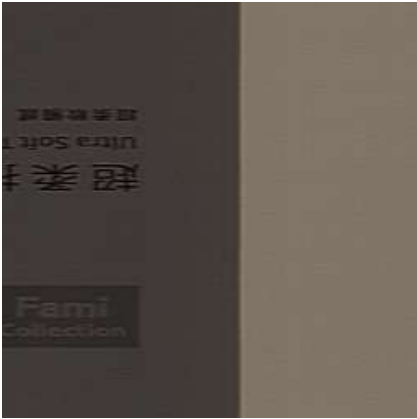
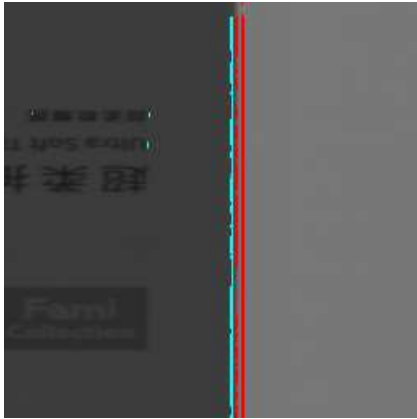
No.	#34, \$27	Date	2023/8/10 下午 12:11:20
Segment	1	Camera	1
Pattern	7802	Position[ x, y ]	567.5 [mm], 5840.2 [m], ( 54.1 [m] )
Type	点状疵点	Size	H:1.5 ,V:132.8 [mm]
Result	-	Area	37.2 [mm2]
Inspection level	5/5,5/5,5/5,5/5,5/5	Label	-
Light	6,6,3/6,6,3

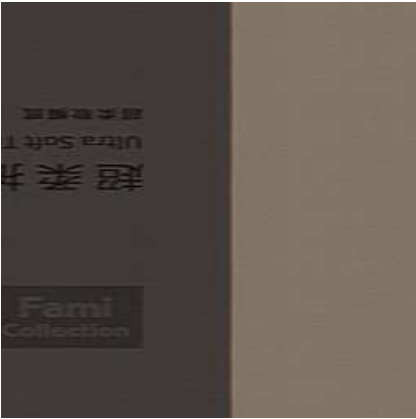
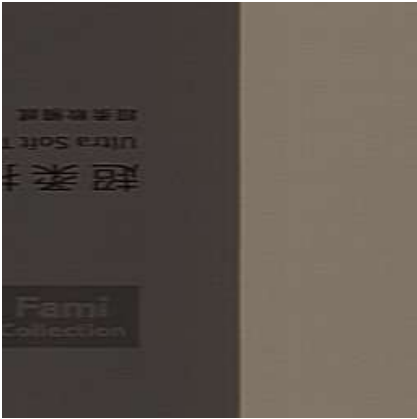
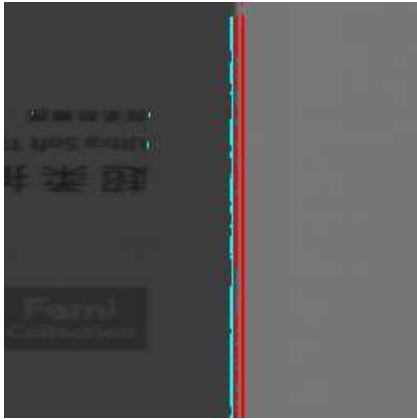
No.	#34, \$27	Date	2023/8/10 下午 12:11:20
Segment	1	Camera	1
Pattern	7802	Position[ x, y ]	699.8 [mm], 5840.0 [m], ( 54.3 [m] )
Type	点状疵点	Size	H:0.5 ,V:118.8 [mm]
Result	-	Area	50.5 [mm2]
Inspection level	5/5,5/5,5/5,5/5,5/5	Label	-
Light	6,6,3/6,6,3

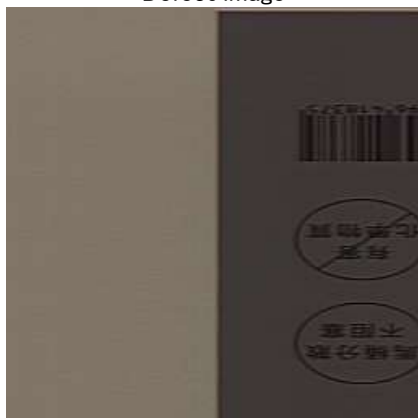
No.	#34, \$27	Date	2023/8/10 下午 12:11:20
Segment	1	Camera	1
Pattern	7802	Position[ x, y ]	699.8 [mm], 5840.2 [m], ( 54.1 [m] )
Type	点状疵点	Size	H:1.5 ,V:131.6 [mm]
Result	-	Area	63.3 [mm2]
Inspection level	5/5,5/5,5/5,5/5,5/5	Label	-
Light	6,6,3/6,6,3

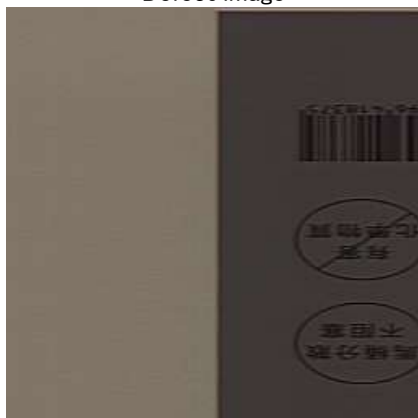
No.	#33, \$26	Date	2023/8/10 下午 12:11:19
Segment	1	Camera	1
Pattern	7801	Position[ x, y ]	126.4 [mm], 5839.2 [m], ( 55.1 [m] )
Type	縱向刀絲疵點	Size	H:0.7 ,V:95.2 [mm]
Result	-	Area	28.3 [mm2]
Inspection level	5/5,5/5,5/5,5/5,5/5	Label	-
Light	6,6,3/6,6,3

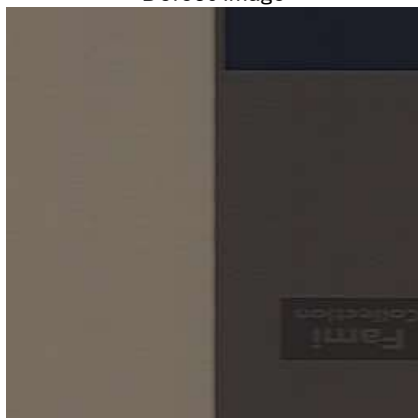
No.	#28, \$23	Date	2023/8/10 下午 12:10:47
Segment	1	Camera	1
Pattern	7746	Position[ x, y ]	447.6 [mm], 5798.4 [m], ( 95.8 [m] )
Type	縱向刀絲疵點	Size	H:0.7 ,V:58.8 [mm]
Result	-	Area	13.5 [mm2]
Inspection level	5/5,5/5,5/5,5/5,5/5	Label	-
Light	6,6,3/6,6,3

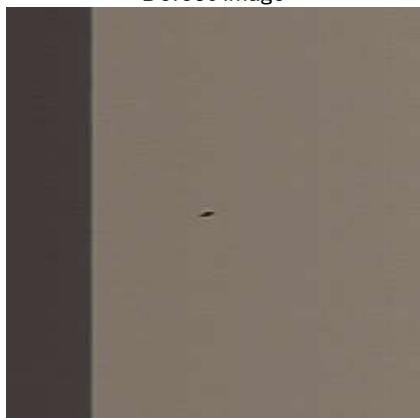
No.	#18, \$15	Date	2023/8/10 上午 11:44:21
Segment	1	Camera	1
Pattern	5037	Position[ x, y ]	900.5 [mm], 3773.6 [m], ( 2120.7 [m] )
Type	点状疵点縱向刀絲疵點橫向刀絲	Size	H:2.9 ,V:2.0 [mm]
Result	-	Area	5.2 [mm2]
Inspection level	5/5,5/5,5/5,5/5,5/5	Label	-
Light	6,6,3/6,6,3

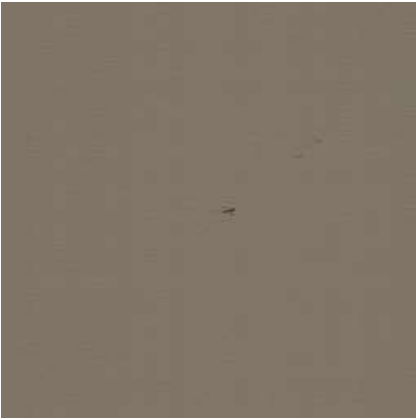
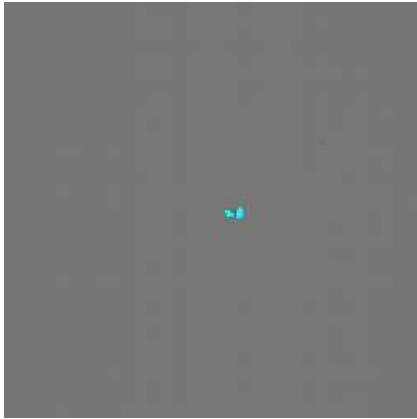
No.	#17, \$14	Date	2023/8/10 上午 11:44:21
Segment	1	Camera	1
Pattern	5036	Position[ x, y ]	654.9 [mm], 3773.6 [m], ( 2120.7 [m] )
Type	縱向刀絲疵點	Size	H:2.7 ,V:2.0 [mm]
Result	-	Area	2.5 [mm2]
Inspection level	5/5,5/5,5/5,5/5,5/5	Label	-
Light	6,6,3/6,6,3

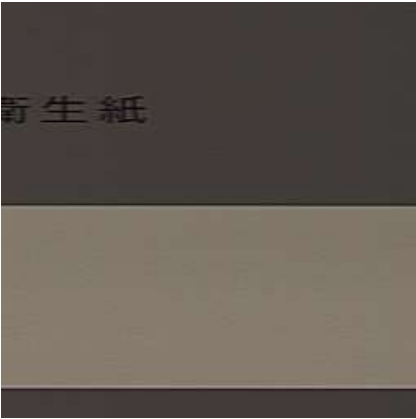
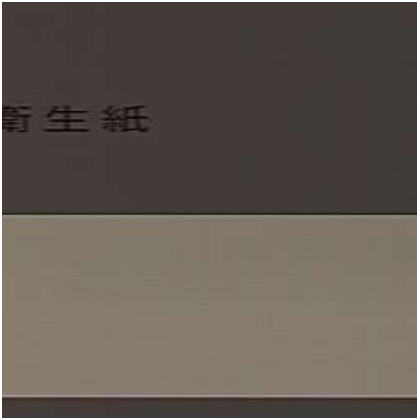
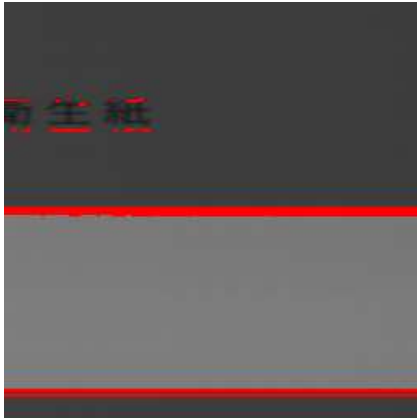
No.	#15, \$12	Date	2023/8/10 上午 11:03:10
Segment	1	Camera	1
Pattern	817	Position[ x, y ]	141.0 [mm], 619.5 [m], ( 5274.7 [m] )
Type	点状疵点	Size	H:178.5 ,V:1.6 [mm]
Result	-	Area	180.0 [mm2]
Inspection level	5/5,5/5,5/5,5/5,5/5	Label	-
Light	6,6,3/6,6,3

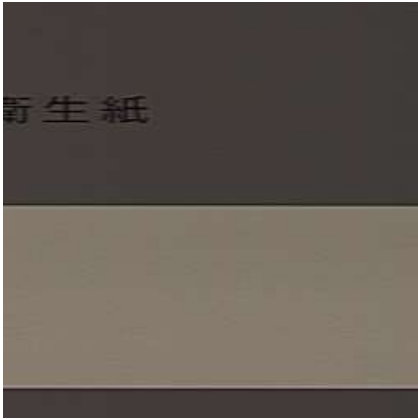
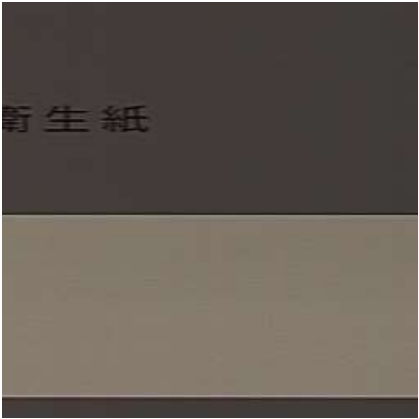
No.	#14, \$11	Date	2023/8/10 上午 11:03:09
Segment	1	Camera	1
Pattern	815	Position[ x, y ]	12.8 [mm], 618.0 [m], ( 5276.2 [m] )
Type	点状疵点	Size	H:27.3 ,V:9.2 [mm]
Result	-	Area	55.0 [mm2]
Inspection level	5/5,5/5,5/5,5/5,5/5	Label	-
Light	6,6,3/6,6,3

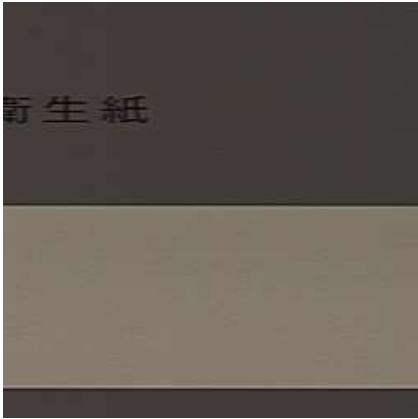
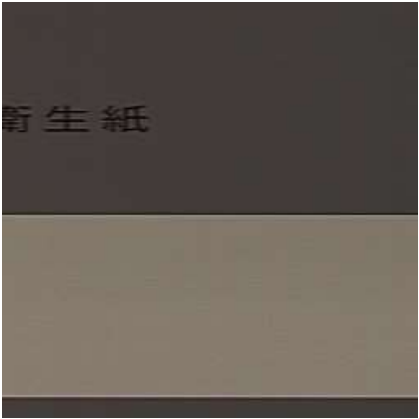
No.	#14, \$11	Date	2023/8/10 上午 11:03:09
Segment	1	Camera	1
Pattern	815	Position[ x, y ]	326.1 [mm], 618.0 [m], ( 5276.2 [m] )
Type	点状疵点	Size	H:30.0 ,V:9.2 [mm]
Result	-	Area	60.2 [mm2]
Inspection level	5/5,5/5,5/5,5/5,5/5	Label	-
Light	6,6,3/6,6,3

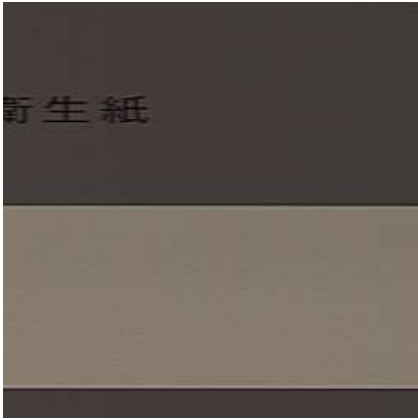
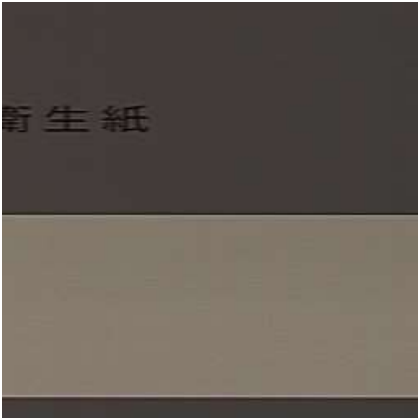
No.	#14, \$11	Date	2023/8/10 上午 11:03:09
Segment	1	Camera	1
Pattern	815	Position[ x, y ]	456.2 [mm], 618.0 [m], ( 5276.2 [m] )
Type	点状疵点	Size	H:89.4 ,V:1.2 [mm]
Result	-	Area	64.0 [mm2]
Inspection level	5/5,5/5,5/5,5/5,5/5	Label	-
Light	6,6,3/6,6,3

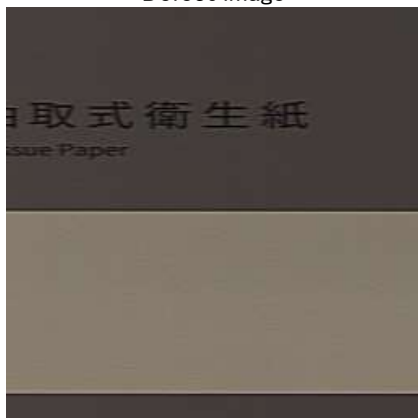
No.	#14, \$11	Date	2023/8/10 上午 11:03:09
Segment	1	Camera	1
Pattern	815	Position[ x, y ]	123.4 [mm], 618.0 [m], ( 5276.2 [m] )
Type	点状疵点	Size	H:138.7 ,V:1.2 [mm]
Result	-	Area	108.6 [mm2]
Inspection level	5/5,5/5,5/5,5/5,5/5	Label	-
Light	6,6,3/6,6,3

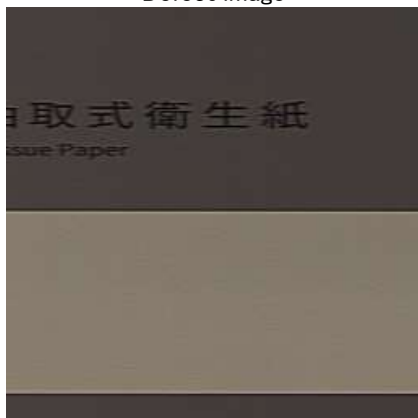
No.	#13, \$10	Date	2023/8/10 上午 11:03:09
Segment	1	Camera	1
Pattern	814	Position[ x, y ]	112.4 [mm], 617.4 [m], ( 5276.8 [m] )
Type	点状疵点	Size	H:20.8 ,V:0.8 [mm]
Result	-	Area	10.4 [mm2]
Inspection level	5/5,5/5,5/5,5/5,5/5	Label	-
Light	6,6,3/6,6,3

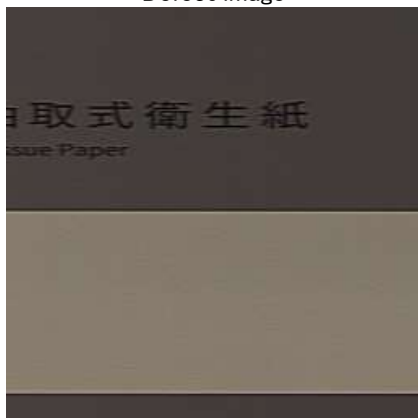
No.	#13, \$10	Date	2023/8/10 上午 11:03:09
Segment	1	Camera	1
Pattern	814	Position[ x, y ]	401.7 [mm], 617.9 [m], ( 5276.4 [m] )
Type	点状疵点	Size	H:51.5 ,V:0.8 [mm]
Result	-	Area	16.9 [mm2]
Inspection level	5/5,5/5,5/5,5/5,5/5	Label	-
Light	6,6,3/6,6,3

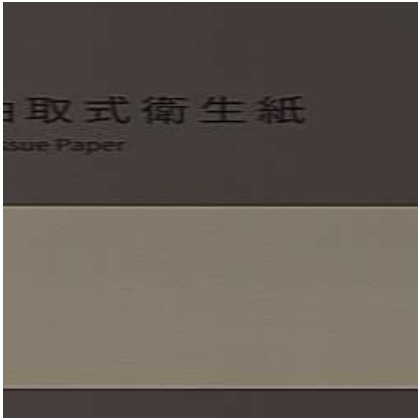
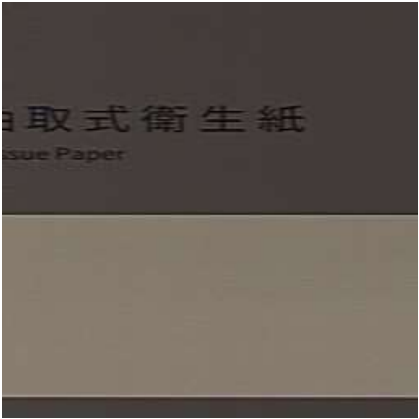
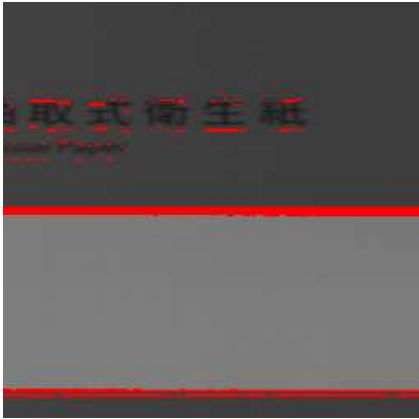
No.	#13, \$10	Date	2023/8/10 上午 11:03:09
Segment	1	Camera	1
Pattern	814	Position[ x, y ]	112.4 [mm], 617.9 [m], ( 5276.4 [m] )
Type	点状疵点	Size	H:27.3 ,V:0.8 [mm]
Result	-	Area	17.8 [mm2]
Inspection level	5/5,5/5,5/5,5/5,5/5	Label	-
Light	6,6,3/6,6,3

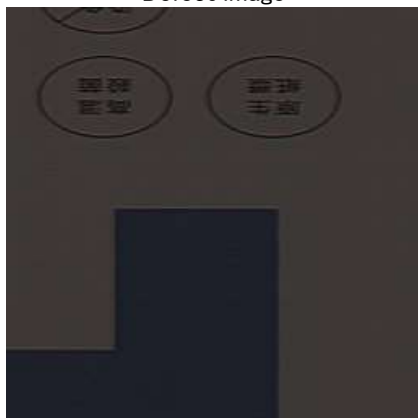
No.	#12, \$9	Date	2023/8/10 上午 11:03:01
Segment	1	Camera	1
Pattern	801	Position[ x, y ]	379.3 [mm], 607.6 [m], ( 5286.7 [m] )
Type	点状疵点	Size	H:12.0 ,V:0.8 [mm]
Result	-	Area	2.1 [mm2]
Inspection level	5/5,5/5,5/5,5/5,5/5	Label	-
Light	6,6,3/6,6,3

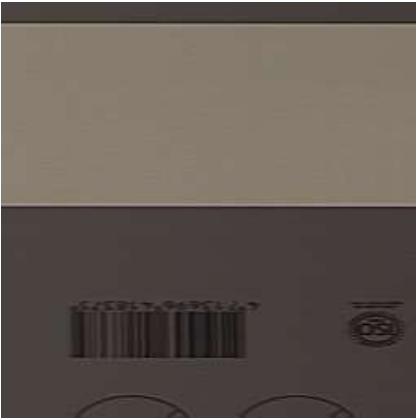
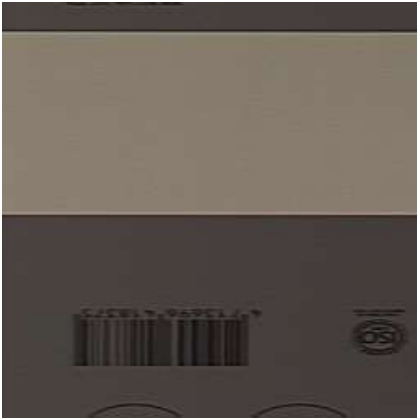
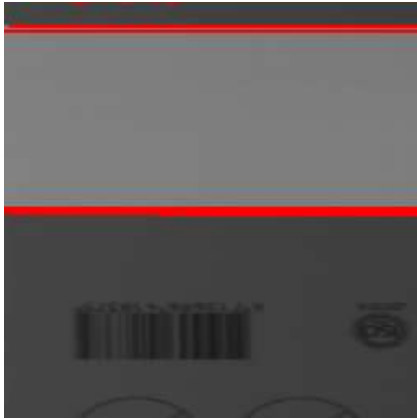
No.	#12, \$9	Date	2023/8/10 上午 11:03:01
Segment	1	Camera	1
Pattern	801	Position[ x, y ]	88.5 [mm], 607.6 [m], ( 5286.7 [m] )
Type	点状疵点	Size	H:72.3 ,V:1.6 [mm]
Result	-	Area	71.4 [mm2]
Inspection level	5/5,5/5,5/5,5/5,5/5	Label	-
Light	6,6,3/6,6,3

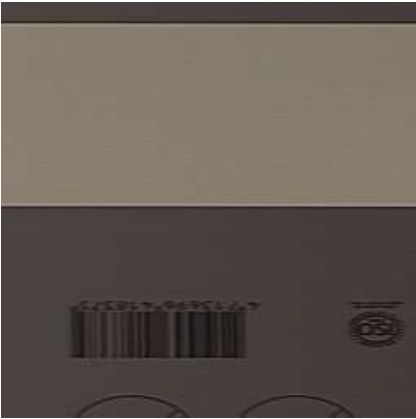
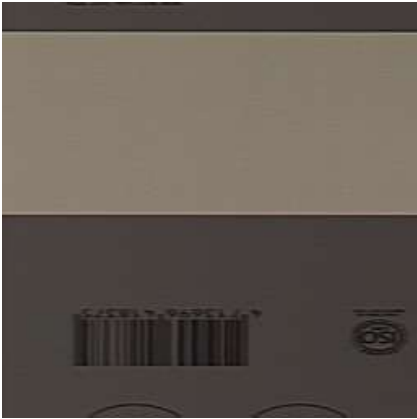
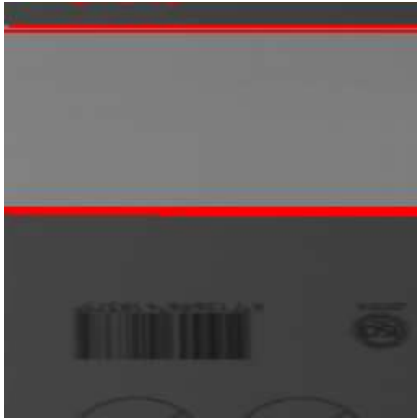
No.	#11, \$8	Date	2023/8/10 上午 11:03:00
Segment	1	Camera	1
Pattern	800	Position[ x, y ]	121.5 [mm], 607.3 [m], ( 5287.0 [m] )
Type	点状疵点	Size	H:1.0 ,V:1.2 [mm]
Result	-	Area	1.0 [mm2]
Inspection level	5/5,5/5,5/5,5/5,5/5	Label	-
Light	6,6,3/6,6,3

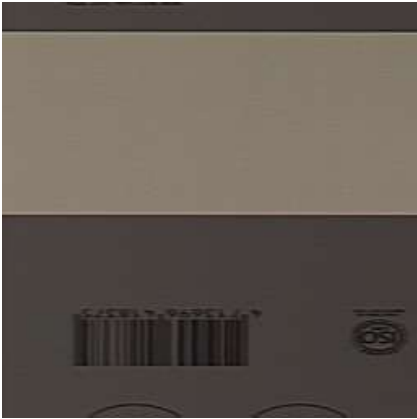
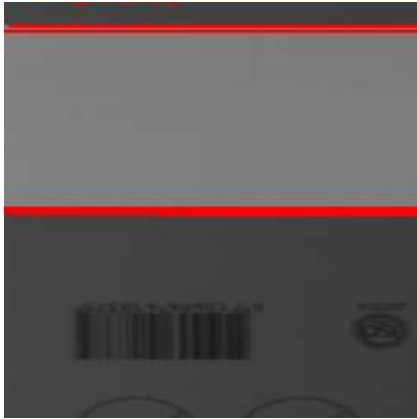
No.	#11, \$8	Date	2023/8/10 上午 11:03:00
Segment	1	Camera	1
Pattern	800	Position[ x, y ]	434.7 [mm], 607.3 [m], ( 5287.0 [m] )
Type	点状疵点	Size	H:24.7 ,V:1.2 [mm]
Result	-	Area	21.3 [mm2]
Inspection level	5/5,5/5,5/5,5/5,5/5	Label	-
Light	6,6,3/6,6,3

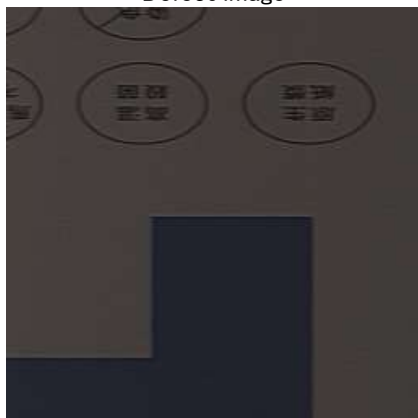
No.	#7, \$6	Date	2023/8/10 上午 11:00:29
Segment	1	Camera	1
Pattern	542	Position[ x, y ]	564.6 [mm], 413.0 [m], ( 5481.3 [m] )
Type	点状疵点縱向刀絲疵點	Size	H:2.2 ,V:132.0 [mm]
Result	-	Area	66.9 [mm2]
Inspection level	5/5,5/5,5/5,5/5,5/5	Label	-
Light	6,6,3/6,6,3

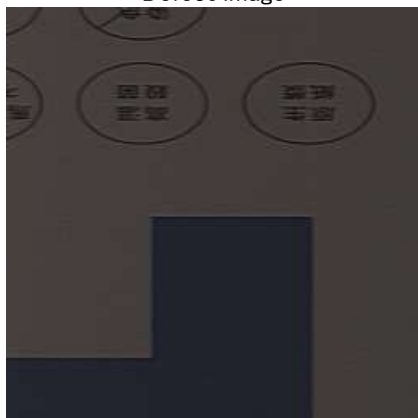
No.	#7, \$6	Date	2023/8/10 上午 11:00:29
Segment	1	Camera	1
Pattern	542	Position[ x, y ]	696.4 [mm], 413.1 [m], ( 5481.1 [m] )
Type	点状疵点縱向刀絲疵點	Size	H:2.2 ,V:289.6 [mm]
Result	-	Area	83.4 [mm2]
Inspection level	5/5,5/5,5/5,5/5,5/5	Label	-
Light	6,6,3/6,6,3
