Inspection Result (Individual Data)

Lot number : 4

商品名	標準透明6-6-3	周長	
顧客名		Ex1	
CODE番号		Ex2	
基材		Ex3

Total defects	26	検査範圍 : 83.6 ~ 1024.2 [mm] 寬度 : 940.6 [mm]
Web length	5749.9 [m]	參照更新 : 週期10<平時>/週期10<平時>
Segments	1 (從左側)

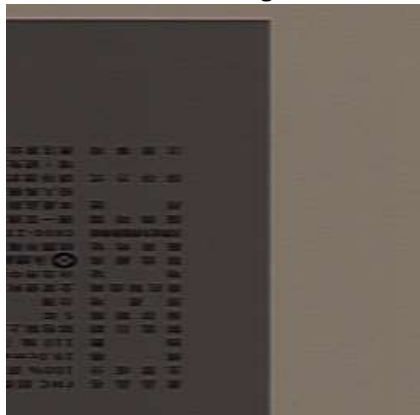
Defect image

No.	#31, \$24	Date	2023/8/9 下午 12:58:34
Segment	1	Camera	1
Pattern	7567	Position[x, y]	874.4 [mm], 5689.6 [m], (60.3 [m])
Type	点状疵点縱向刀絲疵點	Size	H:26.4 ,V:372.0 [mm]
Result	-	Area	90.1 [mm2]
Inspection level	5/5,5/5,5/5,5/5,5/5	Label	-
Light	6,6,3/6,6,3

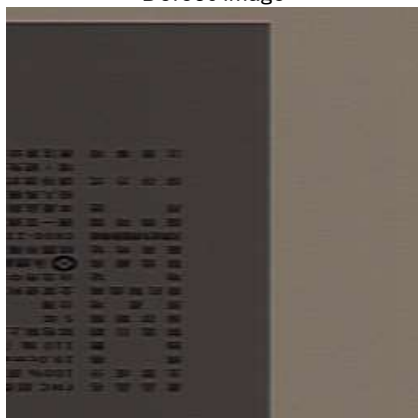
Defect image

No.	#31, \$24	Date	2023/8/9 下午 12:58:34
Segment	1	Camera	1
Pattern	7567	Position[x, y]	555.0 [mm], 5689.6 [m], (60.3 [m])
Type	点状疵点縱向刀絲疵點	Size	H:28.1 ,V:380.4 [mm]
Result	-	Area	90.6 [mm2]
Inspection level	5/5,5/5,5/5,5/5,5/5	Label	-
Light	6,6,3/6,6,3

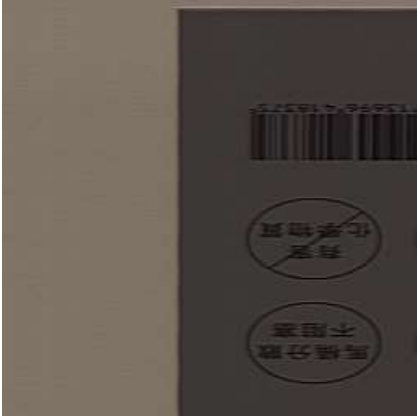
No.	#29, \$22	Date	2023/8/9 下午 12:58:33
Segment	1	Camera	1
Pattern	7565	Position[x, y]	764.0 [mm], 5688.0 [m], (61.8 [m])
Type	縱向刀絲疵點	Size	H:35.6 ,V:180.4 [mm]
Result	-	Area	95.7 [mm2]
Inspection level	5/5,5/5,5/5,5/5,5/5	Label	-
Light	6,6,3/6,6,3

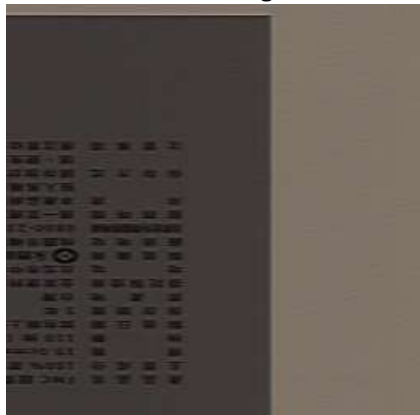
Defect image

No.	#28, \$21	Date	2023/8/9 下午 12:58:32
Segment	1	Camera	1
Pattern	7564	Position[x, y]	871.0 [mm], 5687.3 [m], (62.5 [m])
Type	点状疵点縱向刀絲疵點	Size	H:26.6 ,V:431.2 [mm]
Result	-	Area	230.9 [mm2]
Inspection level	5/5,5/5,5/5,5/5,5/5	Label	-
Light	6,6,3/6,6,3

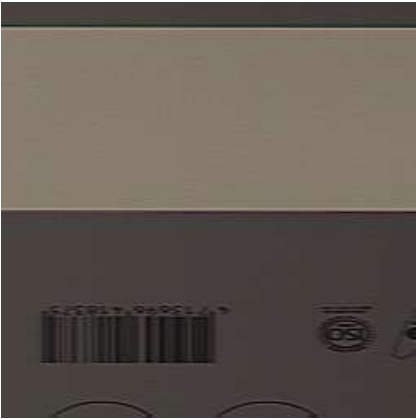
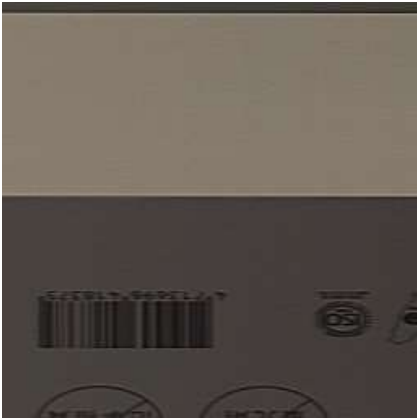
No.	#26, \$20	Date	2023/8/9 下午 12:53:10
Segment	1	Camera	1
Pattern	7425	Position[x, y]	133.4 [mm], 5581.6 [m], (168.2 [m])
Type	点状疵点縱向刀絲疵點橫向刀絲	Size	H:184.1 ,V:159.2 [mm]
Result	-	Area	379.2 [mm2]
Inspection level	5/5,5/5,5/5,5/5,5/5	Label	-
Light	6,6,3/6,6,3

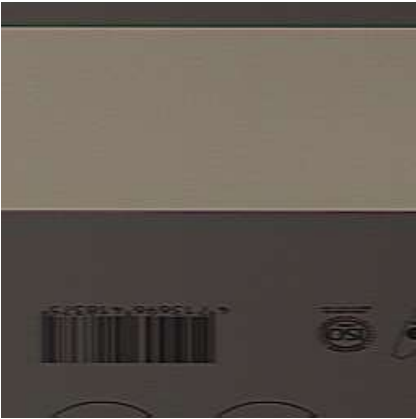
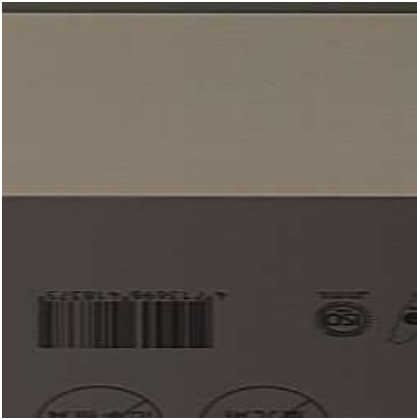
No.	#24, \$19	Date	2023/8/9 下午 12:48:41
Segment	1	Camera	1
Pattern	7424	Position[x, y]	217.1 [mm], 5580.5 [m], (169.3 [m])
Type	点状疵点縱向刀絲疵點	Size	H:47.4 ,V:41.6 [mm]
Result	-	Area	54.9 [mm2]
Inspection level	5/5,5/5,5/5,5/5,5/5	Label	-
Light	6,6,3/6,6,3

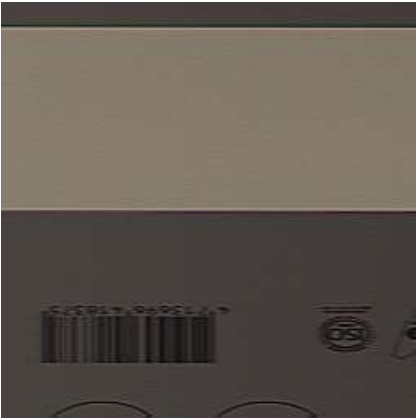
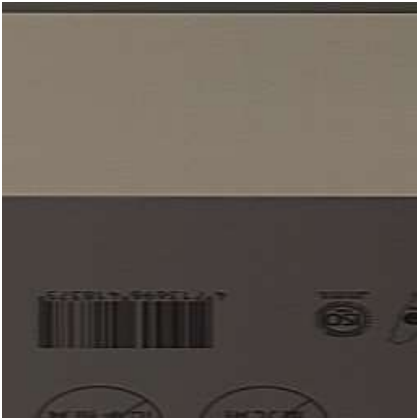
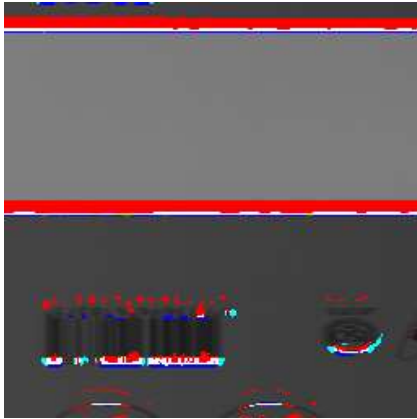
No.	#24, \$19	Date	2023/8/9 下午 12:48:41
Segment	1	Camera	1
Pattern	7424	Position[x, y]	464.5 [mm], 5580.5 [m], (169.3 [m])
Type	点状疵点縱向刀絲疵點	Size	H:82.0 ,V:48.0 [mm]
Result	-	Area	56.9 [mm2]
Inspection level	5/5,5/5,5/5,5/5,5/5	Label	-
Light	6,6,3/6,6,3

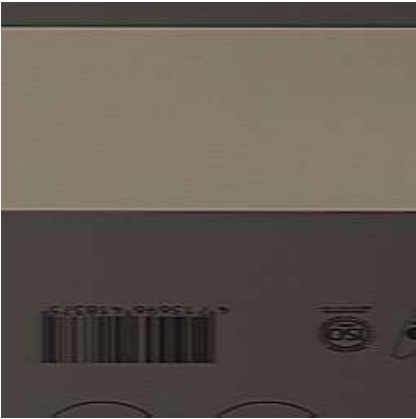
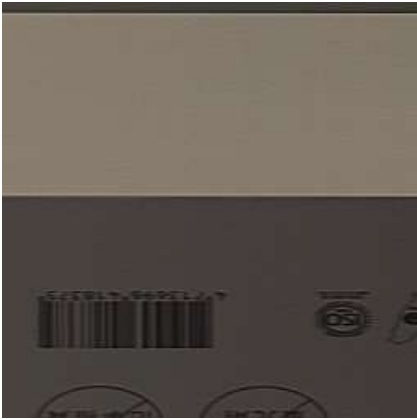
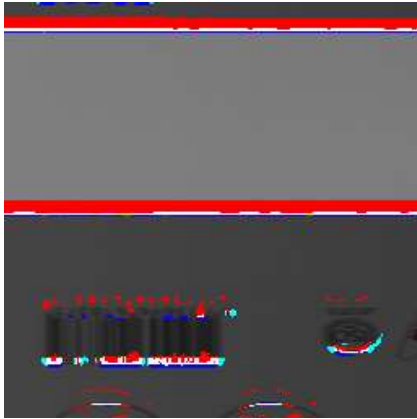
No.	#24, \$19	Date	2023/8/9 下午 12:48:41
Segment	1	Camera	1
Pattern	7424	Position[x, y]	538.2 [mm], 5580.5 [m], (169.3 [m])
Type	点状疵点縱向刀絲疵點	Size	H:59.3 ,V:41.2 [mm]
Result	-	Area	65.9 [mm2]
Inspection level	5/5,5/5,5/5,5/5,5/5	Label	-
Light	6,6,3/6,6,3

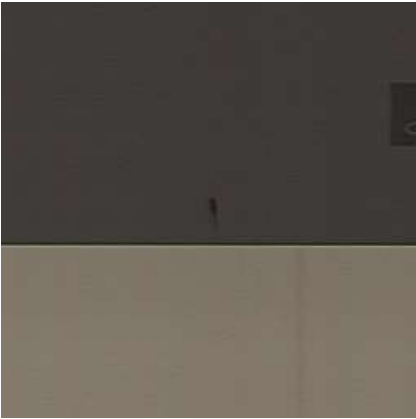
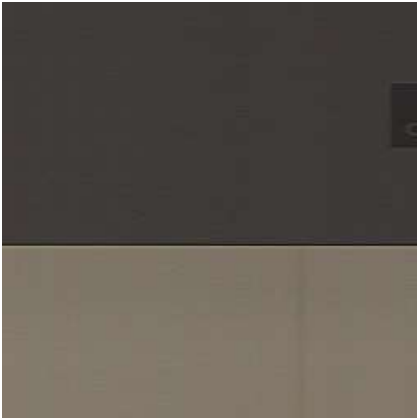
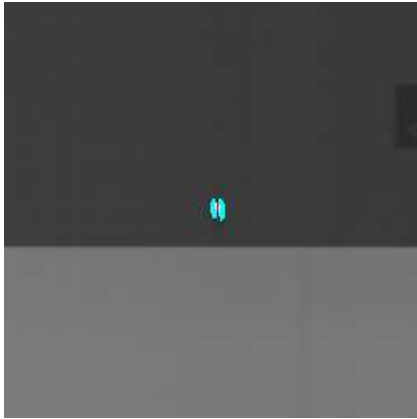
No.	#23, \$18	Date	2023/8/9 下午 12:42:44
Segment	1	Camera	1
Pattern	6836	Position[x, y]	178.3 [mm], 5139.2 [m], (610.6 [m])
Type	点状疵点縱向刀絲疵點	Size	H:2.2 ,V:4.8 [mm]
Result	-	Area	7.7 [mm2]
Inspection level	5/5,5/5,5/5,5/5,5/5	Label	-
Light	6,6,3/6,6,3

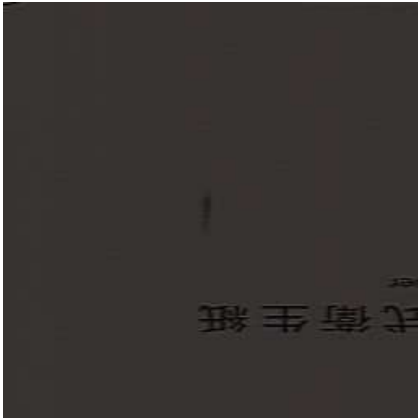
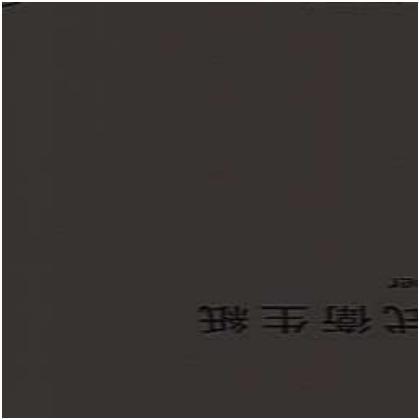
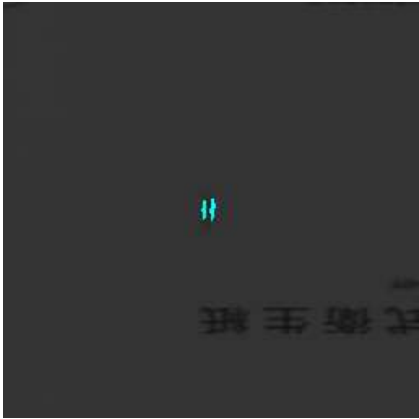
No.	#22, \$17	Date	2023/8/9 下午 12:35:53
Segment	1	Camera	1
Pattern	6155	Position[x, y]	482.0 [mm], 4628.0 [m], (1121.9 [m])
Type	縱向刀絲疵點	Size	H:2.2 ,V:4.8 [mm]
Result	-	Area	5.0 [mm2]
Inspection level	5/5,5/5,5/5,5/5,5/5	Label	-
Light	6,6,3/6,6,3

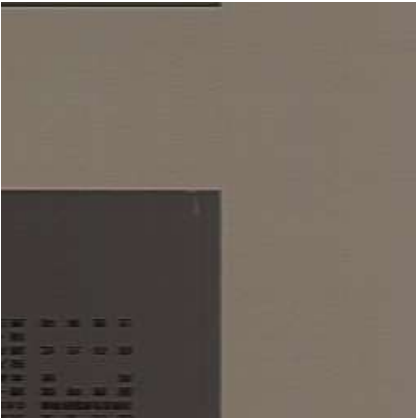
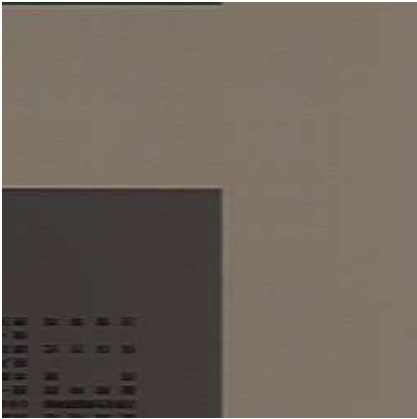
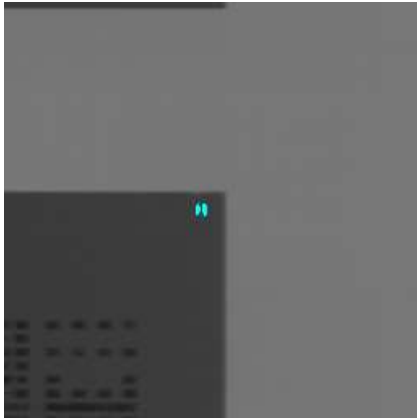
No.	#19, \$14	Date	2023/8/9 下午 12:25:50
Segment	1	Camera	1
Pattern	5155	Position[x, y]	879.3 [mm], 3876.9 [m], (1872.9 [m])
Type	縱向刀絲疵點	Size	H:1.7 ,V:2.4 [mm]
Result	-	Area	2.9 [mm2]
Inspection level	5/5,5/5,5/5,5/5,5/5	Label	-
Light	6,6,3/6,6,3

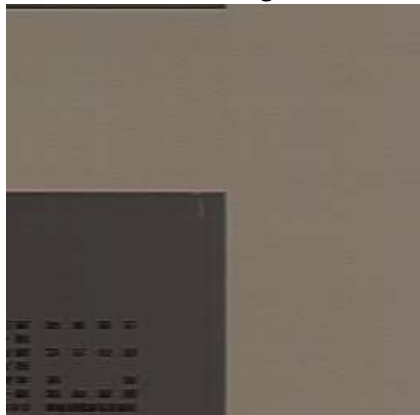
Defect image

No.	#16, \$13	Date	2023/8/9 下午 12:20:43
Segment	1	Camera	1
Pattern	4635	Position[x, y]	375.3 [mm], 3486.4 [m], (2263.5 [m])
Type	点状疵点縱向刀絲疵點	Size	H:1.0 ,V:648.0 [mm]
Result	-	Area	79.2 [mm2]
Inspection level	5/5,5/5,5/5,5/5,5/5	Label	-
Light	6,6,3/6,6,3

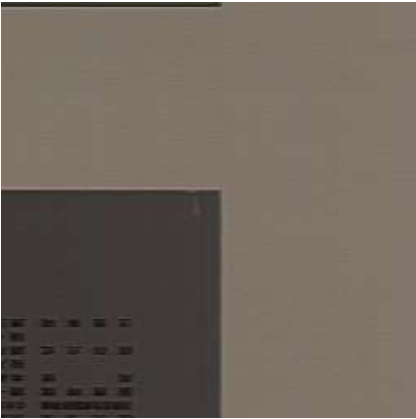
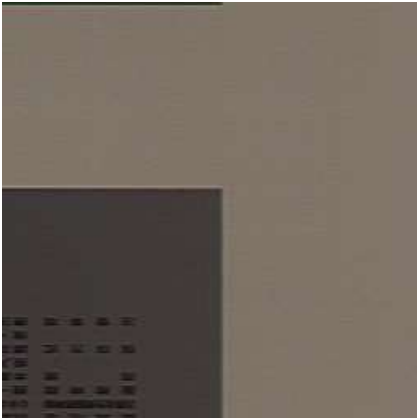
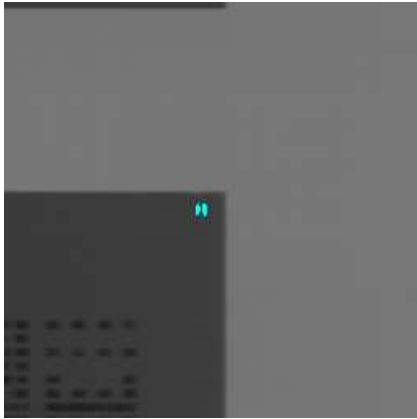
No.	#16, \$13	Date	2023/8/9 下午 12:20:43
Segment	1	Camera	1
Pattern	4635	Position[x, y]	568.2 [mm], 3486.4 [m], (2263.4 [m])
Type	点状疵点縱向刀絲疵點	Size	H:1.2 ,V:794.0 [mm]
Result	-	Area	86.8 [mm2]
Inspection level	5/5,5/5,5/5,5/5,5/5	Label	-
Light	6,6,3/6,6,3

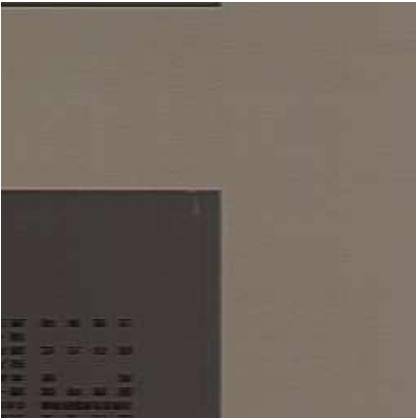
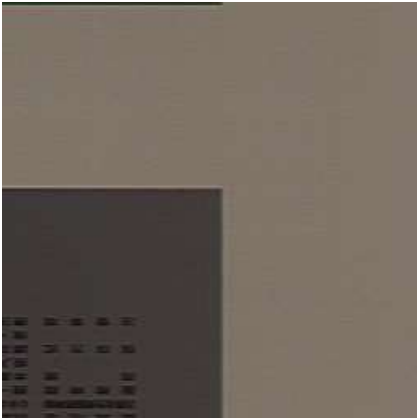
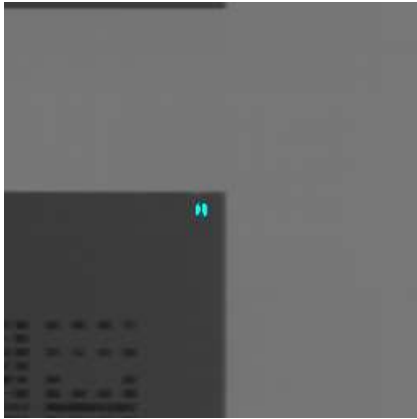
No.	#16, \$13	Date	2023/8/9 下午 12:20:43
Segment	1	Camera	1
Pattern	4635	Position[x, y]	700.1 [mm], 3486.4 [m], (2263.5 [m])
Type	点状疵点縱向刀絲疵點	Size	H:1.2 ,V:648.0 [mm]
Result	-	Area	107.3 [mm2]
Inspection level	5/5,5/5,5/5,5/5,5/5	Label	-
Light	6,6,3/6,6,3

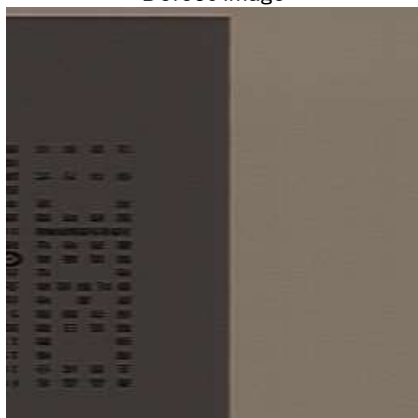
Defect image

No.	#16, \$13	Date	2023/8/9 下午 12:20:43
Segment	1	Camera	1
Pattern	4635	Position[x, y]	243.0 [mm], 3486.4 [m], (2263.5 [m])
Type	点状疵点縱向刀絲疵點	Size	H:2.2 ,V:793.6 [mm]
Result	-	Area	115.5 [mm2]
Inspection level	5/5,5/5,5/5,5/5,5/5	Label	-
Light	6,6,3/6,6,3

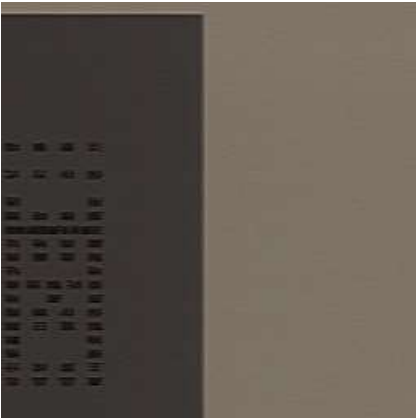
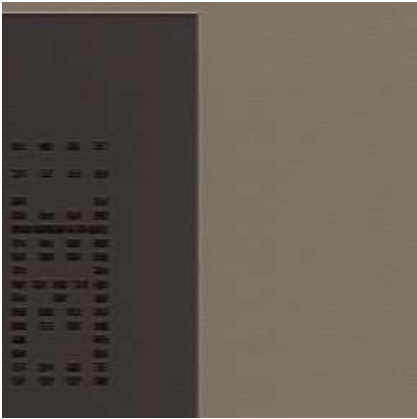
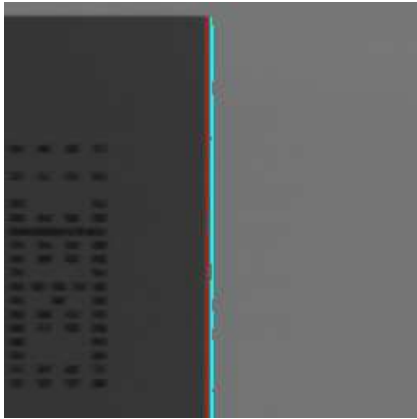
No.	#14, \$11	Date	2023/8/9 下午 12:20:42
Segment	1	Camera	1
Pattern	4633	Position[x, y]	883.9 [mm], 3484.9 [m], (2265.0 [m])
Type	縱向刀絲疵點	Size	H:0.5 ,V:808.0 [mm]
Result	-	Area	116.3 [mm2]
Inspection level	5/5,5/5,5/5,5/5,5/5	Label	-
Light	6,6,3/6,6,3

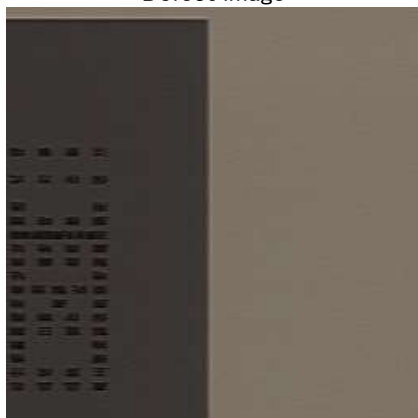
Defect image

No.	#14, \$11	Date	2023/8/9 下午 12:20:42
Segment	1	Camera	1
Pattern	4633	Position[x, y]	700.1 [mm], 3484.8 [m], (2265.0 [m])
Type	点状疵点縱向刀絲疵點	Size	H:1.2 ,V:641.2 [mm]
Result	-	Area	122.4 [mm2]
Inspection level	5/5,5/5,5/5,5/5,5/5	Label	-
Light	6,6,3/6,6,3

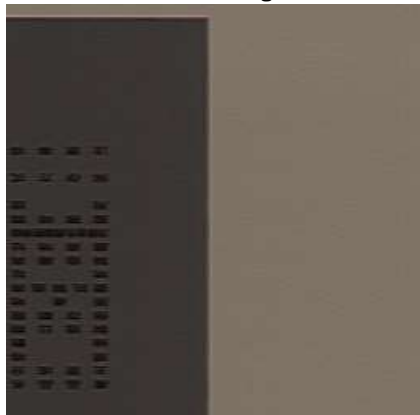
Defect image

No.	#14, \$11	Date	2023/8/9 下午 12:20:42
Segment	1	Camera	1
Pattern	4633	Position[x, y]	568.0 [mm], 3484.9 [m], (2265.0 [m])
Type	点状疵点縱向刀絲疵點	Size	H:1.2 ,V:808.0 [mm]
Result	-	Area	147.1 [mm2]
Inspection level	5/5,5/5,5/5,5/5,5/5	Label	-
Light	6,6,3/6,6,3

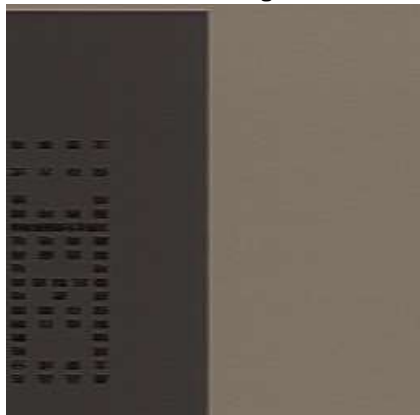
Defect image

No.	#12, \$9	Date	2023/8/9 下午 12:20:40
Segment	1	Camera	1
Pattern	4631	Position[x, y]	243.0 [mm], 3483.7 [m], (2266.2 [m])
Type	点状疵点縱向刀絲疵點	Size	H:2.2 ,V:483.6 [mm]
Result	-	Area	91.4 [mm2]
Inspection level	5/5,5/5,5/5,5/5,5/5	Label	-
Light	6,6,3/6,6,3

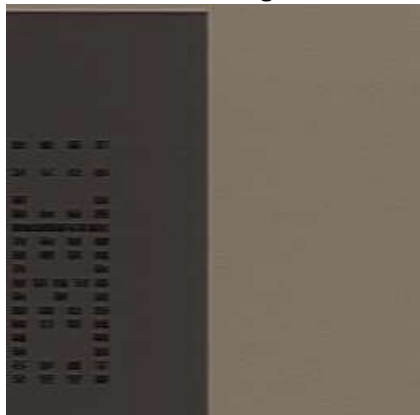
Defect image

No.	#12, \$9	Date	2023/8/9 下午 12:20:40
Segment	1	Camera	1
Pattern	4631	Position[x, y]	568.2 [mm], 3483.6 [m], (2266.3 [m])
Type	縱向刀絲疵點	Size	H:0.5 ,V:426.8 [mm]
Result	-	Area	108.8 [mm2]
Inspection level	5/5,5/5,5/5,5/5,5/5	Label	-
Light	6,6,3/6,6,3

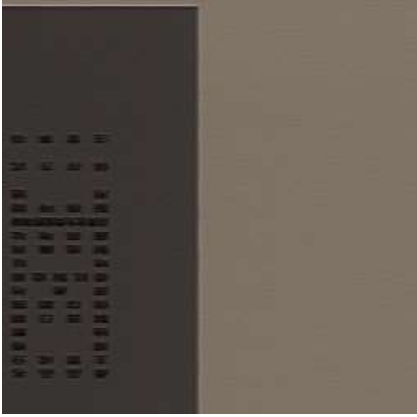
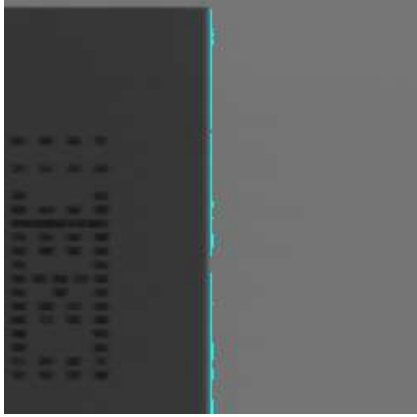
No.	#9, \$8	Date	2023/8/9 下午 12:20:33
Segment	1	Camera	1
Pattern	4618	Position[x, y]	92.9 [mm], 3473.5 [m], (2276.4 [m])
Type	縱向刀絲疵點	Size	H:8.5 ,V:58.8 [mm]
Result	-	Area	7.1 [mm2]
Inspection level	5/5,5/5,5/5,5/5,5/5	Label	-
Light	6,6,3/6,6,3

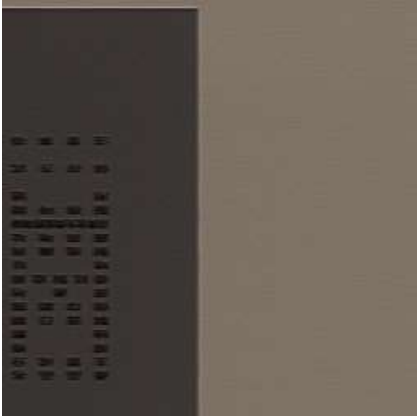
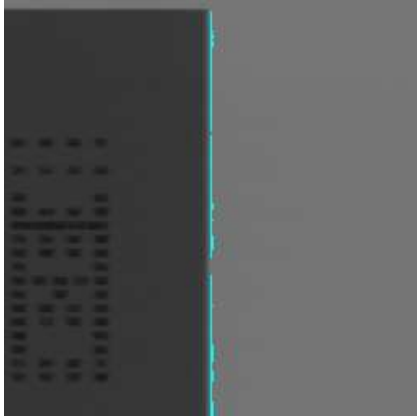
No.	#9, \$8	Date	2023/8/9 下午 12:20:33
Segment	1	Camera	1
Pattern	4618	Position[x, y]	225.0 [mm], 3473.5 [m], (2276.4 [m])
Type	縱向刀絲疵點	Size	H:12.9 ,V:45.2 [mm]
Result	-	Area	8.6 [mm2]
Inspection level	5/5,5/5,5/5,5/5,5/5	Label	-
Light	6,6,3/6,6,3

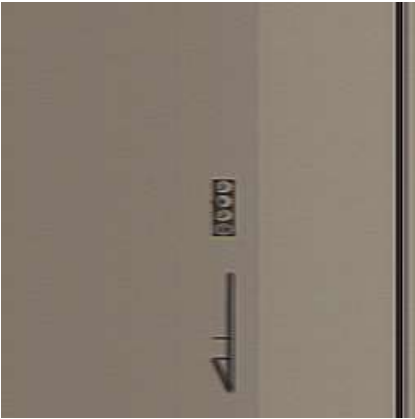
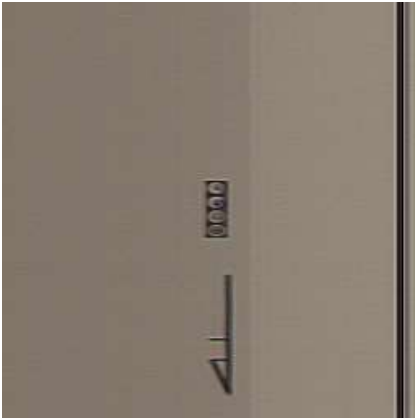
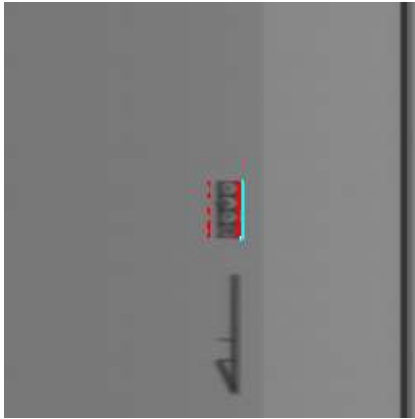
No.	#7, \$6	Date	2023/8/9 下午 12:20:32
Segment	1	Camera	1
Pattern	4616	Position[x, y]	728.6 [mm], 3472.0 [m], (2277.9 [m])
Type	縱向刀絲疵點	Size	H:8.3 ,V:56.4 [mm]
Result	-	Area	5.0 [mm2]
Inspection level	5/5,5/5,5/5,5/5,5/5	Label	-
Light	6,6,3/6,6,3

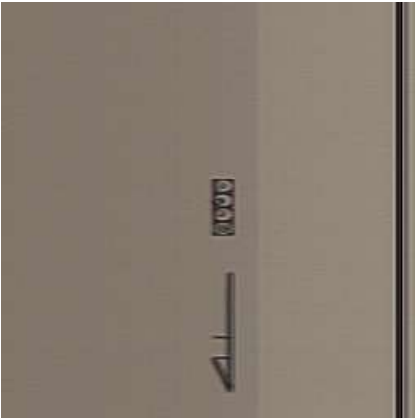
No.	#6, \$5	Date	2023/8/9 下午 12:20:31
Segment	1	Camera	1
Pattern	4615	Position[x, y]	939.6 [mm], 3471.5 [m], (2278.4 [m])
Type	点状疵点縱向刀絲疵點	Size	H:1.0 ,V:14.0 [mm]
Result	-	Area	3.7 [mm2]
Inspection level	5/5,5/5,5/5,5/5,5/5	Label	-
Light	6,6,3/6,6,3

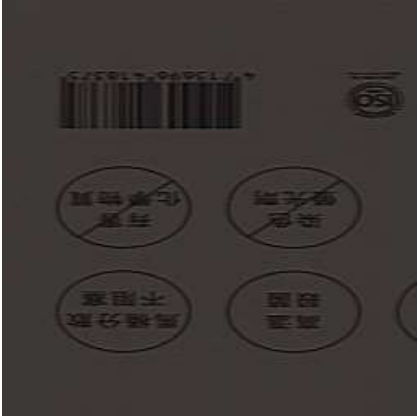
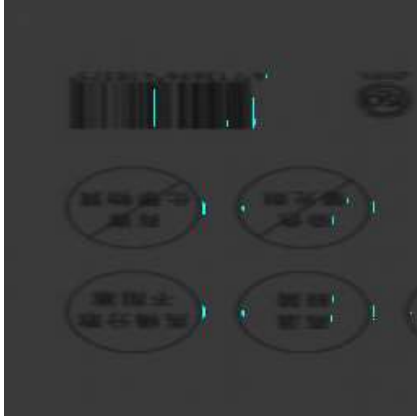
No.	#5, \$4	Date	2023/8/9 下午 12:20:30
Segment	1	Camera	1
Pattern	4614	Position[x, y]	734.7 [mm], 3470.8 [m], (2279.0 [m])
Type	縱向刀絲疵點	Size	H:8.1 ,V:53.6 [mm]
Result	-	Area	4.2 [mm2]
Inspection level	5/5,5/5,5/5,5/5,5/5	Label	-
Light	6,6,3/6,6,3

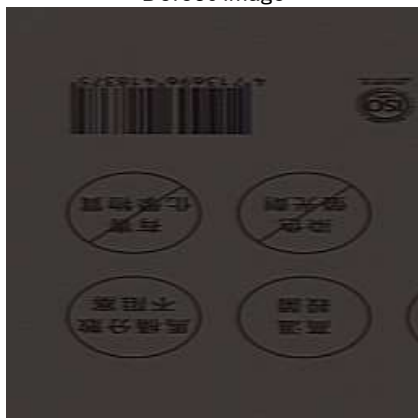
Defect image

No.	#4, \$3	Date	2023/8/9 下午 12:20:20
Segment	1	Camera	1
Pattern	4596	Position[x, y]	730.3 [mm], 3456.9 [m], (2292.9 [m])
Type	縱向刀絲疵點	Size	H:11.5 ,V:8.8 [mm]
Result	-	Area	2.8 [mm2]
Inspection level	5/5,5/5,5/5,5/5,5/5	Label	-
Light	6,6,3/6,6,3

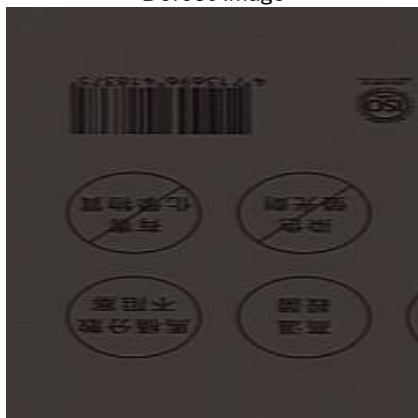
Defect image

No.	#4, \$3	Date	2023/8/9 下午 12:20:20
Segment	1	Camera	1
Pattern	4596	Position[x, y]	939.3 [mm], 3457.2 [m], (2292.7 [m])
Type	点状疵点	Size	H:0.5 ,V:10.8 [mm]
Result	-	Area	3.2 [mm2]
Inspection level	5/5,5/5,5/5,5/5,5/5	Label	-
Light	6,6,3/6,6,3

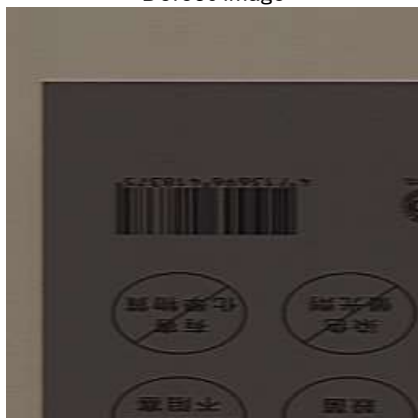
Defect image

No.	#4, \$3	Date	2023/8/9 下午 12:20:20
Segment	1	Camera	1
Pattern	4596	Position[x, y]	725.0 [mm], 3457.3 [m], (2292.6 [m])
Type	縱向刀絲疵點	Size	H:0.5 ,V:9.2 [mm]
Result	-	Area	3.3 [mm2]
Inspection level	5/5,5/5,5/5,5/5,5/5	Label	-
Light	6,6,3/6,6,3
