# Inspection Result (Individual Data)

Lot number : 3

Inspected date : 2023/8/10 上午 09:15:18 ~ 2023/8/10 上午 10:55:13

商品名	標準透明6-6-3	周長	
顧客名		Ex1	
CODE番号		Ex2	
基材		Ex3

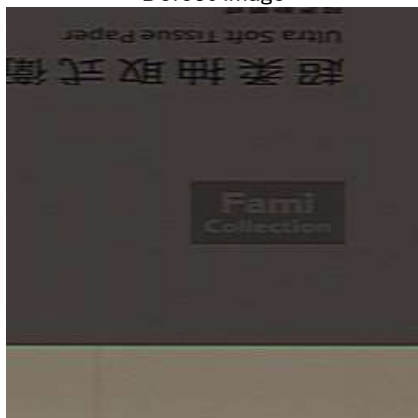
No.	#79, \$58	Date	2023/8/10 上午 10:53:50
Segment	1	Camera	1
Pattern	8141	Position[ x, y ]	203.7 [mm], 6124.7 [m], ( 99.5 [m] )
Type	縱向刀絲疵點	Size	H:5.6 ,V:14.0 [mm]
Result	-	Area	8.9 [mm2]
Inspection level	5/5,5/5,5/5,5/5,5/5	Label	-
Light	6,6,3/6,6,3

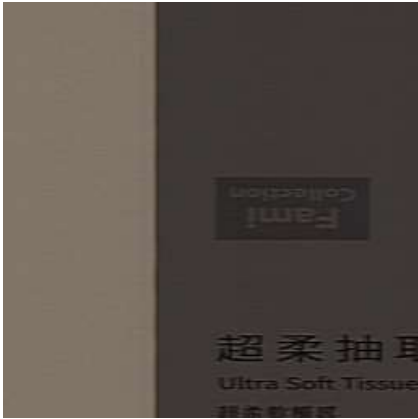
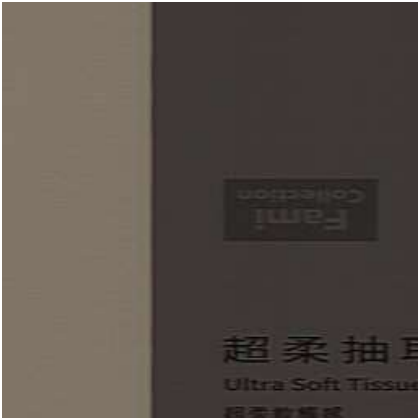
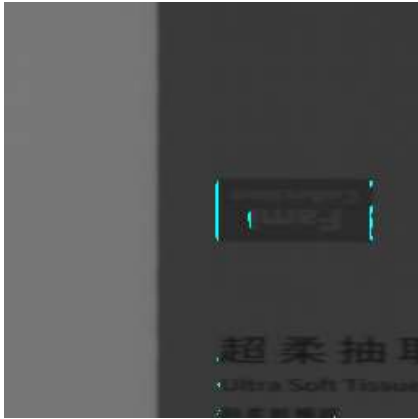
No.	#77, \$56	Date	2023/8/10 上午 10:53:48
Segment	1	Camera	1
Pattern	8139	Position[ x, y ]	383.2 [mm], 6123.1 [m], ( 101.0 [m] )
Type	縱向刀絲疵點	Size	H:5.6 ,V:14.0 [mm]
Result	-	Area	6.9 [mm2]
Inspection level	5/5,5/5,5/5,5,5/5,5/5	Label	-
Light	6,6,3/6,6,3

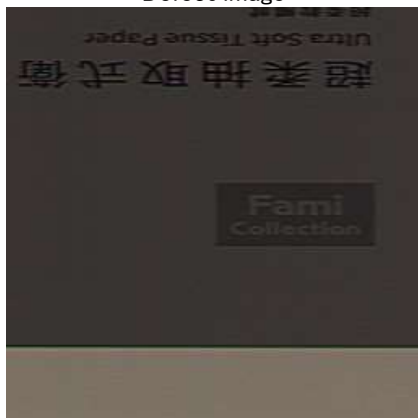
No.	#76, \$55	Date	2023/8/10 上午 10:53:48
Segment	1	Camera	1
Pattern	8138	Position[ x, y ]	383.4 [mm], 6122.8 [m], ( 101.4 [m] )
Type	縱向刀絲疵點	Size	H:5.6 ,V:13.6 [mm]
Result	-	Area	5.0 [mm2]
Inspection level	5/5,5/5,5/5,5/5,5/5	Label	-
Light	6,6,3/6,6,3

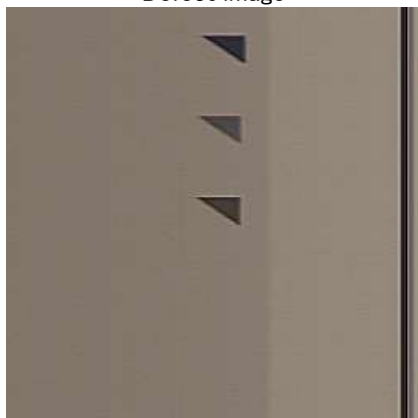
No.	#72, \$53	Date	2023/8/10 上午 10:53:37
Segment	1	Camera	1
Pattern	8119	Position[ x, y ]	696.2 [mm], 6108.2 [m], ( 116.0 [m] )
Type	点状疵点縱向刀絲疵點	Size	H:2.4 ,V:102.8 [mm]
Result	-	Area	119.4 [mm2]
Inspection level	5/5,5/5,5/5,5/5,5/5	Label	-
Light	6,6,3/6,6,3

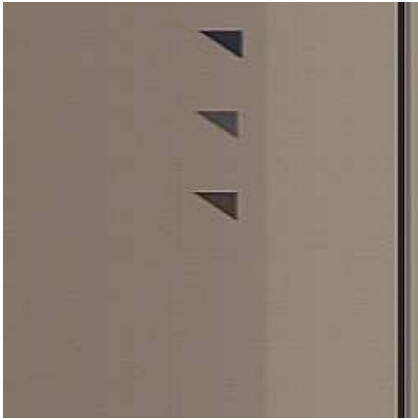
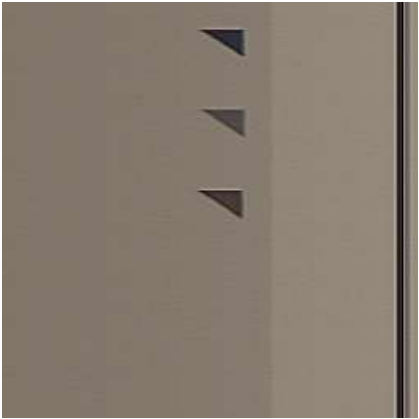
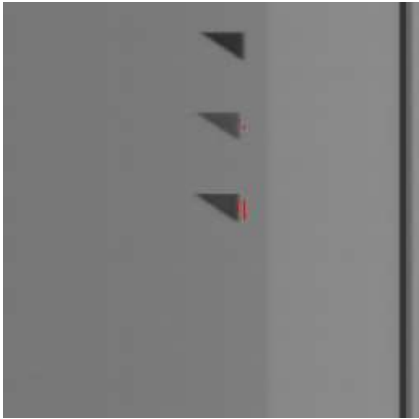
No.	#72, \$53	Date	2023/8/10 上午 10:53:37
Segment	1	Camera	1
Pattern	8119	Position[ x, y ]	695.9 [mm], 6108.3 [m], ( 115.9 [m] )
Type	点状疵点縱向刀絲疵點	Size	H:2.4 ,V:198.4 [mm]
Result	-	Area	120.3 [mm2]
Inspection level	5/5,5/5,5/5,5/5,5/5	Label	-
Light	6,6,3/6,6,3

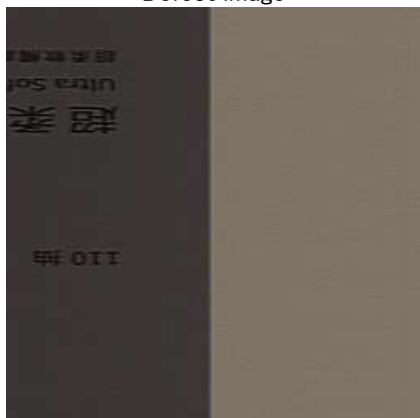
No.	#62, \$45	Date	2023/8/10 上午 10:53:24
Segment	1	Camera	1
Pattern	8098	Position[ x, y ]	697.2 [mm], 6093.1 [m], ( 131.1 [m] )
Type	点状疵点縱向刀絲疵點	Size	H:1.0 ,V:50.8 [mm]
Result	-	Area	22.1 [mm2]
Inspection level	5/5,5/5,5/5,5,5/5,5/5	Label	-
Light	6,6,3/6,6,3

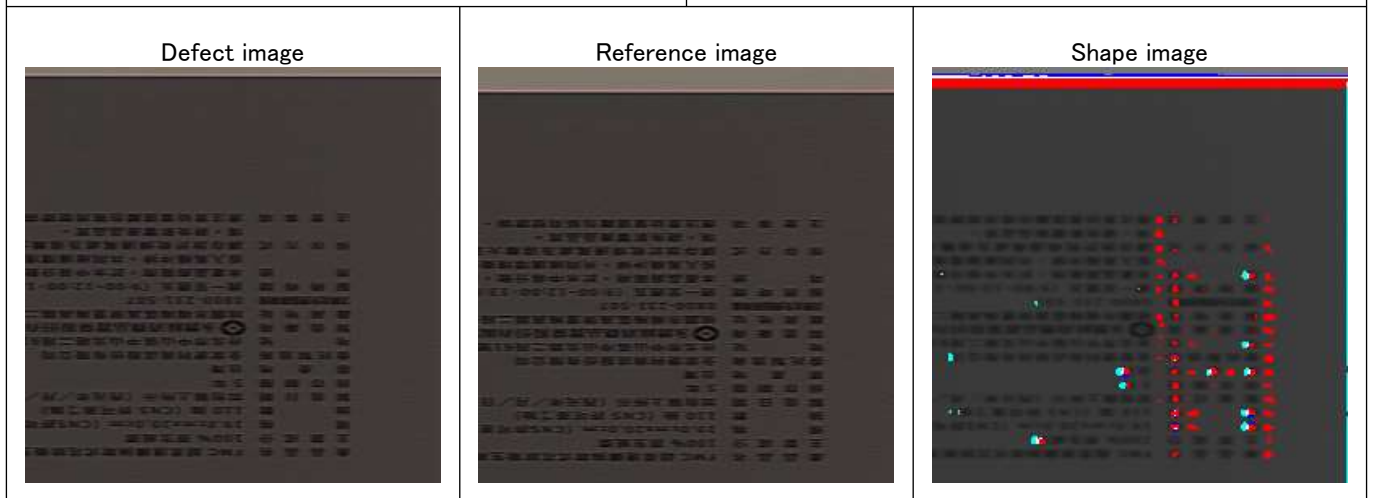
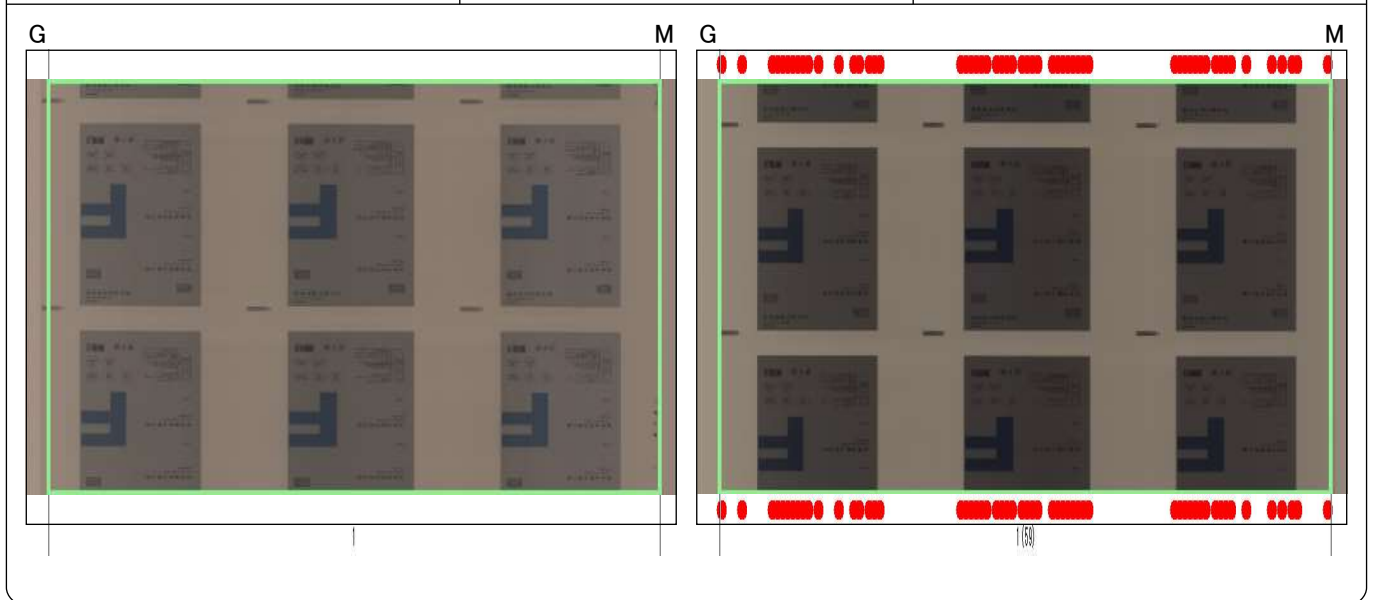
No.	#57, \$42	Date	2023/8/10 上午 10:52:59
Segment	1	Camera	1
Pattern	8054	Position[ x, y ]	478.9 [mm], 6060.0 [m], ( 164.2 [m] )
Type	点状疵点縱向刀絲疵點橫向刀絲	Size	H:366.2 ,V:122.0 [mm]
Result	—	Area	2078.9 [mm2]
Inspection level	5/5,5/5,5/5,5/5,5/5	Label	—
Light	6,6,3/6,6,3

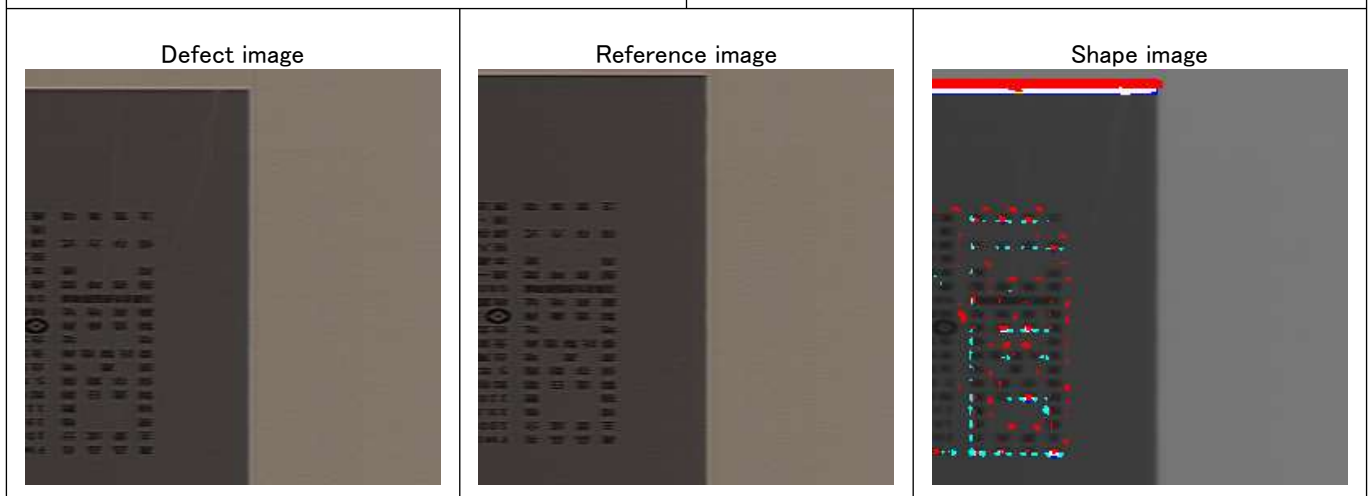
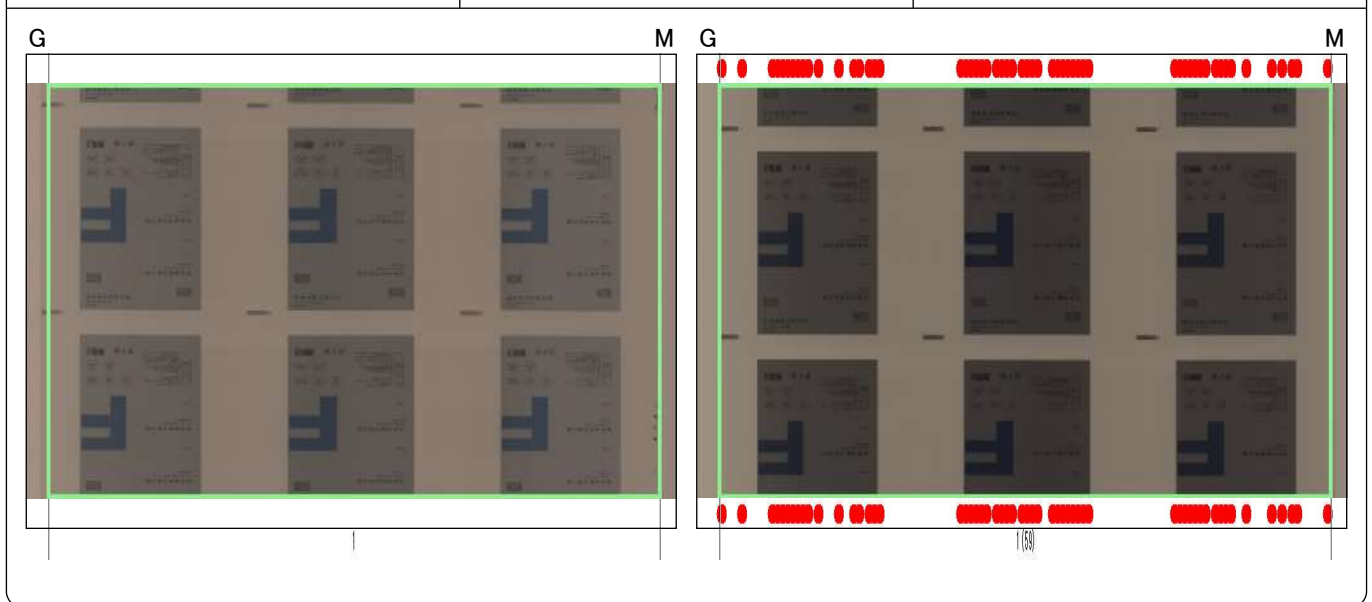
No.	#50, \$37	Date	2023/8/10 上午 10:52:47
Segment	1	Camera	1
Pattern	8035	Position[ x, y ]	151.3 [mm], 6044.8 [m], ( 179.3 [m] )
Type	点状疵点	Size	H:184.6 ,V:2.0 [mm]
Result	-	Area	305.8 [mm2]
Inspection level	5/5,5/5,5/5,5,5/5,5/5	Label	-
Light	6,6,3/6,6,3

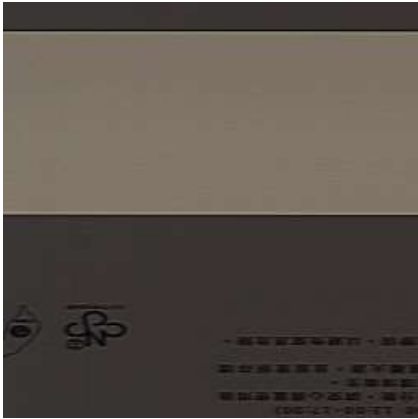
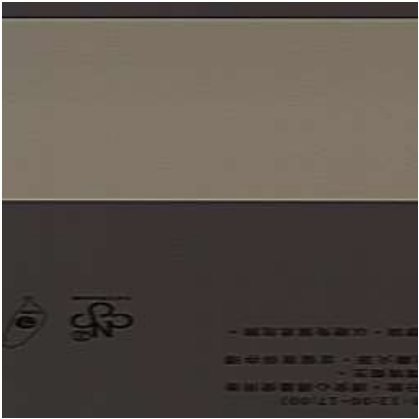
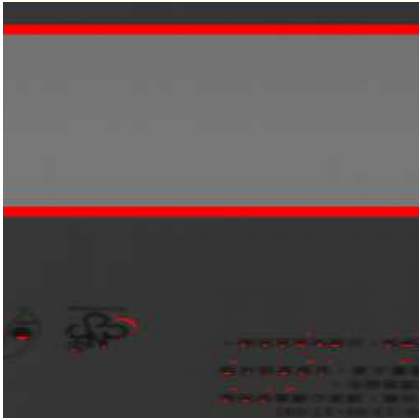
No.	#49, \$36	Date	2023/8/10 上午 10:52:46
Segment	1	Camera	1
Pattern	8034	Position[ x, y ]	148.1 [mm], 6044.1 [m], ( 180.1 [m] )
Type	点状疵点	Size	H:183.1 ,V:1.2 [mm]
Result	-	Area	219.3 [mm2]
Inspection level	5/5,5/5,5/5,5/5,5/5	Label	-
Light	6,6,3/6,6,3

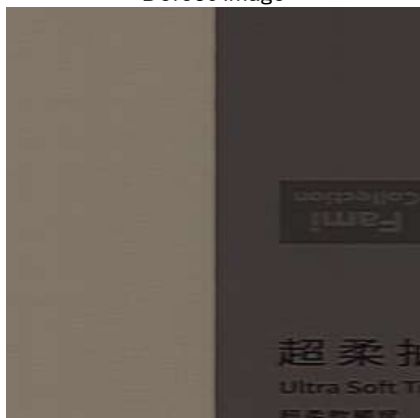
No.	#46, \$33	Date	2023/8/10 上午 10:52:42
Segment	1	Camera	1
Pattern	8027	Position[ x, y ]	699.1 [mm], 6038.3 [m], ( 185.9 [m] )
Type	縱向刀絲疵點	Size	H:0.5 ,V:38.8 [mm]
Result	-	Area	18.0 [mm2]
Inspection level	5/5,5/5,5/5,5,5/5,5/5	Label	-
Light	6,6,3/6,6,3

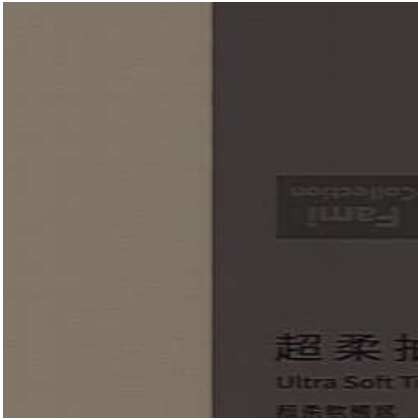
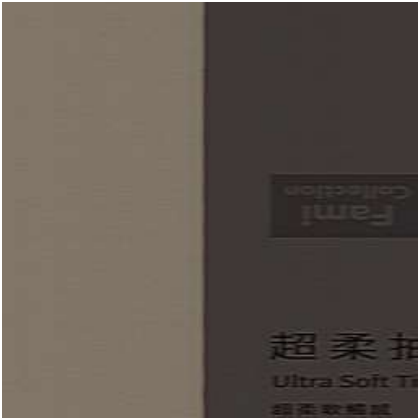
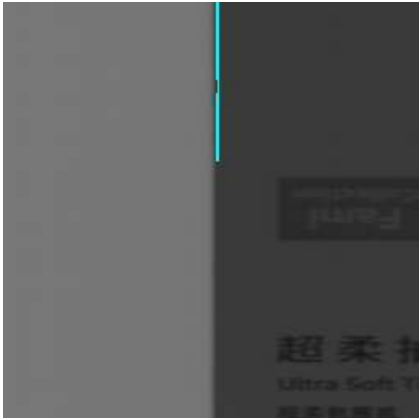
No.	#45, \$32	Date	2023/8/10 上午 10:52:41
Segment	1	Camera	1
Pattern	8026	Position[ x, y ]	241.8 [mm], 6037.7 [m], ( 186.5 [m] )
Type	点状疵点縱向刀絲疵點	Size	H:2.7 ,V:339.6 [mm]
Result	-	Area	164.7 [mm2]
Inspection level	5/5,5/5,5/5,5/5,5/5	Label	-
Light	6,6,3/6,6,3

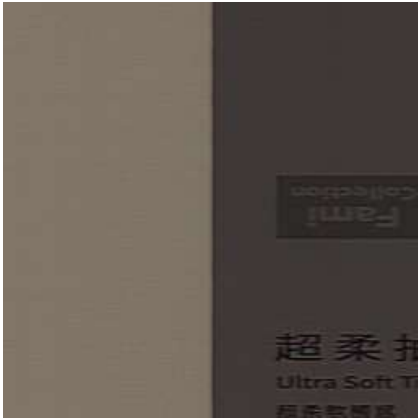
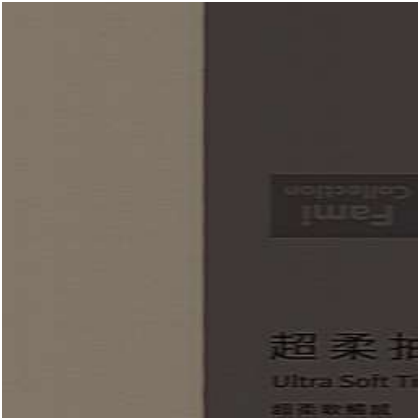
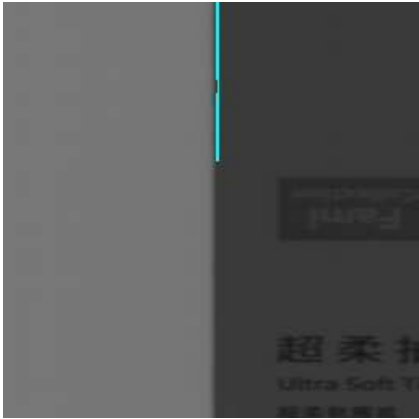
No.	#45, \$32	Date	2023/8/10 上午 10:52:41
Segment	1	Camera	1
Pattern	8026	Position[ x, y ]	373.9 [mm], 6037.6 [m], ( 186.5 [m] )
Type	点状疵点縱向刀絲疵點	Size	H:4.2 ,V:322.0 [mm]
Result	-	Area	177.7 [mm2]
Inspection level	5/5,5/5,5/5,5/5,5/5	Label	-
Light	6,6,3/6,6,3

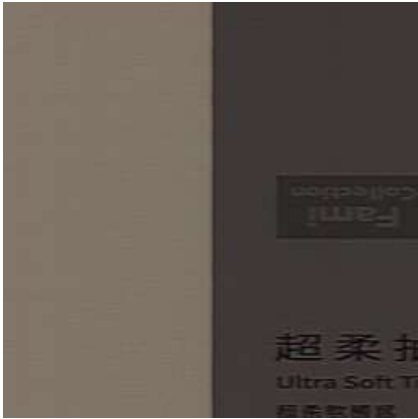
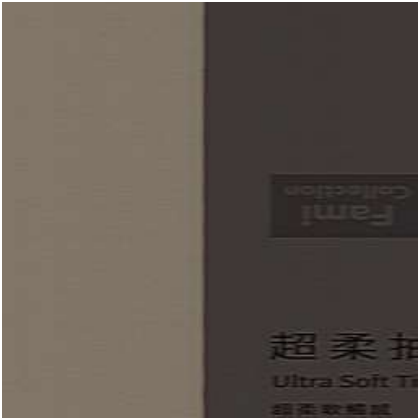
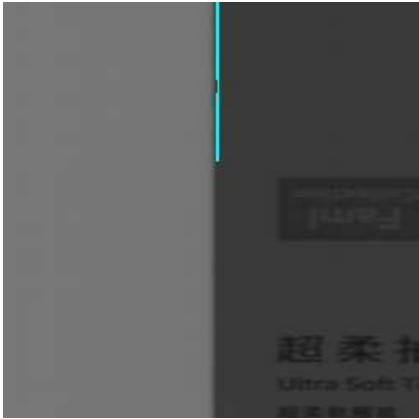
No.	#45, \$32	Date	2023/8/10 上午 10:52:41
Segment	1	Camera	1
Pattern	8026	Position[ x, y ]	567.0 [mm], 6037.8 [m], ( 186.4 [m] )
Type	点状疵点縱向刀絲疵點	Size	H:2.7 ,V:579.6 [mm]
Result	-	Area	191.8 [mm2]
Inspection level	5/5,5/5,5/5,5/5,5/5	Label	-
Light	6,6,3/6,6,3

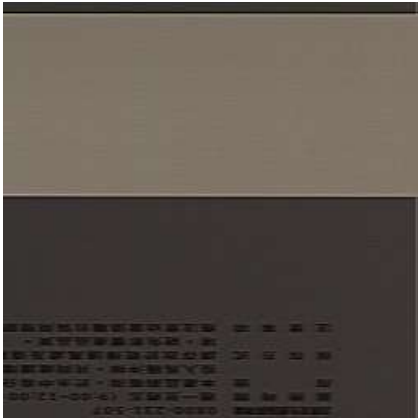
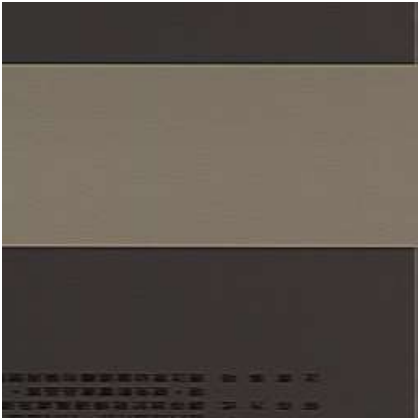
No.	#42, \$31	Date	2023/8/10 上午 10:52:34
Segment	1	Camera	1
Pattern	8017	Position[ x, y ]	445.9 [mm], 6030.6 [m], ( 193.6 [m] )
Type	点状疵点縱向刀絲疵點橫向刀絲	Size	H:193.6 ,V:225.2 [mm]
Result	-	Area	2100.3 [mm2]
Inspection level	5/5,5/5,5/5,5/5,5/5	Label	-
Light	6,6,3/6,6,3

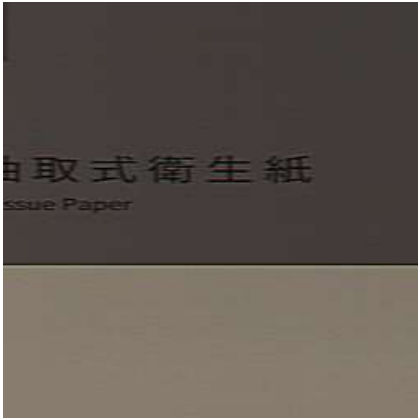
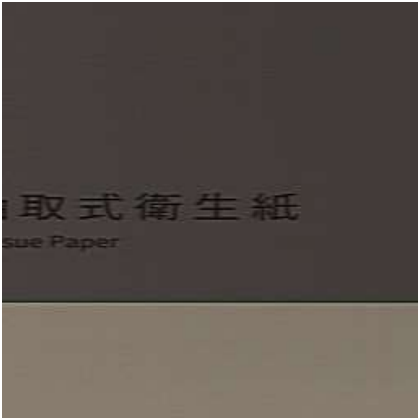
No.	#40, \$29	Date	2023/8/10 上午 10:52:33
Segment	1	Camera	1
Pattern	8015	Position[ x, y ]	119.5 [mm], 6029.0 [m], ( 195.1 [m] )
Type	点状疵点縱向刀絲疵點	Size	H:184.8 ,V:34.8 [mm]
Result	-	Area	1379.1 [mm2]
Inspection level	5/5,5/5,5/5,5,5/5,5/5	Label	-
Light	6,6,3/6,6,3

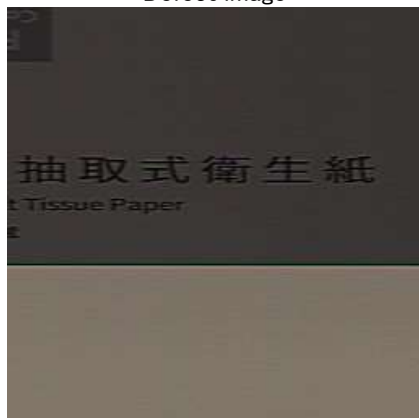
No.	#38, \$27	Date	2023/8/10 上午 10:52:31
Segment	1	Camera	1
Pattern	8013	Position[ x, y ]	765.5 [mm], 6027.6 [m], ( 196.6 [m] )
Type	点状疵点縱向刀絲疵點橫向刀絲	Size	H:184.3 ,V:37.6 [mm]
Result	-	Area	862.4 [mm2]
Inspection level	5/5,5/5,5/5,5,5/5,5/5	Label	-
Light	6,6,3/6,6,3

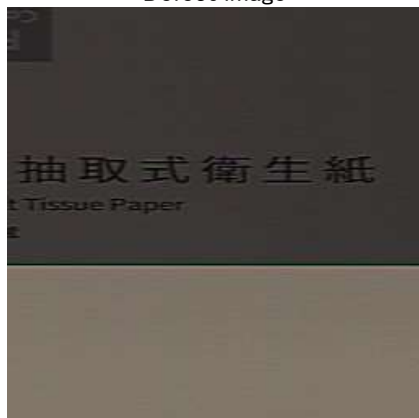
No.	#38, \$27	Date	2023/8/10 上午 10:52:31
Segment	1	Camera	1
Pattern	8013	Position[ x, y ]	772.8 [mm], 6027.5 [m], ( 196.6 [m] )
Type	点状疵点縱向刀絲疵點橫向刀絲	Size	H:184.6 ,V:116.0 [mm]
Result	-	Area	885.9 [mm2]
Inspection level	5/5,5/5,5/5,5,5/5,5/5	Label	-
Light	6,6,3/6,6,3

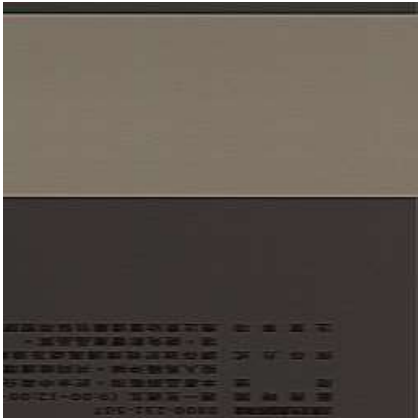
No.	#38, \$27	Date	2023/8/10 上午 10:52:31
Segment	1	Camera	1
Pattern	8013	Position[ x, y ]	436.7 [mm], 6027.5 [m], ( 196.6 [m] )
Type	点状疵点縱向刀絲疵點橫向刀絲	Size	H:193.8 ,V:116.0 [mm]
Result	-	Area	923.4 [mm2]
Inspection level	5/5,5/5,5/5,5/5,5/5	Label	-
Light	6,6,3/6,6,3

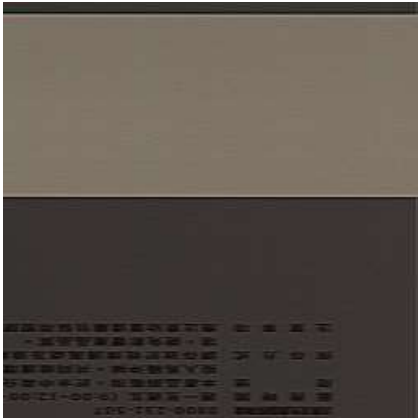
No.	#36, \$26	Date	2023/8/10 上午 10:43:16
Segment	1	Camera	1
Pattern	7899	Position[ x, y ]	464.5 [mm], 5941.0 [m], ( 283.2 [m] )
Type	点状疵点	Size	H:193.4 ,V:2.0 [mm]
Result	-	Area	363.1 [mm2]
Inspection level	5/5,5/5,5/5,5/5,5/5	Label	-
Light	6,6,3/6,6,3

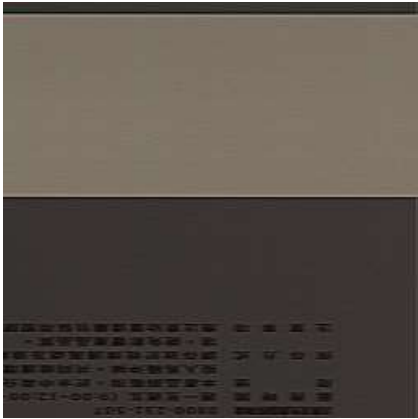
No.	#36, \$26	Date	2023/8/10 上午 10:43:16
Segment	1	Camera	1
Pattern	7899	Position[ x, y ]	148.6 [mm], 5940.9 [m], ( 283.3 [m] )
Type	点状疵点	Size	H:184.6 ,V:2.0 [mm]
Result	-	Area	366.5 [mm2]
Inspection level	5/5,5/5,5/5,5/5,5/5	Label	-
Light	6,6,3/6,6,3

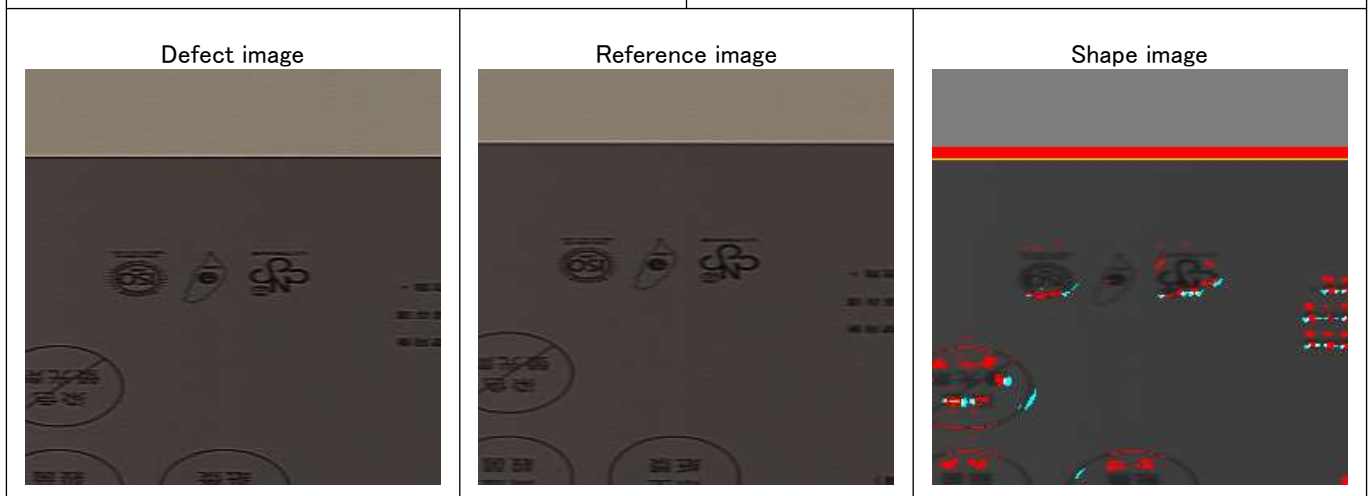
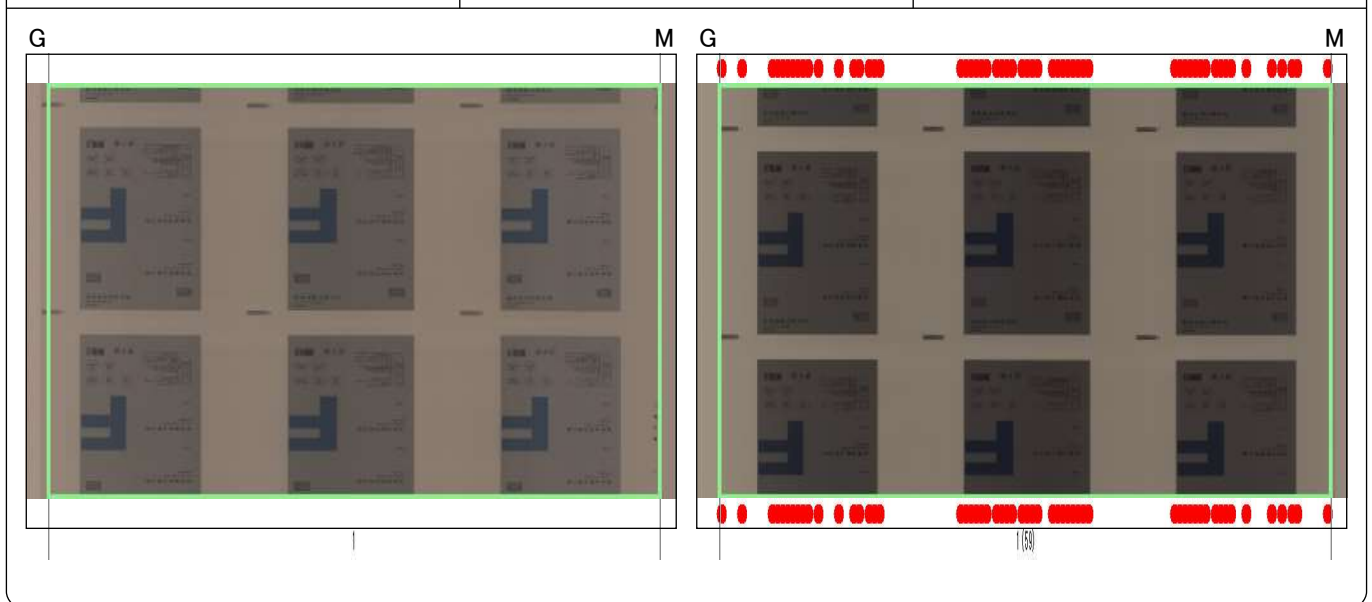
No.	#34, \$25	Date	2023/8/10 上午 10:39:36
Segment	1	Camera	1
Pattern	7898	Position[ x, y ]	468.6 [mm], 5940.2 [m], ( 284.0 [m] )
Type	点状疵点	Size	H:193.1 ,V:1.6 [mm]
Result	-	Area	306.7 [mm2]
Inspection level	5/5,5/5,5/5,5/5,5/5	Label	-
Light	6,6,3/6,6,3

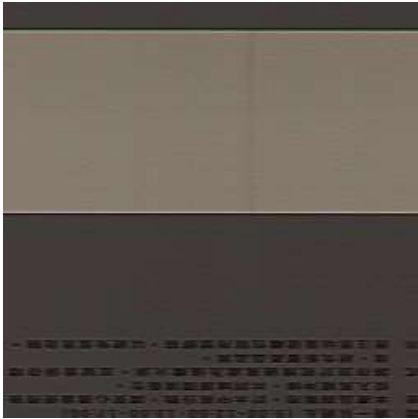
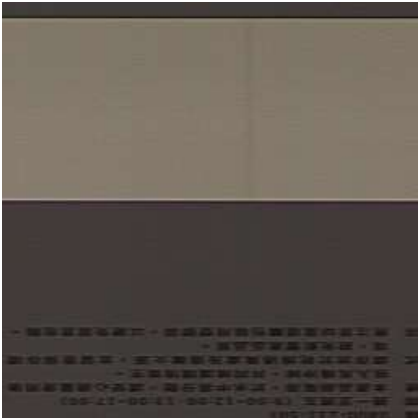
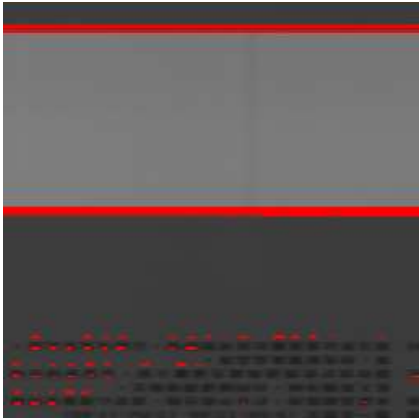
No.	#30, \$23	Date	2023/8/10 上午 10:39:00
Segment	1	Camera	1
Pattern	7841	Position[ x, y ]	707.4 [mm], 5897.7 [m], ( 326.5 [m] )
Type	縱向刀絲疵點	Size	H:5.4 ,V:13.6 [mm]
Result	-	Area	4.2 [mm2]
Inspection level	5/5,5/5,5/5,5/5,5/5	Label	-
Light	6,6,3/6,6,3

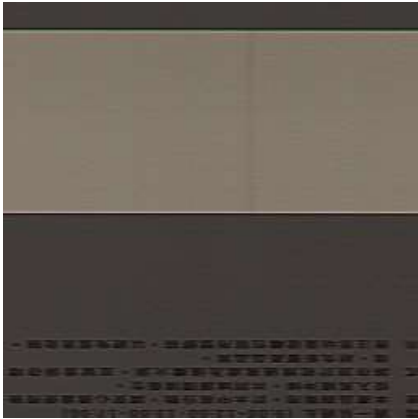
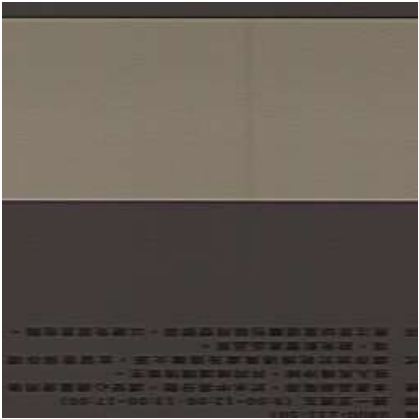
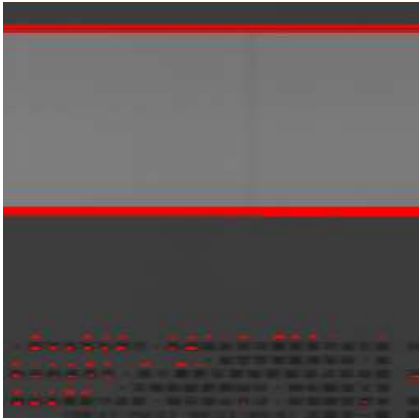
No.	#30, \$23	Date	2023/8/10 上午 10:39:00
Segment	1	Camera	1
Pattern	7841	Position[ x, y ]	203.3 [mm], 5897.8 [m], ( 326.4 [m] )
Type	縱向刀絲疵點	Size	H:5.4 ,V:12.0 [mm]
Result	-	Area	4.4 [mm2]
Inspection level	5/5,5/5,5/5,5/5,5/5	Label	-
Light	6,6,3/6,6,3

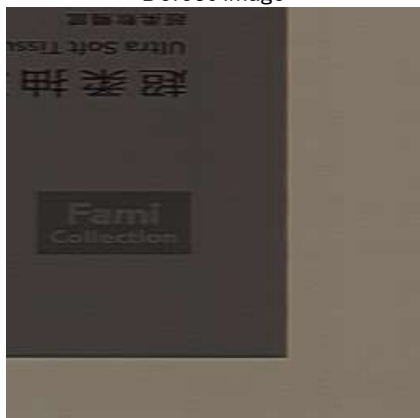
No.	#26, \$19	Date	2023/8/10 上午 10:38:57
Segment	1	Camera	1
Pattern	7837	Position[ x, y ]	225.7 [mm], 5894.4 [m], ( 329.8 [m] )
Type	縱向刀絲疵點	Size	H:0.5 ,V:6.4 [mm]
Result	-	Area	2.5 [mm2]
Inspection level	5/5,5/5,5/5,5/5,5/5	Label	-
Light	6,6,3/6,6,3

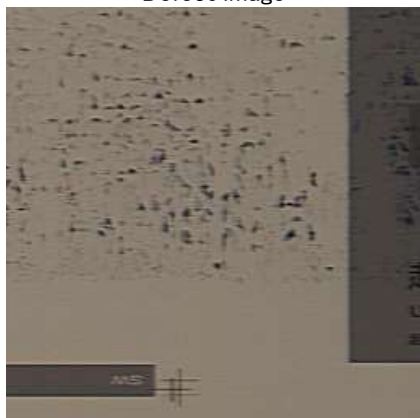
No.	#19, \$14	Date	2023/8/10 上午 10:38:17
Segment	1	Camera	1
Pattern	7768	Position[ x, y ]	86.6 [mm], 5843.2 [m], ( 380.9 [m] )
Type	点状疵点縱向刀絲疵點橫向刀絲	Size	H:91.8 ,V:172.8 [mm]
Result	-	Area	3964.4 [mm2]
Inspection level	5/5,5/5,5/5,5/5,5/5	Label	-
Light	6,6,3/6,6,3

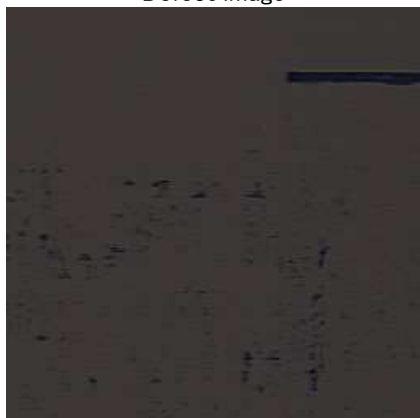
No.	#19, \$14	Date	2023/8/10 上午 10:38:17
Segment	1	Camera	1
Pattern	7768	Position[ x, y ]	410.3 [mm], 5843.2 [m], ( 381.0 [m] )
Type	点状疵点縱向刀絲疵點橫向刀絲	Size	H:83.3 ,V:95.2 [mm]
Result	-	Area	4256.4 [mm2]
Inspection level	5/5,5/5,5/5,5/5,5/5	Label	-
Light	6,6,3/6,6,3

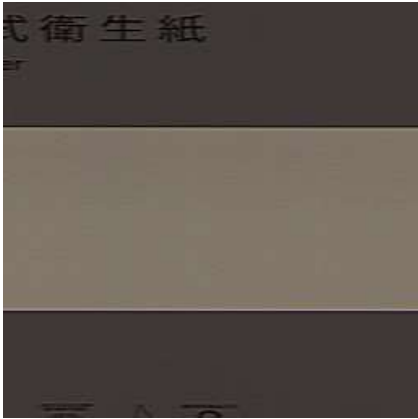
No.	#15, \$12	Date	2023/8/10 上午 10:38:12
Segment	1	Camera	1
Pattern	7760	Position[ x, y ]	463.8 [mm], 5835.9 [m], ( 388.3 [m] )
Type	点状疵点縱向刀絲疵點橫向刀絲	Size	H:194.8 ,V:257.2 [mm]
Result	-	Area	3465.2 [mm2]
Inspection level	5/5,5/5,5/5,5/5,5/5	Label	-
Light	6,6,3/6,6,3

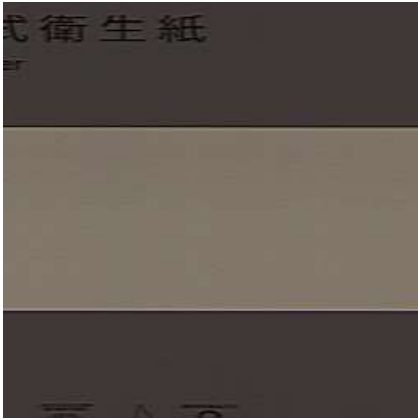
No.	#15, \$12	Date	2023/8/10 上午 10:38:12
Segment	1	Camera	1
Pattern	7760	Position[ x, y ]	488.9 [mm], 5836.2 [m], ( 388.0 [m] )
Type	点状疵点縱向刀絲疵點橫向刀絲	Size	H:192.9 ,V:123.2 [mm]
Result	-	Area	3471.9 [mm2]
Inspection level	5/5,5/5,5/5,5/5,5/5	Label	-
Light	6,6,3/6,6,3

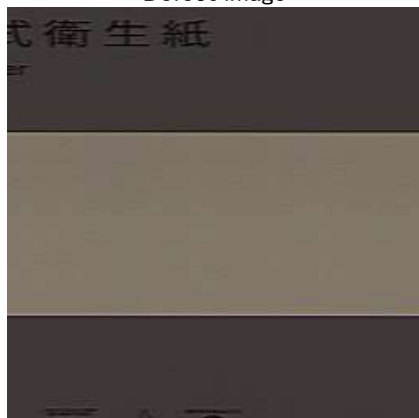
No.	#15, \$12	Date	2023/8/10 上午 10:38:12
Segment	1	Camera	1
Pattern	7760	Position[ x, y ]	776.7 [mm], 5835.9 [m], ( 388.3 [m] )
Type	点状疵点縱向刀絲疵點橫向刀絲	Size	H:185.5 ,V:169.2 [mm]
Result	-	Area	3566.6 [mm2]
Inspection level	5/5,5/5,5/5,5/5,5/5	Label	-
Light	6,6,3/6,6,3

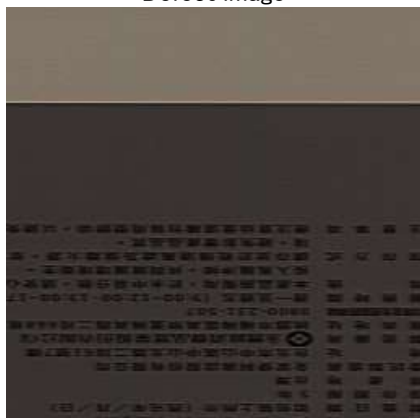
No.	#13, \$10	Date	2023/8/10 上午 10:38:11
Segment	1	Camera	1
Pattern	7758	Position[ x, y ]	450.8 [mm], 5834.4 [m], ( 389.8 [m] )
Type	点状疵点縱向刀絲疵點橫向刀絲	Size	H:194.6 ,V:131.6 [mm]
Result	-	Area	3819.5 [mm2]
Inspection level	5/5,5/5,5/5,5/5,5/5	Label	-
Light	6,6,3/6,6,3

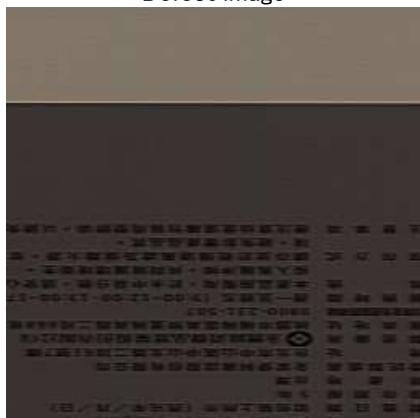
No.	#12, \$9	Date	2023/8/10 上午 10:38:10
Segment	1	Camera	1
Pattern	7757	Position[ x, y ]	158.3 [mm], 5833.6 [m], ( 390.5 [m] )
Type	点状疵点縱向刀絲疵點橫向刀絲	Size	H:186.0 ,V:207.6 [mm]
Result	-	Area	3446.5 [mm2]
Inspection level	5/5,5/5,5/5,5/5,5/5	Label	-
Light	6,6,3/6,6,3

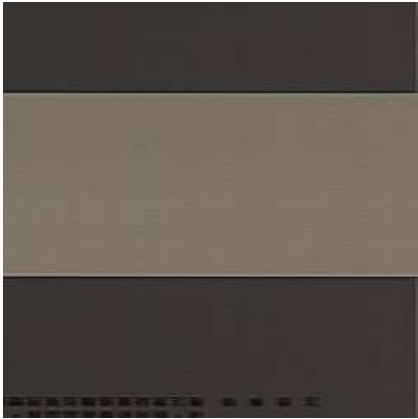
No.	#10, \$8	Date	2023/8/10 上午 10:36:05
Segment	1	Camera	1
Pattern	7724	Position[ x, y ]	487.2 [mm], 5804.6 [m], ( 419.6 [m] )
Type	点状疵点縱向刀絲疵點橫向刀絲	Size	H:194.8 ,V:185.2 [mm]
Result	-	Area	9617.3 [mm2]
Inspection level	5/5,5/5,5/5,5/5,5/5	Label	-
Light	6,6,3/6,6,3

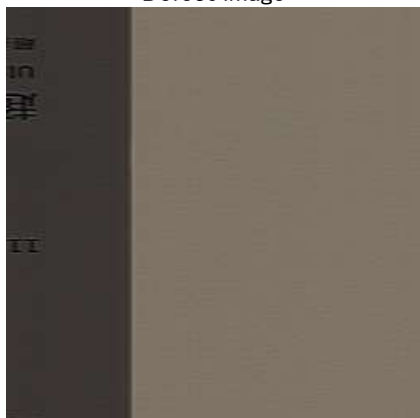
No.	#8, \$7	Date	2023/8/10 上午 10:30:38
Segment	1	Camera	1
Pattern	7722	Position[ x, y ]	146.6 [mm], 5804.0 [m], ( 420.1 [m] )
Type	点状疵点縱向刀絲疵點橫向刀絲	Size	H:184.3 ,V:112.8 [mm]
Result	-	Area	362.0 [mm2]
Inspection level	5/5,5/5,5/5,5/5,5/5	Label	-
Light	6,6,3/6,6,3

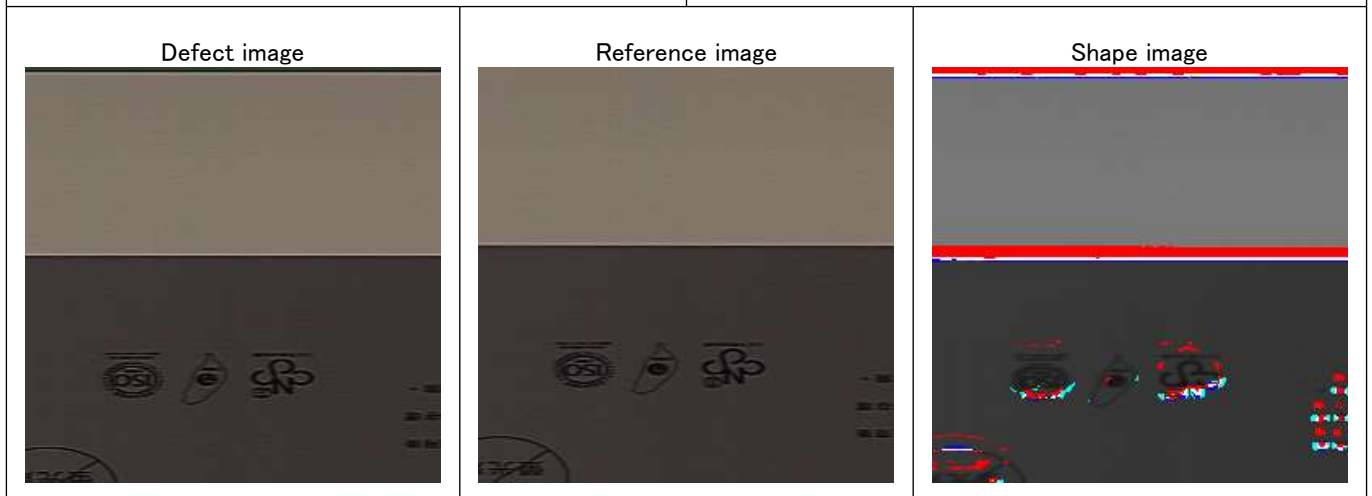
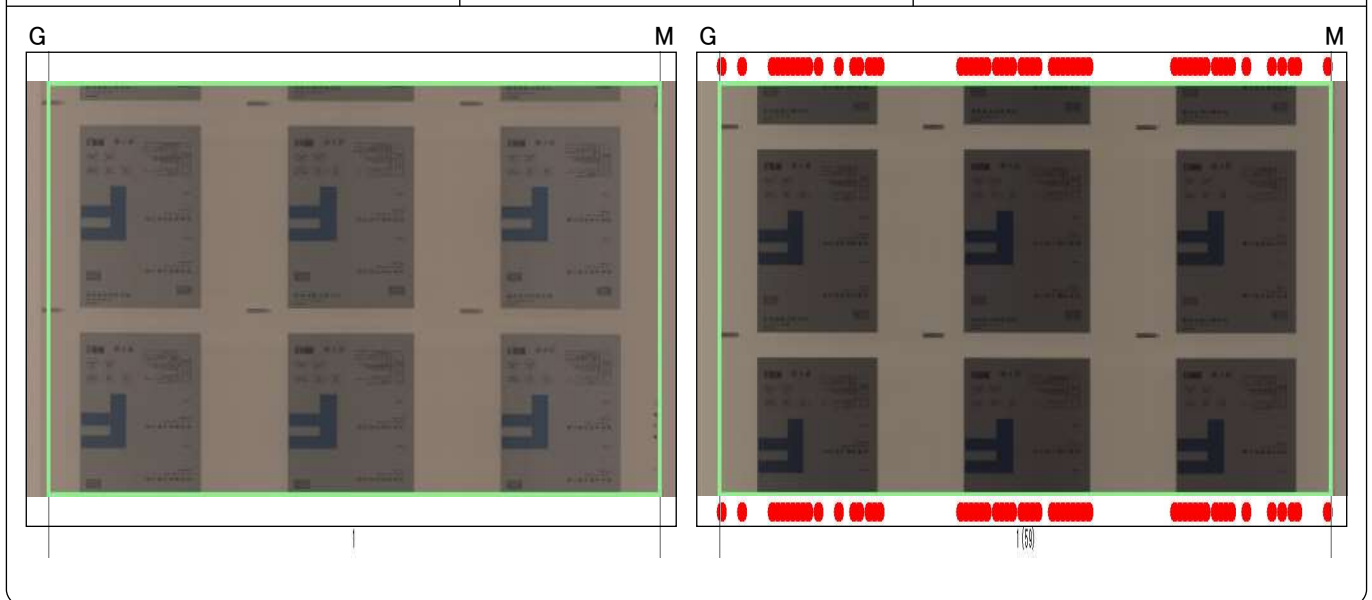
No.	#7, \$6	Date	2023/8/10 上午 10:30:36
Segment	1	Camera	1
Pattern	7721	Position[ x, y ]	768.0 [mm], 5803.6 [m], ( 420.6 [m] )
Type	点状疵点	Size	H:150.9 ,V:1.2 [mm]
Result	-	Area	164.6 [mm2]
Inspection level	5/5,5/5,5/5,5/5,5/5	Label	-
Light	6,6,3/6,6,3

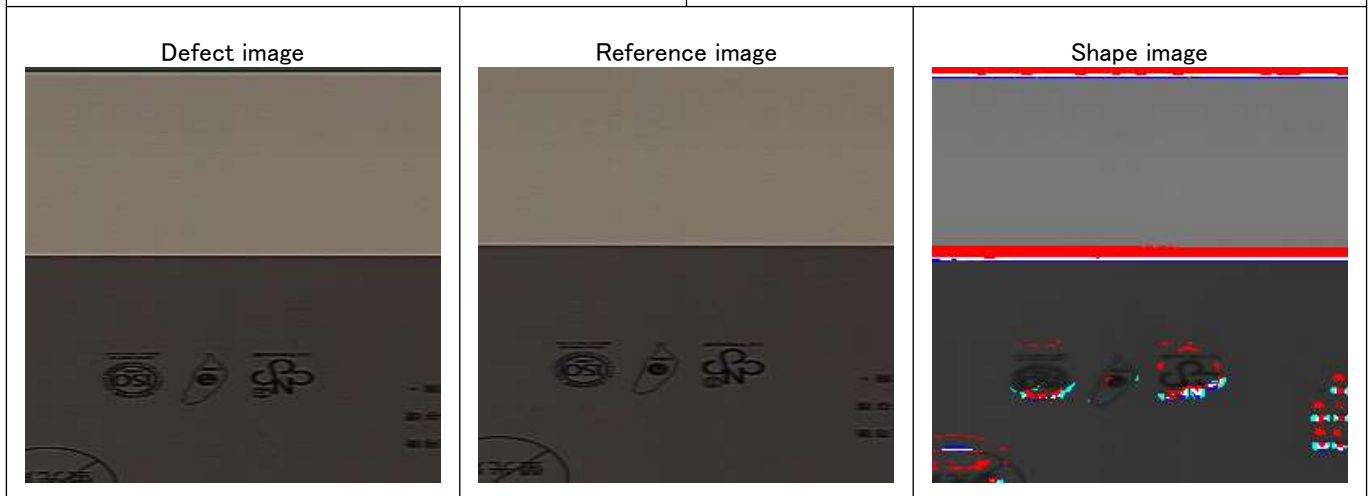
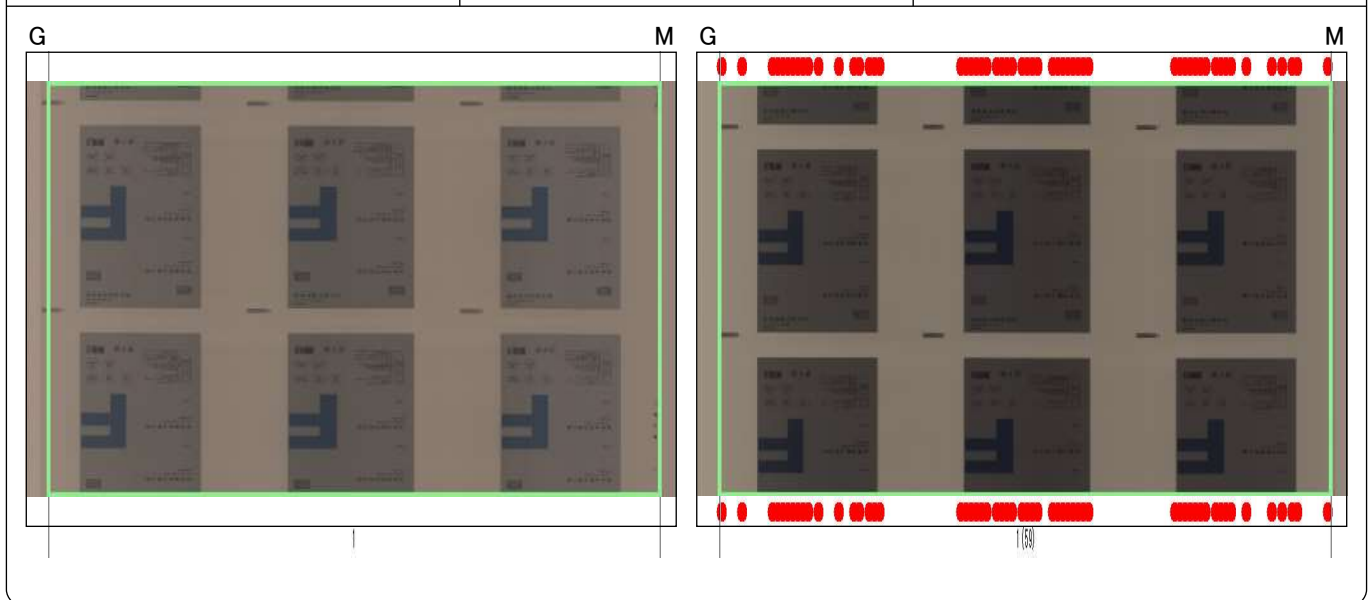
No.	#7, \$6	Date	2023/8/10 上午 10:30:36
Segment	1	Camera	1
Pattern	7721	Position[ x, y ]	466.2 [mm], 5803.6 [m], ( 420.6 [m] )
Type	点状疵点	Size	H:191.4 ,V:1.6 [mm]
Result	-	Area	252.0 [mm2]
Inspection level	5/5,5/5,5/5,5,5/5,5/5	Label	-
Light	6,6,3/6,6,3

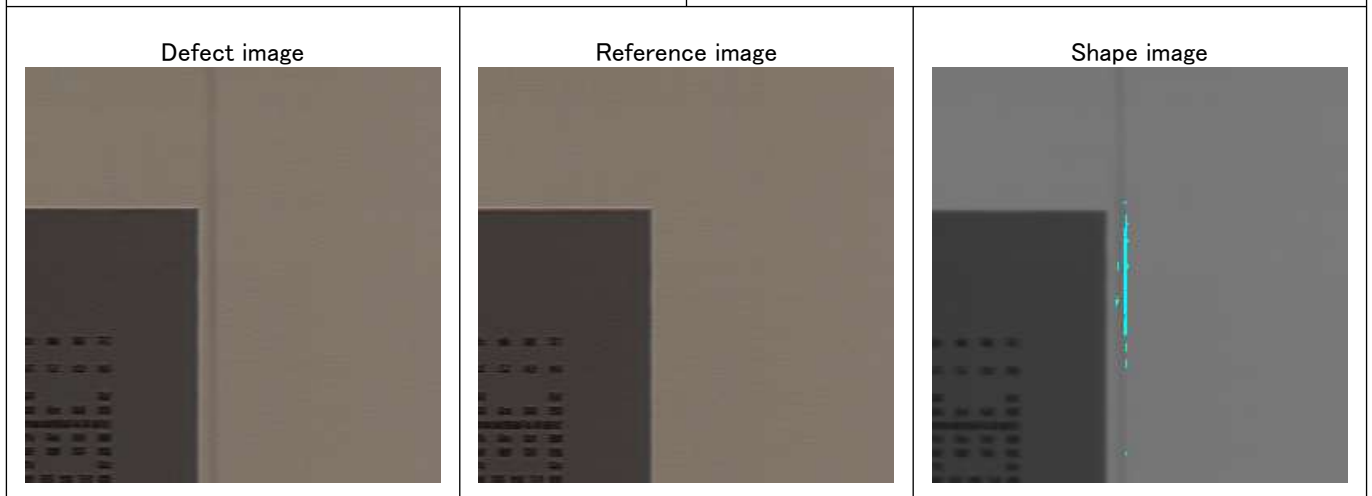
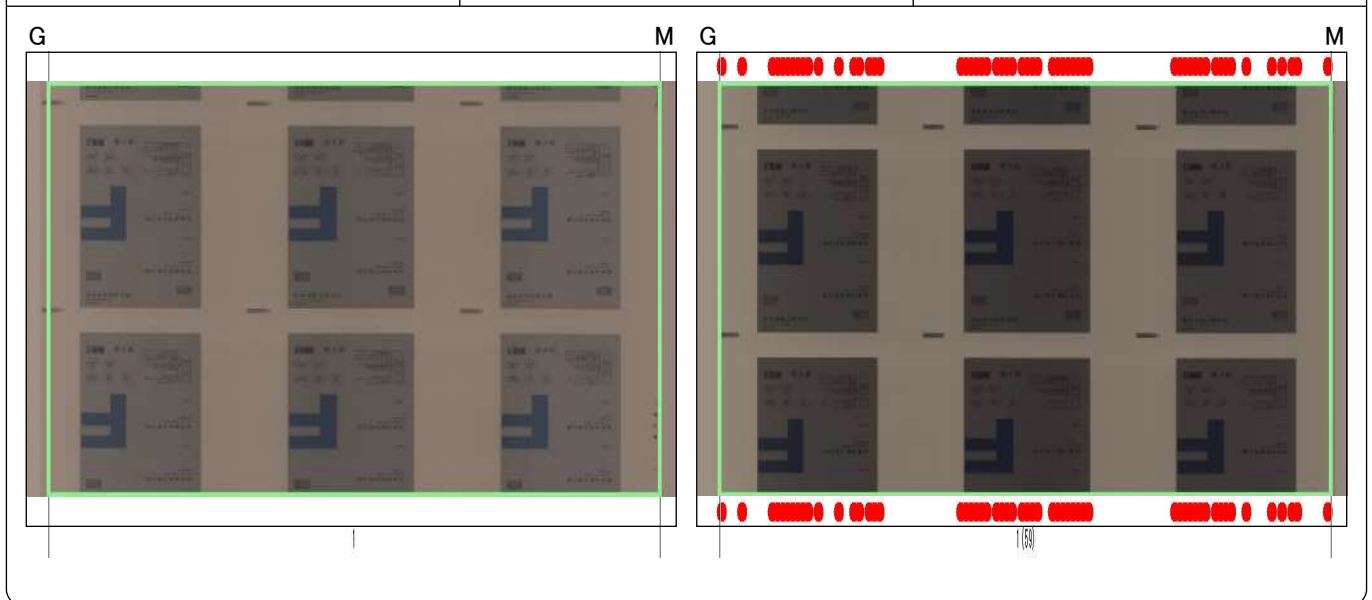
No.	#4, \$3	Date	2023/8/10 上午 09:45:30
Segment	1	Camera	1
Pattern	3098	Position[ x, y ]	883.4 [mm], 2332.0 [m], ( 3892.1 [m] )
Type	縱向刀絲疵點	Size	H:2.0 ,V:28.8 [mm]
Result	-	Area	14.2 [mm2]
Inspection level	5/5,5/5,5/5,5/5,5/5	Label	-
Light	6,6,3/6,6,3
