Inspection Result (Individual Data)

Lot number : 5

Inspected date : 2023/8/10 下午 12:12:08 ~ 2023/8/10 下午 01:31:18

商品名	標準透明6-6-3	周長
顧客名		Ex1
CODE番号		Ex2
基材		Ex3

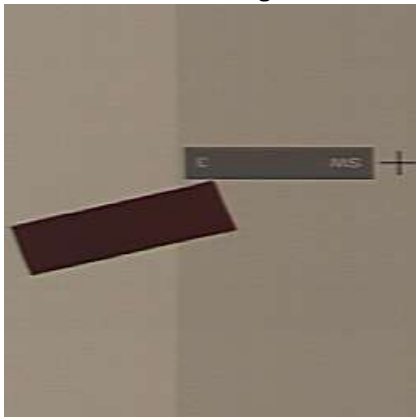
Defect image

No.	#48, \$37	Date	2023/8/10 下午 01:30:38
Segment	1	Camera	1
Pattern	8055	Position[x, y]	700.1 [mm], 6023.0 [m], (43.4 [m])
Type	点状疵点縱向刀絲疵點	Size	H:1.0 ,V:307.2 [mm]
Result	-	Area	68.8 [mm2]
Inspection level	5/5,5/5,5/5,5/5,5/5	Label	-
Light	6,6,3/6,6,3

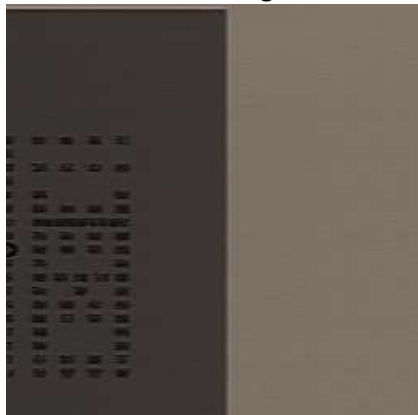
Defect image

No.	#47, \$36	Date	2023/8/10 下午 01:30:38
Segment	1	Camera	1
Pattern	8054	Position[x, y]	700.1 [mm], 6022.7 [m], (43.6 [m])
Type	点状疵点縱向刀絲疵點	Size	H:1.0 ,V:346.8 [mm]
Result	-	Area	68.8 [mm2]
Inspection level	5/5,5/5,5/5,5/5,5/5	Label	-
Light	6,6,3/6,6,3

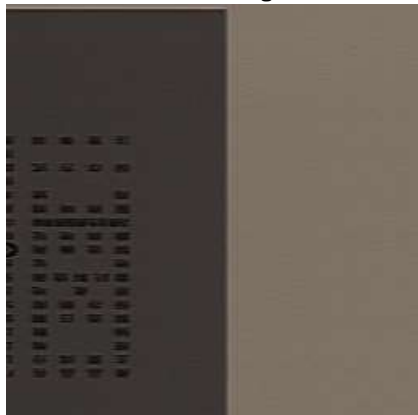
Defect image

No.	#47, \$36	Date	2023/8/10 下午 01:30:38
Segment	1	Camera	1
Pattern	8054	Position[x, y]	700.1 [mm], 6022.3 [m], (44.1 [m])
Type	点状疵点縱向刀絲疵點	Size	H:1.0 ,V:320.4 [mm]
Result	-	Area	68.8 [mm2]
Inspection level	5/5,5/5,5/5,5/5,5/5	Label	-
Light	6,6,3/6,6,3

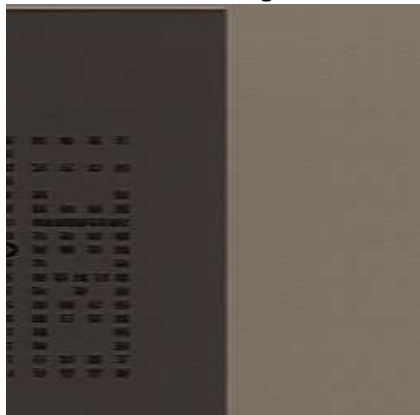
Defect image

No.	#47, \$36	Date	2023/8/10 下午 01:30:38
Segment	1	Camera	1
Pattern	8054	Position[x, y]	374.6 [mm], 6022.4 [m], (44.0 [m])
Type	点状疵点縱向刀絲疵點	Size	H:1.0 ,V:465.2 [mm]
Result	-	Area	79.2 [mm2]
Inspection level	5/5,5/5,5/5,5/5,5/5	Label	-
Light	6,6,3/6,6,3

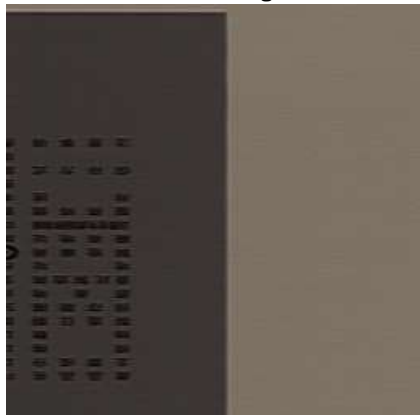
Defect image

No.	#46, \$35	Date	2023/8/10 下午 01:30:37
Segment	1	Camera	1
Pattern	8053	Position[x, y]	700.3 [mm], 6022.0 [m], (44.4 [m])
Type	縱向刀絲疵點	Size	H:0.5 ,V:347.2 [mm]
Result	-	Area	67.2 [mm2]
Inspection level	5/5,5/5,5/5,5/5,5/5	Label	-
Light	6,6,3/6,6,3

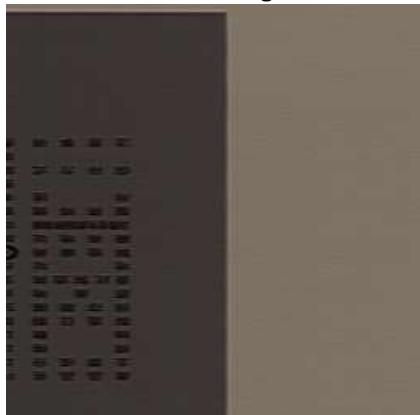
Defect image

No.	#46, \$35	Date	2023/8/10 下午 01:30:37
Segment	1	Camera	1
Pattern	8053	Position[x, y]	700.1 [mm], 6021.6 [m], (44.8 [m])
Type	点状疵点縱向刀絲疵點	Size	H:1.0 ,V:341.2 [mm]
Result	-	Area	68.8 [mm2]
Inspection level	5/5,5/5,5/5,5/5,5/5	Label	-
Light	6,6,3/6,6,3

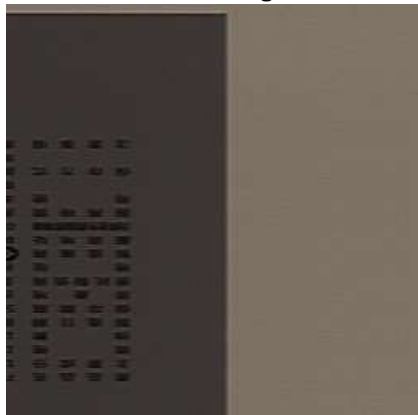
Defect image

No.	#45, \$34	Date	2023/8/10 下午 01:30:36
Segment	1	Camera	1
Pattern	8052	Position[x, y]	568.0 [mm], 6020.8 [m], (45.6 [m])
Type	縱向刀絲疵點	Size	H:0.5 ,V:415.2 [mm]
Result	-	Area	65.8 [mm2]
Inspection level	5/5,5/5,5/5,5/5,5/5	Label	-
Light	6,6,3/6,6,3

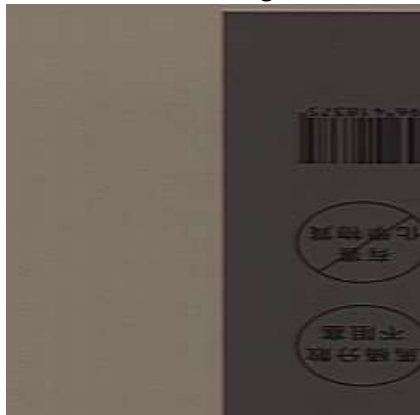
Defect image

No.	#45, \$34	Date	2023/8/10 下午 01:30:36
Segment	1	Camera	1
Pattern	8052	Position[x, y]	700.3 [mm], 6020.9 [m], (45.5 [m])
Type	縱向刀絲疵點	Size	H:0.5 ,V:318.4 [mm]
Result	-	Area	67.8 [mm2]
Inspection level	5/5,5/5,5/5,5,5/5,5/5	Label	-
Light	6,6,3/6,6,3

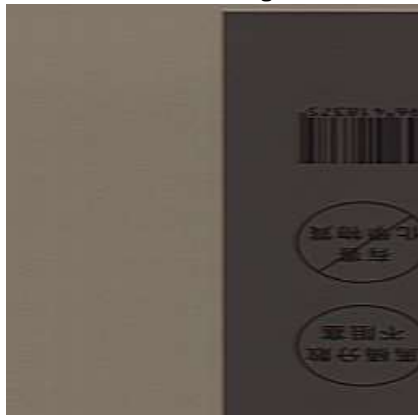
Defect image

No.	#44, \$33	Date	2023/8/10 下午 01:30:36
Segment	1	Camera	1
Pattern	8051	Position[x, y]	700.3 [mm], 6020.5 [m], (45.8 [m])
Type	縱向刀絲疵點	Size	H:0.5 ,V:38.0 [mm]
Result	-	Area	4.0 [mm2]
Inspection level	5/5,5/5,5/5,5,5/5,5/5	Label	-
Light	6,6,3/6,6,3

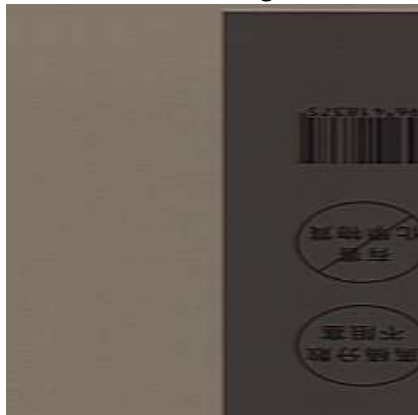
Defect image

No.	#44, \$33	Date	2023/8/10 下午 01:30:36
Segment	1	Camera	1
Pattern	8051	Position[x, y]	568.0 [mm], 6020.7 [m], (45.7 [m])
Type	縱向刀絲疵點	Size	H:0.5 ,V:34.8 [mm]
Result	-	Area	8.9 [mm2]
Inspection level	5/5,5/5,5/5,5,5/5,5/5	Label	-
Light	6,6,3/6,6,3

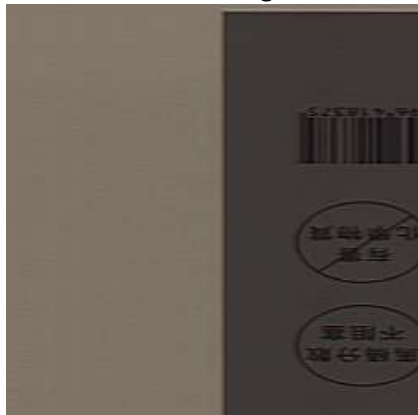
Defect image

No.	#44, \$33	Date	2023/8/10 下午 01:30:36
Segment	1	Camera	1
Pattern	8051	Position[x, y]	700.3 [mm], 6020.7 [m], (45.7 [m])
Type	縱向刀絲疵點	Size	H:0.5 ,V:68.8 [mm]
Result	-	Area	13.2 [mm2]
Inspection level	5/5,5/5,5/5,5,5/5,5/5	Label	-
Light	6,6,3/6,6,3

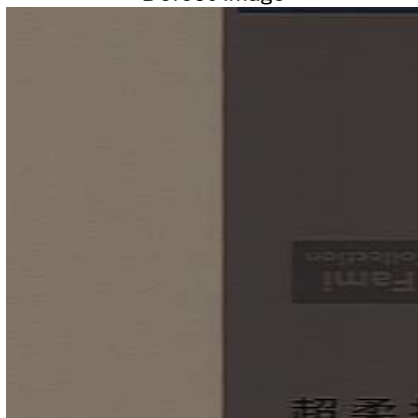
Defect image

No.	#44, \$33	Date	2023/8/10 下午 01:30:36
Segment	1	Camera	1
Pattern	8051	Position[x, y]	700.3 [mm], 6020.3 [m], (46.1 [m])
Type	縱向刀絲疵點	Size	H:0.5 ,V:95.2 [mm]
Result	-	Area	13.8 [mm2]
Inspection level	5/5,5/5,5/5,5/5,5/5	Label	-
Light	6,6,3/6,6,3

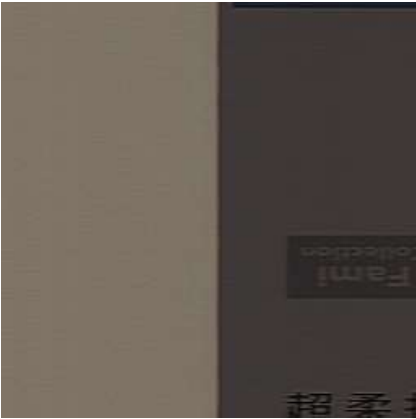
No.	#41, \$32	Date	2023/8/10 下午 01:30:28
Segment	1	Camera	1
Pattern	8038	Position[x, y]	373.2 [mm], 6010.9 [m], (55.5 [m])
Type	点状疵点縱向刀絲疵點	Size	H:2.2 ,V:257.6 [mm]
Result	-	Area	62.9 [mm2]
Inspection level	5/5,5/5,5/5,5/5,5/5	Label	-
Light	6,6,3/6,6,3

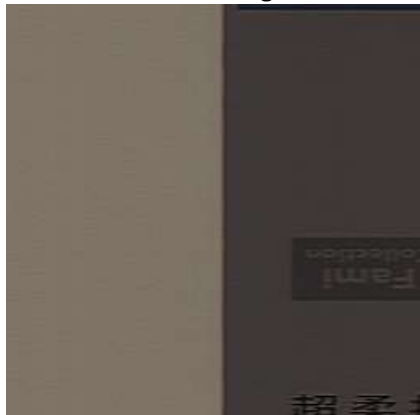
Defect image

No.	#41, \$32	Date	2023/8/10 下午 01:30:28
Segment	1	Camera	1
Pattern	8038	Position[x, y]	698.9 [mm], 6010.9 [m], (55.5 [m])
Type	点状疵点縱向刀絲疵點	Size	H:2.2 ,V:256.4 [mm]
Result	-	Area	85.1 [mm2]
Inspection level	5/5,5/5,5/5,5,5/5,5/5	Label	-
Light	6,6,3/6,6,3

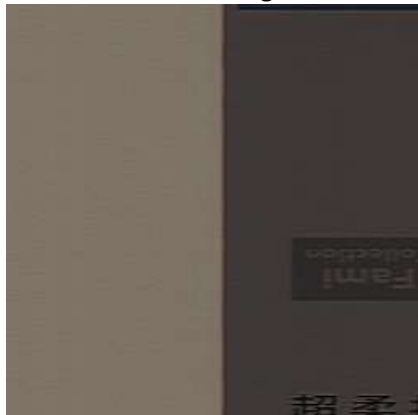
Defect image

No.	#41, \$32	Date	2023/8/10 下午 01:30:28
Segment	1	Camera	1
Pattern	8038	Position[x, y]	567.5 [mm], 6010.5 [m], (55.8 [m])
Type	点状疵点	Size	H:1.5 ,V:298.0 [mm]
Result	-	Area	105.6 [mm2]
Inspection level	5/5,5/5,5/5,5/5,5/5	Label	-
Light	6,6,3/6,6,3

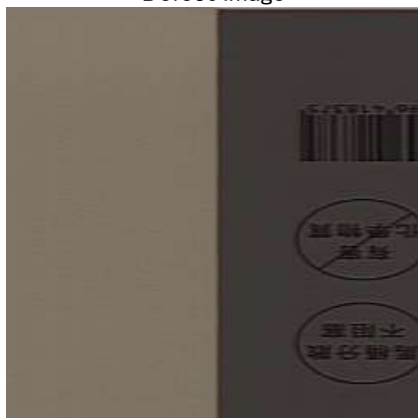
Defect image

No.	#41, \$32	Date	2023/8/10 下午 01:30:28
Segment	1	Camera	1
Pattern	8038	Position[x, y]	699.8 [mm], 6010.5 [m], (55.9 [m])
Type	点状疵点	Size	H:1.5 ,V:325.6 [mm]
Result	-	Area	154.9 [mm2]
Inspection level	5/5,5/5,5/5,5,5/5,5/5	Label	-
Light	6,6,3/6,6,3

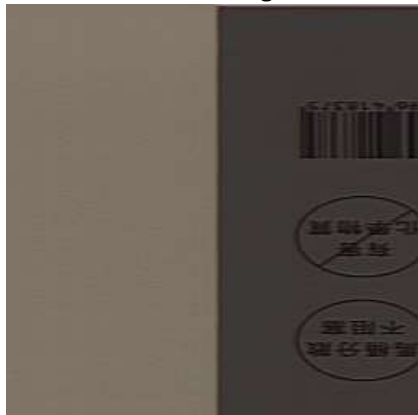
Defect image

No.	#40, \$31	Date	2023/8/10 下午 01:30:28
Segment	1	Camera	1
Pattern	8037	Position[x, y]	372.7 [mm], 6009.7 [m], (56.6 [m])
Type	点状疵点縱向刀絲疵點	Size	H:2.4 ,V:393.6 [mm]
Result	-	Area	89.8 [mm2]
Inspection level	5/5,5/5,5/5,5/5,5/5	Label	-
Light	6,6,3/6,6,3

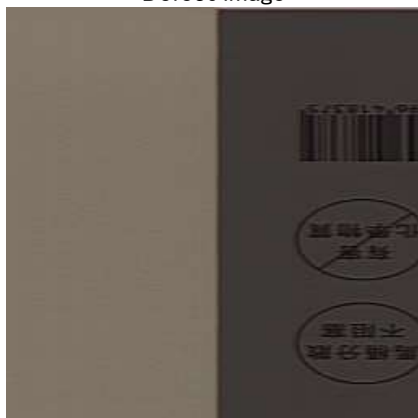
Defect image

No.	#40, \$31	Date	2023/8/10 下午 01:30:28
Segment	1	Camera	1
Pattern	8037	Position[x, y]	698.1 [mm], 6010.1 [m], (56.3 [m])
Type	点状疵点縱向刀絲疵點	Size	H:2.2 ,V:286.8 [mm]
Result	-	Area	114.8 [mm2]
Inspection level	5/5,5/5,5/5,5/5,5/5	Label	-
Light	6,6,3/6,6,3

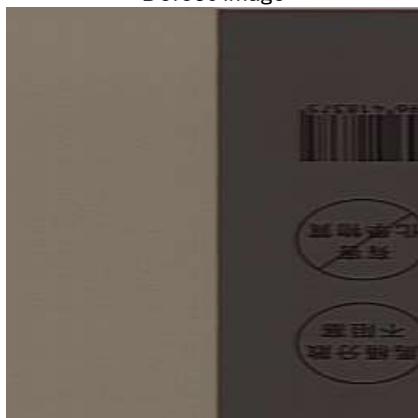
Defect image

No.	#40, \$31	Date	2023/8/10 下午 01:30:28
Segment	1	Camera	1
Pattern	8037	Position[x, y]	698.1 [mm], 6009.8 [m], (56.6 [m])
Type	点状疵点縱向刀絲疵點	Size	H:2.2 ,V:404.8 [mm]
Result	-	Area	158.1 [mm2]
Inspection level	5/5,5/5,5/5,5/5,5/5	Label	-
Light	6,6,3/6,6,3

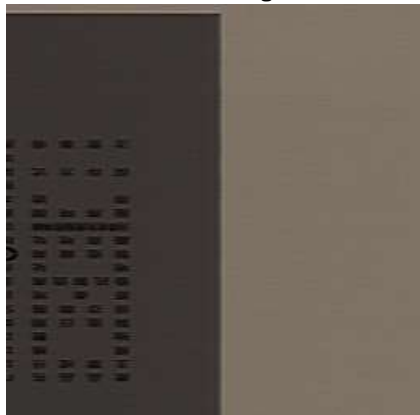
Defect image

No.	#39, \$30	Date	2023/8/10 下午 01:30:27
Segment	1	Camera	1
Pattern	8036	Position[x, y]	698.1 [mm], 6009.0 [m], (57.4 [m])
Type	点状疵点縱向刀絲疵點	Size	H:2.2 ,V:556.0 [mm]
Result	-	Area	163.2 [mm2]
Inspection level	5/5,5/5,5/5,5/5,5/5	Label	-
Light	6,6,3/6,6,3

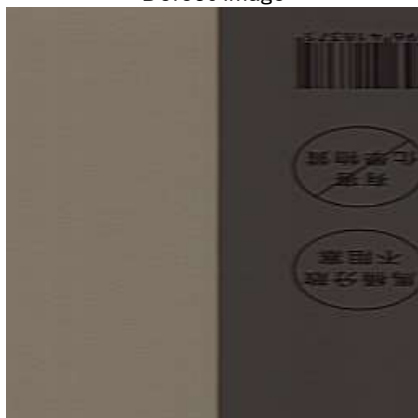
Defect image

No.	#37, \$28	Date	2023/8/10 下午 01:30:26
Segment	1	Camera	1
Pattern	8034	Position[x, y]	699.8 [mm], 6007.8 [m], (58.6 [m])
Type	点状疵点	Size	H:0.5 ,V:19.6 [mm]
Result	-	Area	5.9 [mm2]
Inspection level	5/5,5/5,5/5,5/5,5/5	Label	-
Light	6,6,3/6,6,3

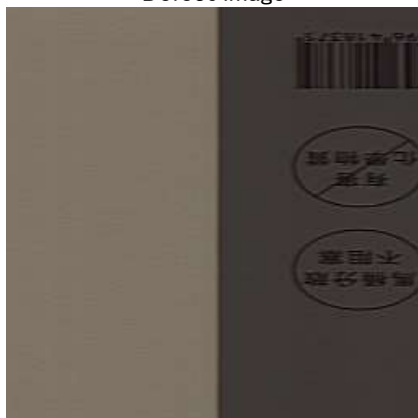
Defect image

No.	#34, \$27	Date	2023/8/10 下午 01:30:18
Segment	1	Camera	1
Pattern	8021	Position[x, y]	376.1 [mm], 5997.8 [m], (68.6 [m])
Type	点状疵点縱向刀絲疵點	Size	H:13.2 ,V:803.2 [mm]
Result	-	Area	437.6 [mm2]
Inspection level	5/5,5/5,5/5,5/5,5/5	Label	-
Light	6,6,3/6,6,3

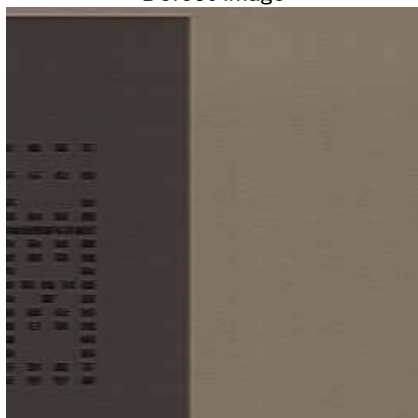
Defect image

No.	#33, \$26	Date	2023/8/10 下午 01:30:18
Segment	1	Camera	1
Pattern	8020	Position[x, y]	241.8 [mm], 5997.1 [m], (69.3 [m])
Type	点状疵点縱向刀絲疵點	Size	H:2.4 ,V:790.4 [mm]
Result	-	Area	326.1 [mm2]
Inspection level	5/5,5/5,5/5,5/5,5/5	Label	-
Light	6,6,3/6,6,3

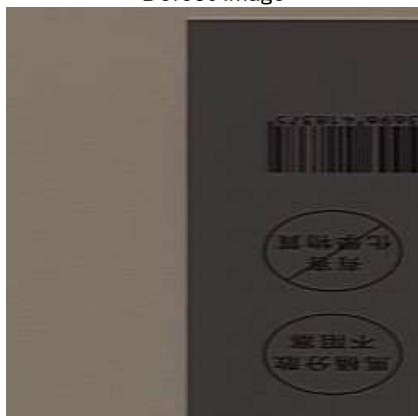
Defect image

No.	#32, \$25	Date	2023/8/10 下午 01:30:17
Segment	1	Camera	1
Pattern	8019	Position[x, y]	700.1 [mm], 5996.4 [m], (70.0 [m])
Type	点状疵点縱向刀絲疵點	Size	H:5.1 ,V:803.2 [mm]
Result	-	Area	220.8 [mm2]
Inspection level	5/5,5/5,5/5,5/5,5/5	Label	-
Light	6,6,3/6,6,3

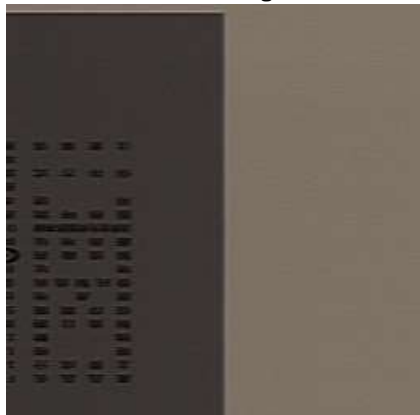
Defect image

No.	#31, \$24	Date	2023/8/10 下午 01:30:16
Segment	1	Camera	1
Pattern	8018	Position[x, y]	567.0 [mm], 5995.6 [m], (70.8 [m])
Type	点状疵点	Size	H:0.5 ,V:325.6 [mm]
Result	-	Area	78.3 [mm2]
Inspection level	5/5,5/5,5/5,5/5,5/5	Label	-
Light	6,6,3/6,6,3

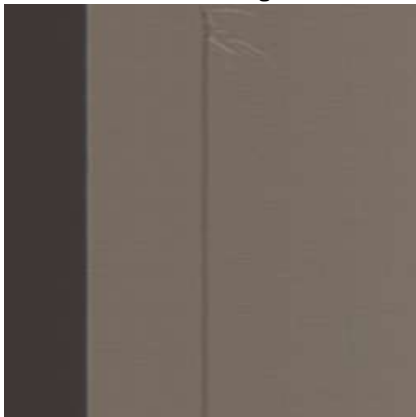
Defect image

No.	#27, \$22	Date	2023/8/10 下午 01:29:45
Segment	1	Camera	1
Pattern	7965	Position[x, y]	898.3 [mm], 5956.3 [m], (110.1 [m])
Type	点状疵点縱向刀絲疵點	Size	H:6.8 ,V:311.2 [mm]
Result	-	Area	269.2 [mm2]
Inspection level	5/5,5/5,5/5,5/5,5/5	Label	-
Light	6,6,3/6,6,3

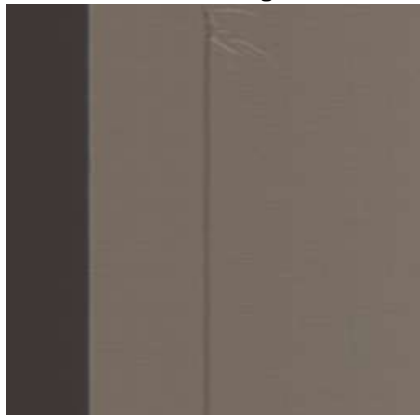
Defect image

No.	#26, \$21	Date	2023/8/10 下午 01:29:45
Segment	1	Camera	1
Pattern	7964	Position[x, y]	905.2 [mm], 5955.1 [m], (111.3 [m])
Type	点状疵点縱向刀絲疵點	Size	H:69.3 ,V:328.8 [mm]
Result	-	Area	517.0 [mm2]
Inspection level	5/5,5/5,5/5,5/5,5/5	Label	-
Light	6,6,3/6,6,3

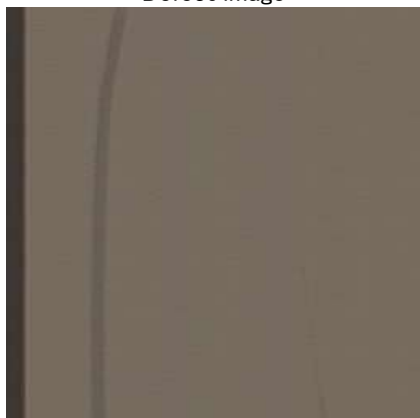
Defect image

No.	#24, \$19	Date	2023/8/10 下午 01:29:44
Segment	1	Camera	1
Pattern	7962	Position[x, y]	636.4 [mm], 5954.2 [m], (112.2 [m])
Type	点状疵点縱向刀絲疵點	Size	H:19.0 ,V:42.4 [mm]
Result	-	Area	91.5 [mm2]
Inspection level	5/5,5/5,5/5,5/5,5/5	Label	-
Light	6,6,3/6,6,3

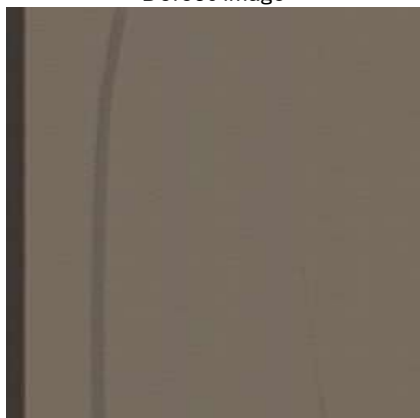
Defect image

No.	#24, \$19	Date	2023/8/10 下午 01:29:44
Segment	1	Camera	1
Pattern	7962	Position[x, y]	300.2 [mm], 5954.2 [m], (112.2 [m])
Type	点状疵点縱向刀絲疵點	Size	H:53.5 ,V:60.4 [mm]
Result	-	Area	106.3 [mm2]
Inspection level	5/5,5/5,5/5,5/5,5/5	Label	-
Light	6,6,3/6,6,3

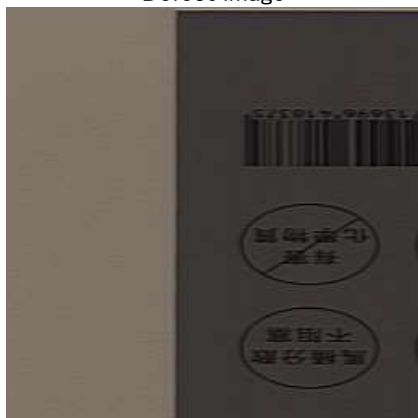
Defect image

No.	#23, \$18	Date	2023/8/10 下午 01:29:43
Segment	1	Camera	1
Pattern	7961	Position[x, y]	770.4 [mm], 5953.0 [m], (113.4 [m])
Type	縱向刀絲疵點	Size	H:0.5 ,V:95.6 [mm]
Result	-	Area	24.6 [mm2]
Inspection level	5/5,5/5,5/5,5/5,5/5	Label	-
Light	6,6,3/6,6,3

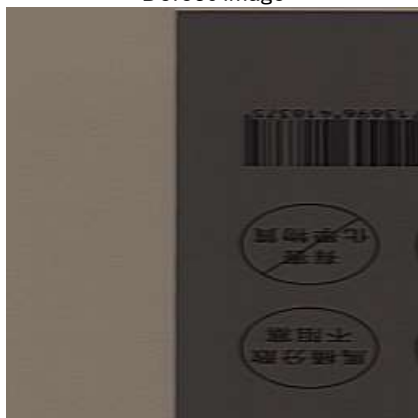
Defect image

No.	#23, \$18	Date	2023/8/10 下午 01:29:43
Segment	1	Camera	1
Pattern	7961	Position[x, y]	447.4 [mm], 5953.0 [m], (113.4 [m])
Type	縱向刀絲疵點	Size	H:0.5 ,V:96.0 [mm]
Result	-	Area	35.8 [mm2]
Inspection level	5/5,5/5,5/5,5/5,5/5	Label	-
Light	6,6,3/6,6,3

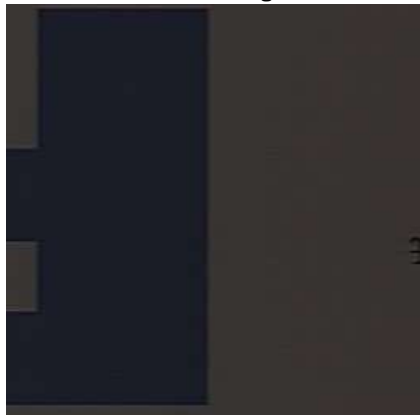
Defect image

No.	#23, \$18	Date	2023/8/10 下午 01:29:43
Segment	1	Camera	1
Pattern	7961	Position[x, y]	448.1 [mm], 5953.4 [m], (113.0 [m])
Type	点状疵点	Size	H:1.2 ,V:95.2 [mm]
Result	-	Area	43.0 [mm2]
Inspection level	5/5,5/5,5/5,5/5,5/5	Label	-
Light	6,6,3/6,6,3

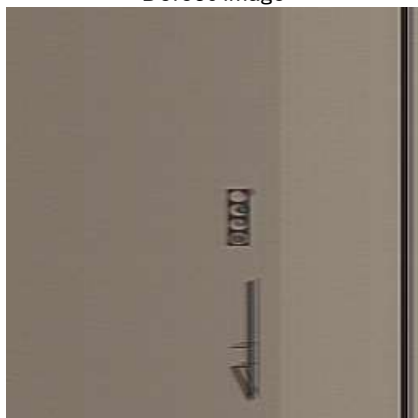
Defect image

No.	#21, \$16	Date	2023/8/10 下午 01:29:41
Segment	1	Camera	1
Pattern	7958	Position[x, y]	399.8 [mm], 5951.0 [m], (115.4 [m])
Type	縱向刀絲疵點	Size	H:0.5 ,V:9.6 [mm]
Result	-	Area	3.6 [mm2]
Inspection level	5/5,5/5,5/5,5/5,5/5	Label	-
Light	6,6,3/6,6,3

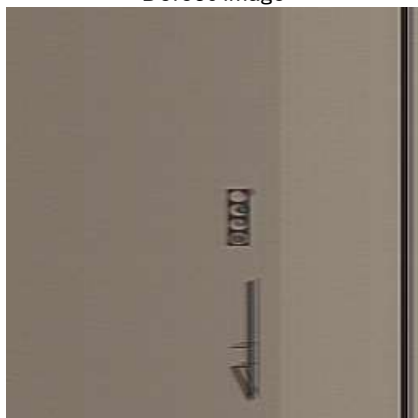
Defect image

No.	#21, \$16	Date	2023/8/10 下午 01:29:41
Segment	1	Camera	1
Pattern	7958	Position[x, y]	383.9 [mm], 5951.0 [m], (115.4 [m])
Type	縱向刀絲疵點	Size	H:0.5 ,V:11.2 [mm]
Result	-	Area	3.8 [mm2]
Inspection level	5/5,5/5,5/5,5/5,5/5	Label	-
Light	6,6,3/6,6,3

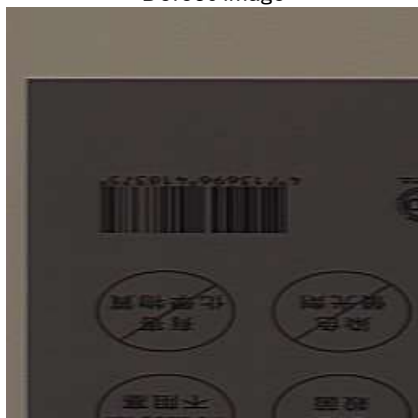
Defect image

No.	#21, \$16	Date	2023/8/10 下午 01:29:41
Segment	1	Camera	1
Pattern	7958	Position[x, y]	399.8 [mm], 5950.6 [m], (115.7 [m])
Type	縱向刀絲疵點	Size	H:0.5 ,V:8.8 [mm]
Result	-	Area	4.1 [mm2]
Inspection level	5/5,5/5,5/5,5/5,5/5	Label	-
Light	6,6,3/6,6,3

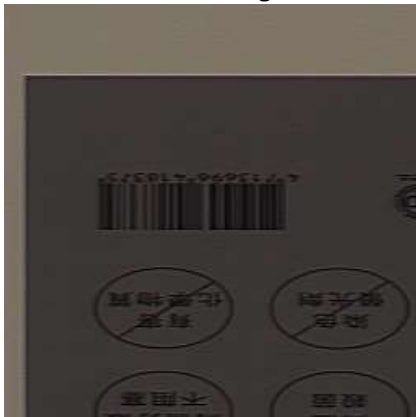
Defect image

No.	#18, \$15	Date	2023/8/10 下午 01:28:42
Segment	1	Camera	1
Pattern	7856	Position[x, y]	240.1 [mm], 5874.5 [m], (191.8 [m])
Type	点状疵点縱向刀絲疵點	Size	H:2.2 ,V:287.6 [mm]
Result	-	Area	62.4 [mm2]
Inspection level	5/5,5/5,5/5,5/5,5/5	Label	-
Light	6,6,3/6,6,3

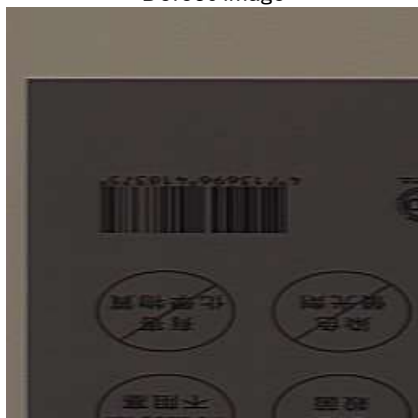
Defect image

No.	#18, \$15	Date	2023/8/10 下午 01:28:42
Segment	1	Camera	1
Pattern	7856	Position[x, y]	372.7 [mm], 5874.6 [m], (191.8 [m])
Type	点状疵点縱向刀絲疵點	Size	H:2.2 ,V:325.6 [mm]
Result	-	Area	92.0 [mm2]
Inspection level	5/5,5/5,5/5,5/5,5/5	Label	-
Light	6,6,3/6,6,3

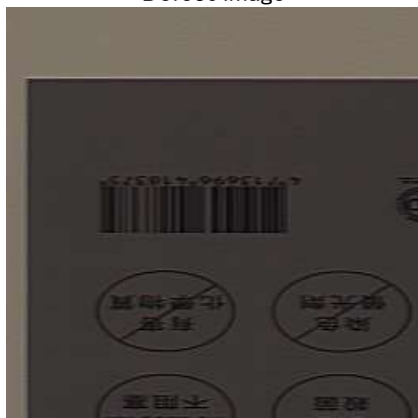
Defect image

No.	#18, \$15	Date	2023/8/10 下午 01:28:42
Segment	1	Camera	1
Pattern	7856	Position[x, y]	698.1 [mm], 5874.5 [m], (191.8 [m])
Type	点状疵点縱向刀絲疵點	Size	H:2.4 ,V:402.4 [mm]
Result	-	Area	95.1 [mm2]
Inspection level	5/5,5/5,5/5,5/5,5/5	Label	-
Light	6,6,3/6,6,3

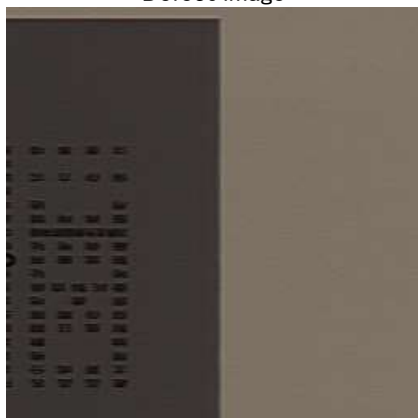
Defect image

No.	#17, \$14	Date	2023/8/10 下午 01:28:41
Segment	1	Camera	1
Pattern	7855	Position[x, y]	565.8 [mm], 5873.9 [m], (192.5 [m])
Type	点状疵点縱向刀絲疵點	Size	H:2.2 ,V:327.6 [mm]
Result	-	Area	65.4 [mm2]
Inspection level	5/5,5/5,5/5,5/5,5/5	Label	-
Light	6,6,3/6,6,3

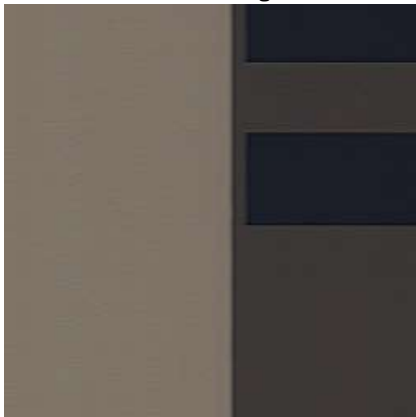
Defect image

No.	#17, \$14	Date	2023/8/10 下午 01:28:41
Segment	1	Camera	1
Pattern	7855	Position[x, y]	372.7 [mm], 5873.9 [m], (192.5 [m])
Type	点状疵点縱向刀絲疵點	Size	H:2.2 ,V:237.6 [mm]
Result	-	Area	84.6 [mm2]
Inspection level	5/5,5/5,5/5,5/5,5/5	Label	-
Light	6,6,3/6,6,3
