# Inspection Result (Individual Data)

Lot number : 5

Inspected date : 2023/8/9 下午 12:59:28 ~ 2023/8/9 下午 02:20:08

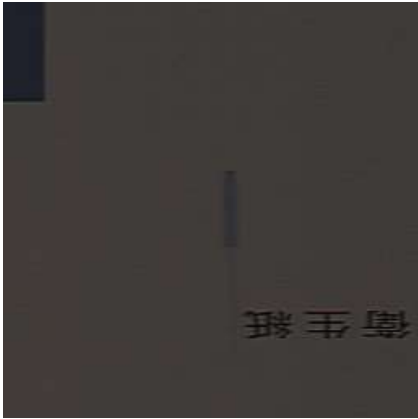
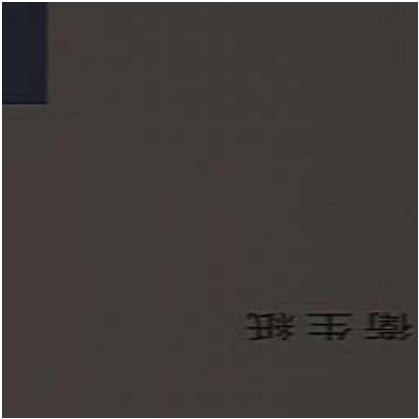
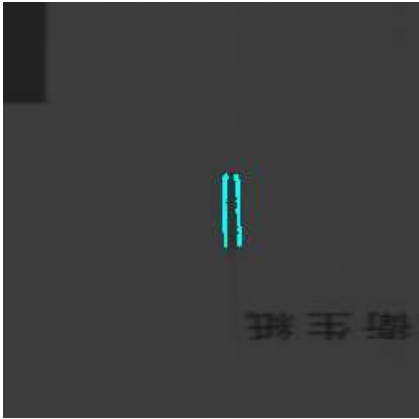
No.	#54, \$41	Date	2023/8/9 下午 02:19:59
Segment	1	Camera	1
Pattern	8012	Position[ x, y ]	157.3 [mm], 6023.7 [m], ( 3.5 [m] )
Type	縱向刀絲疵點	Size	H:2.9 ,V:17.6 [mm]
Result	-	Area	23.1 [mm2]
Inspection level	5/5,5/5,5/5,5/5,5/5	Label	-
Light	6,6,3/6,6,3

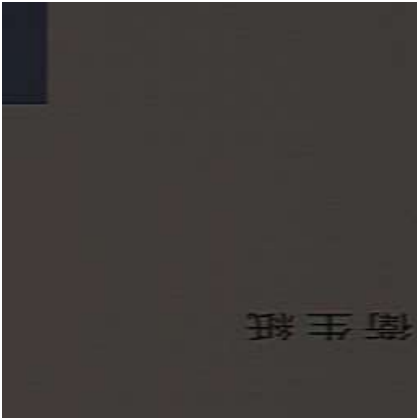
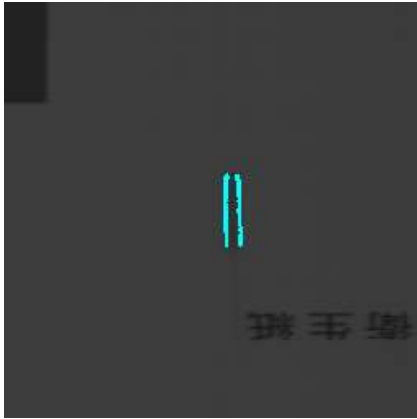
No.	#51, \$40	Date	2023/8/9 下午 02:19:31
Segment	1	Camera	1
Pattern	7967	Position[ x, y ]	15.0 [mm], 5989.2 [m], ( 37.9 [m] )
Type	点状疵点	Size	H:28.8 ,V:7.2 [mm]
Result	-	Area	200.3 [mm2]
Inspection level	5/5,5/5,5/5,5/5,5/5	Label	-
Light	6,6,3/6,6,3

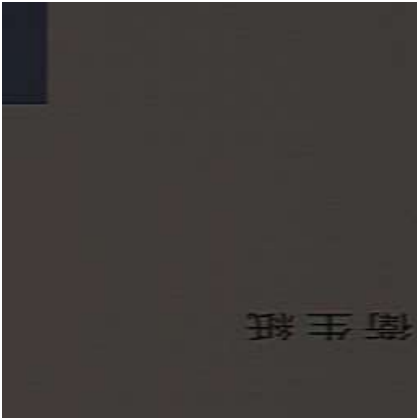
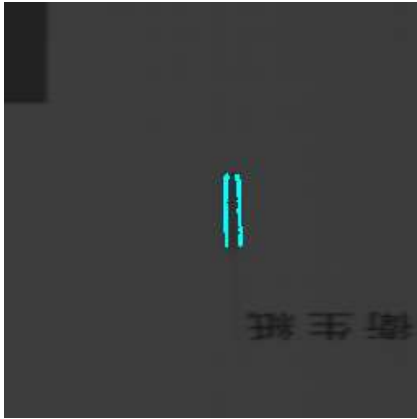
No.	#51, \$40	Date	2023/8/9 下午 02:19:31
Segment	1	Camera	1
Pattern	7967	Position[ x, y ]	65.0 [mm], 5990.0 [m], ( 37.2 [m] )
Type	点状疵点	Size	H:16.1 ,V:33.6 [mm]
Result	-	Area	417.7 [mm2]
Inspection level	5/5,5/5,5/5,5/5,5/5	Label	-
Light	6,6,3/6,6,3

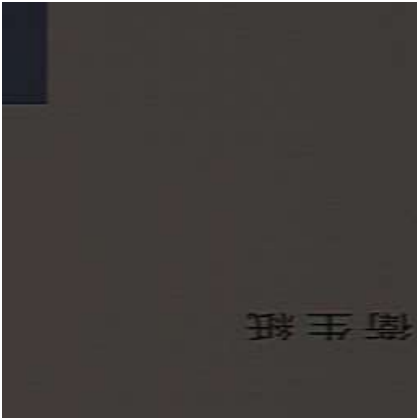
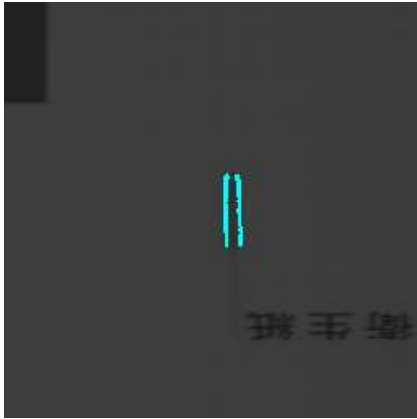
No.	#51, \$40	Date	2023/8/9 下午 02:19:31
Segment	1	Camera	1
Pattern	7967	Position[ x, y ]	65.5 [mm], 5989.2 [m], ( 37.9 [m] )
Type	点状疵点	Size	H:16.4 ,V:42.0 [mm]
Result	-	Area	554.4 [mm2]
Inspection level	5/5,5/5,5/5,5/5,5/5	Label	-
Light	6,6,3/6,6,3

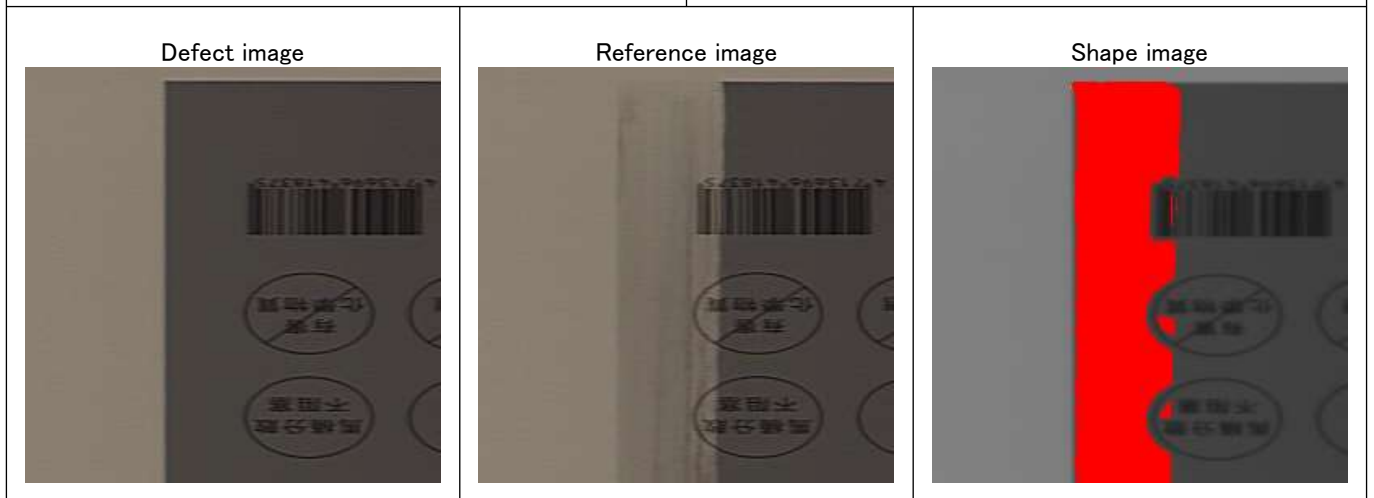
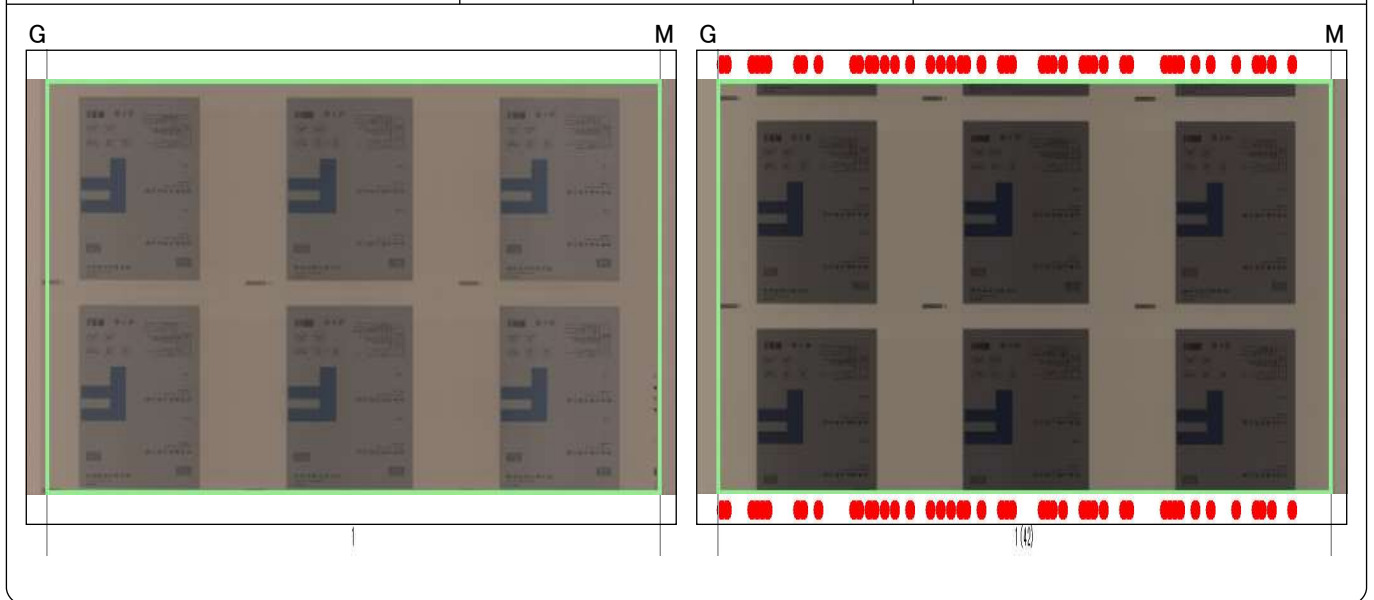
No.	#50, \$39	Date	2023/8/9 下午 02:19:31
Segment	1	Camera	1
Pattern	7966	Position[ x, y ]	65.3 [mm], 5988.5 [m], ( 38.7 [m] )
Type	点状疵点	Size	H:16.1 ,V:17.2 [mm]
Result	—	Area	204.8 [mm2]
Inspection level	5/5,5/5,5/5,5/5,5/5	Label	—
Light	6,6,3/6,6,3

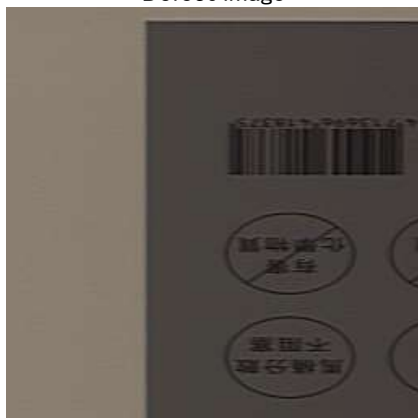
No.	#50, \$39	Date	2023/8/9 下午 02:19:31
Segment	1	Camera	1
Pattern	7966	Position[ x, y ]	65.5 [mm], 5989.2 [m], ( 37.9 [m] )
Type	点状疵点	Size	H:16.4 ,V:50.0 [mm]
Result	-	Area	668.9 [mm2]
Inspection level	5/5,5/5,5/5,5/5,5/5	Label	-
Light	6,6,3/6,6,3

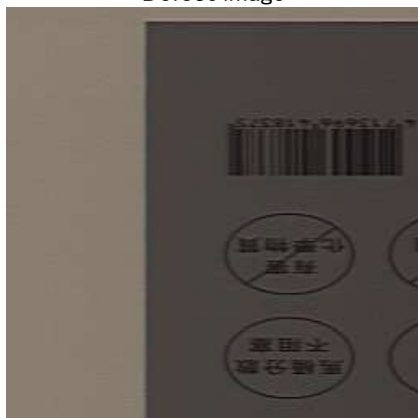
No.	#48, \$37	Date	2023/8/9 下午 02:19:30
Segment	1	Camera	1
Pattern	7964	Position[ x, y ]	65.3 [mm], 5987.7 [m], ( 39.4 [m] )
Type	点状疵点	Size	H:16.1 ,V:34.4 [mm]
Result	-	Area	434.5 [mm2]
Inspection level	5/5,5/5,5/5,5/5,5/5	Label	-
Light	6,6,3/6,6,3

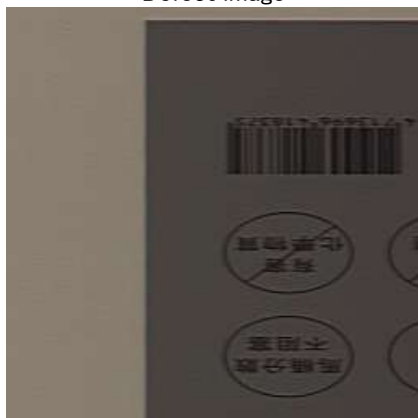
No.	#48, \$37	Date	2023/8/9 下午 02:19:30
Segment	1	Camera	1
Pattern	7964	Position[ x, y ]	64.6 [mm], 5987.1 [m], ( 40.1 [m] )
Type	点状疵点	Size	H:16.6 ,V:173.6 [mm]
Result	-	Area	1968.7 [mm2]
Inspection level	5/5,5/5,5/5,5/5,5/5	Label	-
Light	6,6,3/6,6,3

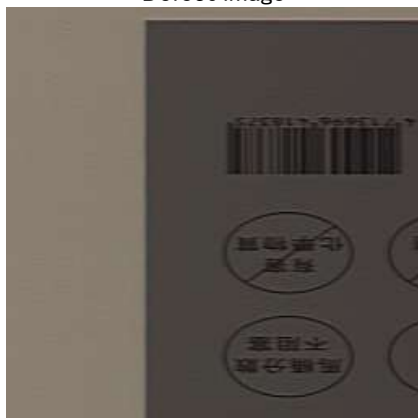
No.	#47, \$36	Date	2023/8/9 下午 02:19:29
Segment	1	Camera	1
Pattern	7963	Position[ x, y ]	18.2 [mm], 5986.2 [m], ( 40.9 [m] )
Type	点状疵点縱向刀絲疵點橫向刀絲	Size	H:29.8 ,V:9.2 [mm]
Result	-	Area	212.2 [mm2]
Inspection level	5/5,5/5,5/5,5/5,5/5	Label	-
Light	6,6,3/6,6,3

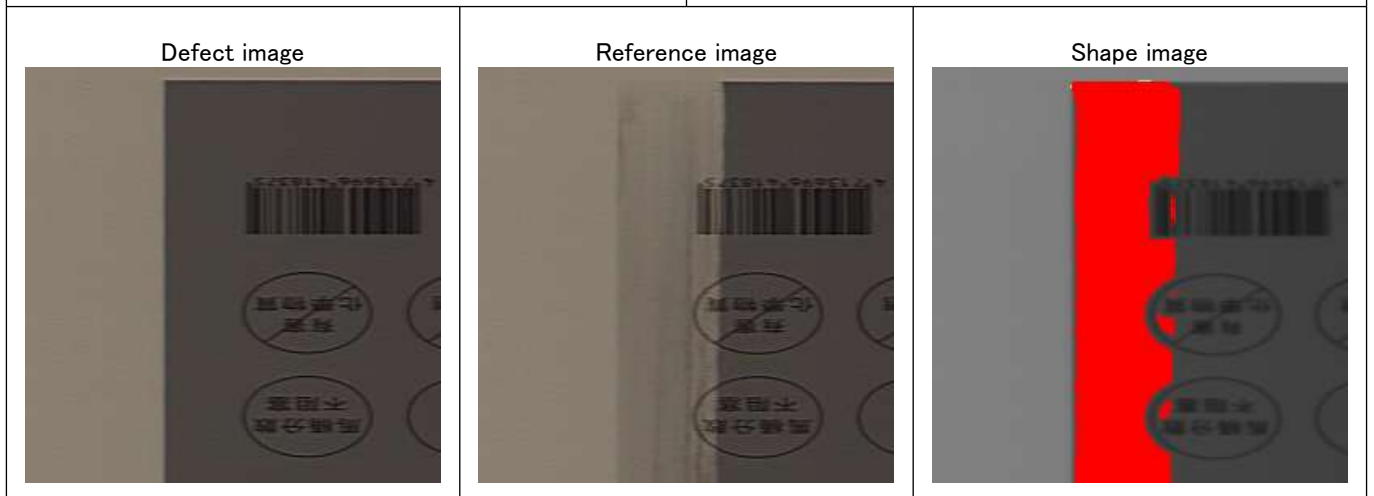
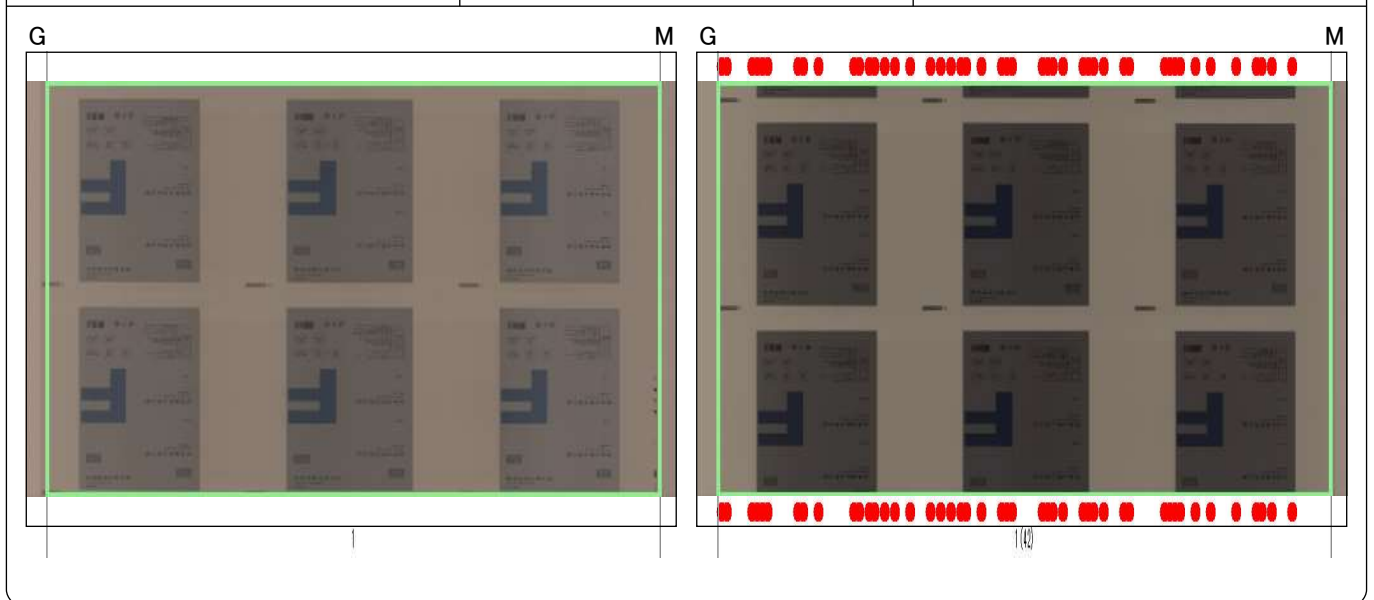
No.	#47, \$36	Date	2023/8/9 下午 02:19:29
Segment	1	Camera	1
Pattern	7963	Position[ x, y ]	65.3 [mm], 5986.2 [m], ( 40.9 [m] )
Type	点状疵点	Size	H:16.4 ,V:17.6 [mm]
Result	-	Area	213.2 [mm2]
Inspection level	5/5,5/5,5/5,5/5,5/5	Label	-
Light	6,6,3/6,6,3

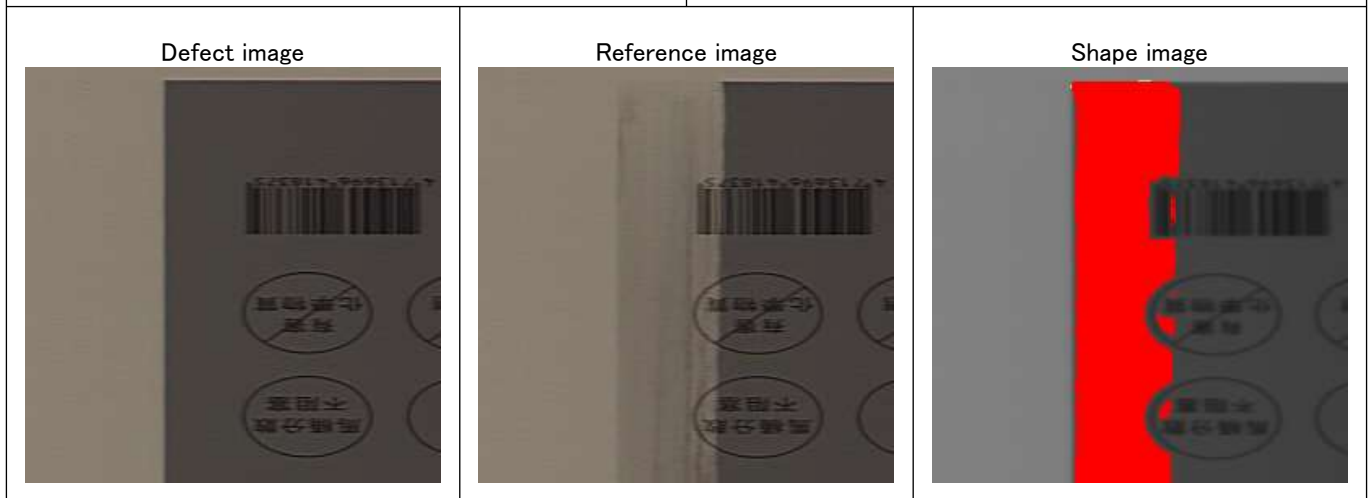
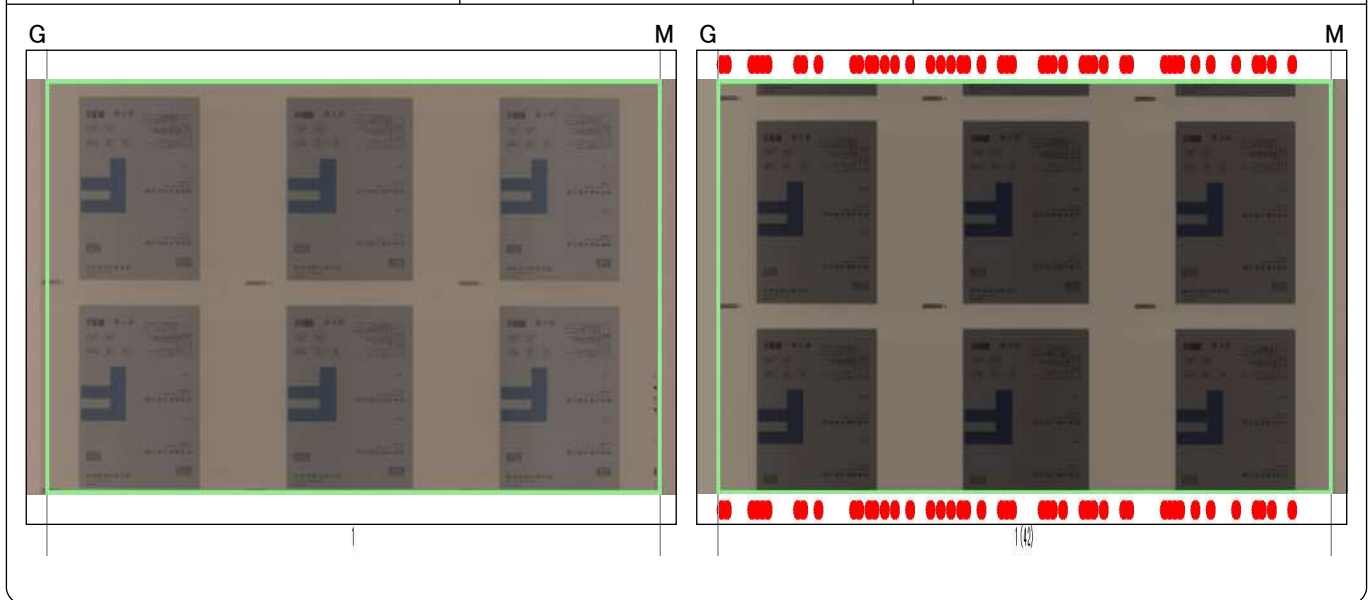
No.	#47, \$36	Date	2023/8/9 下午 02:19:29
Segment	1	Camera	1
Pattern	7963	Position[ x, y ]	65.5 [mm], 5987.0 [m], ( 40.2 [m] )
Type	点状疵点	Size	H:16.4 ,V:50.0 [mm]
Result	—	Area	661.5 [mm2]
Inspection level	5/5,5/5,5/5,5/5,5/5	Label	—
Light	6,6,3/6,6,3

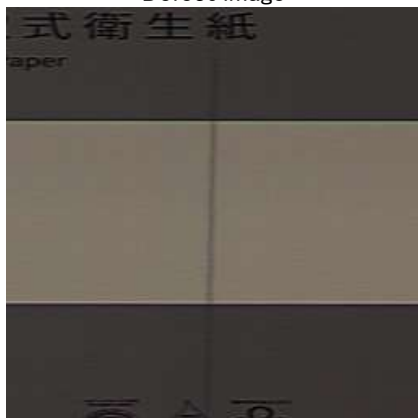
No.	#39, \$30	Date	2023/8/9 下午 02:19:13
Segment	1	Camera	1
Pattern	7937	Position[ x, y ]	451.0 [mm], 5967.1 [m], ( 60.0 [m] )
Type	縱向刀絲疵點	Size	H:2.7 ,V:44.8 [mm]
Result	-	Area	75.3 [mm2]
Inspection level	5/5,5/5,5/5,5/5,5/5	Label	-
Light	6,6,3/6,6,3

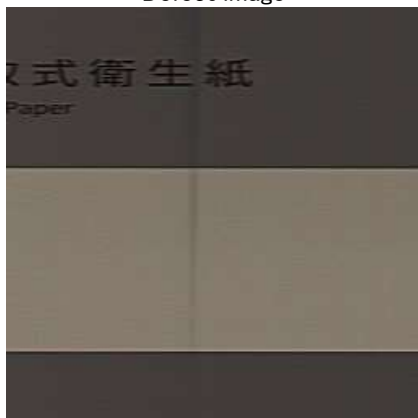
No.	#38, \$29	Date	2023/8/9 下午 02:18:39
Segment	1	Camera	1
Pattern	7880	Position[ x, y ]	128.0 [mm], 5923.9 [m], ( 103.2 [m] )
Type	縱向刀絲疵點	Size	H:2.0 ,V:20.8 [mm]
Result	-	Area	13.4 [mm2]
Inspection level	5/5,5/5,5/5,5/5,5/5	Label	-
Light	6,6,3/6,6,3

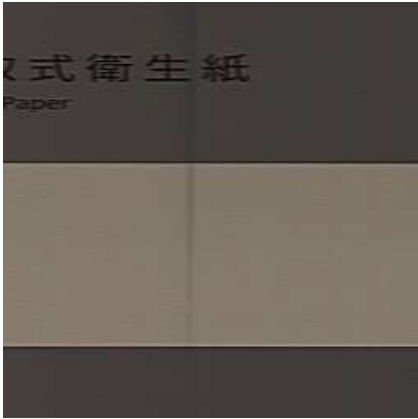
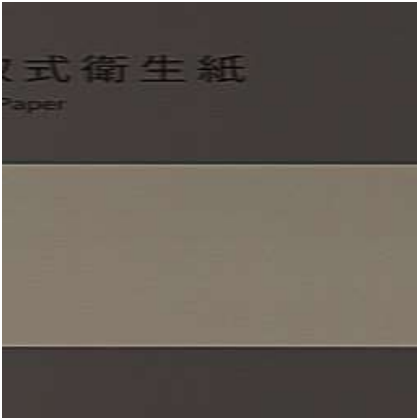
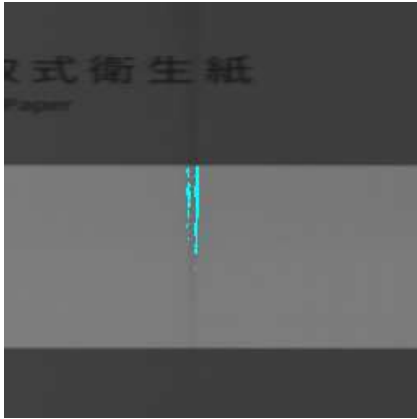
No.	#37, \$28	Date	2023/8/9 下午 02:18:38
Segment	1	Camera	1
Pattern	7879	Position[ x, y ]	132.4 [mm], 5923.2 [m], ( 104.0 [m] )
Type	点状疵点縱向刀絲疵點	Size	H:5.4 ,V:46.0 [mm]
Result	-	Area	143.6 [mm2]
Inspection level	5/5,5/5,5/5,5/5,5/5	Label	-
Light	6,6,3/6,6,3

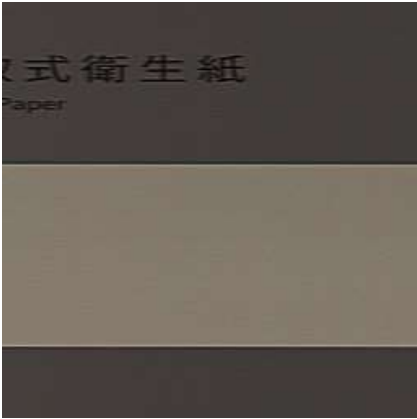
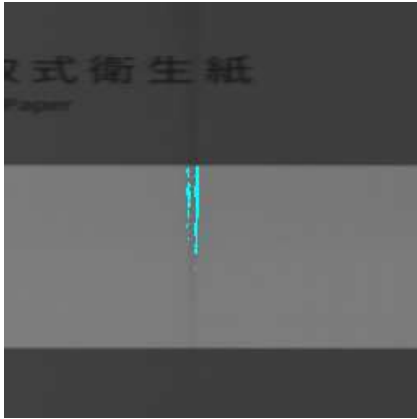
No.	#37, \$28	Date	2023/8/9 下午 02:18:38
Segment	1	Camera	1
Pattern	7879	Position[ x, y ]	450.1 [mm], 5923.2 [m], ( 104.0 [m] )
Type	点状疵点縱向刀絲疵點	Size	H:8.8 ,V:42.8 [mm]
Result	-	Area	223.6 [mm2]
Inspection level	5/5,5/5,5/5,5/5,5/5	Label	-
Light	6,6,3/6,6,3

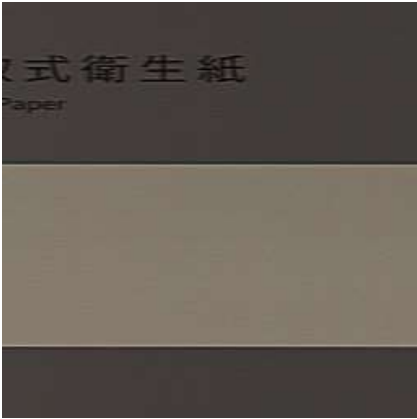
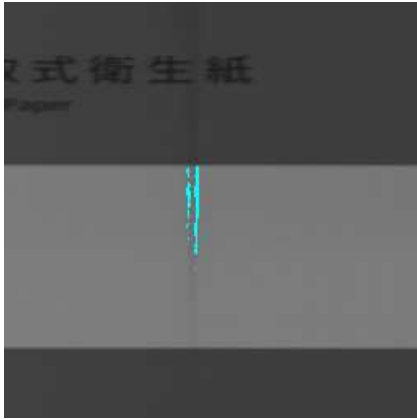
No.	#37, \$28	Date	2023/8/9 下午 02:18:38
Segment	1	Camera	1
Pattern	7879	Position[ x, y ]	448.6 [mm], 5923.6 [m], ( 103.6 [m] )
Type	点状疵点縱向刀絲疵點	Size	H:10.7 ,V:44.8 [mm]
Result	-	Area	318.8 [mm2]
Inspection level	5/5,5/5,5/5,5/5,5/5	Label	-
Light	6,6,3/6,6,3

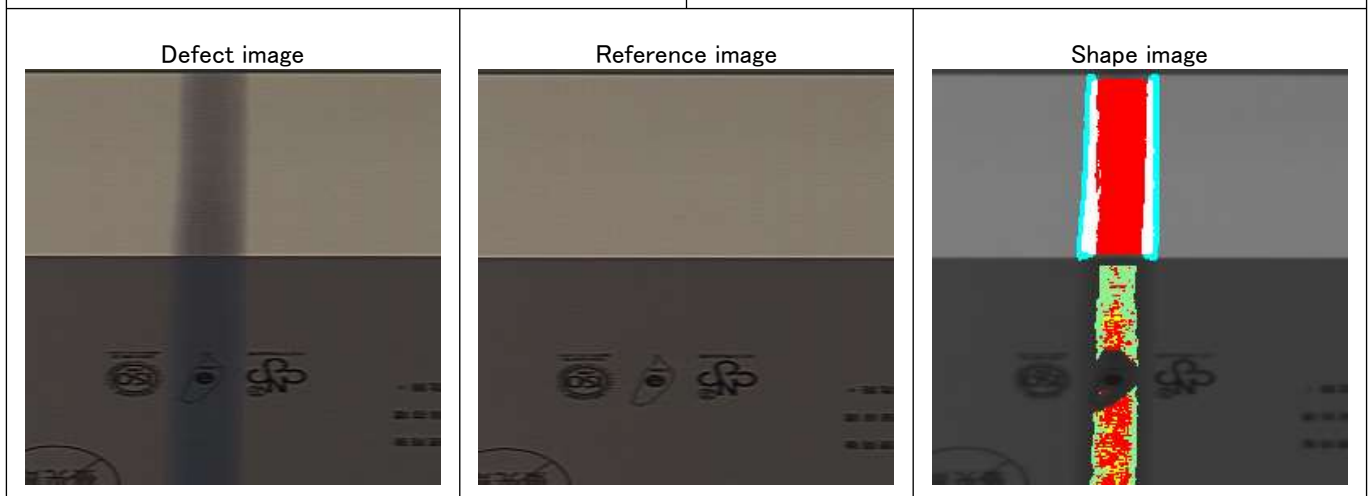
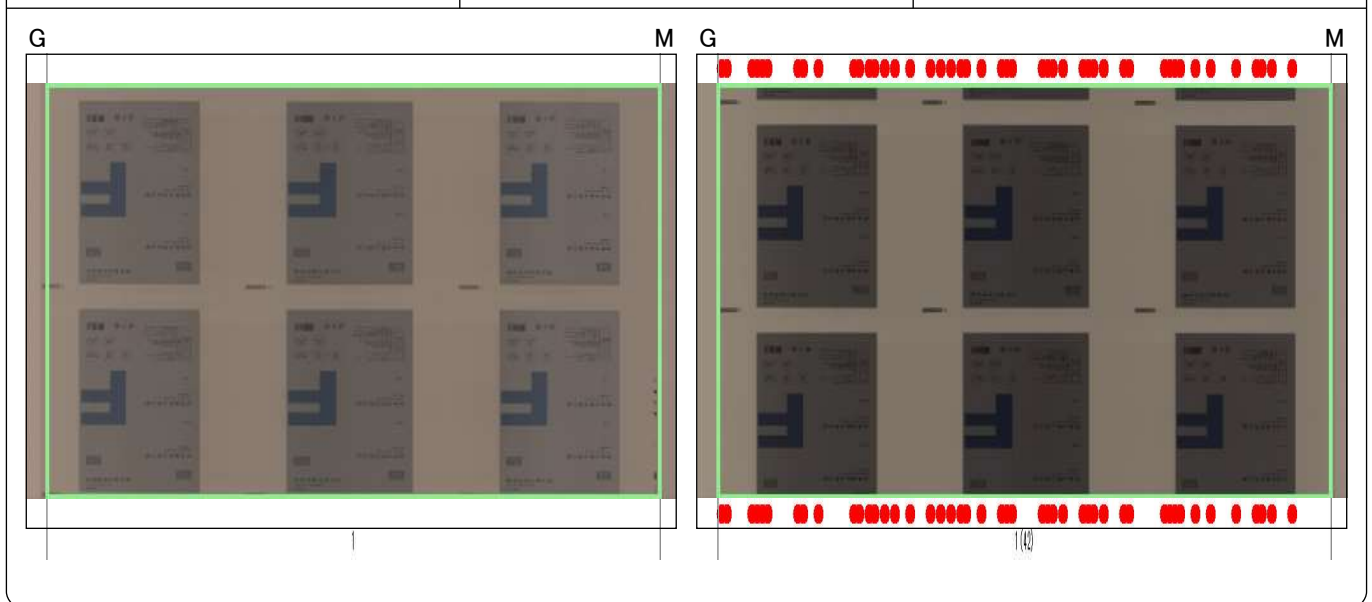
No.	#37, \$28	Date	2023/8/9 下午 02:18:38
Segment	1	Camera	1
Pattern	7879	Position[ x, y ]	127.5 [mm], 5923.6 [m], ( 103.6 [m] )
Type	点状疵点縱向刀絲疵點	Size	H:12.5 ,V:153.2 [mm]
Result	-	Area	847.6 [mm2]
Inspection level	5/5,5/5,5/5,5/5,5/5	Label	-
Light	6,6,3/6,6,3

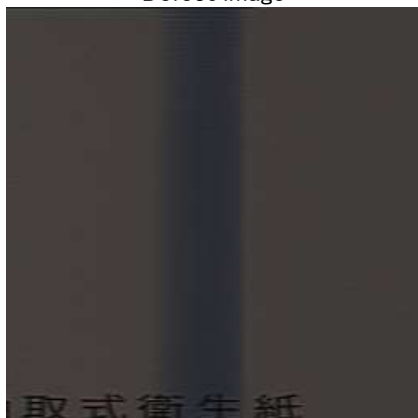
No.	#35, \$26	Date	2023/8/9 下午 02:18:18
Segment	1	Camera	1
Pattern	7845	Position[ x, y ]	121.7 [mm], 5898.0 [m], ( 129.1 [m] )
Type	点状疵点縱向刀絲疵點	Size	H:15.1 ,V:274.4 [mm]
Result	-	Area	2315.7 [mm2]
Inspection level	5/5,5/5,5/5,5/5,5/5	Label	-
Light	6,6,3/6,6,3

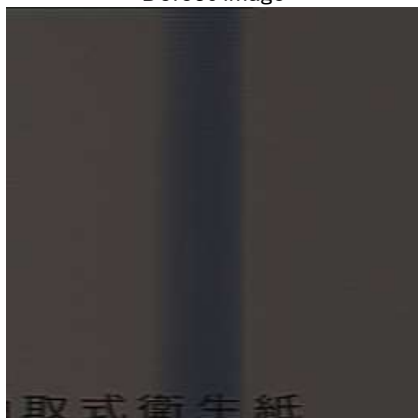
No.	#34, \$25	Date	2023/8/9 下午 02:18:17
Segment	1	Camera	1
Pattern	7844	Position[ x, y ]	377.8 [mm], 5897.3 [m], ( 129.9 [m] )
Type	点状疵点縱向刀絲疵點	Size	H:9.0 ,V:43.2 [mm]
Result	-	Area	245.6 [mm2]
Inspection level	5/5,5/5,5/5,5/5,5/5	Label	-
Light	6,6,3/6,6,3

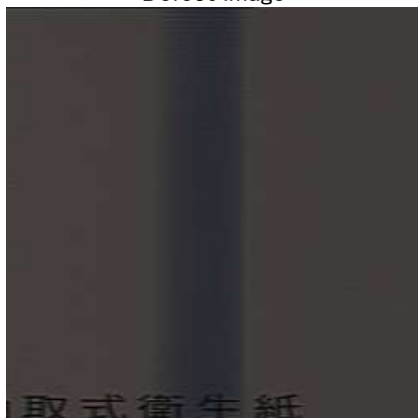
No.	#34, \$25	Date	2023/8/9 下午 02:18:17
Segment	1	Camera	1
Pattern	7844	Position[ x, y ]	444.4 [mm], 5897.3 [m], ( 129.9 [m] )
Type	点状疵点縱向刀絲疵點	Size	H:13.7 ,V:144.8 [mm]
Result	-	Area	532.4 [mm2]
Inspection level	5/5,5/5,5/5,5/5,5/5	Label	-
Light	6,6,3/6,6,3

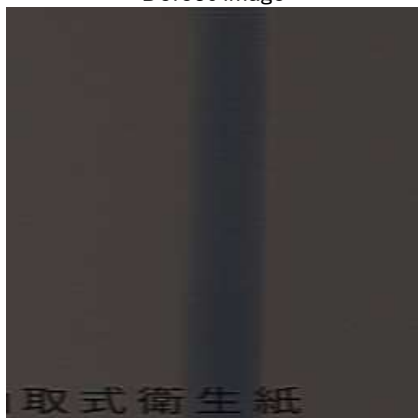
No.	#34, \$25	Date	2023/8/9 下午 02:18:17
Segment	1	Camera	1
Pattern	7844	Position[ x, y ]	124.6 [mm], 5897.3 [m], ( 129.9 [m] )
Type	点状疵点縱向刀絲疵點	Size	H:14.4 ,V:270.8 [mm]
Result	-	Area	1683.7 [mm2]
Inspection level	5/5,5/5,5/5,5/5,5/5	Label	-
Light	6,6,3/6,6,3

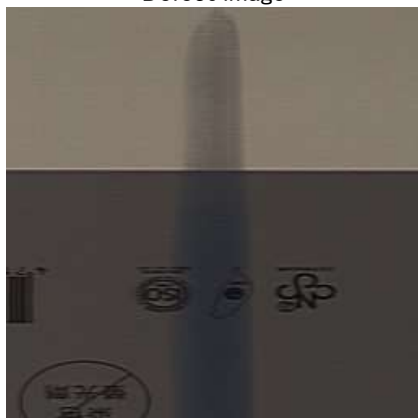
No.	#33, \$24	Date	2023/8/9 下午 02:18:16
Segment	1	Camera	1
Pattern	7842	Position[ x, y ]	123.9 [mm], 5895.8 [m], ( 131.3 [m] )
Type	点状疵点縱向刀絲疵點	Size	H:12.0 ,V:147.6 [mm]
Result	-	Area	739.3 [mm2]
Inspection level	5/5,5/5,5/5,5/5,5/5	Label	-
Light	6,6,3/6,6,3

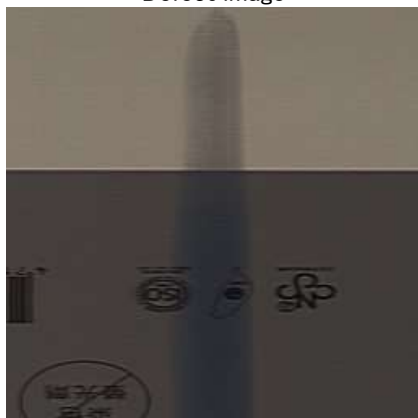
No.	#30, \$23	Date	2023/8/9 下午 02:18:08
Segment	1	Camera	1
Pattern	7829	Position[ x, y ]	374.1 [mm], 5886.0 [m], ( 141.1 [m] )
Type	点状疵点縱向刀絲疵點	Size	H:10.5 ,V:409.6 [mm]
Result	-	Area	483.1 [mm2]
Inspection level	5/5,5/5,5/5,5/5,5/5	Label	-
Light	6,6,3/6,6,3

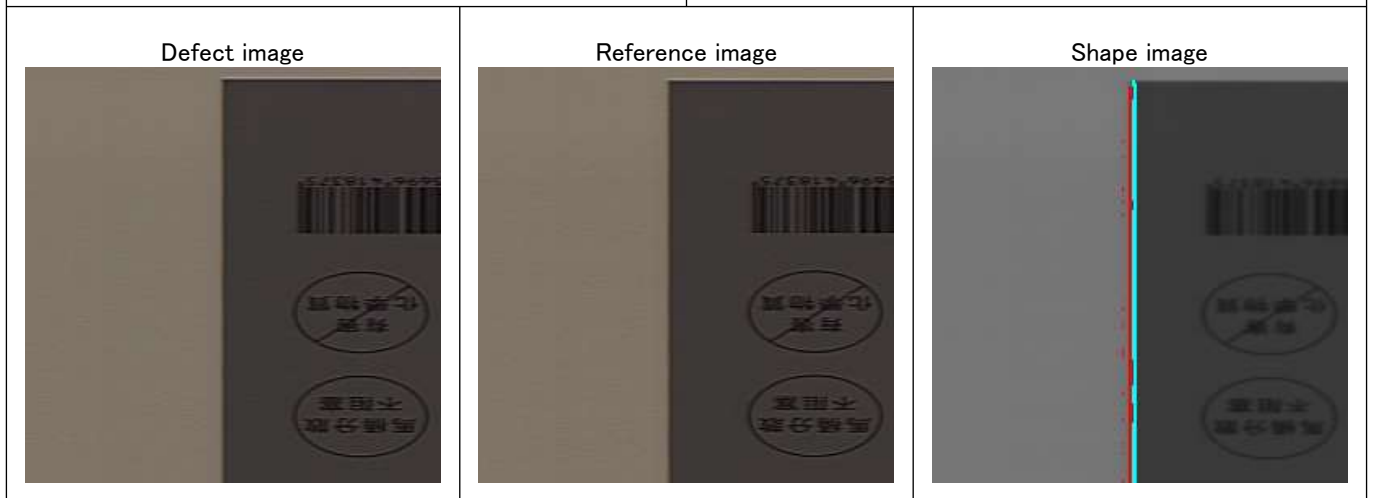
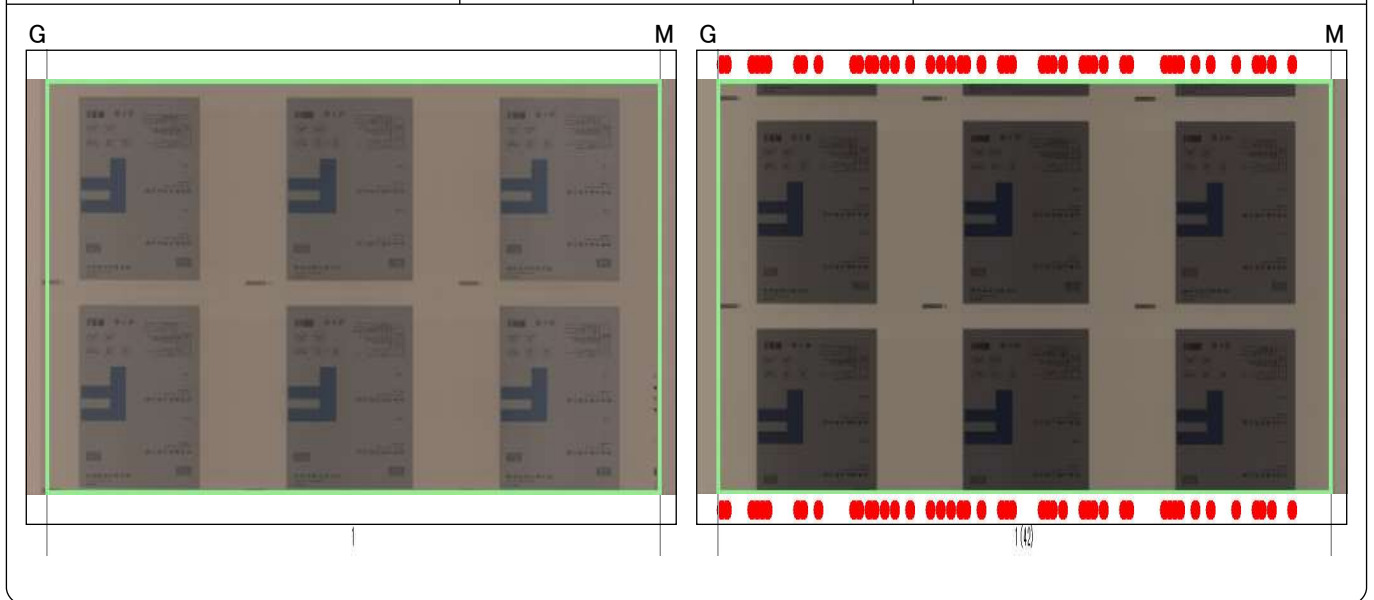
No.	#28, \$21	Date	2023/8/9 下午 02:18:07
Segment	1	Camera	1
Pattern	7827	Position[ x, y ]	568.0 [mm], 5884.4 [m], ( 142.8 [m] )
Type	点状疵点縱向刀絲疵點	Size	H:2.2 ,V:808.0 [mm]
Result	—	Area	146.3 [mm2]
Inspection level	5/5,5/5,5/5,5/5,5/5	Label	—
Light	6,6,3/6,6,3

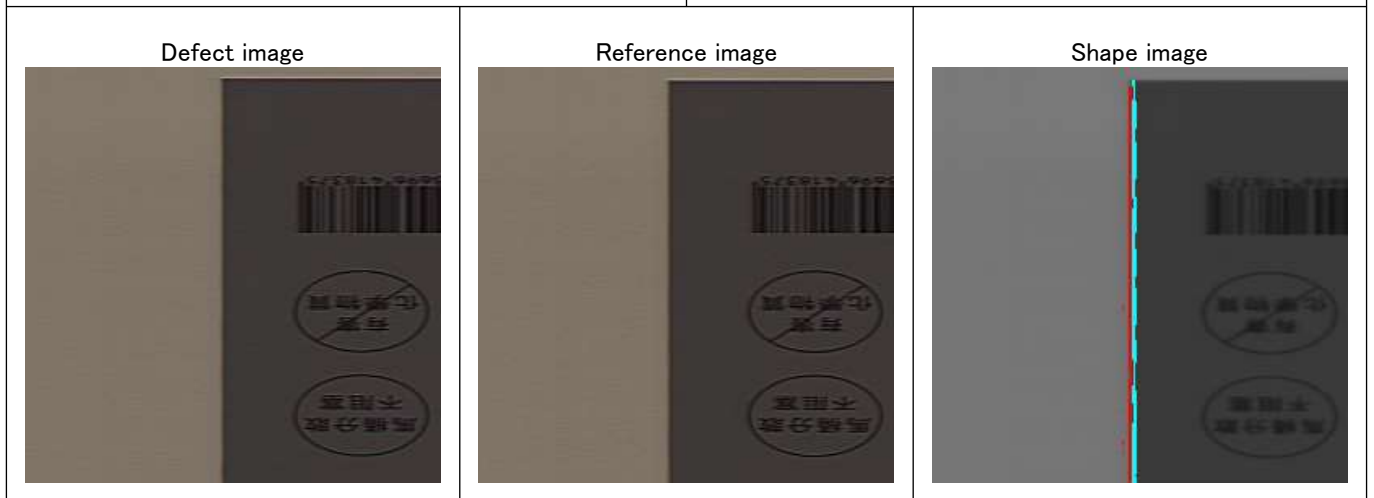
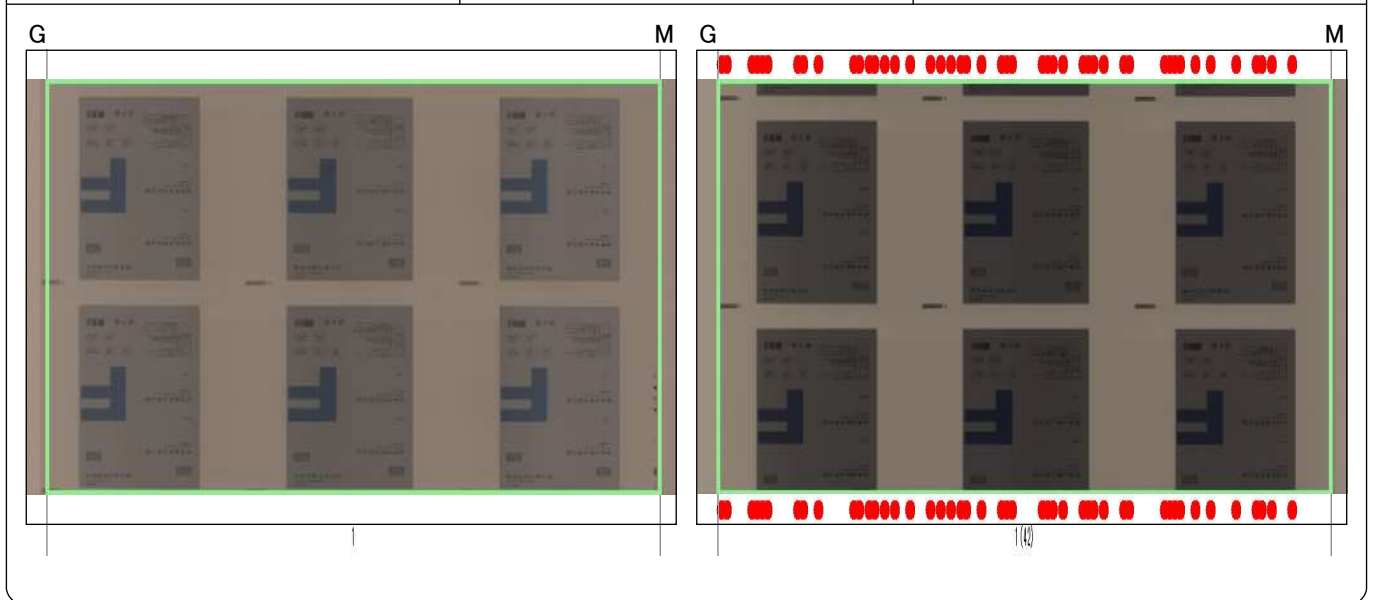
No.	#27, \$20	Date	2023/8/9 下午 02:18:06
Segment	1	Camera	1
Pattern	7826	Position[ x, y ]	374.9 [mm], 5884.1 [m], ( 143.1 [m] )
Type	点状疵点縱向刀絲疵點	Size	H:2.2 ,V:91.2 [mm]
Result	—	Area	34.5 [mm2]
Inspection level	5/5,5/5,5/5,5/5,5/5	Label	—
Light	6,6,3/6,6,3

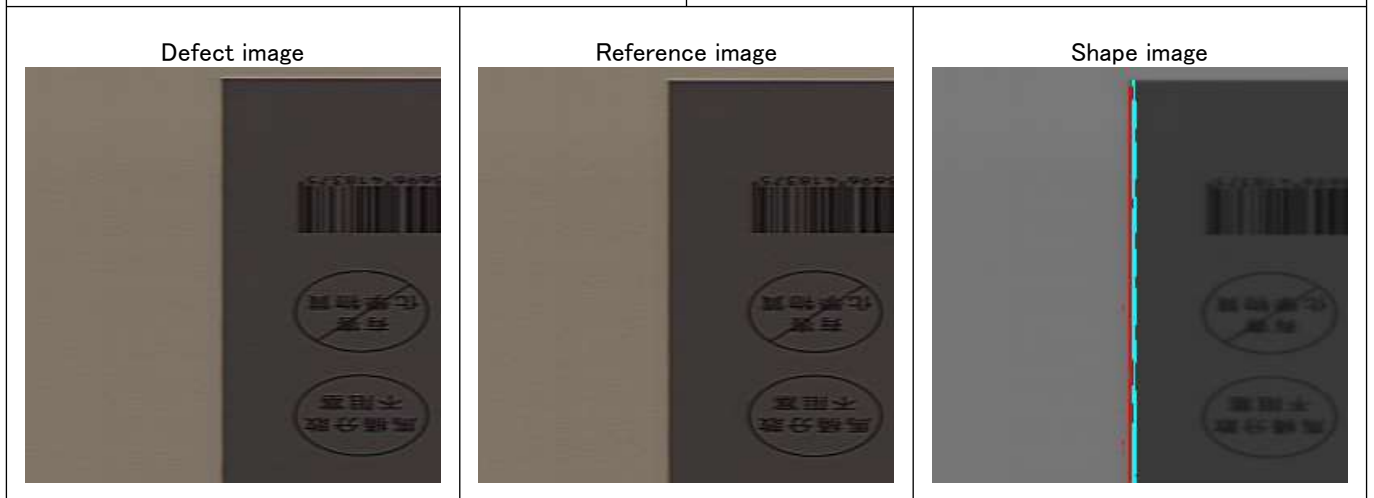
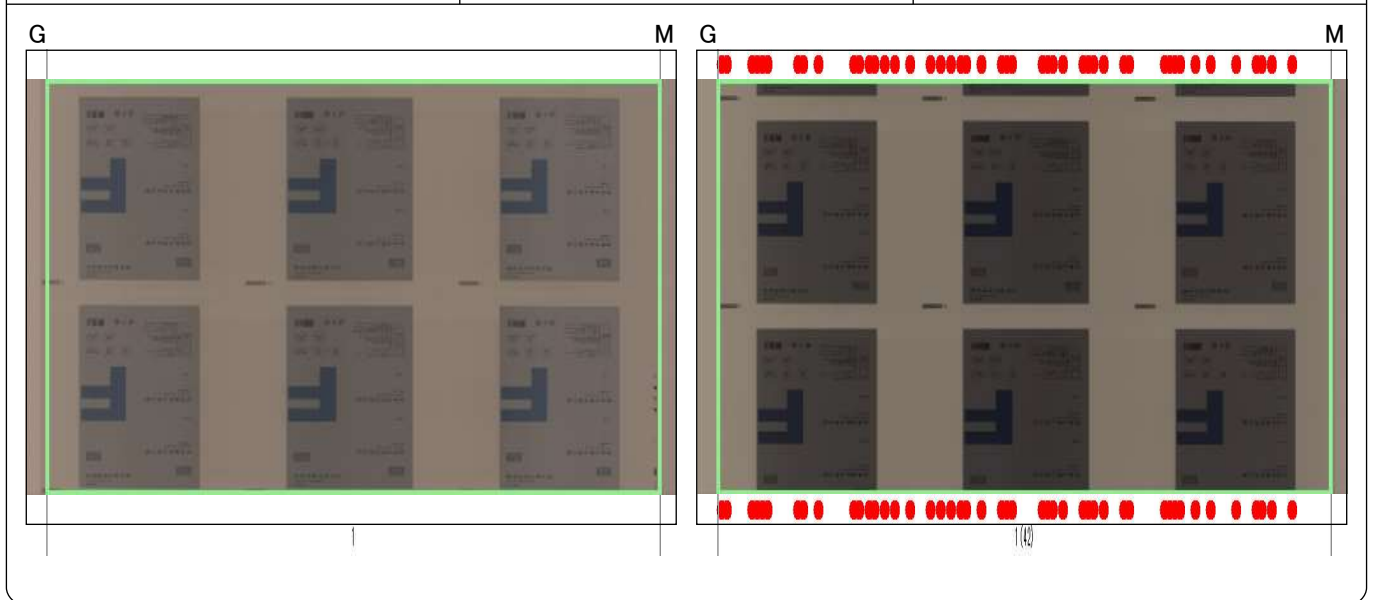
No.	#27, \$20	Date	2023/8/9 下午 02:18:06
Segment	1	Camera	1
Pattern	7826	Position[ x, y ]	699.8 [mm], 5883.5 [m], ( 143.6 [m] )
Type	点状疵点縱向刀絲疵點	Size	H:1.0 ,V:184.4 [mm]
Result	—	Area	56.7 [mm2]
Inspection level	5/5,5/5,5/5,5/5,5/5	Label	—
Light	6,6,3/6,6,3

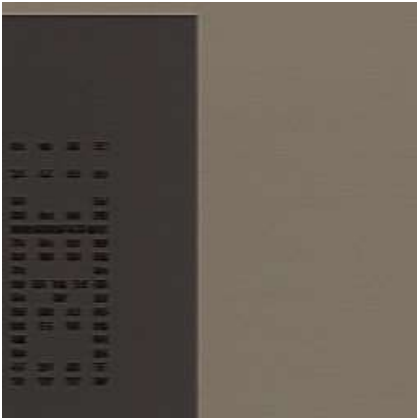
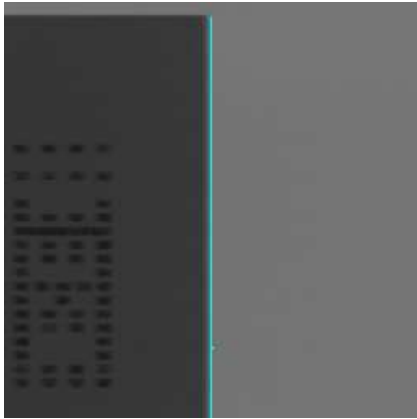
No.	#27, \$20	Date	2023/8/9 下午 02:18:06
Segment	1	Camera	1
Pattern	7826	Position[ x, y ]	568.2 [mm], 5883.7 [m], ( 143.5 [m] )
Type	縱向刀絲疵點	Size	H:0.5 ,V:328.8 [mm]
Result	-	Area	79.3 [mm2]
Inspection level	5/5,5/5,5/5,5/5,5/5	Label	-
Light	6,6,3/6,6,3

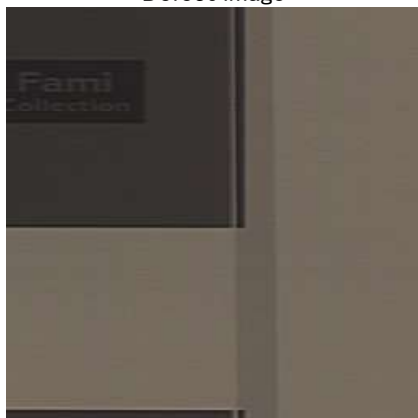
No.	#23, \$18	Date	2023/8/9 下午 02:17:46
Segment	1	Camera	1
Pattern	7793	Position[ x, y ]	562.8 [mm], 5858.7 [m], ( 168.4 [m] )
Type	点状疵点縱向刀絲疵點	Size	H:36.1 ,V:452.0 [mm]
Result	-	Area	1047.0 [mm2]
Inspection level	5/5,5/5,5/5,5/5,5/5	Label	-
Light	6,6,3/6,6,3

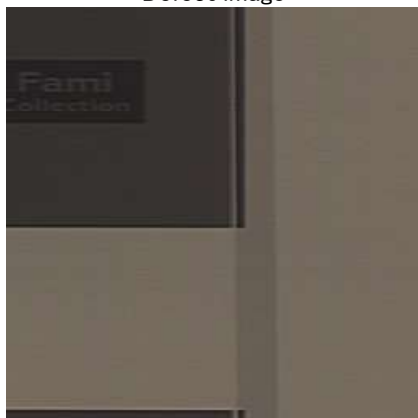
No.	#22, \$17	Date	2023/8/9 下午 02:17:46
Segment	1	Camera	1
Pattern	7792	Position[ x, y ]	376.3 [mm], 5858.1 [m], ( 169.1 [m] )
Type	点状疵点縱向刀絲疵點	Size	H:12.2 ,V:384.8 [mm]
Result	-	Area	653.8 [mm2]
Inspection level	5/5,5/5,5/5,5/5,5/5	Label	-
Light	6,6,3/6,6,3

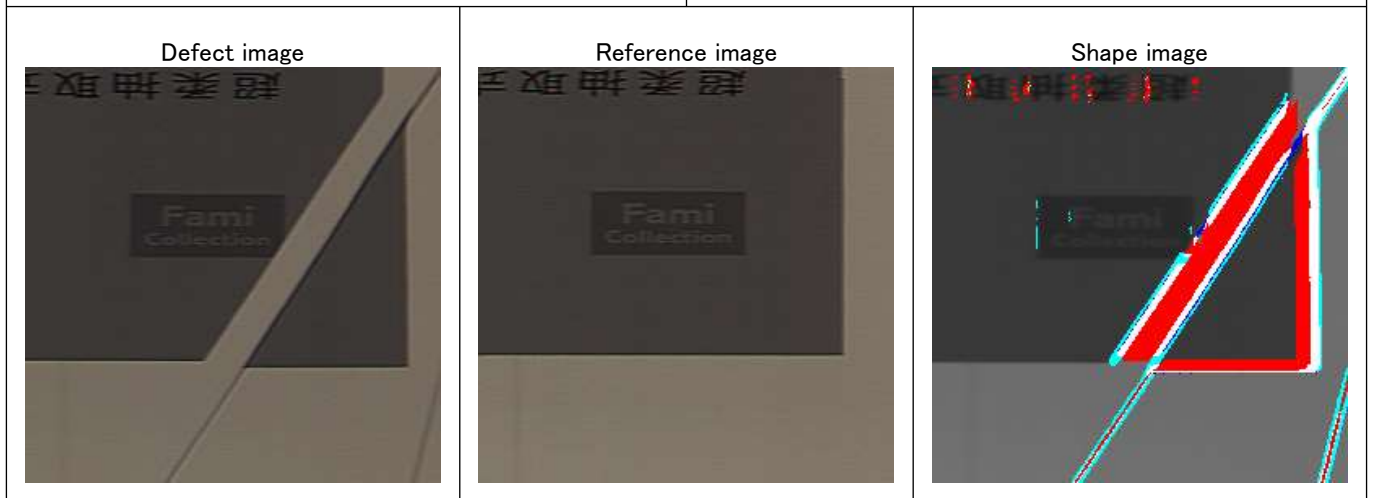
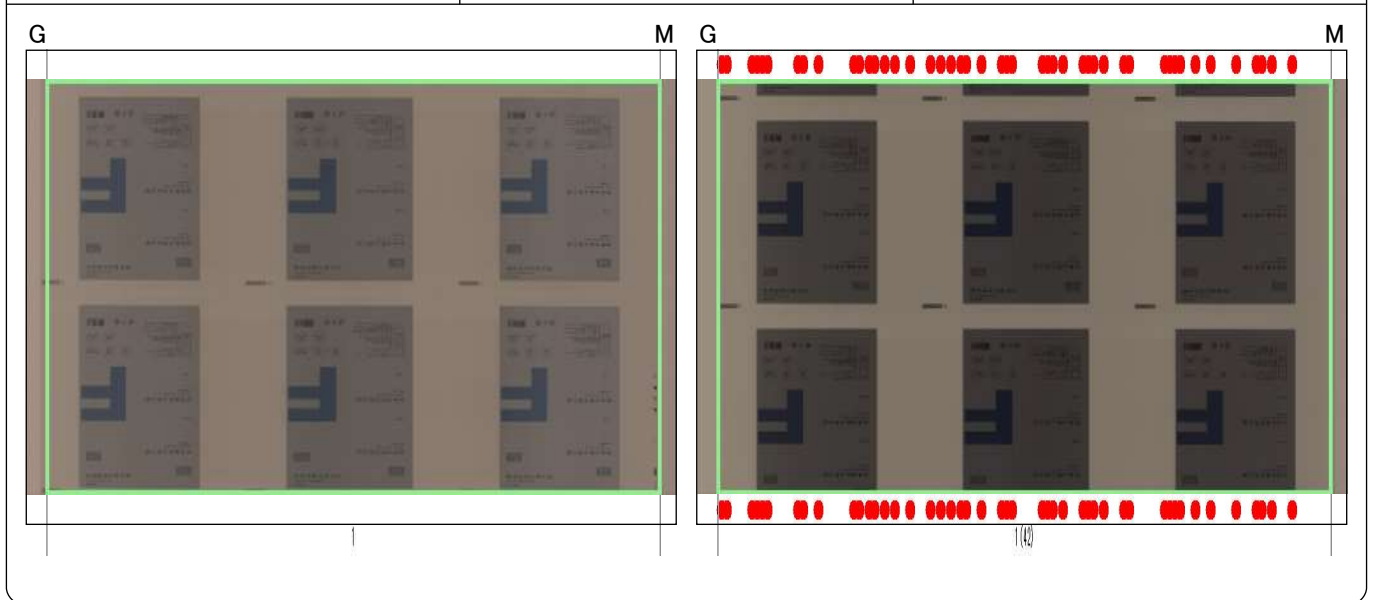
No.	#21, \$16	Date	2023/8/9 下午 02:17:45
Segment	1	Camera	1
Pattern	7791	Position[ x, y ]	401.7 [mm], 5857.5 [m], ( 169.7 [m] )
Type	点状疵点縱向刀絲疵點橫向刀絲	Size	H:205.8 ,V:729.2 [mm]
Result	—	Area	1461.6 [mm2]
Inspection level	5/5,5/5,5/5,5/5,5/5	Label	—
Light	6,6,3/6,6,3

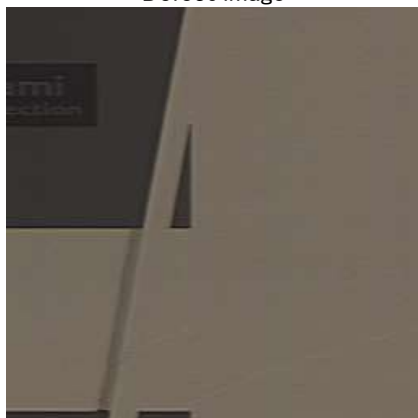
No.	#20, \$15	Date	2023/8/9 下午 02:17:45
Segment	1	Camera	1
Pattern	7790	Position[ x, y ]	529.2 [mm], 5856.8 [m], ( 170.4 [m] )
Type	点状疵点縱向刀絲疵點	Size	H:72.5 ,V:798.4 [mm]
Result	-	Area	3954.8 [mm2]
Inspection level	5/5,5/5,5/5,5/5,5/5	Label	-
Light	6,6,3/6,6,3

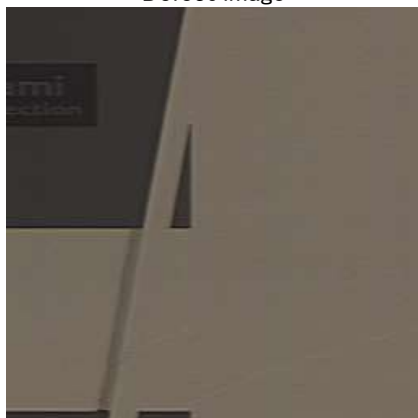
No.	#19, \$14	Date	2023/8/9 下午 02:17:44
Segment	1	Camera	1
Pattern	7789	Position[ x, y ]	583.8 [mm], 5856.0 [m], ( 171.2 [m] )
Type	点状疵点縱向刀絲疵點	Size	H:66.4 ,V:806.4 [mm]
Result	-	Area	432.0 [mm2]
Inspection level	5/5,5/5,5/5,5/5,5/5	Label	-
Light	6,6,3/6,6,3

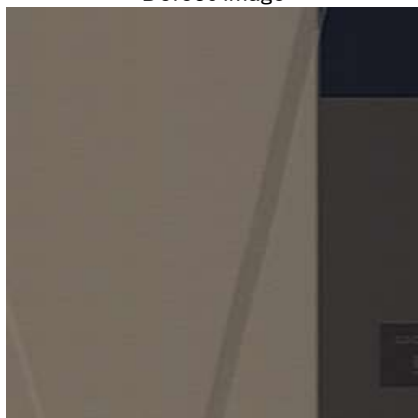
No.	#19, \$14	Date	2023/8/9 下午 02:17:44
Segment	1	Camera	1
Pattern	7789	Position[ x, y ]	355.1 [mm], 5856.0 [m], ( 171.2 [m] )
Type	点状疵点縱向刀絲疵點	Size	H:100.6 ,V:635.6 [mm]
Result	-	Area	1065.0 [mm2]
Inspection level	5/5,5/5,5/5,5/5,5/5	Label	-
Light	6,6,3/6,6,3

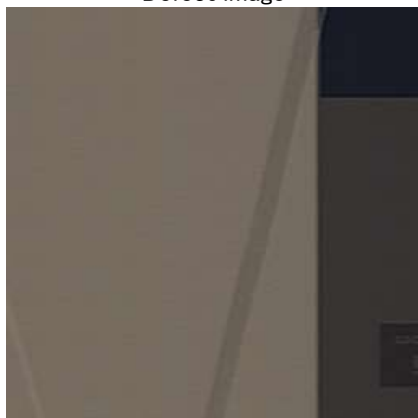
No.	#16, \$13	Date	2023/8/9 下午 02:17:35
Segment	1	Camera	1
Pattern	7775	Position[ x, y ]	108.7 [mm], 5845.3 [m], ( 181.9 [m] )
Type	点状疵点縱向刀絲疵點橫向刀絲	Size	H:197.3 ,V:389.6 [mm]
Result	-	Area	1843.7 [mm2]
Inspection level	5/5,5/5,5/5,5/5,5/5	Label	-
Light	6,6,3/6,6,3

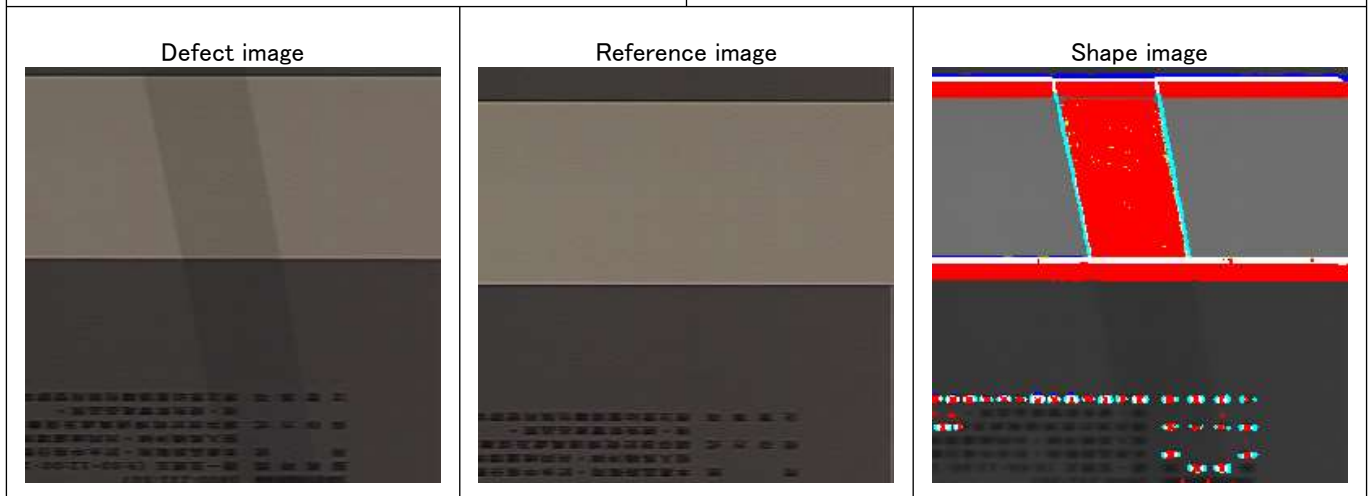
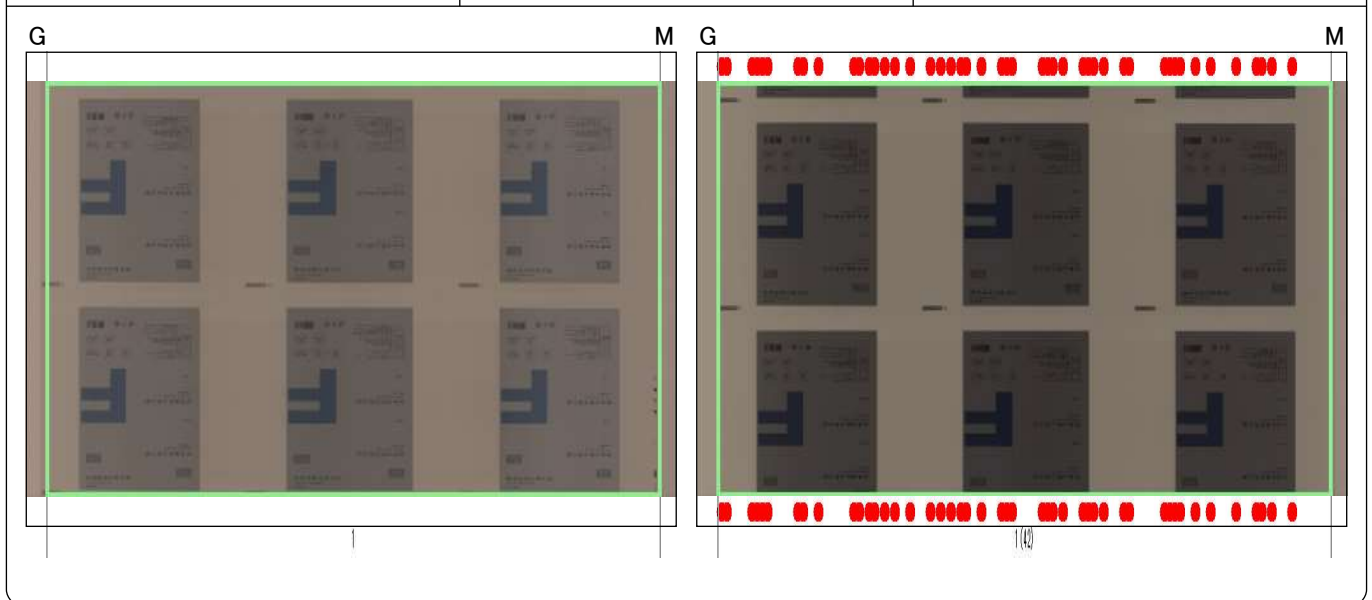
No.	#15, \$12	Date	2023/8/9 下午 02:17:35
Segment	1	Camera	1
Pattern	7774	Position[ x, y ]	267.0 [mm], 5844.3 [m], ( 182.9 [m] )
Type	縱向刀絲疵點	Size	H:53.7 ,V:530.8 [mm]
Result	-	Area	662.1 [mm2]
Inspection level	5/5,5/5,5/5,5/5,5/5	Label	-
Light	6,6,3/6,6,3

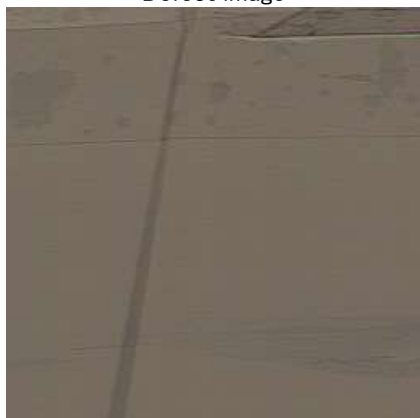
No.	#14, \$11	Date	2023/8/9 下午 02:17:34
Segment	1	Camera	1
Pattern	7773	Position[ x, y ]	704.5 [mm], 5843.8 [m], ( 183.4 [m] )
Type	点状疵点縱向刀絲疵點	Size	H:15.6 ,V:169.2 [mm]
Result	-	Area	262.4 [mm2]
Inspection level	5/5,5/5,5/5,5/5,5/5	Label	-
Light	6,6,3/6,6,3

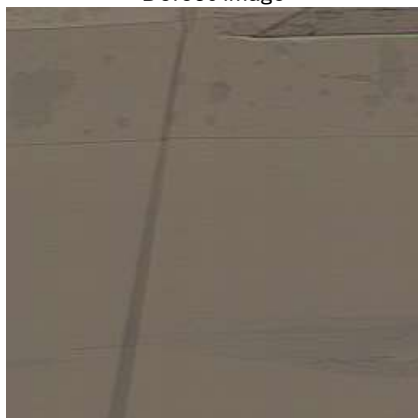
No.	#14, \$11	Date	2023/8/9 下午 02:17:34
Segment	1	Camera	1
Pattern	7773	Position[ x, y ]	700.3 [mm], 5843.5 [m], ( 183.6 [m] )
Type	点状疵点縱向刀絲疵點橫向刀絲	Size	H:12.5 ,V:472.0 [mm]
Result	-	Area	478.3 [mm2]
Inspection level	5/5,5/5,5/5,5/5,5/5	Label	-
Light	6,6,3/6,6,3

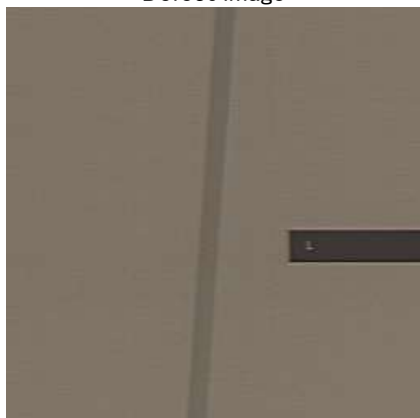
No.	#14, \$11	Date	2023/8/9 下午 02:17:34
Segment	1	Camera	1
Pattern	7773	Position[ x, y ]	625.8 [mm], 5843.4 [m], ( 183.8 [m] )
Type	点状疵点縱向刀絲疵點	Size	H:24.4 ,V:583.2 [mm]
Result	-	Area	924.8 [mm2]
Inspection level	5/5,5/5,5/5,5/5,5/5	Label	-
Light	6,6,3/6,6,3
