# Inspection Result (Individual Data)

Lot number : 5

Inspected date : 2023/8/9 下午 12:59:28 ~ 2023/8/9 下午 02:20:08

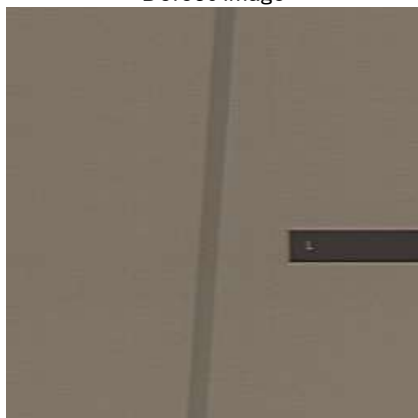
No.	#13, \$10	Date	2023/8/9 下午 02:17:34
Segment	1	Camera	1
Pattern	7772	Position[ x, y ]	879.0 [mm], 5842.8 [m], ( 184.4 [m] )
Type	点状疵点縱向刀絲疵點	Size	H:2.4 ,V:526.8 [mm]
Result	-	Area	286.4 [mm2]
Inspection level	5/5,5/5,5/5,5/5,5/5	Label	-
Light	6,6,3/6,6,3

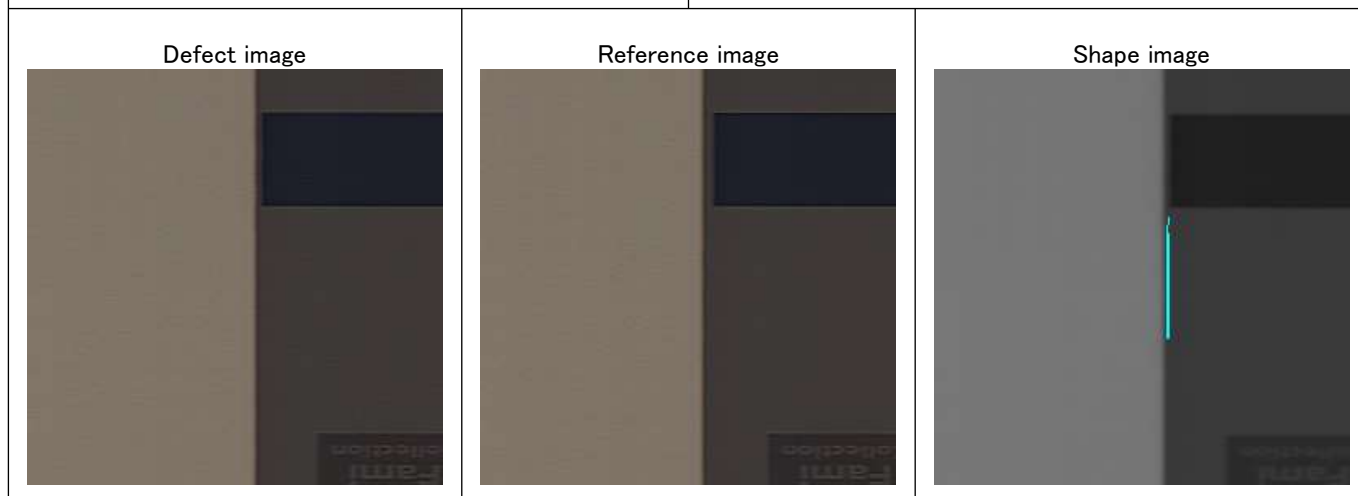
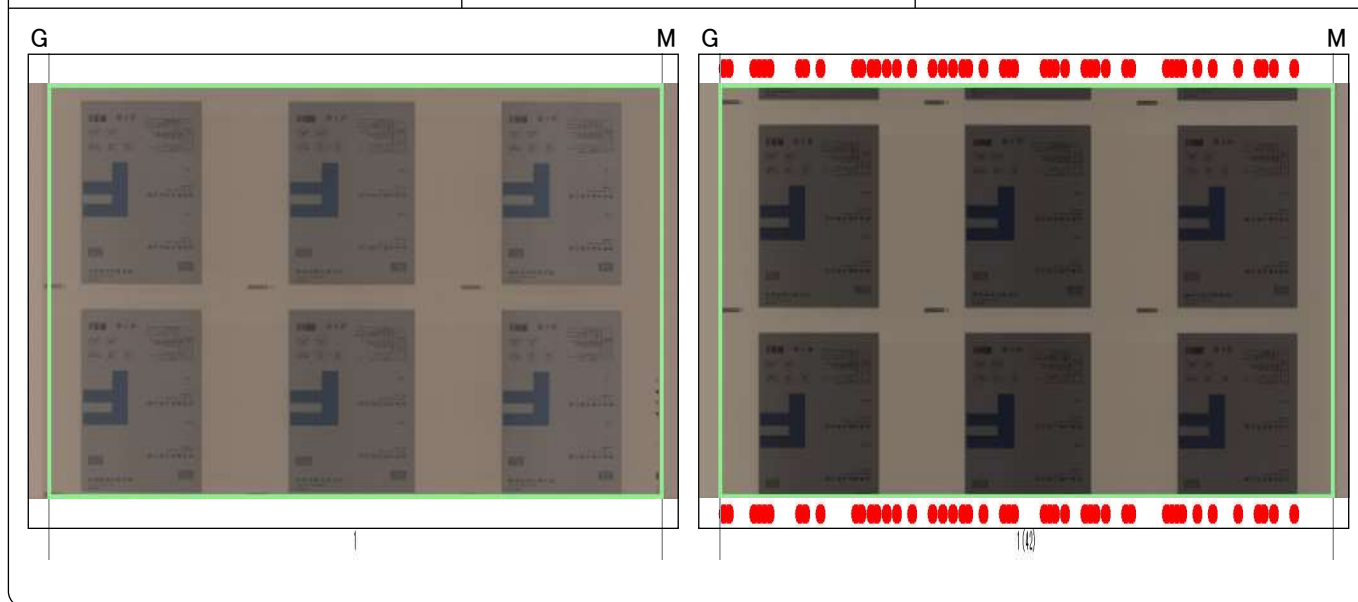
No.	#5, \$4	Date	2023/8/9 下午 02:17:23
Segment	1	Camera	1
Pattern	7755	Position[ x, y ]	697.1 [mm], 5830.4 [m], ( 196.7 [m] )
Type	縱向刀絲疵點	Size	H:0.5 ,V:29.2 [mm]
Result	-	Area	13.1 [mm2]
Inspection level	5/5,5/5,5/5,5/5,5/5	Label	-
Light	6,6,3/6,6,3
