# Inspection Result (Individual Data)

Lot number : 8

商品名	標準透明6-6-3	周長	
顧客名		Ex1	
CODE番号		Ex2	
基材		Ex3

Total defects	21	検査範圍 : 83.6 ~ 1024.2 [mm]	寬度 : 940.6 [mm]
Web length	4343.0 [m]	參照更新 : 無更新/無更新	
Segments	1 ( 從左側 )

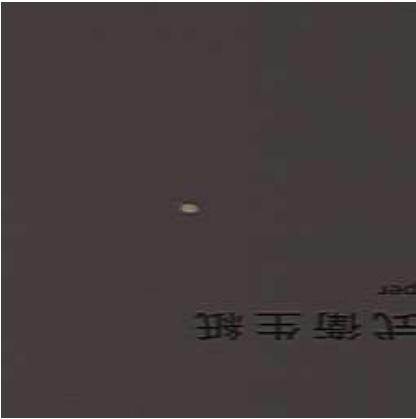
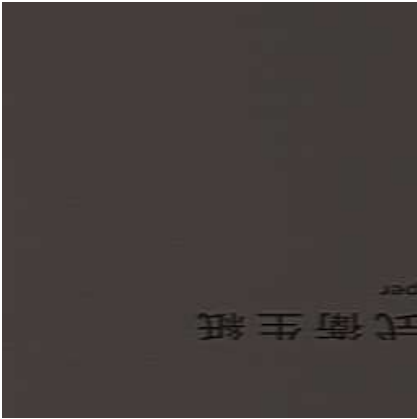
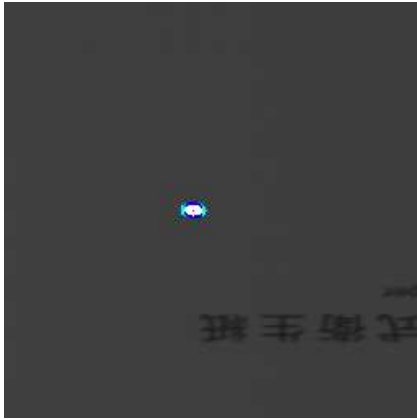
No.	#27, \$20	Date	2023/8/9 下午 05:04:34
Segment	1	Camera	1
Pattern	5709	Position[ x, y ]	159.3 [mm], 4291.5 [m], ( 51.4 [m] )
Type	点状疵点縱向刀絲疵點橫向刀絲	Size	H:3.9 ,V:3.2 [mm]
Result	-	Area	7.5 [mm2]
Inspection level	5/5,5/5,5/5,5/5,5/5	Label	-
Light	6,6,3/6,6,3

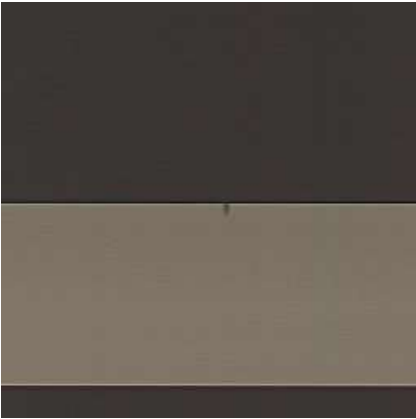
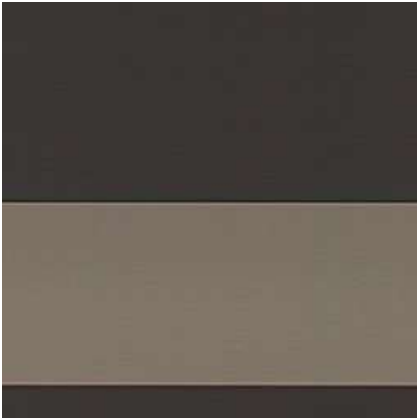
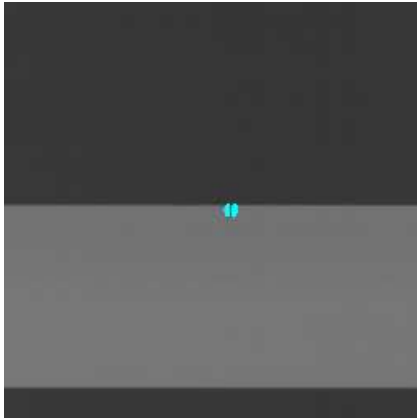
No.	#25, \$18	Date	2023/8/9 下午 05:04:27
Segment	1	Camera	1
Pattern	5696	Position[ x, y ]	493.0 [mm], 4281.9 [m], ( 61.1 [m] )
Type	縱向刀絲疵點	Size	H:2.2 ,V:2.8 [mm]
Result	-	Area	4.5 [mm2]
Inspection level	5/5,5/5,5/5,5/5,5/5	Label	-
Light	6,6,3/6,6,3

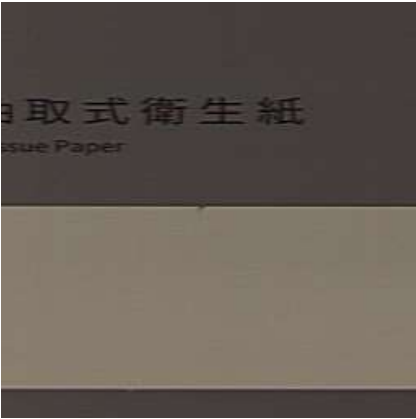
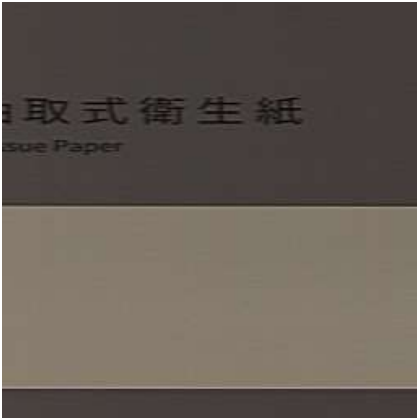
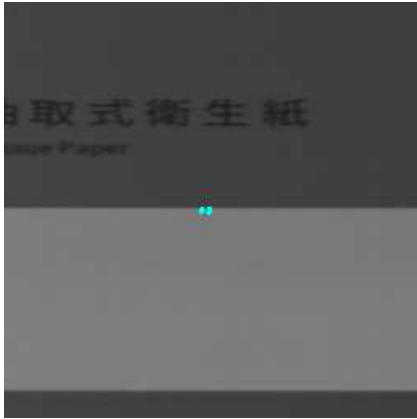
No.	#24, \$17	Date	2023/8/9 下午 05:04:25
Segment	1	Camera	1
Pattern	5692	Position[ x, y ]	121.9 [mm], 4278.9 [m], ( 64.1 [m] )
Type	縱向刀絲疵點	Size	H:2.0 ,V:1.2 [mm]
Result	-	Area	2.1 [mm2]
Inspection level	5/5,5/5,5/5,5/5,5/5	Label	-
Light	6,6,3/6,6,3

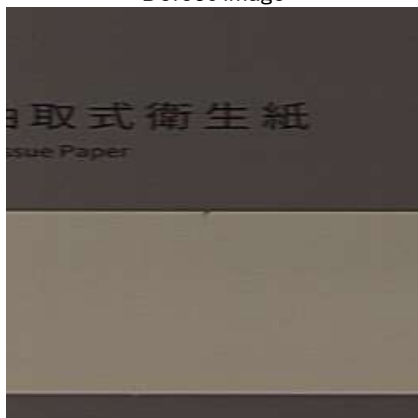
No.	#21, \$16	Date	2023/8/9 下午 05:03:49
Segment	1	Camera	1
Pattern	5622	Position[ x, y ]	205.7 [mm], 4225.9 [m], ( 117.0 [m] )
Type	縱向刀絲疵點	Size	H:0.7 ,V:13.6 [mm]
Result	-	Area	8.6 [mm2]
Inspection level	5/5,5/5,5/5,5/5,5/5	Label	-
Light	6,6,3/6,6,3

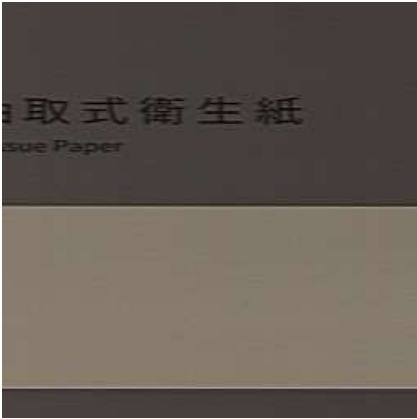
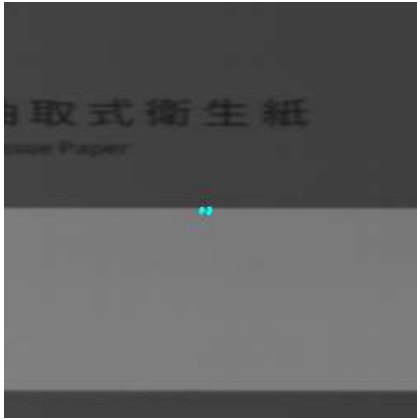
No.	#21, \$16	Date	2023/8/9 下午 05:03:49
Segment	1	Camera	1
Pattern	5622	Position[ x, y ]	772.3 [mm], 4226.2 [m], ( 116.8 [m] )
Type	縱向刀絲疵點	Size	H:0.5 ,V:66.0 [mm]
Result	-	Area	11.5 [mm2]
Inspection level	5/5,5/5,5/5,5/5,5/5	Label	-
Light	6,6,3/6,6,3

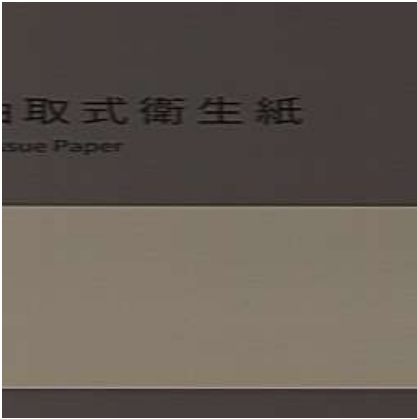
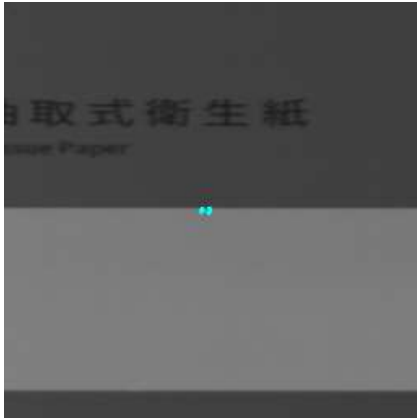
No.	#21, \$16	Date	2023/8/9 下午 05:03:49
Segment	1	Camera	1
Pattern	5622	Position[ x, y ]	129.3 [mm], 4226.2 [m], ( 116.8 [m] )
Type	縱向刀絲疵點	Size	H:0.5 ,V:96.8 [mm]
Result	-	Area	17.0 [mm2]
Inspection level	5/5,5/5,5/5,5/5,5/5	Label	-
Light	6,6,3/6,6,3

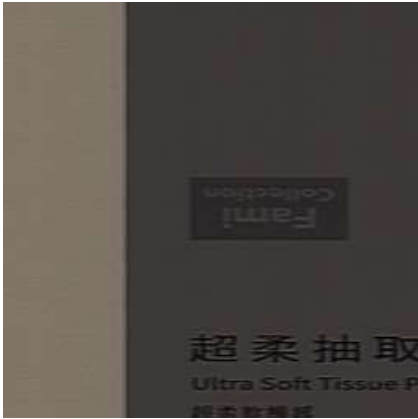
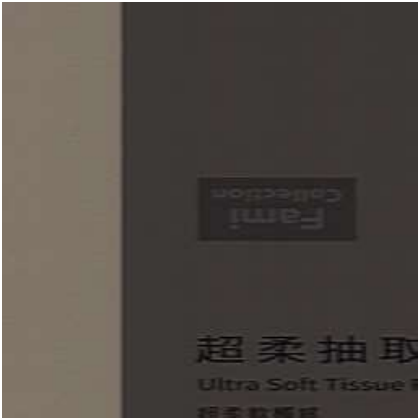
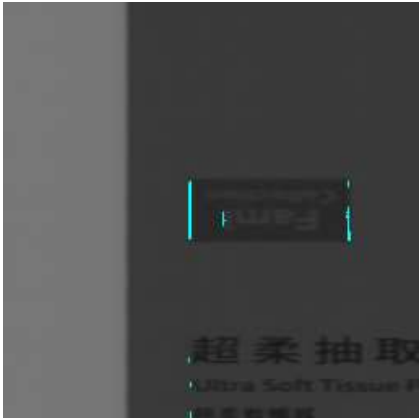
No.	#19, \$14	Date	2023/8/9 下午 05:03:48
Segment	1	Camera	1
Pattern	5620	Position[ x, y ]	385.4 [mm], 4224.8 [m], ( 118.2 [m] )
Type	縱向刀絲疵點	Size	H:0.5 ,V:13.6 [mm]
Result	-	Area	6.5 [mm2]
Inspection level	5/5,5/5,5/5,5/5,5/5	Label	-
Light	6,6,3/6,6,3

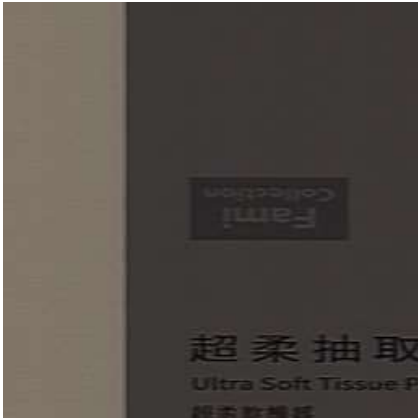
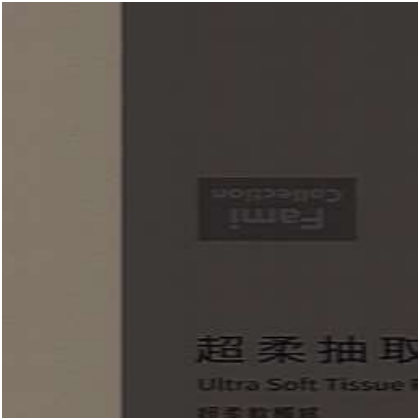
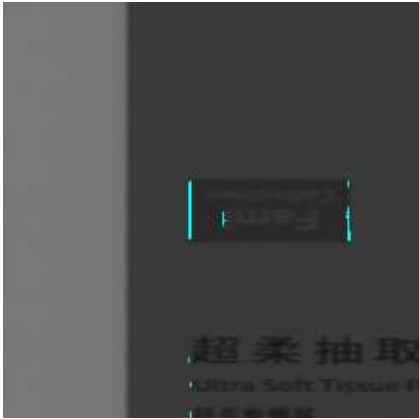
No.	#18, \$13	Date	2023/8/9 下午 05:03:47
Segment	1	Camera	1
Pattern	5619	Position[ x, y ]	531.1 [mm], 4224.4 [m], ( 118.5 [m] )
Type	縱向刀絲疵點	Size	H:5.4 ,V:14.0 [mm]
Result	-	Area	4.9 [mm2]
Inspection level	5/5,5/5,5/5,5/5,5/5	Label	-
Light	6,6,3/6,6,3

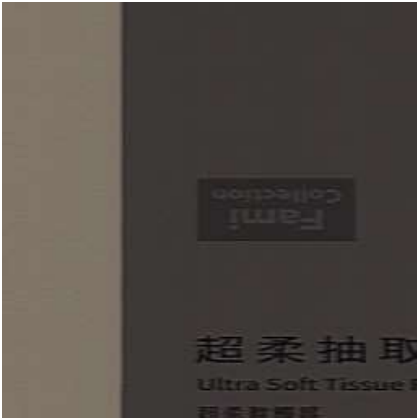
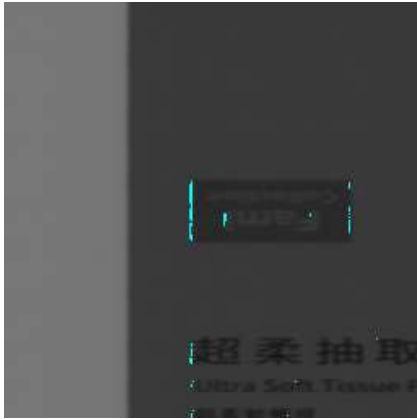
No.	#18, \$13	Date	2023/8/9 下午 05:03:47
Segment	1	Camera	1
Pattern	5619	Position[ x, y ]	386.1 [mm], 4224.4 [m], ( 118.6 [m] )
Type	縱向刀絲疵點	Size	H:5.6 ,V:14.0 [mm]
Result	-	Area	5.7 [mm2]
Inspection level	5/5,5/5,5/5,5/5,5/5	Label	-
Light	6,6,3/6,6,3

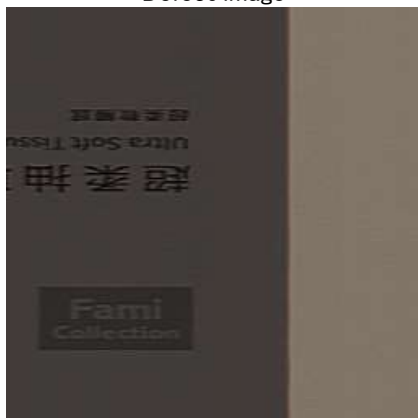
No.	#17, \$12	Date	2023/8/9 下午 05:03:47
Segment	1	Camera	1
Pattern	5618	Position[ x, y ]	229.1 [mm], 4223.7 [m], ( 119.3 [m] )
Type	縱向刀絲疵點	Size	H:0.7 ,V:13.6 [mm]
Result	-	Area	3.6 [mm2]
Inspection level	5/5,5/5,5/5,5/5,5/5	Label	-
Light	6,6,3/6,6,3

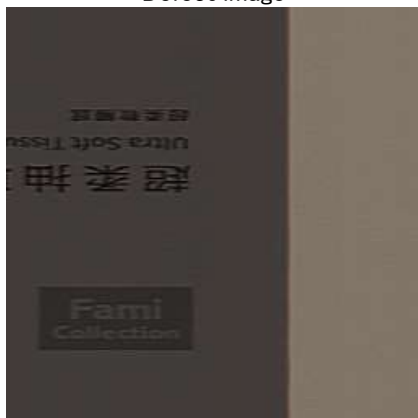
No.	#14, \$11	Date	2023/8/9 下午 05:03:39
Segment	1	Camera	1
Pattern	5602	Position[ x, y ]	773.1 [mm], 4211.6 [m], ( 131.4 [m] )
Type	点状疵点縱向刀絲疵點	Size	H:2.2 ,V:98.0 [mm]
Result	-	Area	136.0 [mm2]
Inspection level	5/5,5/5,5/5,5/5,5/5	Label	-
Light	6,6,3/6,6,3

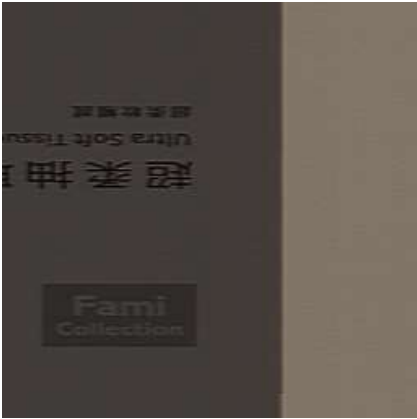
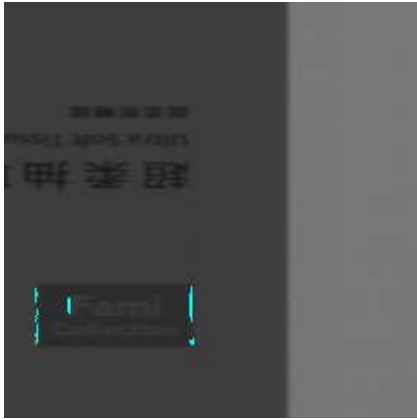
No.	#14, \$11	Date	2023/8/9 下午 05:03:39
Segment	1	Camera	1
Pattern	5602	Position[ x, y ]	450.5 [mm], 4211.2 [m], ( 131.8 [m] )
Type	点状疵点縱向刀絲疵點	Size	H:2.2 ,V:97.6 [mm]
Result	-	Area	140.8 [mm2]
Inspection level	5/5,5/5,5/5,5/5,5/5	Label	-
Light	6,6,3/6,6,3

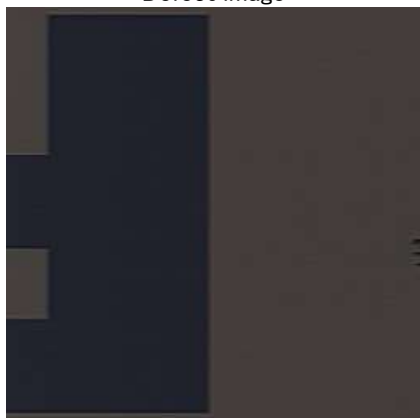
No.	#13, \$10	Date	2023/8/9 下午 05:03:38
Segment	1	Camera	1
Pattern	5601	Position[ x, y ]	772.8 [mm], 4210.8 [m], ( 132.2 [m] )
Type	点状疵点縱向刀絲疵點	Size	H:2.0 ,V:98.0 [mm]
Result	-	Area	105.9 [mm2]
Inspection level	5/5,5/5,5/5,5/5,5/5	Label	-
Light	6,6,3/6,6,3

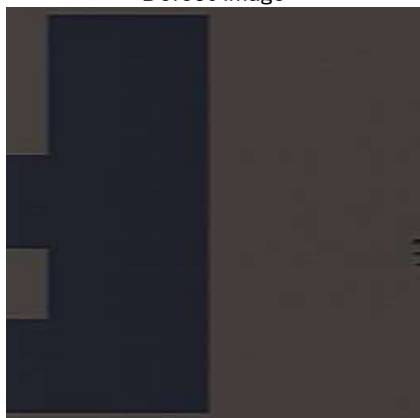
No.	#13, \$10	Date	2023/8/9 下午 05:03:38
Segment	1	Camera	1
Pattern	5601	Position[ x, y ]	129.7 [mm], 4210.8 [m], ( 132.2 [m] )
Type	点状疵点縱向刀絲疵點	Size	H:2.2 ,V:98.0 [mm]
Result	-	Area	114.9 [mm2]
Inspection level	5/5,5/5,5/5,5/5,5/5	Label	-
Light	6,6,3/6,6,3

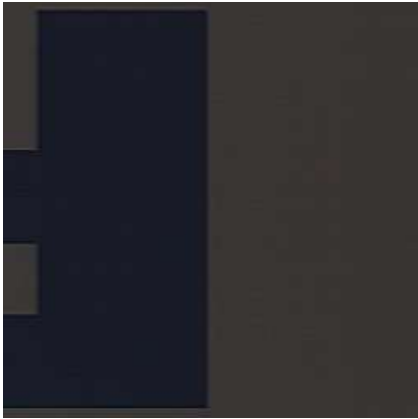
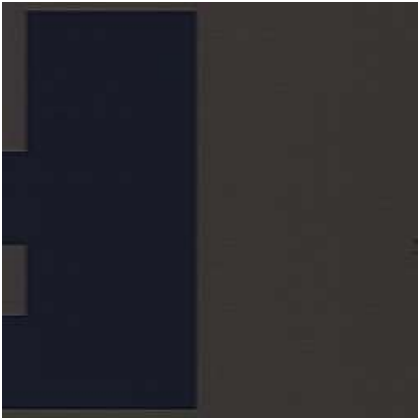
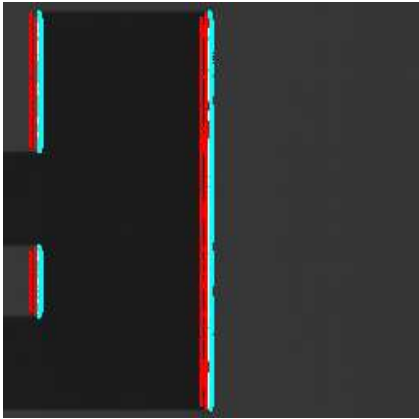
No.	#12, \$9	Date	2023/8/9 下午 05:03:37
Segment	1	Camera	1
Pattern	5600	Position[ x, y ]	773.1 [mm], 4209.7 [m], ( 133.3 [m] )
Type	縱向刀絲疵點	Size	H:0.7 ,V:96.8 [mm]
Result	-	Area	56.4 [mm2]
Inspection level	5/5,5/5,5/5,5/5,5/5	Label	-
Light	6,6,3/6,6,3

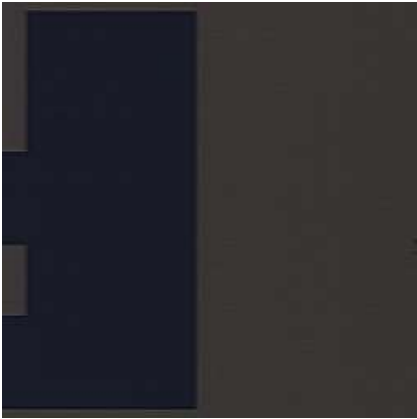
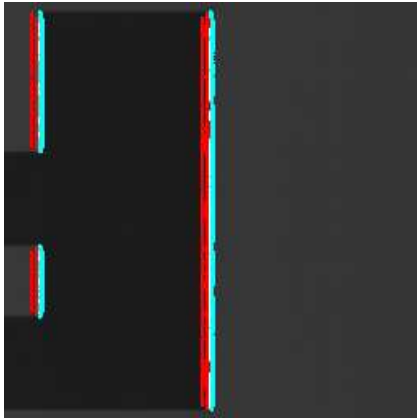
No.	#12, \$9	Date	2023/8/9 下午 05:03:37
Segment	1	Camera	1
Pattern	5600	Position[ x, y ]	450.5 [mm], 4210.1 [m], ( 132.9 [m] )
Type	点状疵点縱向刀絲疵點	Size	H:2.0 ,V:98.0 [mm]
Result	-	Area	65.4 [mm2]
Inspection level	5/5,5/5,5/5,5/5,5/5	Label	-
Light	6,6,3/6,6,3

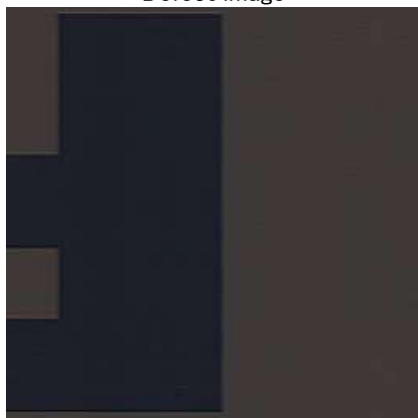
No.	#11, \$8	Date	2023/8/9 下午 05:03:37
Segment	1	Camera	1
Pattern	5599	Position[ x, y ]	702.0 [mm], 4209.3 [m], ( 133.7 [m] )
Type	縱向刀絲疵點	Size	H:0.7 ,V:61.6 [mm]
Result	-	Area	12.3 [mm2]
Inspection level	5/5,5/5,5/5,5/5,5/5	Label	-
Light	6,6,3/6,6,3

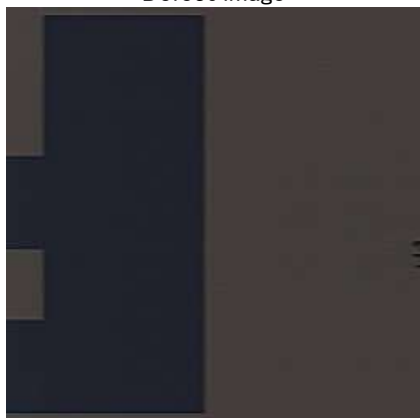
No.	#10, \$7	Date	2023/8/9 下午 05:03:36
Segment	1	Camera	1
Pattern	5598	Position[ x, y ]	409.5 [mm], 4208.7 [m], ( 134.3 [m] )
Type	縱向刀絲疵點	Size	H:5.4 ,V:14.0 [mm]
Result	-	Area	8.1 [mm2]
Inspection level	5/5,5/5,5/5,5/5,5/5	Label	-
Light	6,6,3/6,6,3

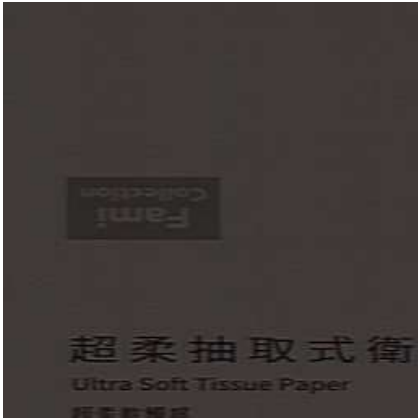
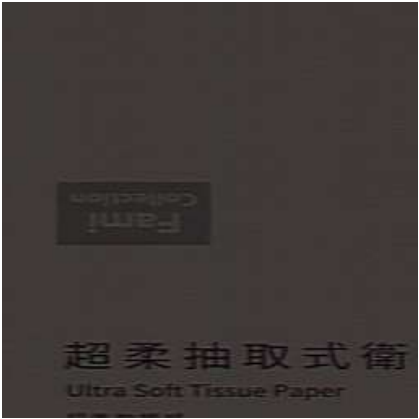
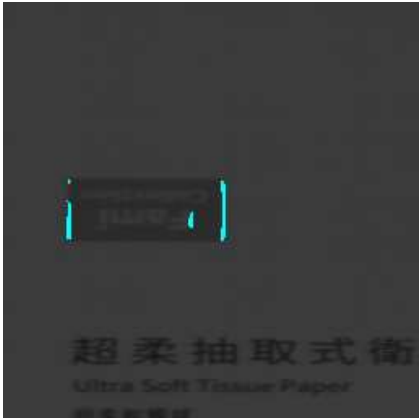
No.	#10, \$7	Date	2023/8/9 下午 05:03:36
Segment	1	Camera	1
Pattern	5598	Position[ x, y ]	733.3 [mm], 4208.3 [m], ( 134.7 [m] )
Type	縱向刀絲疵點	Size	H:5.6 ,V:14.0 [mm]
Result	-	Area	9.7 [mm2]
Inspection level	5/5,5/5,5/5,5/5,5/5	Label	-
Light	6,6,3/6,6,3

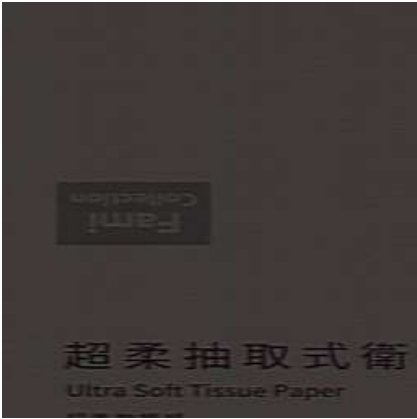
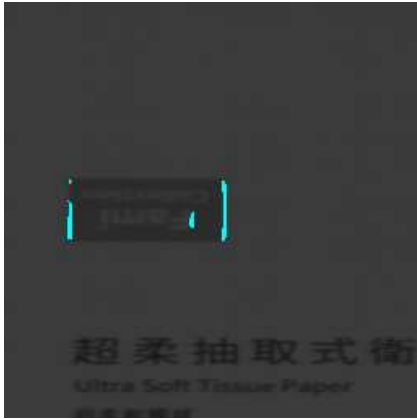
No.	#7, \$6	Date	2023/8/9 下午 05:03:15
Segment	1	Camera	1
Pattern	5556	Position[ x, y ]	788.2 [mm], 4176.5 [m], ( 166.4 [m] )
Type	点状疵点縱向刀絲疵點橫向刀絲	Size	H:184.6 ,V:102.8 [mm]
Result	-	Area	937.6 [mm2]
Inspection level	5/5,5/5,5/5,5/5,5/5	Label	-
Light	6,6,3/6,6,3

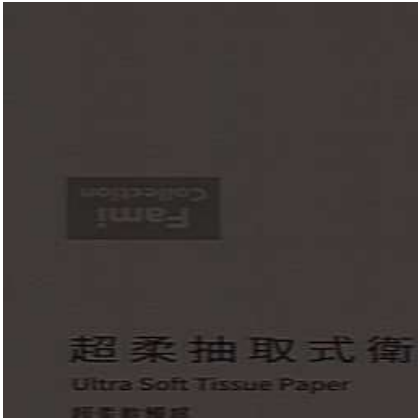
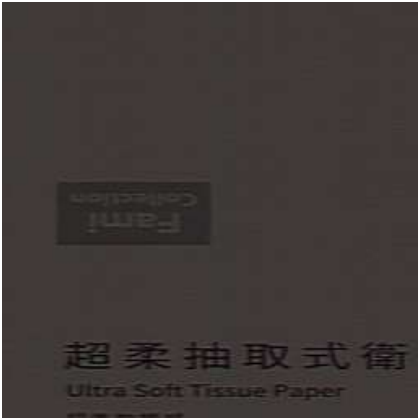
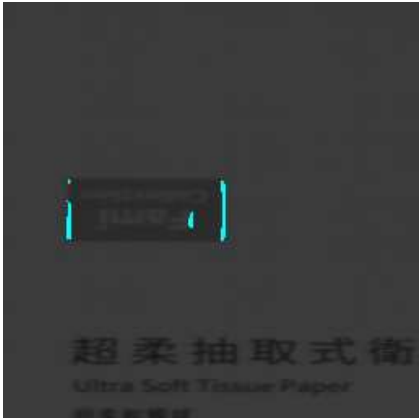
No.	#7, \$6	Date	2023/8/9 下午 05:03:15
Segment	1	Camera	1
Pattern	5556	Position[ x, y ]	732.8 [mm], 4176.8 [m], ( 166.2 [m] )
Type	点状疵点縱向刀絲疵點橫向刀絲	Size	H:255.1 ,V:663.2 [mm]
Result	-	Area	1311.1 [mm2]
Inspection level	5/5,5/5,5/5,5/5,5/5	Label	-
Light	6,6,3/6,6,3

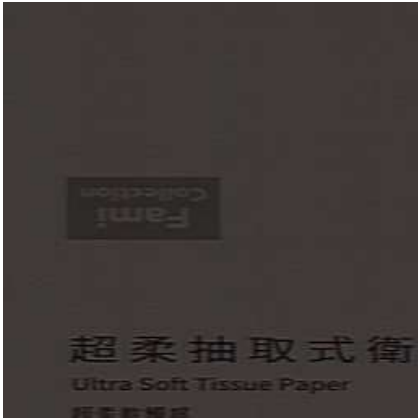
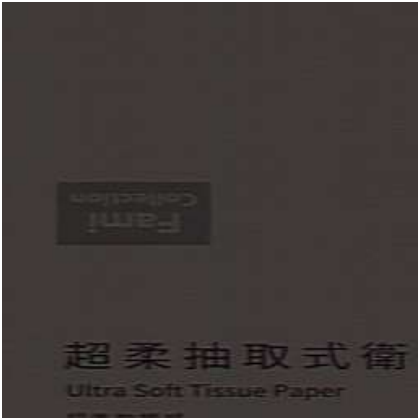
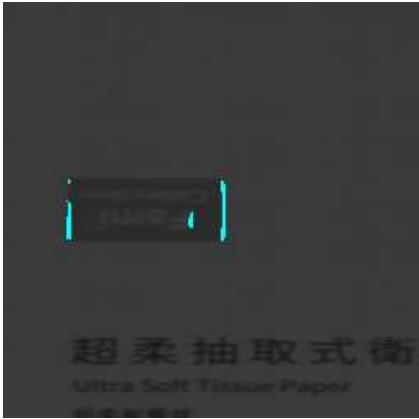
No.	#7, \$6	Date	2023/8/9 下午 05:03:15
Segment	1	Camera	1
Pattern	5556	Position[ x, y ]	125.1 [mm], 4176.9 [m], ( 166.1 [m] )
Type	点状疵点縱向刀絲疵點橫向刀絲	Size	H:185.3 ,V:182.8 [mm]
Result	-	Area	1627.0 [mm2]
Inspection level	5/5,5/5,5/5,5/5,5/5	Label	-
Light	6,6,3/6,6,3

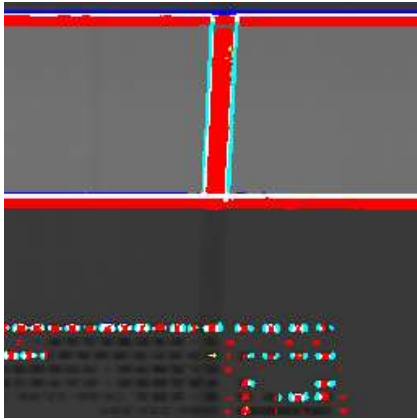
No.	#7, \$6	Date	2023/8/9 下午 05:03:15
Segment	1	Camera	1
Pattern	5556	Position[ x, y ]	116.6 [mm], 4176.6 [m], ( 166.3 [m] )
Type	点状疵点縱向刀絲疵點橫向刀絲	Size	H:242.4 ,V:384.4 [mm]
Result	-	Area	1759.4 [mm2]
Inspection level	5/5,5/5,5/5,5/5,5/5	Label	-
Light	6,6,3/6,6,3

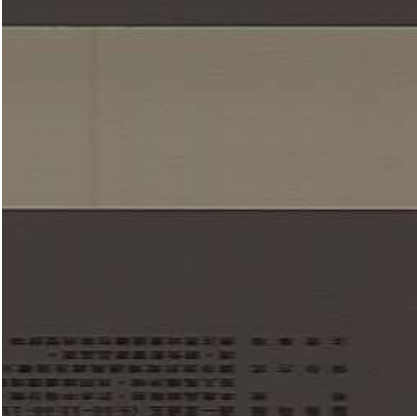
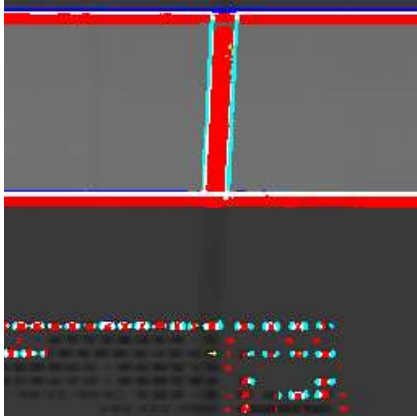
No.	#6, \$5	Date	2023/8/9 下午 05:03:15
Segment	1	Camera	1
Pattern	5555	Position[ x, y ]	156.1 [mm], 4175.7 [m], ( 167.2 [m] )
Type	淡瑕疵縱向刀絲疵點	Size	H:23.2 ,V:71.2 [mm]
Result	-	Area	683.2 [mm2]
Inspection level	5/5,5/5,5/5,5/5,5/5	Label	-
Light	6,6,3/6,6,3

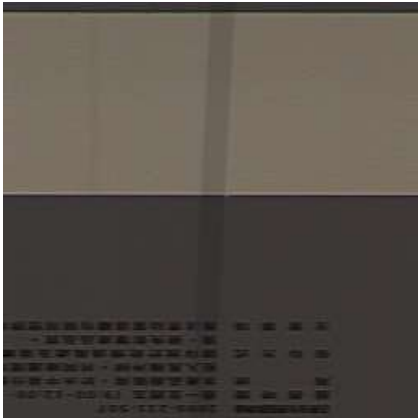
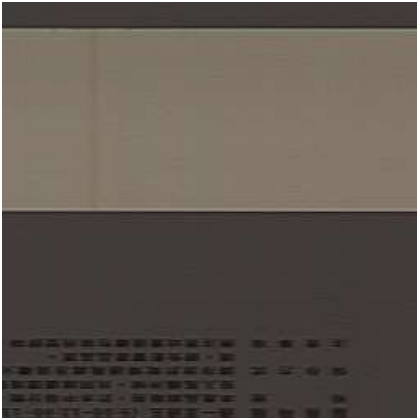
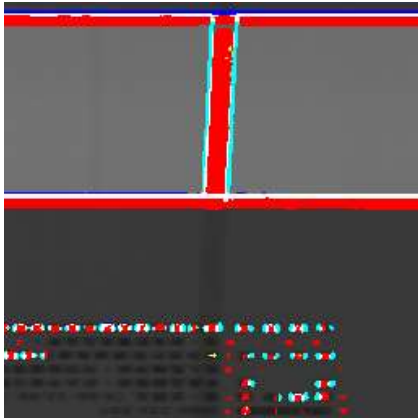
No.	#6, \$5	Date	2023/8/9 下午 05:03:15
Segment	1	Camera	1
Pattern	5555	Position[ x, y ]	100.2 [mm], 4175.8 [m], ( 167.2 [m] )
Type	点状疵点縱向刀絲疵點	Size	H:136.7 ,V:202.8 [mm]
Result	-	Area	836.8 [mm2]
Inspection level	5/5,5/5,5/5,5/5,5/5	Label	-
Light	6,6,3/6,6,3

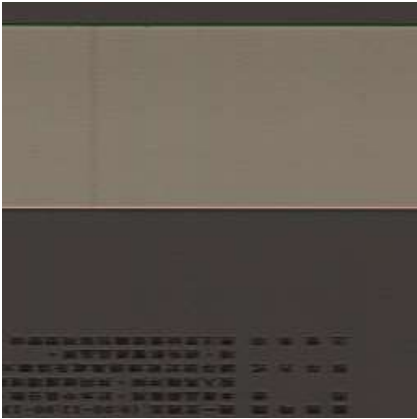
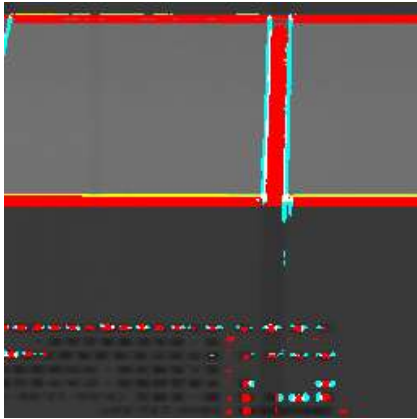
No.	#5, \$4	Date	2023/8/9 下午 05:03:14
Segment	1	Camera	1
Pattern	5554	Position[ x, y ]	699.1 [mm], 4175.0 [m], ( 168.0 [m] )
Type	点状疵点縱向刀絲疵點	Size	H:2.4 ,V:122.4 [mm]
Result	-	Area	83.2 [mm2]
Inspection level	5/5,5/5,5/5,5/5,5/5	Label	-
Light	6,6,3/6,6,3

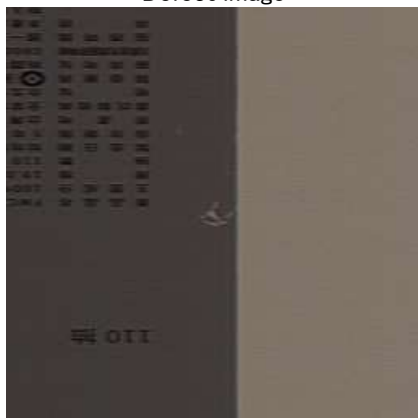
No.	#2, \$1	Date	2023/8/9 下午 04:19:23
Segment	1	Camera	1
Pattern	481	Position[ x, y ]	880.7 [mm], 367.9 [m], ( 3975.0 [m] )
Type	点状疵点縱向刀絲疵點	Size	H:2.4 ,V:4.0 [mm]
Result	-	Area	4.7 [mm2]
Inspection level	5/5,5/5,5/5,5/5,5/5	Label	-
Light	6,6,3/6,6,3
