**Bitfire Development Kit
Bitfire Hardware Errata
Version 1.11**

ARROW ENGINEERING SWEDEN

Revision History		
Version	Date	Updates
1.10	050530	Document public release.
1.11	051019	Version 1.11 HW release notes added and fixed errata removed

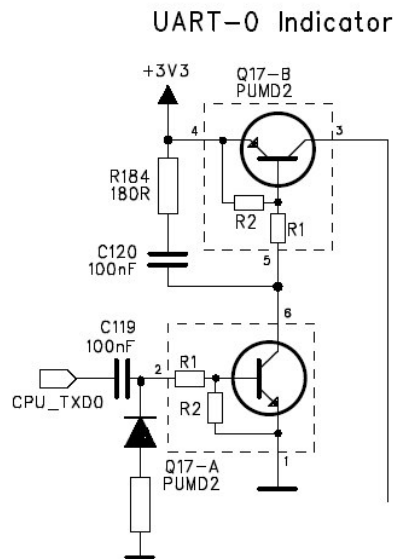
A new feature on V1.11 hardware was implementation of traffic flow indicators on interface ports. Low dataflow in conjunction with high baud rate these will not show traffic activity correctly. The procedure for patching to get correct behavior is the same for all channels. Refer to schematic page “Onboard integrated debug tools”.

Above picture shows TXD channel on UART-0. Place a diode like BAS216, 1N4148 or similar with anode from ground in series with a 180R resistor. This will ensure that positive voltage is seen on the base of Q17 even though the previous packet had a short low level duration.
