Customer Care News

1 Improved design for (Product name) swing-over mechanism and arm

To improve mechanical swing-over drive system and arm, design updates were implemented inside the stainless steel beam, and also on tube nipples rubber bumper plate.

A common failure is the lost of automatic swing-over function when the teeth bar and the cog-wheels are disengaged. Few times a rubber bumper and a plate holding the tube nipples were out of the arm position.

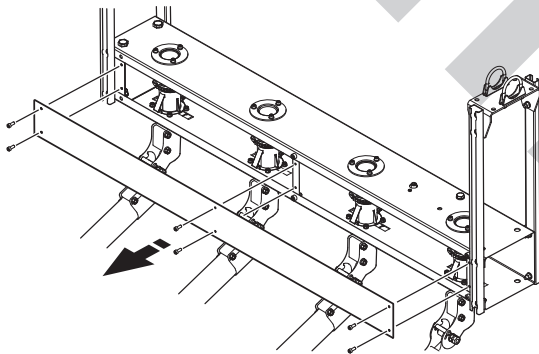
Fig. 1: Removing the beam cover.

1. Turn off the air compressor and take-off system.
2. Remove the beam cover.
3. Disconnect the pneumatic tubes from the cylinder check-choke valves.

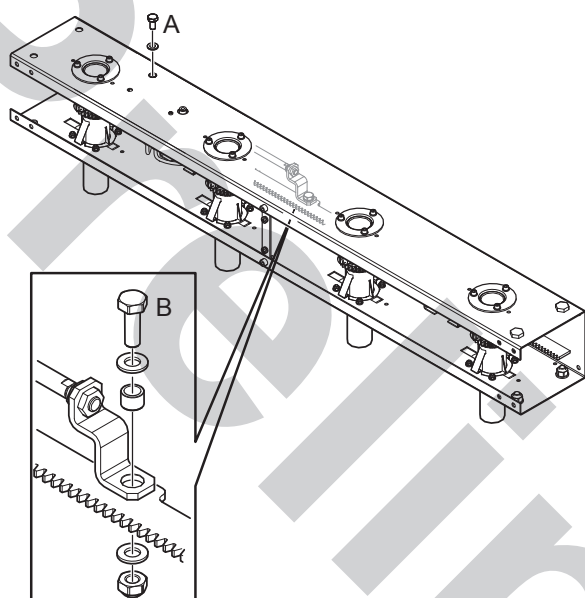
Fig. 2: Unscrewing front and rear cylinder connections.

4. Unscrew the front (A) and the rear (B) connection of the cylinder.
5. Remove the cylinder from the beam.

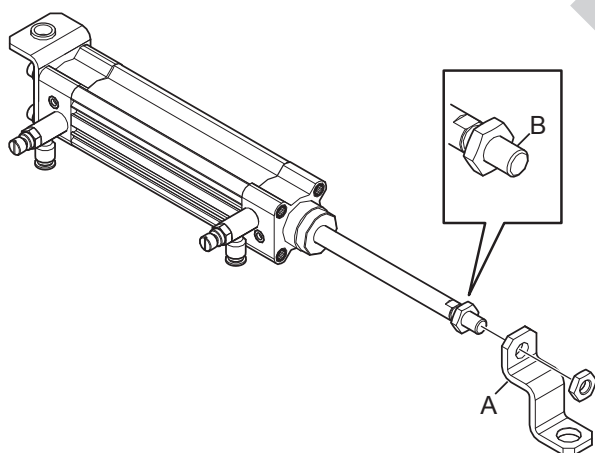
Fig. 3: Unscrewing old cylinder bracket.

6. Unscrew the old cylinder bracket (A).
7. Clean the thread (B) on piston rod by removing glue residues.

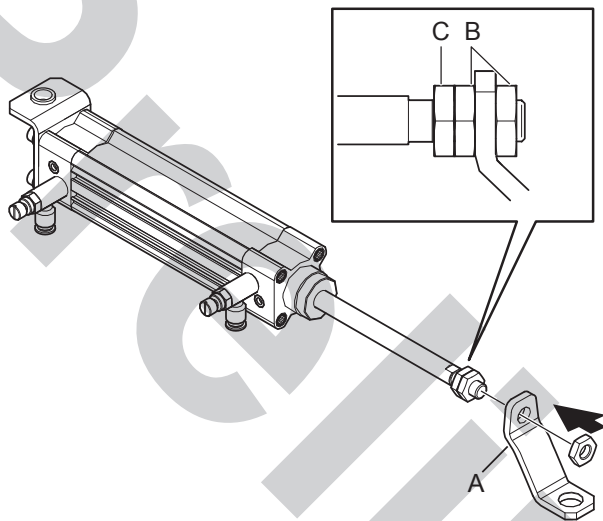
Fig. 4: Installing the new cylinder bracket.

8. Mount the new cylinder bracket (A).
9. Use the old nut (C) and tighten it to the end of the thread.
10. Glue the new nuts (B) to the rod with Loctite 243.

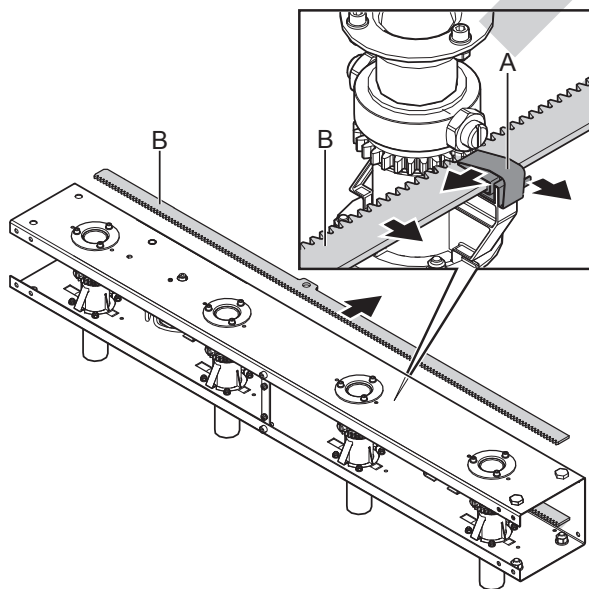
Fig. 5: Removing the main bracket snaps and teeth bar.

11. Remove the main bracket snaps (A) and the old teeth bar (B).

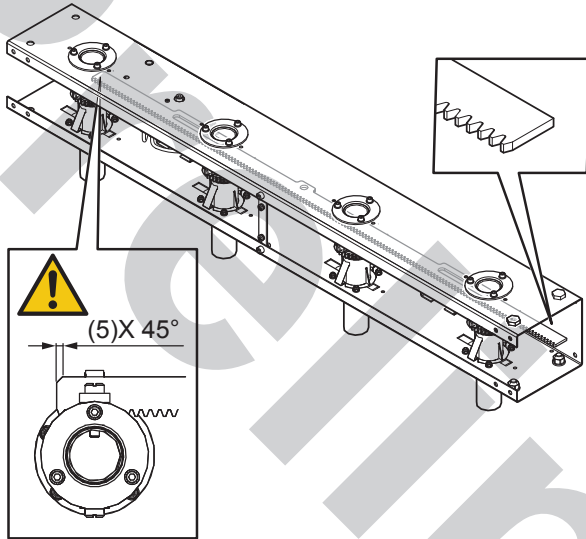
Fig. 6: Mounting position of the new teeth bar.

12. Install the new teeth bar.

Note! The cut (5) x 45° determines the mounting position of the teeth bar on the left side of the beam.

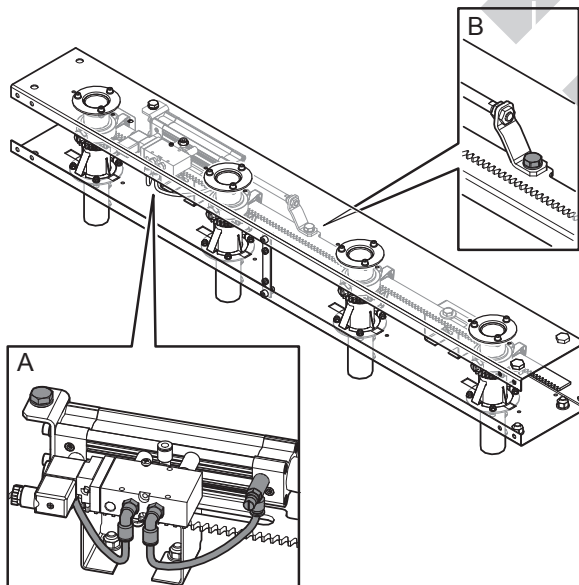
Fig. 7: Mounting cylinder and teeth bar.

13. Mount the cylinder to the beam (A) and the teeth bar (B).

14. Connect the pneumatic tubes to the cylinder check-choke valves.

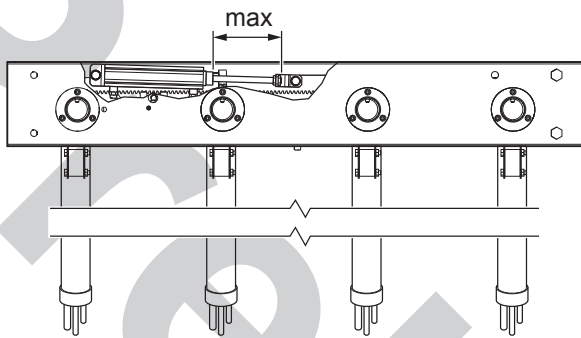
Fig. 8: Setting the position of the arms.

15.Adjust the arms in correct position when the piston rod is maximally extended or retracted.

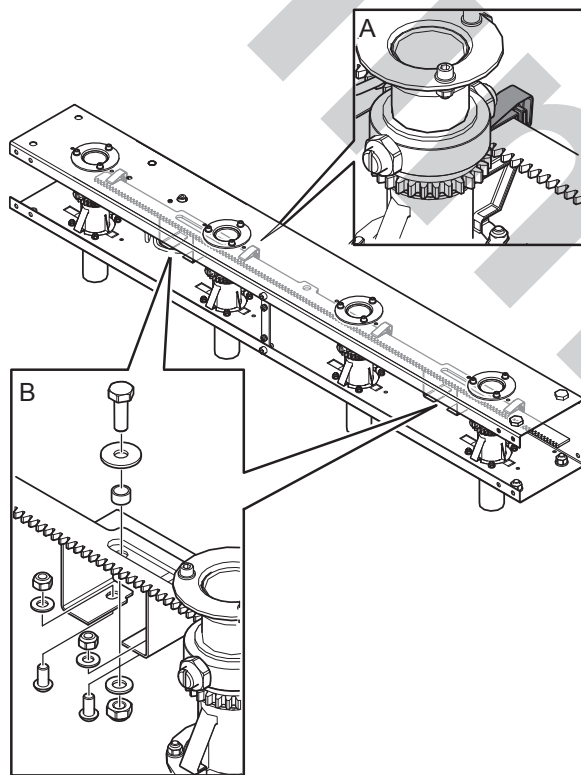
Fig. 9: Mounting the bracket snaps and guiding brackets.

16.Mount the bracket snaps (A) and guiding brackets (B).

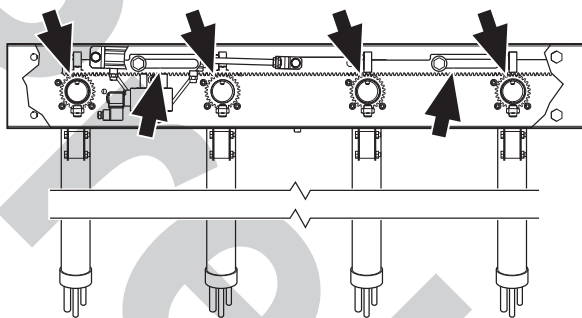
Fig. 10: Lubricating sliding surfaces and cogwheels.

17. Lubricate all sliding surfaces and cogwheels with Molykote Multilub (or similar).
18. Turn on the compressed air regulator valve.
19. Check the function of the system by simulating milking.
20. Install the beam cover back.
21. Make sure that all lock screws are securely tightened.
