Informe de Inspección - Tramo: T03

Fecha: 2025-11-10 12:06:58

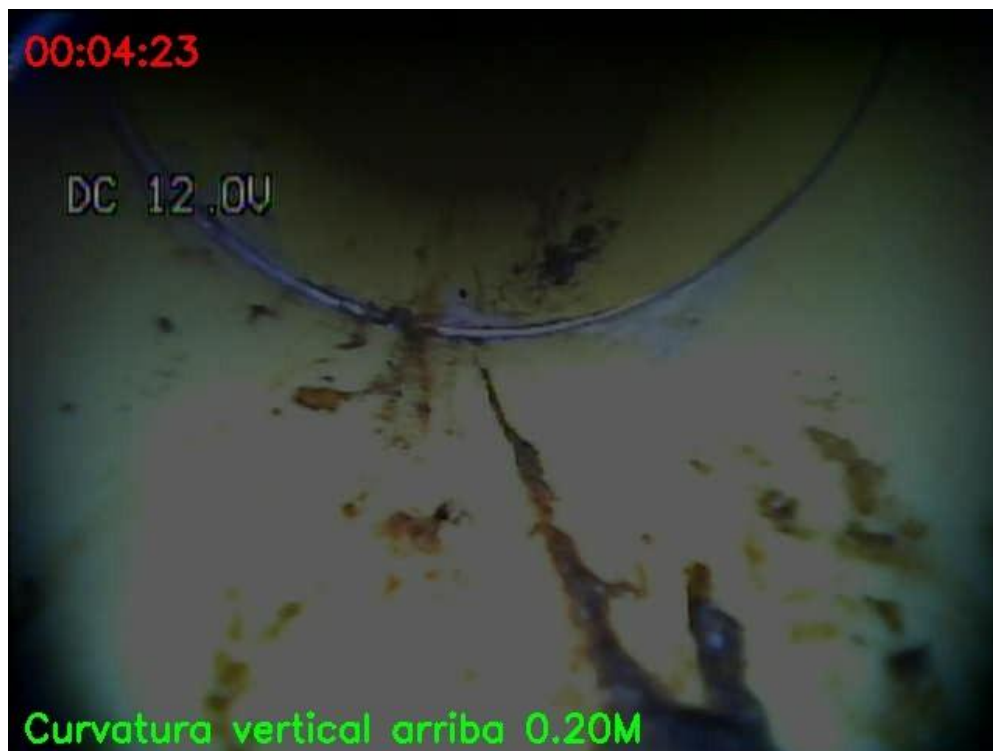
[00:04:23] Curvatura vertical arriba 0.20M

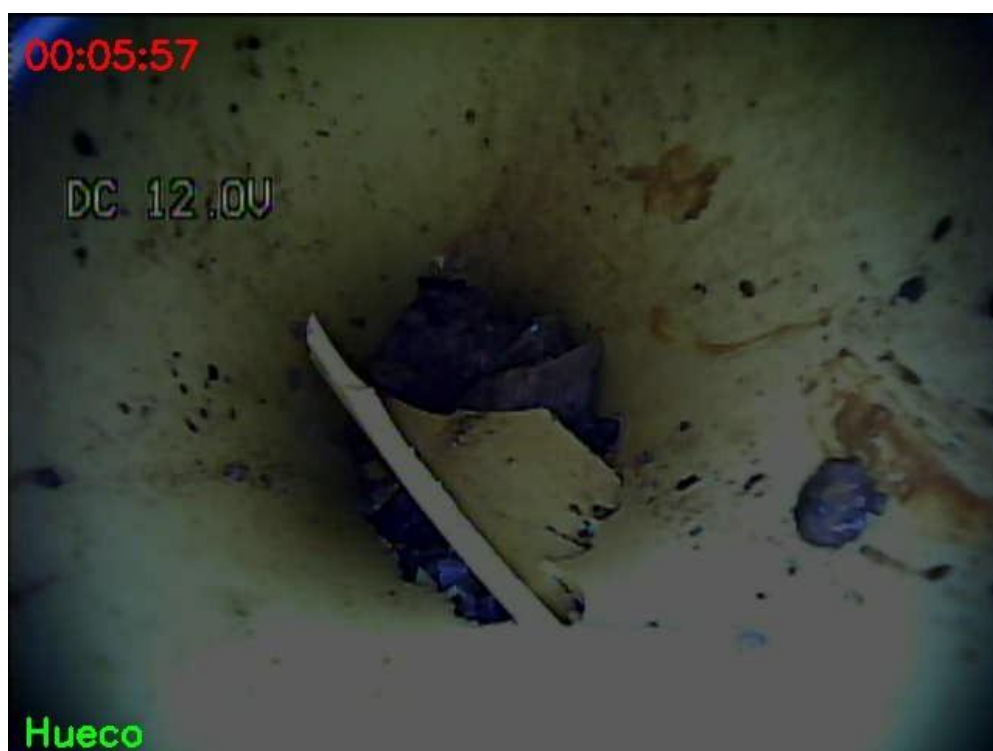
[00:05:57] Hueco. Tubo colapsado 100%

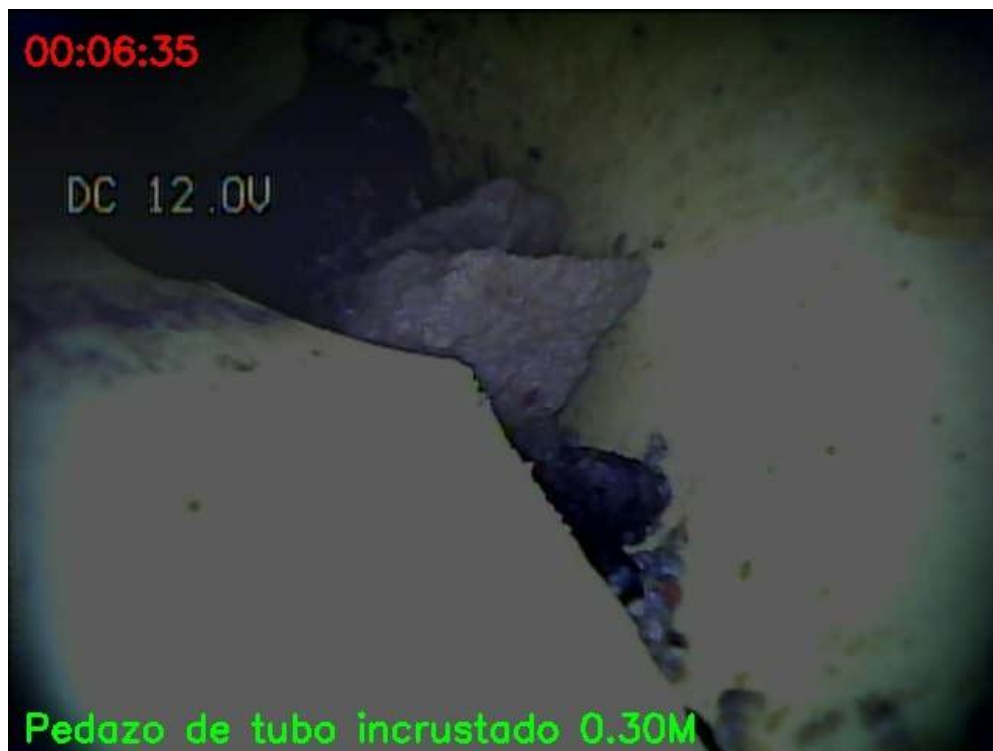
[00:06:35] Pedazo de tubo incrustado 0.30M
