Replacement of cam (532550) driving from the center of the machine to the support and testing stations in machine 222

Registrar: Tzvika Ivyagi and Fadi Sleiman. 12.12.2024

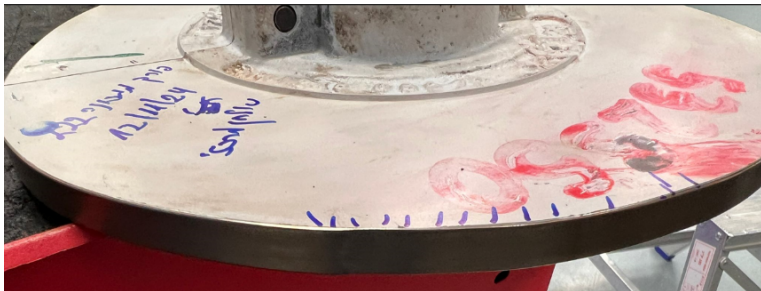
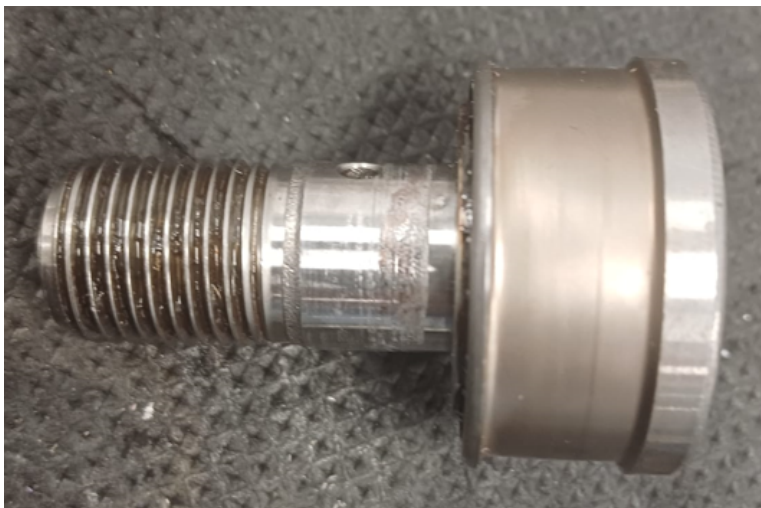
- ☐ On 12.11.2024 in work order 581433 lot 242668277-03 bag number 291, the machine was inspected again and the following findings were recorded:
- ☐ The cam and cam follower were worn out - replaced with new ones.

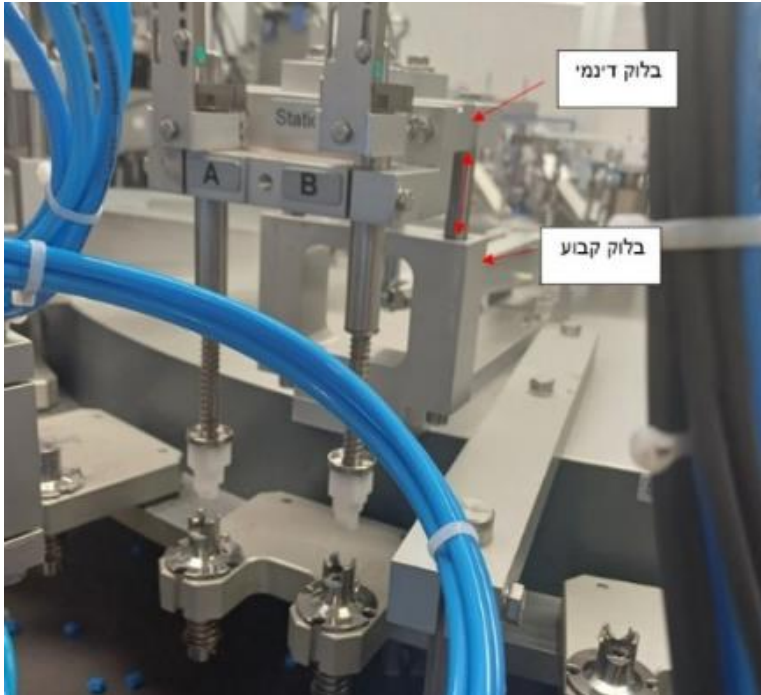
- ☐ Station 24 - When the station moves all the way down, it stops on the block, meaning there was no gap between the fixed block and the dynamic block. However, in this state, the cam follower was checked and it appears that it does not rotate, indicating that the station is functioning properly and the cam is not separating from the cam follower. In all of this, it is necessary to adjust so that there is a safety clearance - at least a few millimeters.

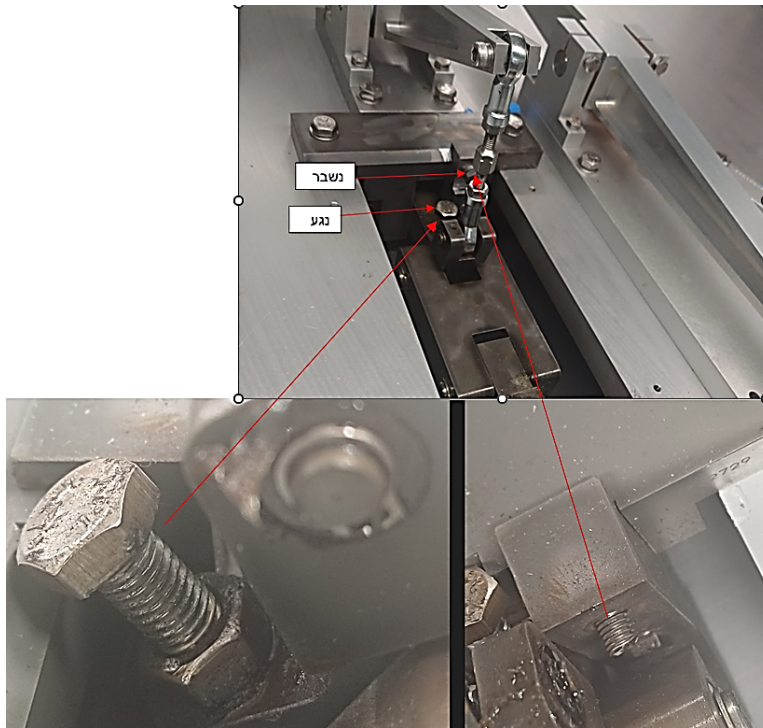
- ❑ Bolt station - Body support during bolt insertion:
- ❑ When the station is in the locking state, the screw (the mechanical stopper) touches the block holding it – the block was ground down.
- ❑ The top screw holding the entire mechanical brake assembly broke and was replaced with a new one.
- ❑ When the station is in idle mode (during table rotation), the stop screw head hit the base plate, which could have caused mechanical pressure on the cam in the affected area - corrected so that there is a large clearance between the screw and the plate.
- ❑ When the body's support was in the most forward position, the joint was not straight – it was aimed to be straight.

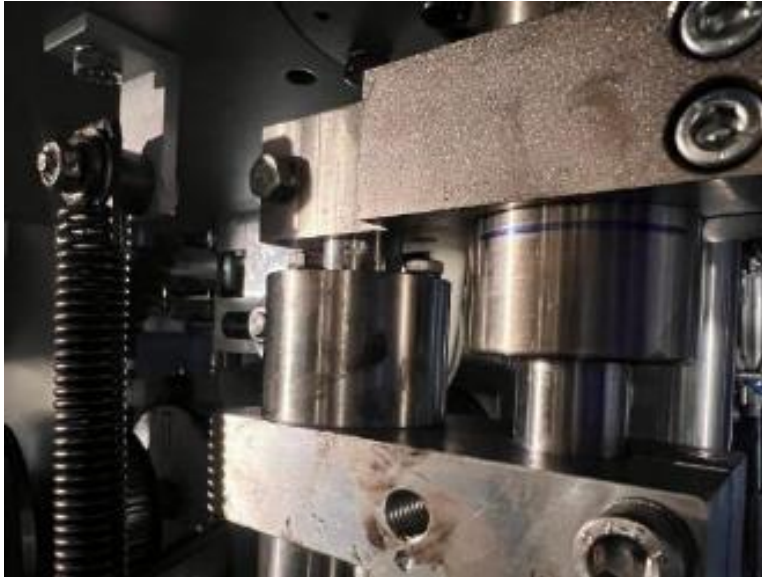
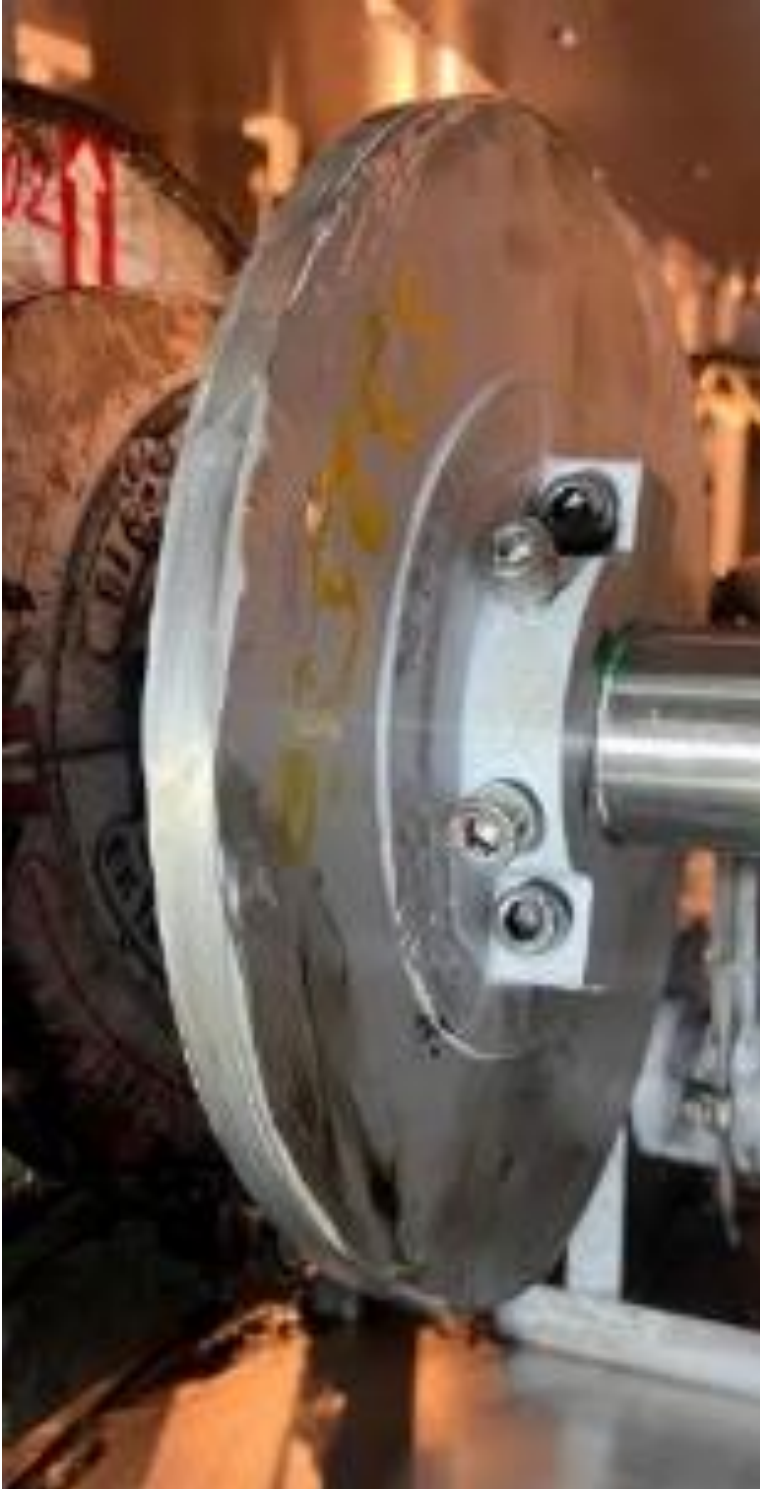
- ☐ On 24/11/24 during a repeat inspection, vibrations were again observed on the test station table.
- ☐ Upon inspection, it appears that the cam follower is stuck and not machined – replaced.
- ☐ After disassembly, signs of wear were observed on it, and no fresh grease was visible.
- ☐ On the new cam, wear marks were observed on the cam edge; it was decided to replace it in a subsequent operation.
- ☐ Grease pipe disassembler, upon inspection it appeared empty of grease, we were unable to inject grease into it using a manual grease gun – the valve connected to the grease manifold was replaced, and grease was injected into the pipe.

- ❑ After reassembly on the arm with a cam follower, grease was observed to be exiting the bearing during manual greasing.
- ❑ Additionally, an inspection of the central axis for freedom of movement was performed after disconnecting all stations connected to it - found to be normal.
- ❑ The lower part of the lower vertical motion bearing was inspected - it was found that the holder of the
- ❑ The lower centering bearing may contact the bearing screws – a clearance of only 0.4 mm is present.
- ❑ On the block above the screws, contact marks from the screw were found.
- ❑ It was decided to increase the distance in the continuation operation.
- ❑ On 12/2/24 we performed a follow-up action:
- ❑ Replacing a new cam, checking the grease outlet at the cam follower, and peripheral greasing
- ❑ Increasing the clearance between the vertical bearing and the upper block by approximately 5 mm

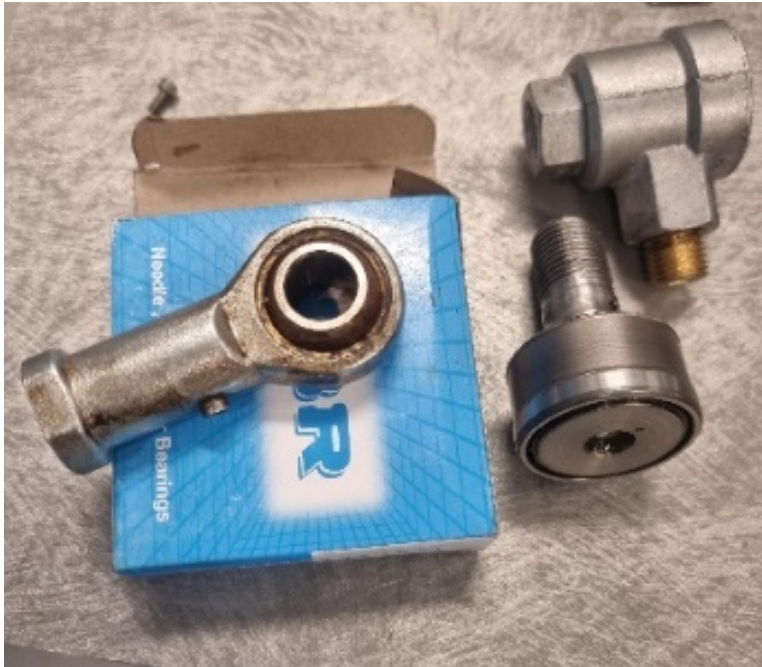
- ☐ The cam – there is slight damage at the point where the arm is in the lower position, currently causing very minor vibrations.

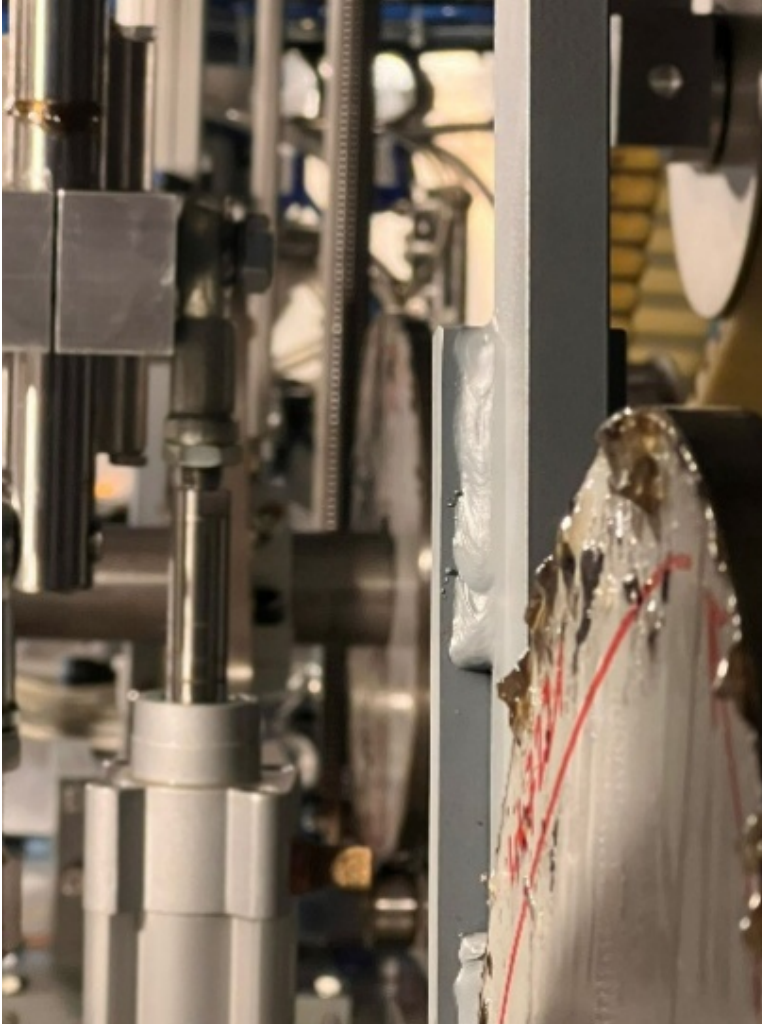
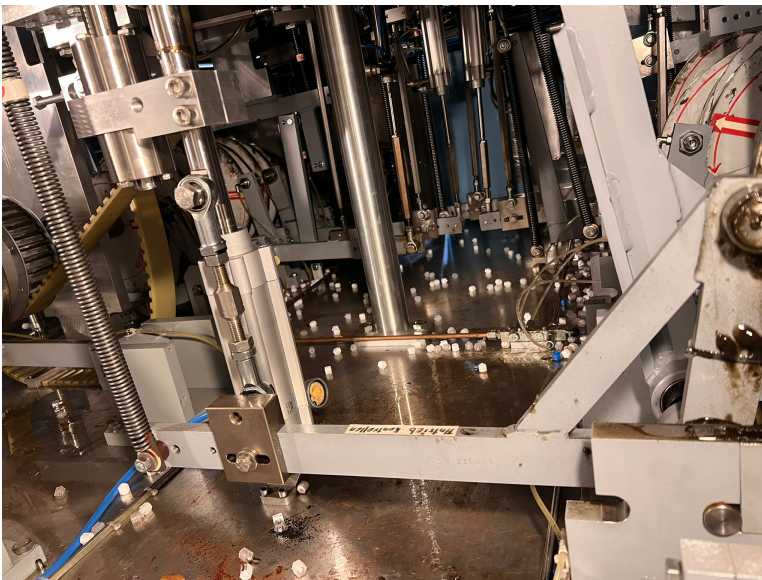
- ☐ On 20/01/20 we inspected the arm of the test stations in machine 223 at Delton.
- ☐ Pressure in the spring piston – Bar 4.

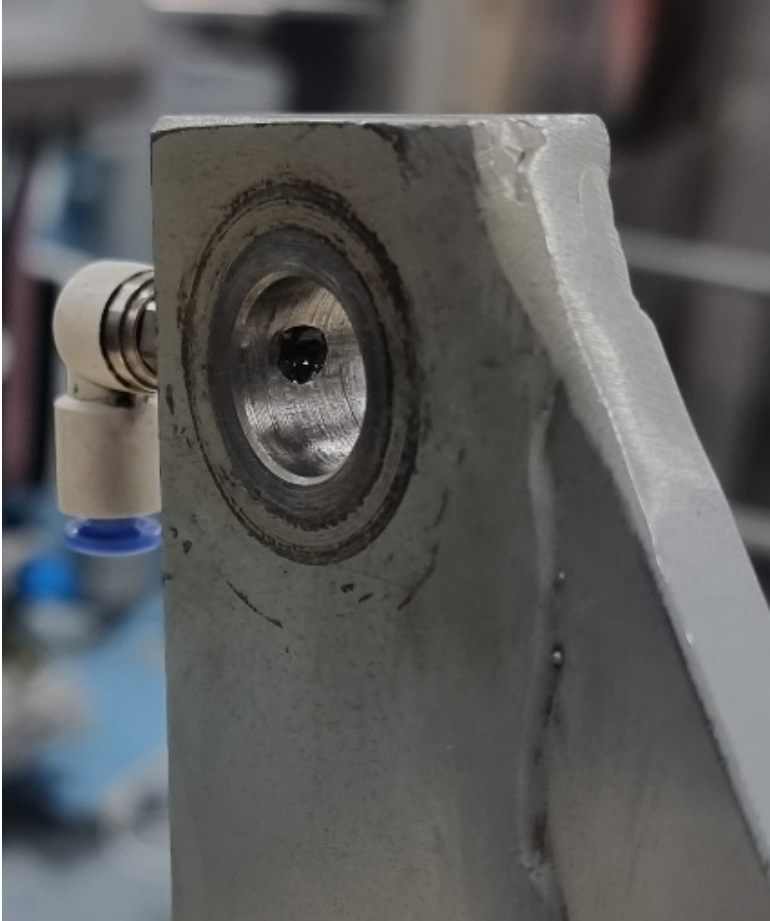
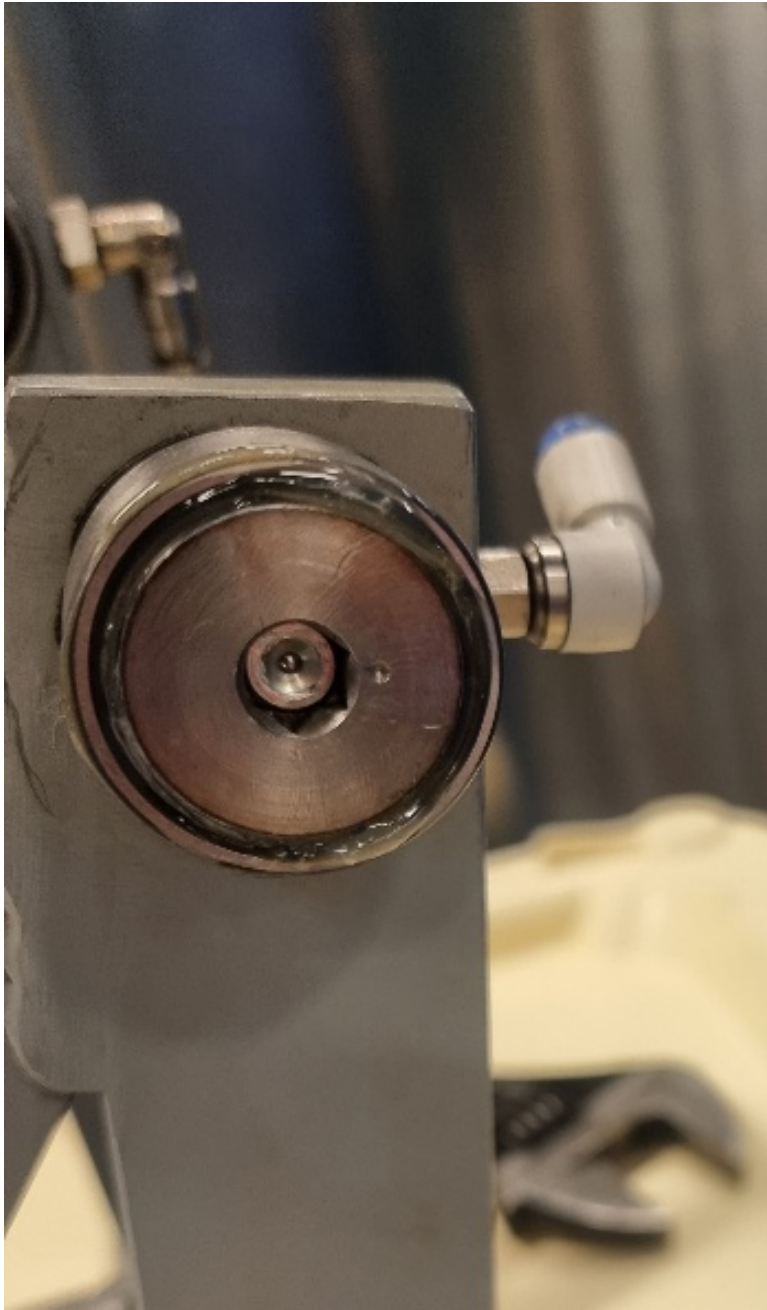
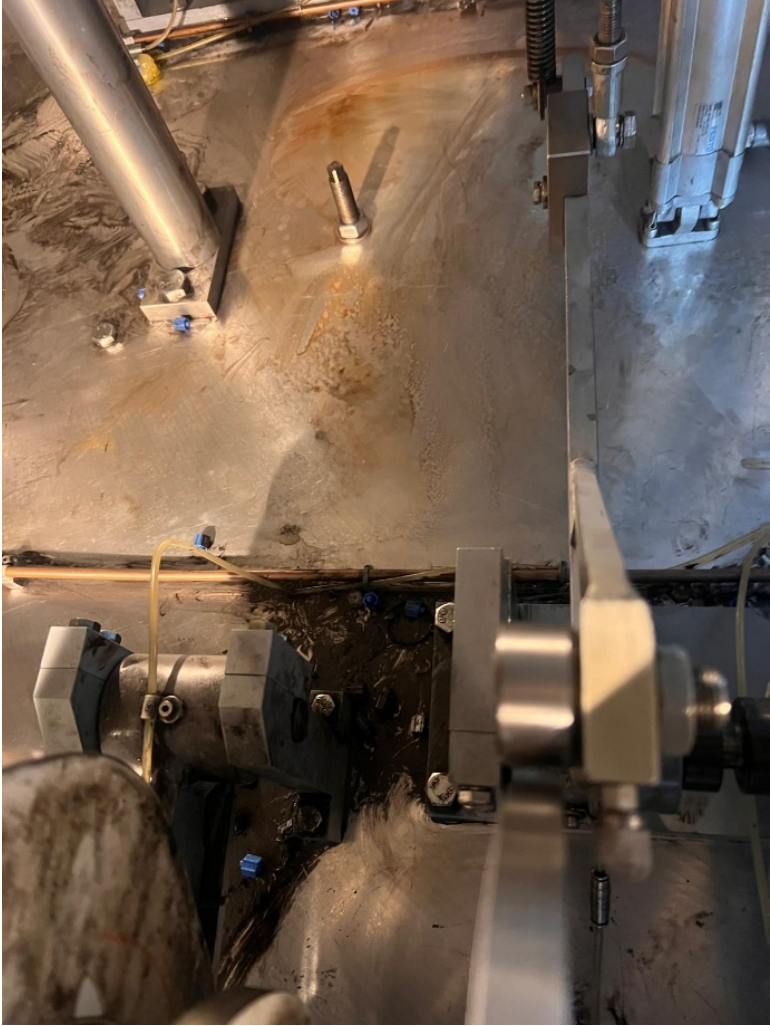
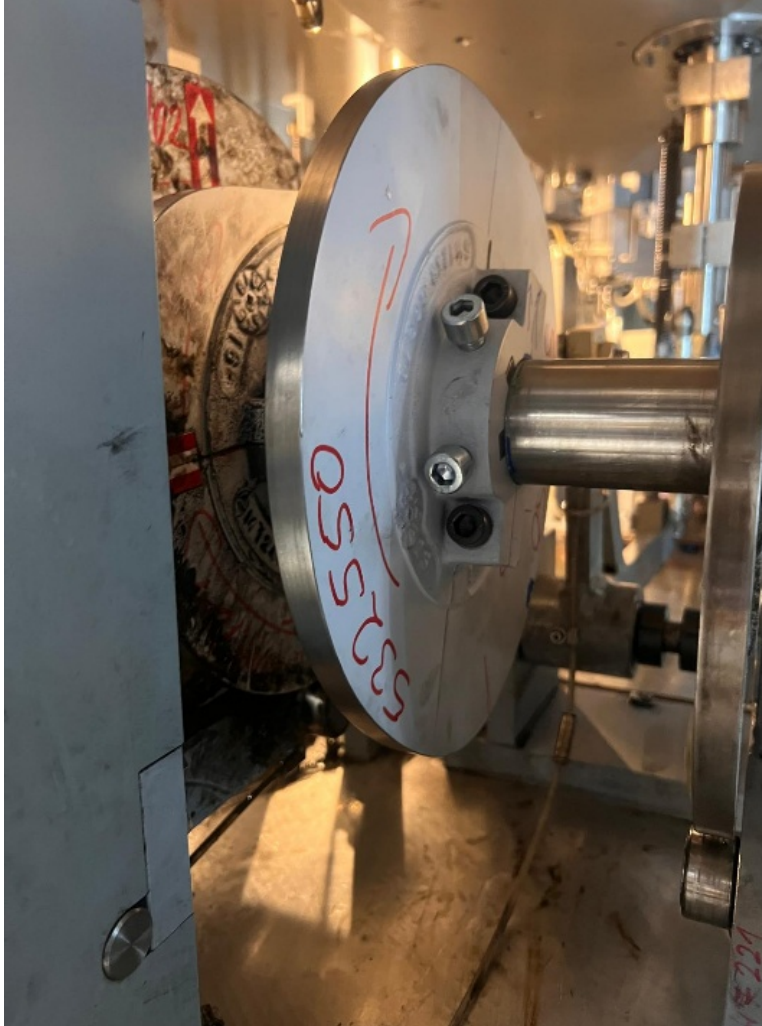
- ☐ The cam follower is well grooved but shows signs of wear.
- ☐ On 2/3/25, the following actions were performed:
- ☐ Replacement of the lower apple bearing in the rod (a disc was missing between it and the stroke block)
- ☐ Replacement of cam and cam follower (including an additional ring between the bushing and the arm)
- ☐ Arm shaft bearing clearance check – normal
- ☐ Checking the free movement of the table up and down, and a repetitive check against the nut support - normal
- ☐ Free grease flow check between the hose connector and the cam follower – Good (Images 2+3)
- ☐ Increasing the piston pressure to 5.5 bar
- ☐ Verification of automatic greasing setting – every 10,000 cycles
- ☐ Adjusting the parallelism of the two blocks guiding the rod that raises and lowers the small table (Image 1)

Important – In the area located in front of stations 7-8, the table vibrates slightly despite the reinforcements, and these vibrations are visible in the supports of the segment stations! These are not vibrations coming from the cam at this stage when everything is normal below.

In the last three cams, the damage occurred at the same point - in the idle state, during the rotation of the table.

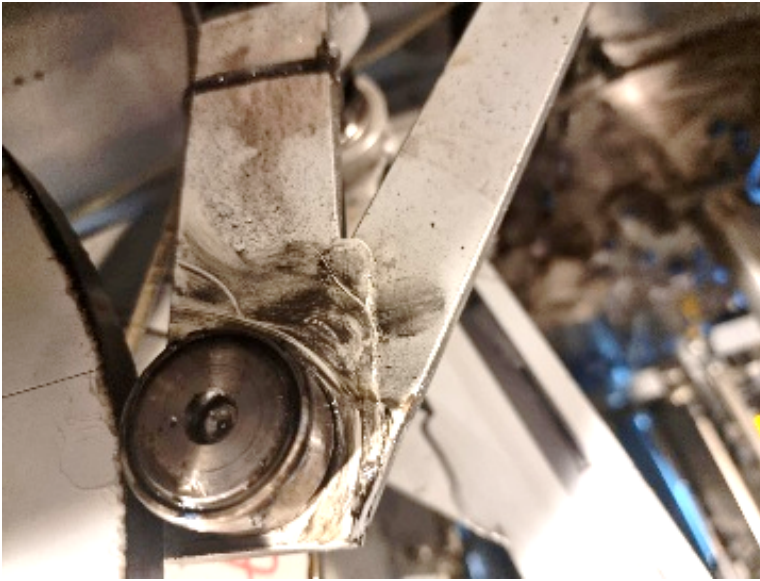
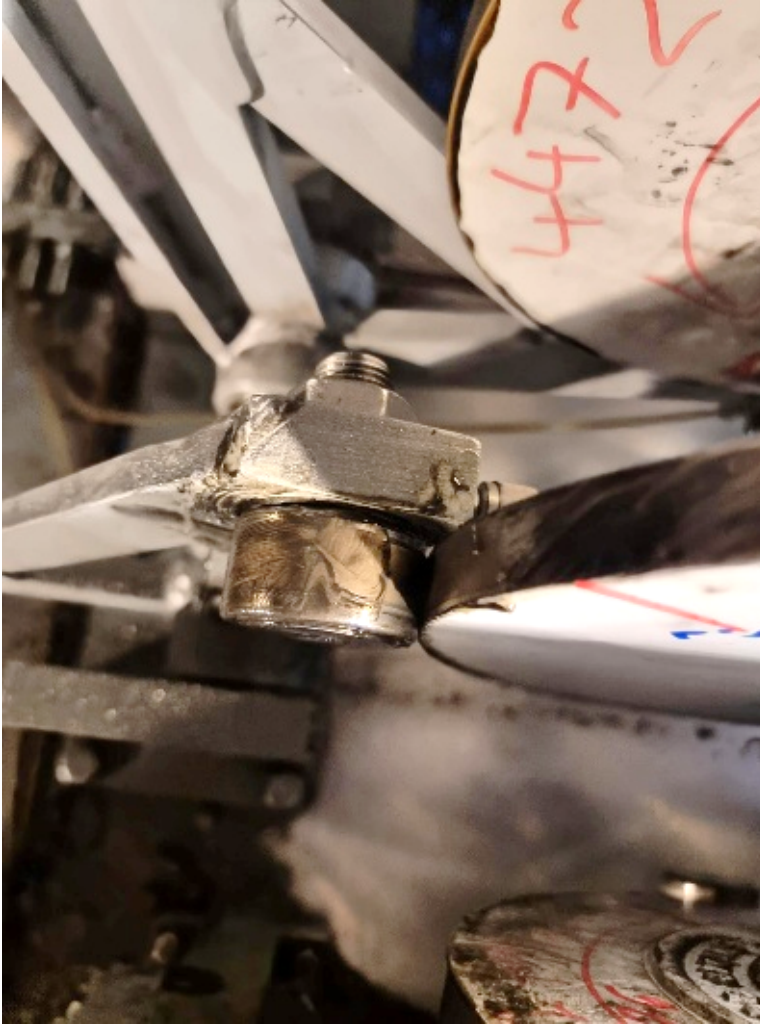
- ☐ Slow-motion filming was performed in both of the above cases. It does not appear that the cam follower separates from the cam at either of the two pressures.
- ☐ We checked the rear support at the Ohm station – intact, no looseness or collisions
- ☐ We checked the central rod – no play – the movement of the rod in the bearing is free up and down.
- ☐ Audit dated 25/2/11:
- ☐ Functional

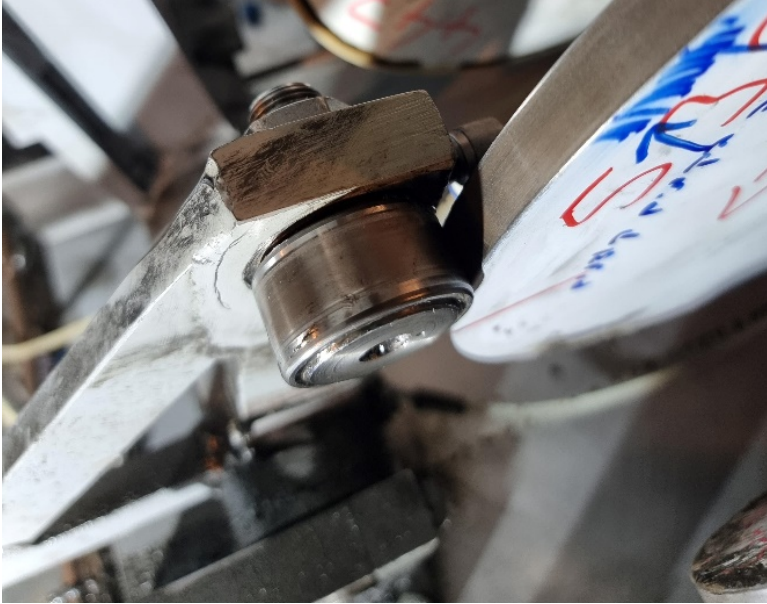
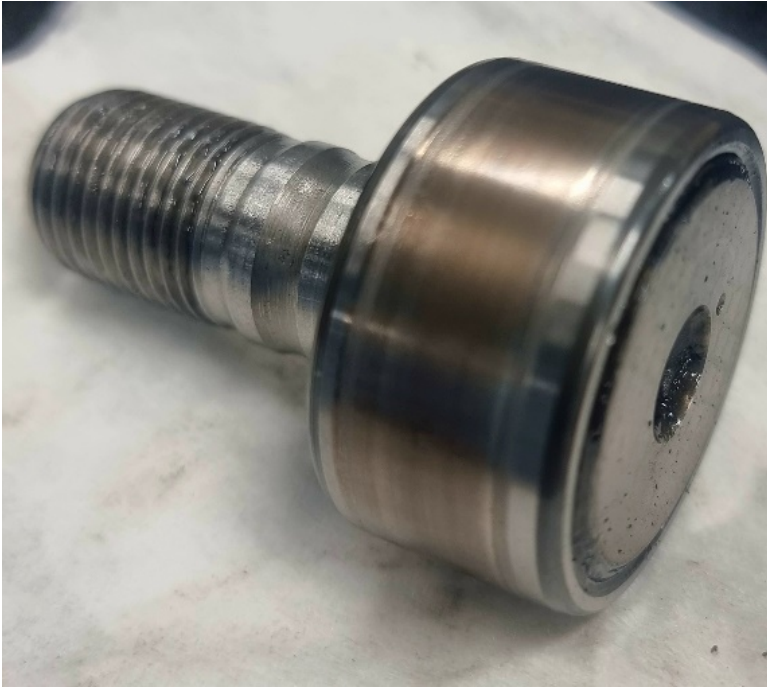
- ☐ Inspection dated 3/3/25:
- ☐ There are slight wear marks on the cam follower; it was replaced with a new cam follower supplied by Sortimat.
- ☐ The old cam follower is disassembled while it rotates freely and threads properly.
