# Aerial Infrared Thermography of a Utility-Scale PV Plant After a Meteorological Tsunami in Brazil

**Abstract** — Aerial Infrared Thermography (aIRT) is a non-destructive and cost-effective method for detecting faults in large-scale PV plants. In this paper, a 1 MW multi-crystalline PV plant-block that was hit by a meteorological tsunami in Brazil in 2016, is inspected systematically using the aIRT method. The main objective was to validate this inspection technique for commercial application. Various failures like hotspots, bypassed substrings, short-circuited and disconnected PV strings were detected at the PV plant using aIRT inspection in less than one hour. The results have proven that this semi-autonomous method is very fast, reliable and effective for large scale PV plants.

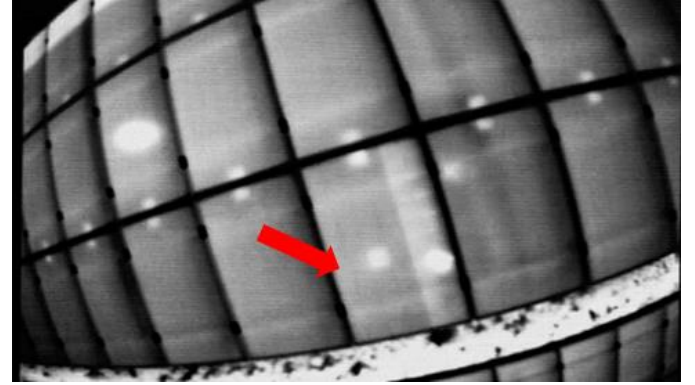
The initial flight altitude of 6m allowed the detection of defects on the PV module level. The flight altitude corresponds to the distance of the focal plane lens of the IRT camera to the POA. Above 20m, the field of view (FOV) was increased, but, at the same time, the detectability of PV module level faults was decreased. Fig. 4, 5 and 6 illustrate IRT images of the same damaged PV module with two hotspots and a bypassed substring at different altitudes. At 6m and 10m, the defects are clearly visible. The bypassed substring and the hotspot with the lower temperature are hardly perceptible at the altitude of 20m.

However, only the hotspot with the higher temperature is still easily detected.

Fig. 4. IRT image of damaged PV module with two hotspots and a bypassed substring, clearly visible at an altitude of 6m.

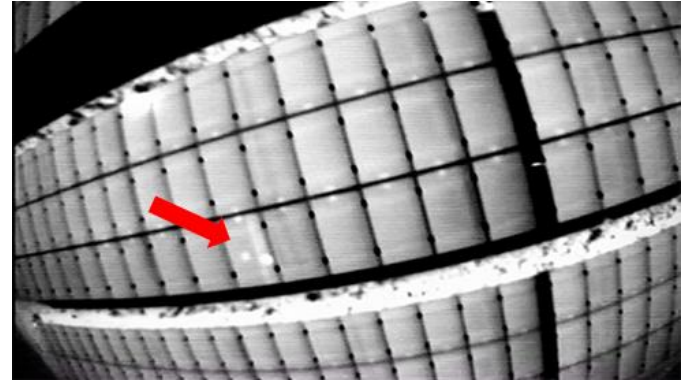
Fig. 5. IRT image of damaged PV module, with two hotspots and a bypassed substring, visible at an altitude of 10m.

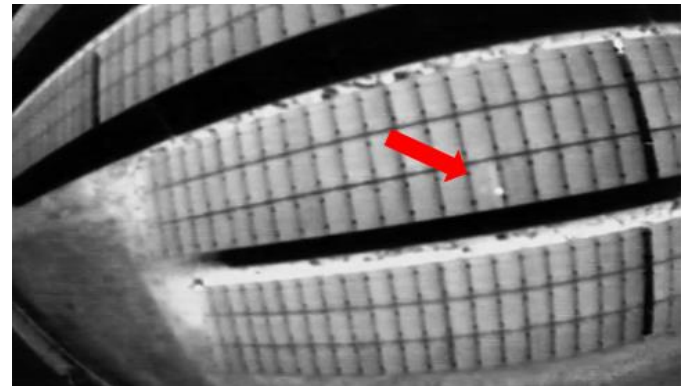
Fig. 6. IRT image of damaged PV module, with one clearly visible hotspot and one hotspot and a bypassed substring that are hardly perceptible at an altitude of 20m.

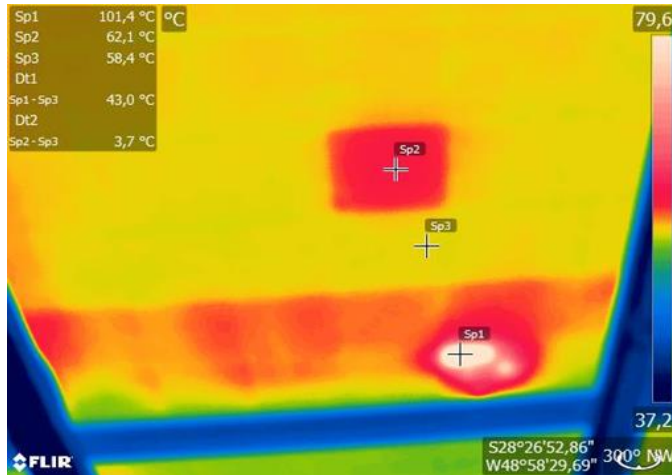
The detailed investigation with the handheld IRT camera revealed a considerable high-temperature difference of 39.3°C between the two hotspots. The absolute temperature of the hotspots was respectively 62.1°C and 101.4°C, compared to

58.4°C of a healthy cell, shown in Fig. 7. This might explain why the high-temperature hotspot is still well visible at 20m and gives hint to a correlation between altitude and hotspot fault detectability, in dependence on the temperature level. The temperature difference of the low-temperature hotspot to a healthy cell is only 3.7°C.

Fig. 7. Radiometric IRT image of damaged PV module with two hotspots and a bypassed substring, presenting temperature differences of 43°C and 3.7°C, respectively.

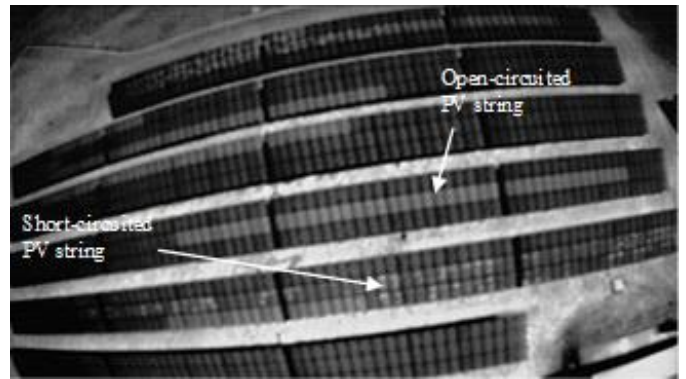
PV array level faults like disconnected modules or short-circuited strings remain clearly visible even at high altitudes and a relatively low temperature difference. Fig. 9 depicts an IRT image at an altitude of 100m. The temperature of the disconnected PV strings differs only slightly (1.9°C) from the temperature of the functioning strings.

Fig. 9. IRT image at an altitude of 100m. Open-circuited and short-circuited PV strings are easily visible.

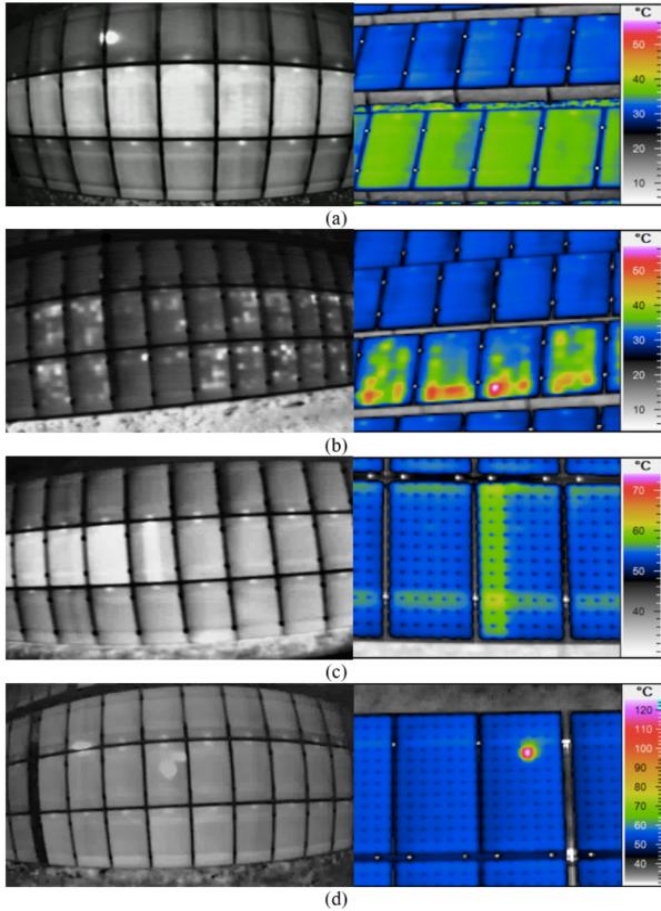
Fig. 11 presents different IRT images classified with the corresponding thermal patterns described in the IEC 62446-3 [18]. In Fig. 11-(a), an IRT image of a disconnected PV string is shown. The temperature of the disconnected PV string is higher in comparison to the functioning PV strings below and above, and homogeneously distributed over the PV modules' surfaces. In a grey-scale pallet, IRT images with higher temperatures are indicated by a brighter grey shade. Therefore, the affected modules appear brighter in the IRT image.

During the investigation, several short-circuited strings have been detected, as seen in Fig. 11-(b). This fault is characterized by a randomly distributed temperature pattern. Fig. 11-(c) depicts an aerial IRT image of a PV module with a bypassed substring in comparison to the corresponding standardized thermal pattern. On the same image, left to that faulty module, open-circuited modules are also visible.

Other types of faults on PV cell or module level, such as micro-cracks, faulty cell interconnections, shading or broken glass appear as hotspots in the IRT image, since in defective areas the PV module becomes reversed biased and heats up. An example is shown in Fig. 11-(d).

Fig. 11. IRT images of damaged modules compared to the corresponding IEC thermal patterns (a) disconnected string (b) short-circuited strings (c) bypassed substring of PV module (d) overheated PV cell.

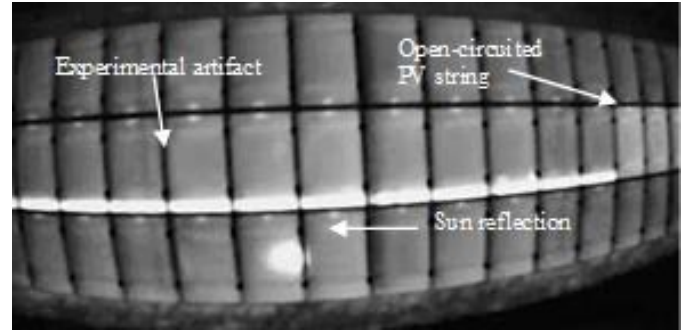
The identification and classification of defects according to their thermal pattern is quite straightforward. However, influences on the thermal images, e.g. experimental artifacts such as self-shading or reflection interferences, have to be considered. In Fig. 12 an IRT image with experimental artifacts is presented to exemplify the issue. The depicted reflection might be mistaken for a hotspot.

Fig. 12. IRT image of PV modules presenting experimental artifacts.

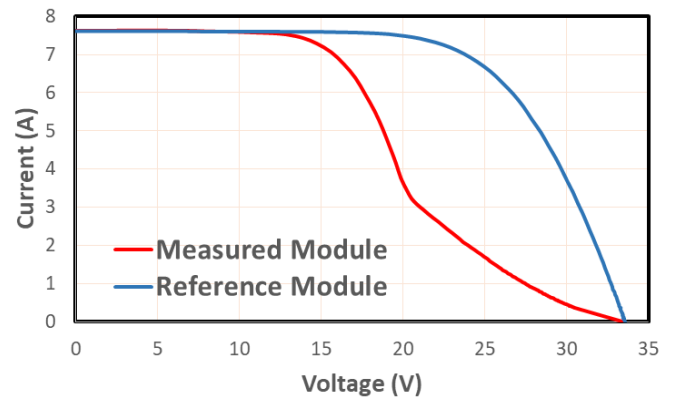
The electrical impact of a defect on the performance of a PV module depends on shape, size, location, and duration of the fault. In order to quantify the effect of the detected defects electrically, I-V curve measurements were carried out. The I-V curve in Fig. 13 presents an inflection point at approximately 20V. The resulting stepped form of the I-V curve is an indication of an active bypass diode over 1/3 of the series connected solar cells. Additionally, a steep slope near the open-circuit voltage can be noticed, indicating a strong increase of the series resistance. In fact, the affected PV cell presents strong burn marks at the backsheet, caused by broken interconnect busbars. The power loss is significantly high at over 45%. The visual representation of the I-V curve corresponds well with the thermal image from the aIRT inspection that revealed a bypassed substring and two hotspots (Fig. 4).

Fig. 13. I-V curve of a PV module with a bypassed substring.

The I-V curve assessment helped to quantify the electrical impact of the detected faults. The electrical effect of a bypassed substring is strong, causing severe performance losses, in the range of 40%. On the contrary, the impact caused by hotspots turned out to be diverse and less expressive. The performance losses caused by the analyzed defects reached up to 25%.
