May 16,2023

Art Place

Reported by: Jesus Zelaya

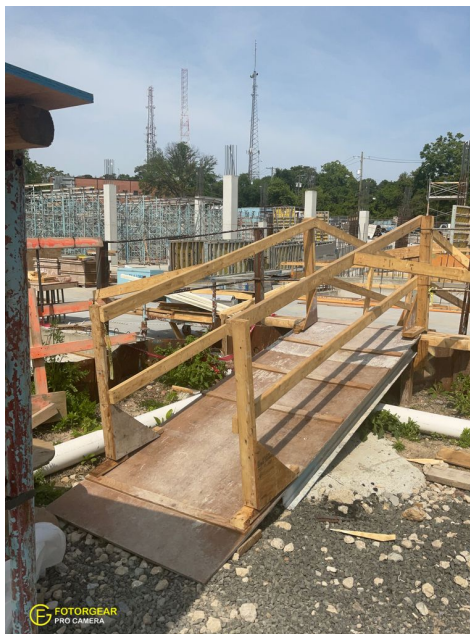
Access to entrance is good but we will added exit signs

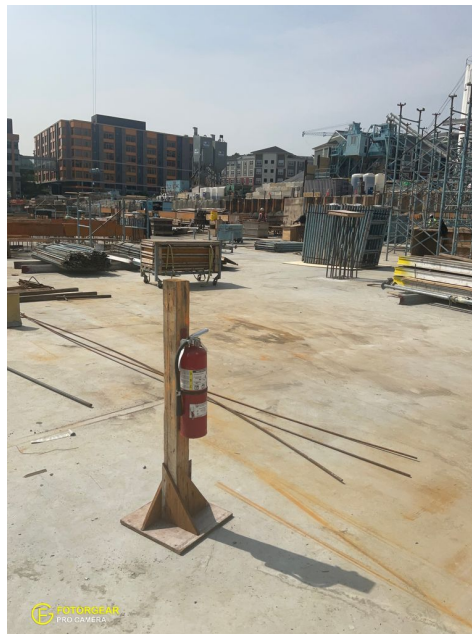
We have installed fire extinguisher with stand but we need to add a sign also we will paint the stand orange

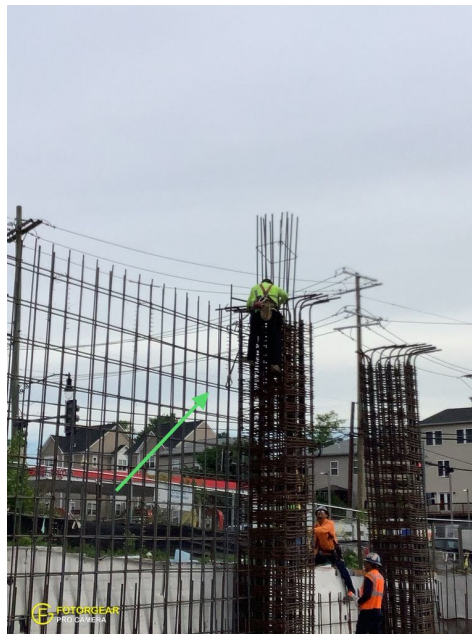
Fall protection arrest system today we found a rebar guy working in a wall he was tie off working safe

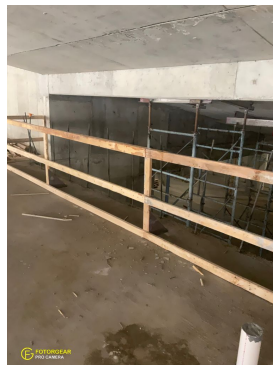
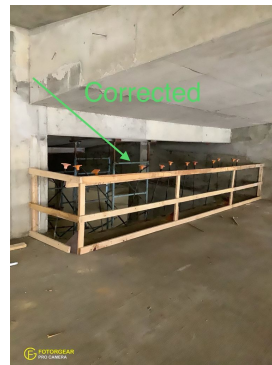
Under the ramp we found some rebars were not cover . Correction made at the moment

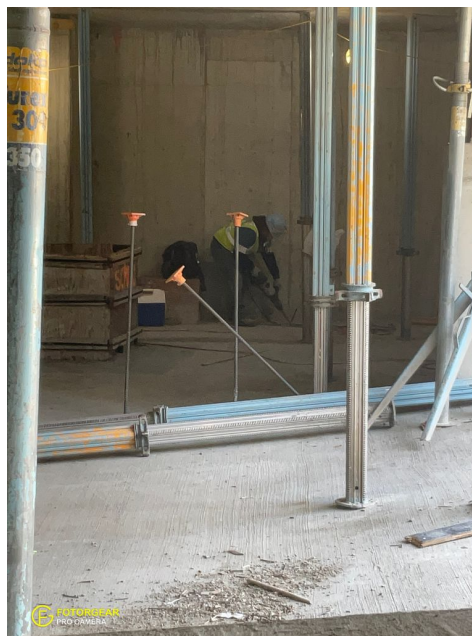
We found a miller and long employee chipping concrete not using Water or Vacuum
we explained how to work safe with silica

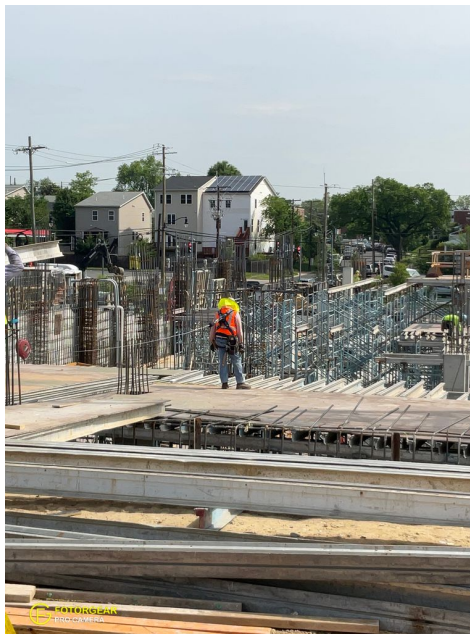
Ground level there is a small excavation needs barricade also the miller long employee was tie off which is safe

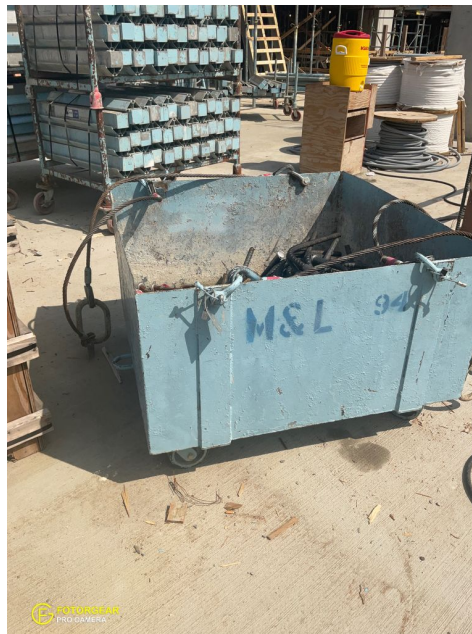
We did an inspection in rigging equipment to ensure they are in good condition . Saul will be taking picture of all capacity tag to have good control

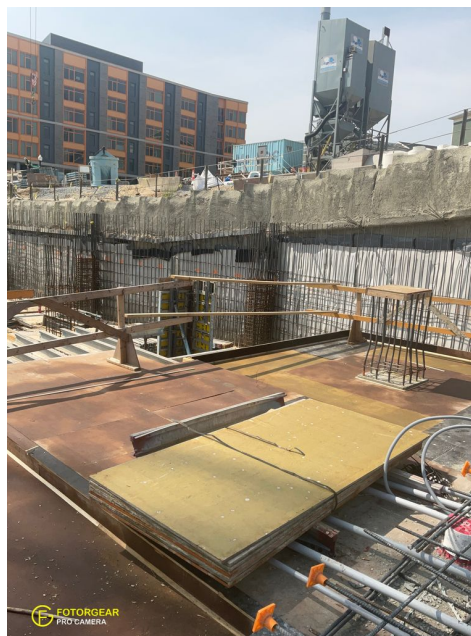
Fall protection hazard all guardrails must be installed properly this needs a 1 stand in the middle also 2x4 need to be fix
