May 16,2023

This report is a follow up to the safety inspection completed on May 16,2023. The purpose of the inspection was to identify potential safety hazards and/or OSHA violations. Attached is a list of observations and recommendations based on the conditions present at the time of my visit. Please review the report and verify that all potential hazards are corrected. If you have any questions or require additional information after reviewing this report, please don't hesitate to contact me.

**7000 Carnation**

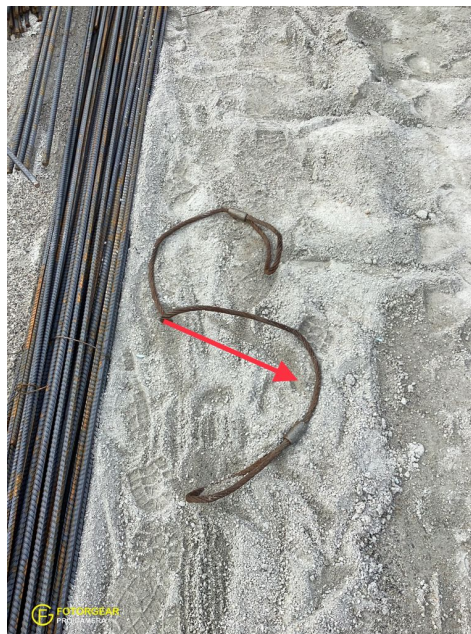
We found a wire rope in bad condition and no tag on it. We took it out of service.

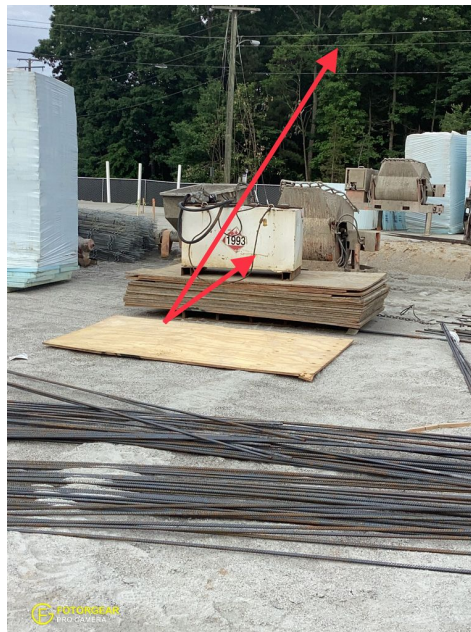
Fuel tank needs hard barrier around also a spill kit and a fire extinguisher. Also we recommend that we put poles in both entrance with flagging to warn truck drivers about the power lines above.

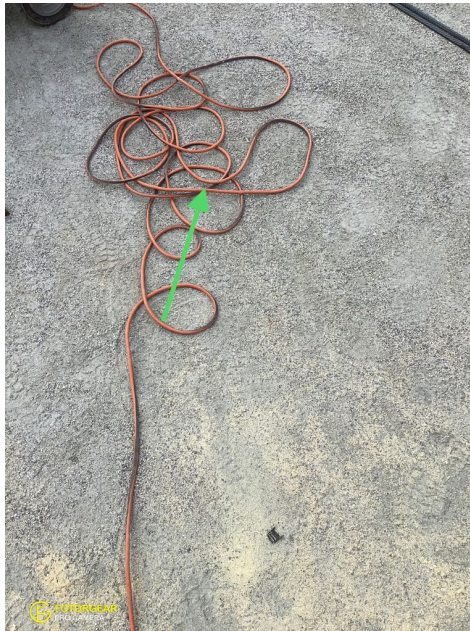
Extension cords check out okay today.

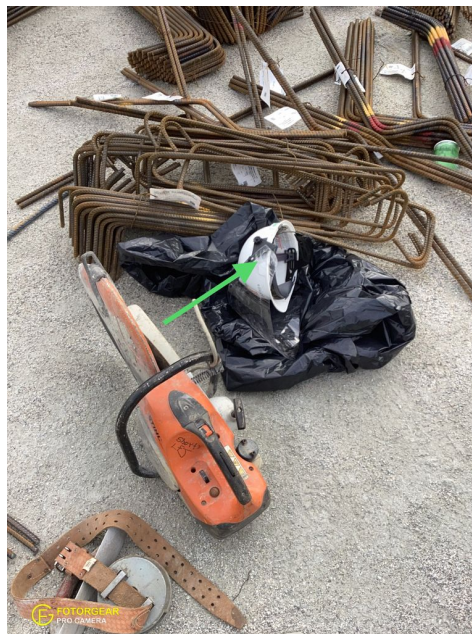
Concrete crew with the proper P. P. E. for the job.

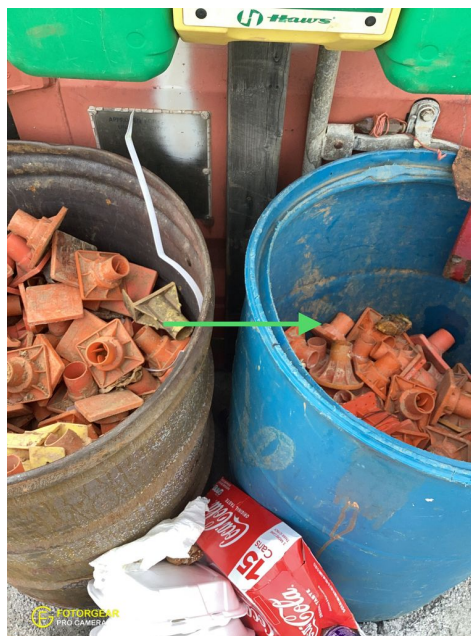
Concrete crew with plenty of rebarcaps for the job.

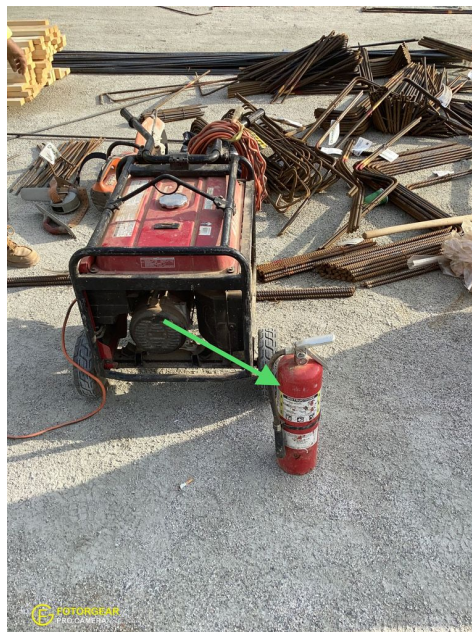
Concrete. Fire extinguisher on site check out okay.

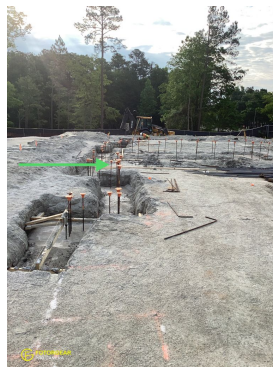
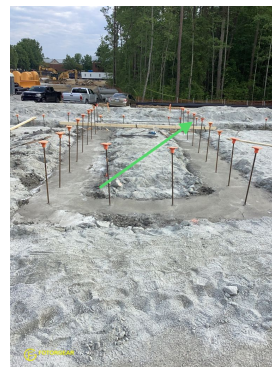
Concrete crew good job with the rebar caps on place.
