This report is a follow up to the safety inspection completed on May 16,2023. The purpose of the inspection was to identify potential safety hazards and/or OSHA violations. Attached is a list of observations and recommendations based on the conditions present at the time of my visit. Please review the report and verify that all potential hazards are corrected. If you have any questions or require additional information after reviewing this report, please don't hesitate to contact me.

**May 16,2023**

**White Oak Town Center**

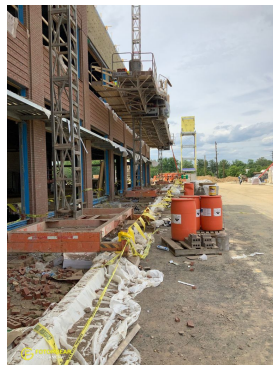
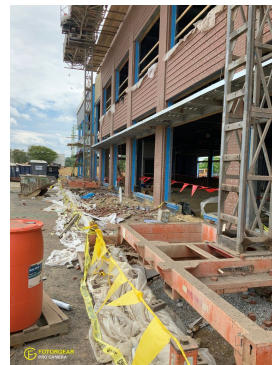
The scaffold has a warning line on the inside and outside to keep workers away, great job Ramon's crew.

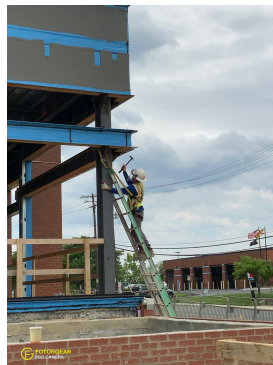
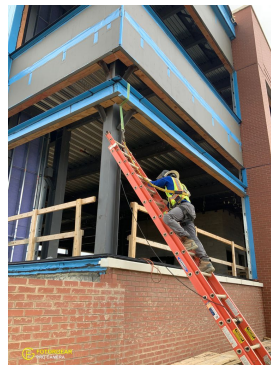
Concrete: Elias is working off a ladder and knowing that he needed to use both hands he's tied-off, the one correction we made was that he needed to use a cross-arm strap instead of the tie-back on the lanyard.

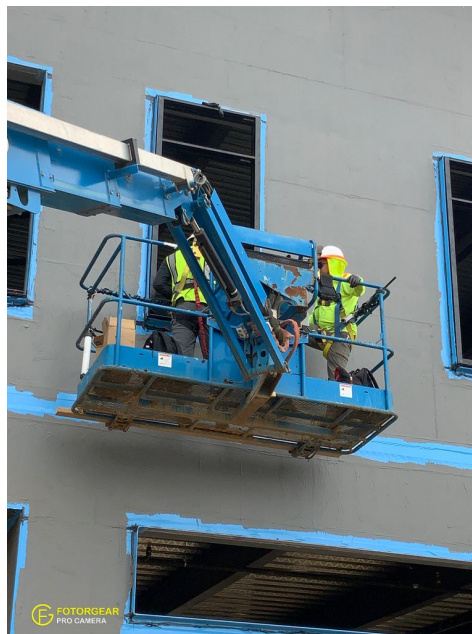
The guy on the left is not clipped-off, corrected immediately.

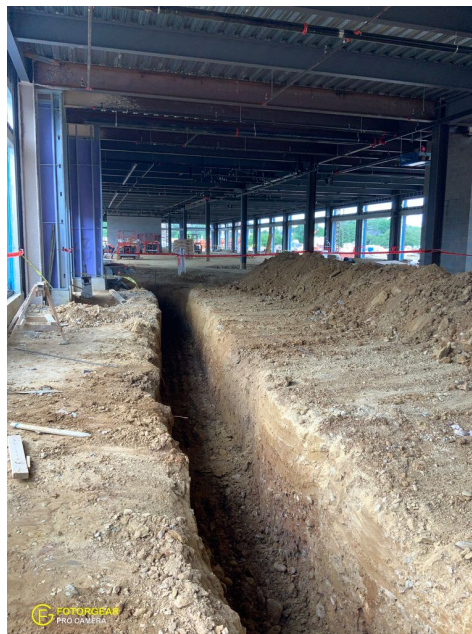
Excavation is protected with danger tape all the way around, looks good, thank you.

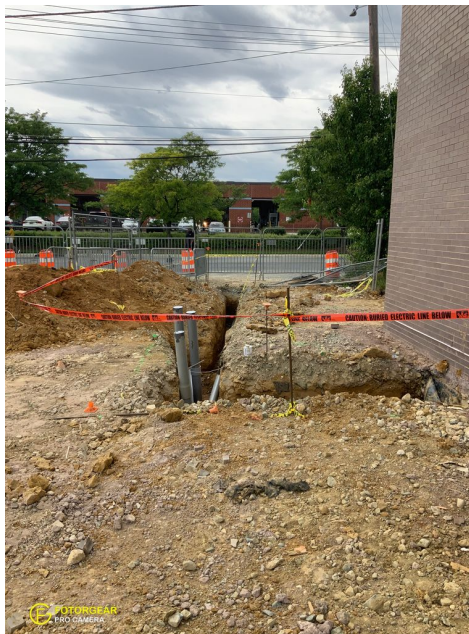
Excavations: when using rebars to install warning lines, they need to be protected with caps, i found 3 rebars without caps, corrected
