May 16,2023

This report is a follow up to the safety inspection completed on May 16,2023. The purpose of the inspection was to identify potential safety hazards and/or OSHA violations. Attached is a list of observations and recommendations based on the conditions present at the time of my visit. Please review the report and verify that all potential hazards are corrected. If you have any questions or require additional information after reviewing this report, please don't hesitate to contact me.

FAIRFAX CORNER

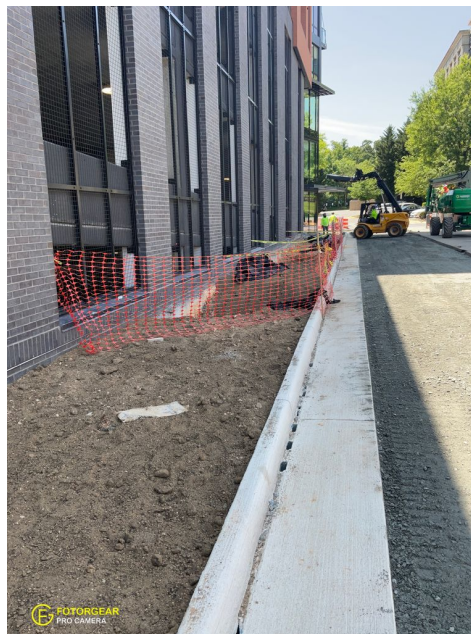
There are 2 small excavation they have installed barricade around which is safe

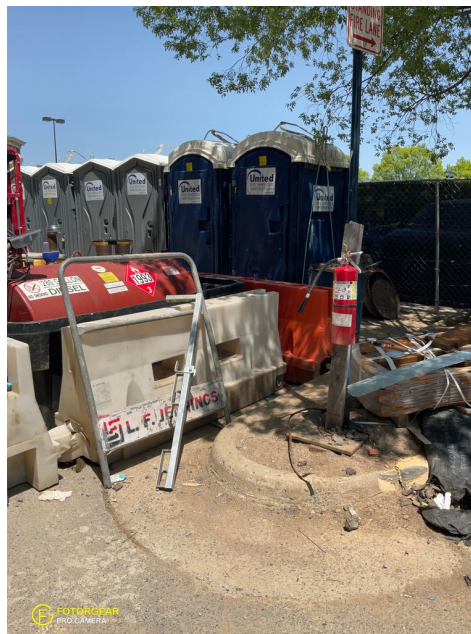
Ground level these fire extinguisher was missing tag and we added a tag

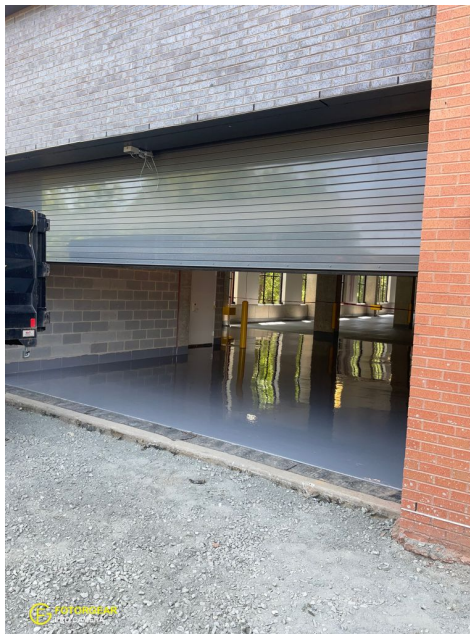
Level 1 when they are adding the coat to the floor they need to put DANGER Tape on both side for more precautions

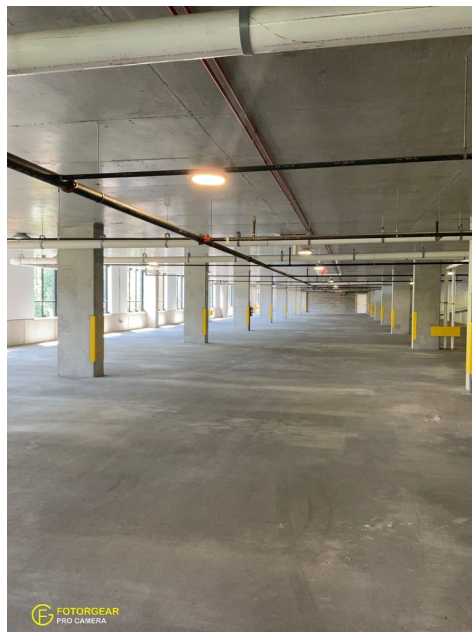
Level 2 these fire extinguishers are there in level 2 3 4 in the parking garage

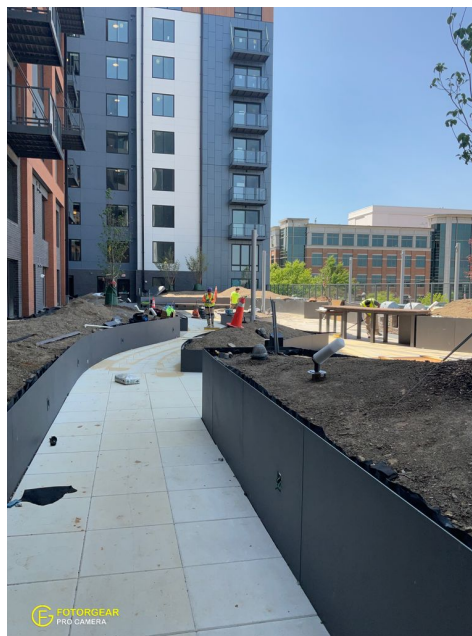
Level 4 we found some guys courtyard working with not personal protective equipment they need to wear PPE

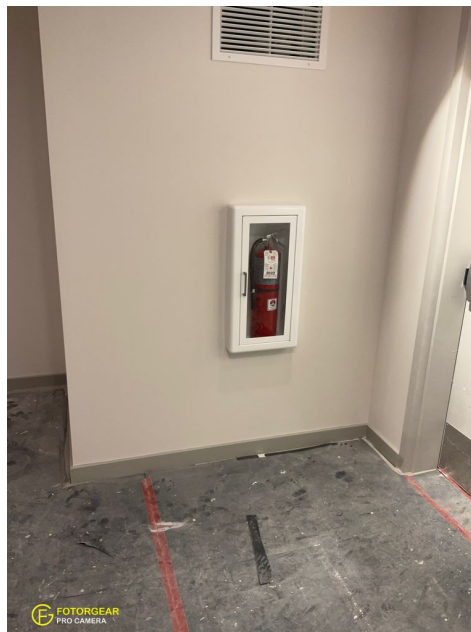
They have installed the new fire extinguisher inside the new cabinets
