This report is a follow up to the safety inspection completed on May 16,2023. The purpose of the inspection was to identify potential safety hazards and/or OSHA violations. Attached is a list of observations and recommendations based on the conditions present at the time of my visit. Please review the report and verify that all potential hazards are corrected. If you have any questions or require additional information after reviewing this report, please don't hesitate to contact me.

**May 16,2023**

**Springfield Plaza**

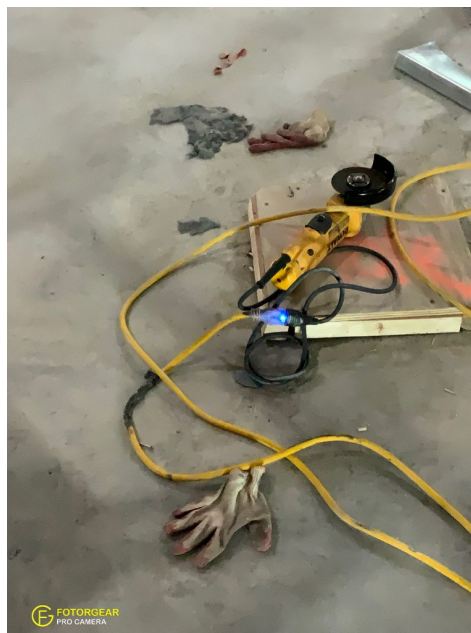
The extension cord is damaged, i asked the guy using it to please cut it and fix it, he put it away immediately.

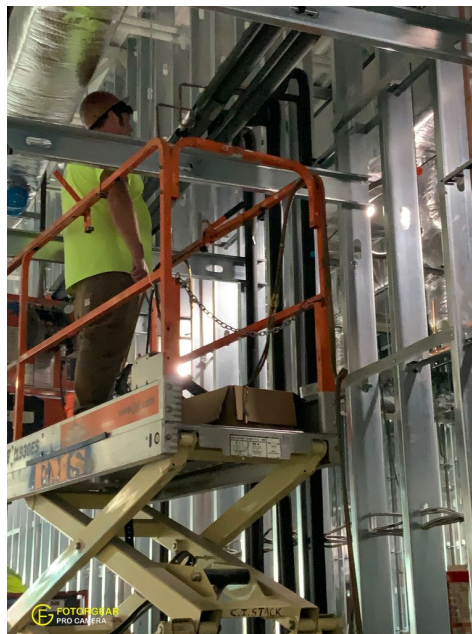
Safety chain is being use by everybody on scissor lifts, good job guys

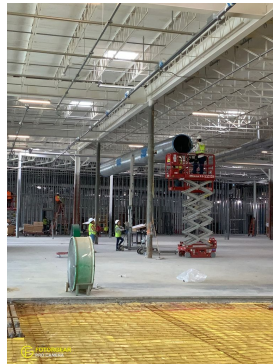
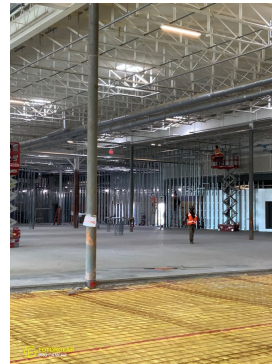
Housekeeping looks good, very organized, great job team!
