Reference: LM-PR-011 CC130J Program – Issue Reporting Procedure

Wings, Wing upper surface door - Illustrated parts data	
DM Code: C130-A-57-20-04-00A-941A-A	Type: IPD
Revision Date: Sep 01, 2019	Issue No: 006
Reason for update: IPB-2019-00126 - Technical change	
Quality Assurance	
First Verification: Table top	Second Verification: Not defined
Applicability: ALL	
Wings, Wing upper surface door (sheet 1 of 2)

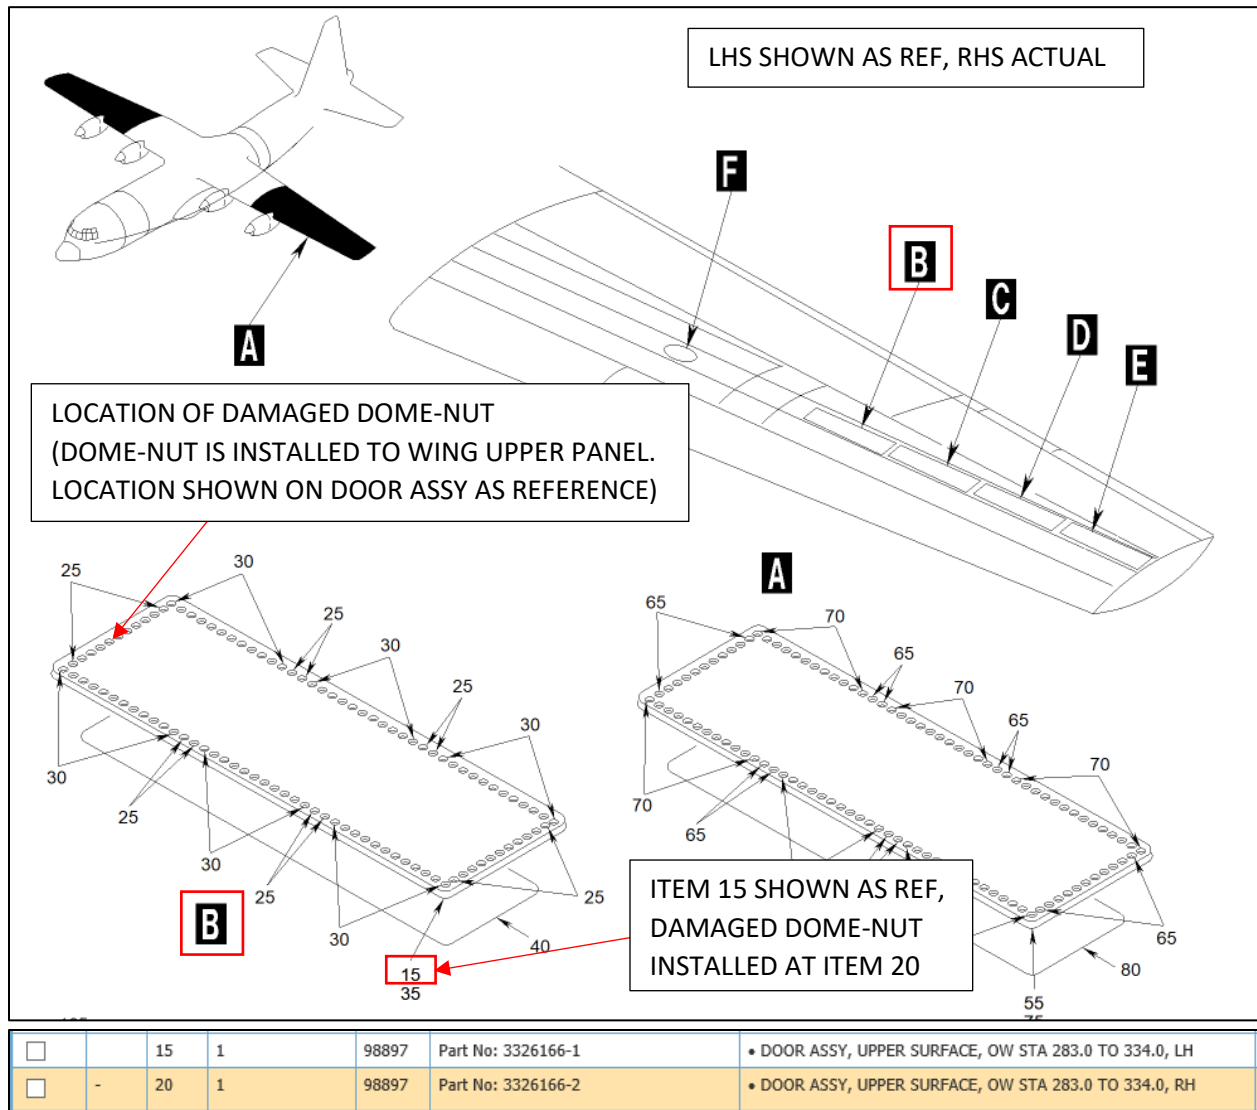
Figure 1: Location of damaged dome nut per DMC C130-A-57-20-04-00A-941A-A

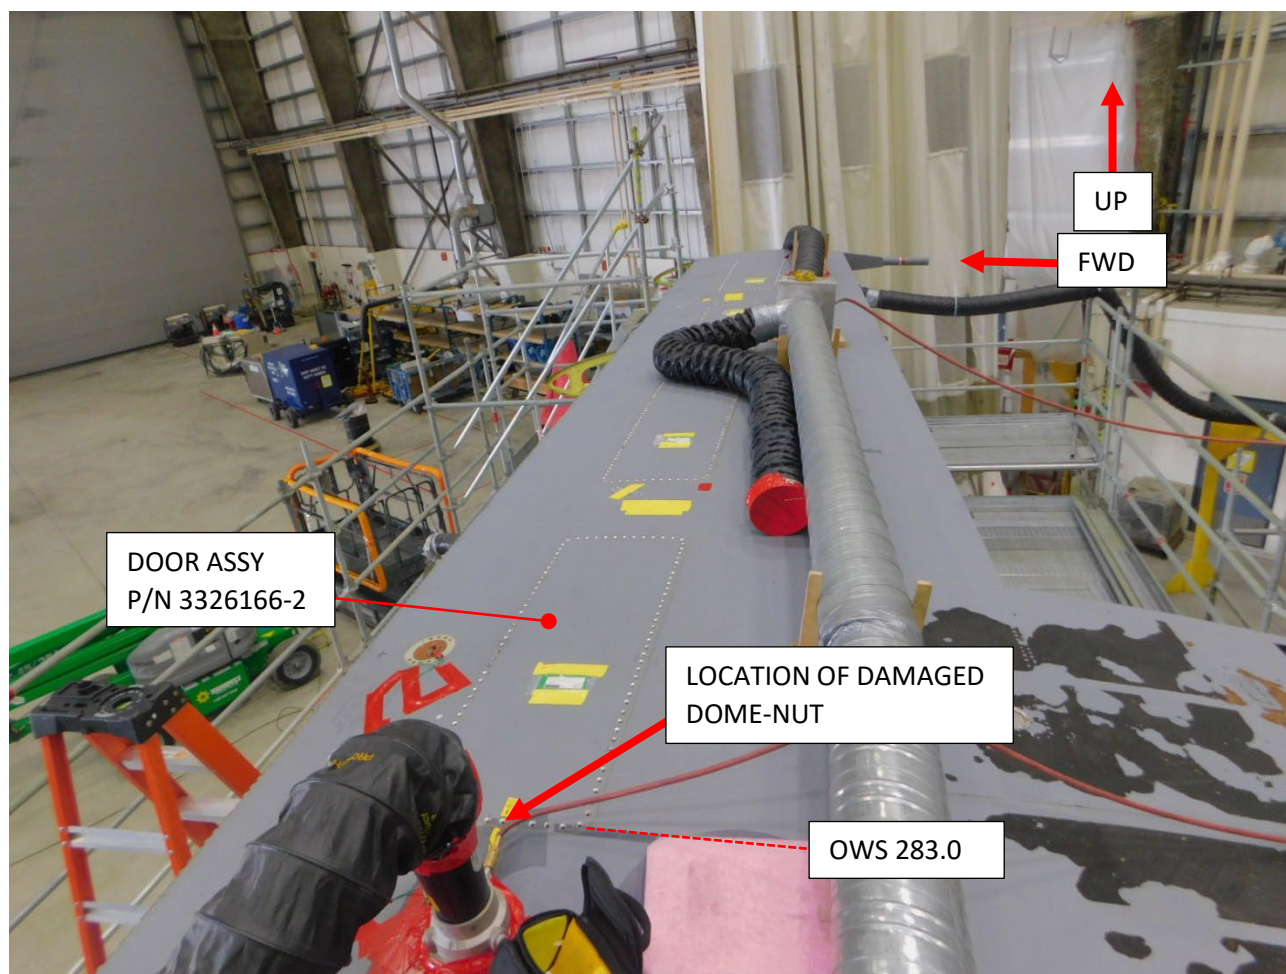
Figure 2: View looking OUTBD at location of damaged dome-nut on RH Outer Wing Upper Surface

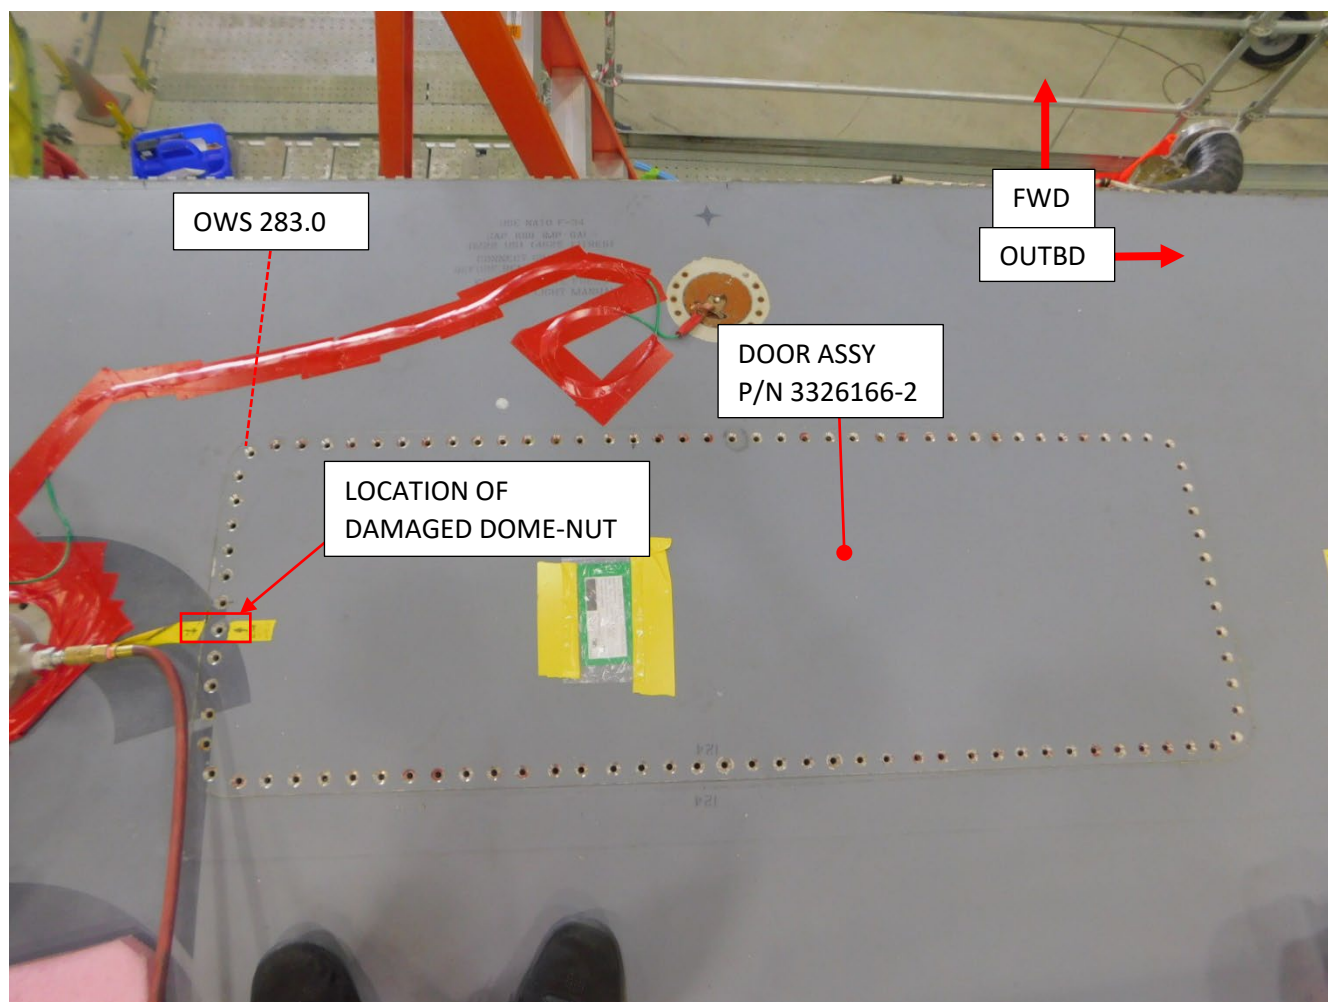
Figure 3: View looking down at location of damaged dome-nut on RH Outer Wing Upper Surface

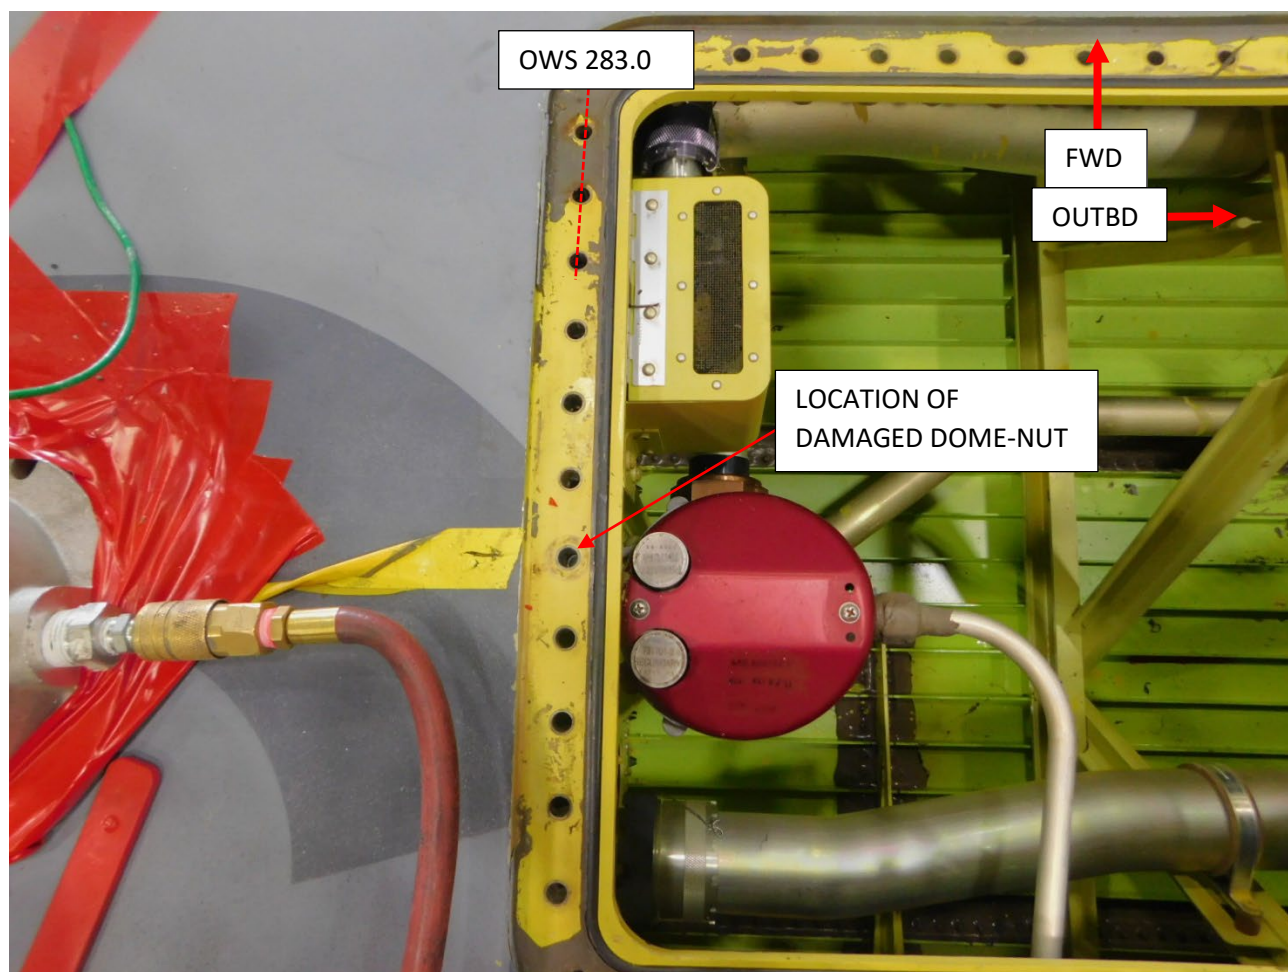
Figure 4: View looking down at location of damaged dome-nut on RH Outer Wing Upper Surface
(Door Assy Removed)
