**Reference:** LM-PR-011 CC130J Program – Issue Reporting Procedure

Table 1 – Damage Description – Gouges on Cargo Tie-Down Wells

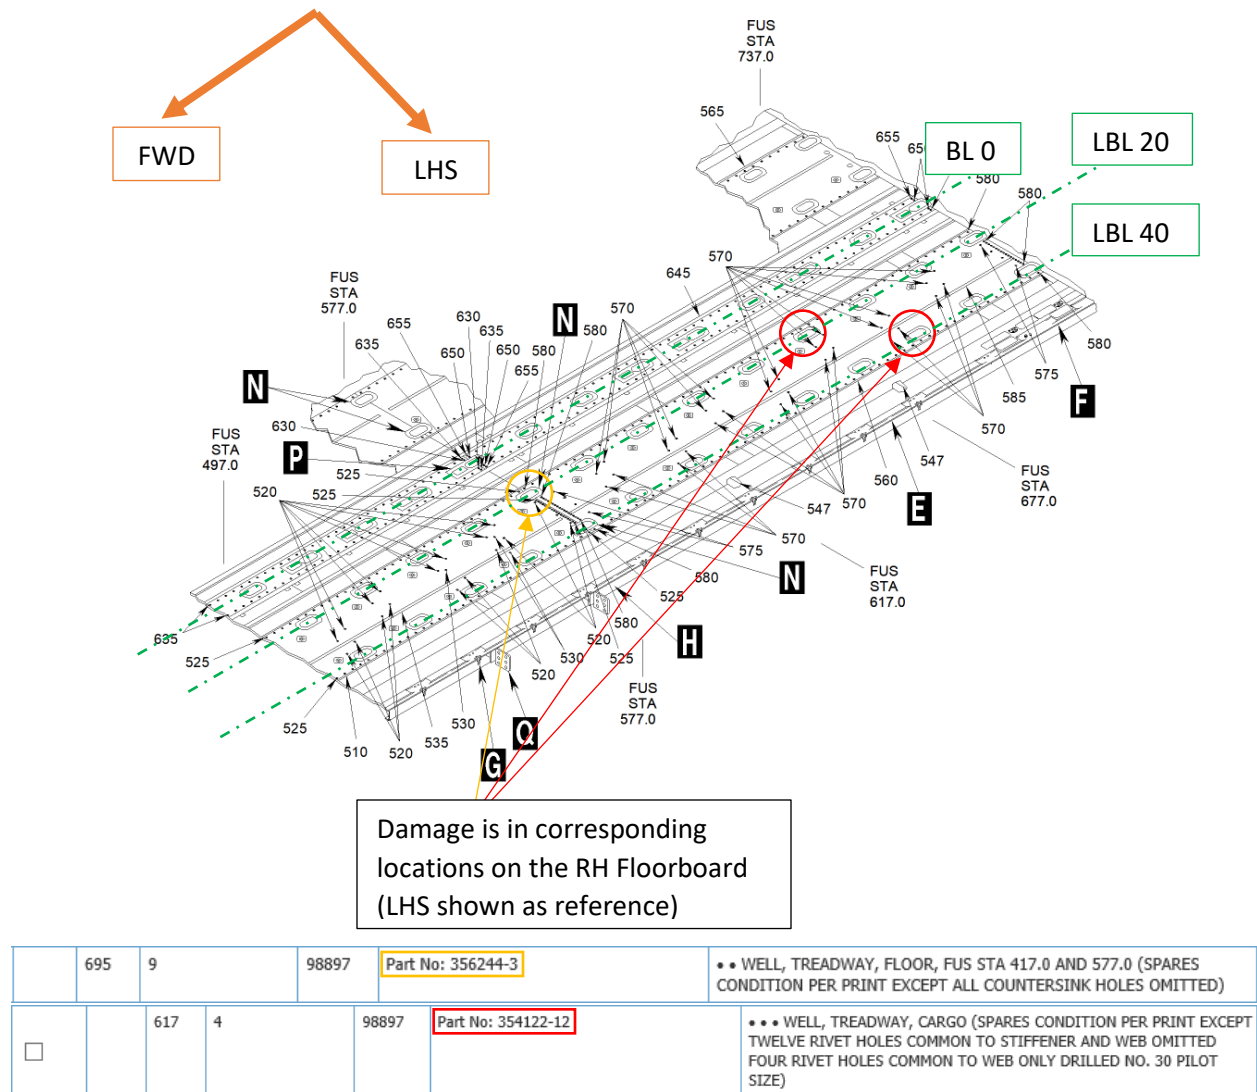
Figure 1 – Location of discrepant Tie-Down Wells as per IPC Ch. C130-A-53-20-01-00A-941A-A

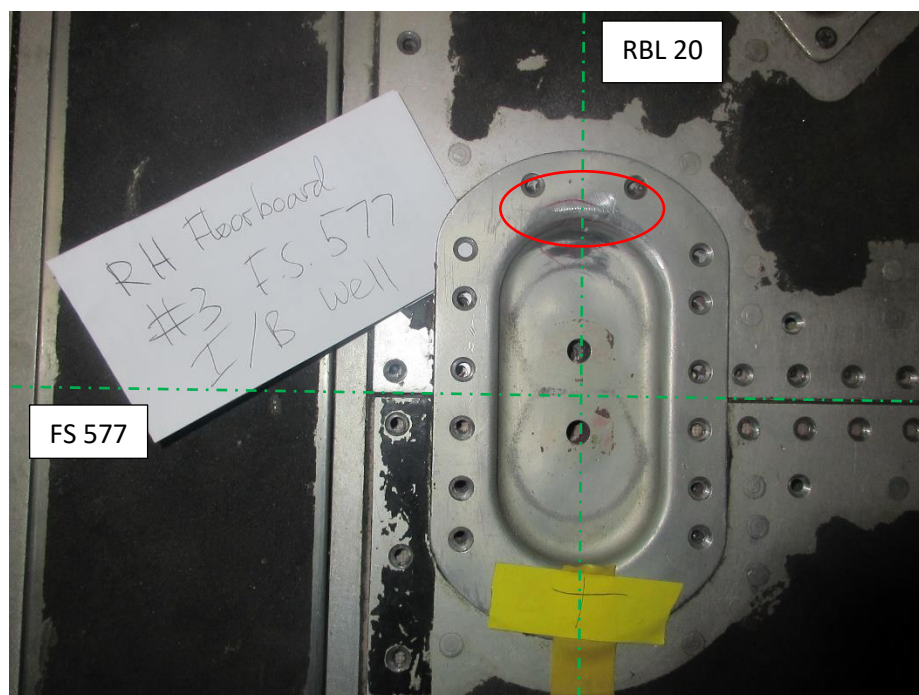
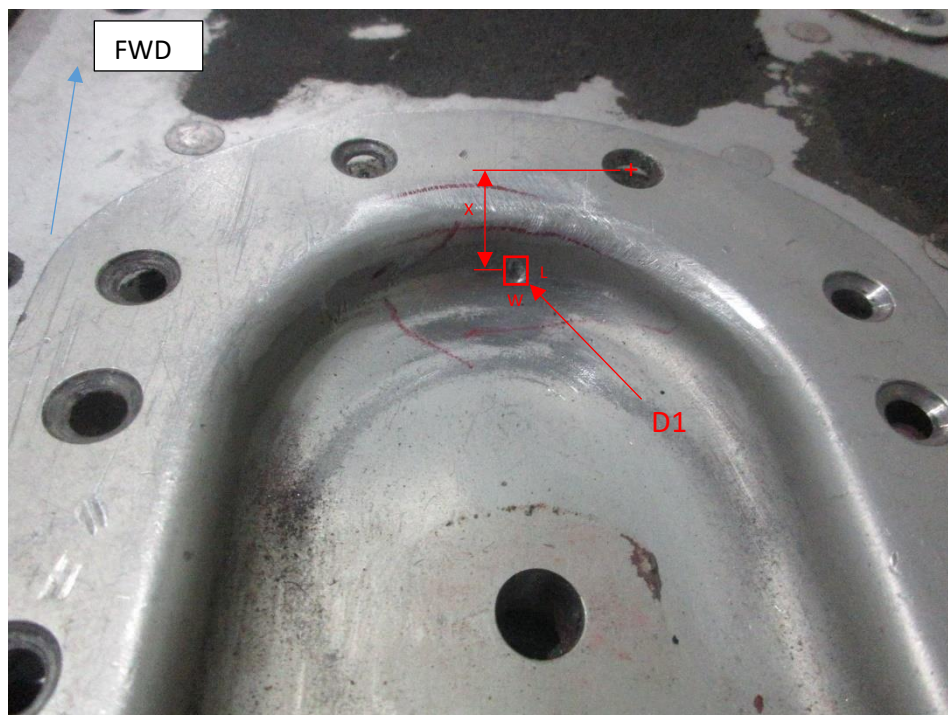
Identification	Tie-down Well P/N	Length (L)	Width (W)	Depth	Distance to closest fastener (X)
FS 577 Damage, D1	356244-3	0.133"	0.155"	0.014"	0.808"
FS 677 Damage, D2	354122-12	0.335"	0.149"	0.017"	0.680"
FS 697 Damage, D3	354122-12	0.206"	0.174"	0.018"	0.600"

Figure 2 – Close-up of FS 577 Damage, D1.  
(Reference Table 1 for damage description)

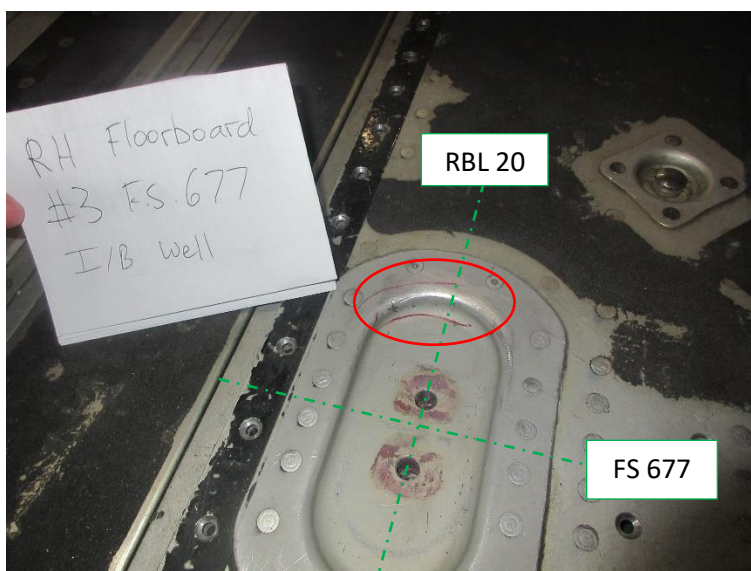
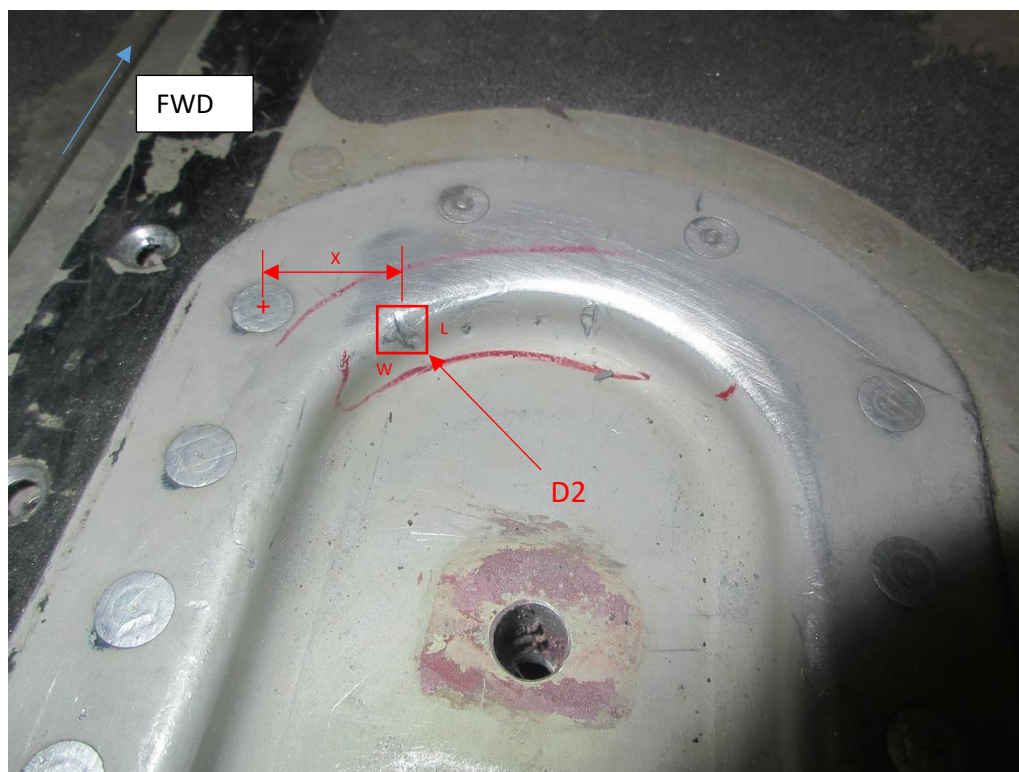
Figure 3 - Close-up of FS 677 Damage, D2.  
(Reference Table 1 for damage description.)

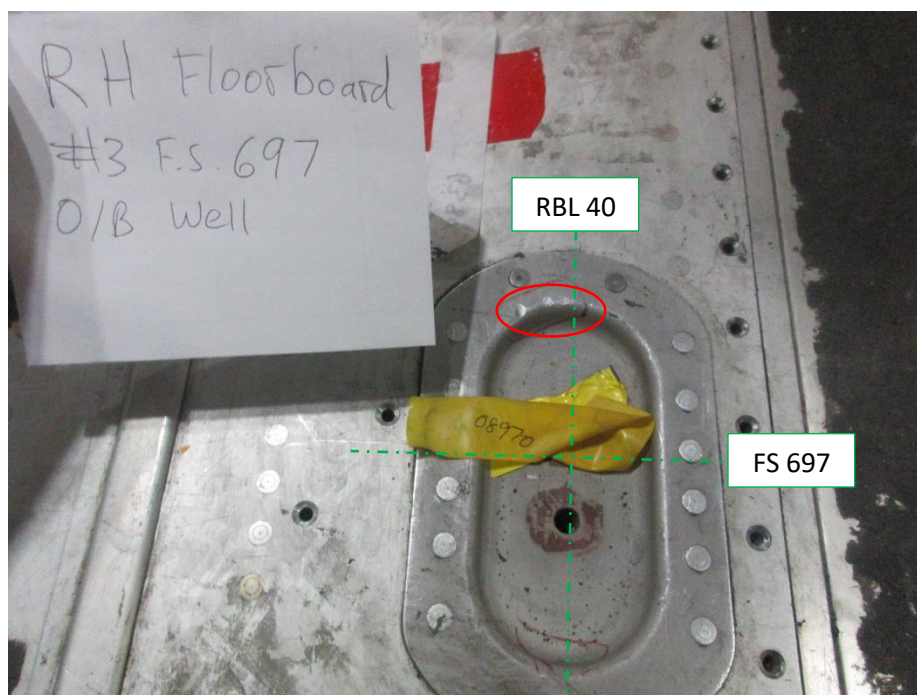
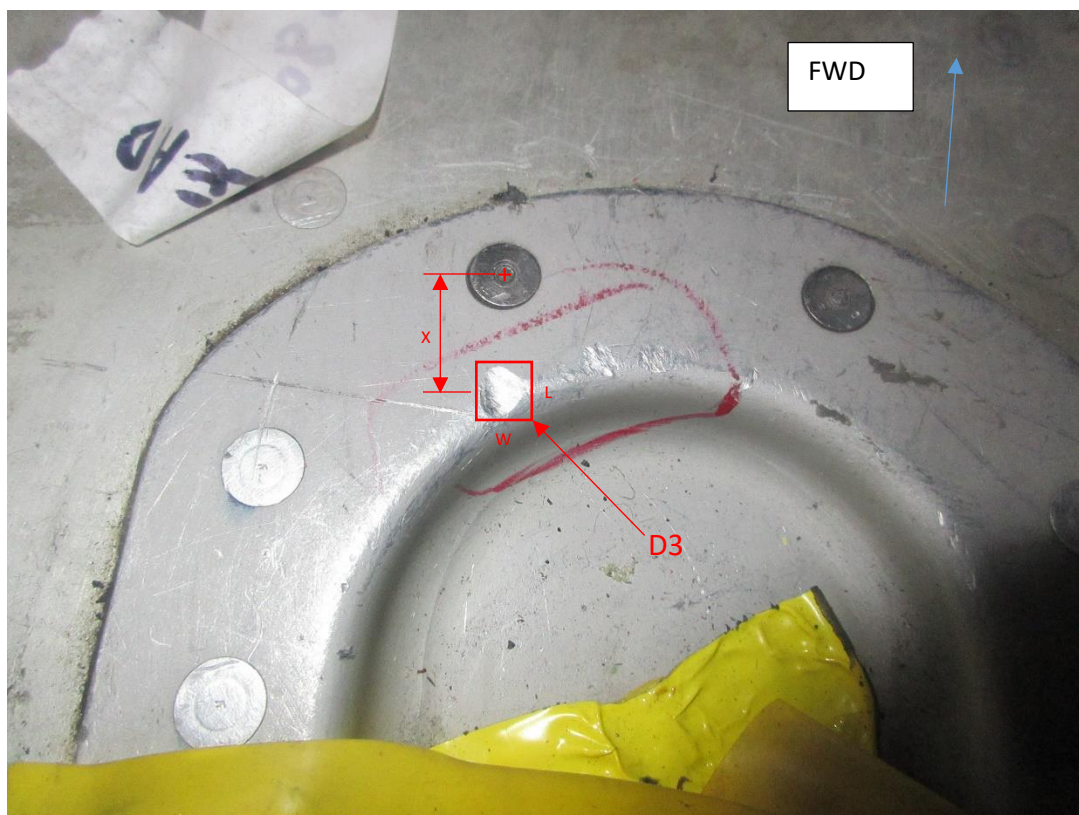
Figure 4 - Close-up of FS 697 Damage, D3.  
(Reference Table 1 for damage description.)
