INSPECTION REPORT

411 SAMPLE STREET
EASTERN ONTARIO, ON

Inspection Date: Sunday, January 10, 2016

Kingfisher Home Inspections
1253 Powers Road
Perth, ON K7H 3C5
(613) 812-3864

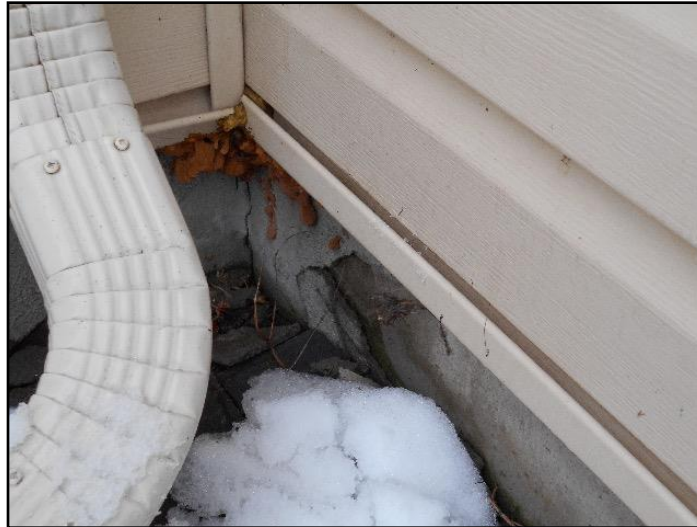
4. Aluminum downspouts

Aluminum downspouts and deterioration of parking layer in certain areas.

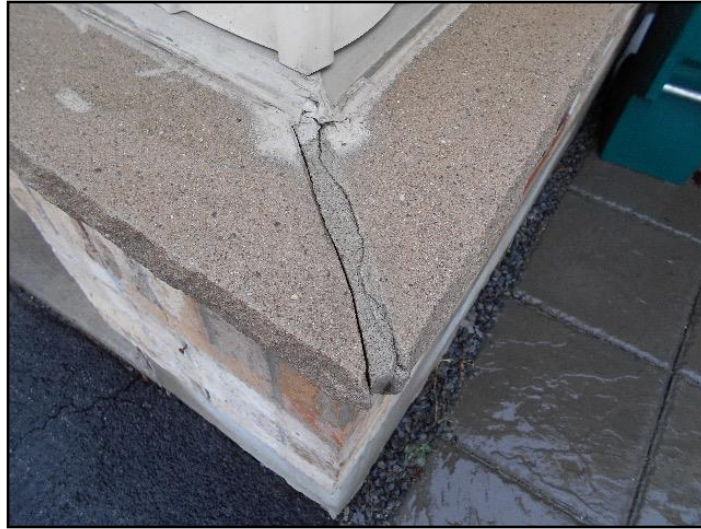
5. Brick

Corner of brickwork at garage door show deterioration of mortar. Minor repointing needed.

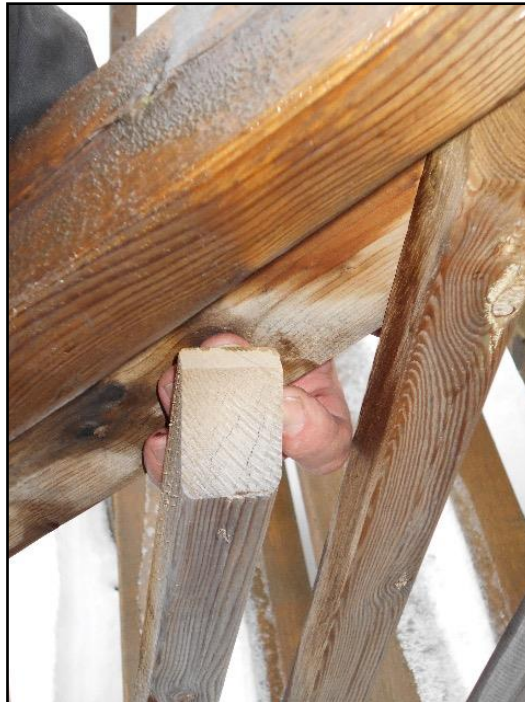
6. Railings

Spindle not attached at bottom right handrail

One verticle spindle unattached at the bottom of the right railing. Needs screwing on.

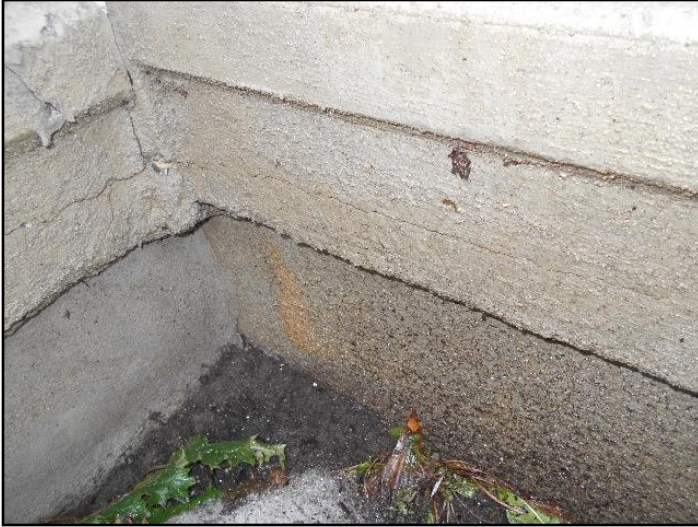
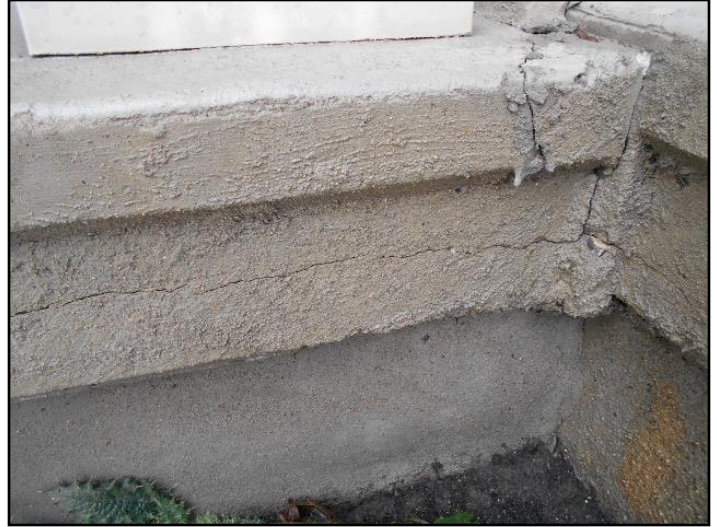
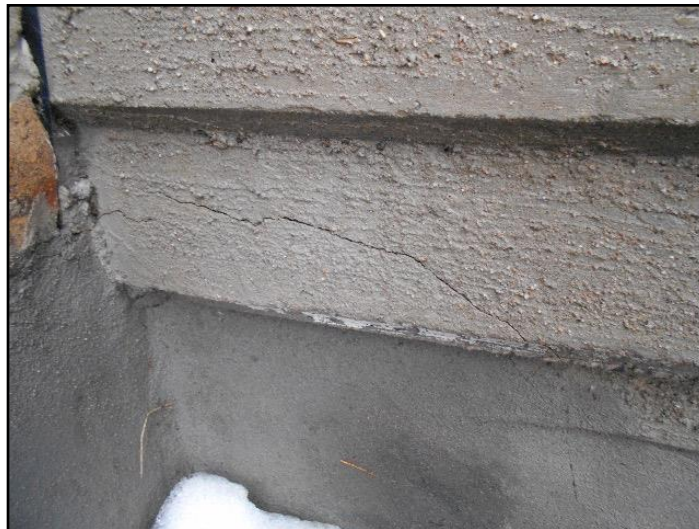
Some horizontal cracking seen at each end of porch deck, as well as neighbouring porch.

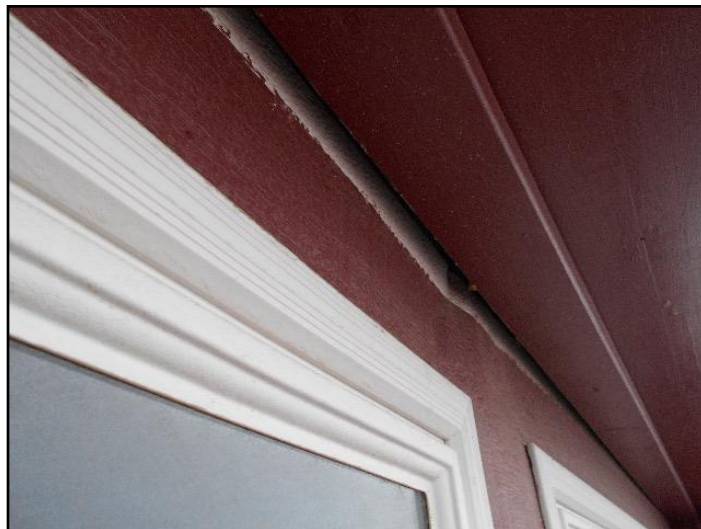
Garage: • Minor dent in top of garage door noted. Safety features of automatic door opener tested and are functional.

11. garage door.

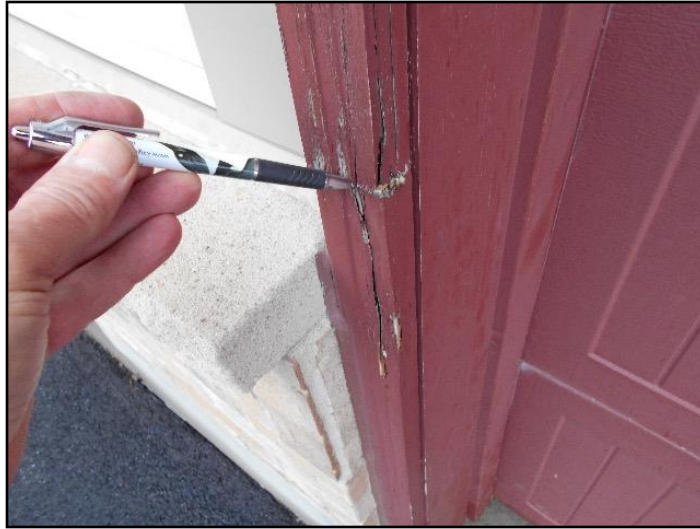
Some deterioration noted. Recommend filling/painting in the spring, or cover with aluminum trim.

12. Garage door molding.

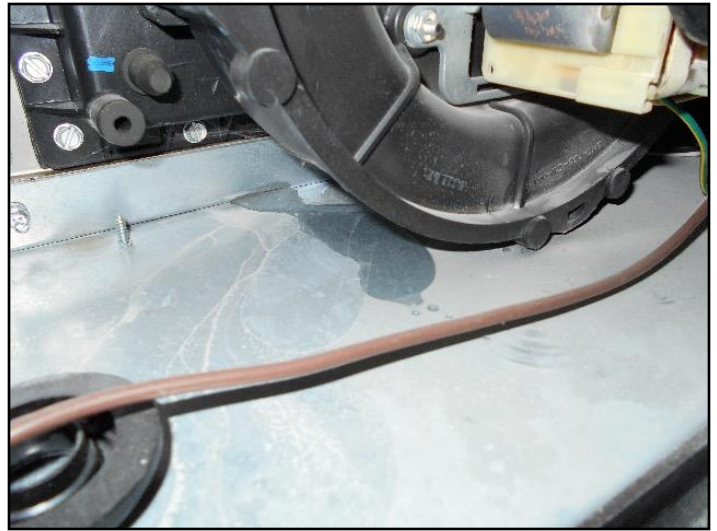
Condition: • Condensate leaking inside cabinet

Implication(s): Condensate drain plugged.

1. Rust on heat shield, sometimes caused by backdrafting.
2. Condensate leaking out into cabinet.
3. Exhaust fan seems noisy, perhaps a failing bearing.
4. Humidifier is seeping, needs cleaning and sealing.

23. Condensate leaking out.

Recommend servicing by a qualified burner technician.

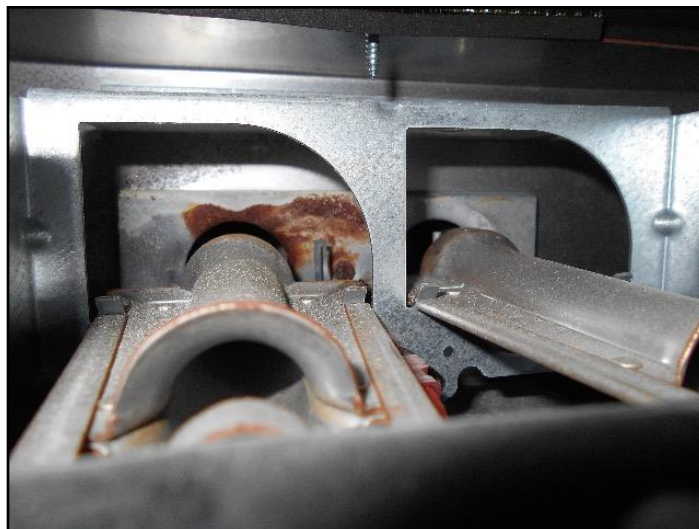
Condition: • [Rust](#)

24. Rust on heat shield.

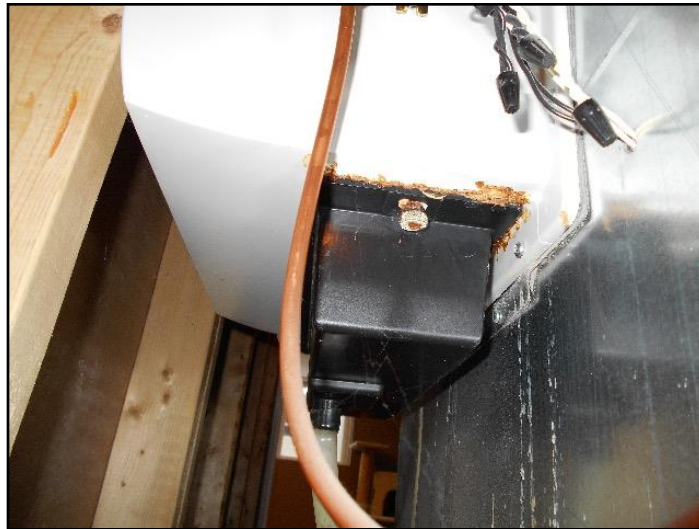
26. Duct mounted bypass humidifer

Condition: • [Leak](#)

Implication(s): Chance of water damage to contents, finishes and/or structure | Damage to equipment

Humidifier seeping, requires service/cleaning.

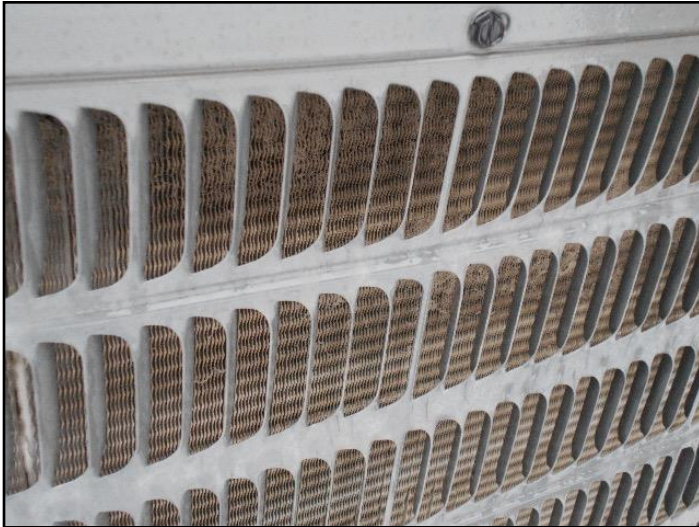
27. Condensor coil mostly clean.
