TWIN PEAKS PROPERTY INSPECTIONS

RESIDENTIAL INSPECTION

1234 Main Street
Oshawa, ON L1G 3V2

Buyer Name
02/01/2023 9:00AM

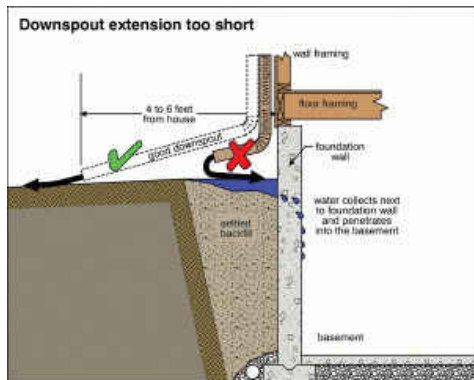
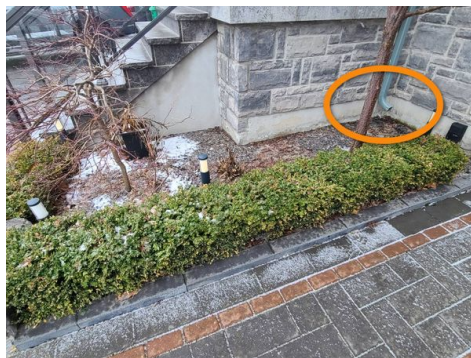
2.2.1 Roof Drainage Systems

DOWNSPOUTS DRAIN NEAR HOUSE

One or more downspouts drain too close to the home's foundation. This can result in excessive moisture in the soil at the foundation, which can lead to water leakage or structural movement. Recommend a qualified contractor or handyman to add extensions to drain minimum 4-6 feet from the foundation.

Contact a qualified professional.

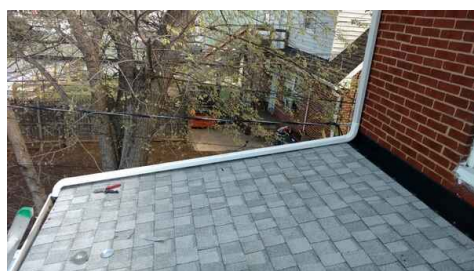
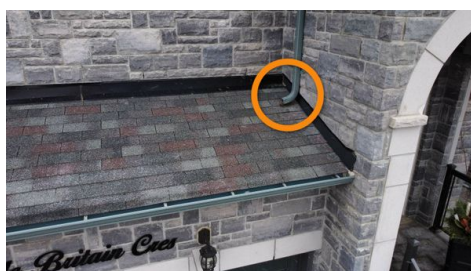
2.2.2 Roof Drainage Systems

DOWNSPOUT DRAINING ON ROOF

Downspout observed to be draining onto the roof. This can cause premature wear of the shingles in this area. Recommend a qualified aluminum or roofing contractor to install downspout extension to drain the water directly to the eavestrough below.

Sample of typical repair

Contact a qualified professional.

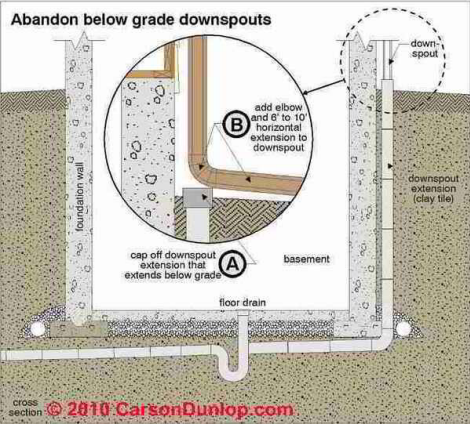
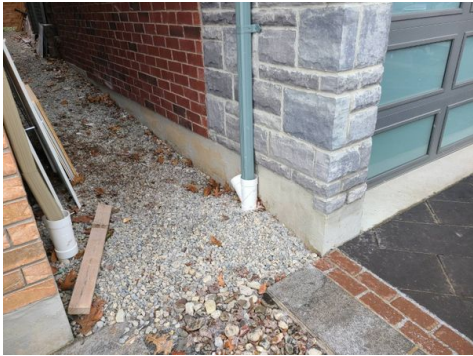
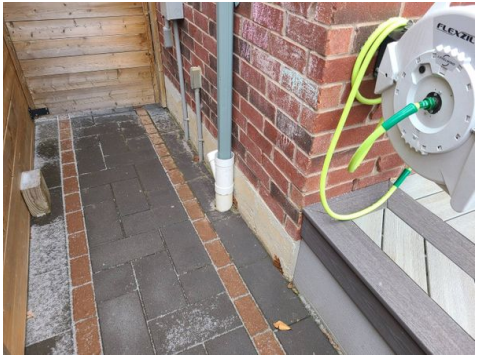
2.2.3 Roof Drainage Systems

DOWNSPOUTS DRAIN UNDERGROUND

FRONT

The downspout was found to be draining underground. The preferred method of discharging water is **above grade**, away from the foundation.

As the underground pipe ages, it is vulnerable to partial obstruction, blockage or drainage collapse due to tree roots, leaf debris or expiration of the building materials. This can result in excessive moisture in the soil at the foundation, which can lead to interior leakage.

Recommend a qualified contractor adjust downspout extensions to drain above grade, at least 6 feet from the foundation.

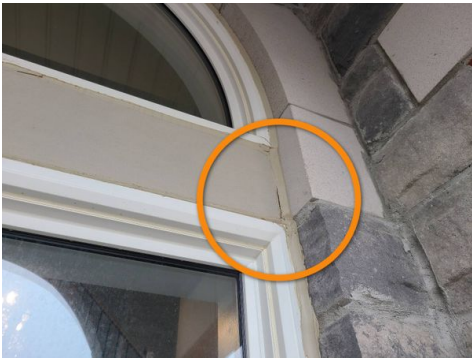
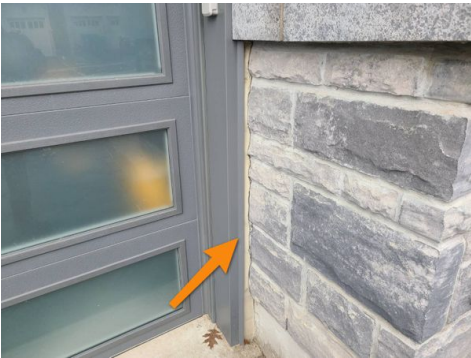
3.1.1 Exterior Finishes, Flashing & Trim

CAULKING REQUIRED

FRONT EXTERIOR

Caulking sealant missing or deteriorated. Caulking is responsible for sealing vulnerable gaps in the building and for extending the life of building materials. Recommend repairs.

Contact a qualified professional.

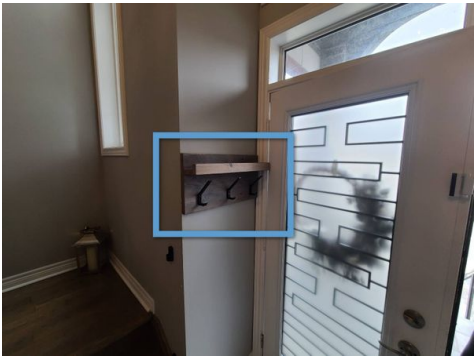
3.3.1 Exterior Doors

DOOR OBSTRUCTED

FRONT DOOR

The front door is obstructed from fully opening by a wall mounted shelf. This is a double door system and is the side of the door which is not used for typical daily use. However it is an inconvenience and could be an issue for moving large items (furniture) in and out. Recommend removing the shelf.

Contact a qualified professional.

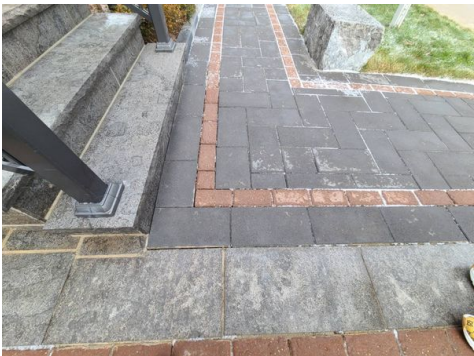
3.6.1 Vegetation, Grading, Drainage & Retaining Walls
(With respect to their effect on the condition of the building)

FILL CRACKS ON LANDSCAPE STONES

EXTERIOR WALKWAYS

The interlocking walkway is missing jointing sand between stones, which can lead to movement of the walkway. Recommend the installation of polymeric sand to fill the gaps and extend the life of the interlocking.

Contact a qualified landscaping contractor

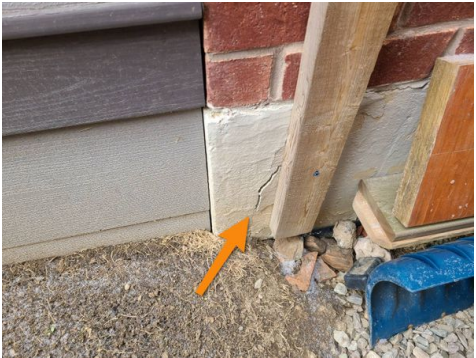
4.1.1 Foundation

FOUNDATION CRACKS - MINOR

LEFT REAR EXTERIOR

Minor cracking was noted at the foundation. This condition is common as concrete ages and shrinkage cracks occur. If the crack becomes larger or begins to leak, a foundation repair contractor should be contacted for repairs. Common repairs include epoxy injection or interior/exterior waterproofing repairs.

Contact a foundation contractor.

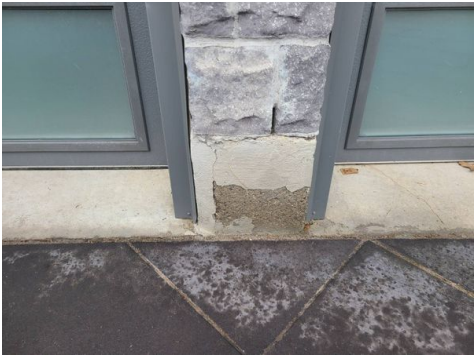
4.1.2 Foundation

PARGING DAMAGE

GARAGE FRONT

Parging damage was noted. Parging plays an important role in the foundation wall, both esthetically and functionally to help keep water away from the foundation. Recommend hiring a general contractor or masonry contractor to repair.

Contact a qualified masonry professional.

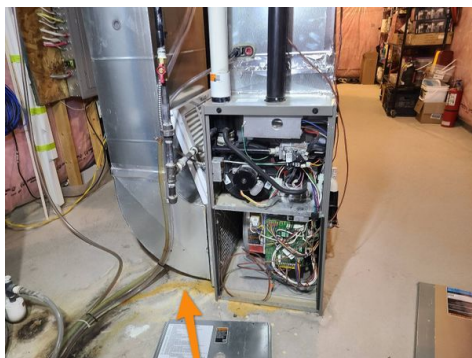
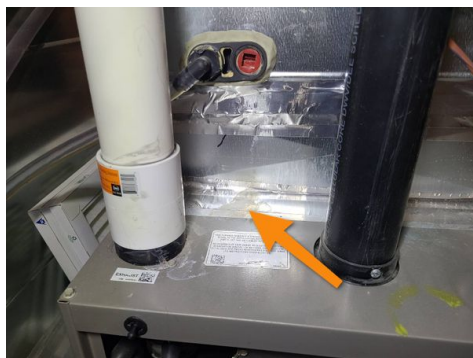
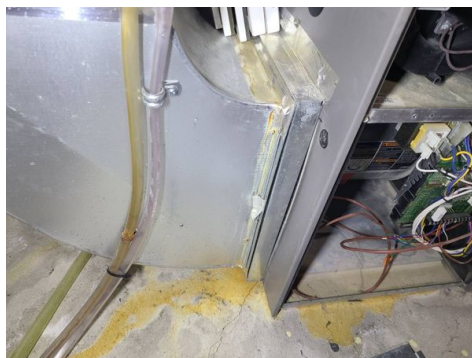
5.1.1 Equipment

AIR CONDITIONER COIL LEAK

FURNACE

The air conditioner coil is leaking. This could lead to equipment failure and damage to the interior finishings. Recommend a qualified HVAC contractor to investigate and repair as soon as possible.

Contact a qualified HVAC professional.

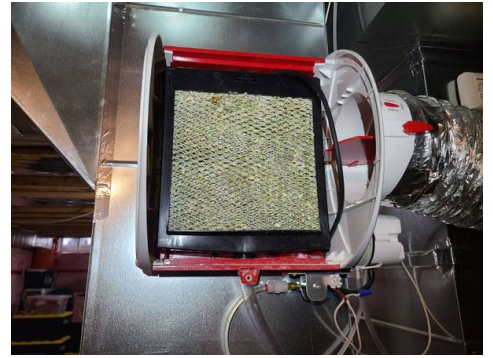
5.5.1 Humidifier

REPLACE FILTER

Annual humidifier filter replacement is required to improve interior air quality. Recommend replacing each fall.

Recommended DIY Project

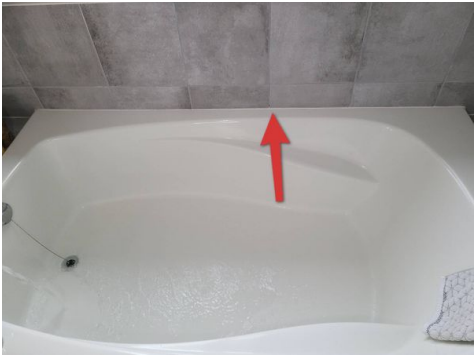
7.3.1 Water Supply, Distribution Systems & Fixtures

MASTER BATHROOM TUB

Silicone sealant needs to be installed or replaced. Silicone is an important part of the waterproofing system. Recommend installation as soon as possible to limit chance of water leakage.

Contact a qualified professional.

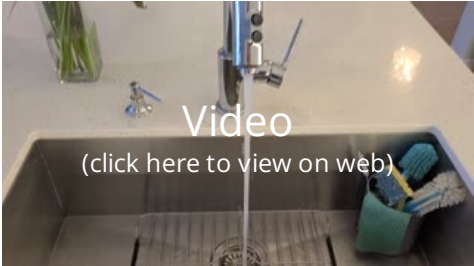
7.3.2 Water Supply, Distribution Systems & Fixtures

FAUCET UPGRADE

KITCHEN

The faucet is older and the diverter is partially obstructed. It is still functional, so replacement only when desired.

Contact a qualified plumbing contractor.

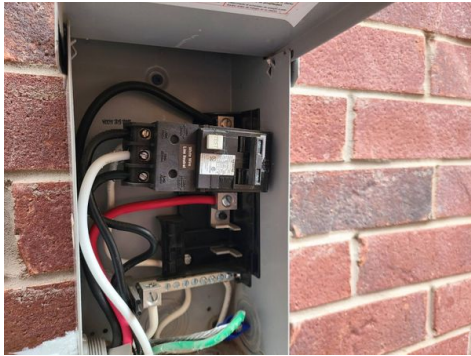
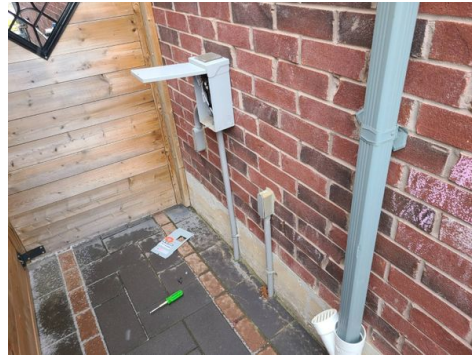
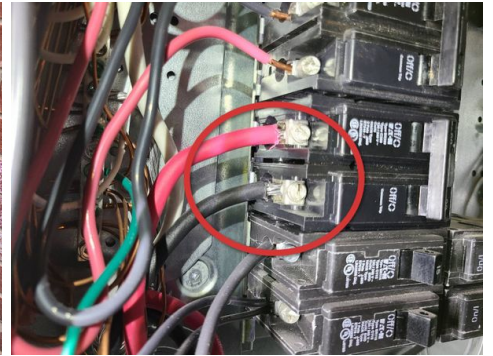
8.1.1 Service Entrance Conductors

ANTI-OXIDANT PASTE - MISSING OR DAMAGED

HOT TUB

Missing anti-oxidant paste was observed on the electrical wires. Anti-oxidant paste is required on multi-strand aluminum conductors to limit the chance of corrosion and electrical hazards. Recommend repairs by a qualified electrical contractor.

Contact a qualified electrical contractor.

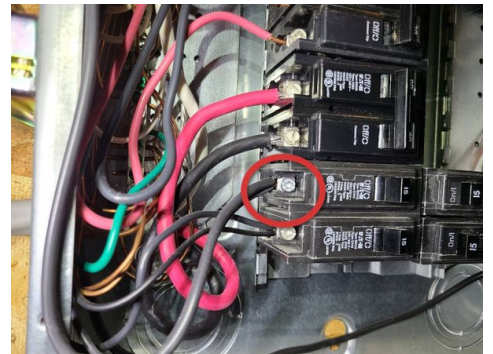
8.3.1 Branch Wiring Circuits, Breakers & Fuses

DOUBLE TAPS

Double taps noted on panel. This occurs when multiple wires are connected to a terminal designed for one. This is an electrical hazard. Recommend having a licensed electrician further evaluate and repair.

Contact a qualified electrical contractor.

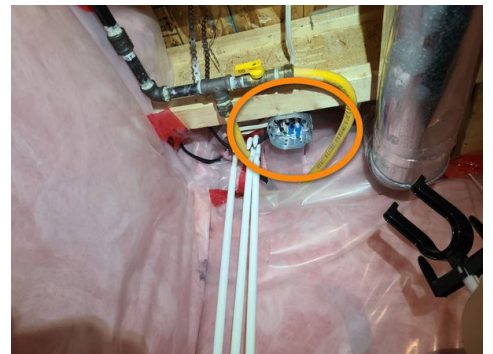
8.4.1 Lighting Fixtures, Switches & Receptacles

COVER PLATES MISSING

BASEMENT

One or more receptacles are missing a cover plate. This causes short and shock risk for occupants. Recommend installation of cover plate(s).

Contact a qualified electrical contractor.

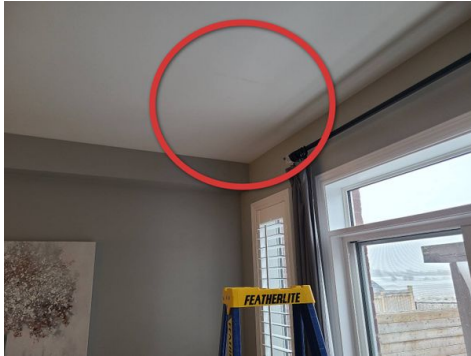
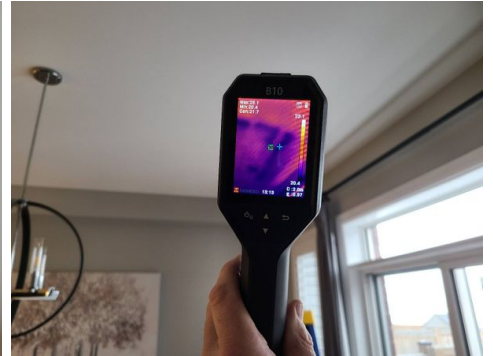
11.5.1 Ceilings

SIGNS OF WATER LEAKAGE

KITCHEN CEILING

Signs of water leakage were present on the kitchen ceiling. The bathroom above includes a shower and bathtub. Thermal imaging showed areas which were inconsistent with adjacent surfaces, indicating a leak. This appears to be a small leak but should still be corrected right away. On-going water leakage can lead to further damage to interior finishes and the structure. I recommend having a plumbing contractor evaluate and repair as necessary.

Contact a qualified plumbing contractor.

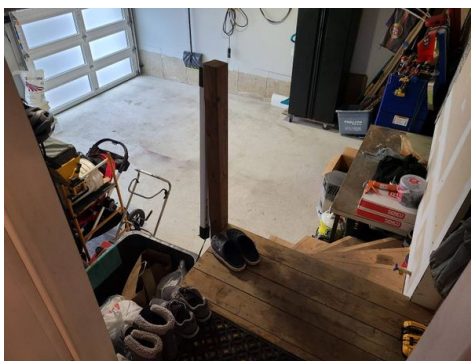
NO HANDRAIL AND POOR SUPPORT

The garage staircase had no handrails, which is a safety hazard. The attic storage structure is also poorly supported and unsafe for occupants. Repairs should be completed by a carpentry contractor before it is used.

No handrail

Contact a qualified carpenter.

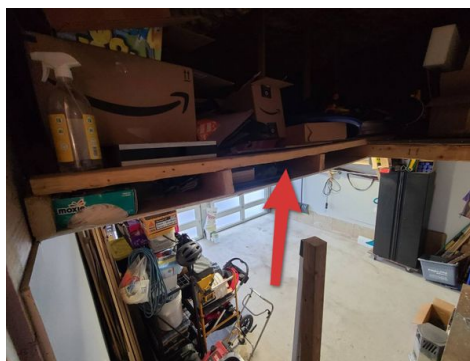
Poorly supported structure

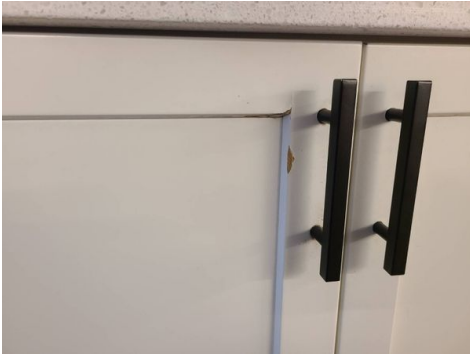
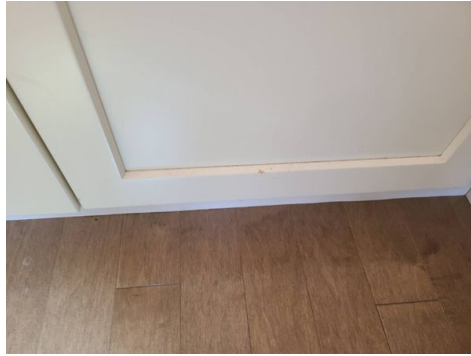
11.9.1 Countertops & Cabinets

CABINETS DAMAGED

Damage was noted on the kitchen cabinets. Recommend a qualified cabinets contractor evaluate and repair.

Contact a qualified cabinet contractor.

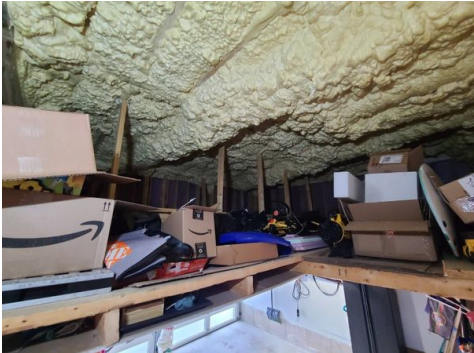
13.2.1 Walls & Firewalls

FIRE WALL/CEILING NOT UP TO CODE

GARAGE

The garage ceiling separating the home and garage is not compliant with modern building standards. Fires often originate in the garage, so firewalls should be built with materials to prevent the spreading of a fire into the home living space. This is accomplished by installing drywall to create the fire stop.

The ceiling currently has exposed spray foam insulation and should be covered with drywall. I recommend hiring a qualified contractor to frame and install drywall to meet building code requirements.

Contact a qualified professional.
