YOUR INSPECTION REPORT

Your Street

Sample, ON A1A1A1

Monday, November 21, 2022

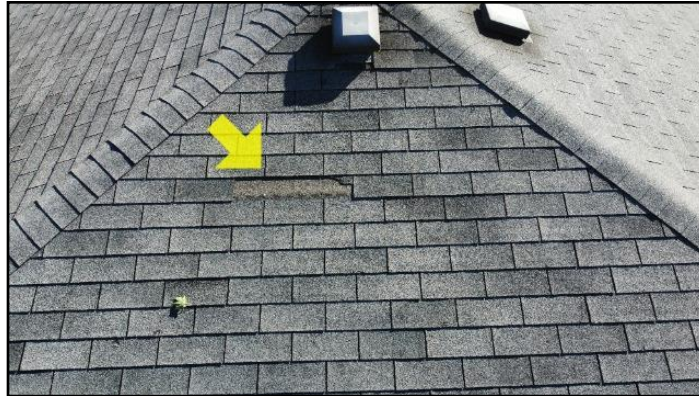
Condition: • [Missing, loose or torn](#)

Implication(s): Chance of water damage to structure, finishes and contents

Missing/torn shingle(s)

Task: Repair

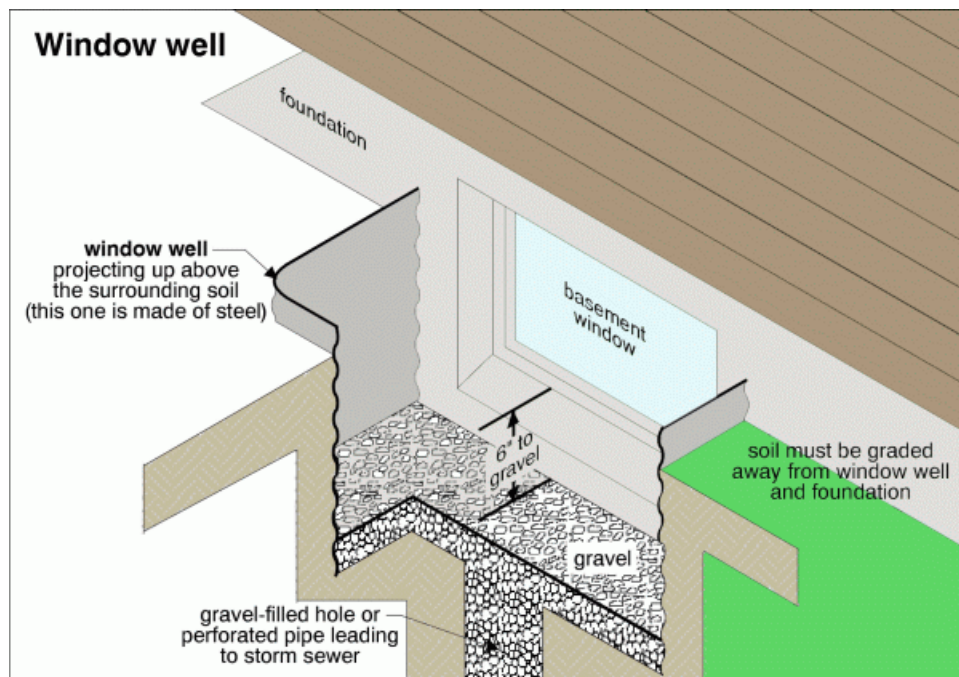
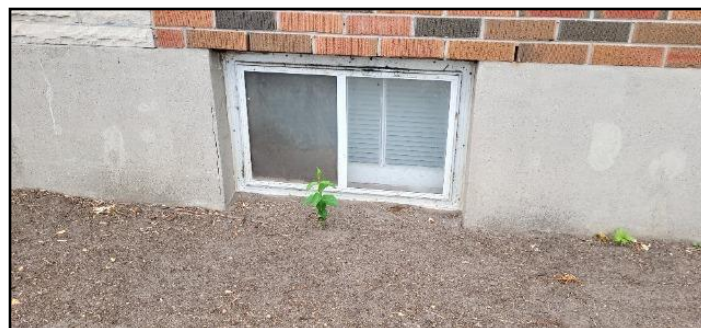
This window is at grade level. To reduce the potential for damage, a window well should be installed. Efforts should be made to keep water/snow away from the window until corrections are made. A window well cover can be a temporary proactive measure.

Implication(s): Chance of water damage to structure, finishes and contents | Material deterioration

Missing window well

Task: Correct - Install window well

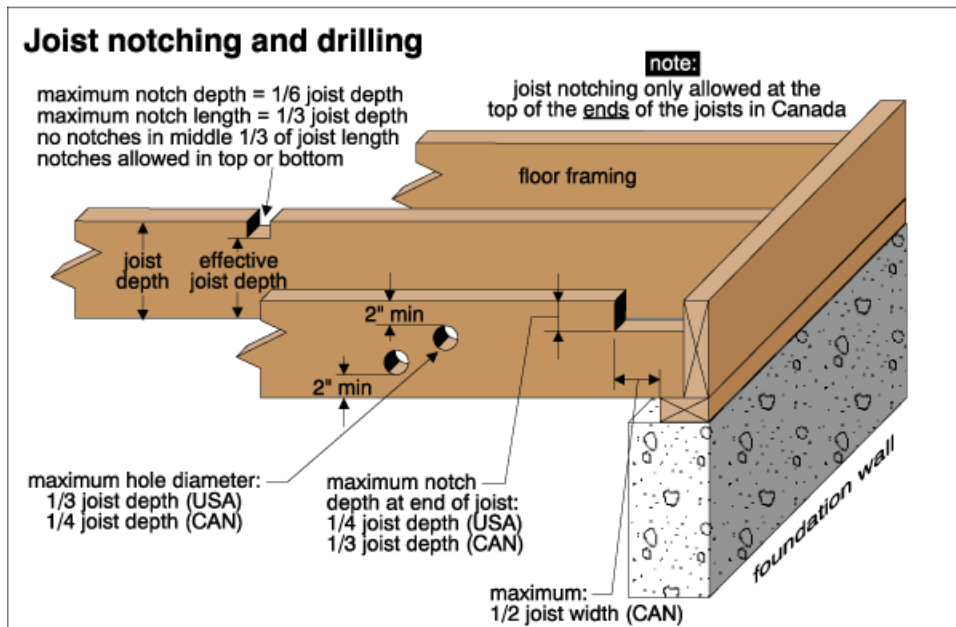
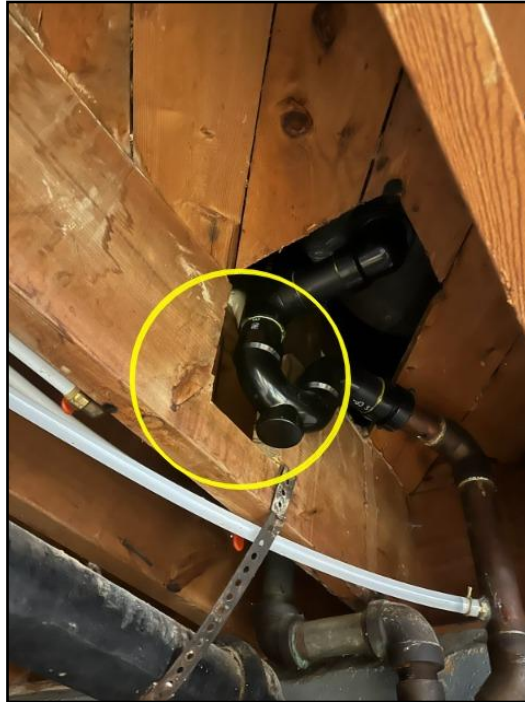
A joist has been notched to accommodate the bathtub plumbing trap. A bathtub can have significant weight when filled with water. A qualified contractor should advise on the appropriate repair method to re-support the joist.

Implication(s): Weakened structure

Notched joist

Task: Repair

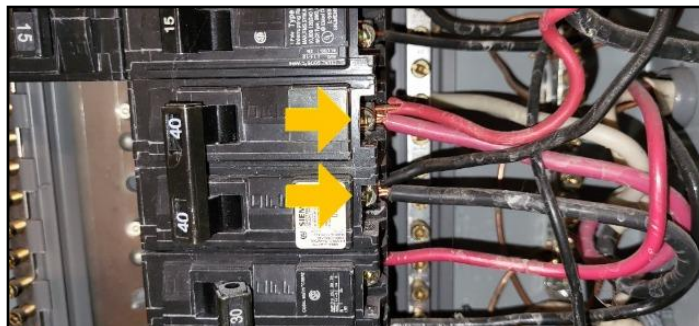
A qualified electrician should further evaluate the breaker size compared to the gauge of wire. For example, there is a 40-amp breaker powering a 10-gauge wire. This breaker is also "double-tapped" with an 8-gauge stranded wire, which is generally not permitted.

Implication(s): Equipment overheating | Fire hazard

Breaker too big, Double taps

Task: Further evaluation

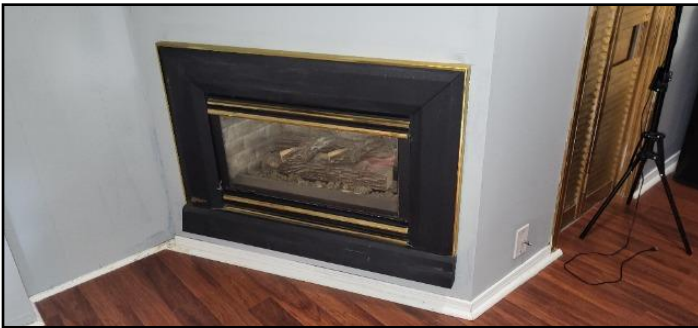
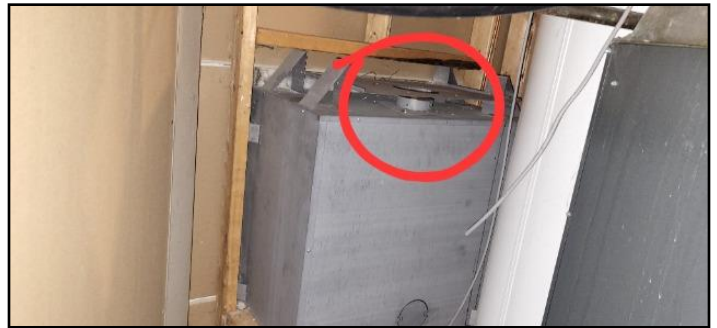
The exhaust vent installation for the gas fireplace is incomplete and this will allow hazardous combustion gases into the home if used. This can be a life safety issue. A technician will need to evaluate the installation compared to the manufacturer's installation requirements and make corrections before this fireplace can be safely used.

Inoperative (intallation incomplete)

Inoperative (installation incomplete)

Task: Correct

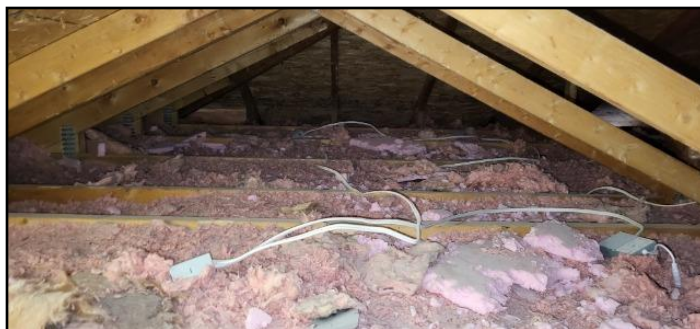
The attic insulation is lower than current standards. Increasing insulation is considered a discretionary improvement that may improve comfort and lower energy bills. Check your eligibility for any home efficiency rebates.

Implication(s): Increased heating and cooling costs

Amount less than current standards

Task: Improve

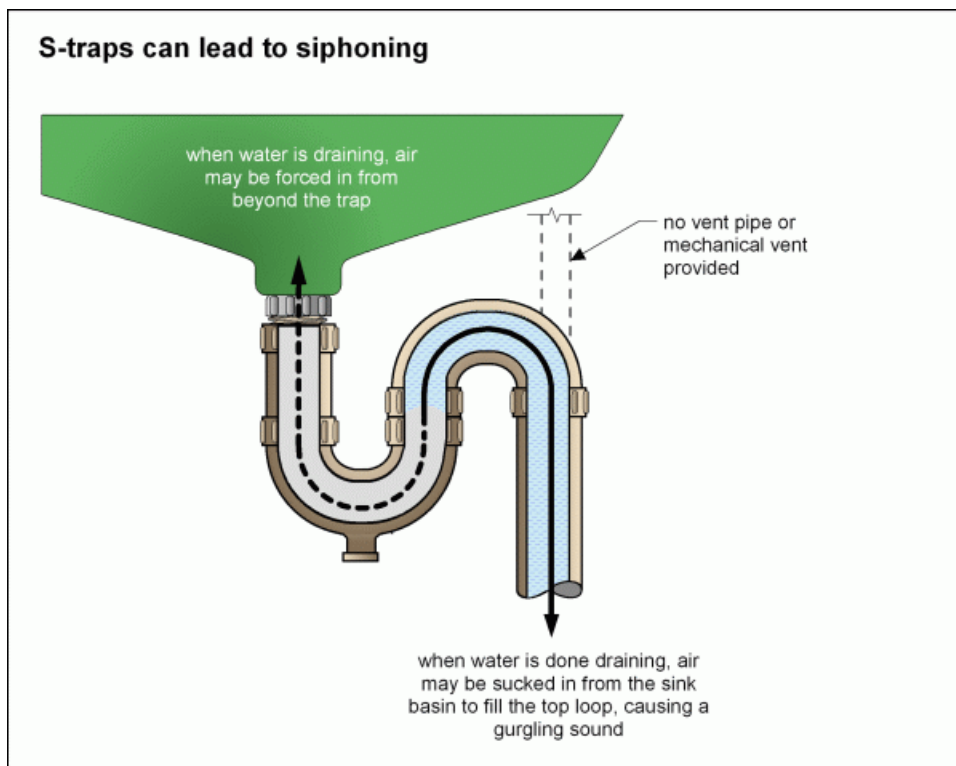
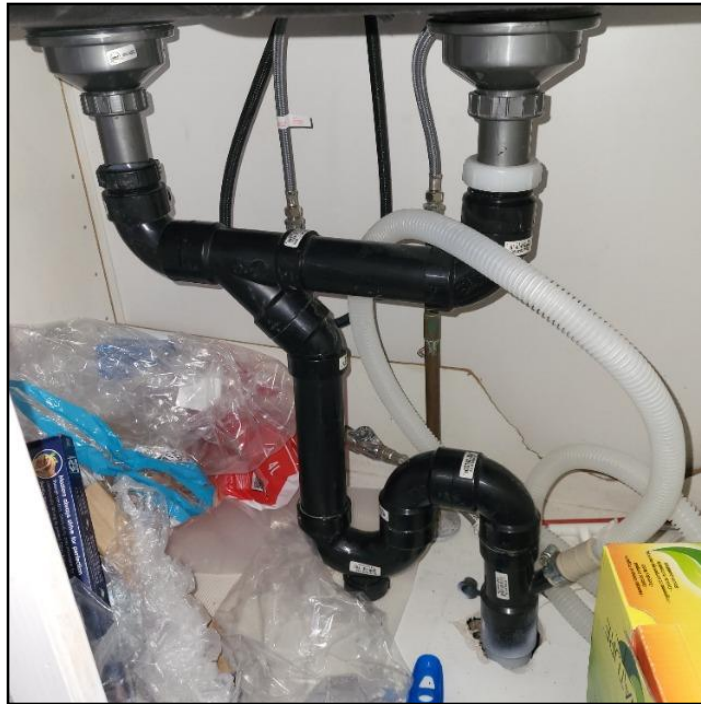
Residential traps should be P-type. The current waste plumbing installation (including the dishwasher connection downstream of the trap) should be evaluated by a qualified plumber and corrected. Monitor for odors that may indicate siphoning allowing sewer gases to enter the home.

Implication(s): Reduced operability | Fixtures slow to drain

Nonstandard shape

Task: Correct

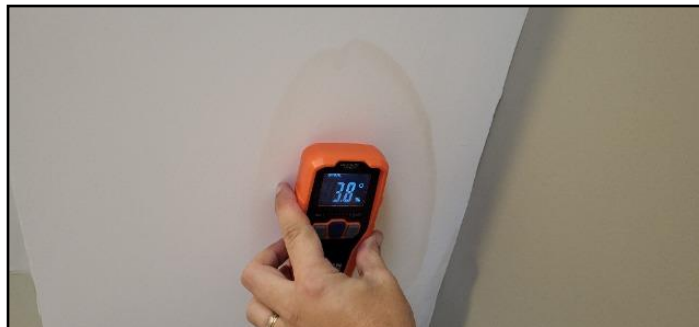
The stain was checked with a moisture meter after running water in the bathroom above and did not have elevated levels at the time of the inspection. After repairs (i.e. painting) are completed, inspect the area periodically for any changes.

Implication(s): Chance of water damage to structure, finishes and contents

Water stain

Task: Repair, Monitor for future correction
