Client <b>OLUFSEN SHIP &amp; OFFSHORE AS</b>		Rpt. No. <b>4/1411211D</b>	Side No. <b>1</b>
Project <b>BESTILLING: 48705-1723</b>		Location / Date <b>Killingøy / 21.11.14</b>	
Manufacturer <b>OLUFSEN SHIP &amp; OFFSHORE AS</b>		Drawing No. <b>AF25-1012M09</b>	
Object <b>IN-SERVICE INSPECTION OF ROV FRAME</b>		Operator <b>D. L. COSTACHE/PCN322552</b>	
Weld No./Item I.D. <b>ROV ID: 05</b>		Examination Extent <b>100% OF BELOW</b>	
Code <b>ISO3452-1</b>	Procedure <b>OTI QP04/</b>	Acceptance Criteria <b>DNV Classification note 7 Sect. 4.8 /ISO 5817</b>	
Penetrant <b>Bycotest RP20</b>	Cleaner <b>Bycotest C10</b>	Developer <b>Bycotest D30A</b>	UV Light <b>-</b>
Material Type <b>Aluminium</b>	Joint Configuration <b>Diverse /</b>	WPS/Process <b>/ 131</b>	Ambient Light <b>&gt; 1000Lux</b>
			Ambient Temp. (°C) <b>&gt;18</b>
			Surface Condition <b>Acceptable</b>
			Pen. Time (minutes) <b>20</b>
			Dev. Time (minutes) <b>20</b>

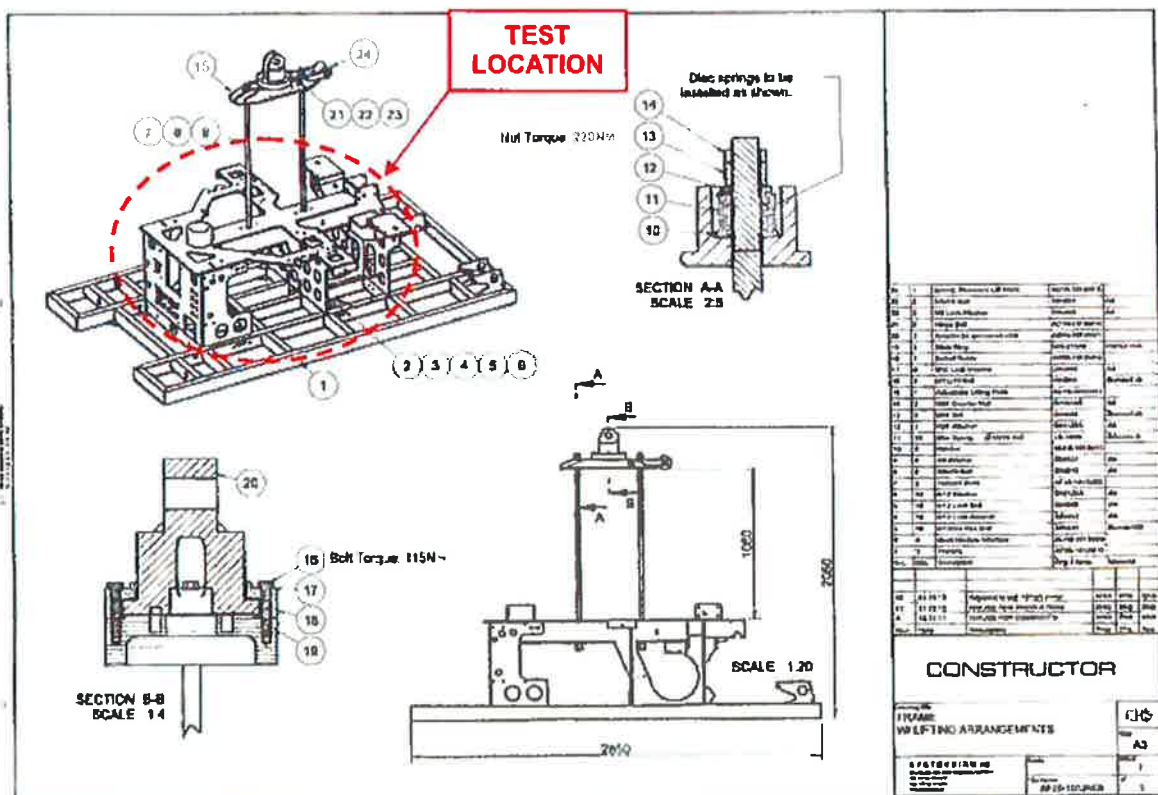
Acceptable To Specification
