# **Inspection Report**

**Property Address:**  
103 Fawnbrook Drive  
Greer SC 29650

**Date:12/4/2019**

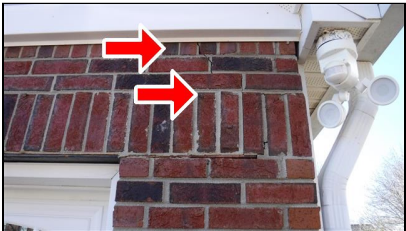
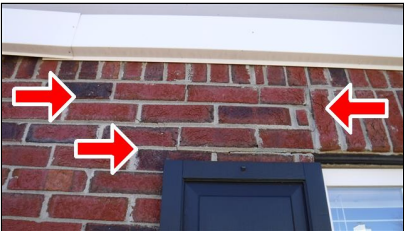
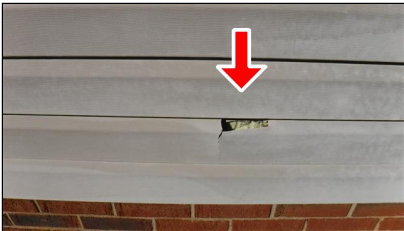
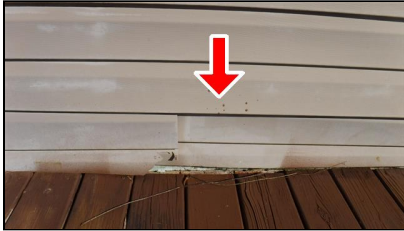
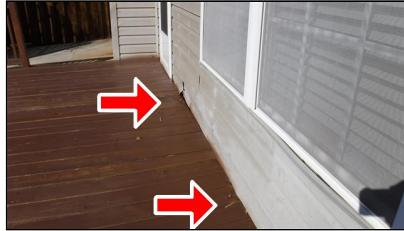
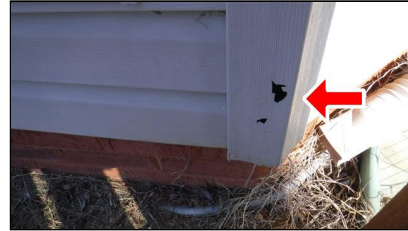
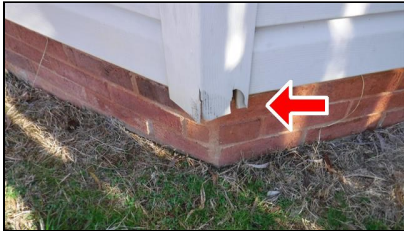
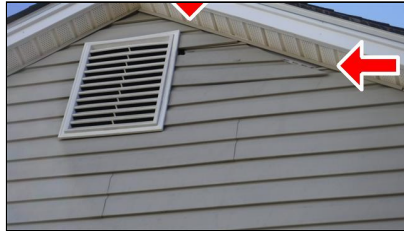
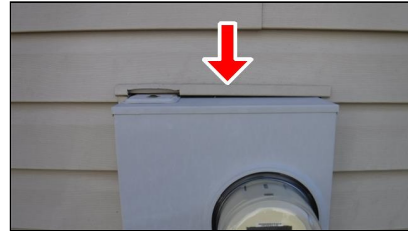
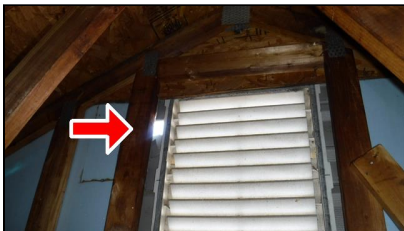
**1.0** On the front brick siding, on the right side of the garage door opening, the brick has shifted as indicated by the crack at the top and there is a crack in the brick siding over the front left window, have reviewed/repared by a qualified contractor.

The siding is loose on the rear of the home & upper right gable wall, damaged in many areas and there is a hole in the upper right gable wall, have reviewed/repared by a qualified contractor.

Sealant needed around the electric meter housing to prevent water entry behind it, have properly sealed by a qualified contractor.

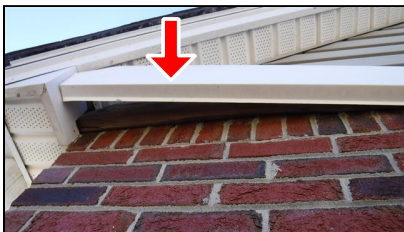
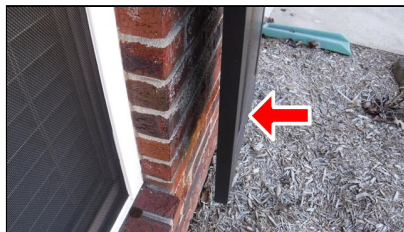
**1.1** On the front left gable wall, there is loose trim, have repaired by a qualified contractor.  
The front shutters are loose in many areas, have repaired by a qualified contractor.

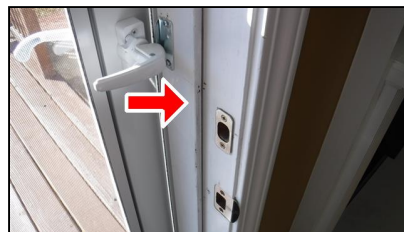
1.3 Item 1(Picture)

**1.3** The rear door is missing a piece of weather stripping and the rear door & door to the garage deadbolts are difficult to lock/unlock, have repaired by a qualified contractor.

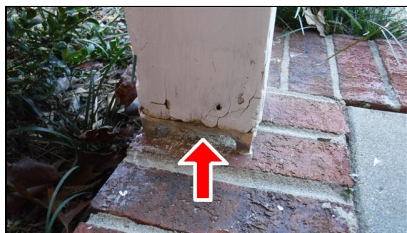
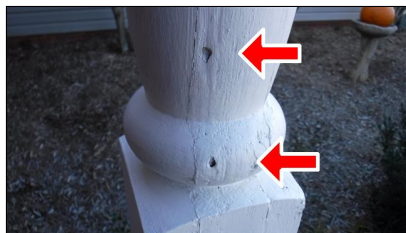
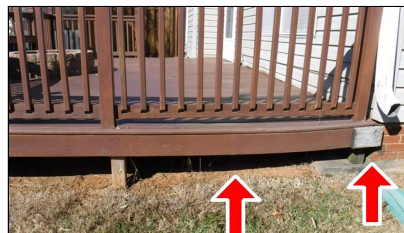
**1.5** There is rot on the front porch post at the bottom & in the middle, have reviewed/repared by a qualified contractor.

On the rear deck, one of its band joists is sagging/not properly attached to its post, the deck is not level and most likely is not sitting on proper footings, have reviewed/repared by a qualified contractor.

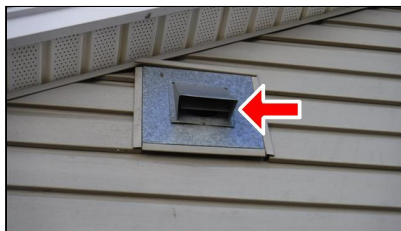
1.10 Item 1(Picture)

**1.10** On the right side of the home, the dryer vent door will not close, have cleaned/repared by a qualified contractor to prevent drafts & unwanted pest entry.

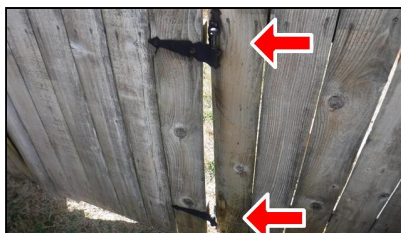
1.11 Item 1(Picture)

**1.11** The fence gate on the left side has come off the fence, have repaired by a qualified contractor.

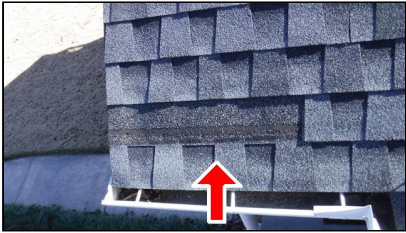
2.0 Item 1(Picture)

**2.0** On the front left gable roof, on its right side, there is a missing shingle, have repaired by a qualified roofer.

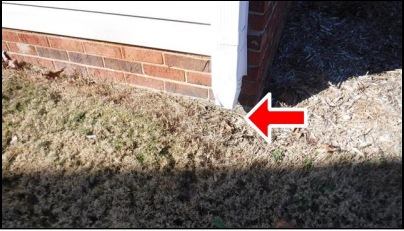
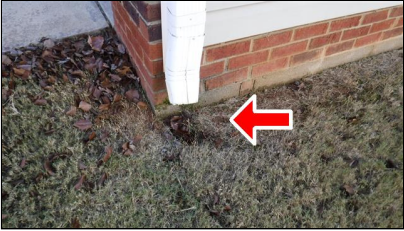
**2.2** Several of the downspouts do not have splashblocks or extensions on them, add where needed to direct water away from the foundation.

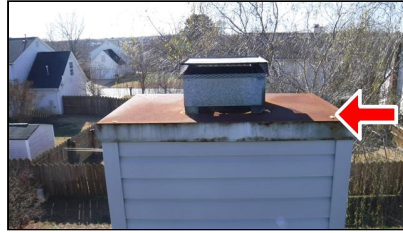
2.5 Item 1(Picture)

**2.5** The metal chimney crown does not slope away from the center, this allows standing water & it is heavy rusted, this can allow leakage, have reviewed/ repaired by a qualified chimney professional.

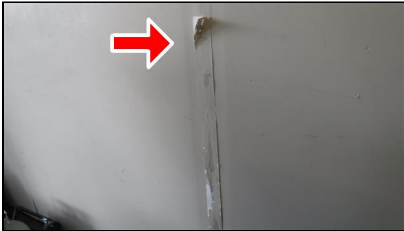
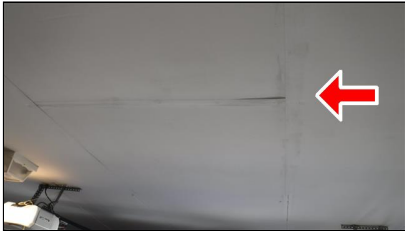
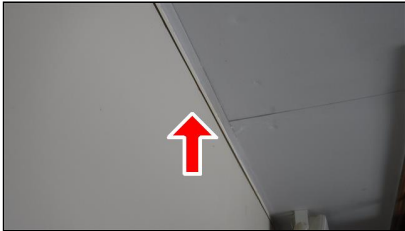
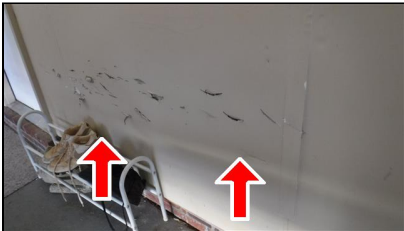
3.2 In the garage, there are many holes in the drywall and the drywall tape is coming off many seams, have repaired by a qualified contractor.

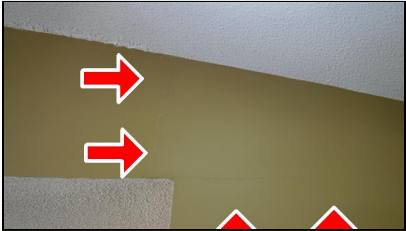
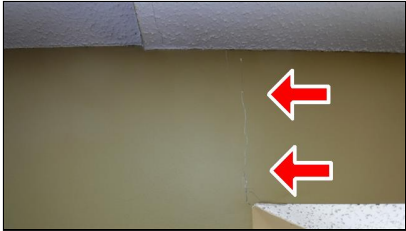
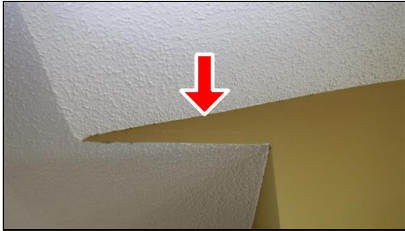
**4.1** On the living room wall at the kitchen opening, on the wall above the breakfast nook bay & on the wall above the master hallway, there are cracks in the drywall, these do not appear to be structural, have reviewed/repared by a qualified contractor.

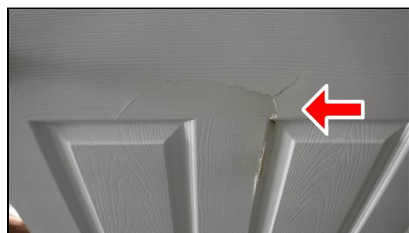
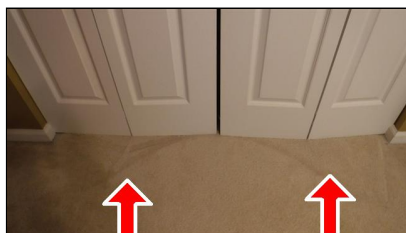
**4.5** The master toilet room door rubs on its jamb & the master bedroom door is damaged, have repaired by a qualified contractor.

The front right bedroom closet bi-fold doors rub hard on the carpet, have repaired by a qualified contractor.

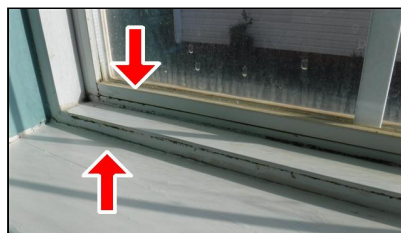
4.6 Item 1(Picture)

**4.6** On the master bath window over the tub, there are some stains indicating possible previous leakage, have reviewed by a qualified contractor for further evaluation & repaired if needed.

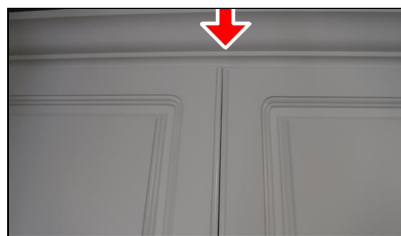
6.9 Item 1(Picture)

**6.9** Several of the double cabinet doors rub against each other, have repaired/adjusted by a qualified contractor.

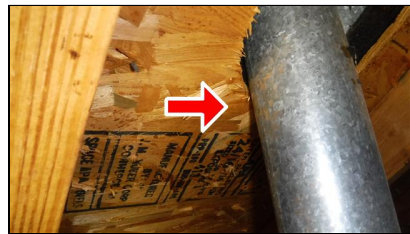
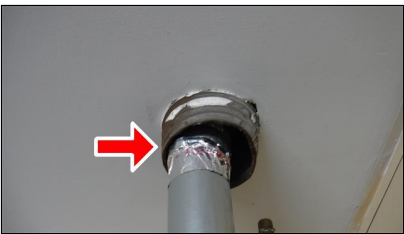
**7.3** Above the water heater, one of the flue pipe joints does not appear to be put together correctly & have been taped, have reviewed/repared by a qualified plumber.  
In the attic, the water heater flue pipe is touching the wood at the roof, B-vent flue pipe has to maintain a 1 inch clearance to combustibles & insulation, have repaired by a qualified contractor.

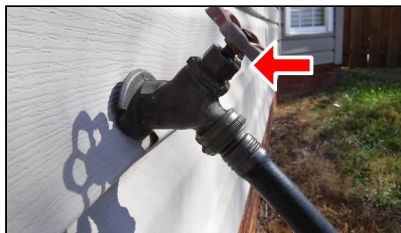
7.5 Item 1(Picture)

**7.5** The exterior hose spigots are leaking at their valve stem when the water is turned on & there is back pressure applied, have repaired by a qualified plumber.

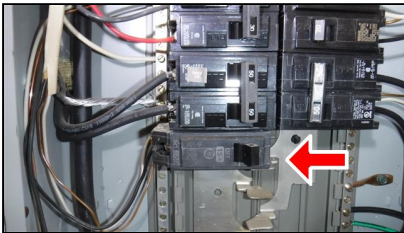
8.2 Item 1(Picture)

**8.2** In the garage panel, one of the breakers is not the panel type (has GE breaker in Siemens panel) and this one breaker is not labeled, have repaired by a qualified electrician.

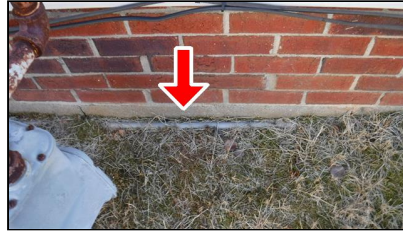
8.4 Item 1(Picture)

**8.4** There is electrical wiring in conduit that is partially buried along the right & rear of the home, it is not at the proper depth, have reviewed/repared by a qualified electrician.

In the attic at the power fan, its wiring is spliced outside its junction box, have repaired by a qualified electrician.

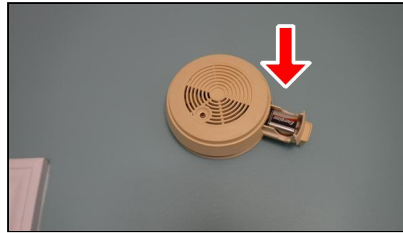
8.9 Item 1(Picture)

**8.9** The smoke detectors have their batteries pulled out, have replaced and very operation.

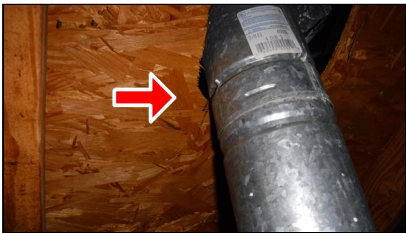
9.4 Item 1(Picture)

**9.4** In the attic, the furnace flue pipe is in contact with the roof wood sheathing, this is a fire hazard, this type vent (B-vent) has to maintain a 1 inch clearance to combustibles & insulation, have repaired by a qualified HVAC contractor.

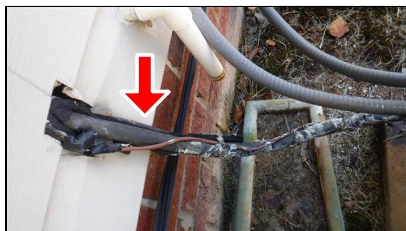
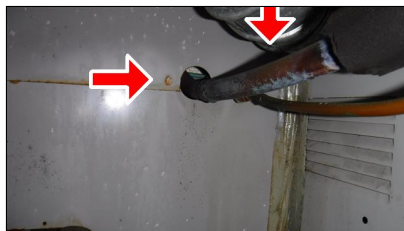
**9.5** On the A/C coil in the attic, there are openings around the refrigeration piping, this is wasting conditioned air, have properly sealed by a qualified HVAC contractor.

In the attic & on the exterior at the compressor unit, there is missing insulation on the refrigeration piping, have repaired by a qualified HVAC contractor.

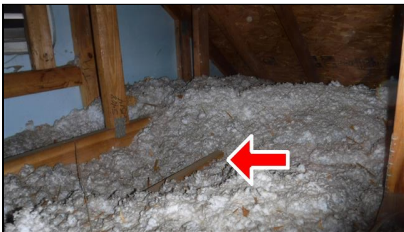
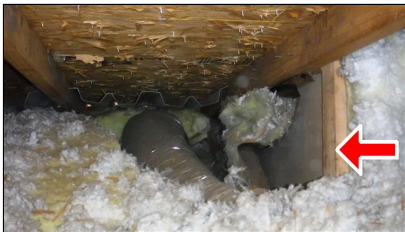
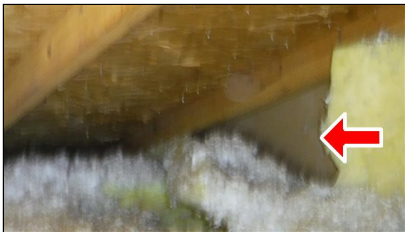
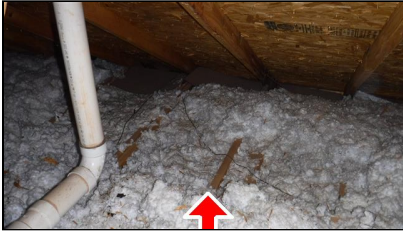
**10.0** In the attic, the insulation has come off the skylight wells in a couple of areas and the blown insulation is low in several areas in the attic, have repaired by a qualified contractor.

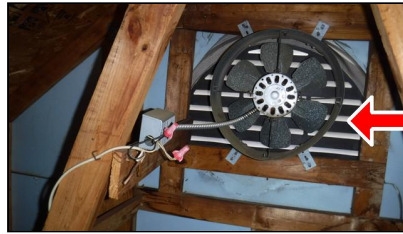
10.5 Item 1(Picture)

**10.5** The attic power fan was not operational and would be ineffective since it is installed on a gable vent, have reviewed/repaired by a qualified contractor.
