Inspection Report

Property Address:
103 Fawnbrook Drive
Greer SC 29650

MacBar Consulting Inc

Date:12/4/2019

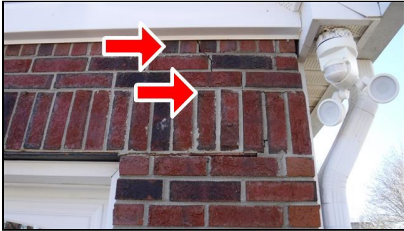
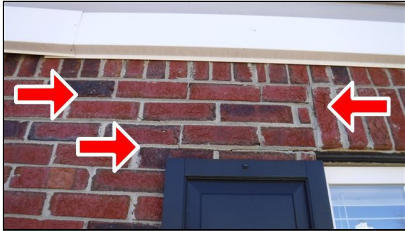
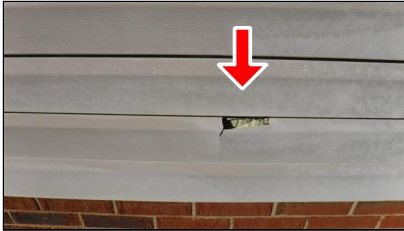
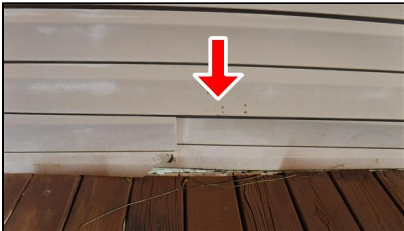
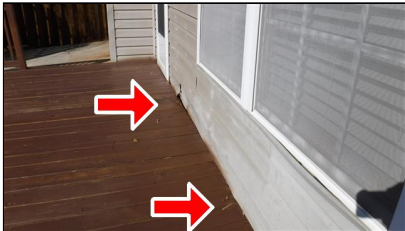
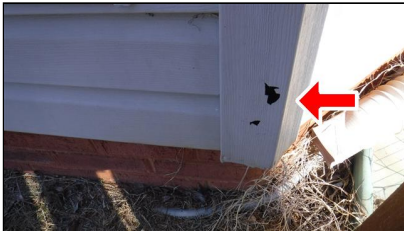
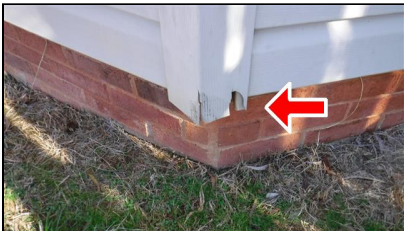
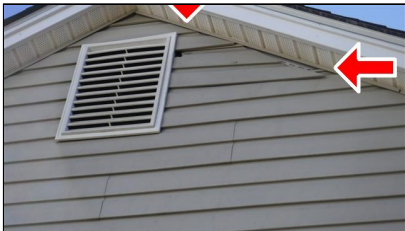
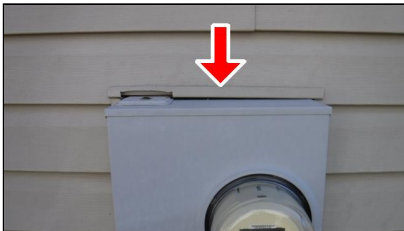
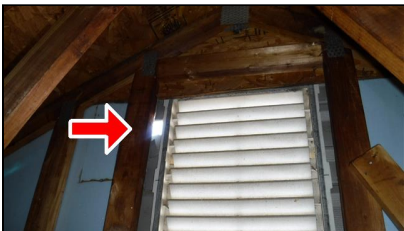
1.0 On the front brick siding, on the right side of the garage door opening, the brick has shifted as indicated by the crack at the top and there is a crack in the brick siding over the front left window, have reviewed/repared by a qualified contractor.

The siding is loose on the rear of the home & upper right gable wall, damaged in many areas and there is a hole in the upper right gable wall, have reviewed/repared by a qualified contractor.

Sealant needed around the electric meter housing to prevent water entry behind it, have properly sealed by a qualified contractor.

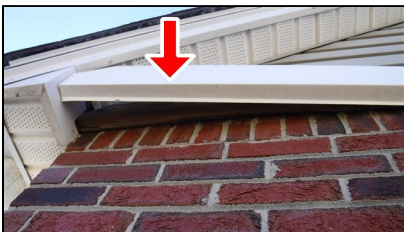
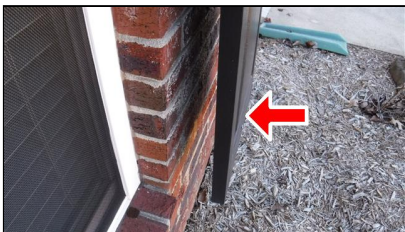
1.1 On the front left gable wall, there is loose trim, have repaired by a qualified contractor.
The front shutters are loose in many areas, have repaired by a qualified contractor.

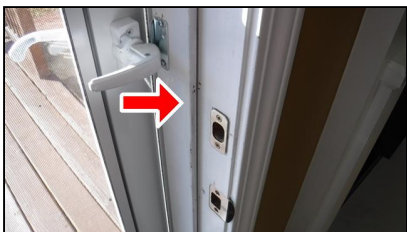
1.3 Item 1(Picture)

1.3 The rear door is missing a piece of weather stripping and the rear door & door to the garage deadbolts are difficult to lock/unlock, have repaired by a qualified contractor.

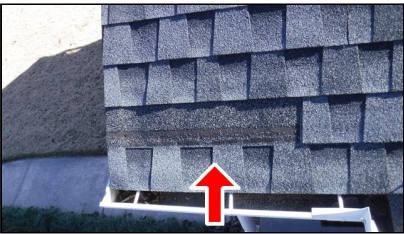
2.0 Item 1(Picture)

On the front left gable roof, on its right side, there is a missing shingle, have repaired by a qualified roofer.

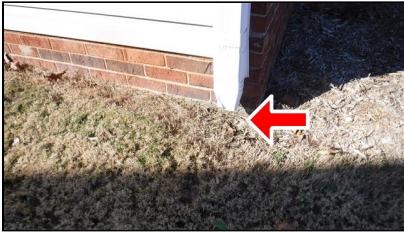
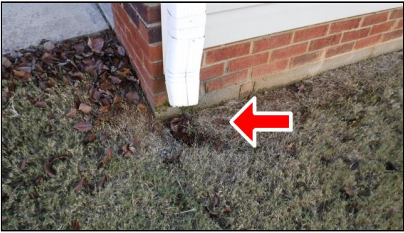
2.2 Item 1(Picture)2.2 Item 2(Picture)

Several of the downspouts do not have splashblocks or extensions on them, add where needed to direct water away from the foundation.

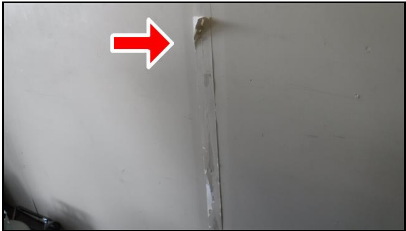
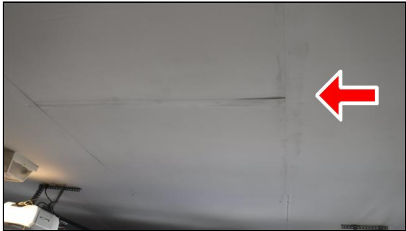
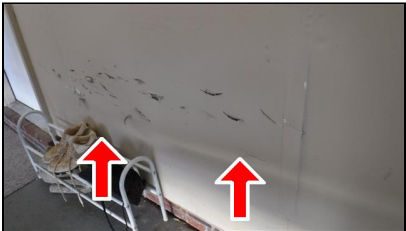
3.2 In the garage, there are many holes in the drywall and the drywall tape is coming off many seams, have repaired by a qualified contractor.

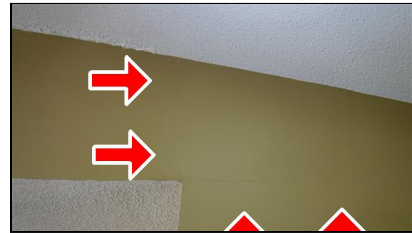
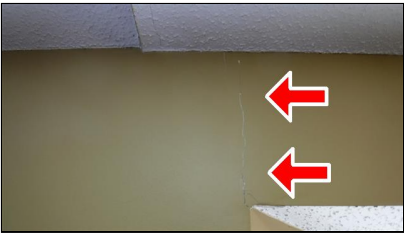
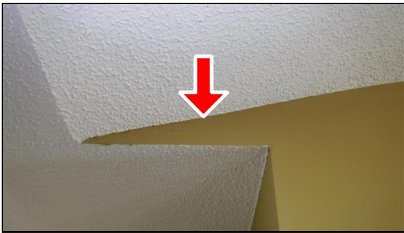
4.1 On the living room wall at the kitchen opening, on the wall above the breakfast nook bay & on the wall above the master hallway, there are cracks in the drywall, these do not appear to be structural, have reviewed/repared by a qualified contractor.

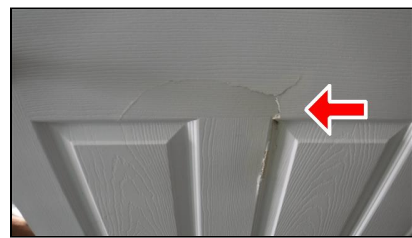
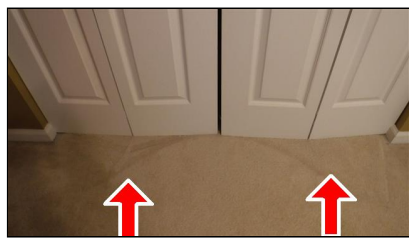
4.5 The master toilet room door rubs on its jamb & the master bedroom door is damaged, have repaired by a qualified contractor.

The front right bedroom closet bi-fold doors rub hard on the carpet, have repaired by a qualified contractor.

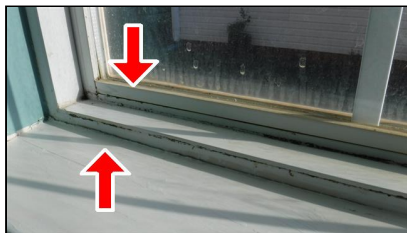
4.6 Item 1(Picture)

4.6 On the master bath window over the tub, there are some stains indicating possible previous leakage, have reviewed by a qualified contractor for further evaluation & repaired if needed

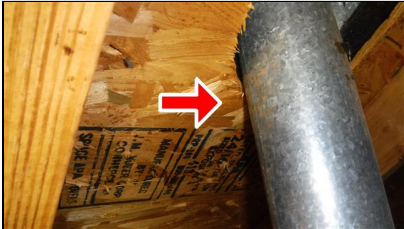
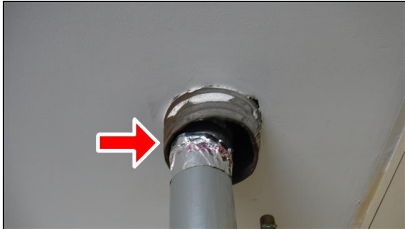
7.3 Above the water heater, one of the flue pipe joints does not appear to be put together correctly & have been taped, have reviewed/repaired by a qualified plumber.

In the attic, the water heater flue pipe is touching the wood at the roof, B-vent flue pipe has to maintain a 1 inch clearance to combustibles & insulation, have repaired by a qualified contractor.

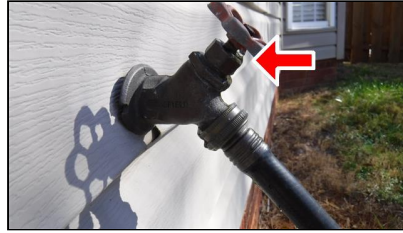
7.5 Item 1(Picture)

7.5 The exterior hose spigots are leaking at their valve stem when the water is turned on & there is back pressure applied, have repaired by a qualified plumber.

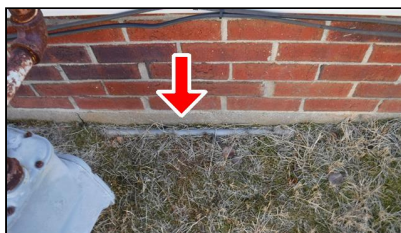
8.4 Item 1(Picture)

8.4 There is electrical wiring in conduit that is partially buried along the right & rear of the home, it is not at the proper depth, have reviewed/repared by a qualified electrician.

In the attic at the power fan, its wiring is spliced outside its junction box, have repaired by a qualified electrician.

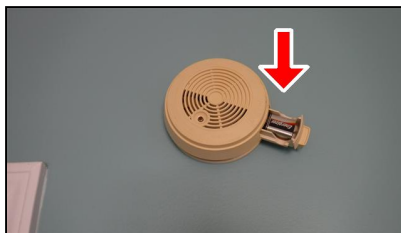
8.9 Item 1(Picture)

8.9 The smoke detectors have their batteries pulled out, have replaced and very operation.

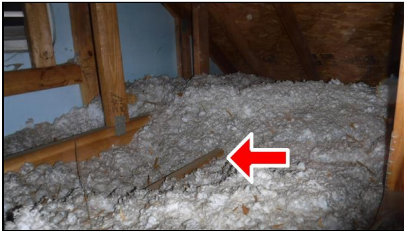
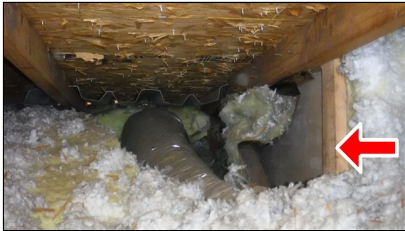
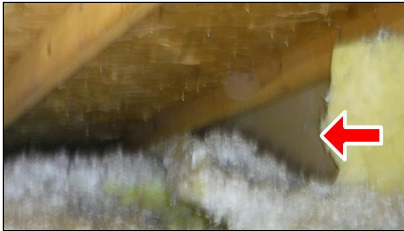
10.0 In the attic, the insulation has come off the skylight wells in a couple of areas and the blown insulation is low in several areas in the attic, have repaired by a qualified contractor.

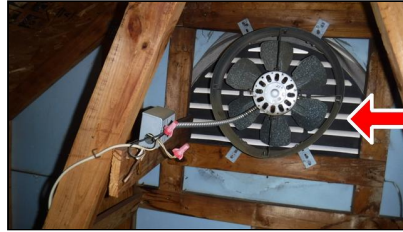
10.5 Item 1(Picture)

10.5 The attic power fan was not operational and would be ineffective since it is installed on a gable vent, have reviewed/repaired by a qualified contractor.
