Report on the investigation of  
the enclosed space accident  
on board the fishing vessel

***Sunbeam (FR487)***

in Fraserburgh, Scotland

on 14 August 2018

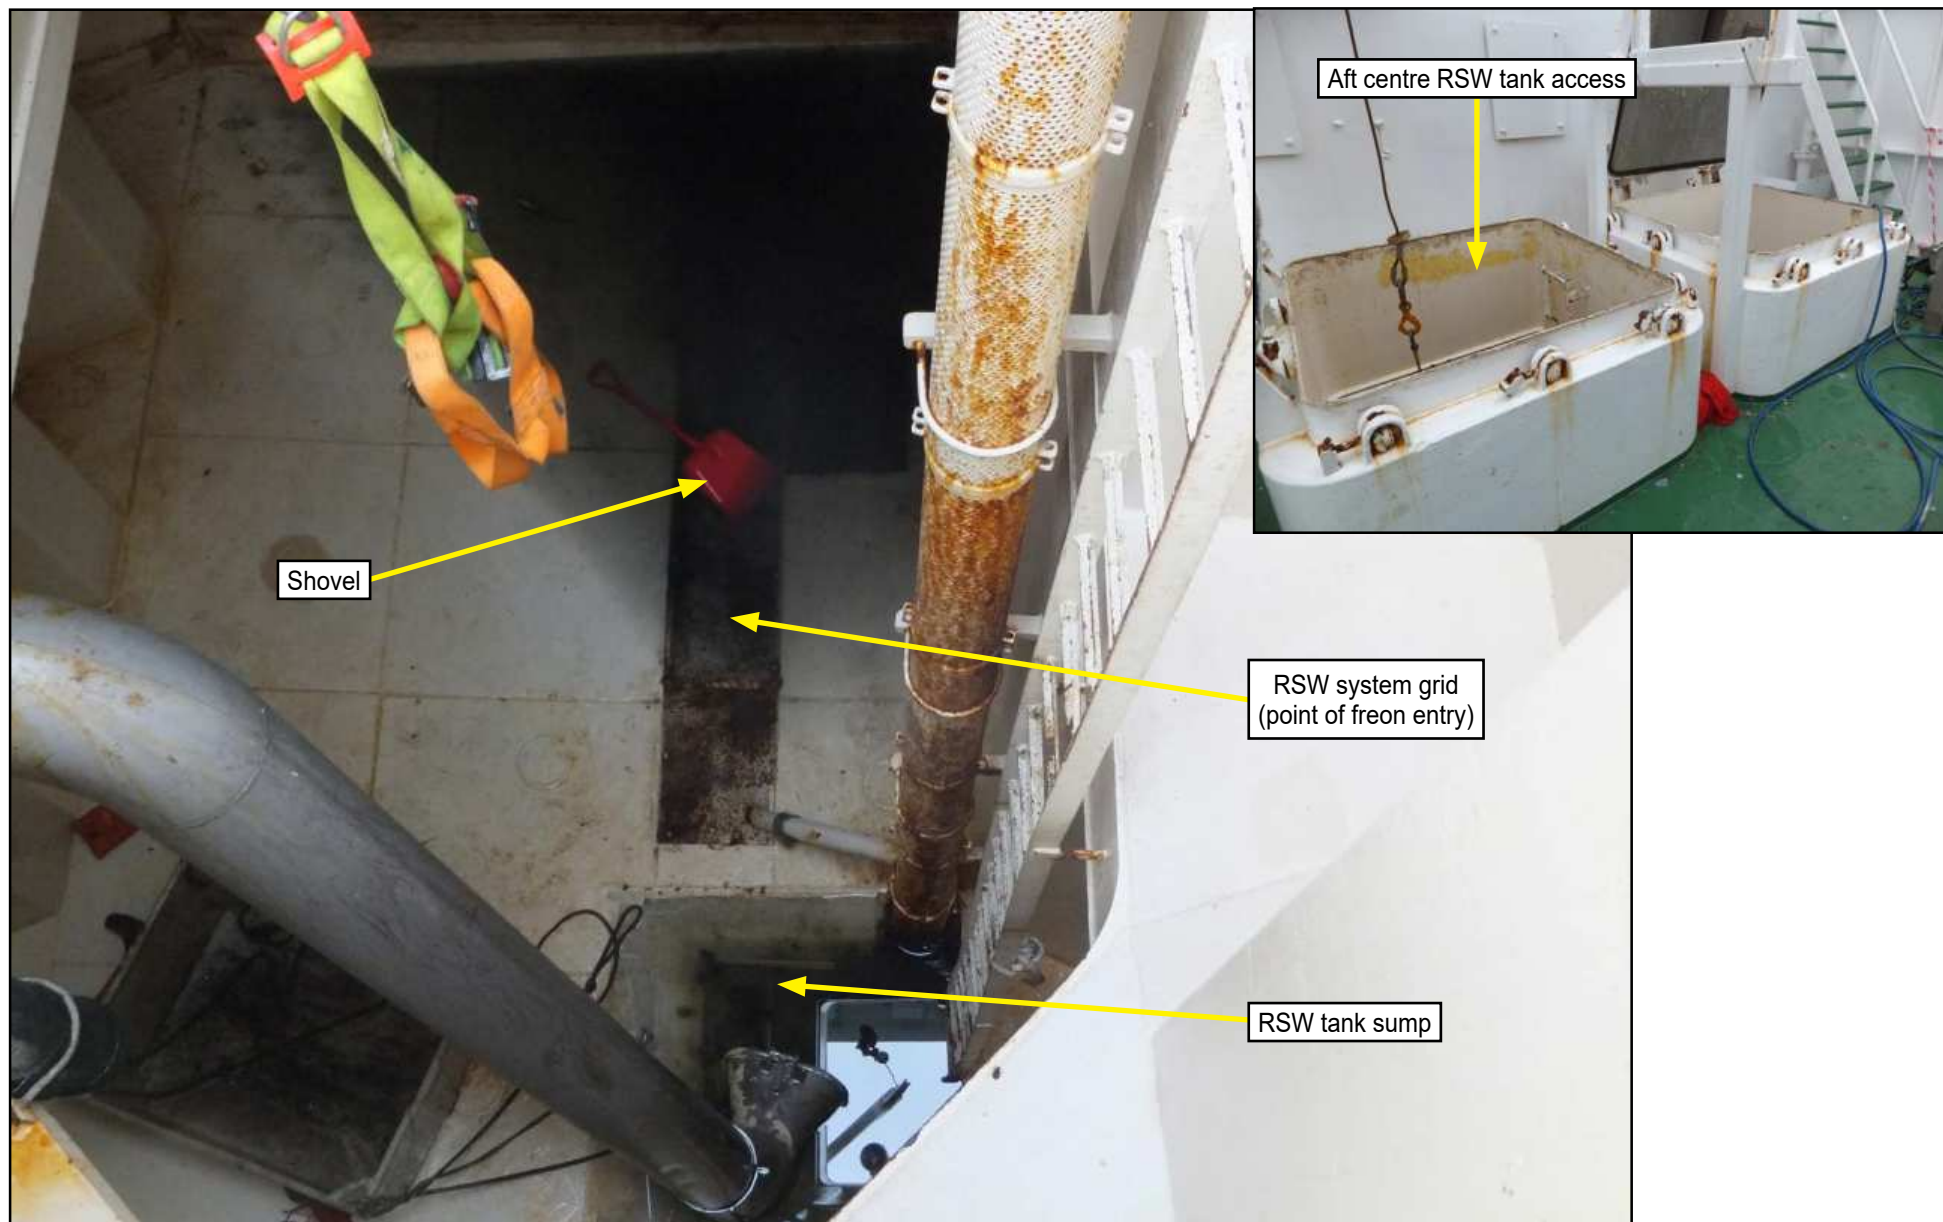
Returning to the upper deck, the 2/E looked into the aft centre RSW tank (**Figure 2**) and saw Mr Ironside lying face down at the bottom of the tank, near a pool of water. The 2/E raised the alarm by shouting loudly, and other members of the crew ran to assist. The 2/E then descended the ladder into the tank and found that Mr Ironside was unconscious and not breathing. One of the deck crew also descended the ladder and assisted the 2/E with cardio pulmonary resuscitation.

**Figure 2:** *Sunbeam's* aft centre RSW tank after the accident showing the shovel and residual water with hatch access inset.

Although the aft centre RSW's tank hatch was open, there was no ventilation system inside, so the Freon settled in the lower part of the tank. Two of the crewmen at the bottom of the tank collapsed; however, the crewman who was on the ladder only reported throat tightening and light headedness, tending to confirm that higher concentrations of Freon were at the lower part of the tank, where Mr Ironside was found.

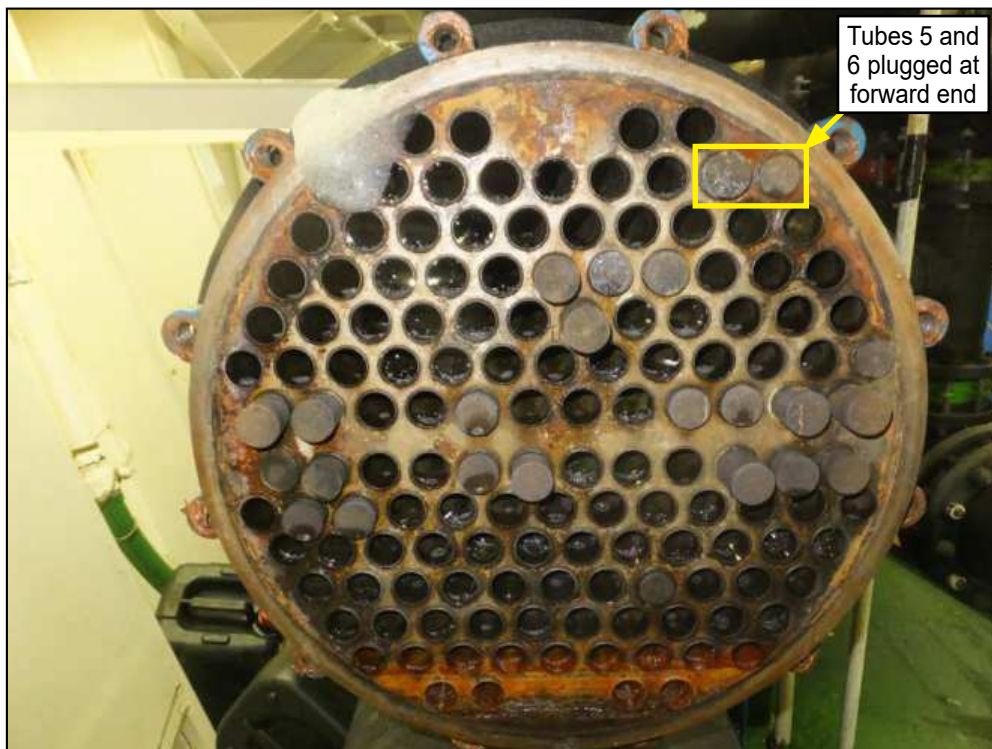
27 plugged tubes, 23 had a plug in each end and 4 of the tubes<sup>9</sup> had a plug fitted at only one end (**Figures 5a and 5b**). Pressure testing identified leaks on four of the tubes<sup>10</sup> in the starboard evaporator; one of which, tube 5, had been plugged at only one end.

**Figure 5a:** Sunbeam's starboard upper heat exchanger, forward end showing tubes 5 and 6 sealed with brass plugs

- *The method for sealing the leaking tubes by fitting brass plugs at both ends of a leaking tube was suitable... However, it is clear that a mistake was made in plugging Tube 5, when only its forward end was sealed. This was compounded by not having a post repair check process in place for the heat exchanger after the plugs were fitted. A post repair pressure test or pulling a vacuum and holding it for a period of time, prior to recharging the system with R22, would have clearly shown there were still leaks.*

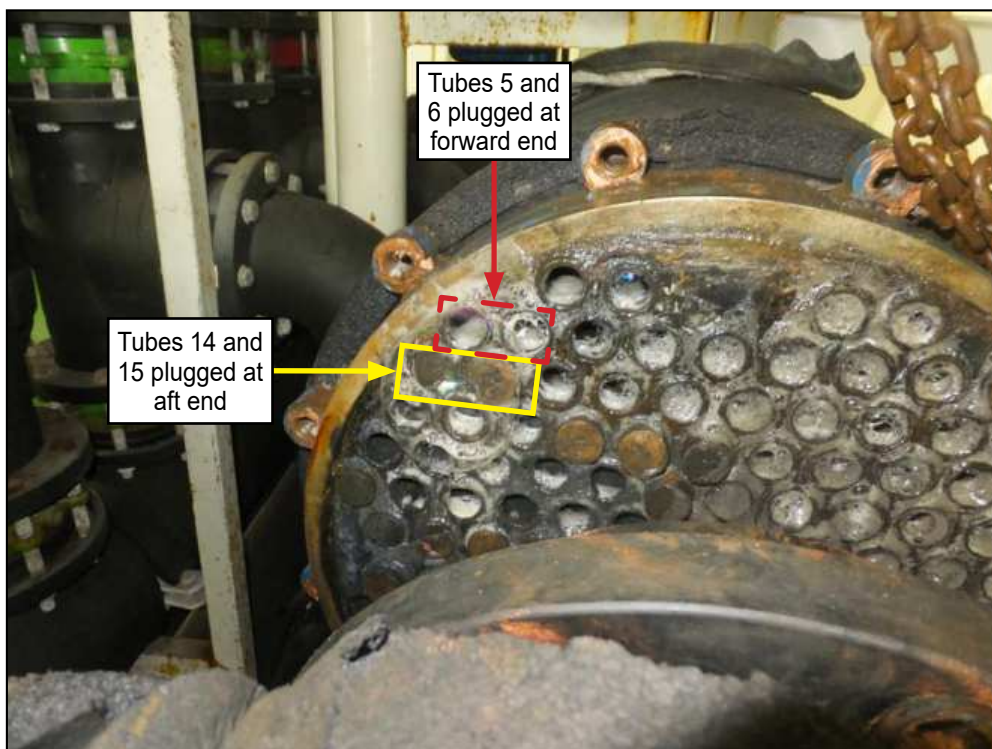
**Figure 5b:** Sunbeam's starboard upper heat exchanger, aft end showing tubes 14 and 15 sealed with brass plugs (immediately below tubes 5 and 6)

<sup>9</sup> Tubes 5, 6, 14 and 15 were plugged at only one end.

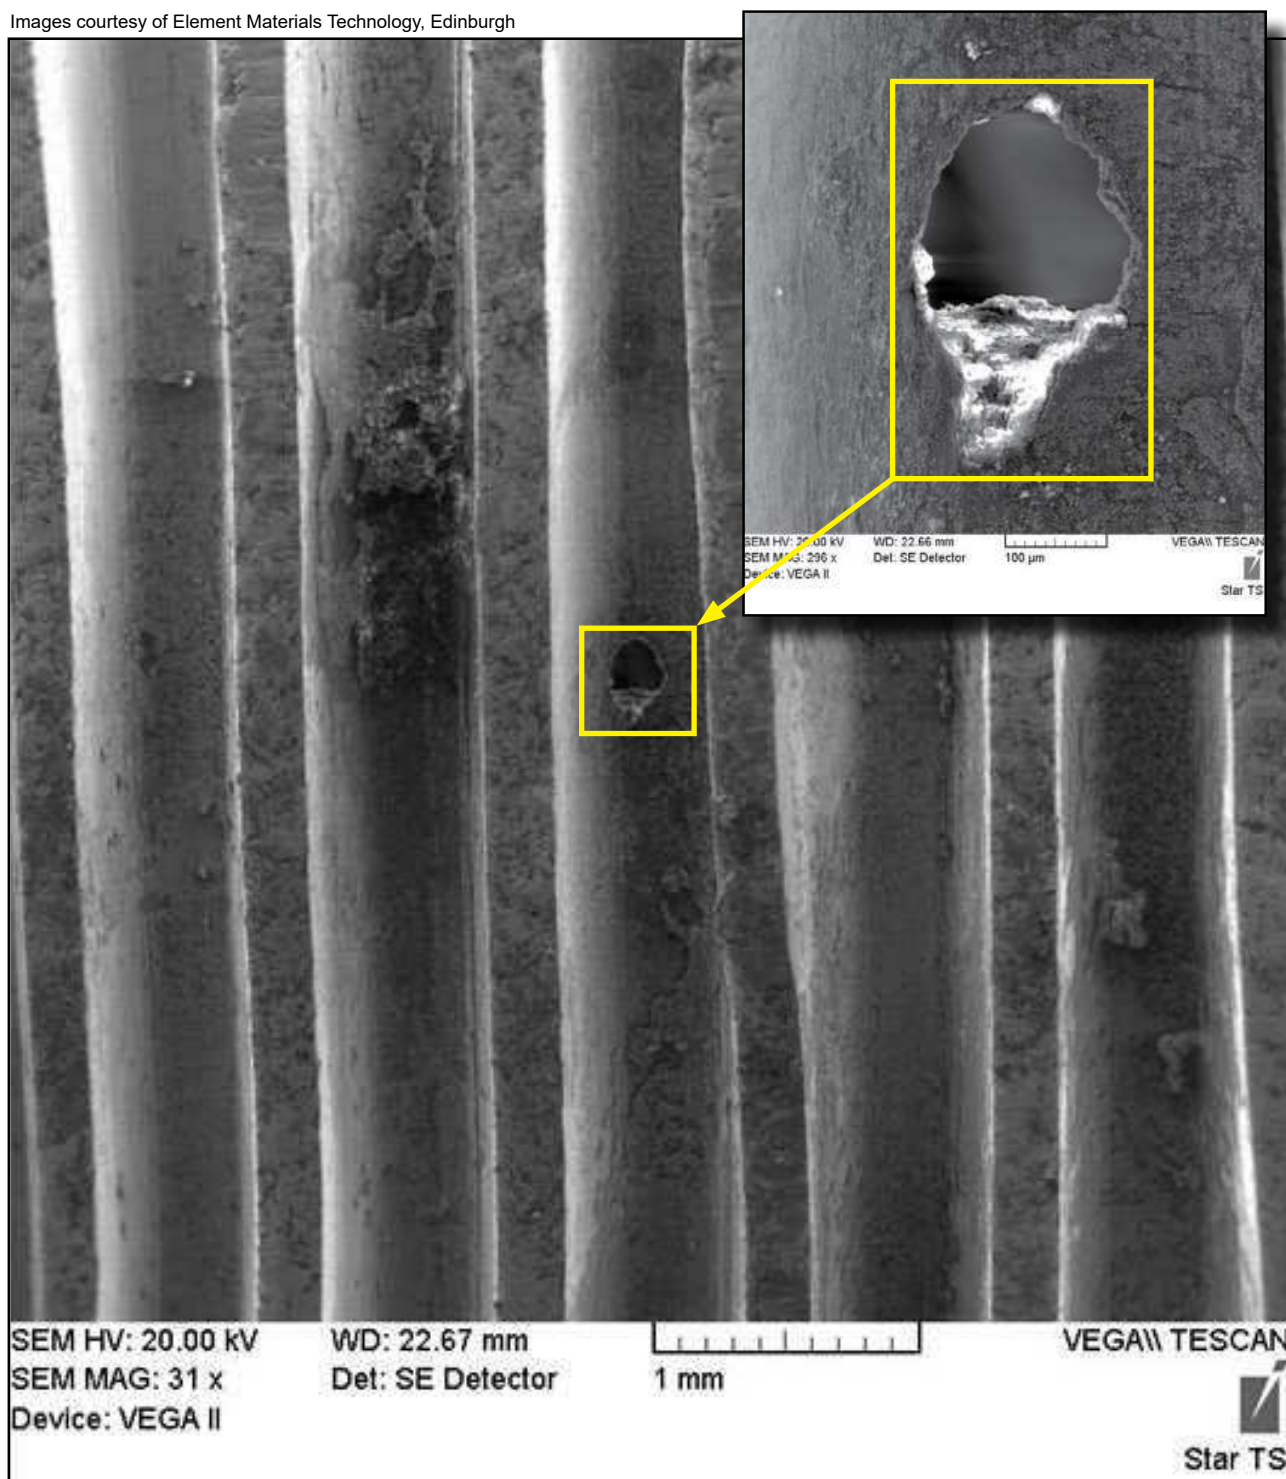
STS subcontracted Element Materials Technology (EMT) of Edinburgh to conduct metallurgical examination and test of tubes 5, 13, 60 and 71 that had failed leak tests on board and had been extracted from the starboard evaporator. These tests identified the presence of pinholes and cracks in the tubes (**Figure 6**) and EMT's report concluded that *'the failure of the tubes was attributable to pitting and cracking caused by intergranular corrosion which initiated in the tube bores.'*

**Figure 6:** Microscopic examination of failed heat exchanger tubes with detail inset

- *While corrosion was the key factor in the failure...the EMT report provides further evidence that there was internal pressure applied ...at the point of failure. The extent of corrosion at the point of failure was such that only a relatively small pressure difference would be needed to cause it.*

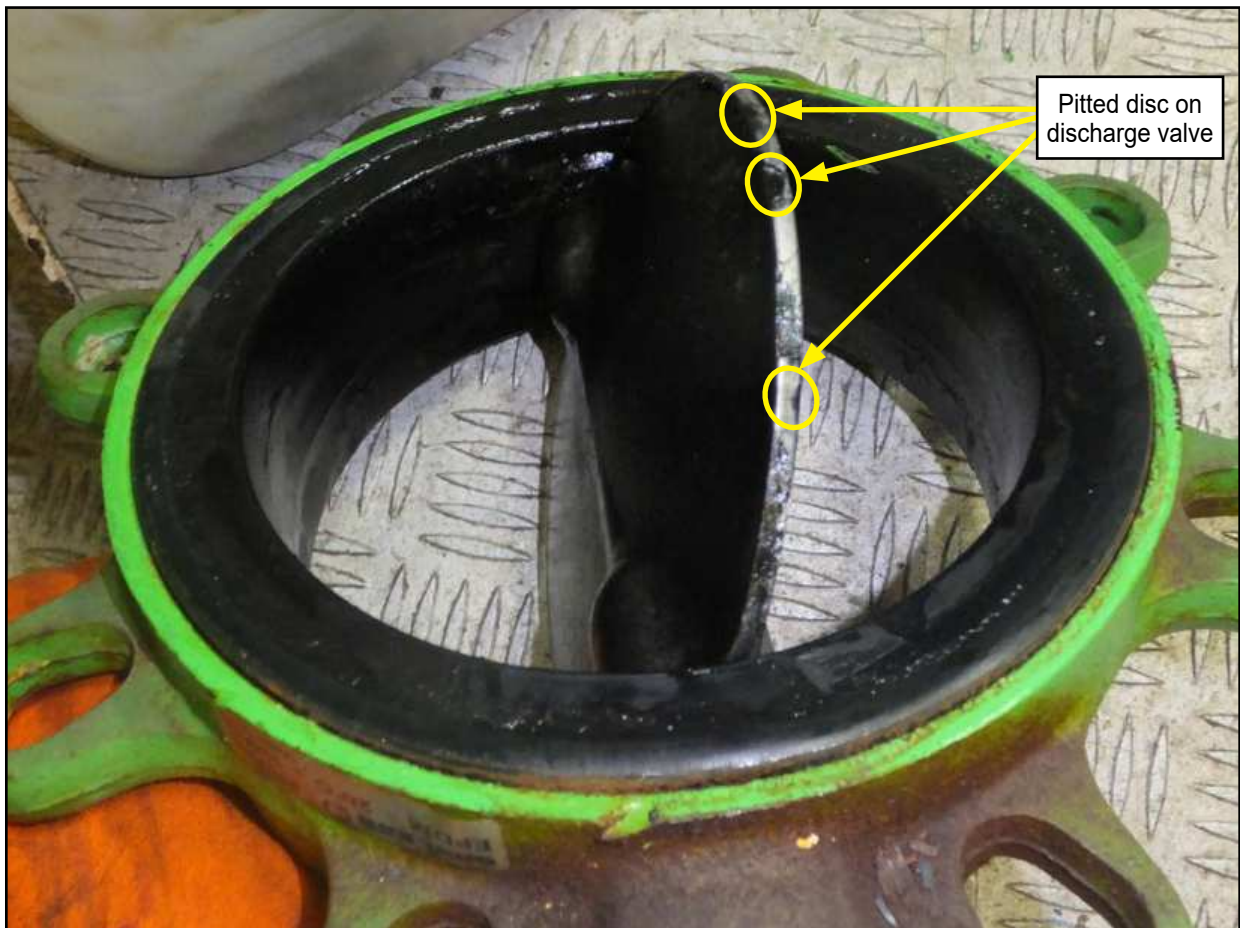
STS also removed the aft centre RSW tank's seawater inlet and return isolation valves for inspection and testing. Visual inspection of the pump discharge isolating valve for the aft centre RSW tank identified that its disc was damaged by significant notches around the edge (**Figure 7a**). Visual inspection of the pump suction valve for the aft centre RSW also showed a significant notch on the disc edge (**Figure 7b**). Visual inspection of the isolating valves for the other RSW tanks did not reveal significant disc damage.

- *The most direct route for R22 gas from the top starboard evaporator to any of the RSW Tanks was via a common manifold line that also had other top (pump discharge) isolating valves connecting it to the other aft tanks (**Figure 8**). It is my opinion that R22 was only seen in the middle aft tank as, although closed at the time of the incident, the top (pump discharge) isolating valve provided the path of least resistance to the R22. This was probably due to the extent of damage seen on its disc edge compared to the other adjacent valves.*

**Figure 7a:** Aft centre RSW pump discharge isolating valve showing significant notches on disc edge

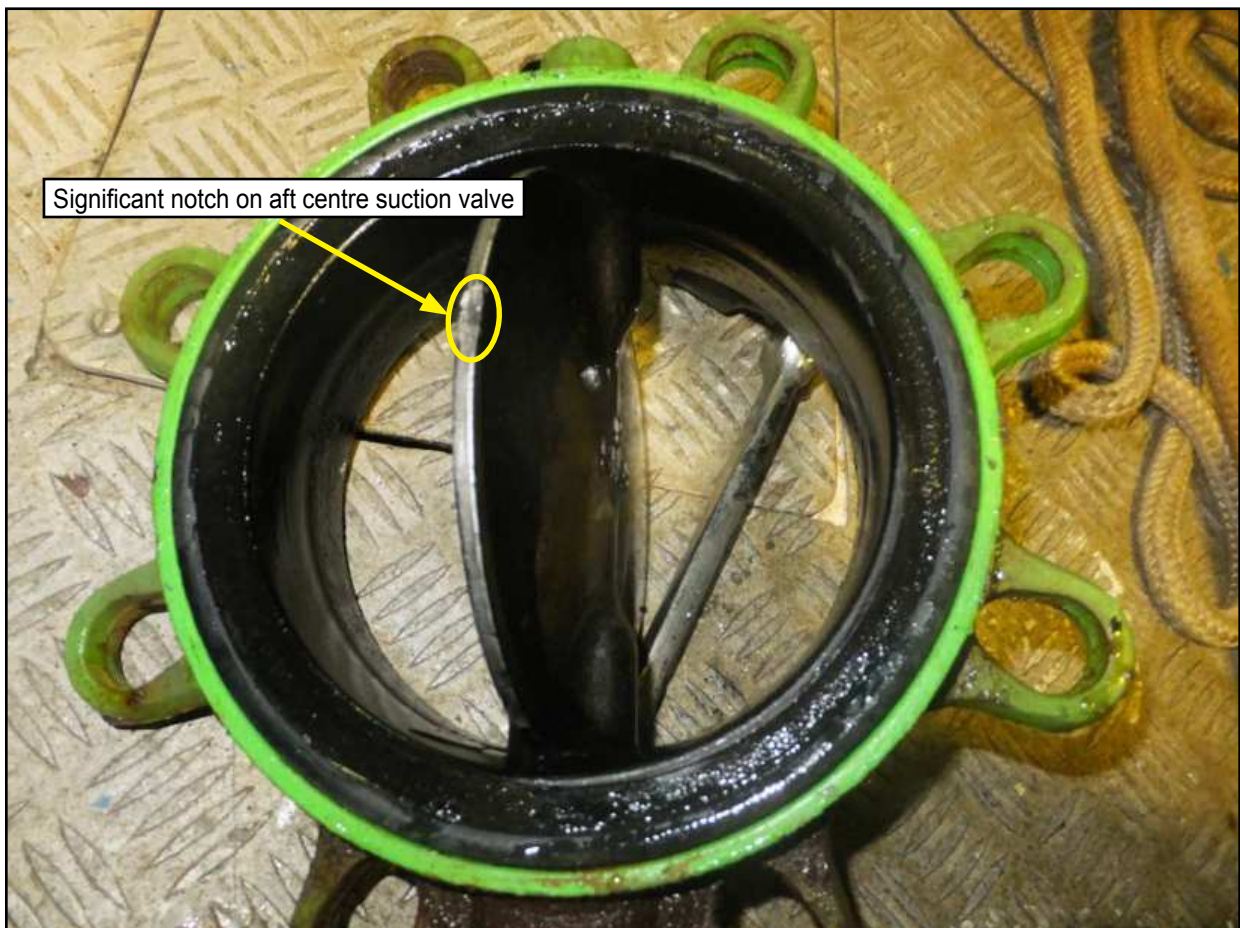
Sunbeam's seawater isolating valves were not designed to be gastight but were tested to identify whether Freon (in a gaseous form) could pass through them when in the shut position. The tests demonstrated that Freon gas would leak past both valves when in the shut position by gravity from the evaporators located above.

**Figure 7b:** Aft centre RSW pump suction isolating valve showing a single significant notch on disc edge

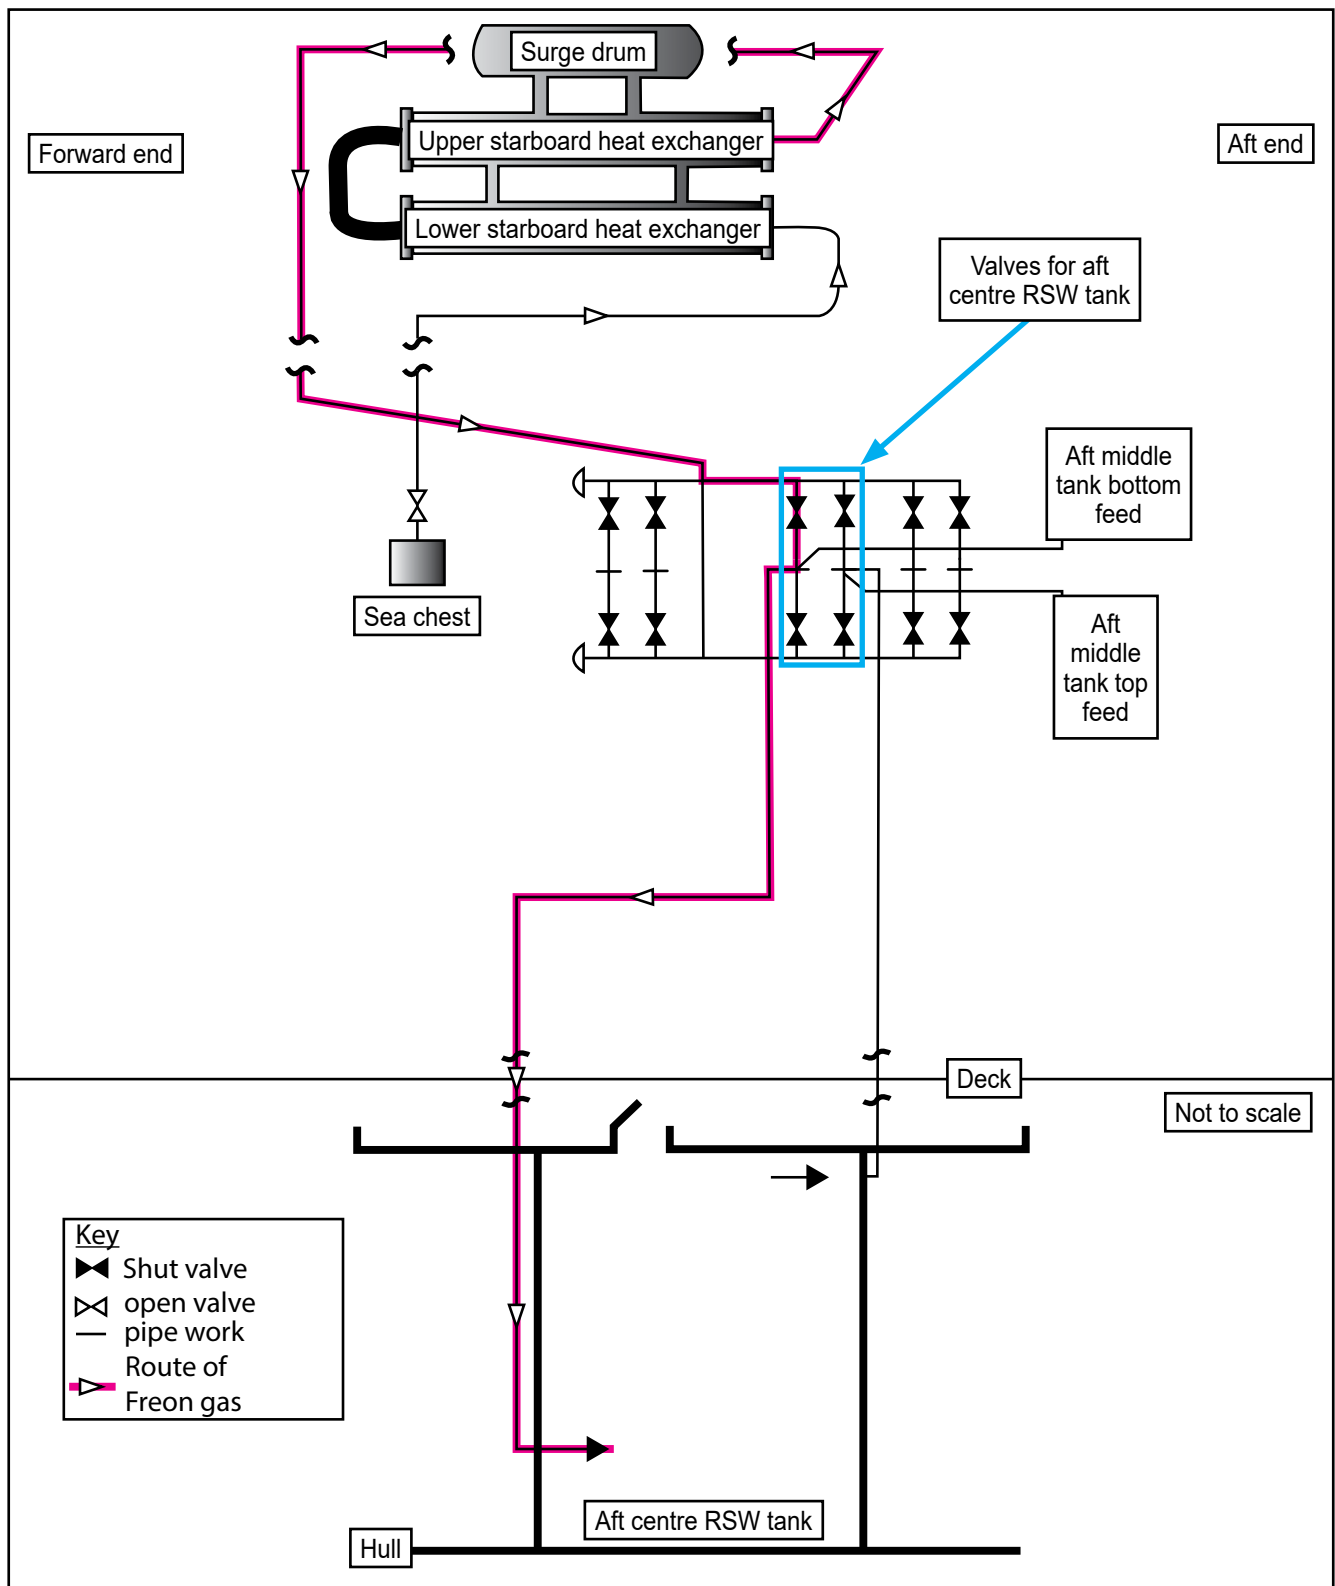
**Figure 8:** Schematic diagram of *Sunbeam's* RSW system highlighting the freon gas' route through the RSW system into the aft centre RSW tank

STS's technical analysis demonstrated that there was a credible pathway for the Freon gas to escape out of the refrigeration plant and into the aft centre RSW tank. First, the Freon leaked through the corroded and failed tubes of the starboard evaporator into the RSW system pipework. The denser than air Freon gas then descended down into the aft centre RSW tank via damaged non-gastight seawater isolation valves (**Figure 8**). With the tank empty of water over the weekend, there was also sufficient time for the Freon gas to build up to a point where the displacement of oxygen meant that the atmosphere could not support life.
