MA2020-6

MARINE ACCIDENT INVESTIGATION REPORT

Accident type	Collision
Date and time	Around 4:22 on September 2, 2019 (local time, UTC+9 hours)
Location	Akashi Kaikyo Traffic Route Around 019° true bearing, 1.3 nautical miles (M) from Esaki Lighthouse (approximately 34°37.6'N, 135°00.0'E)
Summary of the Accident	<p>The car carrier GLOVIS COMPANION was proceeding west in the Akashi-Kaikyo Traffic Route and the fishing vessel HIGASHIDA MARU was proceeding southeast and attempting to cross the Akashi-Kaikyo Traffic Route when both vessels collided in the Akashi-Kaikyo Traffic Route.</p> <p>The master of HIGASHIDA MARU was injured, and her bow sustained crushing and other damage, while GLOVIS COMPANION sustained abrasions on her starboard- side shell plating.</p>
Process and Progress of the Investigation	<p>(1) Set up of the Investigation</p> <p>The Japan Transport Safety Board (hereinafter referred to as “JTSB”) appointed an investigator-in-charge and two other marine accident investigators to investigate this accident on September 2, 2019.</p> <p>(2) Collection of Evidence</p> <p>September 3 to 5, December 9 and 10, 2019: On-site investigations and Interviews</p> <p>October 7, and 1

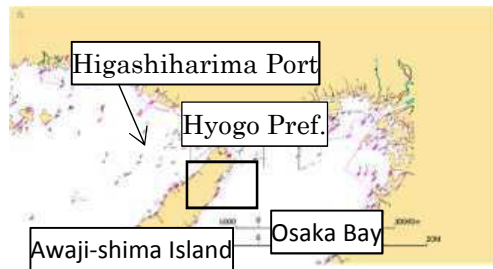
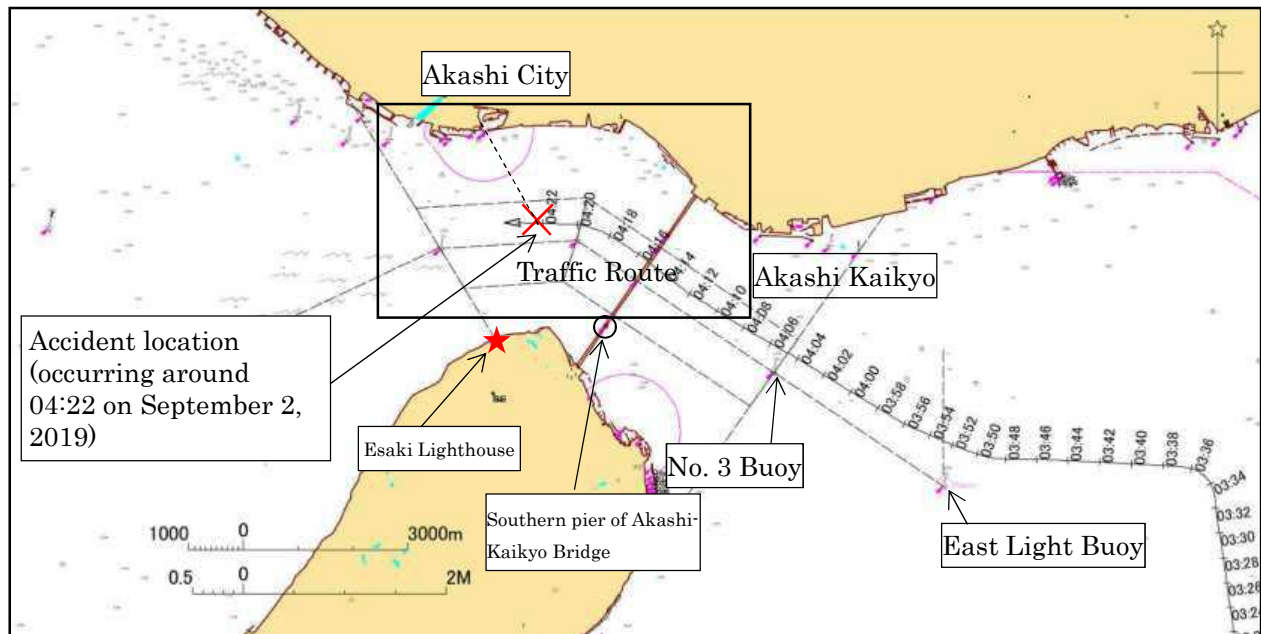
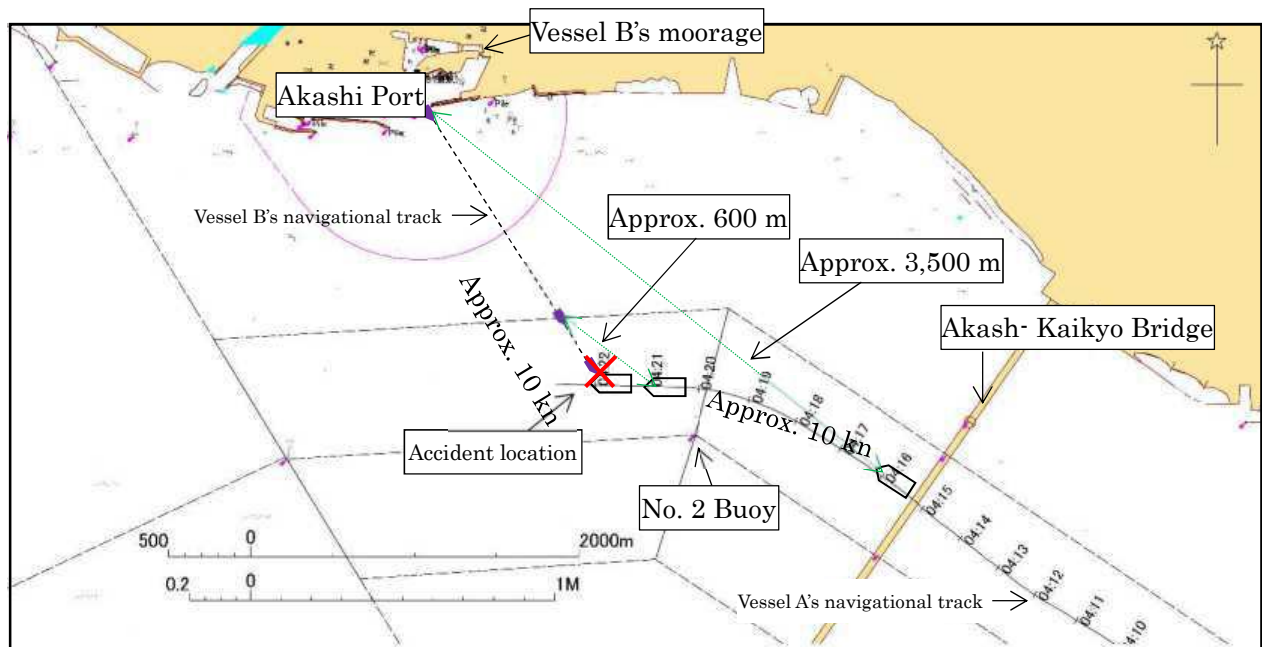
Attached Figure 1 Outline Map of the Course of the Accident Events

<p>Pilot A notified Osaka MARTIS of the accident and reported that Vessel B was moving away from Vessel A's starboard stern.</p> <p>At around 04:05, Vessel B, with Master B being the only crew member aboard, departed her moorage at Akashi Port, Akashi City, Hyogo Prefecture, with navigation lights on for fishing grounds to the east of Awaji-shima Island for the purpose of conducting pole-and-line fishing of Japanese Spanish mackerel.</p> <p>At around 04:16, Master B passed Akashi Port's breakwater, sat on a chair in the wheelhouse, and performed ship maneuvering by manual steering.</p> <p>Vessel B proceeded southeast at a speed of about 10 kn, with Master B thinking that there were no vessels proceeding west from the direction of Akashi-Kaikyo Bridge at the time he set the south pier of Akashi-Kaikyo Bridge as his heading mark.</p> <p>Master B was observing several vessels proceeding east in the Traffic Route and was considering which of the vessels to pass by their sterns when crossing the route.</p> <p>Vessel B entered the Traffic Route from the north side of the route at around 04:21 and, as Master B was observing the movements of vessels proceeding east, she collided with Vessel A at around 04:22.</p> <p>Master B's forehead, etc., struck a clear view screen in the collision, and after he returned to Akashi Port under his own power without knowing what he had collided with, he was diagnosed at a hospital as having a forehead bruise, lacerations, and chest fracture. (See Attached Figure 1 "Outline Map of the Course of the Accident Events")</p>

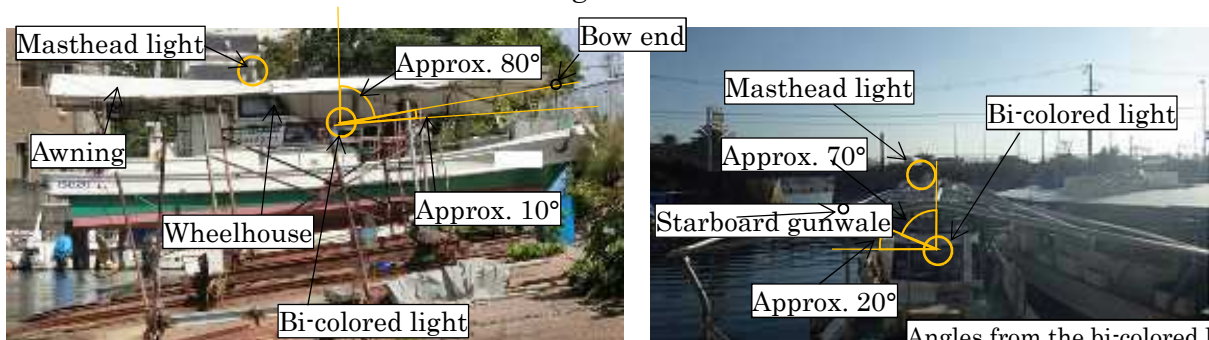
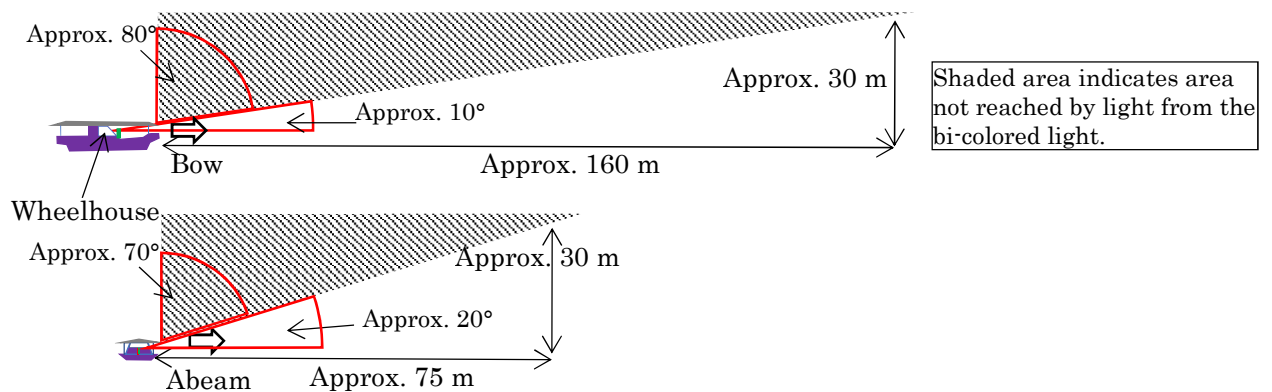
Attached Figure 3 Vessel B

(d) The condition of the light of the bi-colored light was such that light would reach a target at a height of approximately 30 m above the ocean's surface when the target was at a horizontal distance from Vessel B of approximately 160 m or more in the direction of the bow and approximately 75 m or more directly abeam.

Reach of light from the bi-colored light at a target 30-m above the ocean's surface

Angles from the bi-colored light to the bow end and both sides of the awning
Approx. 10° upward toward bow
Approx. 20° upward directly abeam

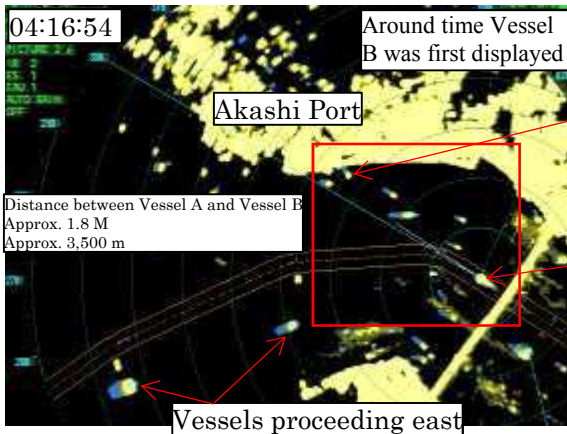
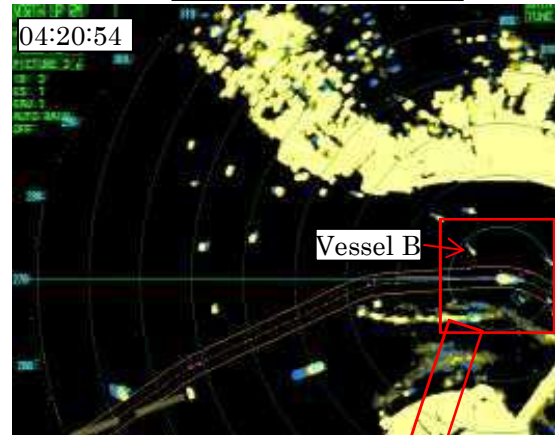
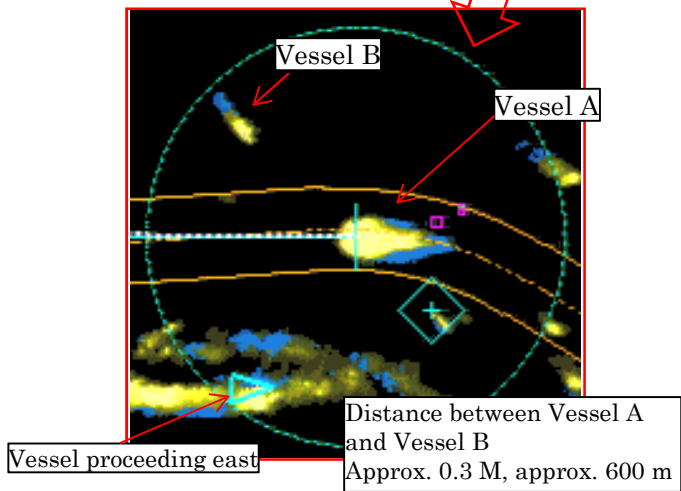
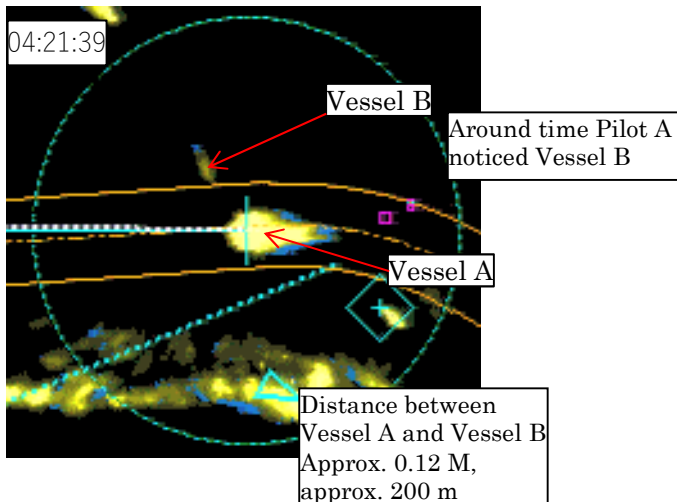
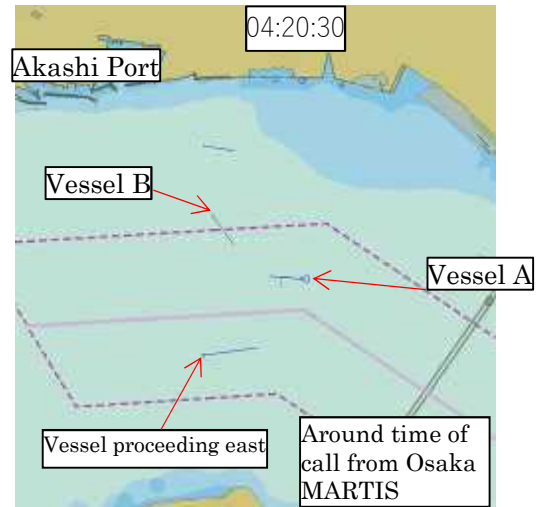
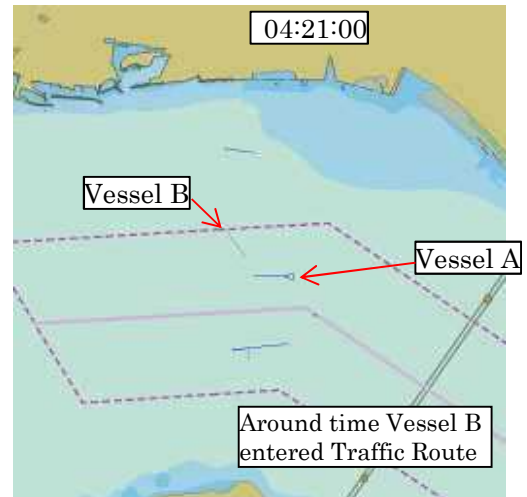
Attached Figure 4 Radar Images, etc., from Vessel A's VDR

According to the images provided by Osaka MARTIS and 3 M-range radar images recorded by Vessel A's VDR, the situation was as follows.

- Vessel B proceeded southeast from Akashi Port and entered the route and, after approaching to approximately 200 m at 330° (true bearing; hereinafter the same) from Vessel A, proceeded south-southwest until just prior to the collision.
- From between around 04:16 and 04:22, passage in the Traffic Route was displayed as being one vessel proceeding west (Vessel A) and four vessels proceeding east.

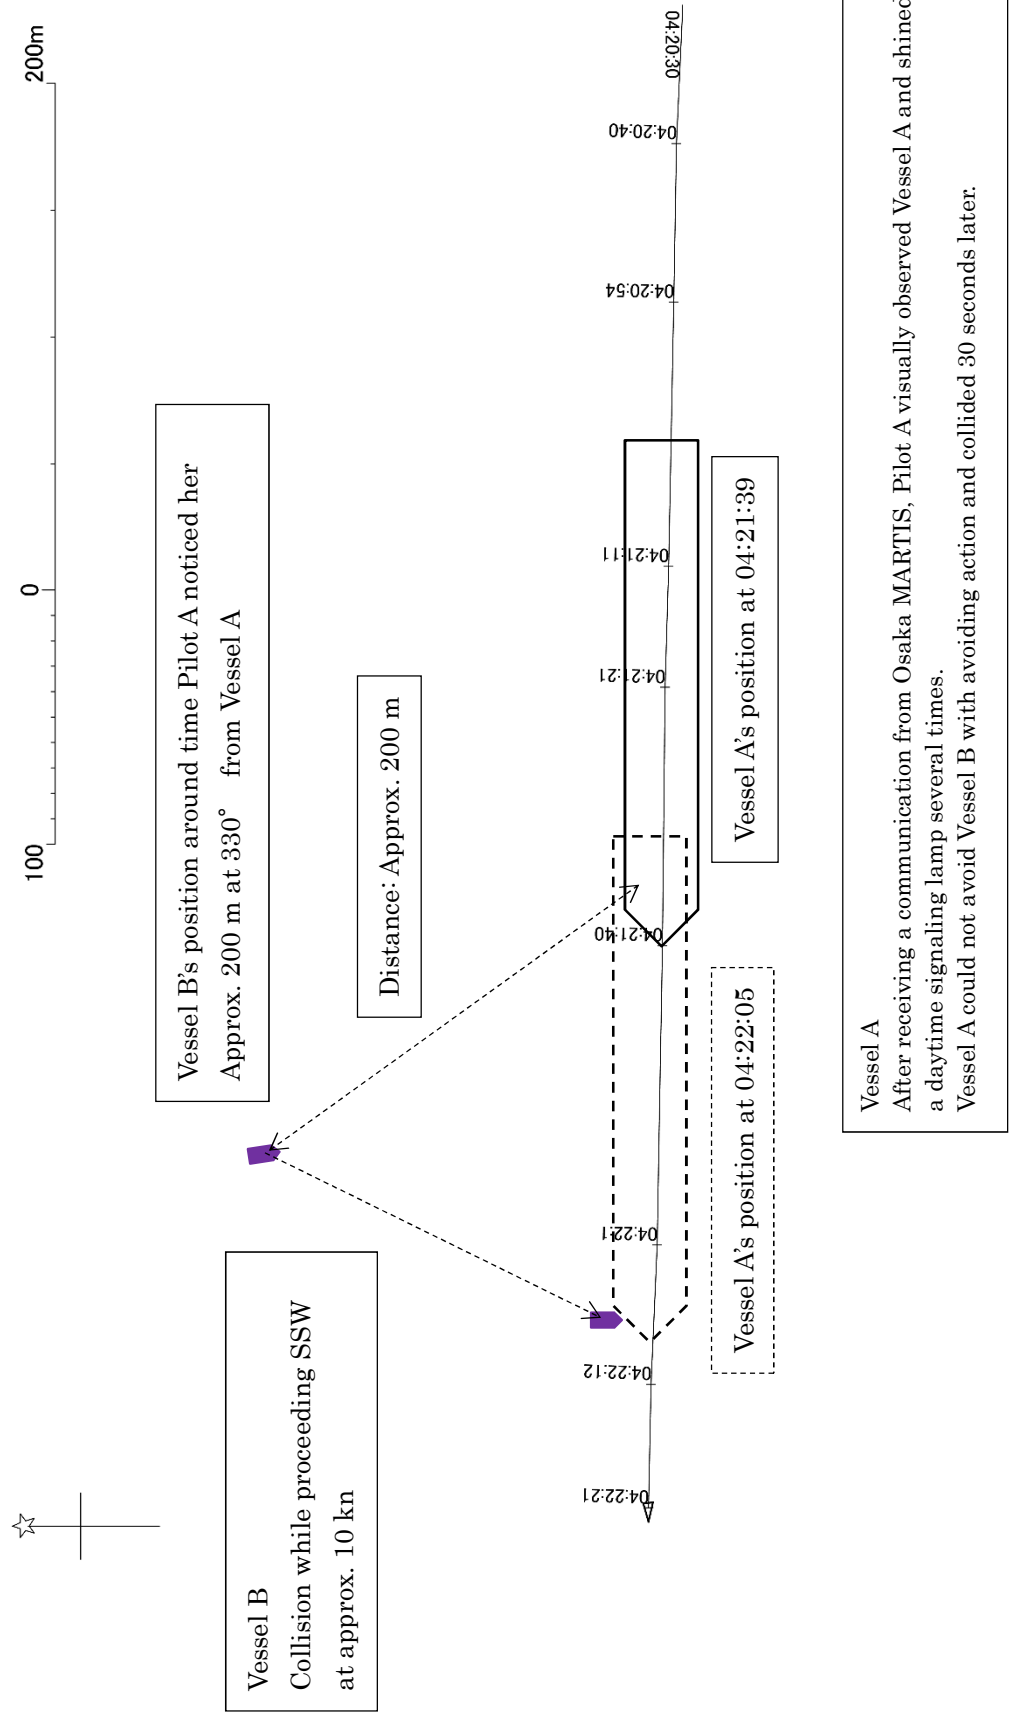
Attached Figure 5 Situation from the Time Pilot A Noticed Vessel B until the Collision

<p>Vessel B.</p> <p>It is probable that, when Pilot A noticed Vessel B, Vessel A could not evade Vessel B, which had approached to approximately 200 m, by her own action alone.</p> <p>It is probable that Vessel B was proceeding southeast at a speed of approximately 10 kn after leaving Akashi Port, with Master B alone aboard.</p> <p>It is probable that, because Vessel B was proceeding south-southwest after entering the Traffic Route and collided with Vessel A, Master B turned the rudder to starboard with the intention of passing the sterns of vessels that were proceeding east.</p> <p>It is highly probable that Vessel A and Vessel B did not possess means of mutual communication, such as VHF, etc.</p> <p>(3) Circumstances of lookout of Vessel A and Vessel B</p> <p>It is probable that, although he knew that, at the time of the accident, it was a time of day when fishing vessels leave port, Pilot A continued to navigate by directing his attention to maintaining Vessel A's path within the Traffic Route and did not make any specific requests for lookout giving attention to the situation outside of the Traffic Route to Master A because he thought that fishing vessels would navigate by giving way to Vessel A and he had not received a report of Vessel B's approach.</p> <p>It is probable that Pilot A used the daylight signal to alert the approaching fishing boat just prior to the accident but was unable to arouse Master B's attention.</p> <p>It is probable that Master A and Navigation Officer A did not notice Vessel B's approach until Pilot A used the daylight signal and did not report Vessel B's approach to Pilot A.</p> <p>It is probable that Master A was giving instructions to crew members but his instructions to Navigation Officer A to provide lookout of the situation outside of the Traffic Route were incomplete.</p> <p>It is probable that Master B was not sufficiently checking the Traffic Route's situation after setting the south pier of Akashi-Kaikyo Bridge as his heading mark.</p> <p>It is somewhat likely that, at the time of the accident, there were several vessels proceeding eastbound Vessel B's west and Master B was directing his attention to the vessels proceeding east and did not notice Vessel A proceeding west because he was considering which of the vessels to pass by their sterns.</p> <p>It is probable that, after entering the Traffic Route from the north, Master B continued crossing the route with his attention directed at the vessels proceeding east.</p> <p>It is highly probable that Master B was required to give way to</p>
