Report on the investigation of
the grounding of

Astral

on Princessa Shoal,

10 March 2008

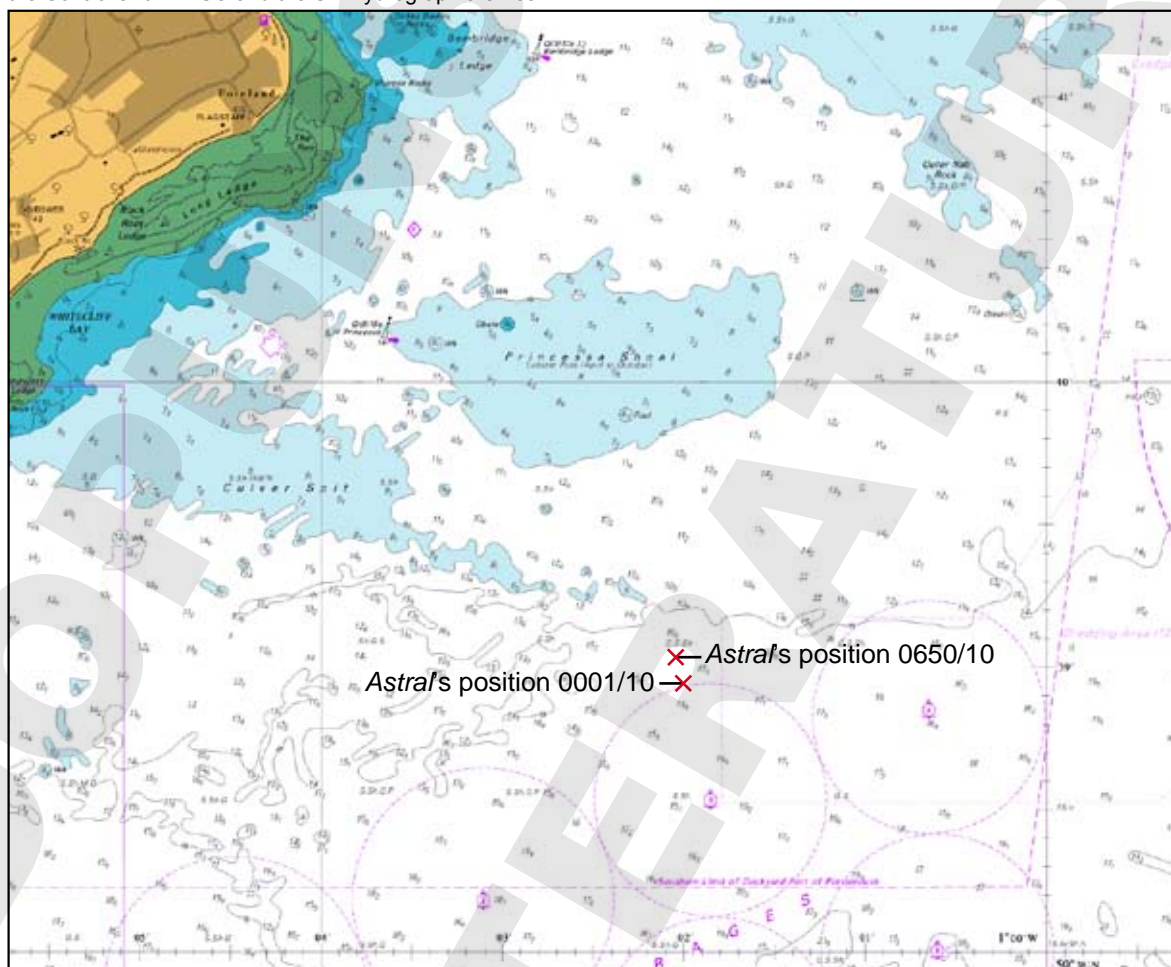
Figure 5

Astral's position at start of dragging anchor

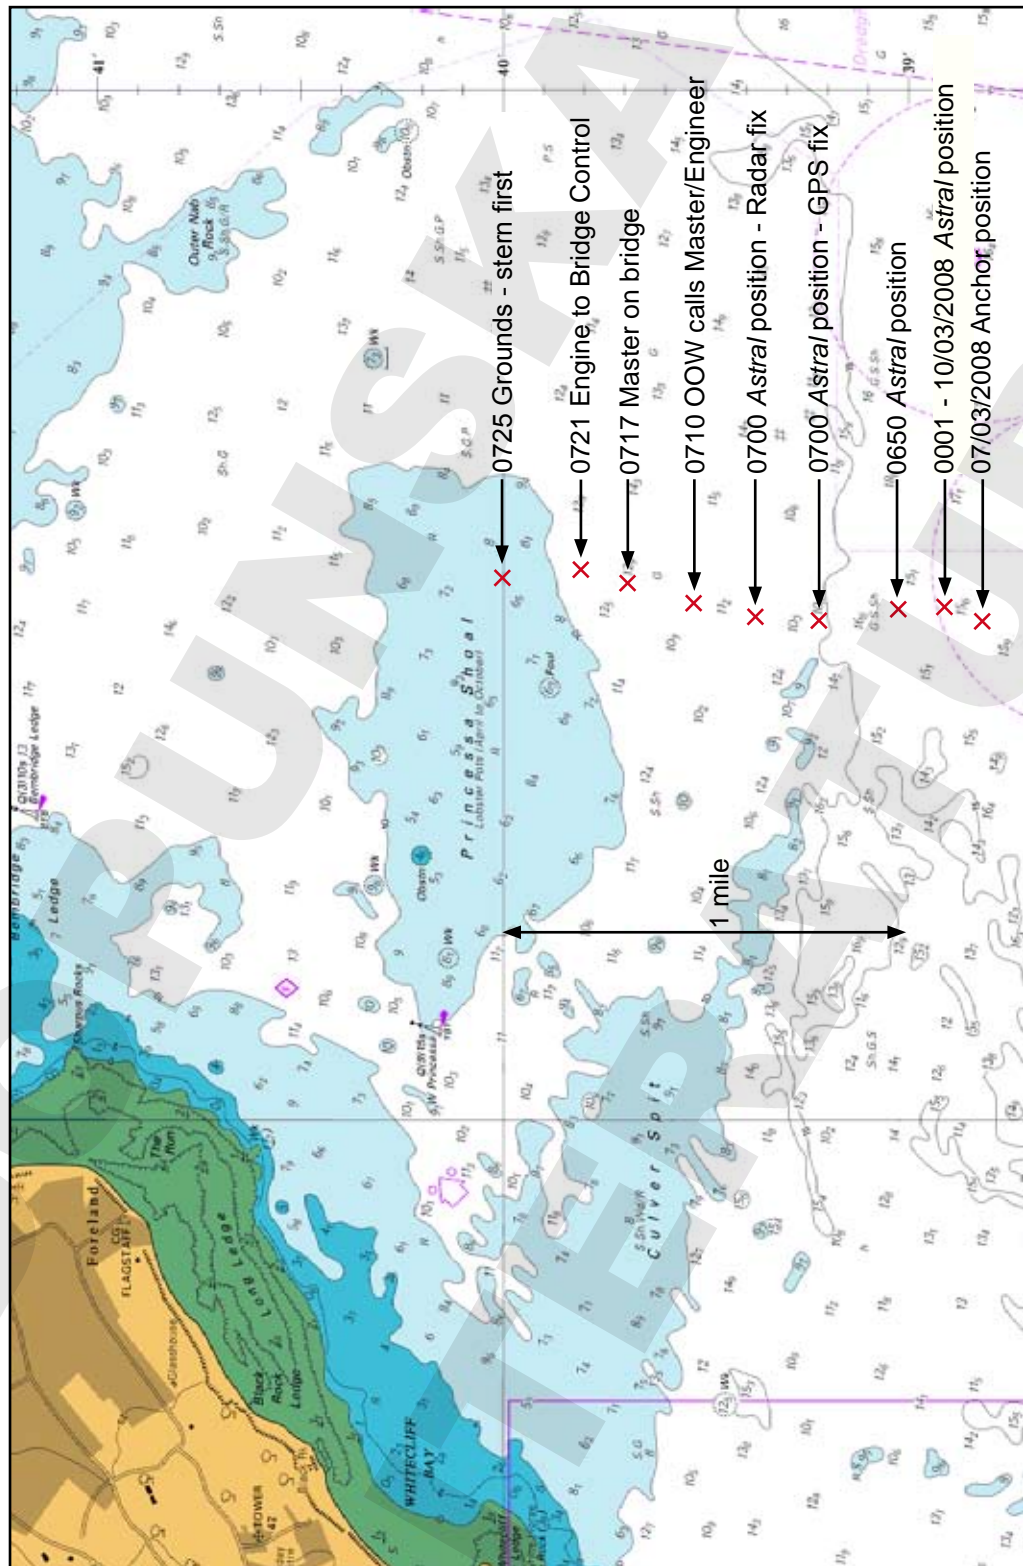
Figure 6

At 0704 the 2/ON observed the range and bearing of the Nab Tower from the radar cursor as 077° x 3.16nm (**Figure 6**), and wrote this in the logbook as the 0700 position, but did not plot this on the chart. The 2/ON believed that the discrepancy between this position and his previous position was due to the cable stretching² in the deteriorating weather, moving the ship's position to the north.

Astral grounded stern first at 0725 and again at 0726 in charted depths of between 6.5 and 8m (**Figure 6**). At 0726, the master called VTS by VHF radio, stating that *Astral* was aground and requested tug assistance.

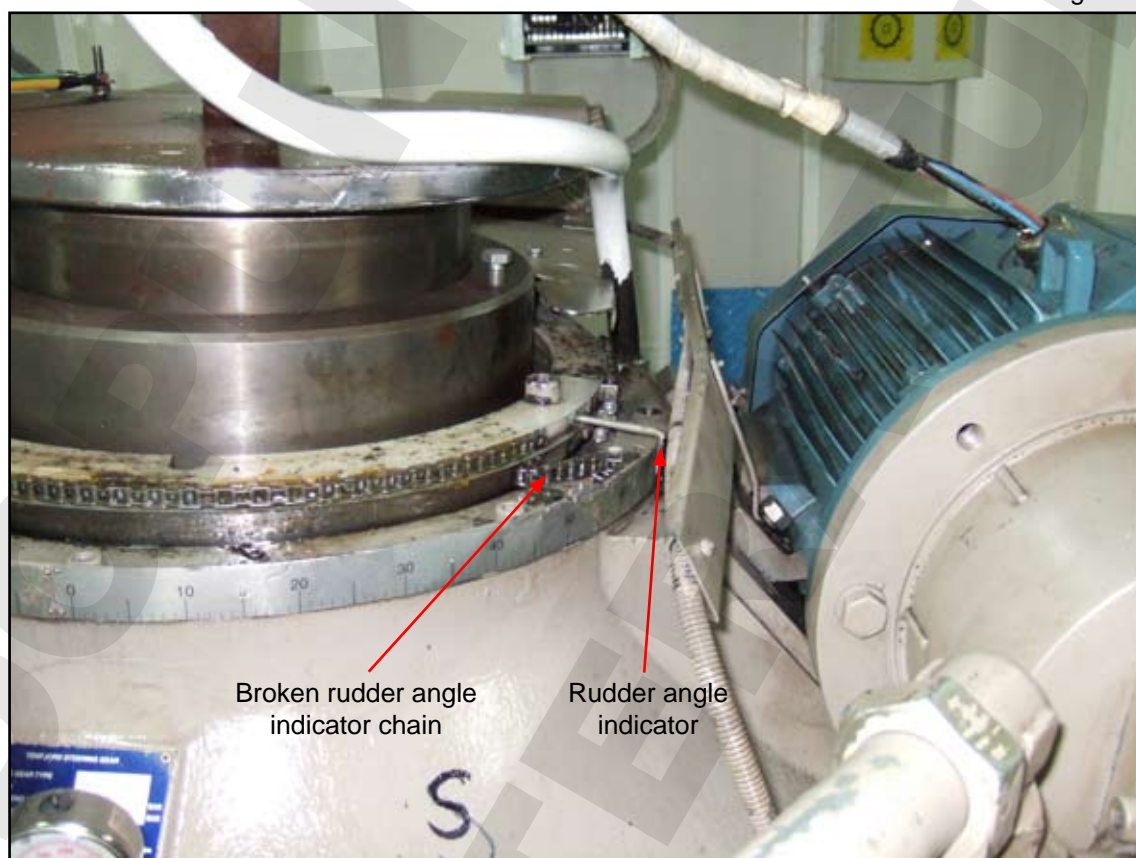
Figure 7

It was immediately apparent to the master that the vessel had lost steering and the rudder indicated hard over to starboard, an angle of 72° (**Figure 7**). An inspection by the chief engineer showed substantial damage to the steering gear, the steering motor and the adjacent hull structure, with no water ingress evident. As the rudder angle indicator chain arrangement had been snapped by the impact it was not possible to identify the actual position of the rudder.

Damaged rudder indicator

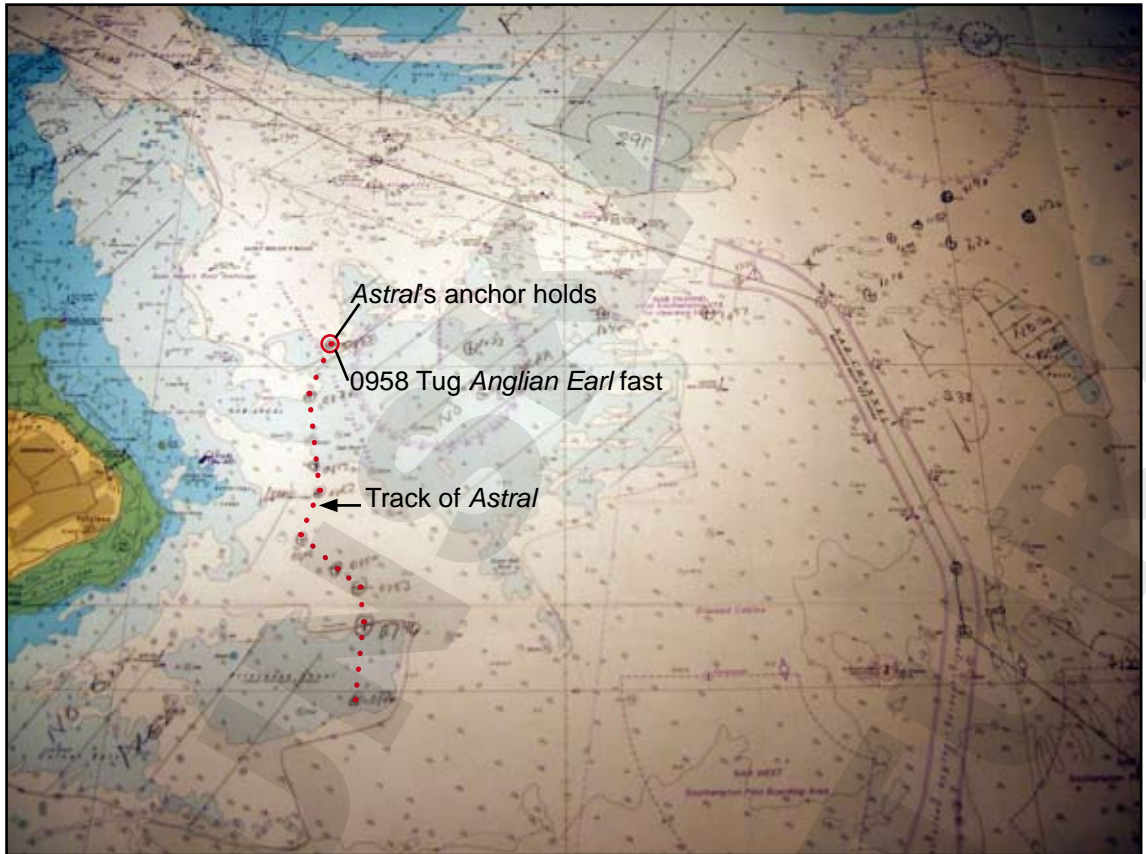
Copy of chart showing *Astra's* positions following grounding

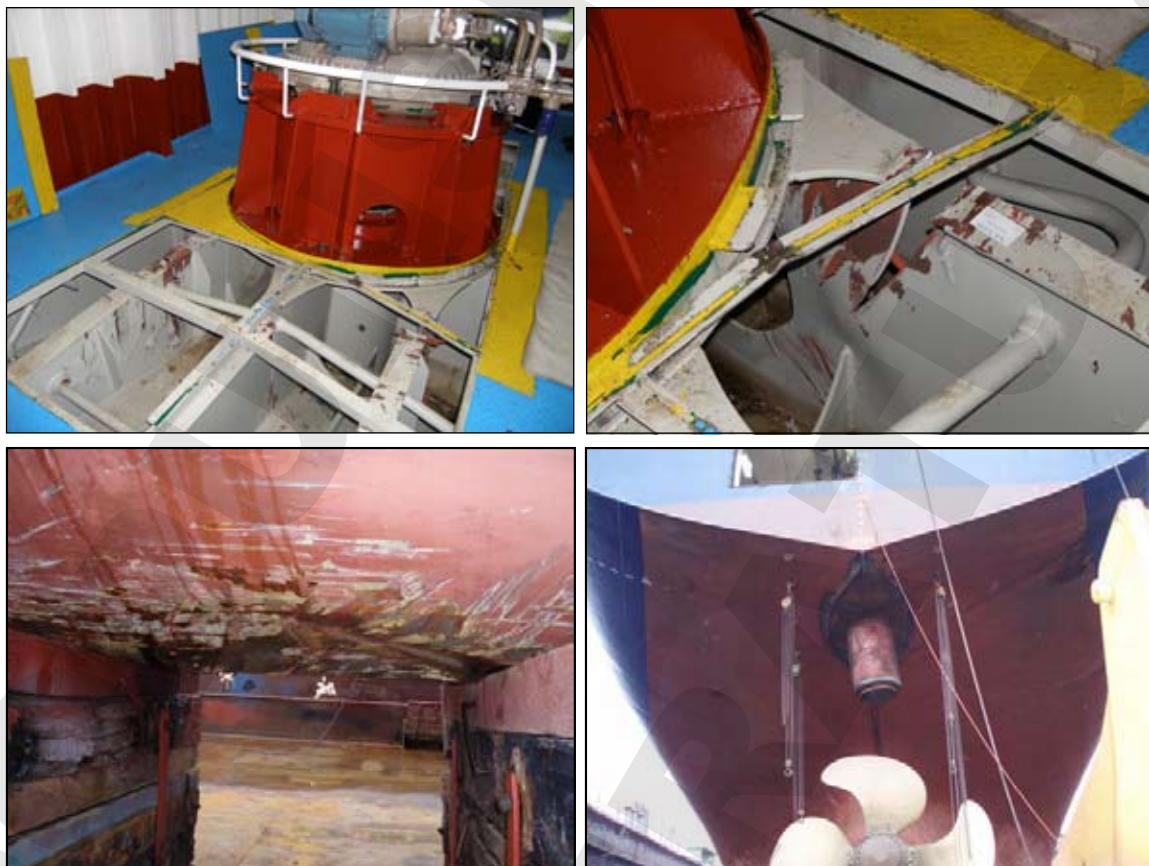
Figure 10

Extensive damage was caused to *Astral's* fish tail rudder, which was cracked on both sides along 80% of its length. Her steering gear had been lifted vertically from its mountings and landed back on the mounting bolts, stripping the threads or shearing all the securing bolts. The steering gear room shell structure, shell

plating and frames were significantly damaged (**Figure 10**) as the rudder was thrust upwards. The rudder was removed and placed on deck before the vessel was towed to Denmark for repairs.

The Bureau Veritas (BV) Survey report in the Fredericia Shipyard in Denmark, between 27 March and 16 April noted that the vessel's bottom plating had severe indents and scratches in several places. Bottom plating, totalling around 84m² and damaged frames were replaced (**Figure 10**).

Damage to *Astral*

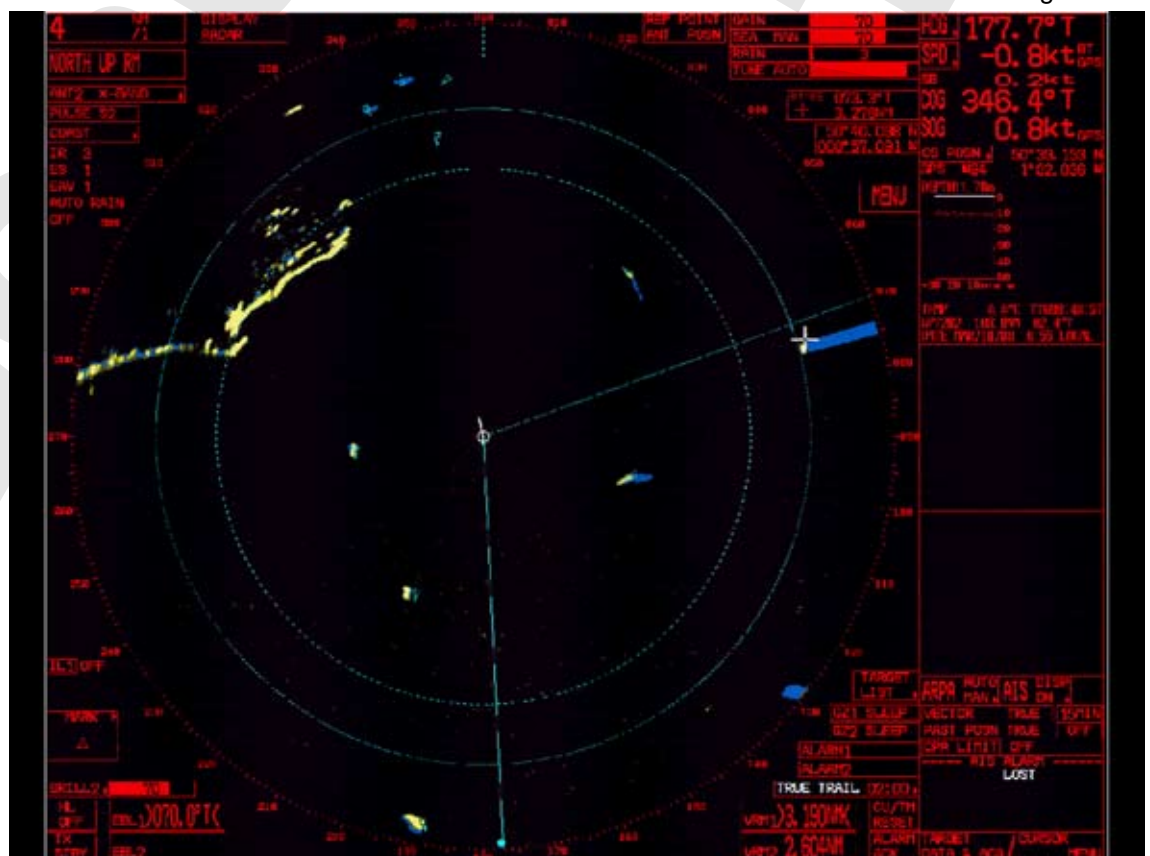
Astral starts to drag anchor at 0655
