DELICATA CASUALTY INVESTIGATION REPORT

Bosun's Fall Overboard

Rio de La Plata, Oriental Republic of Uruguay | 17 March 2020

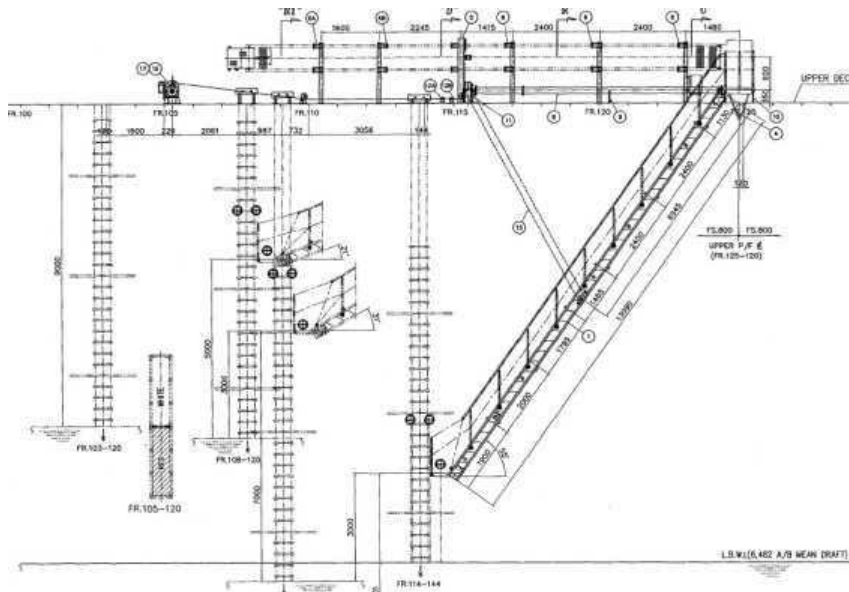
Figure 1: Pilot transfer arrangement plan for starboard side. The port side arrangement is symmetrical.

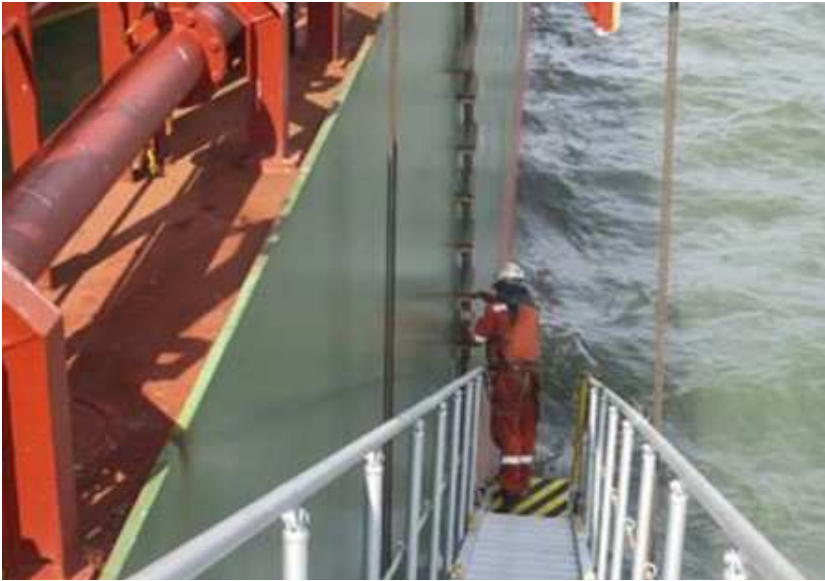
Figure 2: Arrangement of accommodation and pilot ladders at the time of the incident, taken from the top of the accommodation ladder.

13. The OS began loosening the shackles which attached the top of the pilot ladder to the pad eyes on deck. The Bosun attempted to lift the pilot ladder. They were unable to raise the pilot ladder because it was secured to the hull near the accommodation ladder's bottom platform. The Bosun then went down the accommodation ladder to untie the pilot ladder from the hull securing point, while the OS remained at the top of the pilot ladder.
