Report on the investigation of  
the capsizing and foundering of the fishing vessel

***Sarah Jayne (BM 249)***

6nm east of Berry Head, Brixham

11 September 2012

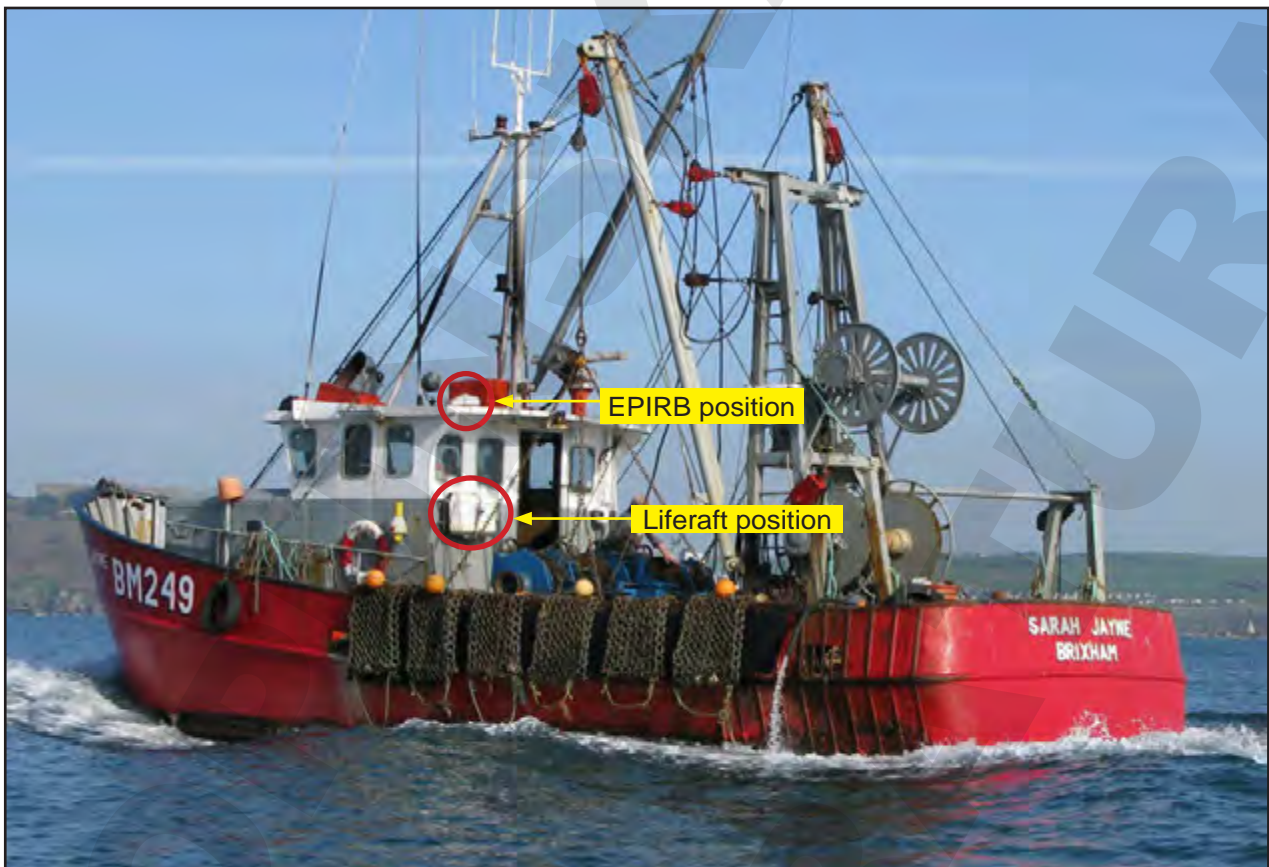
**Figure 7:** *Sarah Jayne* (liferaft and EPIRB positions)

In accordance with The Fishing Vessels Code of Practice for the Safety of Small Fishing Vessels, the vessel was fitted with a 4-man Seasafe ISO9650-1 standard liferaft, mounted vertically on the external aft bulkhead of the wheelhouse. The liferaft, manufactured in January 2012, was on hire and had been fitted by the owner in August 2012 to replace his own liferaft (**Figure 7**), which was due its periodic service. The owner had intended to fit the latter on the wheelhouse roof as a spare.

A McMurdo E3 EPIRB was purchased and registered to *Sarah Jayne* in September 2005. This replaced a previous emergency beacon that had been fitted in 2001. The EPIRB was fitted in a float-free canister mounted on the aft port side of the wheelhouse roof (**Figure 7**). The EPIRB was serviced in September 2010 and a new ‘Break-thru’ HRU was listed on the service invoice.

No transmission was received from the EPIRB following the vessel’s capsizing and foundering.

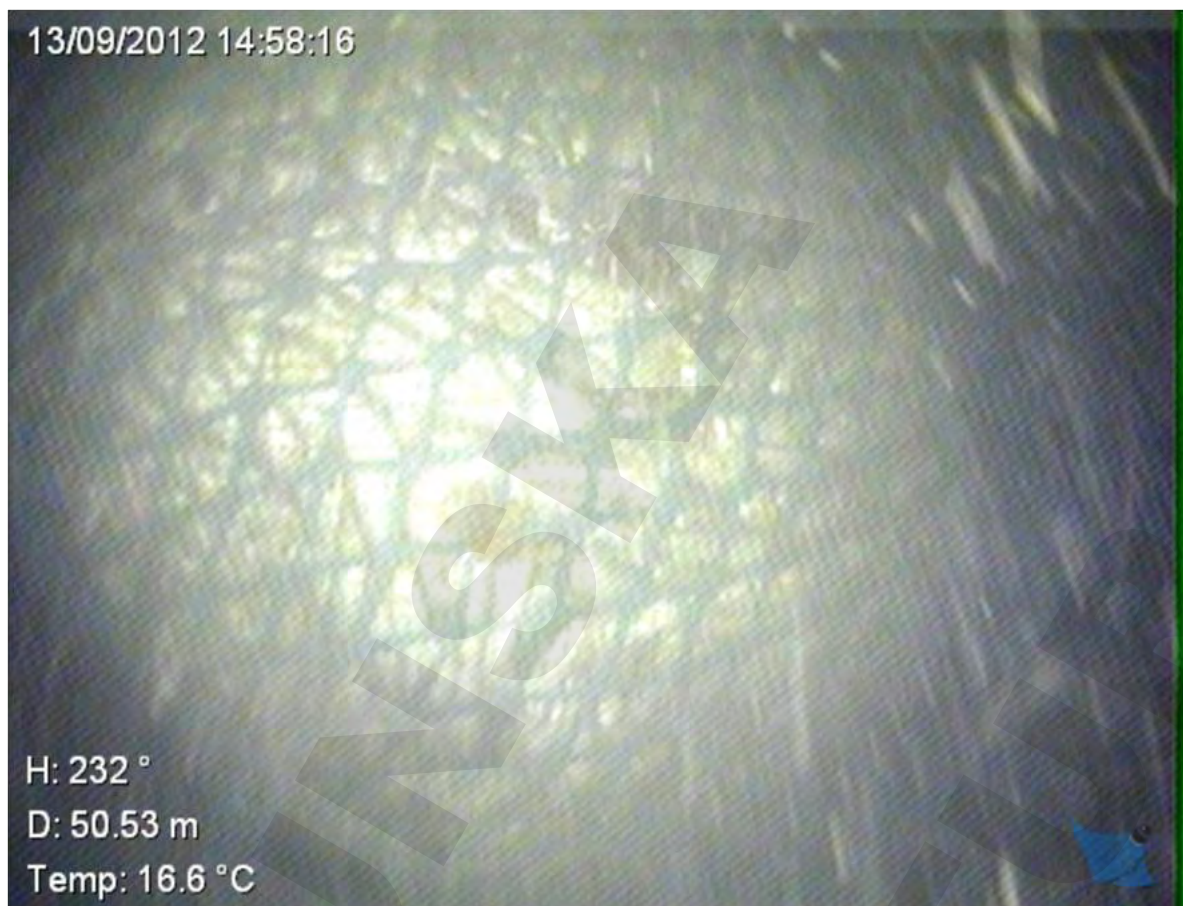
Figure 8: Sarah Jayne's net

- The wreck was upright on the seabed with the net, still significantly full with fish, attached to the vessel (**Figure 8**).
- The Seasafe liferaft was on the seabed to the port side of the vessel with the painter leading up and over the bulwark rail (**Figures 9 and 10**).
- The fish hold hatch cover was on the starboard side of the main deck with the access hatch open and a securing lug damaged (**Figure 11**).
- At least two of the freeing ports on the starboard side appeared to be closed.
- The engine room escape hatch cover and starboard side door to the galley/mess were closed.
- The wheelhouse door was open.
- The trawl doors were in their stowed position although the port trawl door was not lying vertically.
- The port lifebuoy was floating in the vicinity of the engine exhaust.

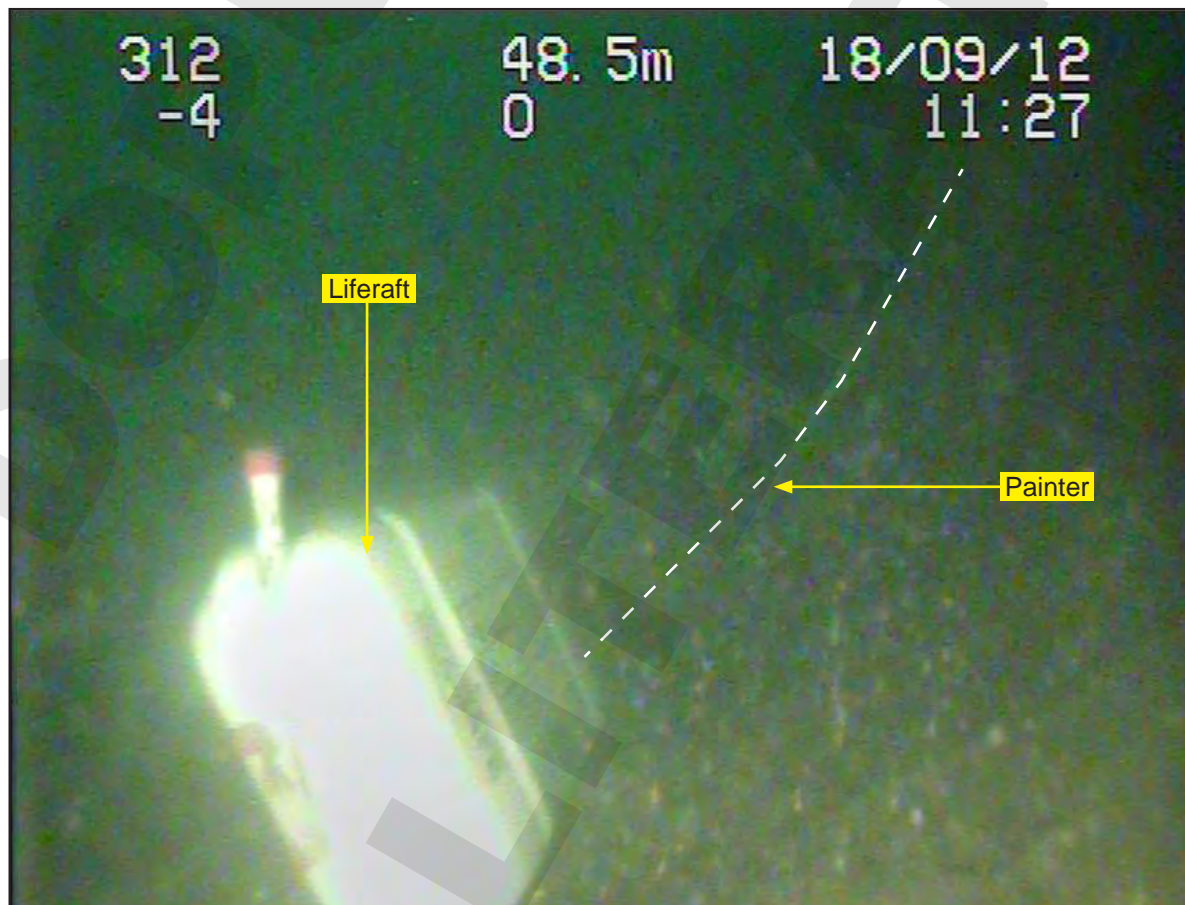
Figure 9: Liferaft on seabed with painter

The wreck survey revealed that the liferaft released from its cradle when *Sarah Jayne* foundered. However, it did not rise to the surface and inflate as intended. Given the liferaft was new, it is unlikely it was defective. A more likely explanation is as follows.

When the vessel initially capsized, the depth of the liferaft might not have been sufficient to cause the HRU to activate. Even if the HRU had activated, the liferaft would have only floated up to the main deck as the vessel was upside down. As the vessel sank and turned the right way up, given the likely stern attitude, the liferaft might have floated up and become trapped under the lip of the wheelhouse roof. All the time the liferaft was submerged, its drain holes would have allowed water to fill the canister. Once on the seabed, the buoyancy of the canister would eventually have reduced to the point at which it was neutrally buoyant and then, with the assistance of tidal current, it would have drifted over the port side and then onto the seabed, where it was located during the underwater inspections.

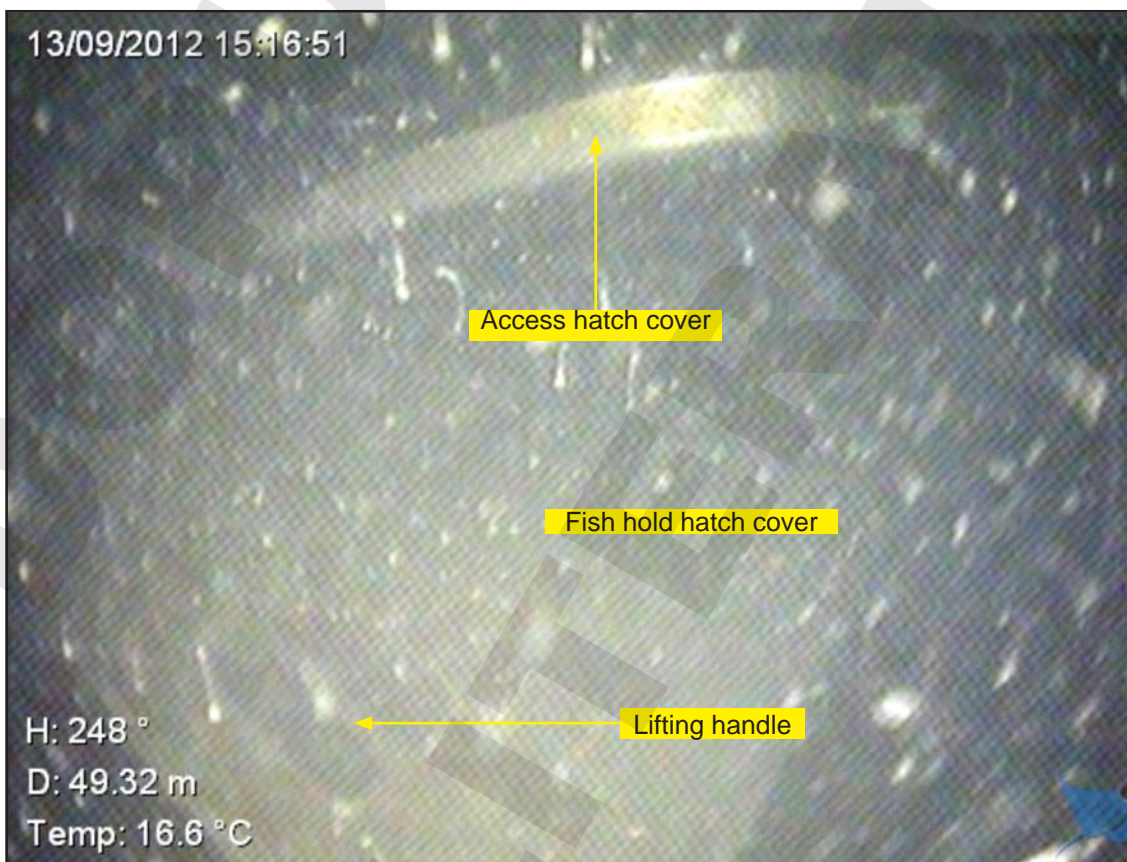
**Figure 11:** Fish hold hatch cover

'Lift-off' hatch covers, such as that fitted to *Sarah Jayne's* fish hold hatch, were permitted under the 1975 Rules, which did not specify that the cover should be permanently attached to the vessel. It appears that this did not cause undue delay in the mate and crewman replacing the cover. However, the 2012 Seafish Construction Standards require the hatch covers of new vessels to be secured by hinges on the forward side or otherwise permanently attached to the structure. This will ensure that any delay in closing the hatch is kept to a minimum.

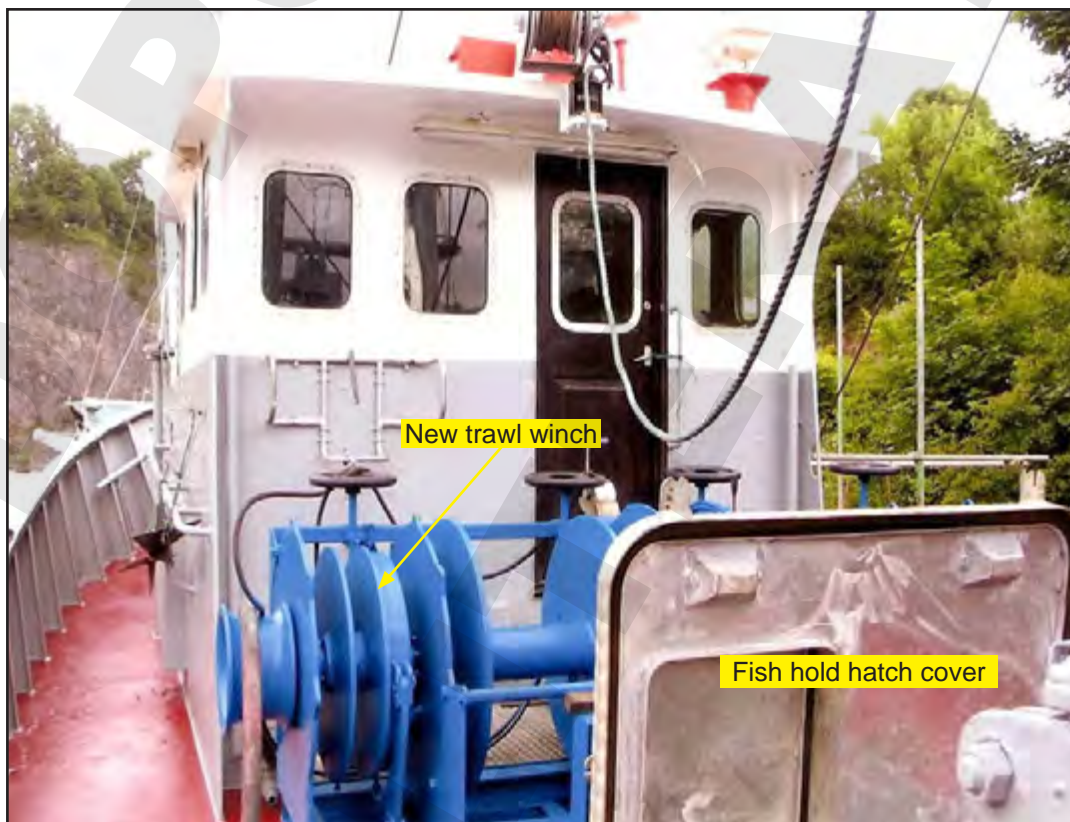
**Figure 12:** Sarah Jayne's new trawl winch and fish hold hatch cover in 2006

- Replacement of the original Gardner 8L3B engine (dry weight 3.2te) with a new Cummins NTA 855-M engine (dry weight 1.45te).
- Replacement of the original trawl winch (weight unknown) in 2006 with a North Sea Winch GF-80 (**Figure 12**).
- Installation of a small net drum (estimated weight 0.25te), approximately 3m above the main deck.

The new main engine was approximately 1.75te lighter than the original engine. Removing this weight from low down in the vessel would have raised the vessel's VCG and, consequently, degraded her stability. The fitting of the additional net drum 3m above the main deck, although only an estimated 0.25te, would also have raised the vessel's VCG. The difference in weight between the original and replacement trawl winches could not be determined and so its effect on the vessel's VCG is unknown.
