MARINE SAFETY INVESTIGATION REPORT

Safety investigation into the grounding of the
Maltese registered container vessel

APL DANUBE

MARINE SAFETY INVESTIGATION REPORT NO. 08/2020

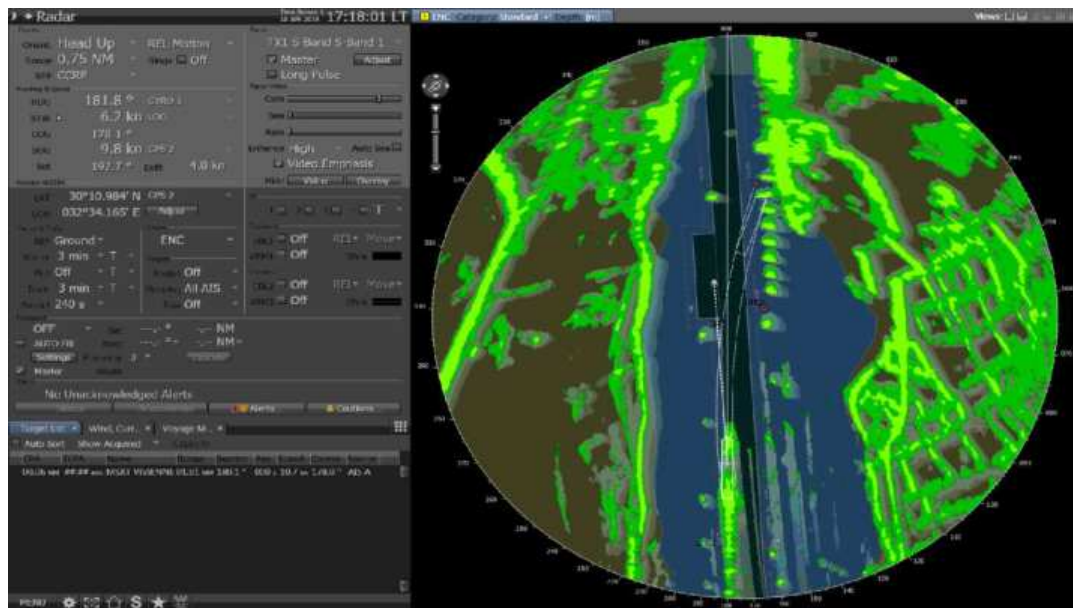
The master, who was standing behind the S-band radar / ECDIS, walked towards the starboard side of the conning console (Figure 6) to discuss the vessel's maintenance with the chief officer. The last helm order given by the pilot was 182°, at around 1718 (Figure 8). At this time, the master and the chief officer were still engaged in conversation, near the starboard side of the console. As the vessel approached the Km 133 mark, the bow of *APL Danube* took a sheer to starboard.

Figure 8: Extract from S-band radar showing the vessels' position at 1718

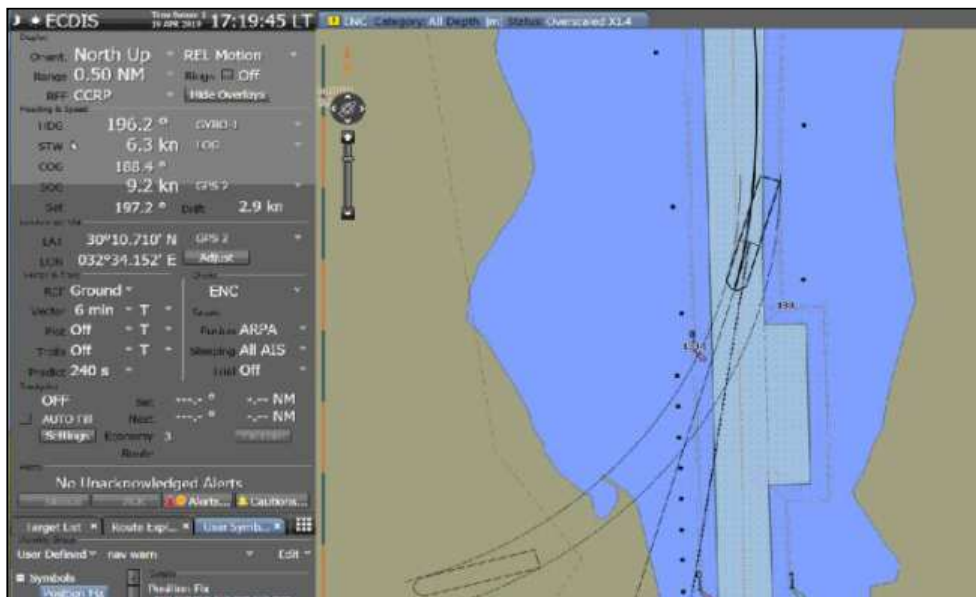
About 15 seconds later, following the pilot's advice, the master stopped the main engine, pulled the telegraph to 'dead slow astern' and subsequently to 'full astern'. Within 12 seconds, the main engine was reversed and running astern. The vessel's speed at that time was 9.2 knots ahead and the wheel was placed amidships (Figure 9).

Figure 9: 1719:45 Extract from ECDIS¹¹ showing the relative position of the vessel to the channel; at the time, the vessel's main engine had started running astern

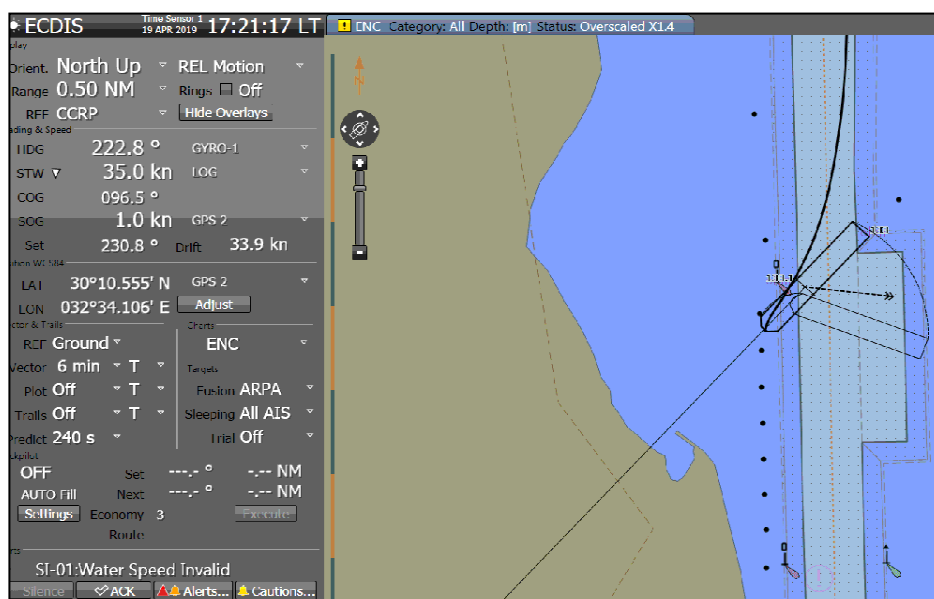
Figure 10: 1721:17 ECDIS extract – showing relative position of the vessel's bow to the channel

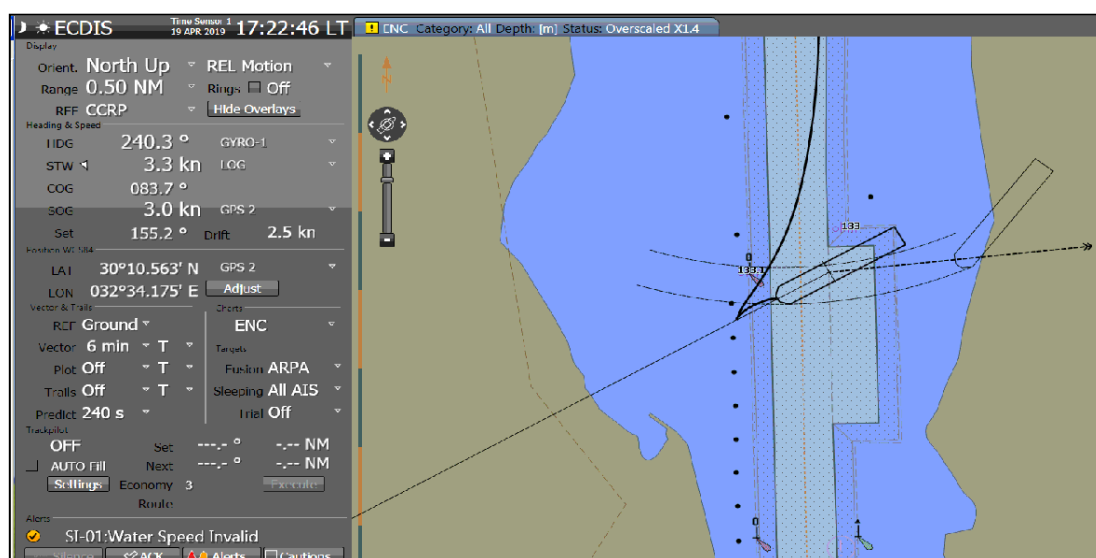
In the engine-room, the first steering gear alarm came in at 1722:40, thereafter, the emergency switchboard breaker tripped due to an overload on steering gear pump no. 1. The vessel was still making sternway with a speed of three knots (Figure 11) and with the main engine telegraph still on ‘full astern’.

Figure 11: 1722:46 ECDIS extract – Steering gear alarms, vessel moving astern with three knots

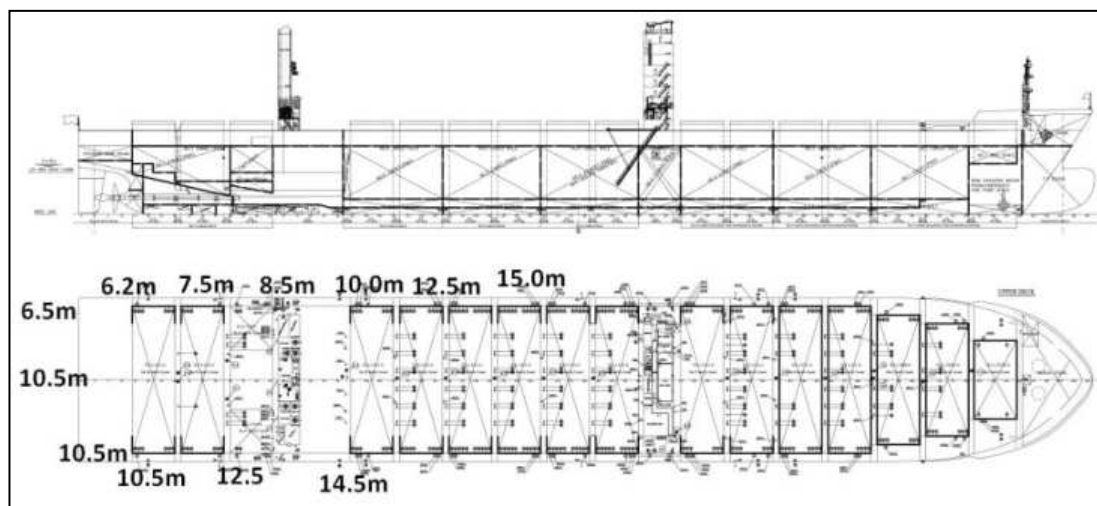
Thereafter, the Company was contacted and advised of the situation, and the crew members were called to stand by at the mooring stations. At about 1840, the depths around the vessel were manually measured and the vessel was confirmed to be aground (Figure 12).

Figure 12: Plan showing the sounding depth results taken manually around the vessel

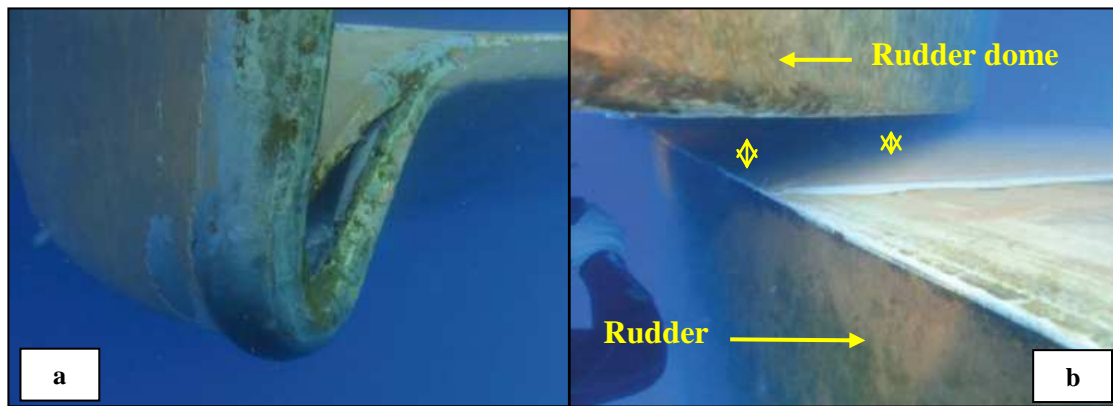
During the vessel's stay in the anchorage, an in-water survey was carried out to assess the damages sustained. The underwater inspection revealed that 60% of the rudder was damaged (total length of rudder being 10,200 mm):

- the lower part of the rudder, approximately 6,440 mm, was found heavily bent to starboard (Figure 13a);
- the rudder position was found deflected from the centreline by about 15° to starboard (Figure 13b);
- the clearances between the rudder and the rudder dome were noticed to be 25 mm forward and 105 mm aft (Figure 13b).

Figure 13: a) showing rudder bent/twisted to starboard; b) showing rudder deflected 15° to starboard and clearances from rudder dome misaligned

- .7 Following the initial groundings of the vessel, she also ran aground by the stern, resulting in severe damages to her propeller and rudder.

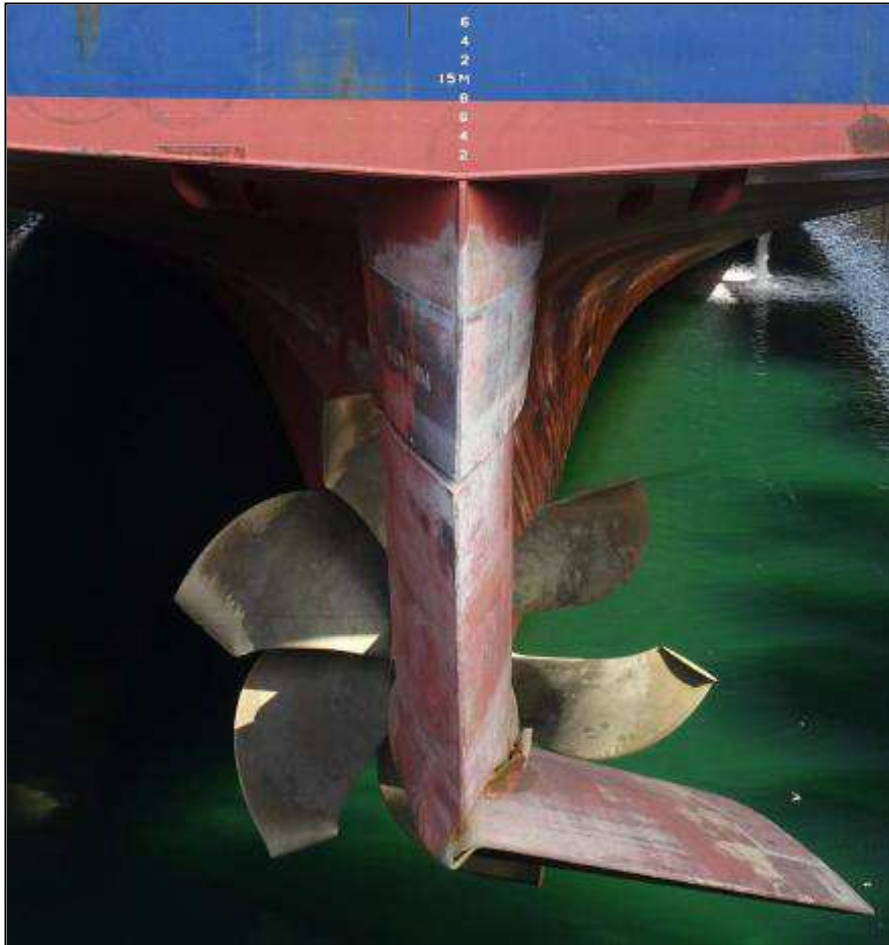
The edges of all six propeller blades had sheared off (Figure 14).

Figure 14: Extent of damages to the propeller blades

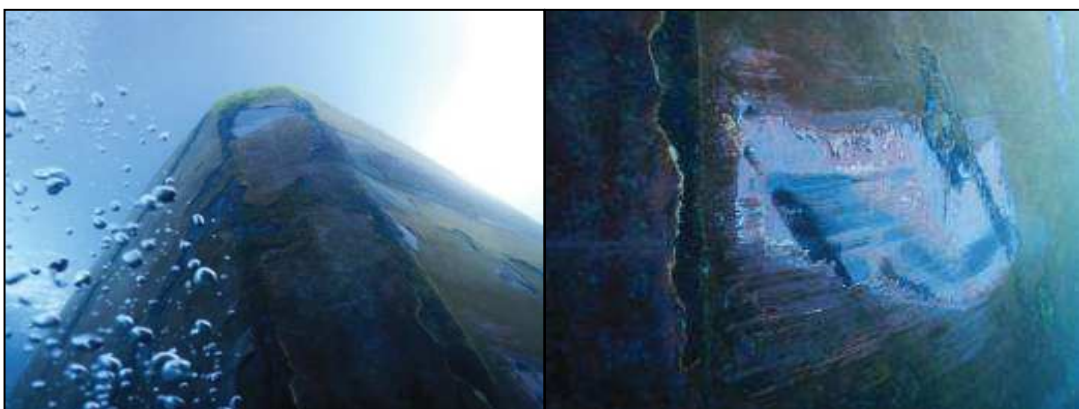
Paint scratches were also noticed at the bulbous bow area (Figure 15) and on the aft portion of the bilge keel, both port and starboard.

Figure 15: Various paint scratches on the bulbous bow, evidence of bottom contact

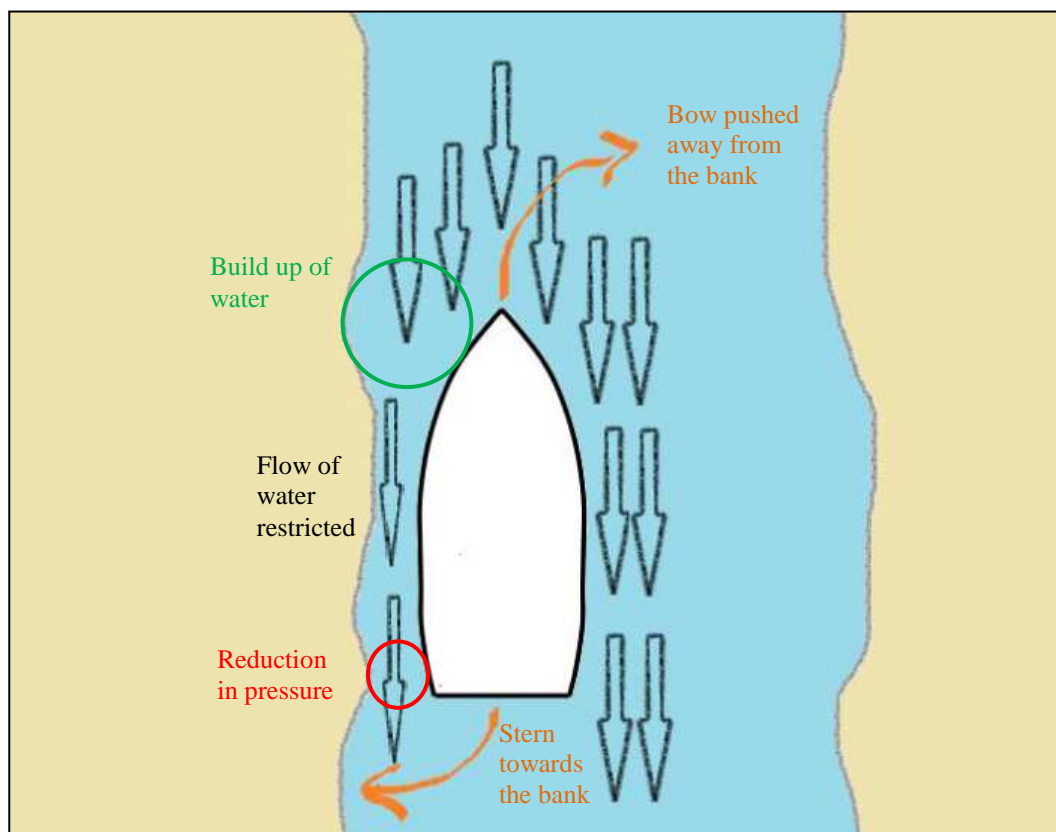
While a vessel moves in close proximity to a bank, there would generally be a build up in the water level near her bow, and a gradual reduction of pressure towards her stern (Figure 16). As in the case of water poured through a funnel, where water tends to accumulate before the stem of the funnel, the water would tend to accumulate ahead of the vessel's bow. This would create a bank cushion effect which would

cause the bow to move away from the closest bank. In the case of *APL Danube*, this had caused the vessel's bow to sheer to starboard. Additionally, the proximity of a vessel's hull towards the bank would restrict the flow of water between the vessel and the bank. This would result in a loss of pressure along her stern, leading to an increase in the water's velocity and a drop in water level on that side. This in turn would result in a thrust towards the bank (bank suction effect). In the case of a vessel of the size of *APL Danube*, having a longer parallel body with a transom stern, the thrust would be exacerbated at the stern.

Figure 16: Bank Effect

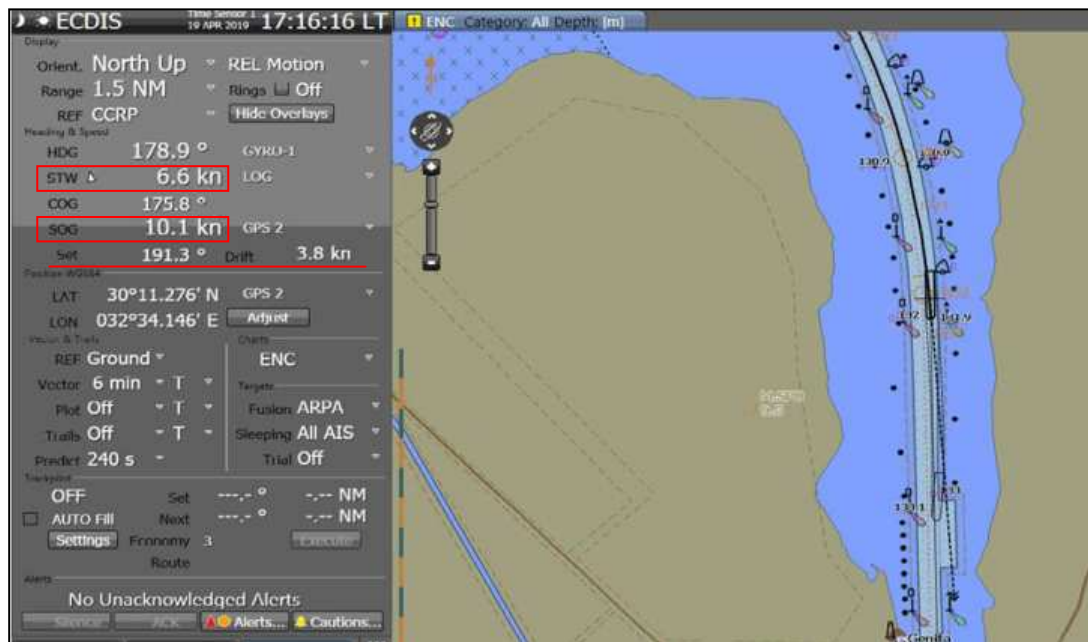
However, the VDR data indicated that the vessel had already been affected by the South-going stream earlier than 1712, as a marked difference of two knots between the STW and the SOG (drift) was noted. Furthermore, as the vessel was leaving Little Bitter Lake to her stern, and rounding the Canal's bend, the drift had increased to almost four knots (Figure 17). This marked increase in the drift experienced by *APL Danube* would most probably have been the effect of water being channelled to pass through a narrower part of the Canal, causing a venturi effect.

Figure 17: Vessel experienced a sudden increase of drift

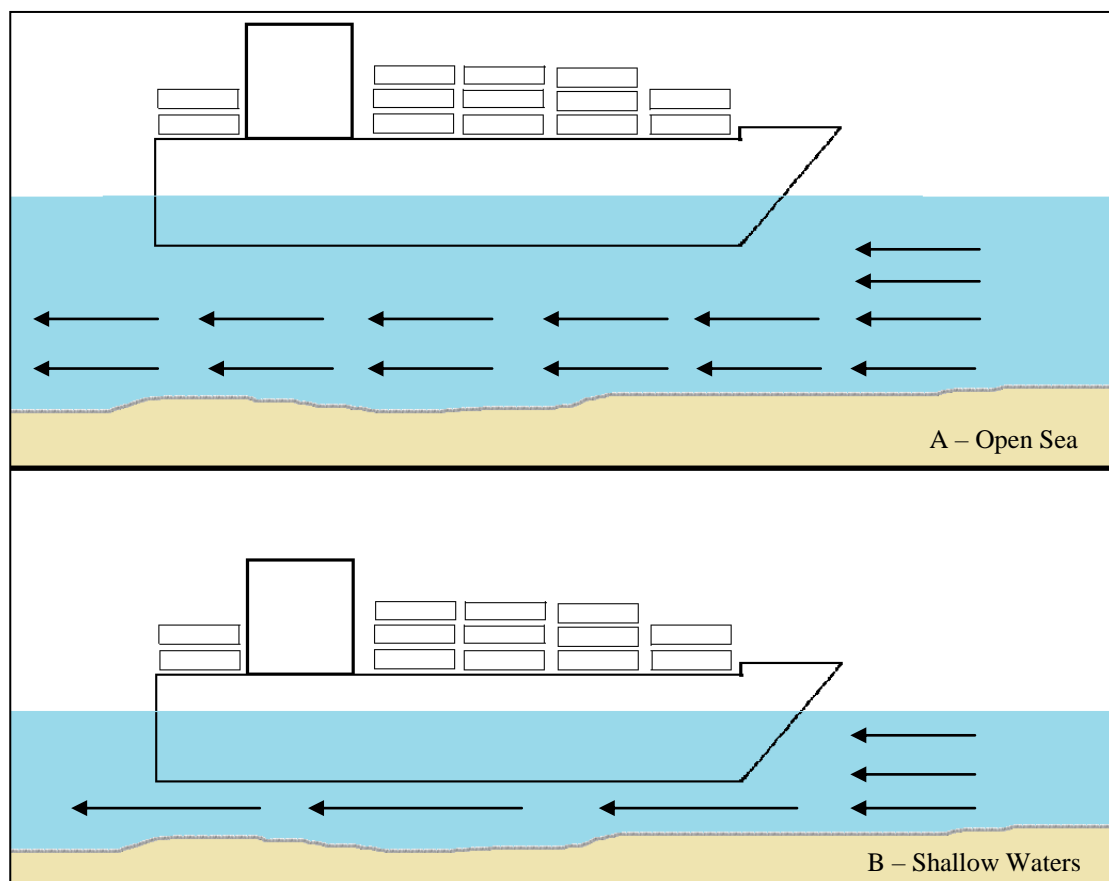
18b), which causes an increase in the water's velocity passing beneath the hull and consequently a loss in pressure (Venturi effect), which results in an increase in the vessel's draft and a trim by the head or stern. The main factors which contribute to squat are the vessel's block coefficient and her speed through water.

In fact, with the speed through the water with which the vessel was proceeding, it would have resulted in a squat (Figure 18b) of about half a metre, thereby increasing *APL Danube*'s draft by the same amount. Although squat did not contribute directly to the vessel's loss of steerageway, it would have caused the vessel's bow and stern to touch the bottom earlier than expected.

Figure 18: Squat effect

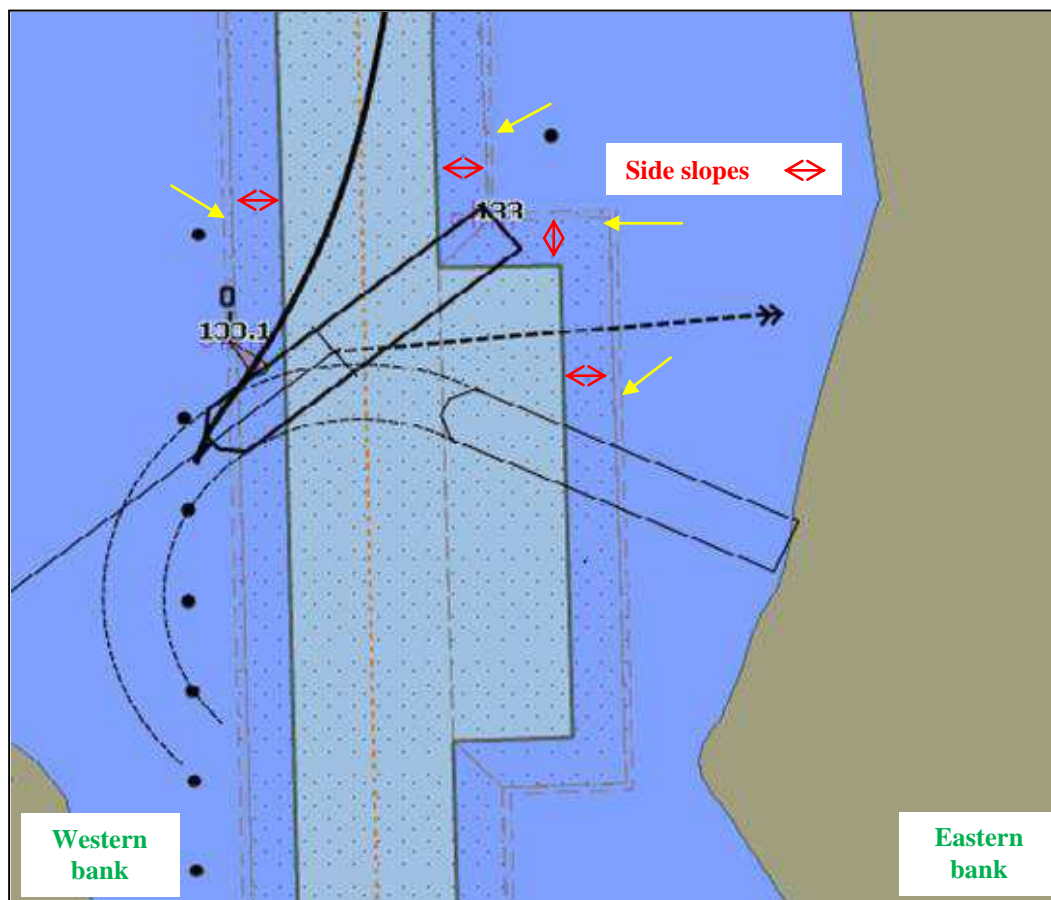
The main engine was running on full astern and, at around 1721:21, the vessel was making a sternway of about one knot. At 1721:38, while the port anchor was dropped, and the vessel was positioned in between the Western bank and the corner of the garage in the Eastern bank (Figure 19).

Figure 19: 1721:46 ECDIS extract – showing the position of the vessel in relation to the canal. The yellow arrows indicate the line on which lateral marks have been positioned – in this Southern part of the canal, the depth on this line were estimated to be 9m (vide Figure 4).

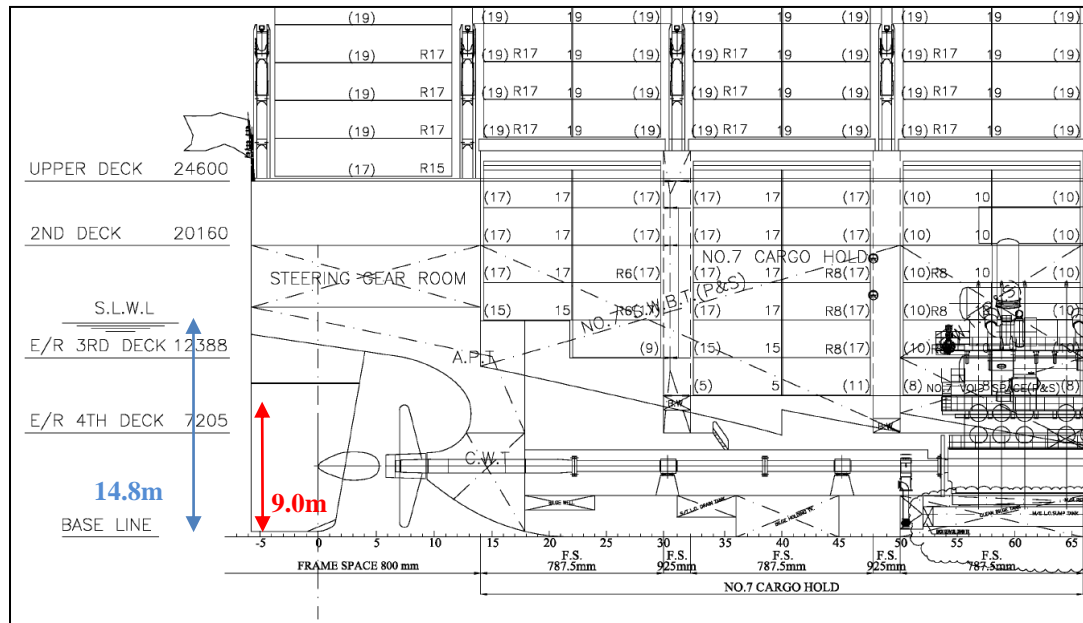
it is probable that, at this stage, the vessel's rudder and propeller were already in contact with the Eastern bank (Figure 20).

Figure 20: An extract from the General Arrangement Plan, showing the relation of the vessel's aft draft (blue) to the depth of the channel's slopes (red)

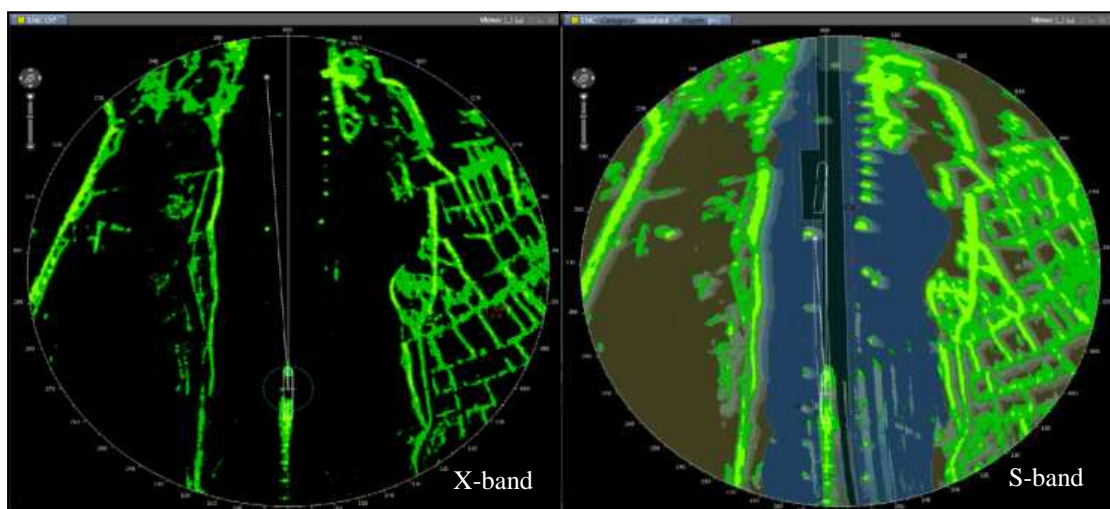
Figures 21a and 21b: Displays at 1717:01. The figure to the left (21a) shows the display of the X-band radar and that on the right (21b) shows the display of the S-band radar

At this time, the pilot was advising for the vessel to be steadied on a heading of 180°. As indicated in Figure 21b, the vessel's position in relation to the navigable channel was prominent on the S-band radar, due to the ENC chart being overlaid on the display screen. On the X-band radar, the vessel's position in relation to the navigable channel is not clear. It may be claimed that due to this, the pilot was probably not aware of the vessel's exact position in relation to the navigable channel. Additionally, the sudden increase of drift of up to 4.0 knots might therefore not have been counteracted by the pilot.

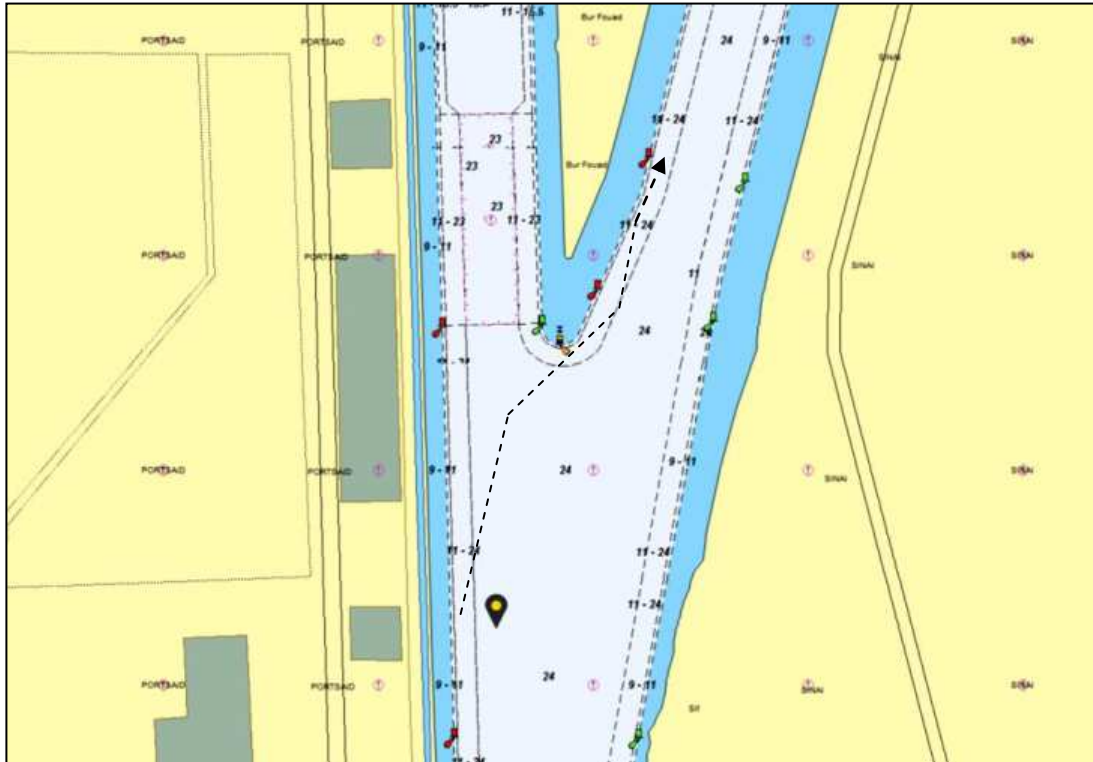
On 29 March 2019, under the same master, the vessel had also experienced a sheer to starboard while Northbound through the Suez Canal, just before passing Bur Fouad Peninsula (Figure 22), which was deduced to have been caused by bank effect.

Figure 22: An approximate reconstruction of the path taken by APL Danube on 29 March 2019
(Adopted from the EMCIP)
