**Fall of a suspended load, resulting in injuries
to two crewmen on board the general cargo vessel
ZEA Servant
in Campbeltown, Scotland
on 2 March 2019**

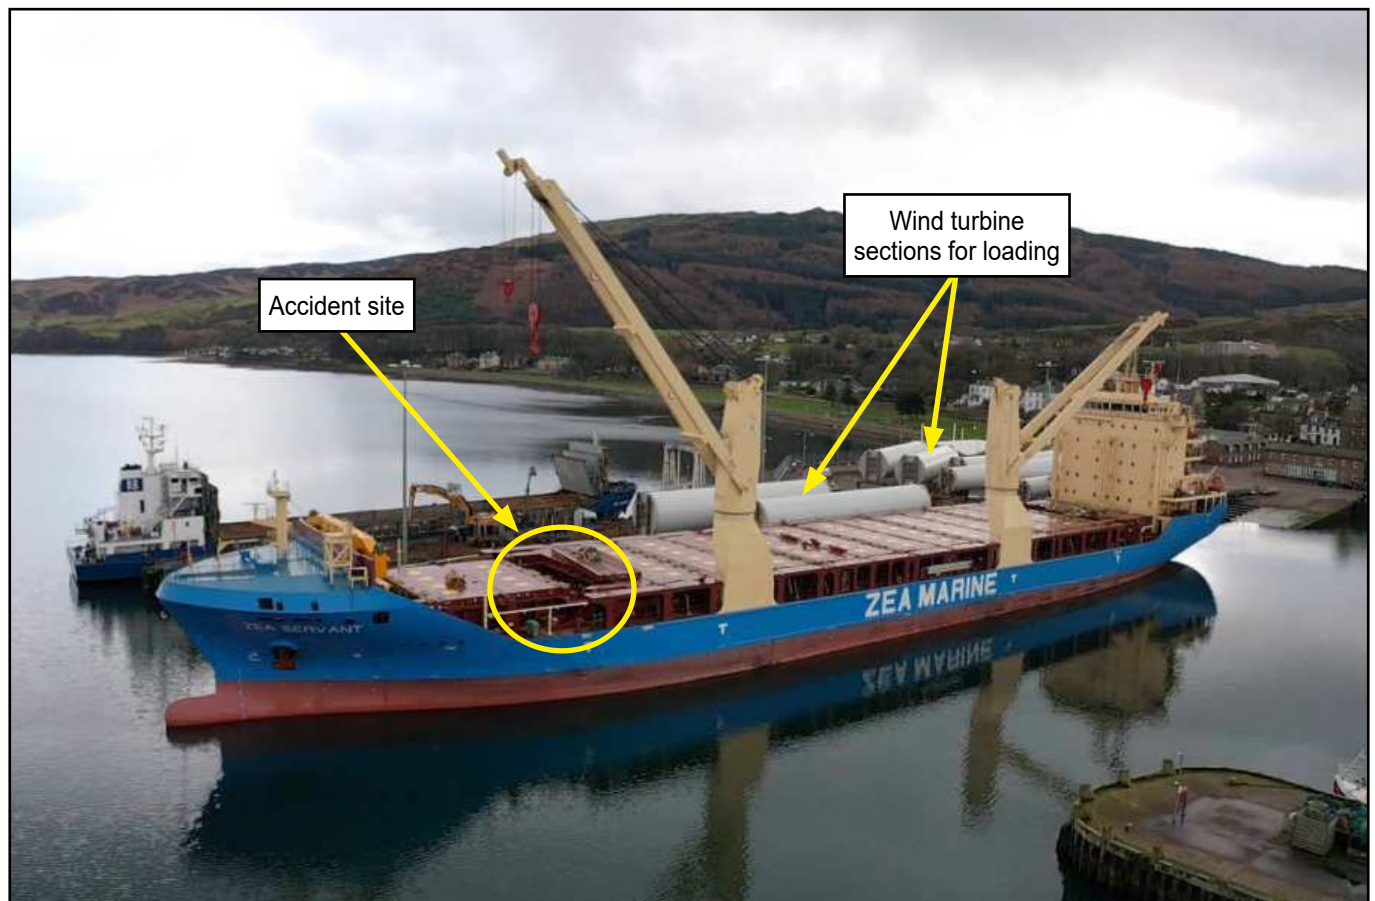
Figure 1: *ZEA Servant* berthed in Campbeltown showing accident site and wind turbine sections for loading

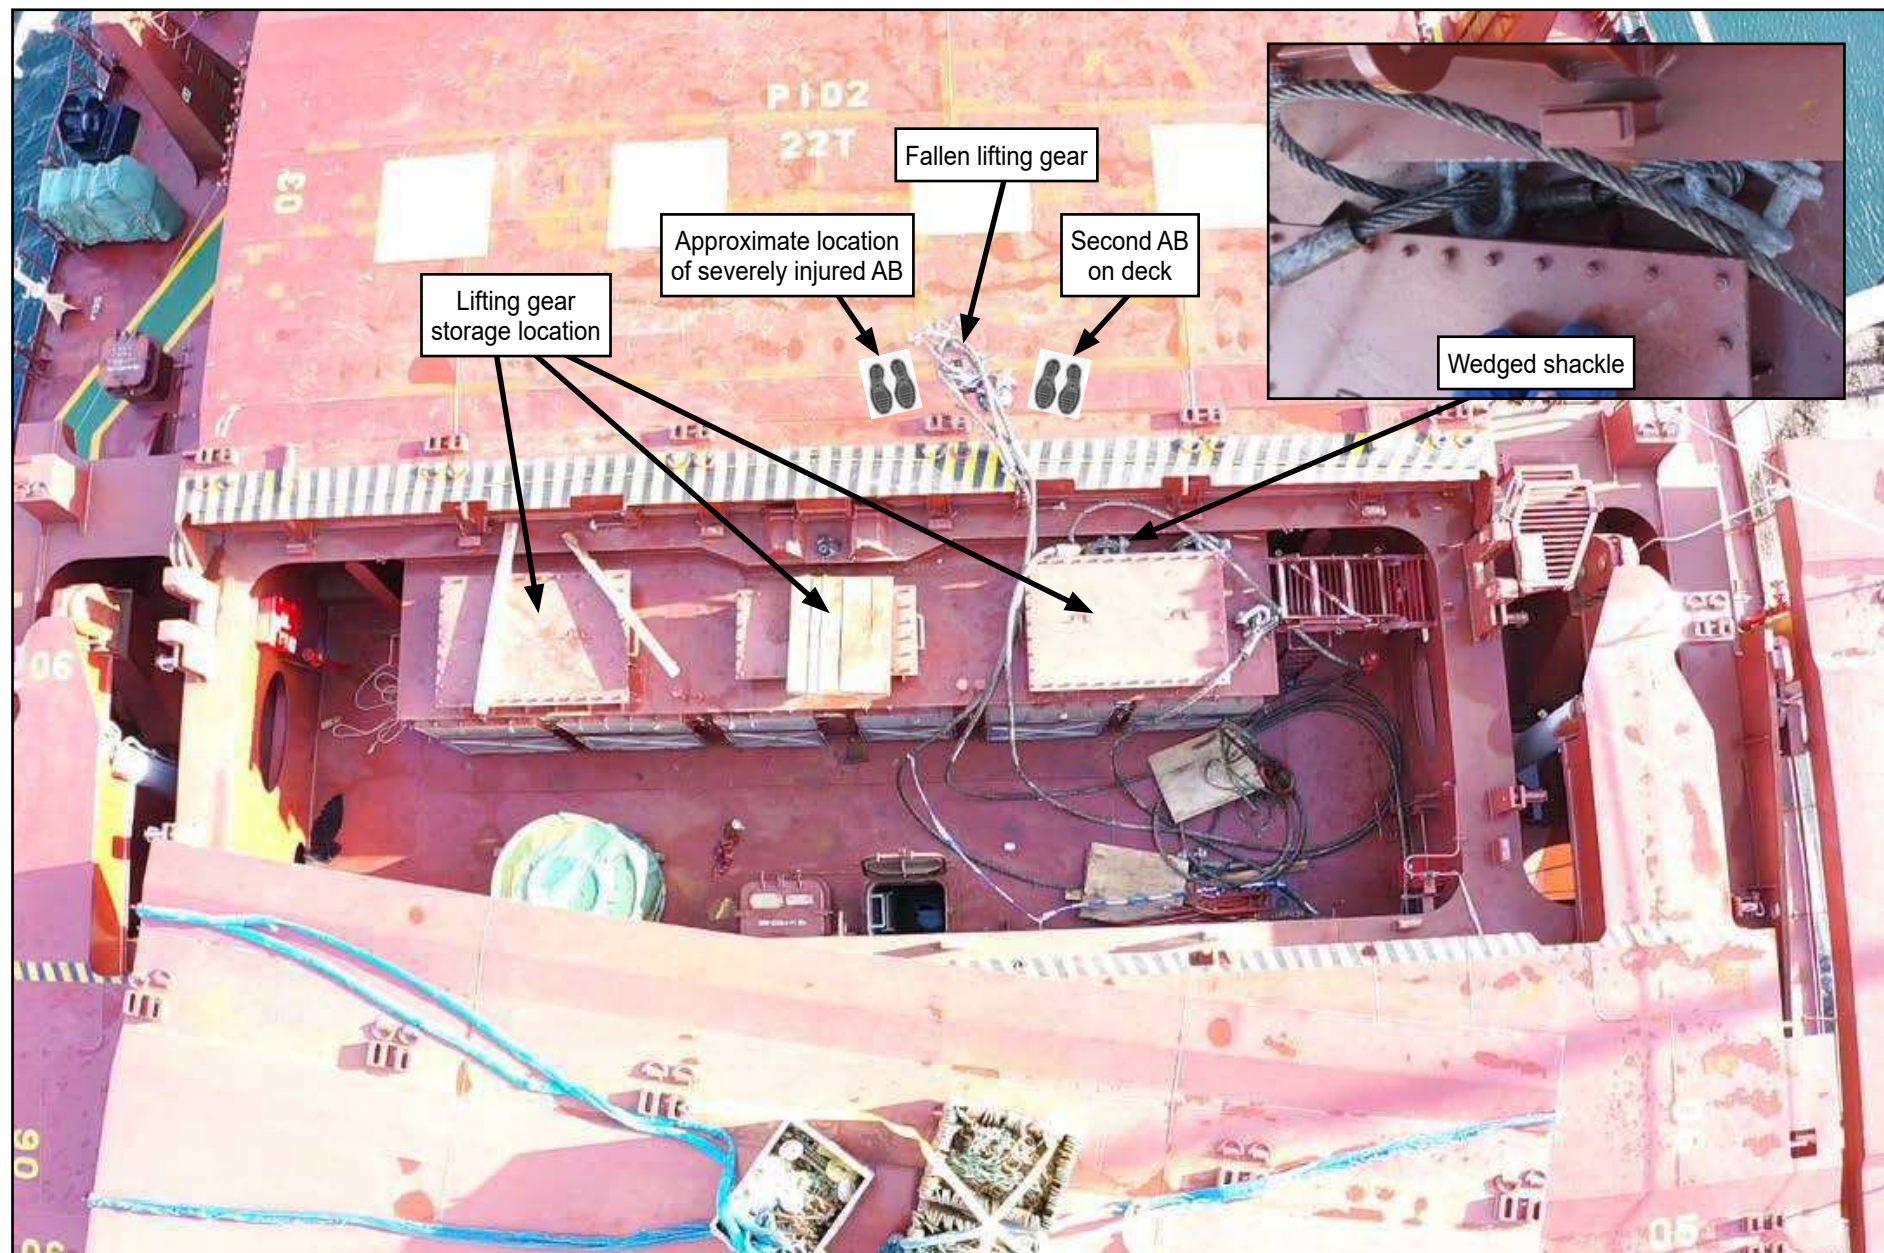
Shortly after the lifting operation recommenced, a shackle at the lower end of the load became snagged on a ventilation trunk coaming (**Figure 2**). The chief officer immediately instructed the crane driver to stop, but at the same time the fibre sling parted and the lifting gear fell to the deck, striking both ABs.

Figure 2: Plan view of the ventilation duct space and accident site (**inset:** close up of wedged shackle)

ZEA Servant had not been built with a dedicated storage area for the heavy cargo hold hatch cover lifting gear. As a result, the crew had devised a local arrangement to store the lifting gear on top of wooden pallets in the cargo hold ventilation duct space (**Figure 2**). This might have appeared appropriate as a suitable storage space because it was accessible; however, it was an area where there was a significant number of potential snagging hazards, especially for lifting slings with shackles at their ends.

- Identified an alternative and more suitable location to stow the cargo hold hatch cover lifting gear and developed a lifting plan for its removal and re-stowing.
- Notified its fleet of the importance of crew safety awareness, including the need for self-protection measures and safe positioning during lifting operations.
- Notified its fleet of the importance of the safety brief and the responsibilities of those supervising lifting operations.
- Undertaken a review of the vessel's safety management system.
- Provided additional safety training to *ZEA Servant's* crew on the procedure to open hatches and the inspection of lifting equipment.
- Issued a fleet circular requiring checks to lifting equipment, including SWL of each component, certification and the condition of fibre slings.
- Required shore managers to inspect operational safety of crew.

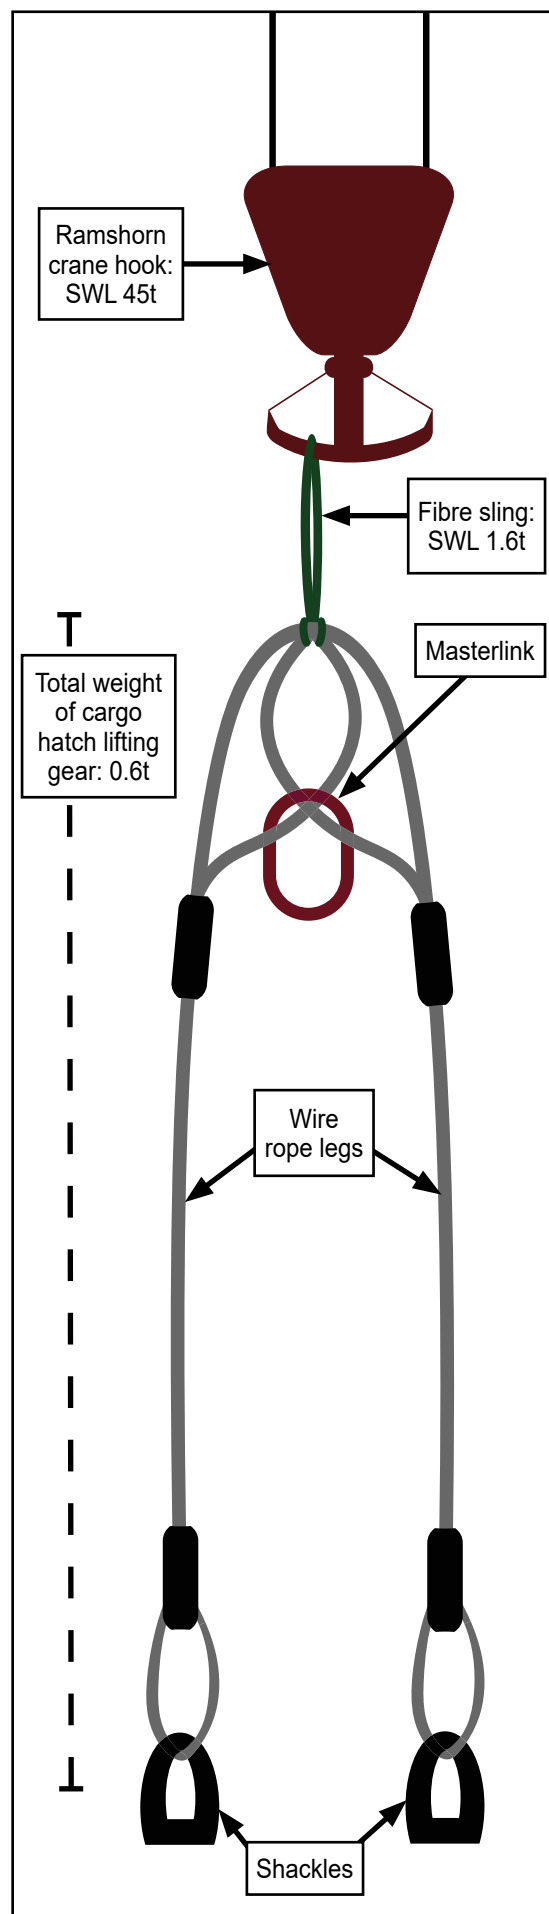
ZEA Servant's forward crane had a safe working load (SWL) of 250 tonnes (t), and its ramshorn hook had a SWL of 45t. The crane was in date for survey and had no known defects. The cargo hold hatch cover lifting gear was made up of two slinging sets; each set weighed 0.6t and consisted of two 17m long, 52-millimetre (mm) diameter, wire rope legs joined together with a master link (**Figure 3**). Each wire leg had a shackle attached to an eye at the lower end.

Figure 3: Cargo hold hatch cover lifting gear - attachment to crane hook with fibre sling

The crew used fibre slings to connect the hatch cover lifting gear to the crane's ramshorn hook because of the weight of the gear and the restricted amount of space around the ventilation coamings. The crew had used the same method to remove the lifting gear from the ventilation duct space on at least five previous occasions and had experienced similar snagging events. When these had occurred, the deck crew had manually freed the gear after the crane had stopped hauling.

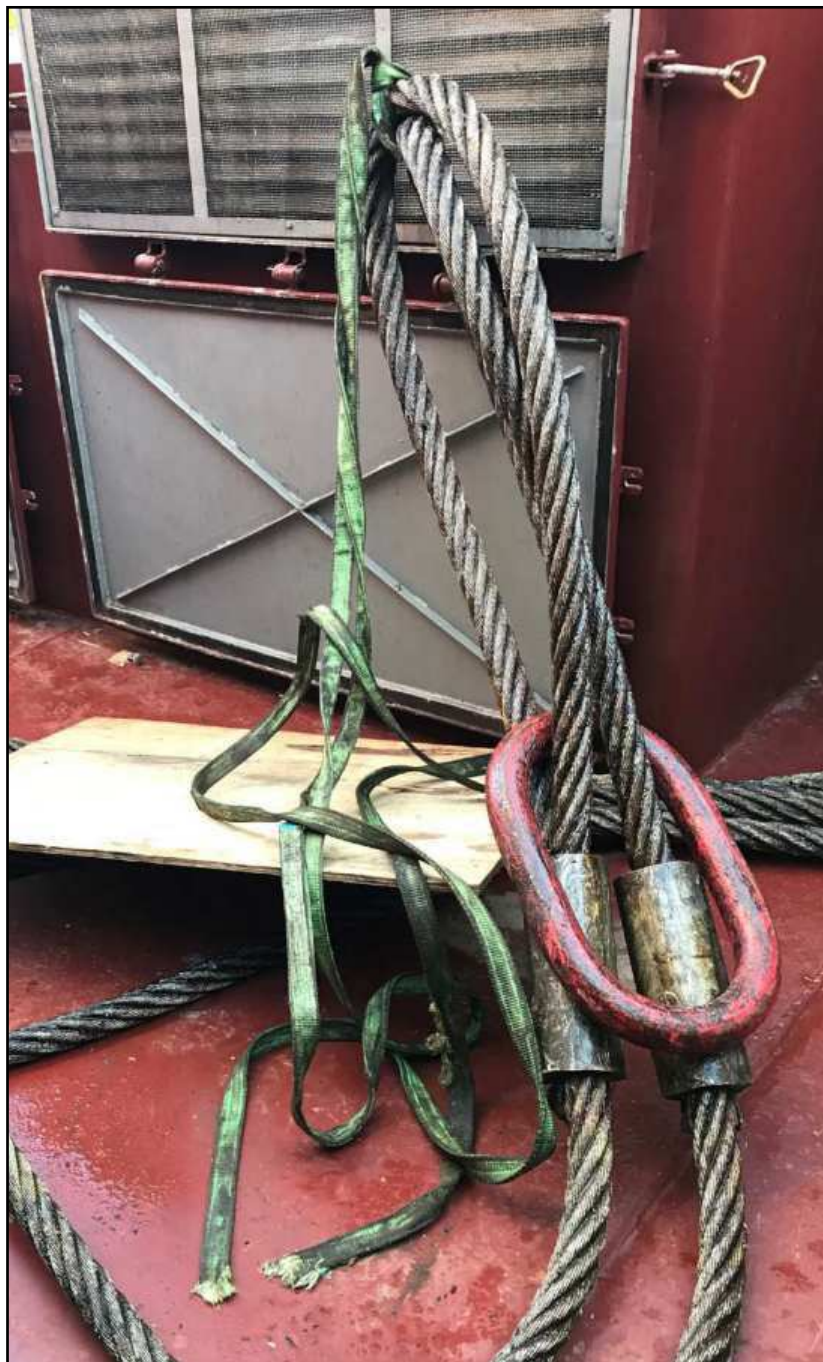
The fibre sling that parted (**Figure 4**) had been rigged using a choke hitch; it was one of several similar slings on board and had an SWL of 2t with a factor of safety of 6:1. This equated to a minimum breaking load (MBL) of 12t in a straight pull. These values reduced to 1.6t SWL and 9.6t MBL in a choke hitch configuration.

After the accident the parted sling (**Figure 4**) and five other similar slings from *ZEA Servant* were examined at an expert testing centre. The report of these tests stated that all six slings would have failed a visual inspection as they were soiled and had illegible identification markings. The parted sling was also noted to have some localised damage. During destructive testing, one of the other fibre slings failed at a load of 6.4t when rigged in the choke hitch configuration. The test laboratory report estimated that the actual breaking load of the parted sling at the time of the accident would have been 6.25t.

Figure 4: Broken fibre sling (after the accident)

The load fell because the synthetic fibre sling used to lift it parted under tension. It was reasonable to use such a fibre sling as its SWL was more than twice the weight of the load being lifted when rigged using a choke hitch. However, the fibre sling in use was in a poor condition, with local damage, soiling (**Figure 4**) and illegible identification markings. It therefore should have been discarded. Destructive load tests and laboratory analysis showed that its residual strength was almost half its design MBL.

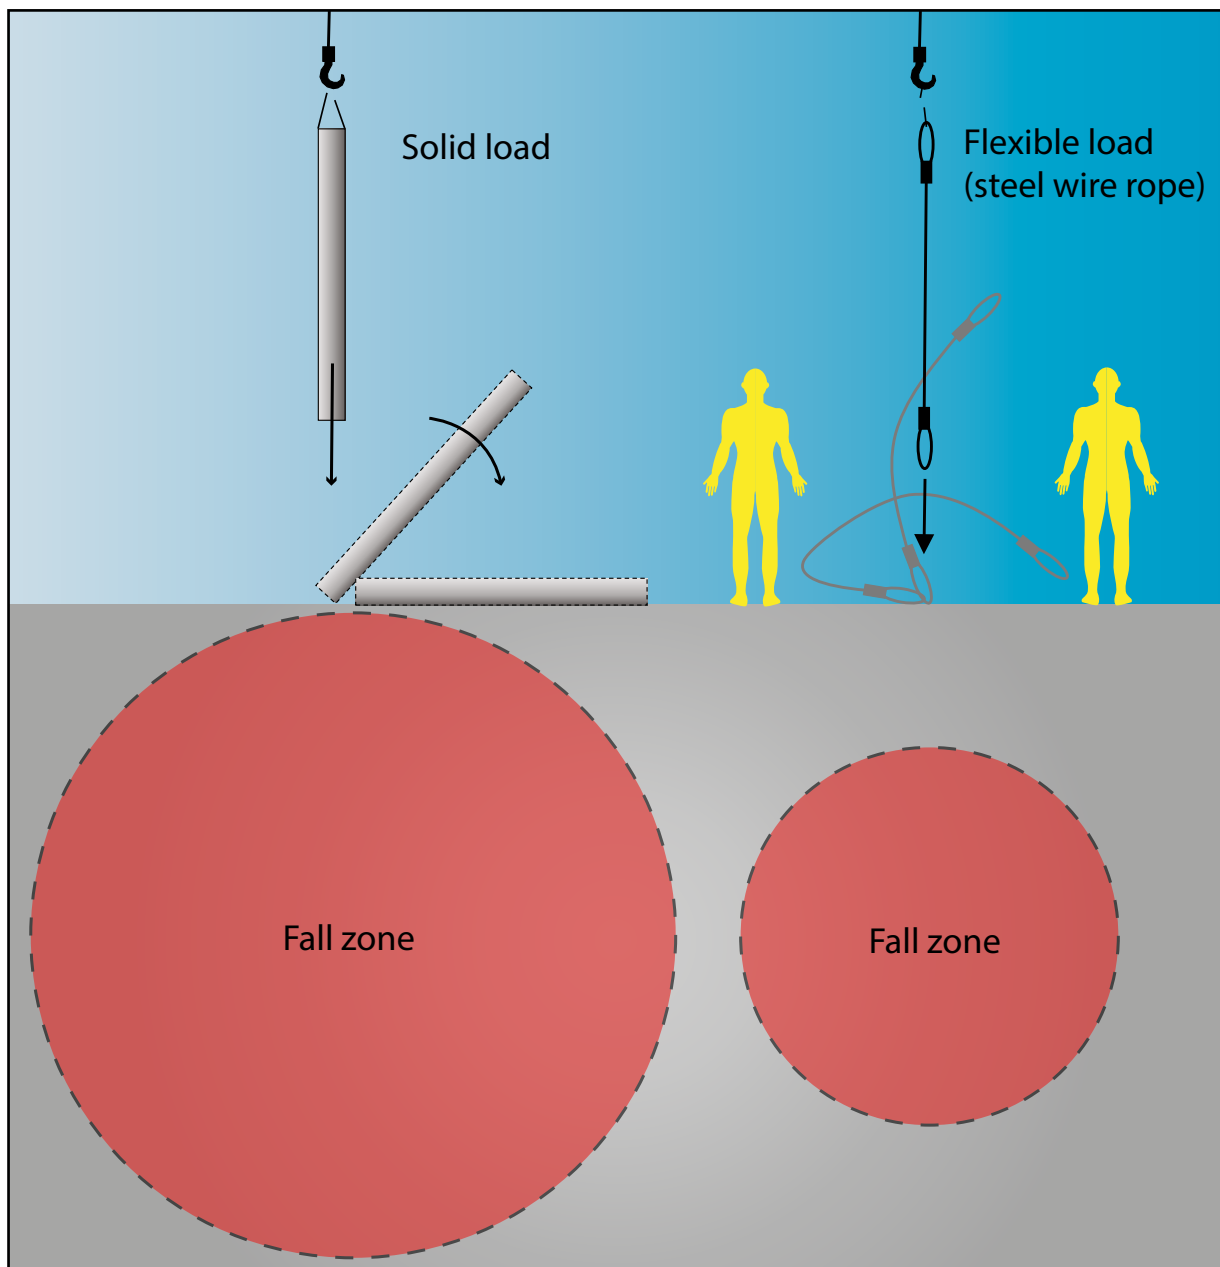
All lifting operations should be properly risk assessed and planned, and safe systems of work put in place. Lifting plans and safe systems of work should address the foreseeable risks involved in the work and identify all the appropriate resources necessary for safe completion of the task. Factors to consider when developing a lifting plan include: appropriate equipment, suitably qualified personnel, rigging arrangements, lift route, other proximate hazards, visibility, weather and an assessment of the fall zone (**Figure 5**).

The fall zone is not limited to the immediate area directly beneath the load; instead it is the reasonably foreseeable area that partially or completely suspended loads could fall into in the event of an accident. Solid loads can bounce, roll, topple over or fragment in any direction on impact with the ground. Flexible loads, such as steel wire ropes, will collapse into an area dependent on their stiffness of the wire ropes (**Figure 6**). Having assessed the hazards and resources, the plan should then set out clearly the actions involved at each step of the operation and identify the responsibilities of those involved.

Figure 5: Illustration of the fall zone around a suspended load

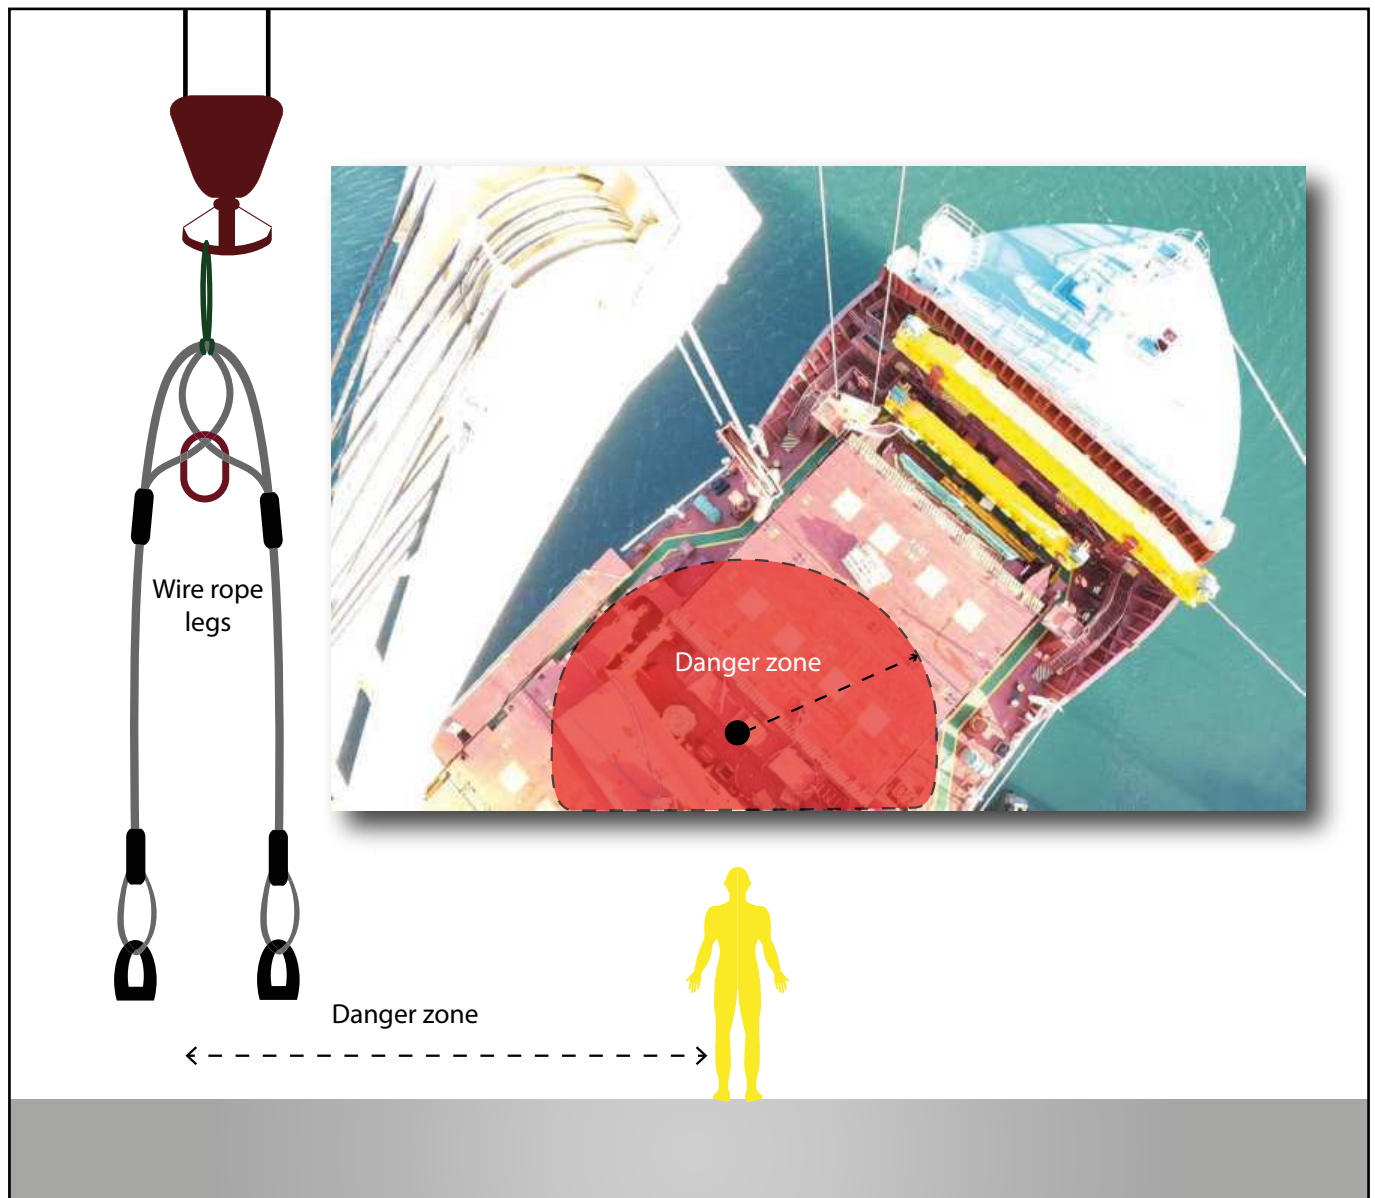
ZEA Servant's safety management system did not contain a risk assessment or a procedure for the stowage and handling of the cargo hold hatch cover lifting gear, nor any guidance for the conduct of a lifting plan and the identification of fall zones. Had a fall zone assessment been undertaken, it would have been evident that it was unsafe for the crew to position themselves so close to the suspended load.

Figure 6: Illustration of the estimate of the danger zone that the lift would have created on board *ZEA Servant*
