Report on the investigation into the contact  
made by the tanker

***Vallermosa,***

***Navion Fennia*** and ***BW Orinoco***

at the Fawley Marine Terminal

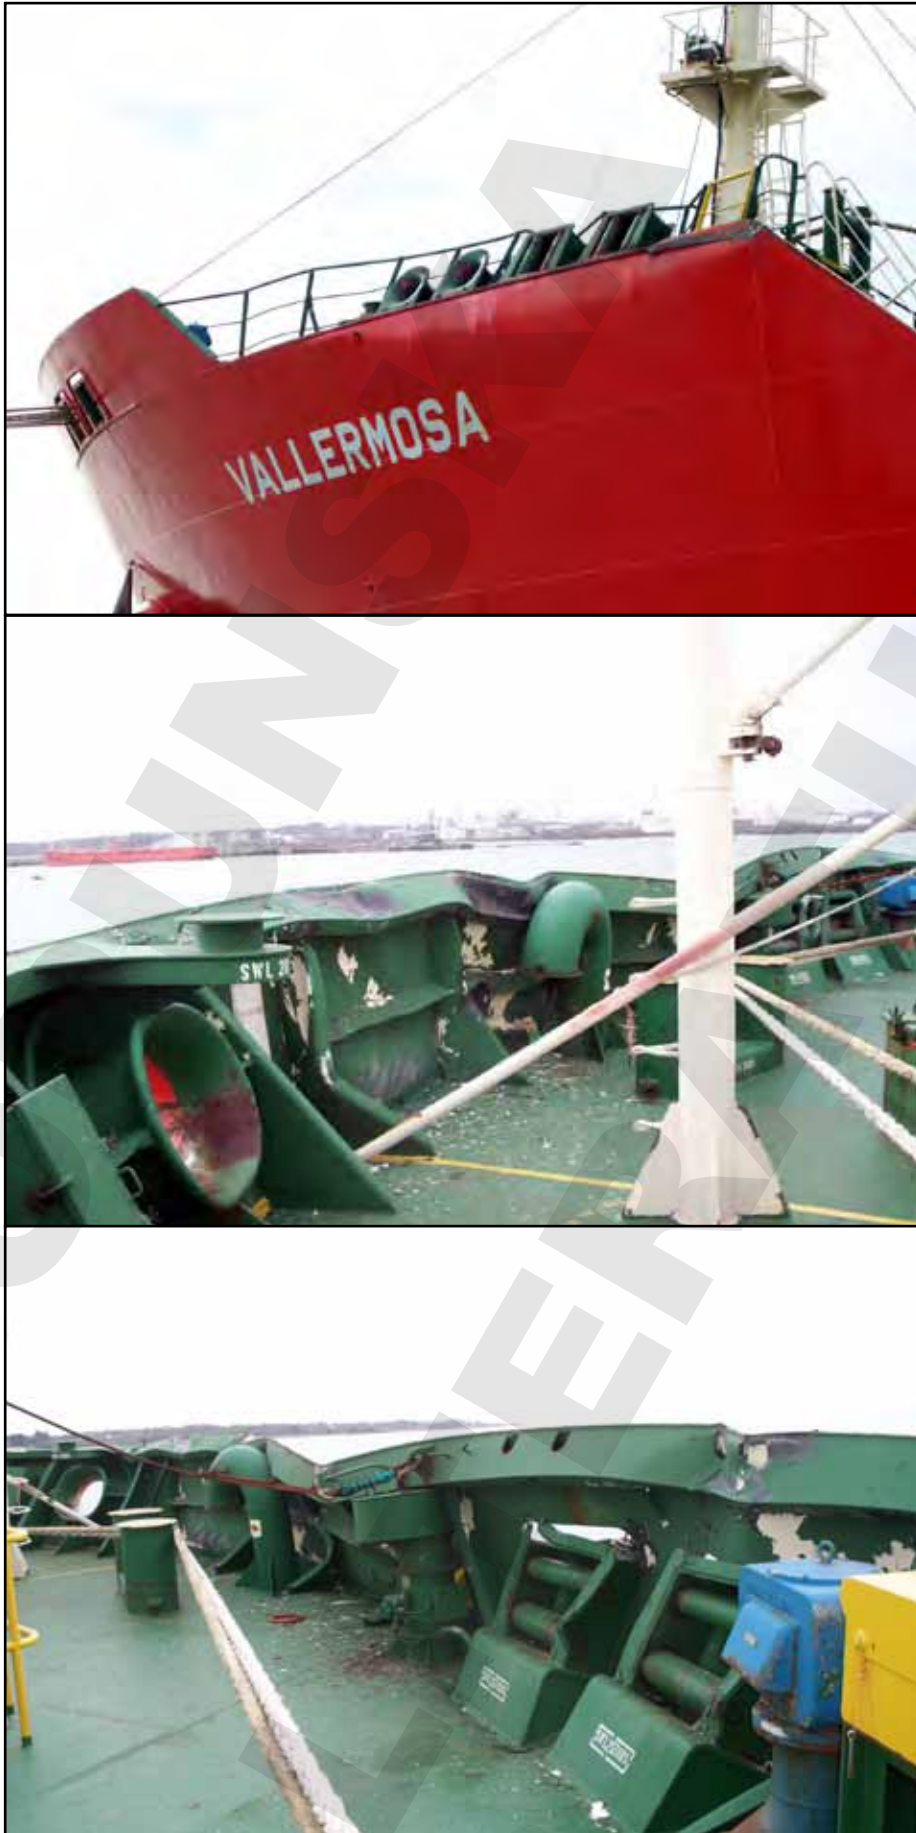
*Vallermosa* sustained damage (**Figure 6**) to the port and starboard side forecastle bulwark and connecting brackets, the forecastle deck was heavily buckled over a 15m length. Two fairleads on the port side and two on the starboard side were damaged along with the ventilation trunking to the forward store. Following discharge of her cargo, the vessel proceeded to Portland, where temporary repairs were effected. Permanent repairs were subsequently carried out in Flushing (**Figure 7**).

Damage sustained by *Vallermosa*

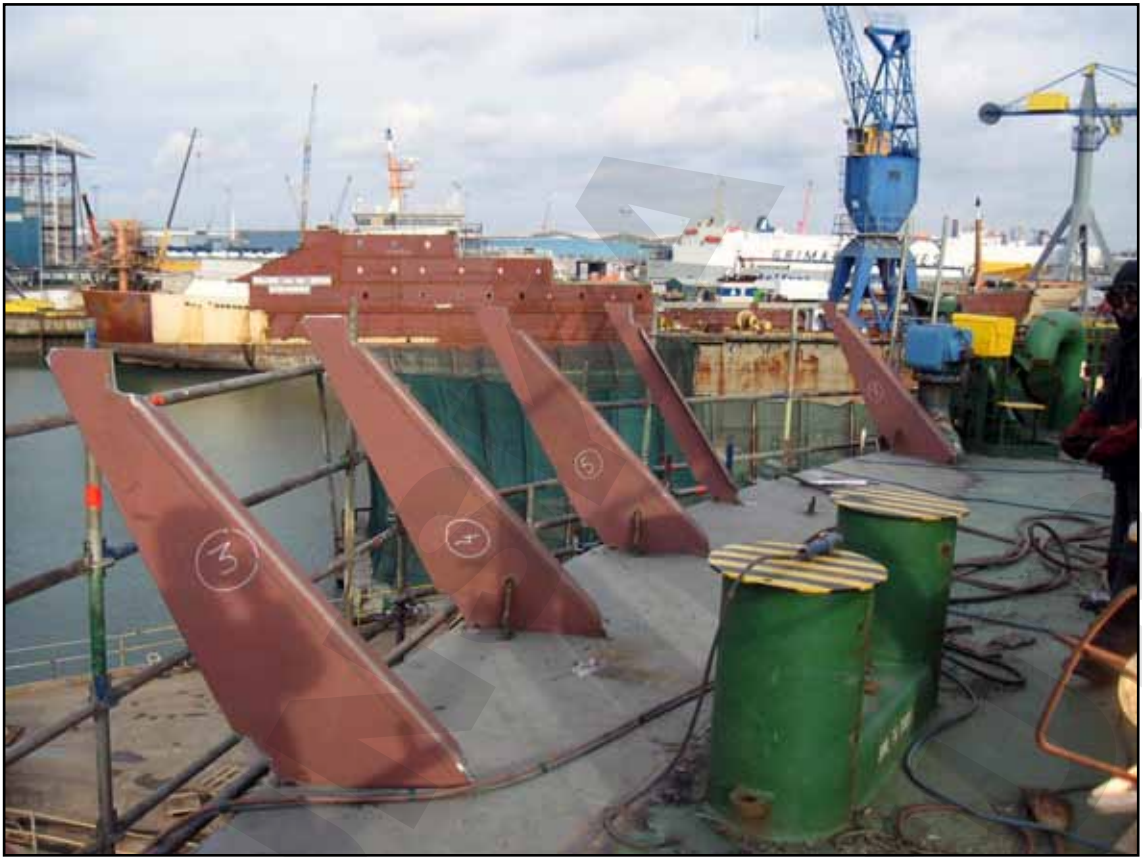
Figure 7

*Vallermosa* undergoing repairs in Flushing

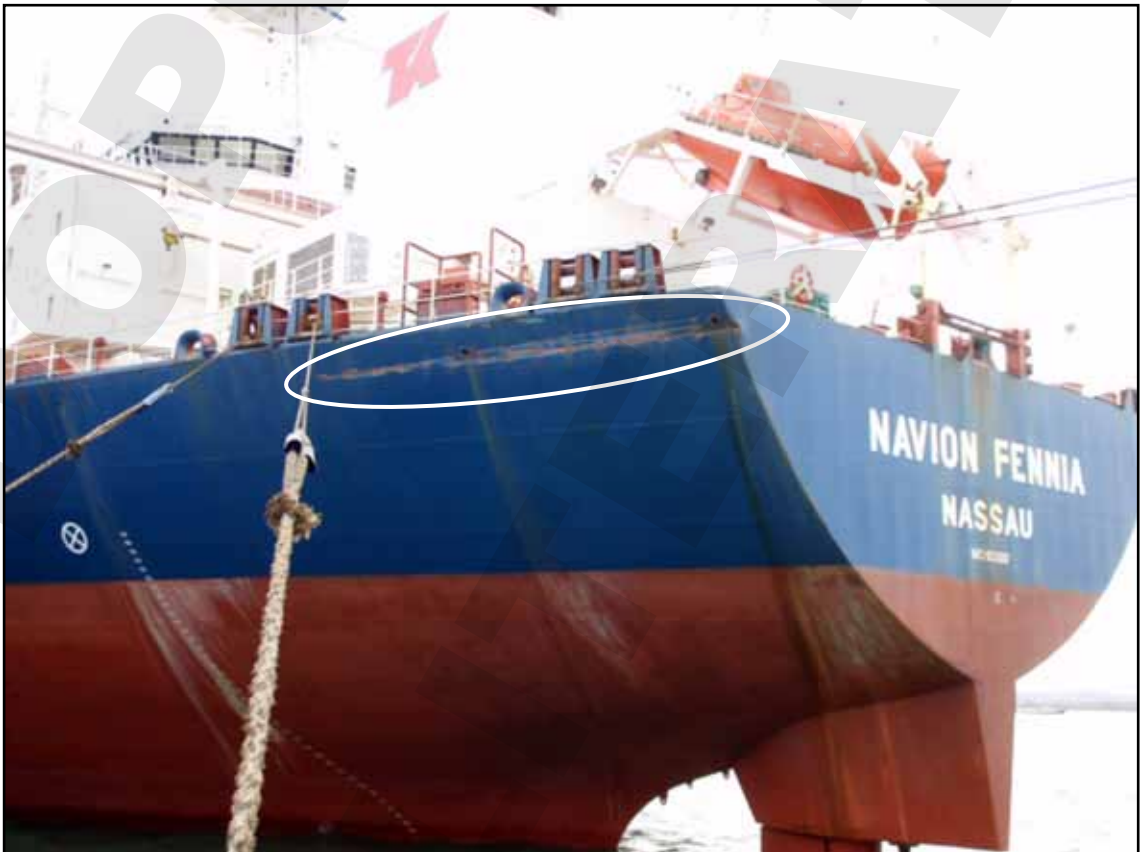
Figure 8

*Navion Fennia*, which was starboard side alongside Fawley Marine Terminal berth 5, sustained damage to her port quarter (**Figure 8**). This consisted of torn and indented plating with buckling of associated stiffeners. Temporary repairs were effected before the vessel left the Solent, allowing permanent repairs to be deferred until her next docking period.

Damage sustained by *Navion Fennia*

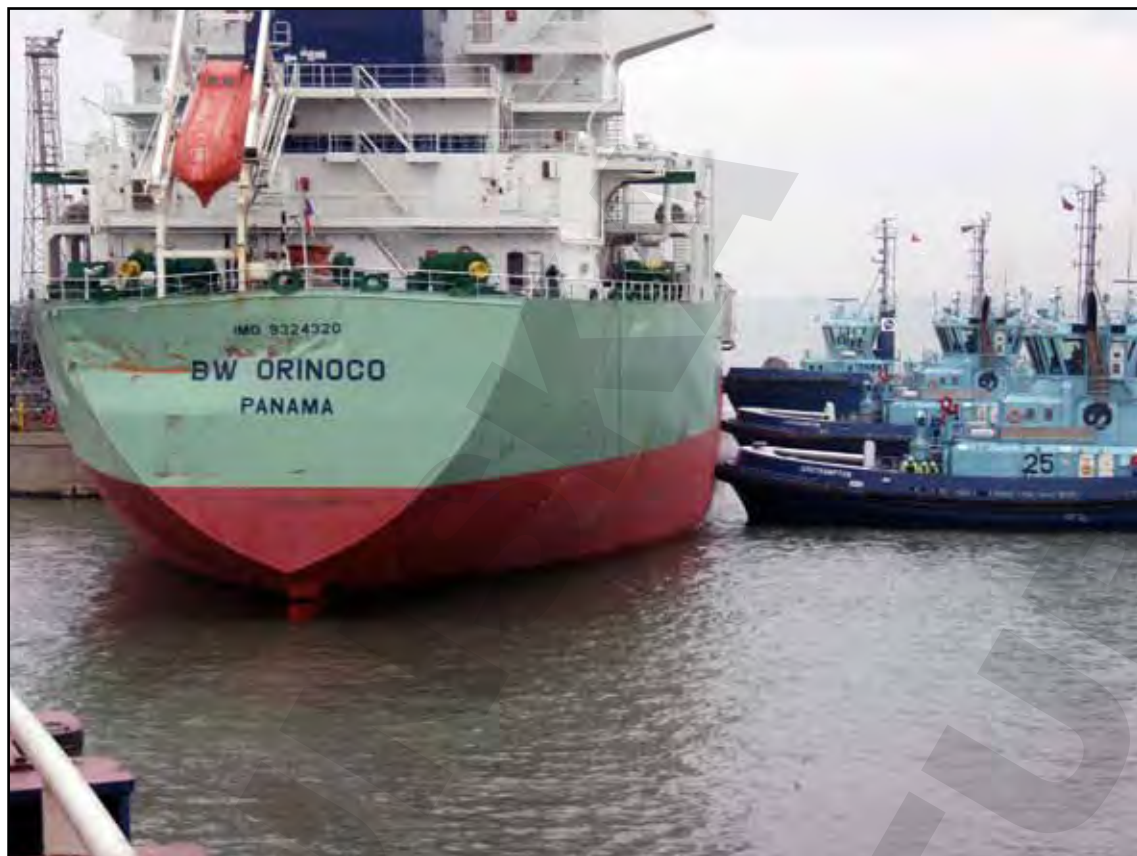
Figure 9

*BW Orinoco*, port side alongside Fawley Marine Terminal berth 4, sustained extensive damage to her port quarter, stern structure, poop deck and steering gear (**Figure 9**). The vessel required steelwork replacement (**Figure 10**), and repairs were also required to the freefall lifeboat davit before she could leave the Solent.

Damage sustained by *BW Orinoco*

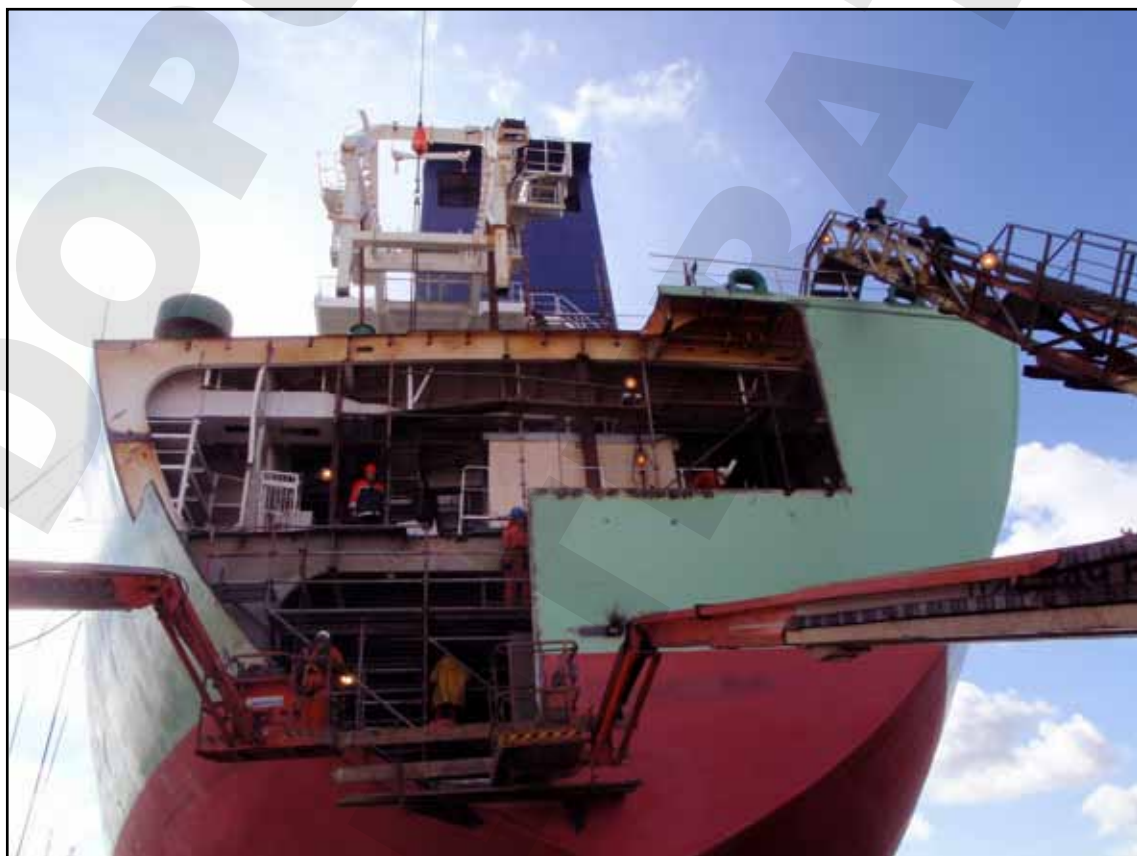
Figure 10

Repair work to *BW Orinoco*

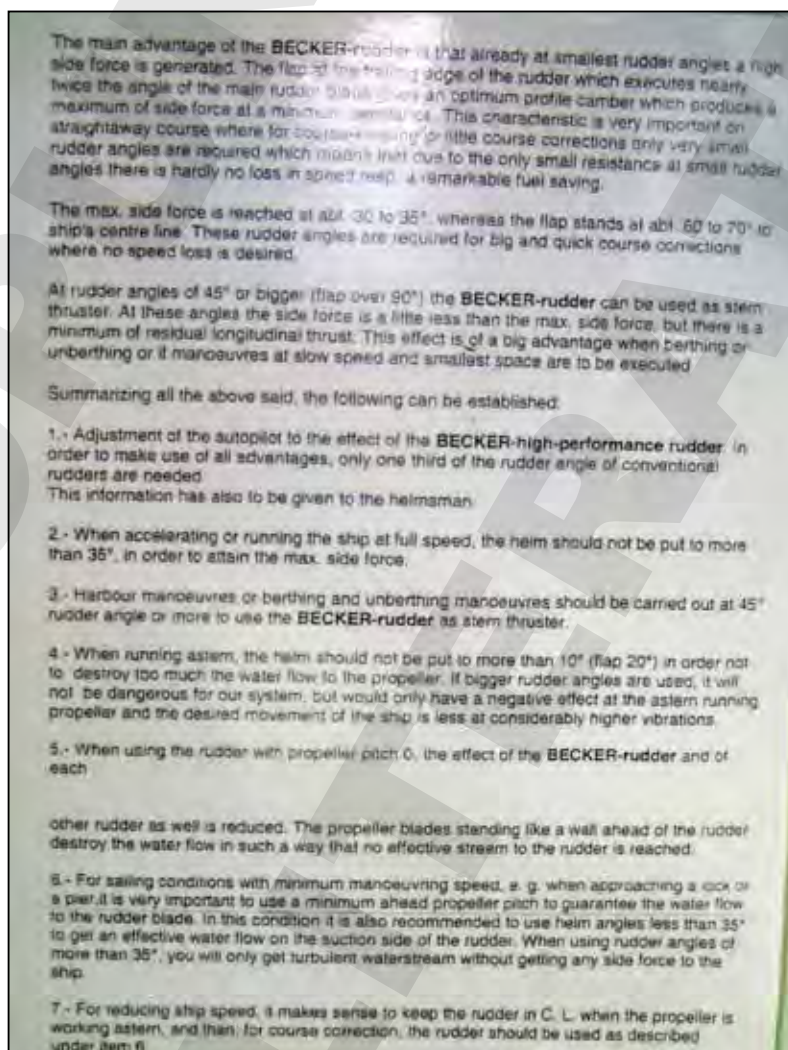
Figure 13

The manufacturer estimated that the Becker rudder was three times as effective as a conventional rudder. The advice posted at *Vallermosa's* steering position (**Figure 13**), located beneath the helm and obscured from the pilot's view warned:

*"It is very important to use a minimum ahead propeller pitch to guarantee the water flow to the rudder blade. In this condition it is also recommended to use helm angles less than 35° to get an effective water flow on the suction side of the rudder. When using rudder angles of more than 35°, you will get turbulent water stream without getting any side force to the ship."*

Advice on use of the Becker rudder

- *The ship entered Southampton Water at too high a speed, resulting from prolonged use of full ahead power in the bend round Calshot Spit. This lay at the heart of all that went wrong subsequently.*
- *There was no allowance for the possibility of a sheer to starboard, once the engine was stopped, due to the cessation of screw bias effects.*
- *The Becker rudder was used inappropriately and in contravention of the recommendations for use of such rudders posted on the bridge.*

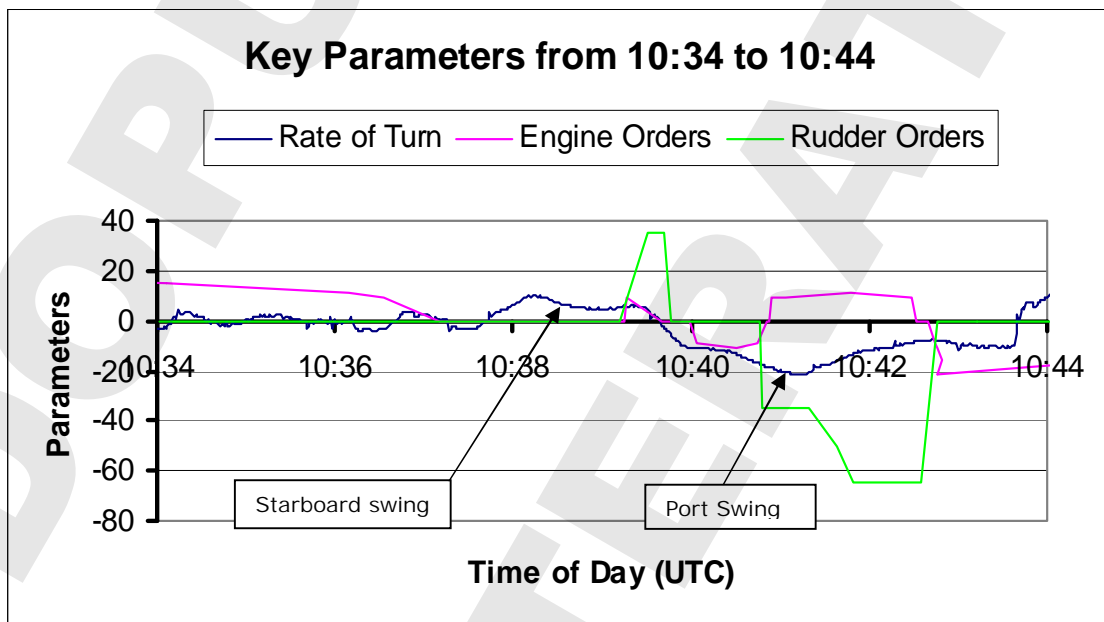
At 10:34 the ship was making about 11.5 knots over the ground with the engines on half ahead, having been reduced from full ahead. Figure 8 indicates the turn rate, rudder commands and engine orders over this last period.

Figure 8: Measured Parameters in Period Leading to Collision
