MARINE SAFETY INVESTIGATION REPORT

Safety investigation into a fatality and serious injuries on board the
Maltese-registered passenger/ro-ro vessel

Euroferry Malta

MARINE SAFETY INVESTIGATION REPORT NO. 17/2020

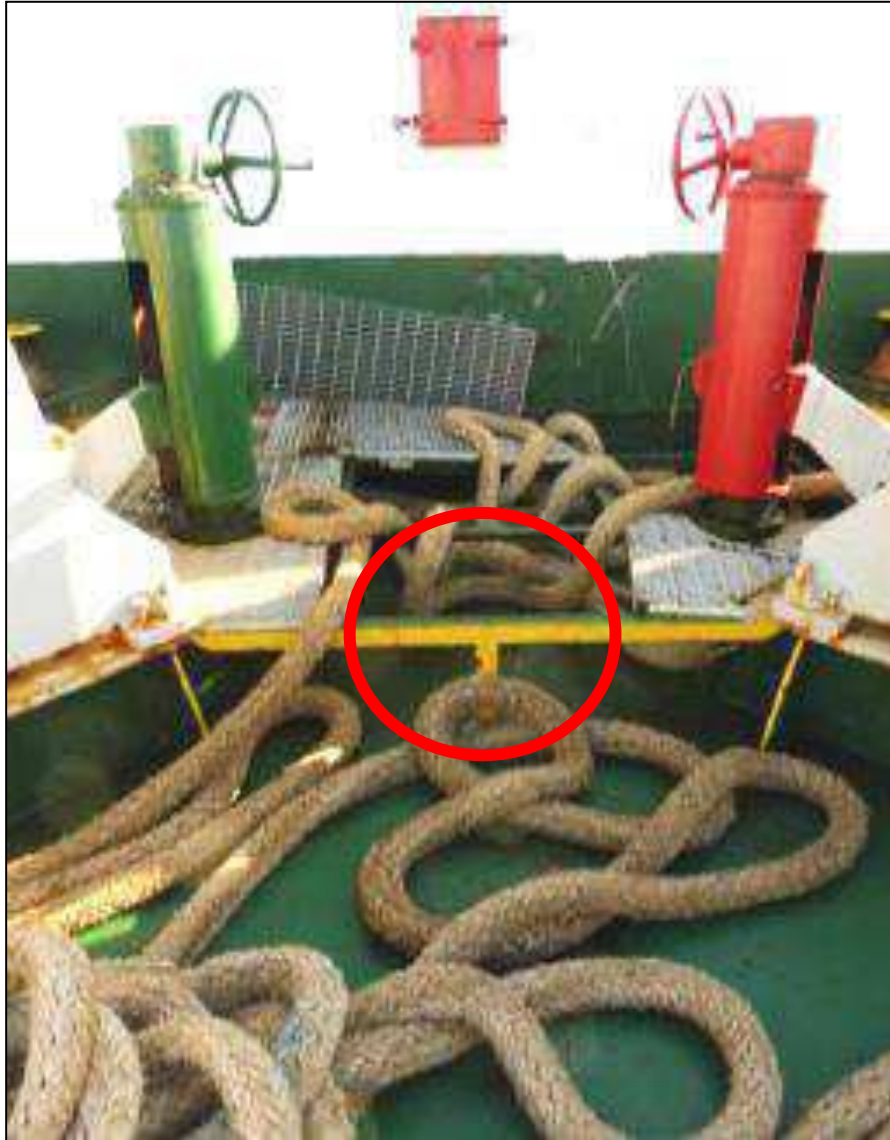
Eventually, the chief officer found AB 1 lying face down and unresponsive between the two windlasses (Figure 12). He checked for vital signs and, on not noticing any, he called for AB 4. The chief officer and AB 4 carried AB 1 towards the accommodation entrance. He then noticed that the bosun and the other two ABs had managed to walk back.

Figure 12: Area (red circle) where the fatally injured crew member was found

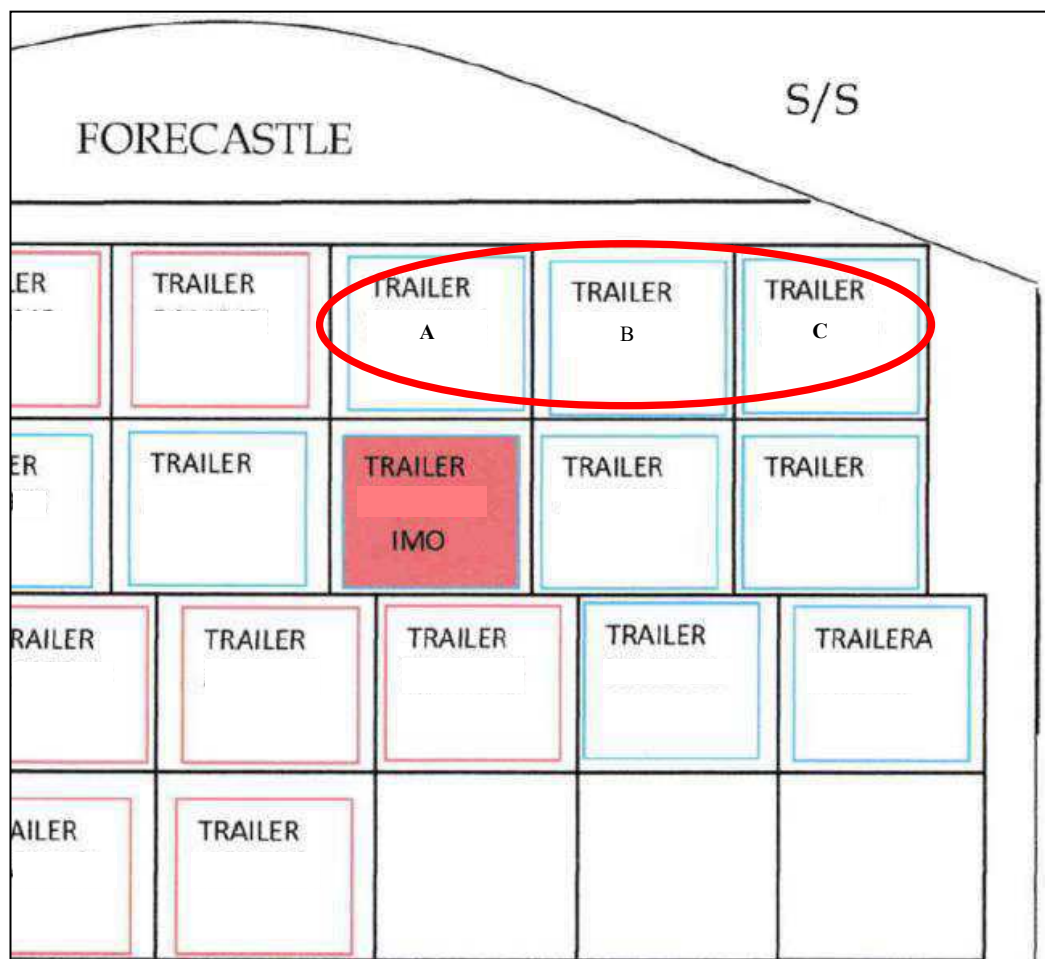
Three trailers (Figures 13 to 15), located on the starboard side, just aft of the deckhouse, were found to have sustained substantial damages.

Figure 13: Location of damaged trailers (A, B and C)

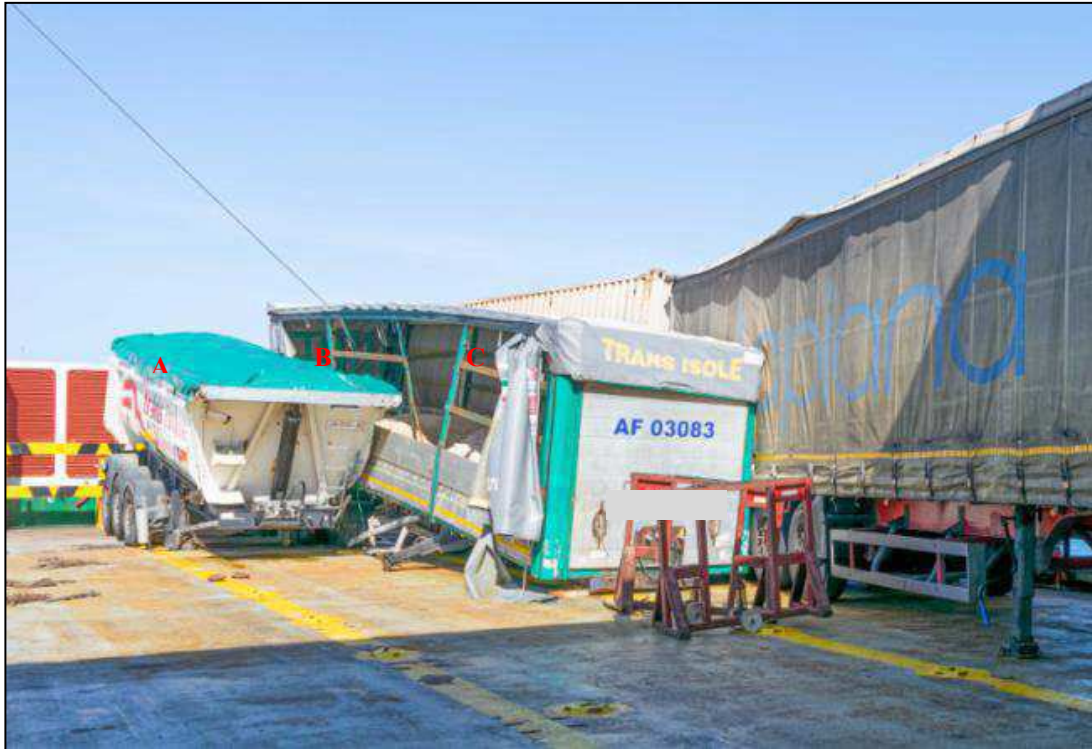
Figure 14: Damaged trailers A, B and C, seen from aft

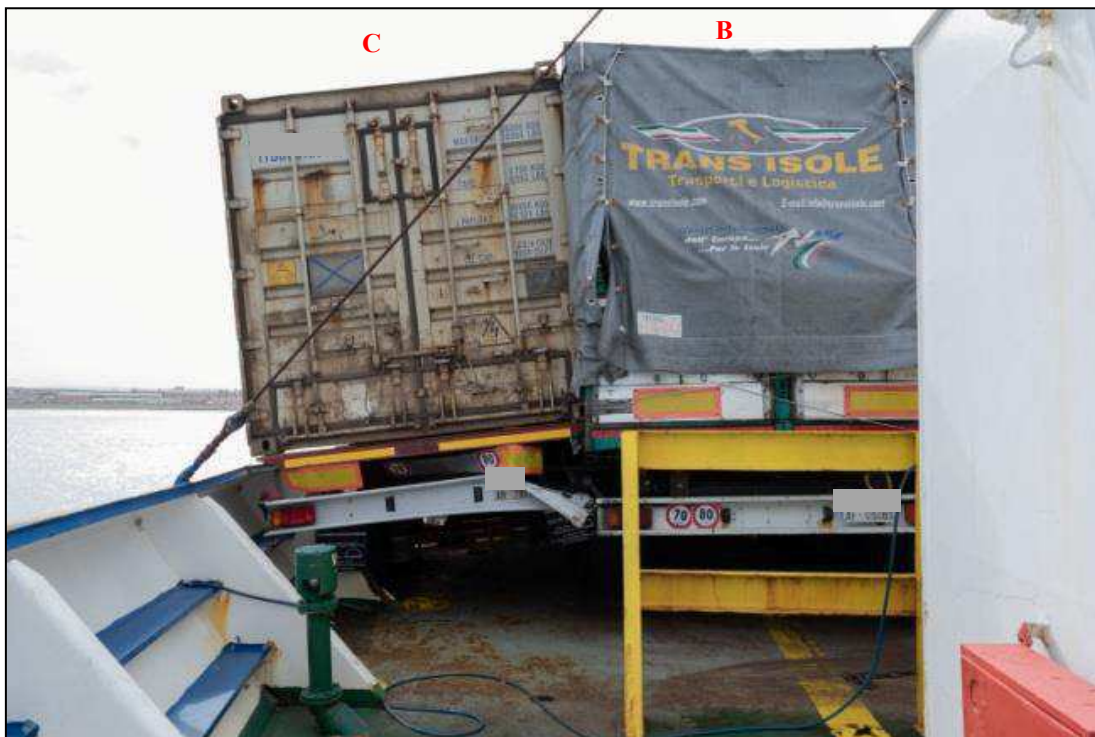
Figure 15: Trailers B and C, seen from forward

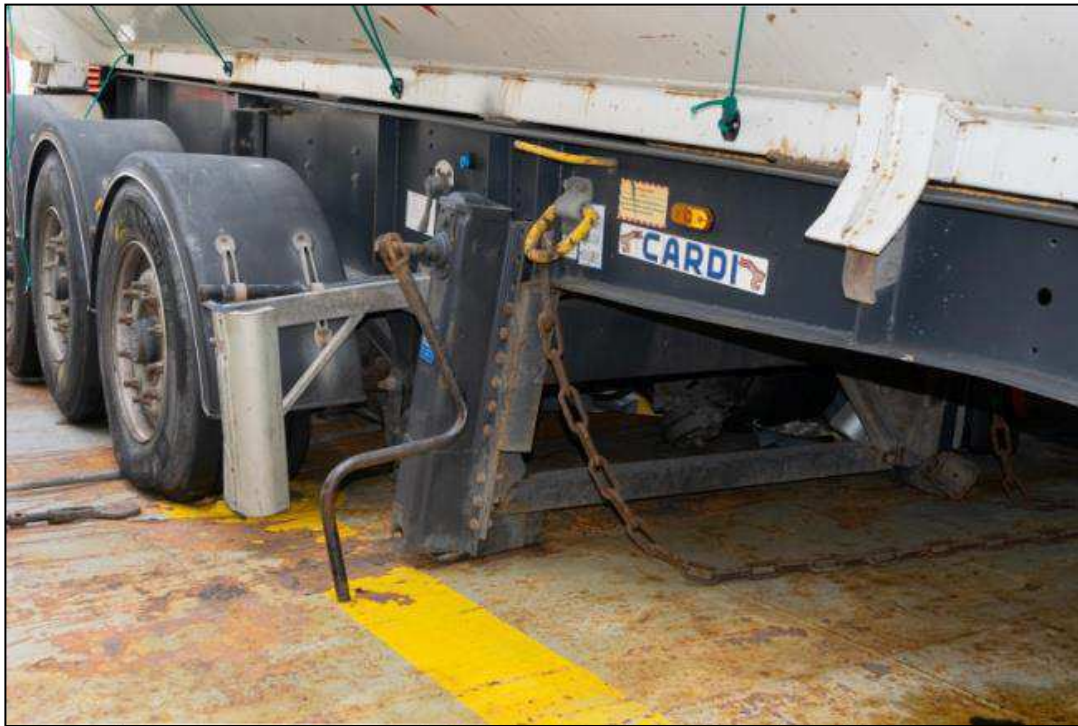
The trestles and landing gear of trailers A and B had failed, resulting in damages to the two trailers. The damages to trailer B were more pronounced (Figures 16 to 18).

Figure 16: Damaged landing gear of trailer A

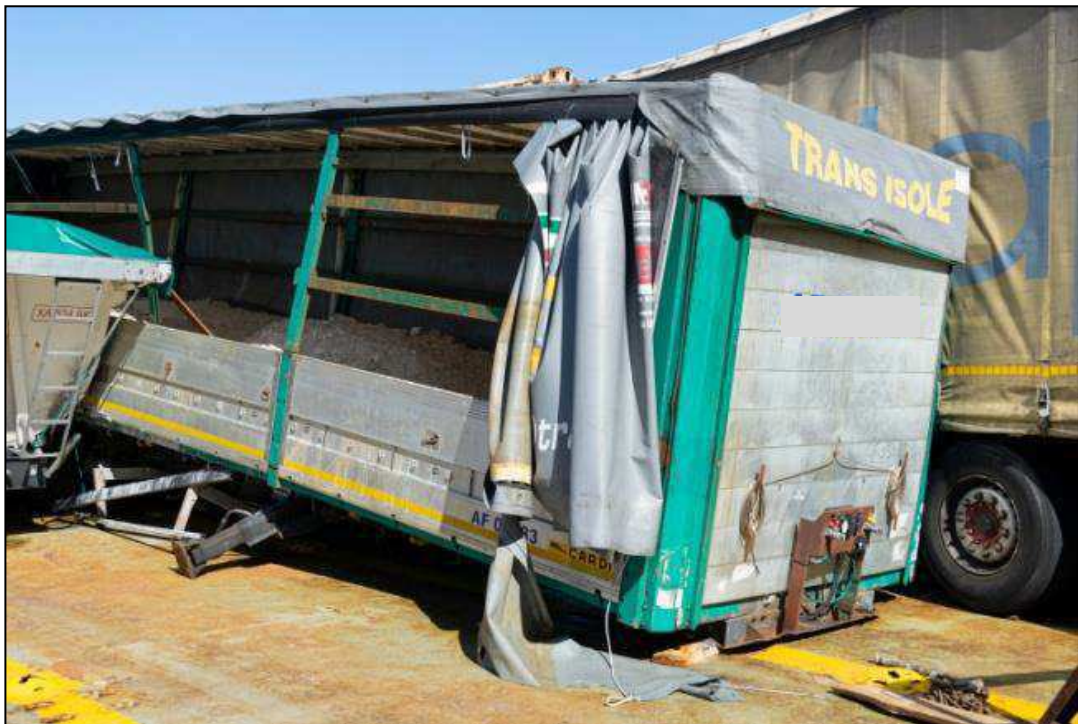
Figure 17: Damaged landing gear of trailer B

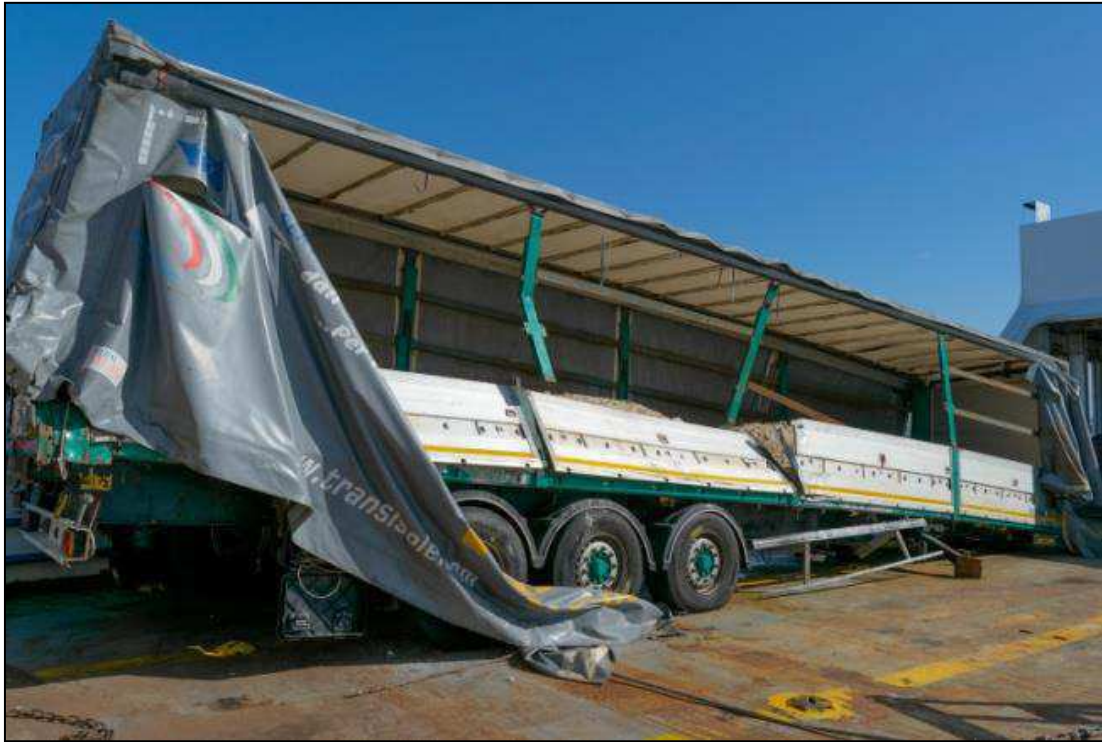
Figure 18: Damaged trailer B

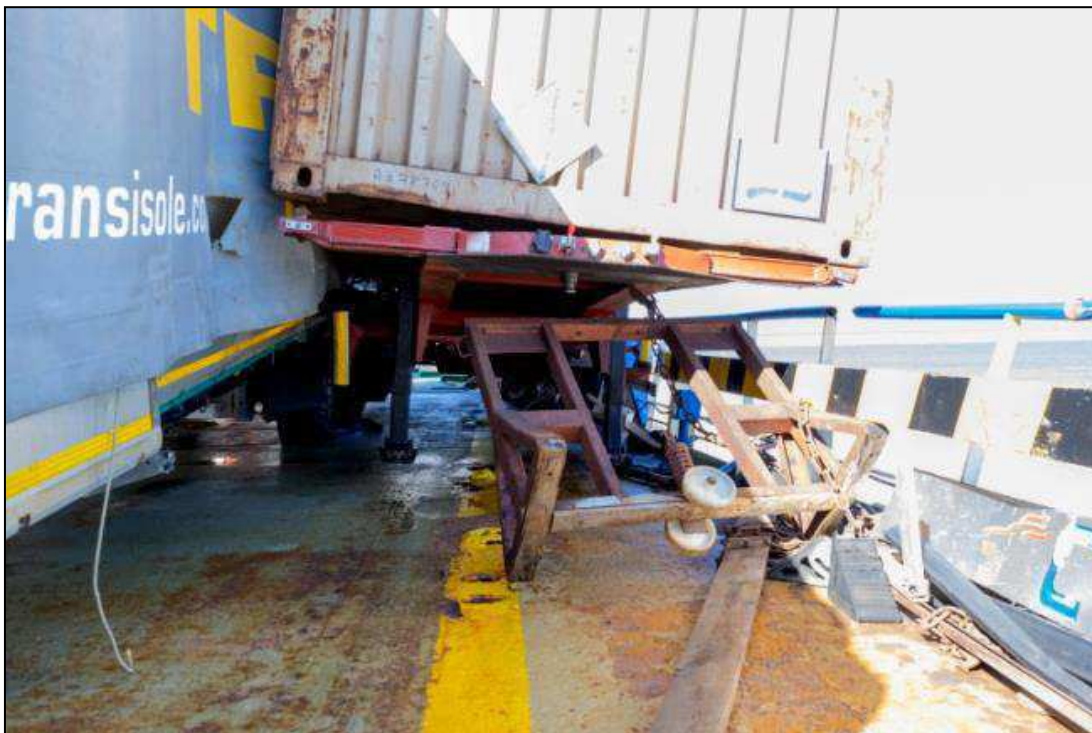
Trailer C was pushed towards the vessel's bulwark and guard rails, causing the container on it to incline over the vessel's side (Figure 19).

Figure 19: Damaged trailer C

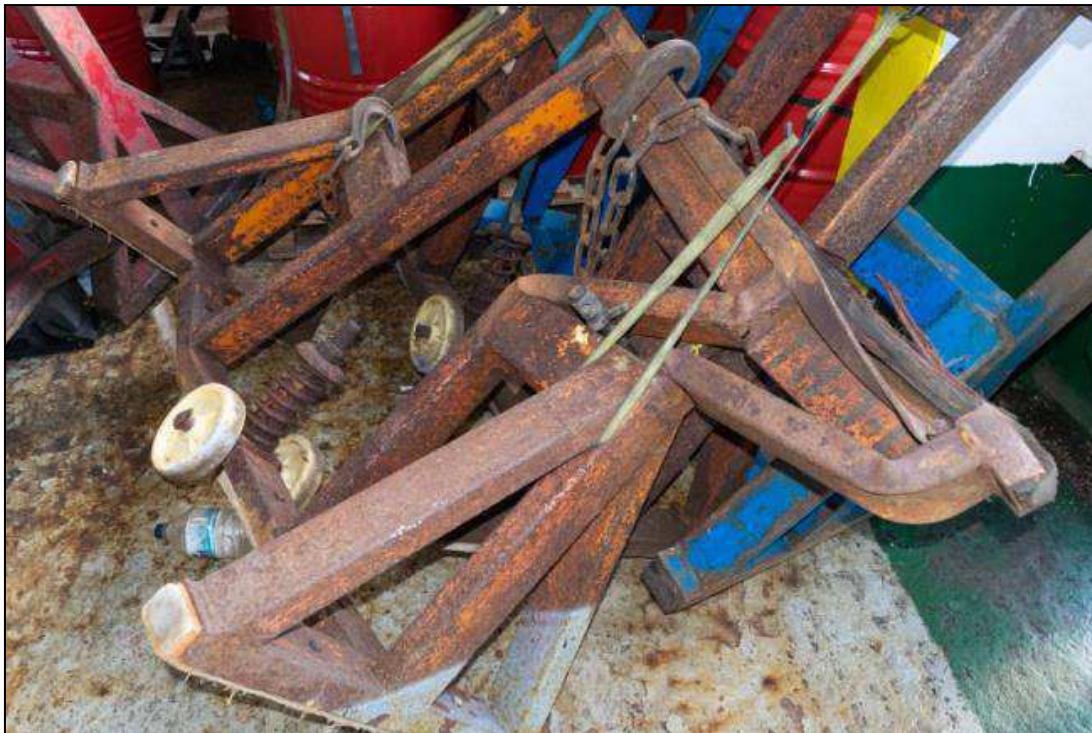
Due to the heavy weather and the subsequent cargo movements, it was reported that two of the vessel's trestles (Figure 20), four securing chains and four shackles were damaged.

Figure 20: A damaged trestle

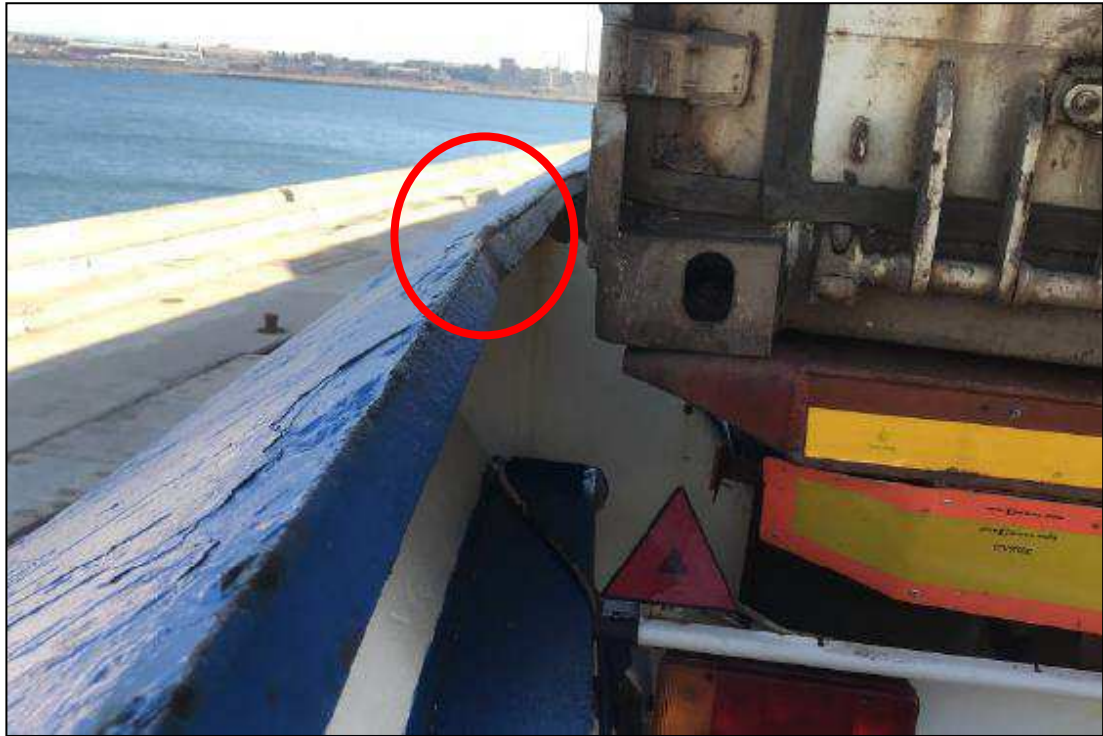
The vessel sustained minor structural damages to her gunwale, bulwark stiffeners, guard rails and an air vent in the vicinity of trailer C (Figures 21 to 24).

Figure 21: Dented gunwale

against the starboard gunwale of the vessel (Figure 21). Trailer C was pushed to the extent that its landing gear was lifted off the deck and the corner socket of the container on the trailer was lifted off the securing twist lock (Figure 19). It is highly likely that the lateral acceleration on this trailer, acting towards the starboard side of the vessel, in addition to its instability after its landing gear was lifted off the deck, resulted in damages to the gunwale, bulwark stiffeners and guard rails around the area of possible contact.

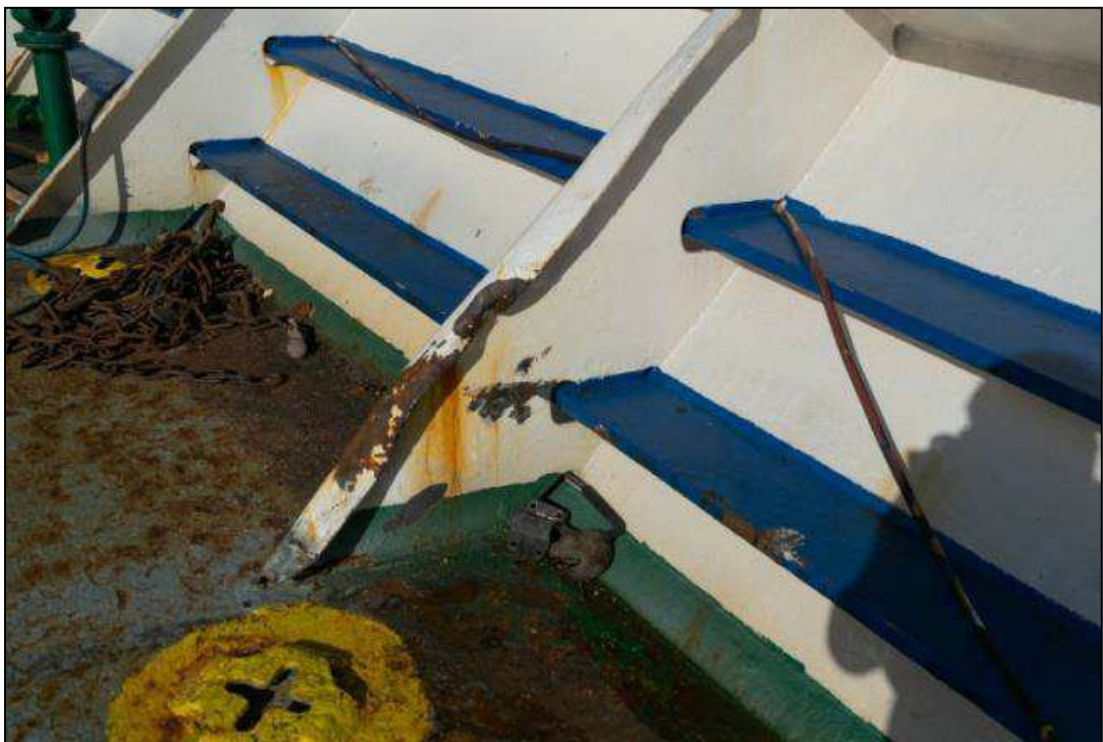
Figure 22: Damaged bulwark stiffener

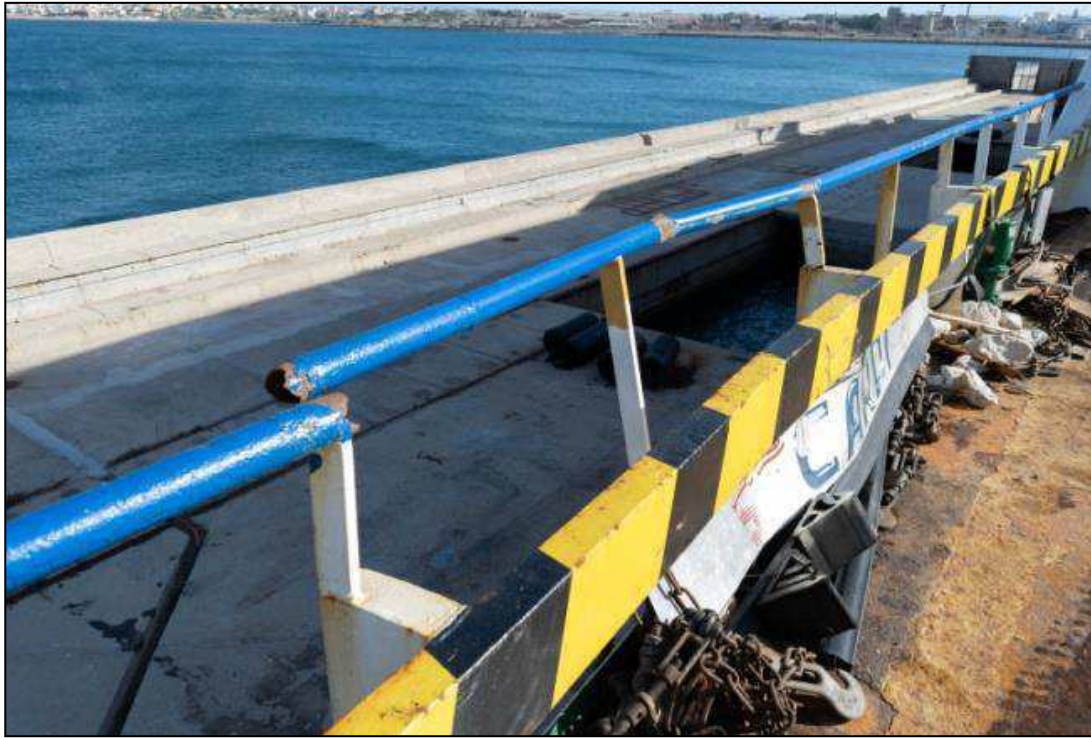
Figure 23: Damaged guard rails

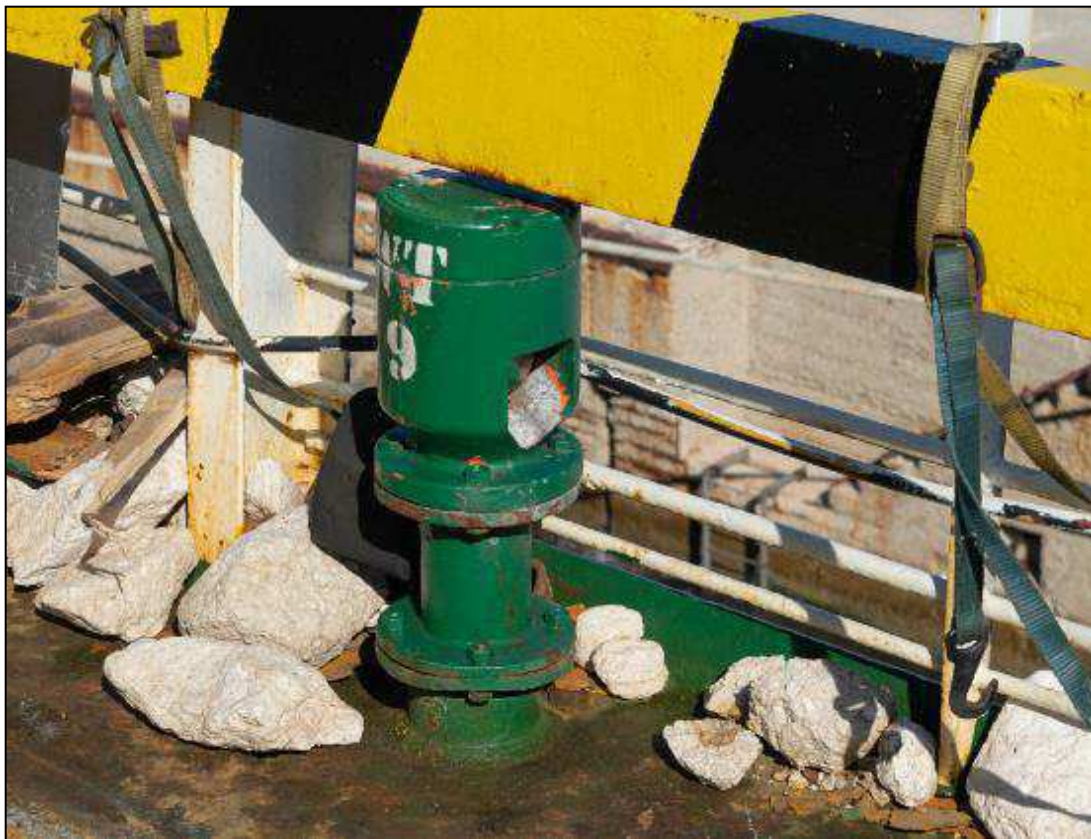
Figure 24: Damaged water ballast tank air vent, and cargo which escaped from trailer B

The damages to the water ballast tank air vent (Figure 24) most likely seemed to be the result of cargo falling out from trailer B and striking this air vent.

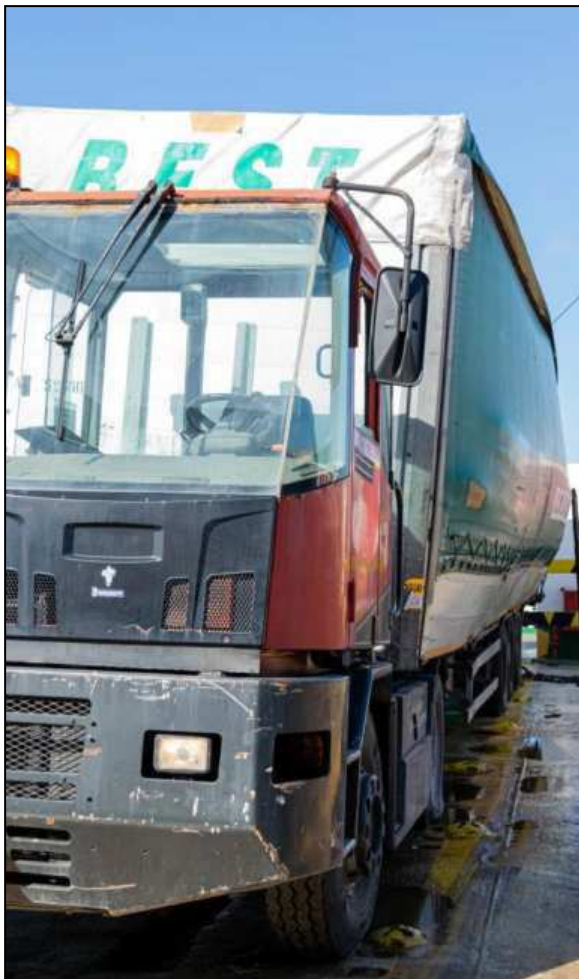
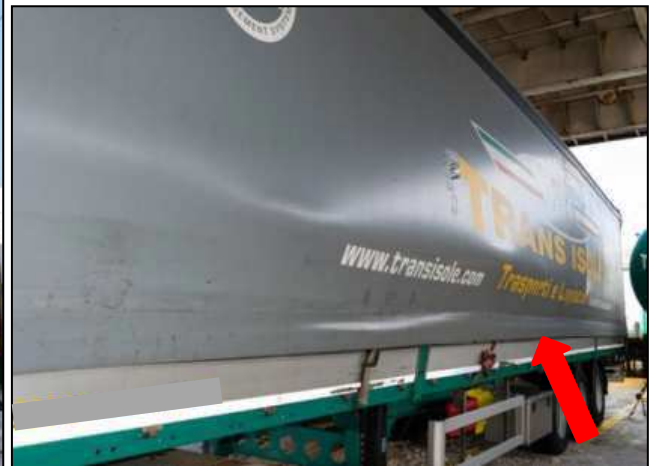
The rolling and the pitching motions of the vessel under the heavy weather conditions caused the cargo within the trailers, especially those loaded on Deck 4, to shift. This resulted in bulging of the sides of some of the trailers (Figures 26a and 26b).

Figures 26a and 26b: Bulging of the sides due to internal cargo shift

Cargo shifts in curtain-sided semi-trailers would lead to a centre of gravity shift towards the bulging side and upward to the side curtain top rail. The MSIU is aware that it is not unusual for vessels to experience problems with curtain-sided units, such as the one in Figures 26a and 26b. Although it is recommended that vehicles with high centres of gravity are stowed in positions of minimal roll, it is not always possible to accommodate this arrangement.
