MARINE TRANSPORTATION SAFETY INVESTIGATION REPORT M18P0014

ENGINE ROOM FIRE

Container vessel *MOL Prestige*

31 January 2018

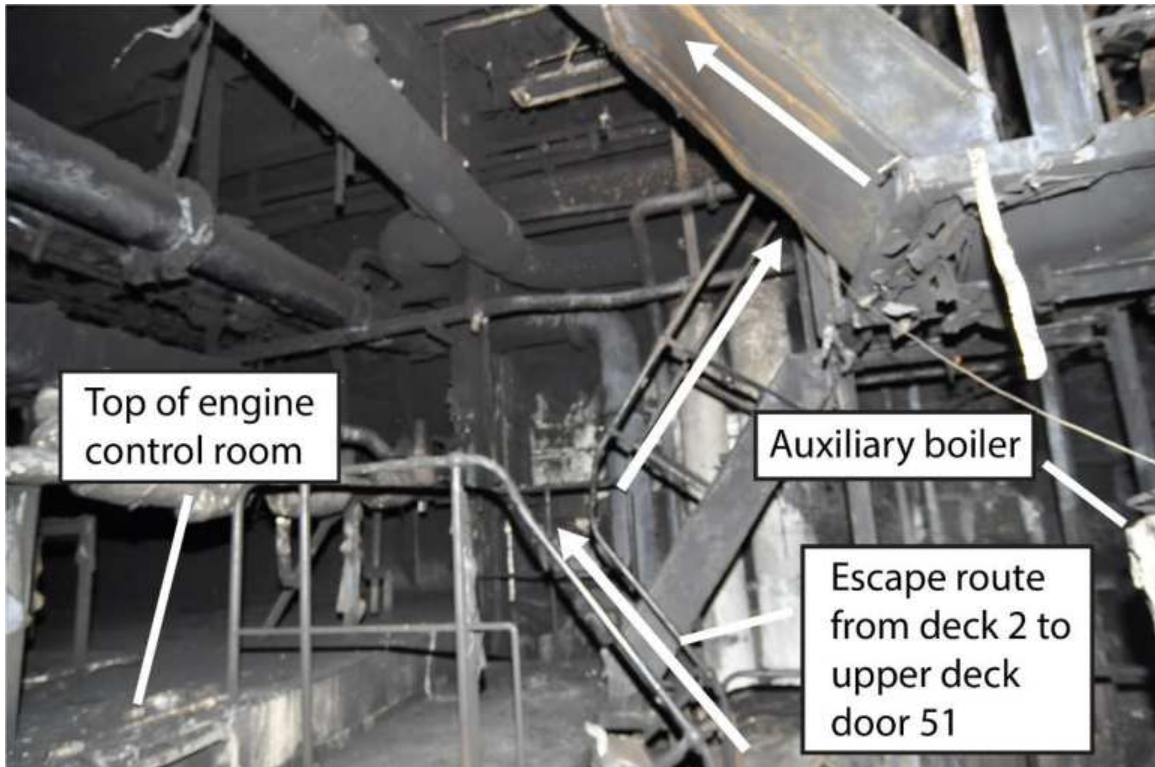
Figure 9. Route used by the crew to exit the engine room, showing the stairs from deck 2 to door 51 on the upper deck (Source: United States Coast Guard, with TSB annotations)

At 2138, 3 of the 6 crew in the ECR donned the EEBDs and followed the chief officer out of the engine room using the lifeline attached to the chief officer. As the 4 crew members made their way up the stairs (figures 9, 10, and 11), they encountered dense smoke and heat from the fire. The chief officer tripped while making his way up the stairs and grasped the railings to regain his balance, burning the palms of his hands. The chief engineer also tripped on the stairs and burned his arms upon making contact with the railings. The second engineer similarly sustained burns to his palms and forearms. The fourth engineer slipped and hit his head, which dislodged his EEBD and caused burns to his ears.

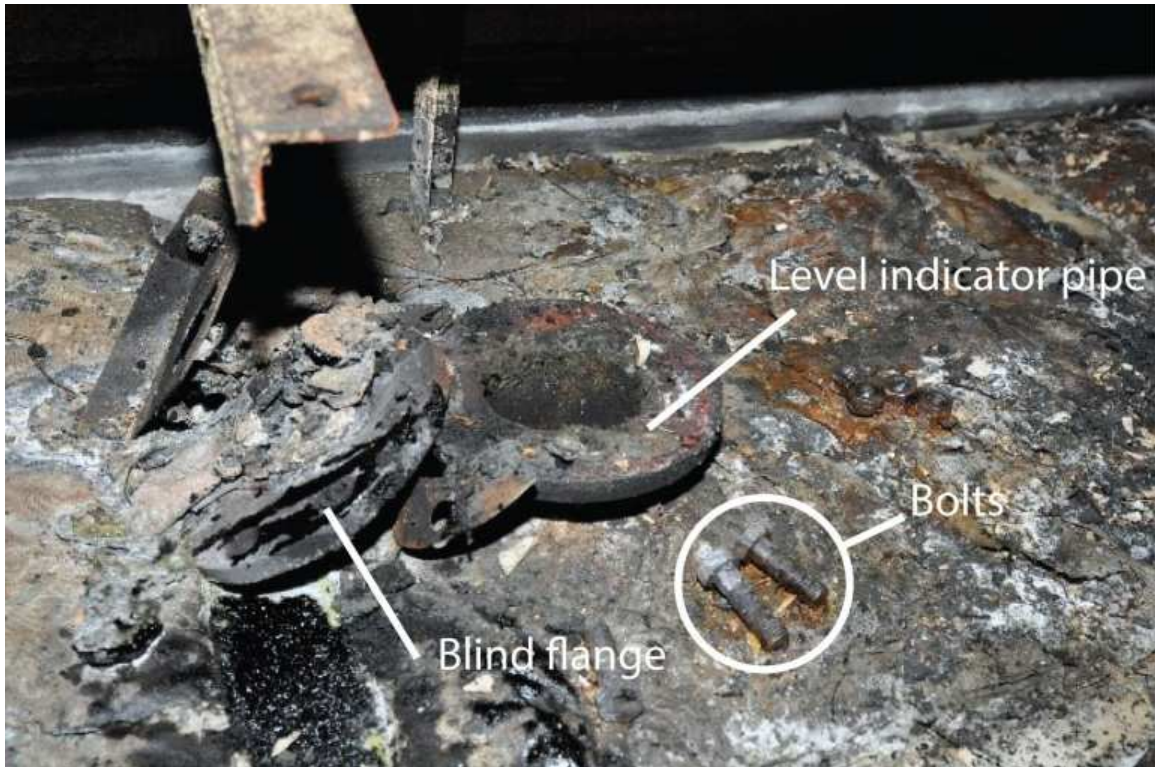
Figure 15. Opening of the level indicator pipe on top of the settling tank as found post-fire. Also shown are the blind flange, nuts, and bolts on top of the tank. (Source: TSB)

be subject to frothover because oil in the tank above 100 °C would cause any water in the tank, or added to the tank, to boil instantly. The high temperature in the settling tank, in conjunction with the open level indicator pipe on the settling tank, created unsafe conditions that allowed frothover to expunge oil and fumes out of the tank and the steam explosion, which resulted in the fire.

At the time of the occurrence, the temperature of the HFO in the settling tank was 120 °C. Following the occurrence, the TSB examined the alarm logs from 15 January until the day of the occurrence and found that the high-temperature alarm for the settling tank had activated on 26 January on the engine room alarm panel. The TSB could not determine if the HFO settling tank temperature was checked or whether any other action was taken as a result of the alarm.

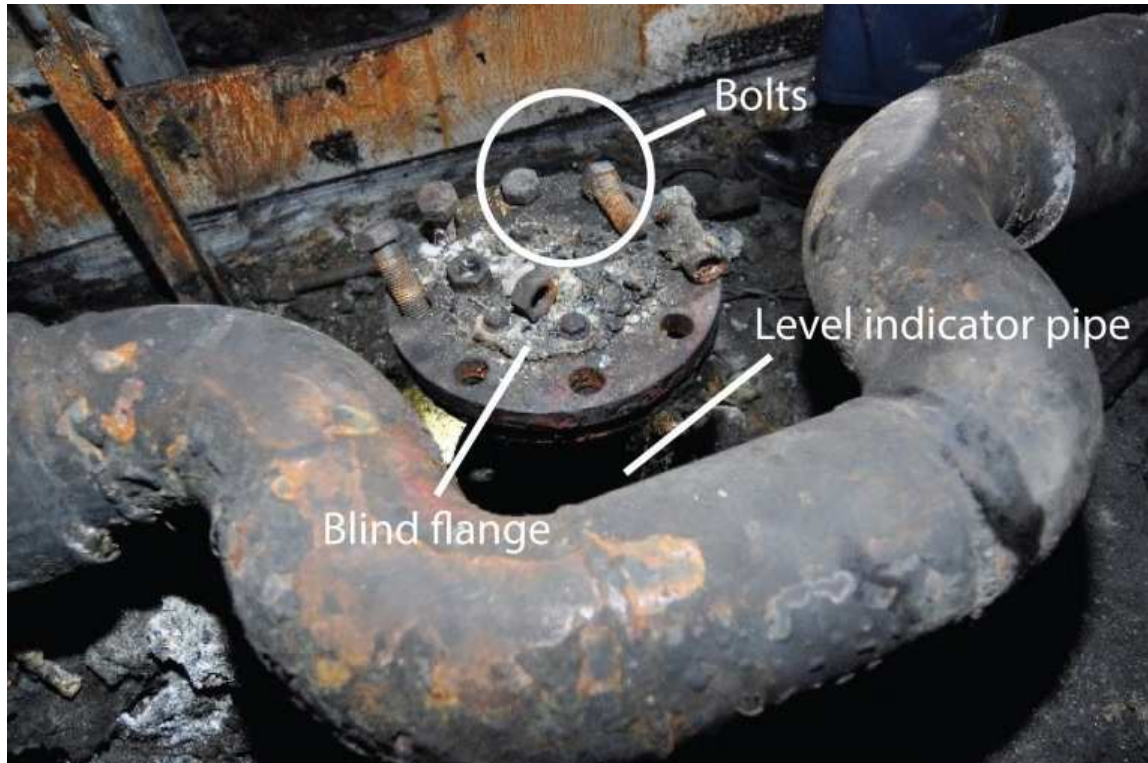
Figure 16. Blind flange secured by 1 bolt on the level indicator pipe on the heavy fuel oil service tank (Source: TSB)

On 24 January, the chief engineer recorded the quantity as 70 m³. The tank was sounded after the fire and was found to be at 94.6 m³, which is 83% of the total tank capacity

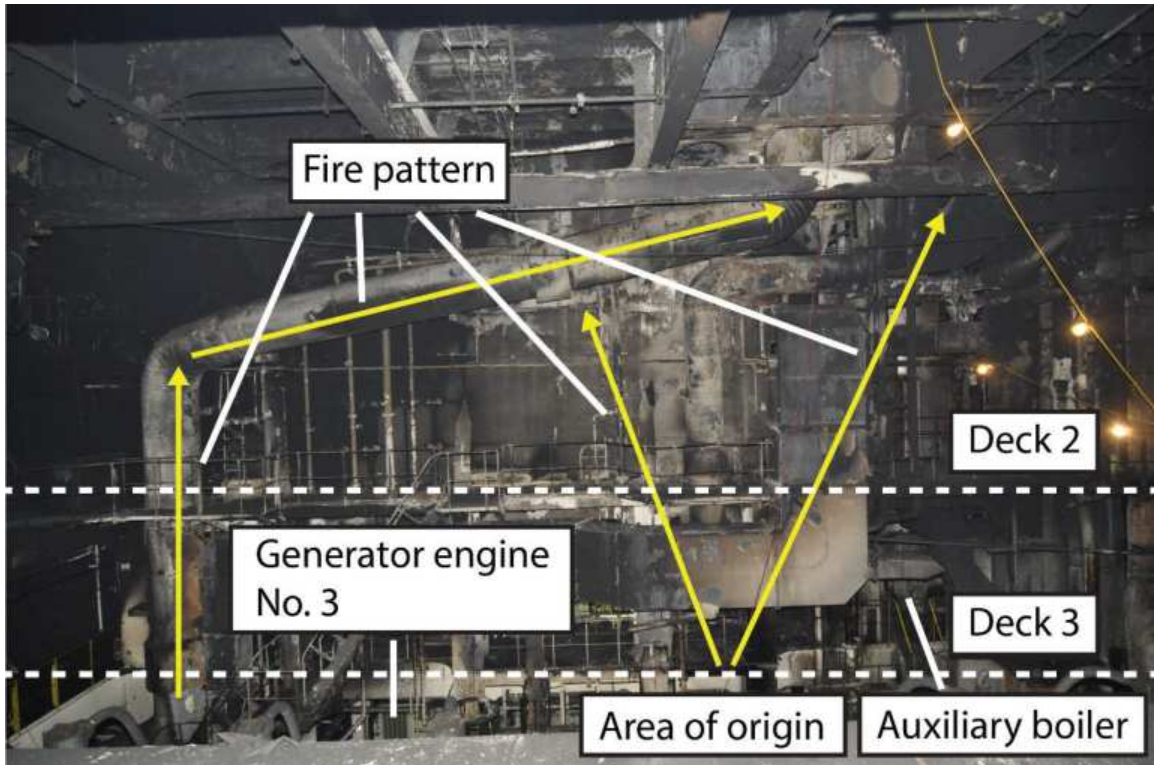
Figure 19. Fire pattern analysis conducted by Kirkland Fire Department (Source: Kirkland Fire Department with TSB annotations).

Information gathered from the CCTV footage indicated that oil was initially expelled from the settling tank through the open level indicator pipe, and fell onto decks 3 and 4 and onto the oily water separator on the bottom deck. The fire then started on deck 3 between the auxiliary boiler and the settling tank, where there was evidence of heat sources, including uninsulated steam lines, the exhaust manifold for generator engine No. 3, and electrical fittings.

Fire patterns determined that this was the area of origin of the fire. Soon after, the burning oil then flowed down to deck 4 near generator engine No. 3 and onto the bottom deck near the oily water separator. The fire also travelled back to the top of the settling tank, where the bulk of the spilled oil was located. This became the seat of the fire fuelled by the HFO overflowing from the level indicator pipe on the settling tank.

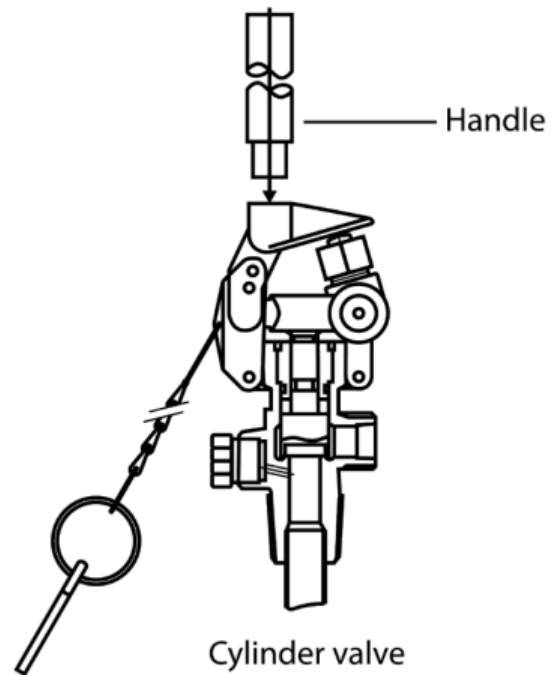
Figure 25. CO₂ cylinder valve (Source: Original equipment manufacturer manual, with TSB annotations)

- The stop valve for the main engine room was leaking.
- The crew manually released 84 cylinders (Figure 25), which included some cylinders marked for the cargo holds.
