Report on the investigation
of the fatal crush accident
on the general cargo vessel

Karina C

at Seville, Spain

on 24 May 2019

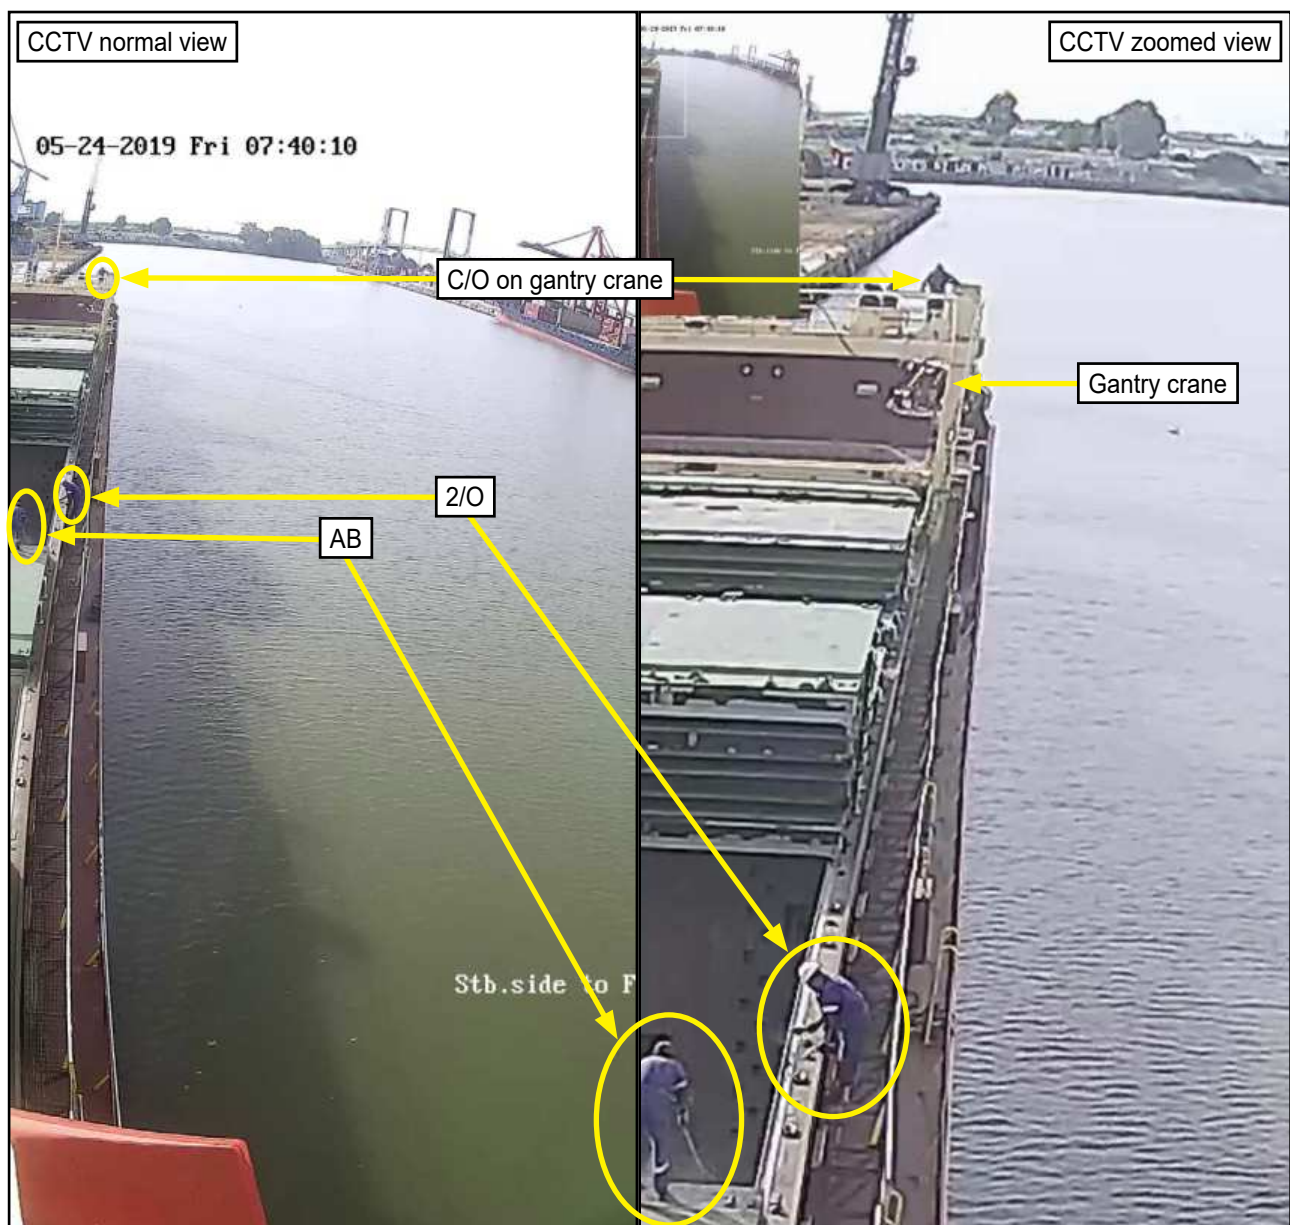
Figure 1: Crew working on deck

During the task of clearing the cement residue from the hatch covers and coamings, one AB was observed walking along and leaning over the unprotected edge of a hatch cover (**Figure 1**). Working close to unprotected open hatch covers is a well-recognised hazard and the consequence of a simple slip or trip, or even a medical event, can often have fatal consequences. The UK Working at Height Regulations require personnel working in such areas to be protected, either by the rigging of temporary guardrails, or by the wearing of a safety harness and the rigging of a fall prevention system (**Figure 18**). This requirement was repeated in Carisbrooke's SMS manual, but on the day of the accident, portable guardrails were not rigged and safety harnesses and fall prevention lanyards were not used.

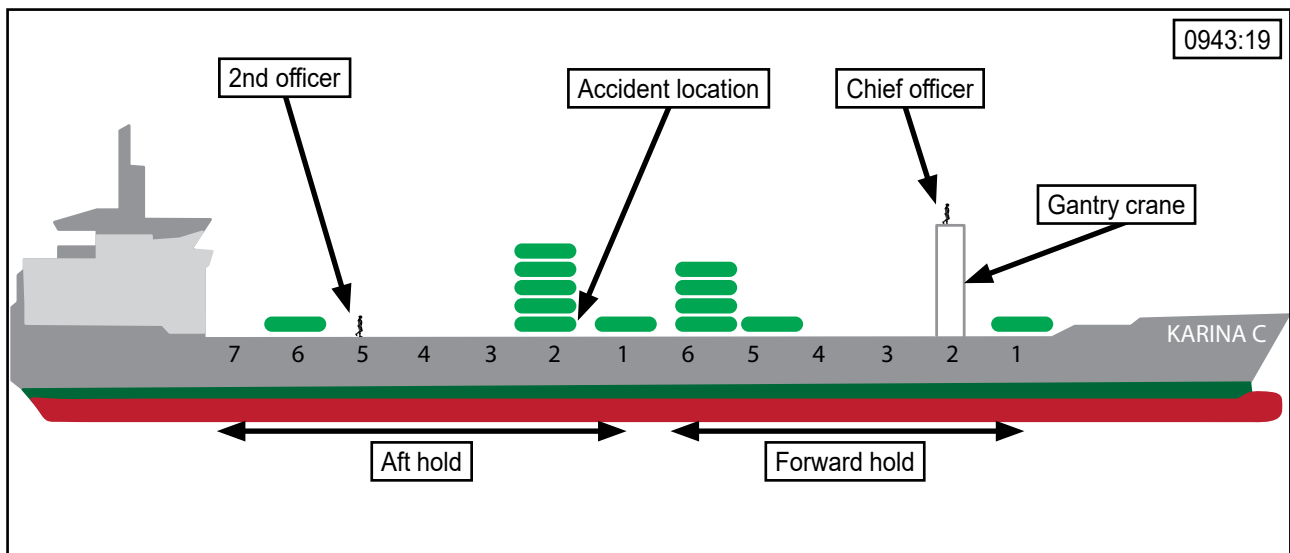
Figure 2: *Karina C*'s cargo hold hatch cover locations immediately before the accident

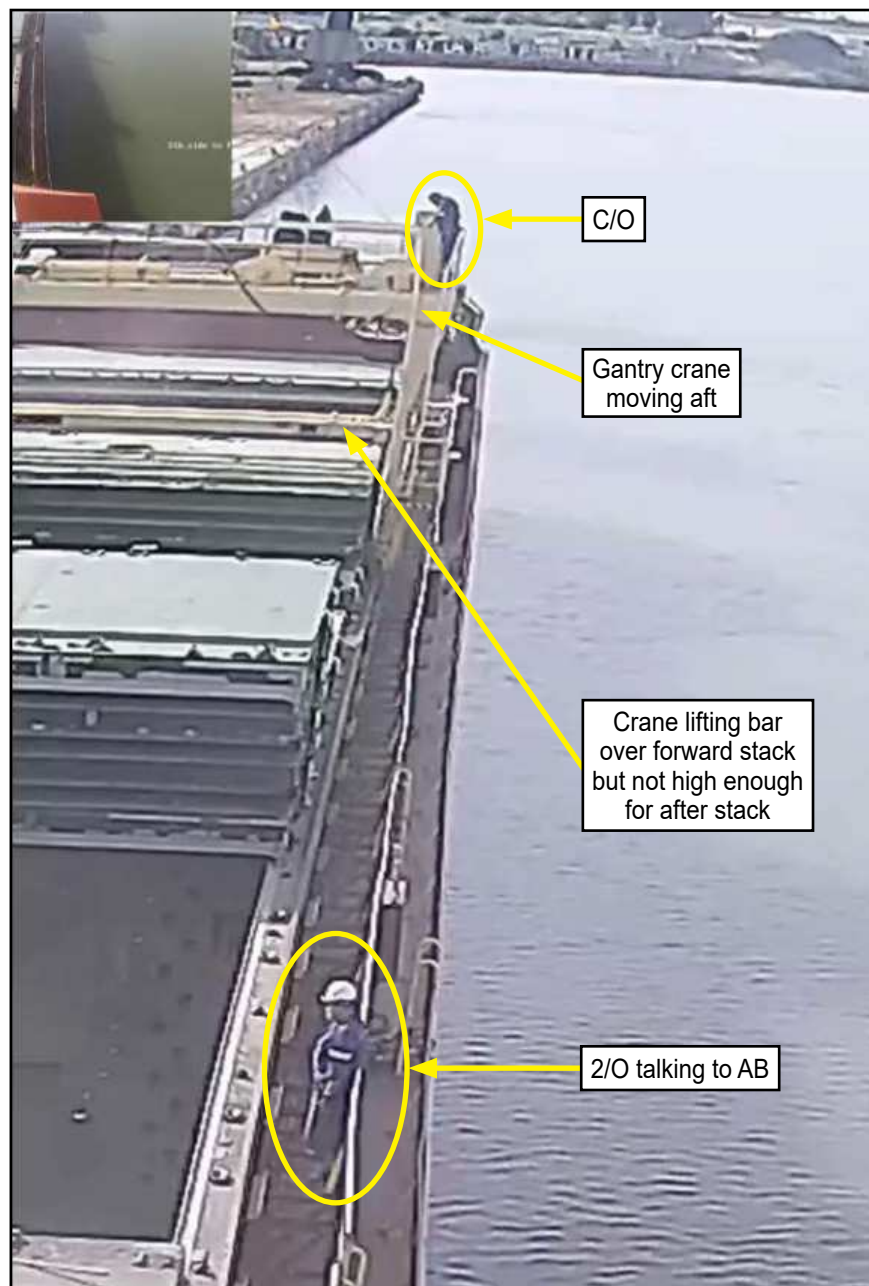
Figure 3: Second officer leaning on the starboard walkway guardrails while the gantry crane was being driven aft

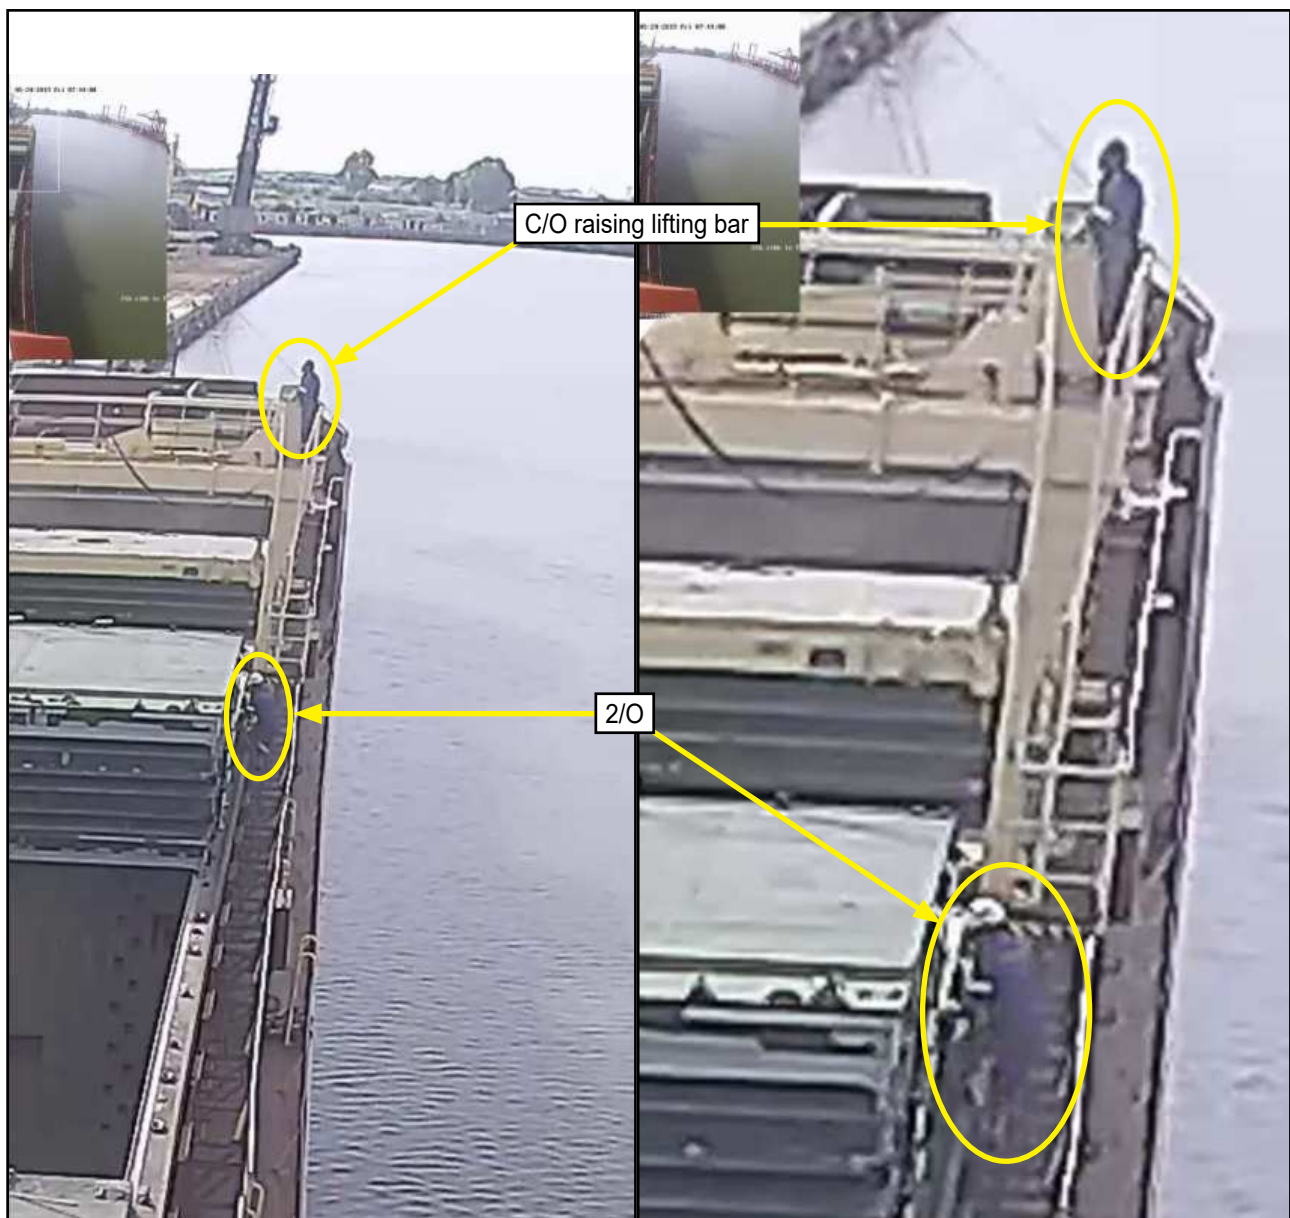
Figure 4: Zoomed CCTV screenshot showing the second officer climbing onto cargo hold hatch coaming at 0944:10

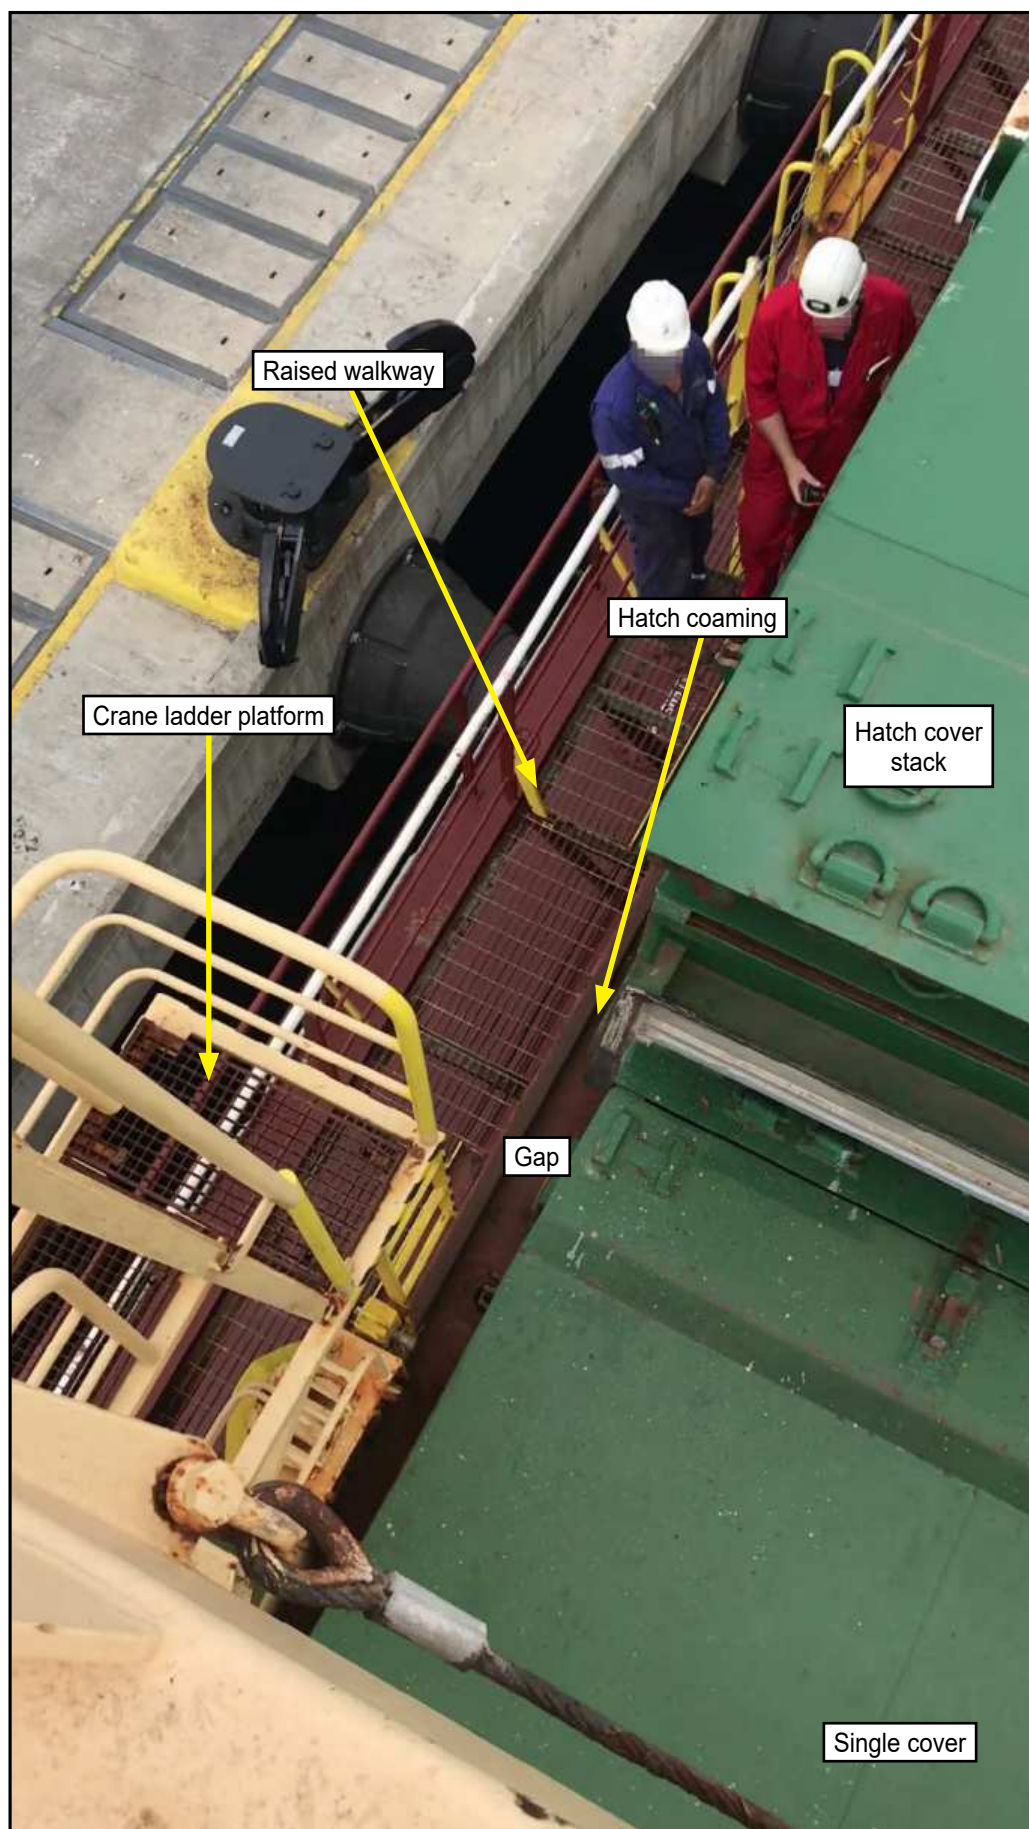
Figure 5: Reconstruction showing the distance between the crane ladder platform and the stack of hatch covers when the second officer climbed onto the coaming

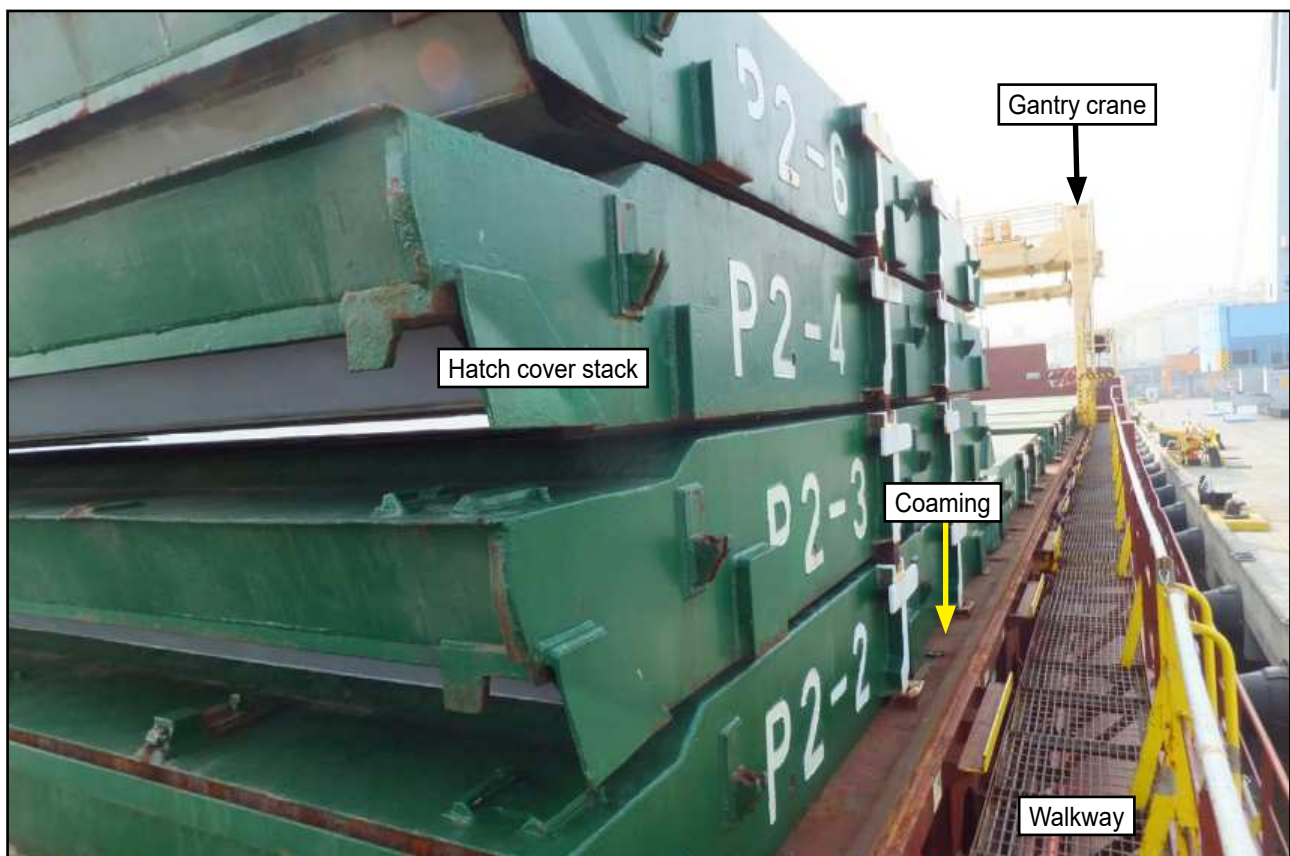
Figure 8: Starboard walkway showing stack of hatch covers and gantry crane

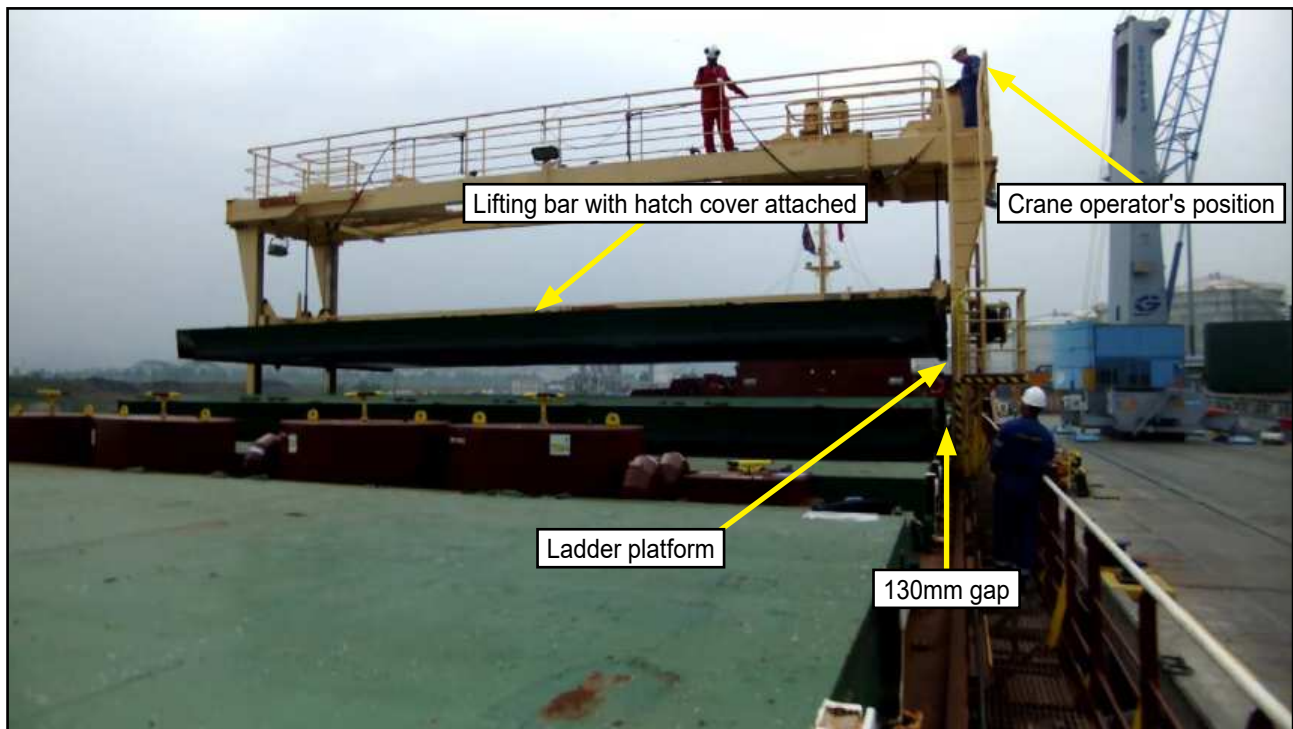
The operating position was located at the top of the crane on the starboard side. Access to the crane control platform was by one of two short vertical ladders (one from the starboard walkway, the other from the top of the hatch covers) to an intermediate platform, and then an inclined ladder to the top. The vertical distance between the raised walkway and the crane operator's platform was 4.75m (**Figure 9**).

Figure 9: Gantry crane looking from aft

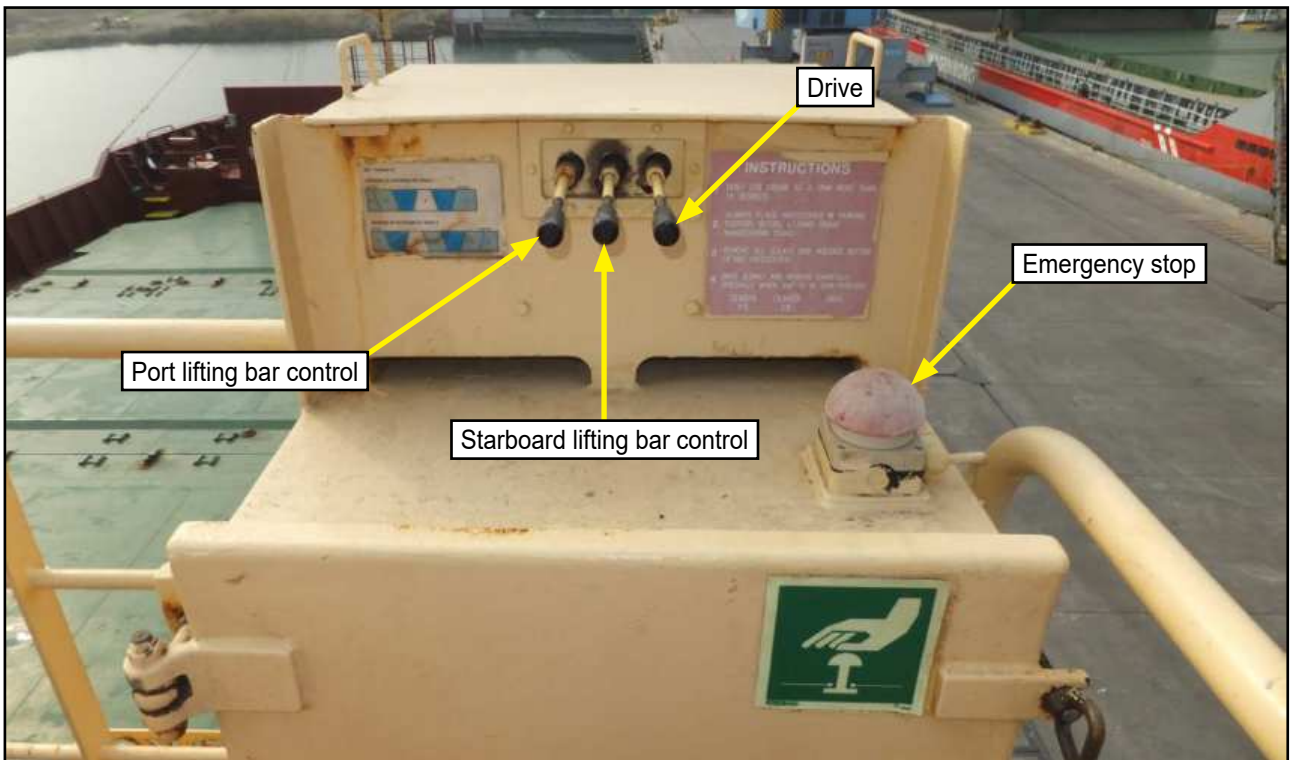
The crane had three control levers: two for operating the lifting bar through hydraulically-operated cylinders and wires, and one for driving the crane forward or aft (**Figure 10**). The drive lever had three positions: forward, stop and reverse. The crane speed was variable depending on the position of the drive lever; at the extreme end position of the lever, the crane reached a speed of 20m/minute. Bringing the drive lever to stop applied brakes on the two forward wheels.

Figure 10: Gantry crane control panel

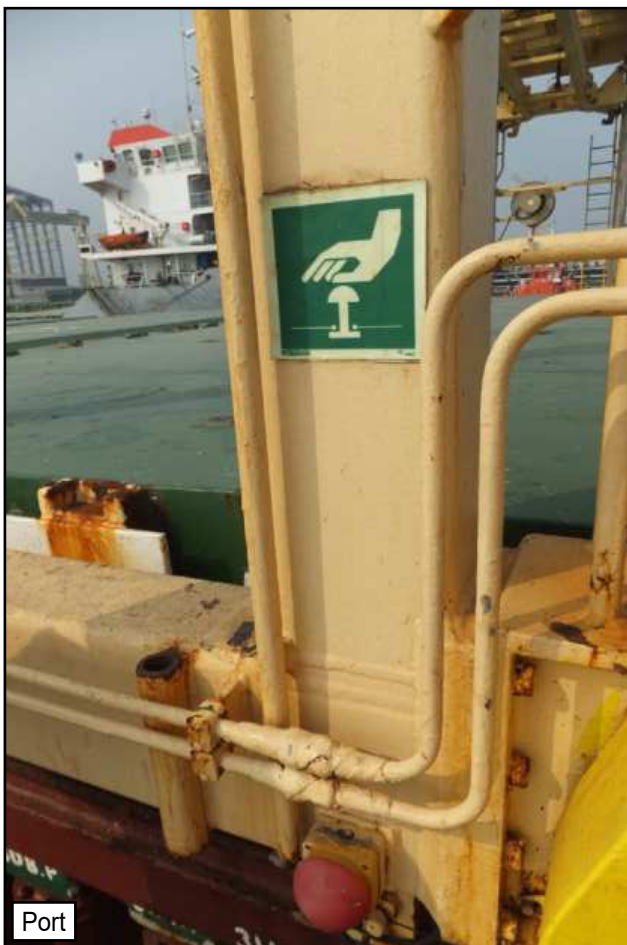
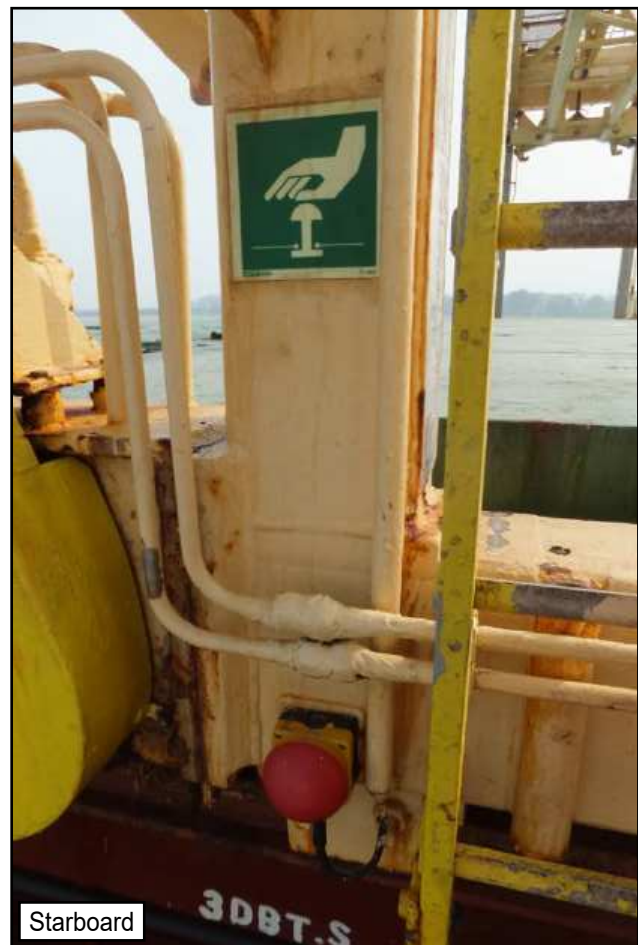
Figure 11: Gantry crane emergency stops

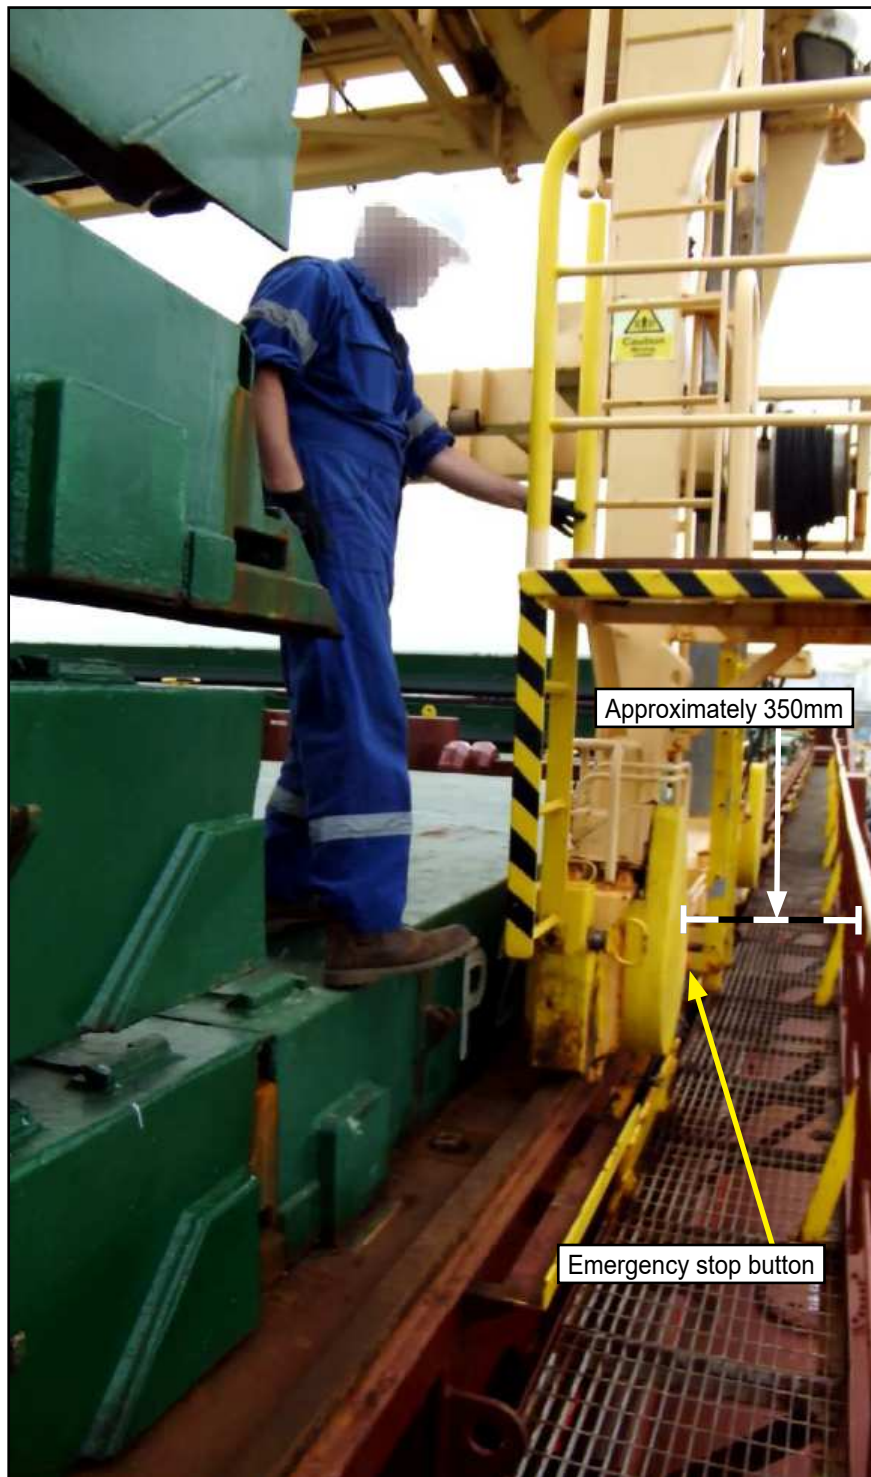
Figure 12: Access to starboard emergency stop

- It was impossible for the 2/O to reach the gantry crane emergency stop button (**Figure 12**) from the position in which he became trapped.
- The gantry crane's audible warning bell could be clearly heard at walkway level.

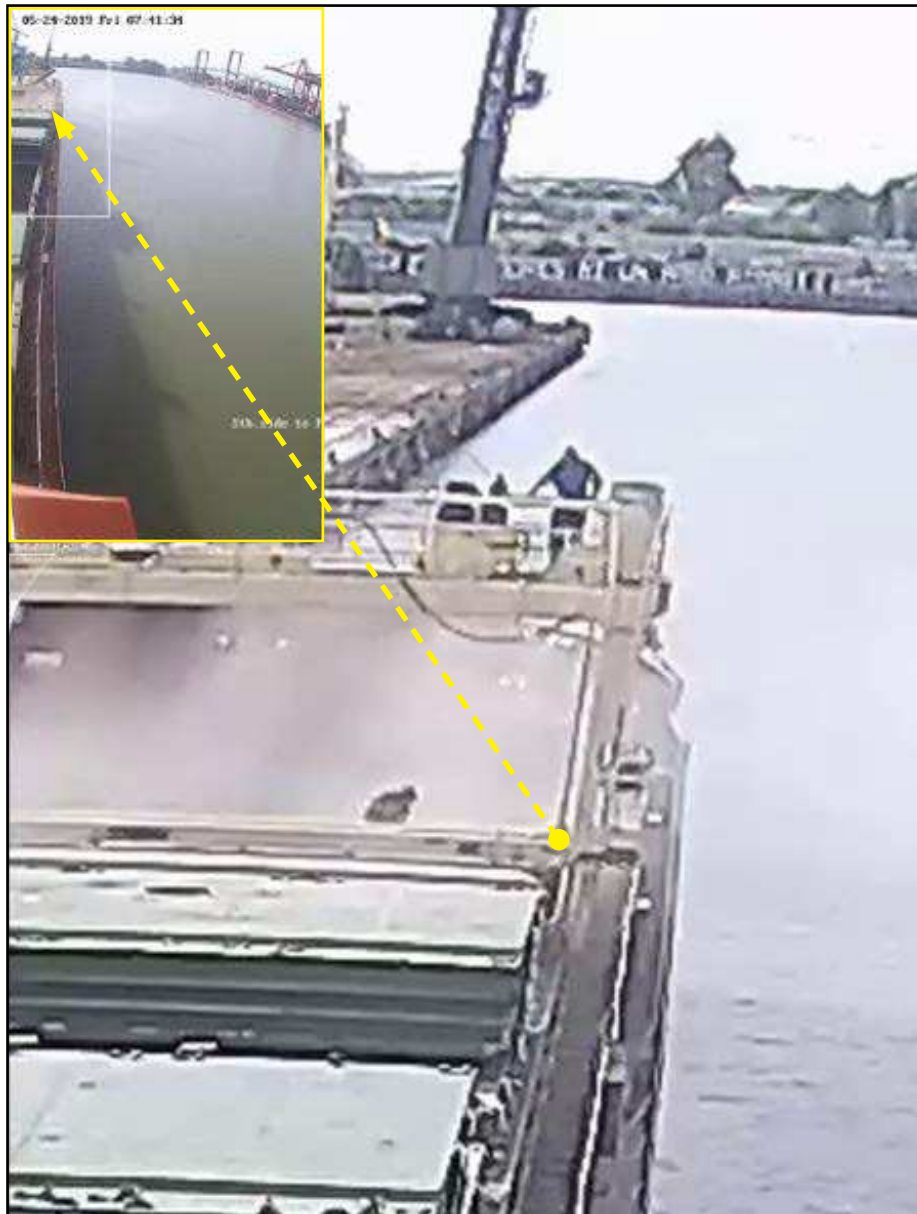
The company's *RA D15 – Loading and Discharging Dusty Cargo (Annex C)* required the use of suitable personal protective equipment (PPE), which included face masks and goggles. During the pre-departure cleaning operation occasional clouds of cement dust were created (**Figure 13**). The deck cadet and two ABs were wearing face masks and eye protection; the 2/O and C/O were not.

Figure 13: CCTV screenshot showing cement dust cloud

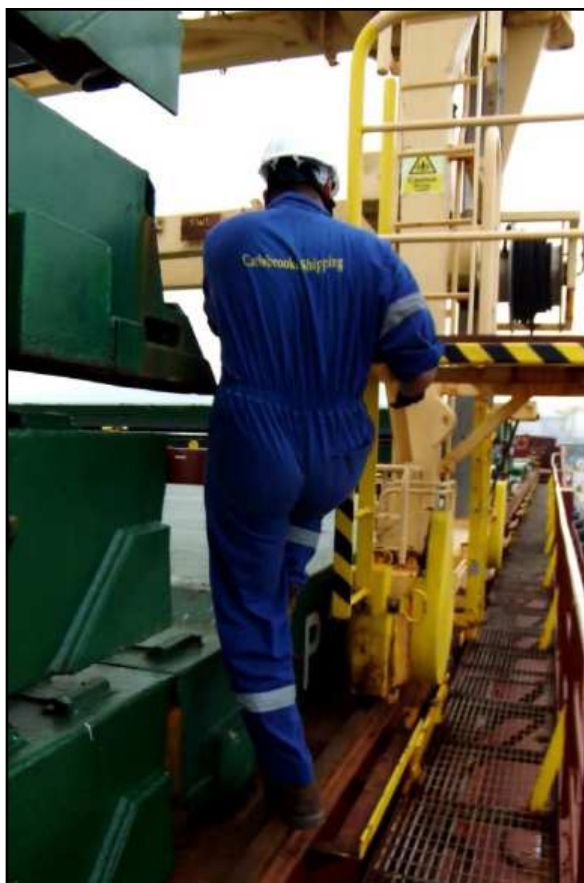
Figure 14: Climbing through the gap between the hatch covers and gantry crane (reconstruction)

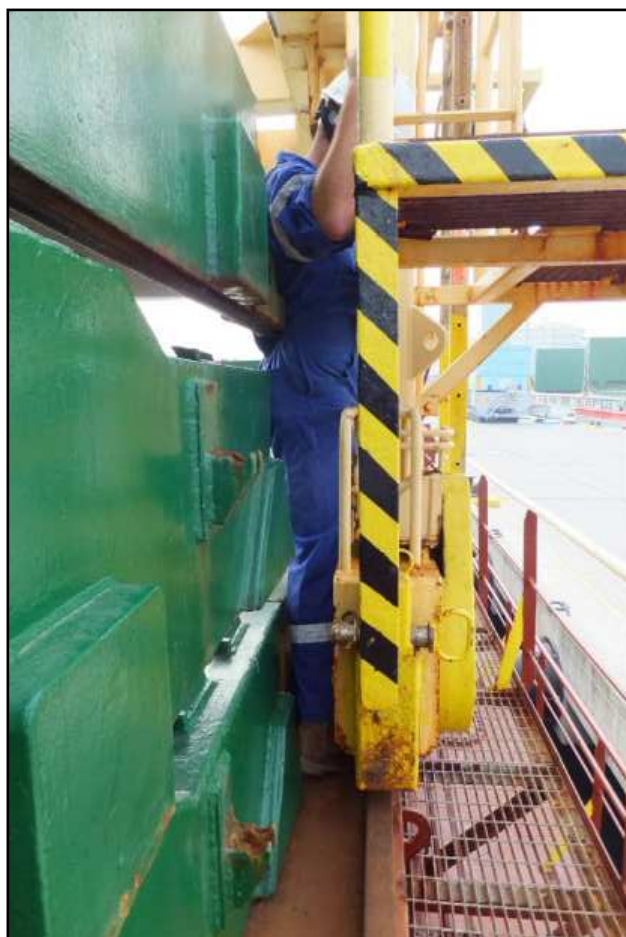
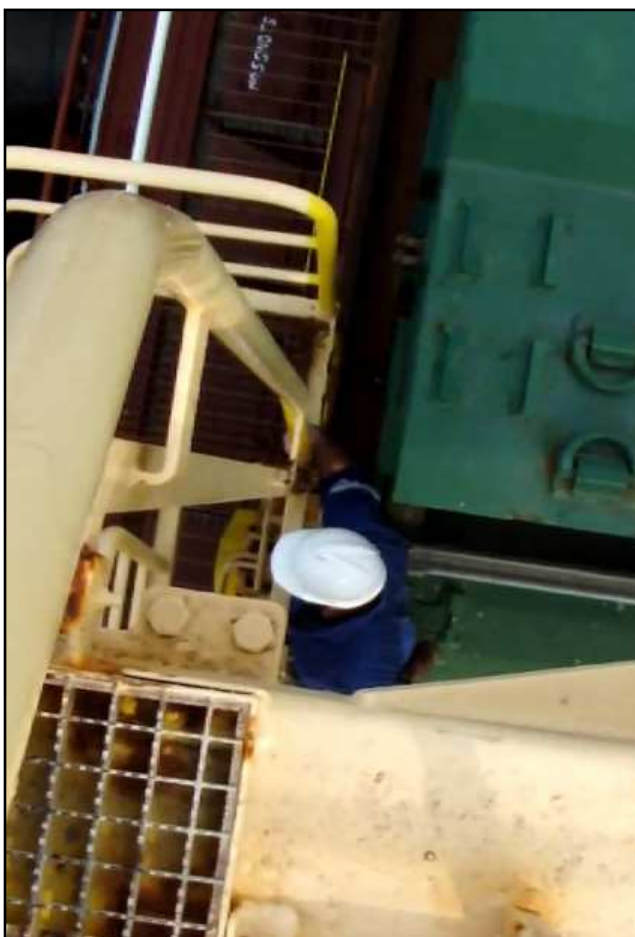
Figure 15: Reconstruction showing size of the gap between the ladder platform and the stacked hatch covers

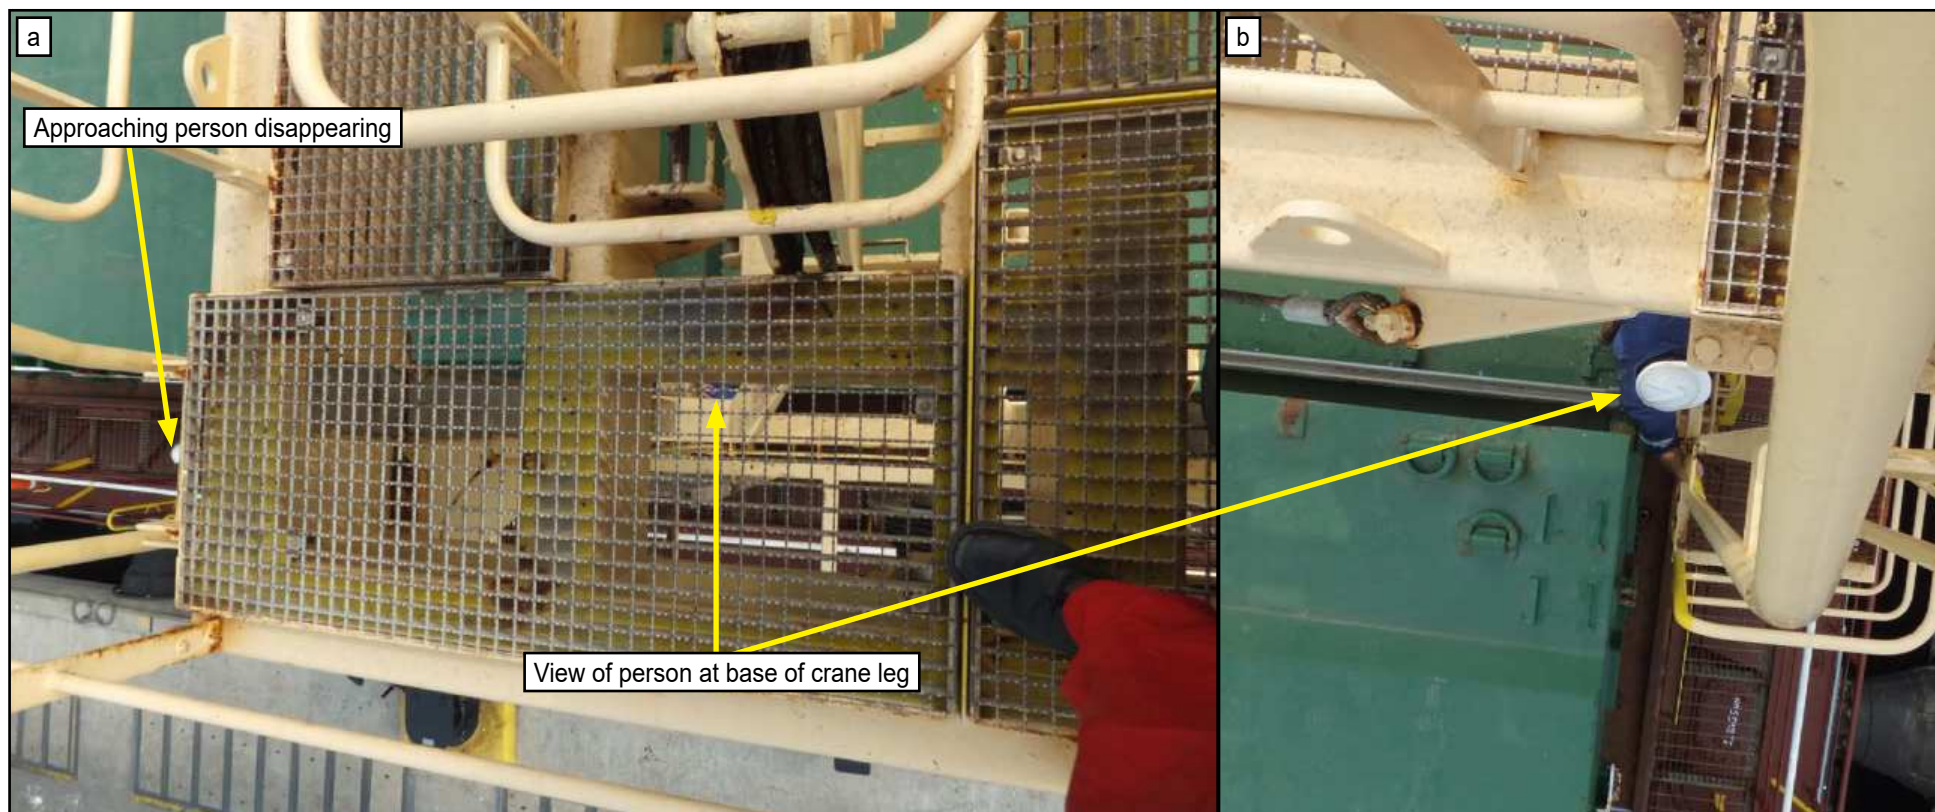
- The flashing amber warning light was visible from the walkways but was difficult to see in bright sunlight.

Figure 16: View directly below from the gantry crane operator's position (a) and above ladder (b)

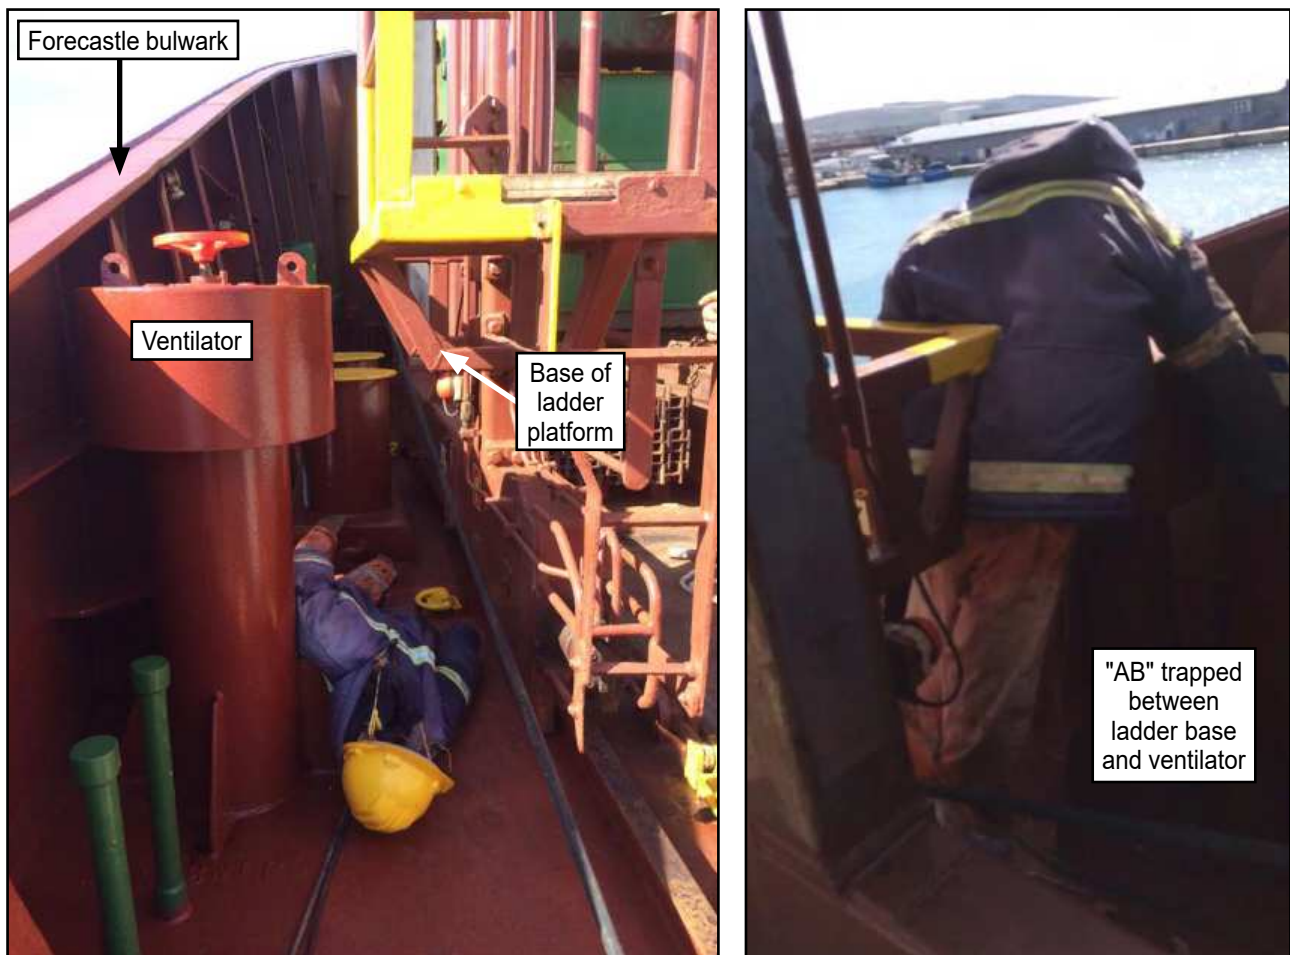
For the majority of the crane's path, the outboard space was unobstructed, allowing safe access past the crane. However, the forecastle area narrowed and the walkway was obstructed by the vent and other deck fittings. The AB, who had not had his minimum hours of rest in the last 24 hours, was not concentrating and misjudged the available space.

After the accident, a Carisbrooke superintendent, who was on board at the time, carried out a reconstruction and took photographs of the accident site (**Figure 17**). He also sent the CCTV recordings of the accident to Carisbrooke. The master

Figure 17: Reconstruction of gantry crane accident on board *Vectis Progress*

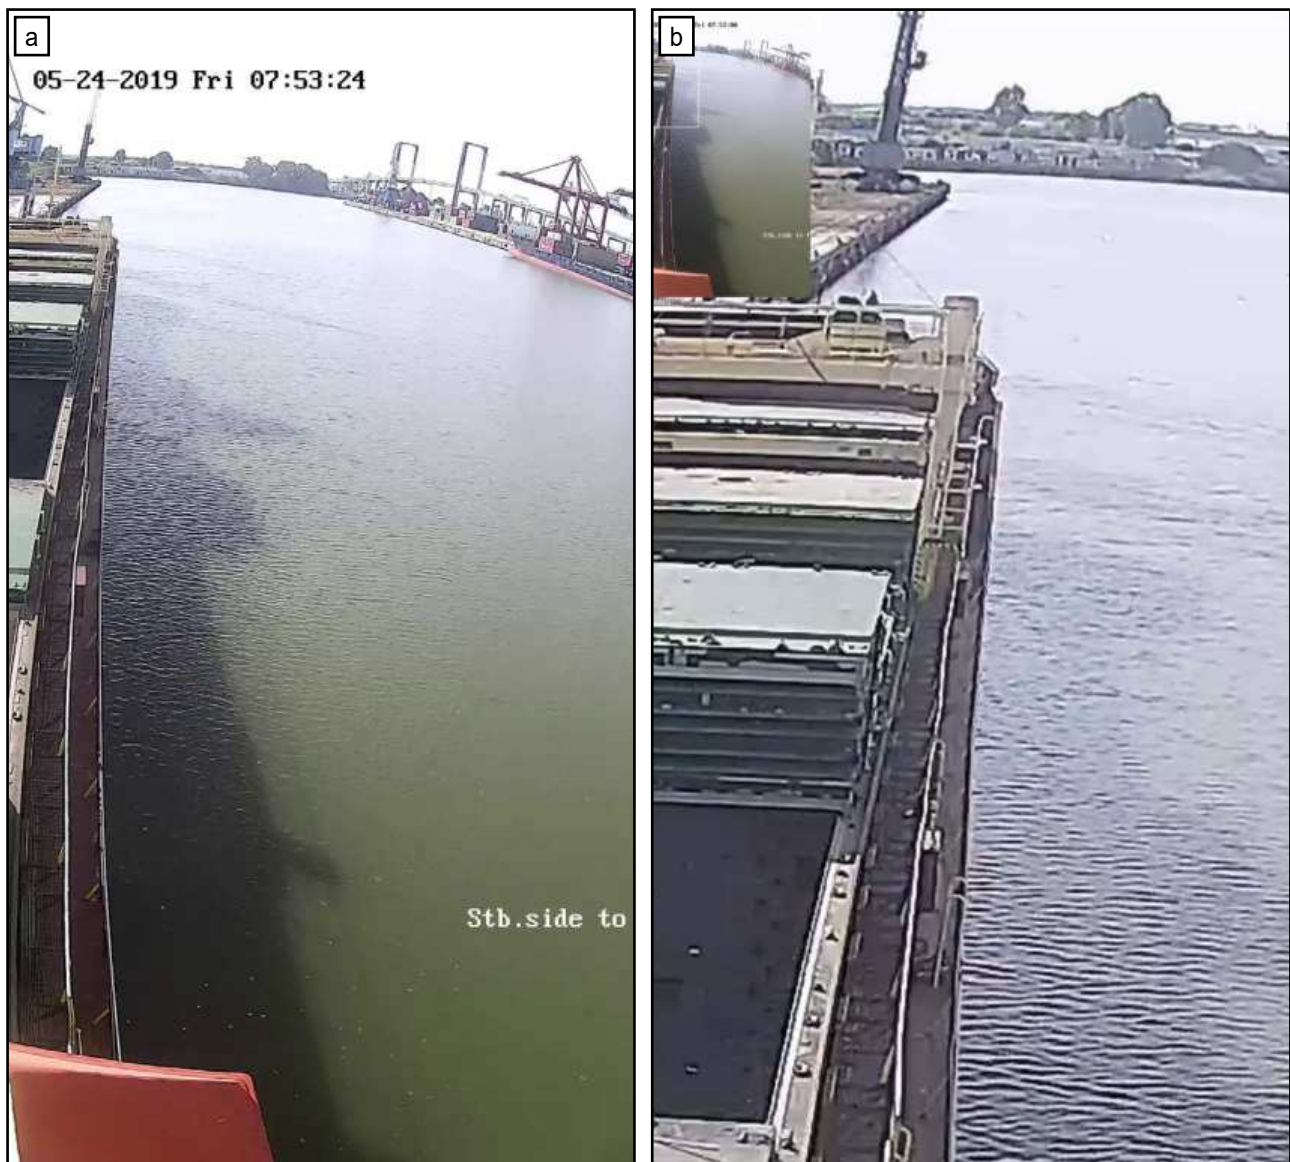
The CCTV recording was obtained by the MAIB in October 2019. From close examination of the recording it was apparent that the crane was involved with the accident. Using commercially available software, the footage was enlarged (**Figure 20**) to make the sequence of events significantly clearer. From the zoomed images it was evident that the 2/O had been trapped by the crane and crushed between the moving crane's ladder platform and the stack of hatch covers.

Figure 20: CCTV snapshot of the starboard side of cargo deck (unenhanced (a) and enhanced (b), showing significantly more detail)
