National Transportation Safety Board

Marine Accident Brief

Contact of Tanker *American Liberty* with Multiple Vessels

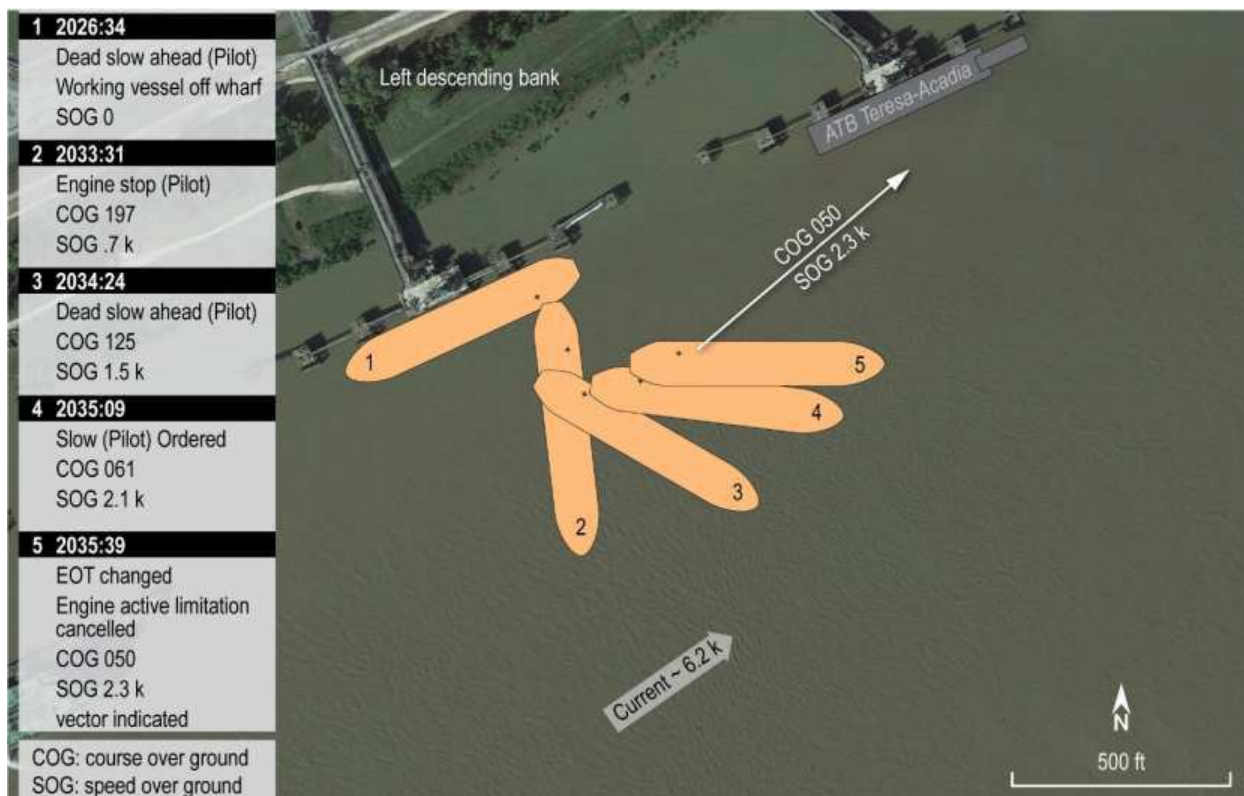
The *American Liberty*'s positions as it came off the dock and its vector at 2035:39, based on the vessel's ECDIS data and AIS data.

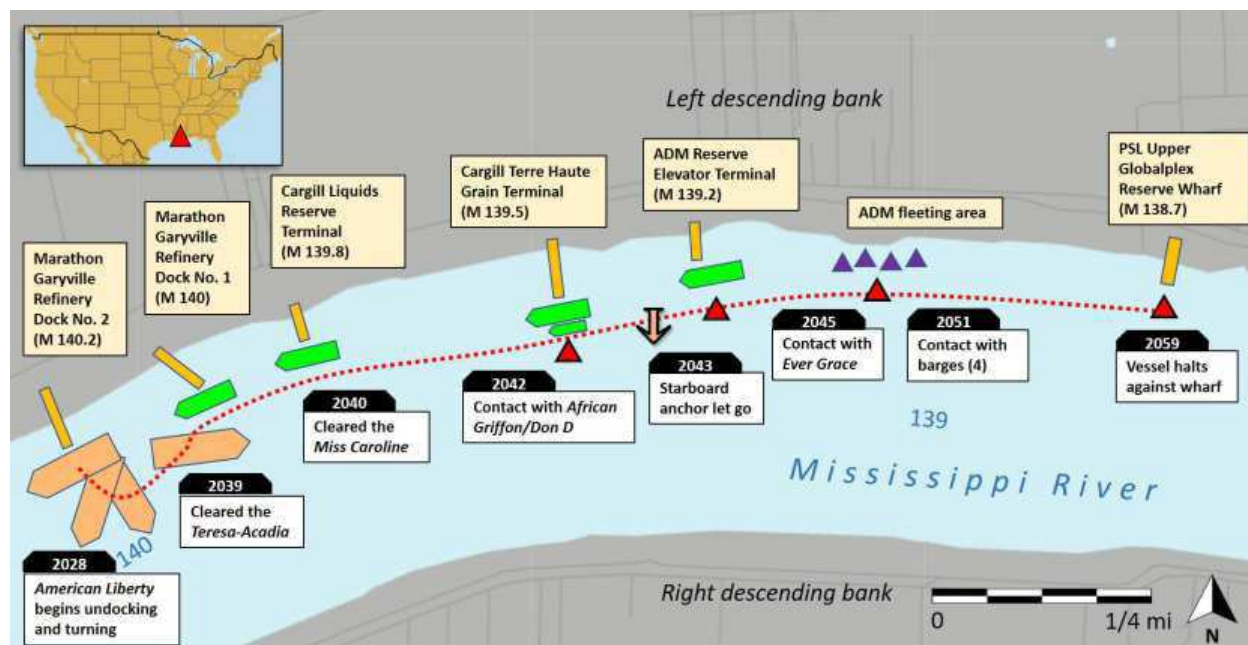
From where the *American Liberty* was moored, there were five wharfs on the left descending bank downriver. All vessels were moored starboard-side-to, bow pointed upriver. Shown is the vessel's AIS track (red dots) getting underway, turning counterclockwise, moving bow first downriver, and contacting vessels and wharfs along the left descending bank, as indicated by the red triangles. Not to scale. (Background Source: Google Maps)

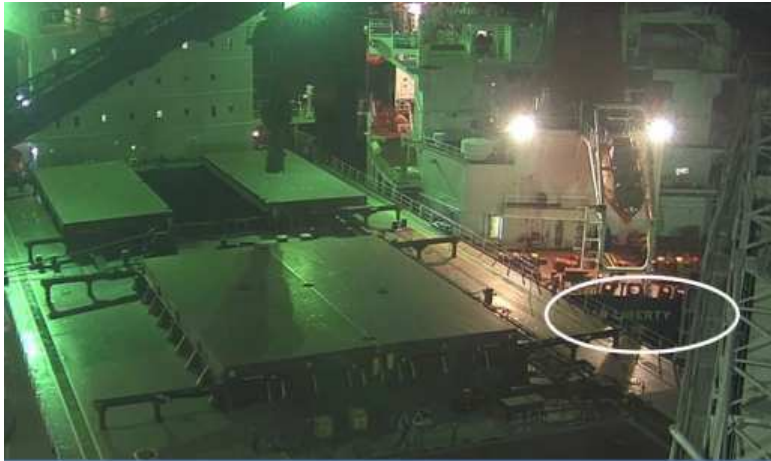
The *American Liberty* (name on the stern is circled), as it drifted down the port side of the *Ever Grace* at ADM Reserve Elevator Terminal. (Source: ADM)

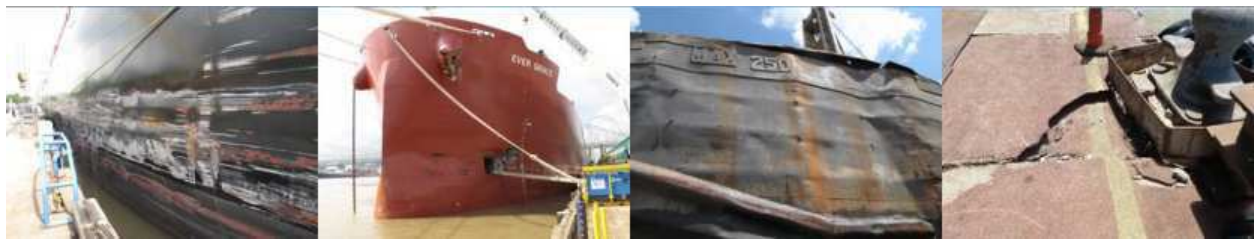
Damage. The *American Liberty* suffered \$1,704,934 in damages to the hull plating down the port side, from cargo tank #2 to the steering gear room; the hull was holed in three places, but the cargo tanks in the double hull were not penetrated. The *African Griffon* had \$5,000 in damages including an inset 15 feet long by 5 feet wide and a fractured frame to the port side of the hull adjacent to cargo hold #1. The *Don D* suffered \$504,519 in damages, which included multiple holes in the hull at the starboard stern and the port bow. The *Ever Grace* suffered \$97,188 in damages, which included two hull punctures and up to 2-foot-deep plate indents over an area 32 feet long and 12 feet wide on the port bow. Initial damage to the ADM Elevator Reserve Terminal was to two mooring platforms and catwalks, 100 feet of the concrete wharf, fenders, and a security camera/tower. Damages were revised to \$32,150,000 to demolish and rebuild the facility including the wharf, moorings systems, loading tower and foundation, ship loader, conveyor system, crane tower, and vacuum tower. Eleven ADM hopper barges suffered estimated damages of \$221,000. The PSL Upper Globalplex Reserve Wharf suffered \$5,881,210 in damages including a destroyed mooring dolphin and catwalk, damaged bridge, pipeline, conduit, wharf structure, and a navigation light. Combined accident damages to the ships, barges, and wharfs were \$40,563,851.

Postaccident damage from left: *American Liberty*, *Ever Grace*, *Don D*, and ADM Reserve Elevator Terminal. (Source: AECOM)

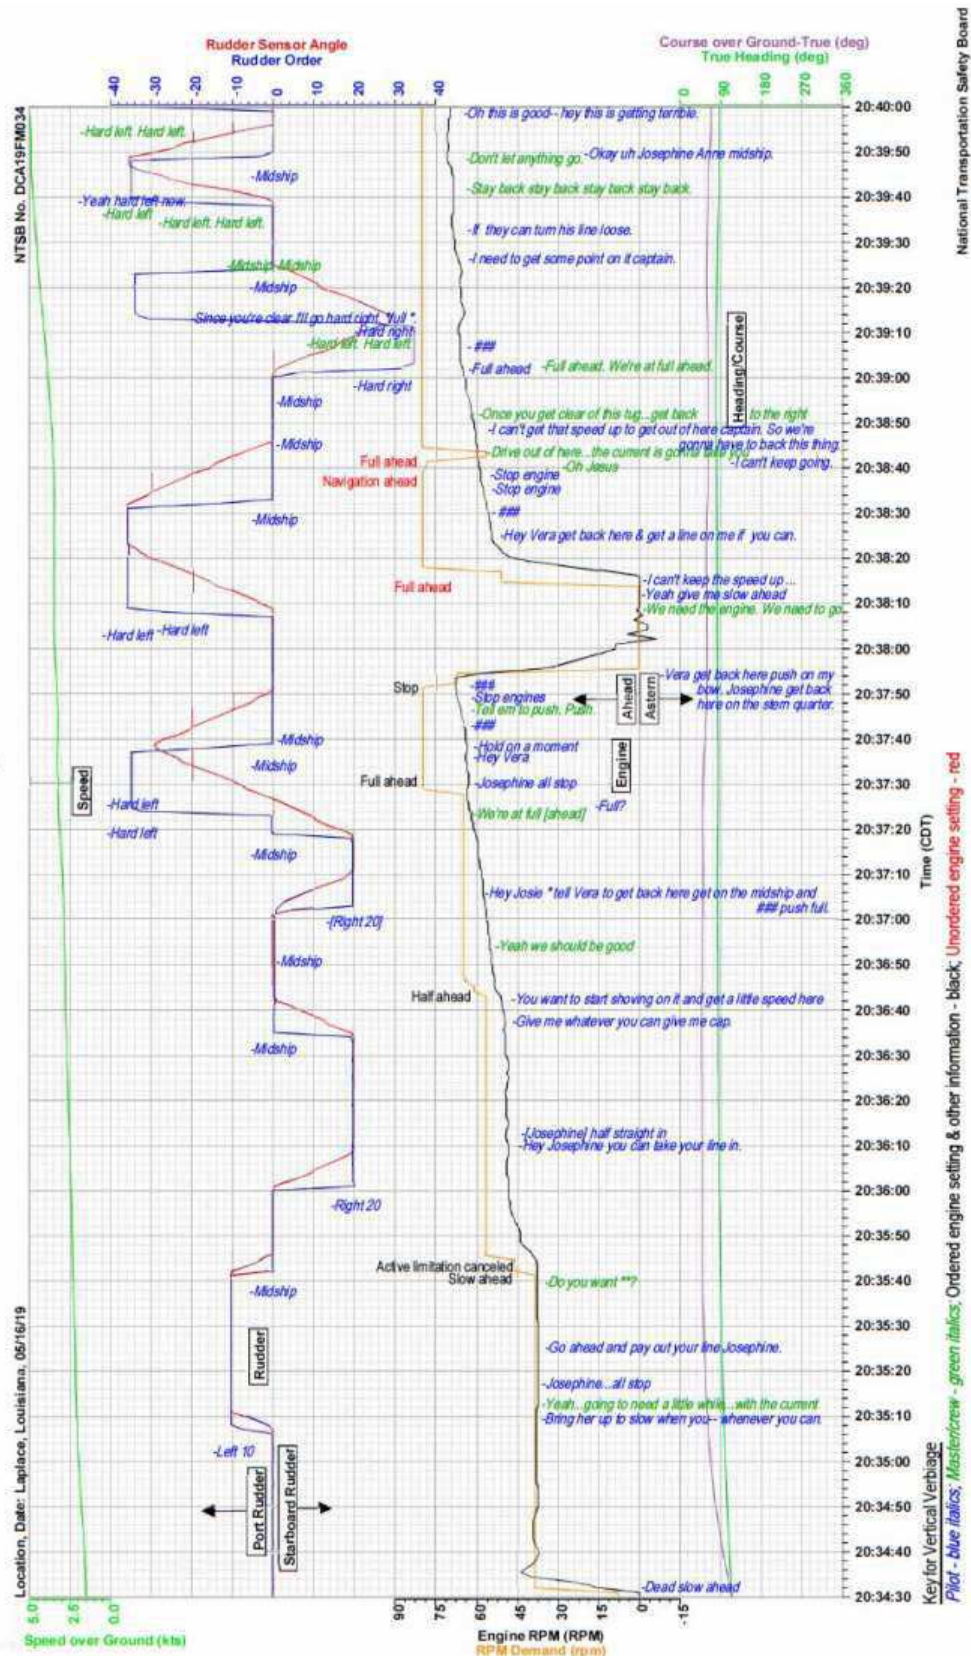
The engine manufacturer reviewed a graph of the engine parametric data, which included rpm data from the VDR. They concluded that the engine responded as expected, and that the engine appeared to have hit its torque limit beginning with the speed increase from dead slow ahead to slow, and then to half and full ahead. When the engine reached its torque (load) limit, the rate of acceleration was lowered. The manufacturer noted that operation with large rudder angles restricts the flow of water from the propeller, so more torque will be required to turn the propeller. In addition, as the vessel moved into the following current, it had a negative speed through the water, and the water flowing past the propeller from astern increased the torque required to turn the propeller. They commented that these effects of engine acceleration with limitations are well known for propellers directly coupled to two-stroke engines and that “actual power delivered is solely determined by the torque required by the propeller for a specific rpm in a given operational condition.”

The *American Liberty*'s parametric data graphed for Speed, Rudder, Engine, and Heading/ Course from 2034:30 to 2040:00:
