SAFETY INVESTIGATION REPORT

REPORT NO.: 14/2020

MV LEOPOLD STAFF **Damage to equipment leading to the inadvertent release of the FFLB in position 15° 59' S 019° 18' W 25 May 2019**

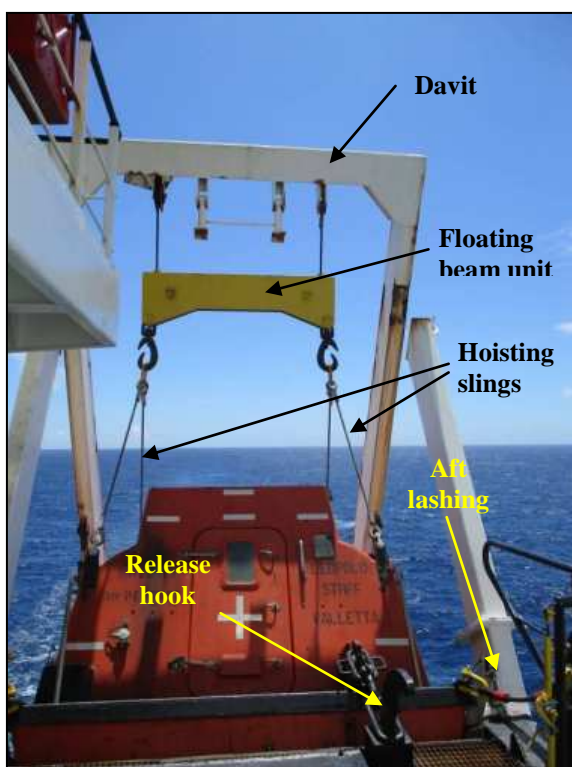
Figure 1: FFLB as seen from its stern

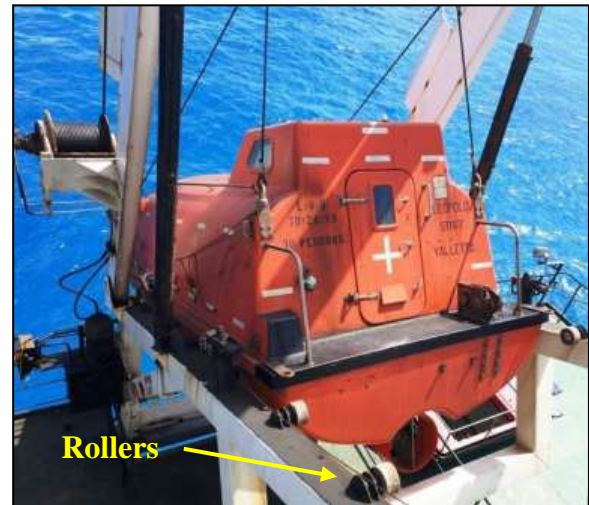
The chief officer instructed the bosun to lower the lifeboat back on the ramp and slide it down, to allow for maintenance works on the rollers. The bosun lowered the lifeboat to a distance of about two metres (Figure 2). As soon as the bosun stopped lowering, it was observed that the hoisting slings were slipping from their ferrule, one by one. In that moment, the floating beam unit recoiled and, at around 1040, the lifeboat slid down to the water.

Figure 2: Position of lifeboat when the hoisting slings started to slip

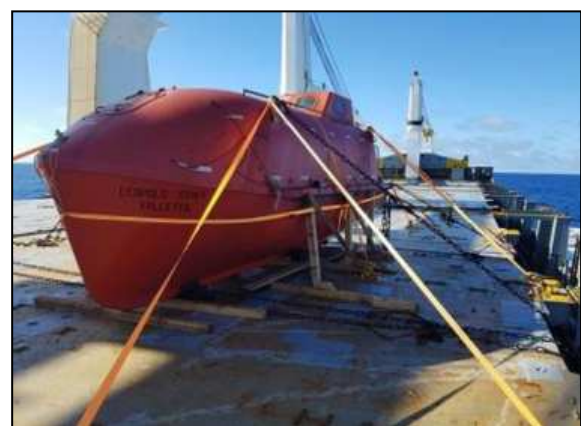
Due to the three metre swell that was rolling the vessel slightly and due to the absence of sound hoisting slings on board, the master assessed that the recovery of the lifeboat by using the lifeboat's davit, was dangerous². In view of the situation, he decided to secure the lifeboat on deck by the use of the vessel's cargo crane (Figure 3).

Figure 3: FFLB secured on deck

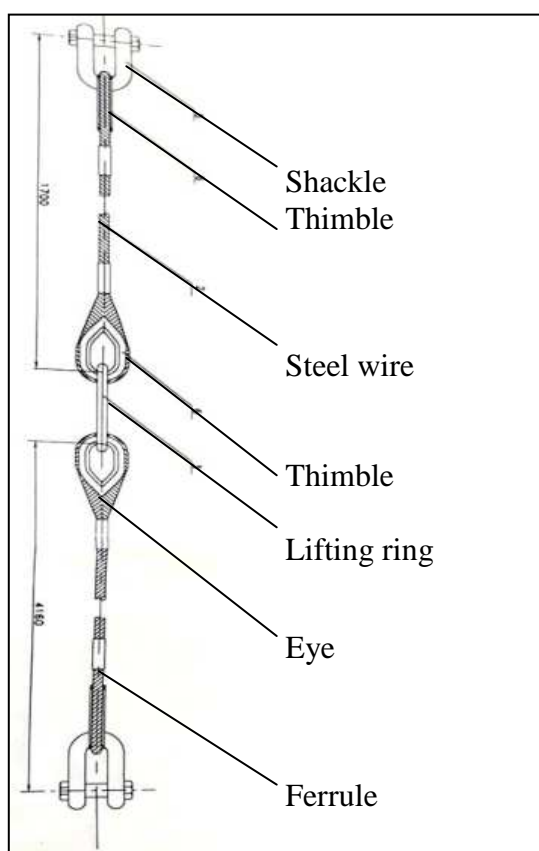
The hoisting slings consisted of two sets, each made up of two steel wires of different lengths, ending with hard eyes (Figure 4). The two steel wires were connected by a lifting ring. Each set of hoisting slings had a shackle on each end – one connected to the fore part of the lifeboat and the other to the aft part (Figure 1).

The steel wires were galvanised, had a rope construction of 18*7 with a steel core, and were of 16 mm diameter. The Minimum Breaking Load (MBL) of the steel wire was indicated to be 165 KN³. A pair of this assembly was connected on both port and starboard sides of the lifeboat, for hoisting.

Figure 4: Assembly of hoisting slings

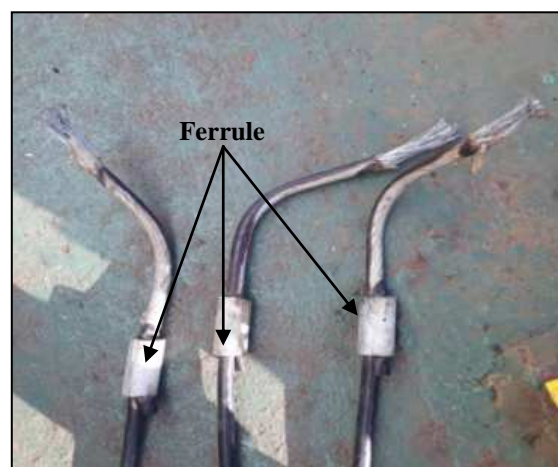
No damages to the FFLB were noticed following this occurrence. However, all four hoisting slings were found to be damaged in the same manner. The steel wires, which were turned in on themselves to form an eye and then clamped with a ferrule, had slipped from their ferrule (Figures 5 & 6).

Figure 5: Showing three of four damaged hoisting slings that were connected on the FFLB

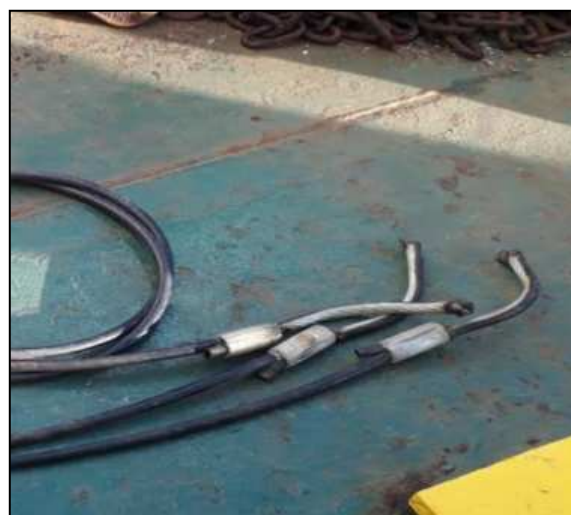
Figure 6: Showing three of four damaged hoisting slings that were connected to the floating beam unit

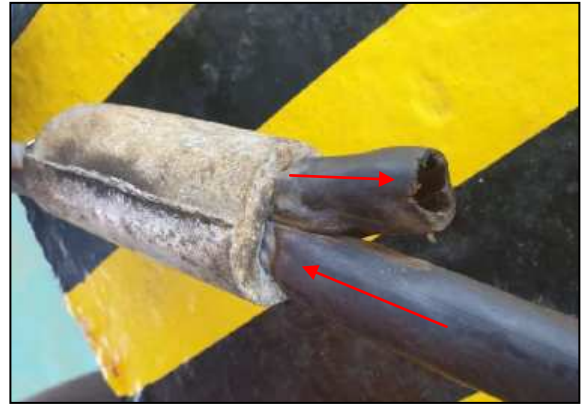
The hoisting slings were completely covered with PVC sheathing. This sheathing was also found to be covering the section of steel wire forming the eye and passing through the ferrule (Figure 7).

Figure 7: Sheathing passed through the ferrule in both directions

Evidence suggested that the steel wire had slipped from the ferrule. This further suggested that the ferrules and the steel wires passing through them were not fused together. The MSIU believes that this could have occurred due to:

- inadequate pressure applied during swaging; and/or
- the presence of sheathing inside the ferrule.

European Standard EN 13411-3+A1:2008 – “Terminations for steel wire ropes: Safety. Ferrules and ferrule-securing” specifies that if a rope end is to be pressed within the ferrule, the serving shall consist of only a strand or wire.

14/2020_R1 Publish an information notice, highlighting the dangers of sheathed steel wires on board ships due to restricted access to the wire rope for a thorough inspection;
