MARINE SAFETY INVESTIGATION REPORT

Safety investigation into the grounding of the
Maltese registered LPG

SEASURFER

in the Port of Praia
Ilha de Santiago, Cabo Verde
on 12 October 2019

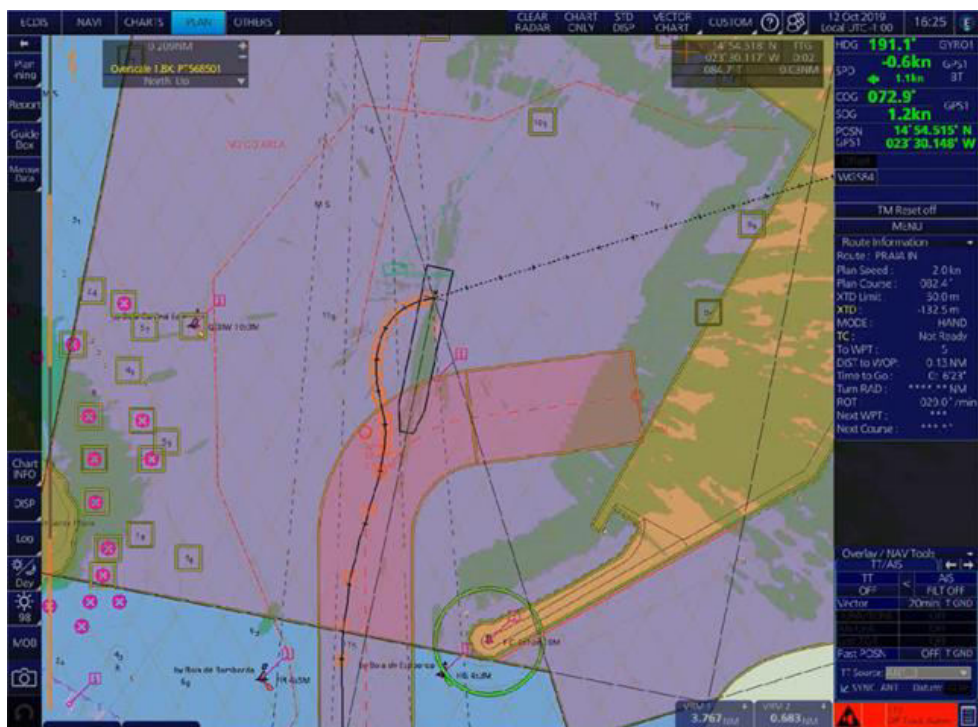
Figure 7: *Seasurfer* dropped starboard anchor at 1625

As soon as the anchor was dropped, *Seasurfer* started swinging to starboard. The pilot ordered the helm hard to port and the engine dead slow ahead to check the swing. By this time, seven shackles of anchor chain had run out, the vessel was heading West, and ahead at 0.50 knots (Figure 8). The helm was put amidships and the main engine was stopped. The pilot ordered dead slow astern and the tug was shifted to starboard midships. The master directed the pilot to shift the tug to the starboard bow. A few minutes later, the main engine was stopped.

- .4 The exceptionally large leverage and inertia of rotation when the starboard anchor hit the sea bed, exacerbated the rate of turn and *Seasurfer* swung further to starboard, heading almost West;

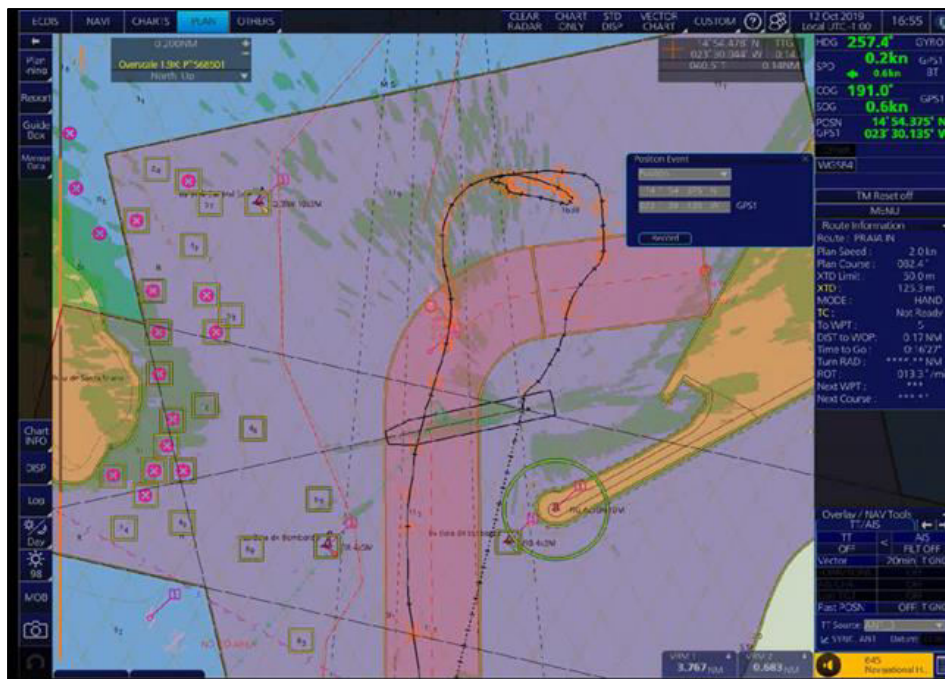
Figure 12: ECDIS image at 1655 showing position of *Seasurfer* relative to the breakwater

The cumulative effect of weighing of the anchor, tug pushing on the starboard side, main engine running ahead and with the helm to port, set the vessel laterally moving Southwards. By the time *Seasurfer* had picked up five shackles of the anchor chain, she was heading almost West. At this point, the breakwater was reportedly 80 m on her port quarter (Figure 12).

The master ordered the anchor brakes open, with the intention of allowing the bow to move to port and draw the stern away from the breakwater. He ordered the main engine full ahead and told the pilot to instruct the tug to push, in order to swing the bow to port. The master then ordered the forward station to hold the anchor, whilst the pilot advised the master to stop the main engine.

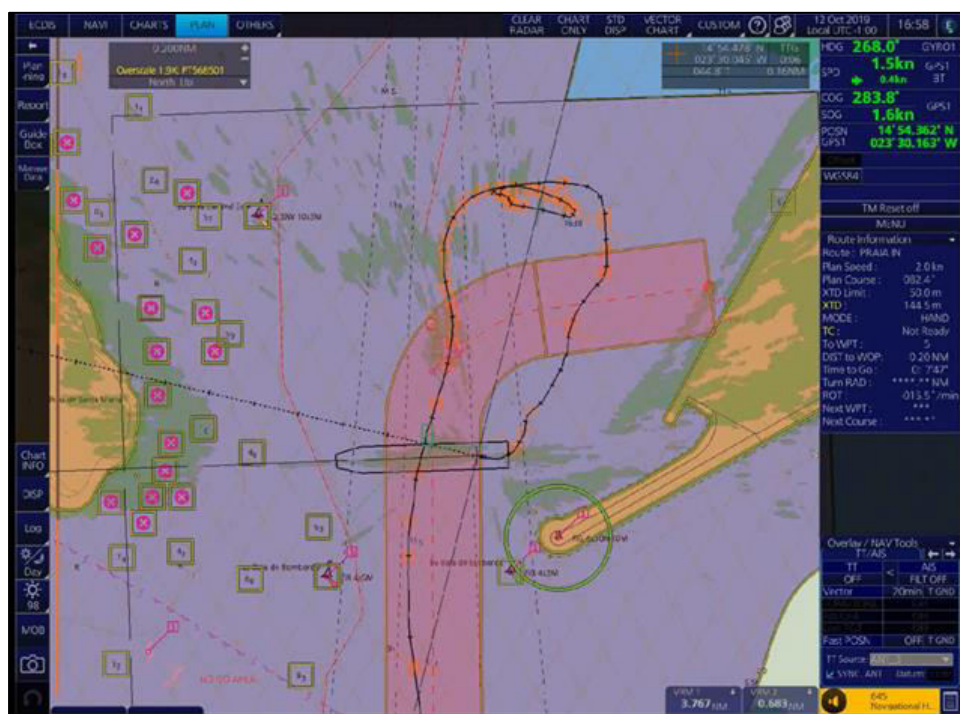
Figure 13: ECDIS image at 1658

At 1658 (Figure 13), nine shackles of anchor chain had run out, leading aft on moderate stay. The vessel was moving ahead at 1.5 knots and the shoaling depth lay close ahead. The bow started to swing slowly to starboard and the pilot advised the master to set the main engine to half astern, with the helm midships.

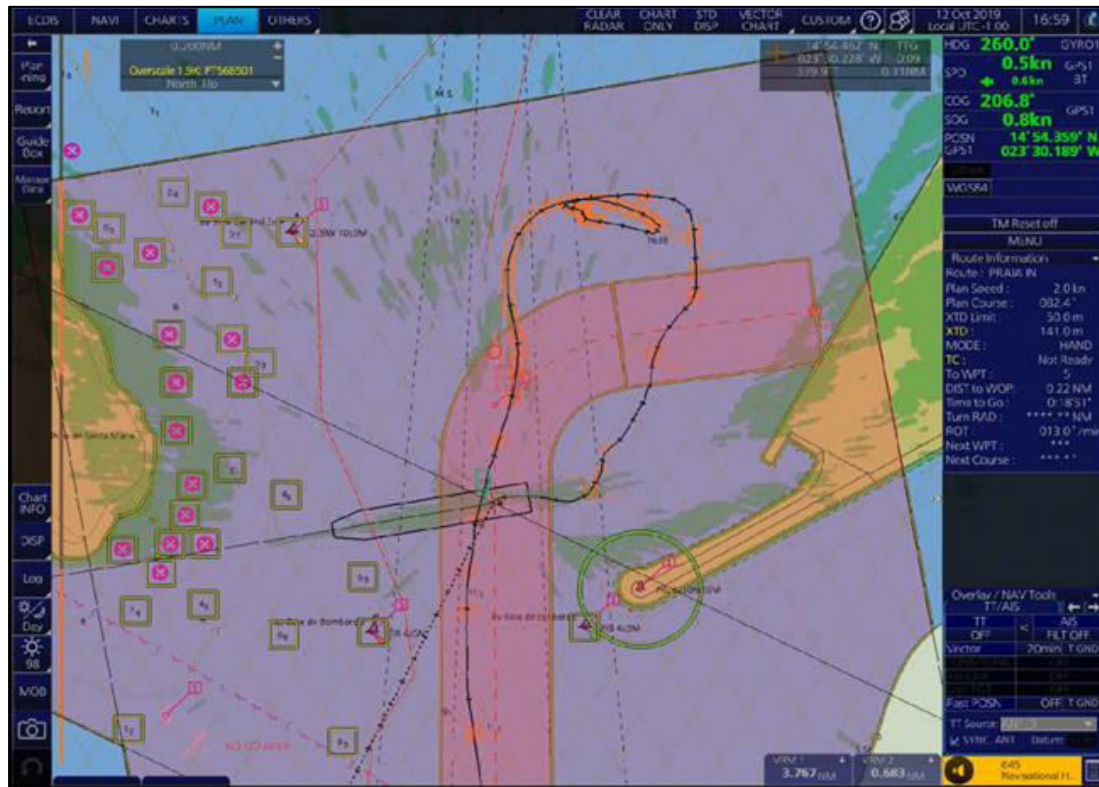
Figure 14: ECDIS image at 1659 showing the bow crossing the 10 m depth contour

At 1659, the master stopped the main engine and almost immediately ordered dead slow ahead. The helm was turned hard over to port. The pilot advised the master to stop the main engine but a few seconds later, the bow crossed the 10 m contour and made contact with the seabed (Figure 14).

- .1 The vessel's bow advanced beyond the limits of the navigational fairway and came in contact with the shoaling depth.

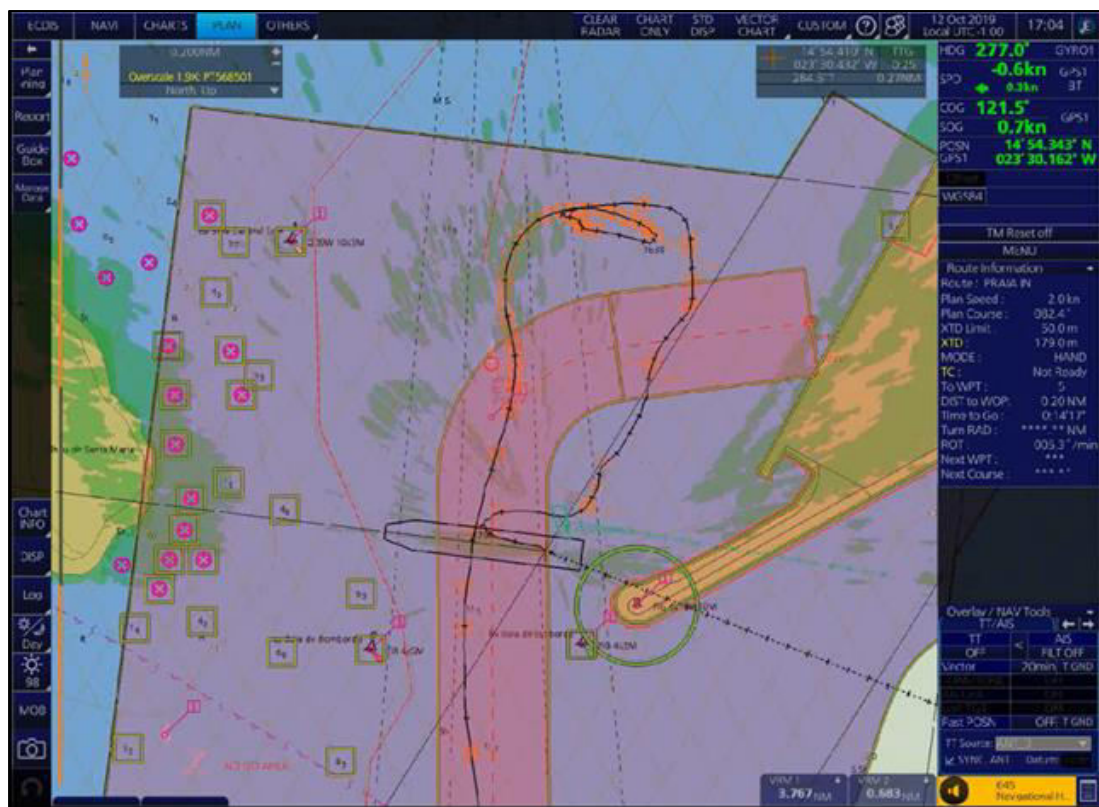
Figure 15: ECDIS image at 1704, showing *Seasurfer* heaved off the shoal

The master stopped the main engine and followed it up with a dead slow astern and full astern, with the helm amidships. About five minutes later, although the bow was heaved off the shoal (Figure 15), the stern started to close-in on the breakwater bullnose. The main engine was stopped and the tug was sent aft to make fast on the starboard quarter. The forward station was instructed to heave up the anchor. At this point, the pilot asked the master as to his intentions, the latter replying that he wanted to swing the bow into the turning basin and requested the pilot to instruct the tug to push from the stern.

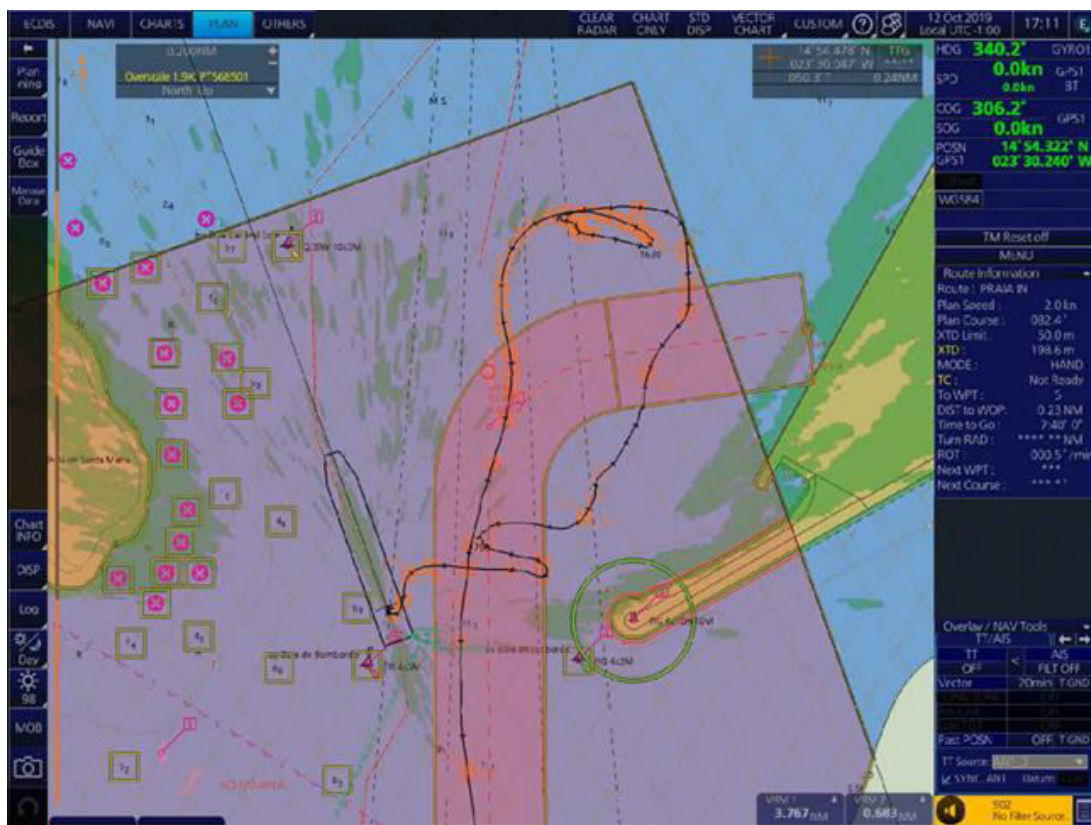
Figure 16: ECDIS image at 1711. *Seasurfer* is aground with her port side lying along the 10 m depth contour

As the stern drew closer to the breakwater bullnose, the master ordered half ahead and full ahead at 1704. Following the pilot's advice, the helm was set hard over to starboard and the bow started to swing to starboard. The master stopped the main engine and ordered dead slow astern, half astern and the helm midship. The pilot advised the master to cast off the tug. At 1708, the master stopped the main engine and then ordered dead slow ahead, slow ahead and half ahead, whilst the tug was instructed to push from the port quarter. *Seasurfer* rapidly turned around to starboard and the vessel's port side ended up just outside the 10 m contour (Figure 16).

The chief engineer, who was in the engine-room, felt the impact and noticed the vibrations; he also heard the propeller blades touching the seabed. He called the bridge and informed the master of his observations. Straightway, the master stopped the main engine, put the rudder amidships, and informed the pilot that the vessel had ran aground, with her stern resting close to the port lateral buoy, in position 14° 54.32' N 023° 30.24' W.
