Report on the investigation of

Young Lady

Dragging anchor 5 miles east of Teesport and
snagging the CATS gas pipeline,
resulting in material damage to the pipe

25 June 2007

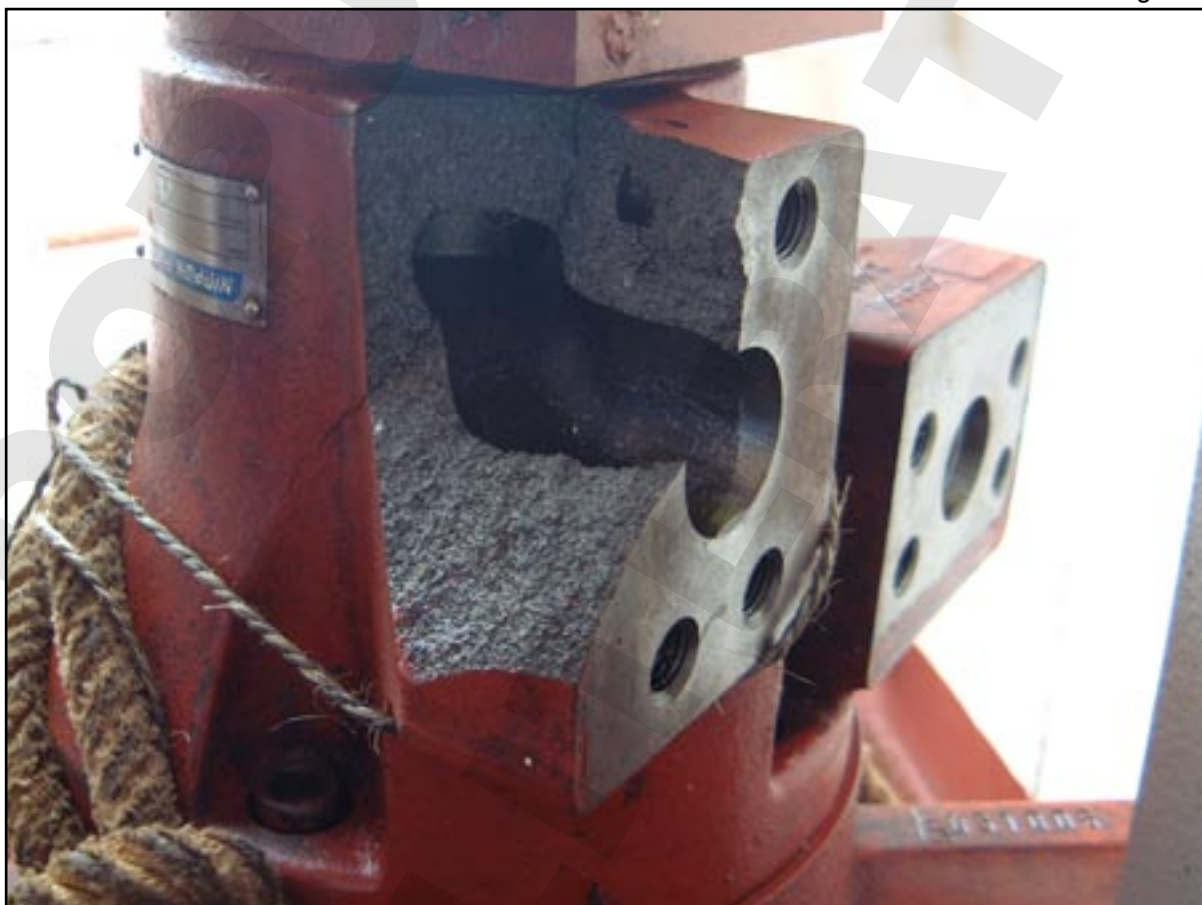
Figure 7

Damage to the port windlass hydraulic motor unit

It was not until 1330, when the crew had replaced the port windlass hydraulic motor, that it was possible to take the weight off the bitter end, remove the pin and finally slip the cable. *Young Lady* made ground to the north-east and awaited further instructions.

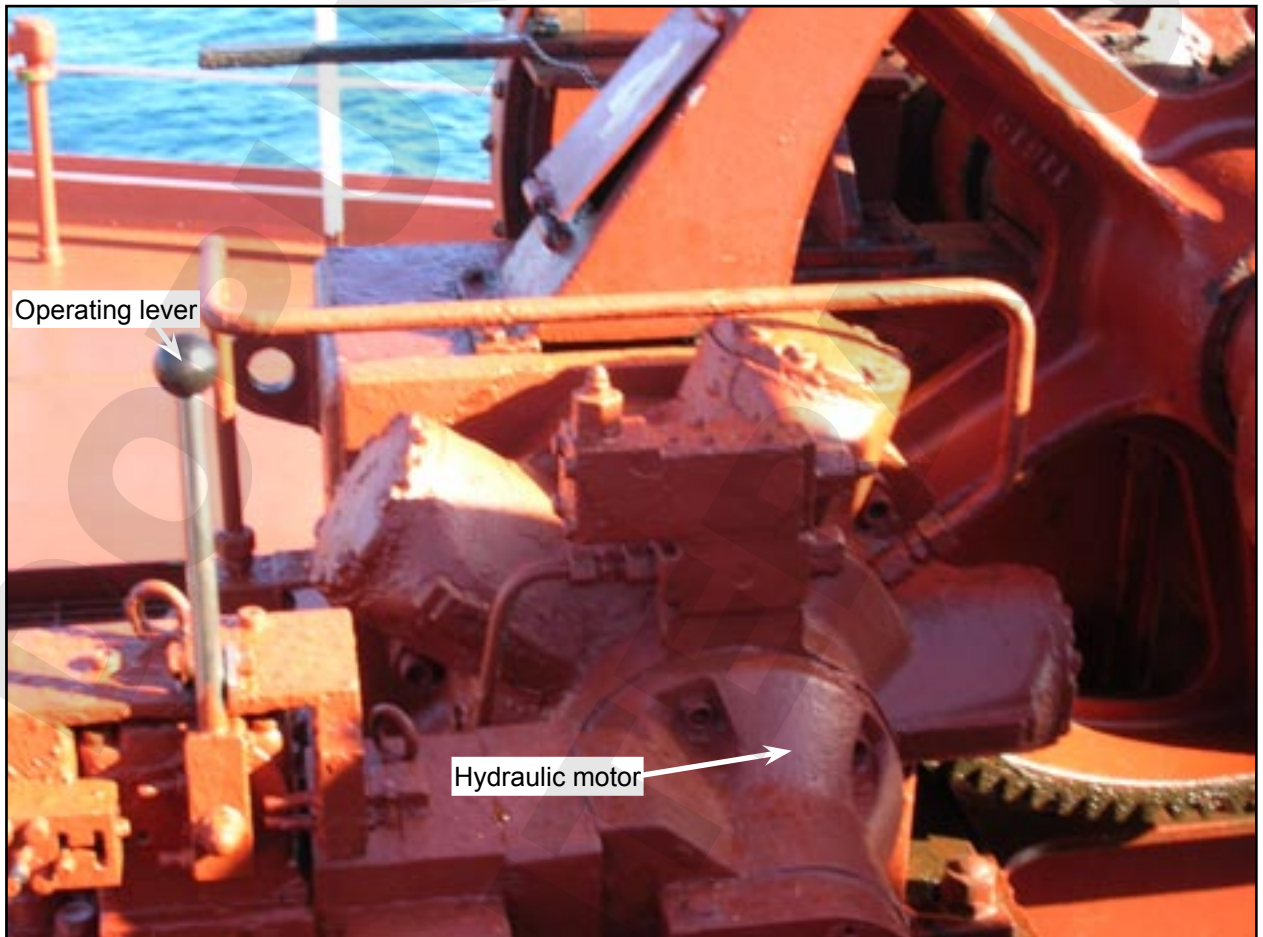
Figure 14

The hydraulic system was fitted with two in-line relief valves designed to operate when a hydraulic pressure of 240 Kgf was reached. One relief valve was fitted to guard against shock loads, and the other relief valve was fitted to guard against a gradual increase in hydraulic pressure encountered during the heaving operation. There was no relief valve fitted within the hydraulic motor itself.

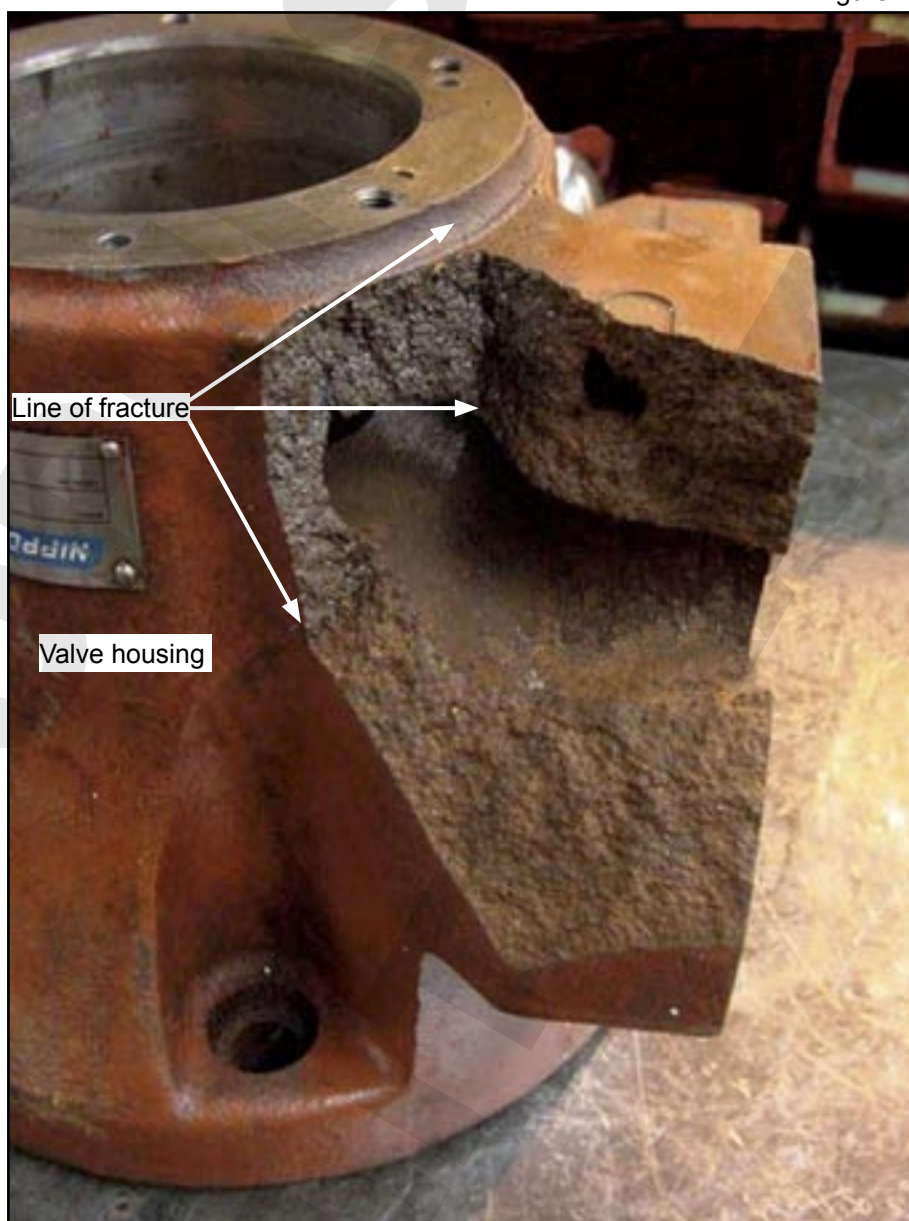
Figure 19

Comparison of the required and the actual capacities showed that there was little reserve power over and above the minimum required. When confronted with the weather conditions of 25 June, and when due consideration is given to the advice provided by the classification society, the potential risk of windlass failure was significantly greater than that faced under normal operating conditions.

Damage to motor casing

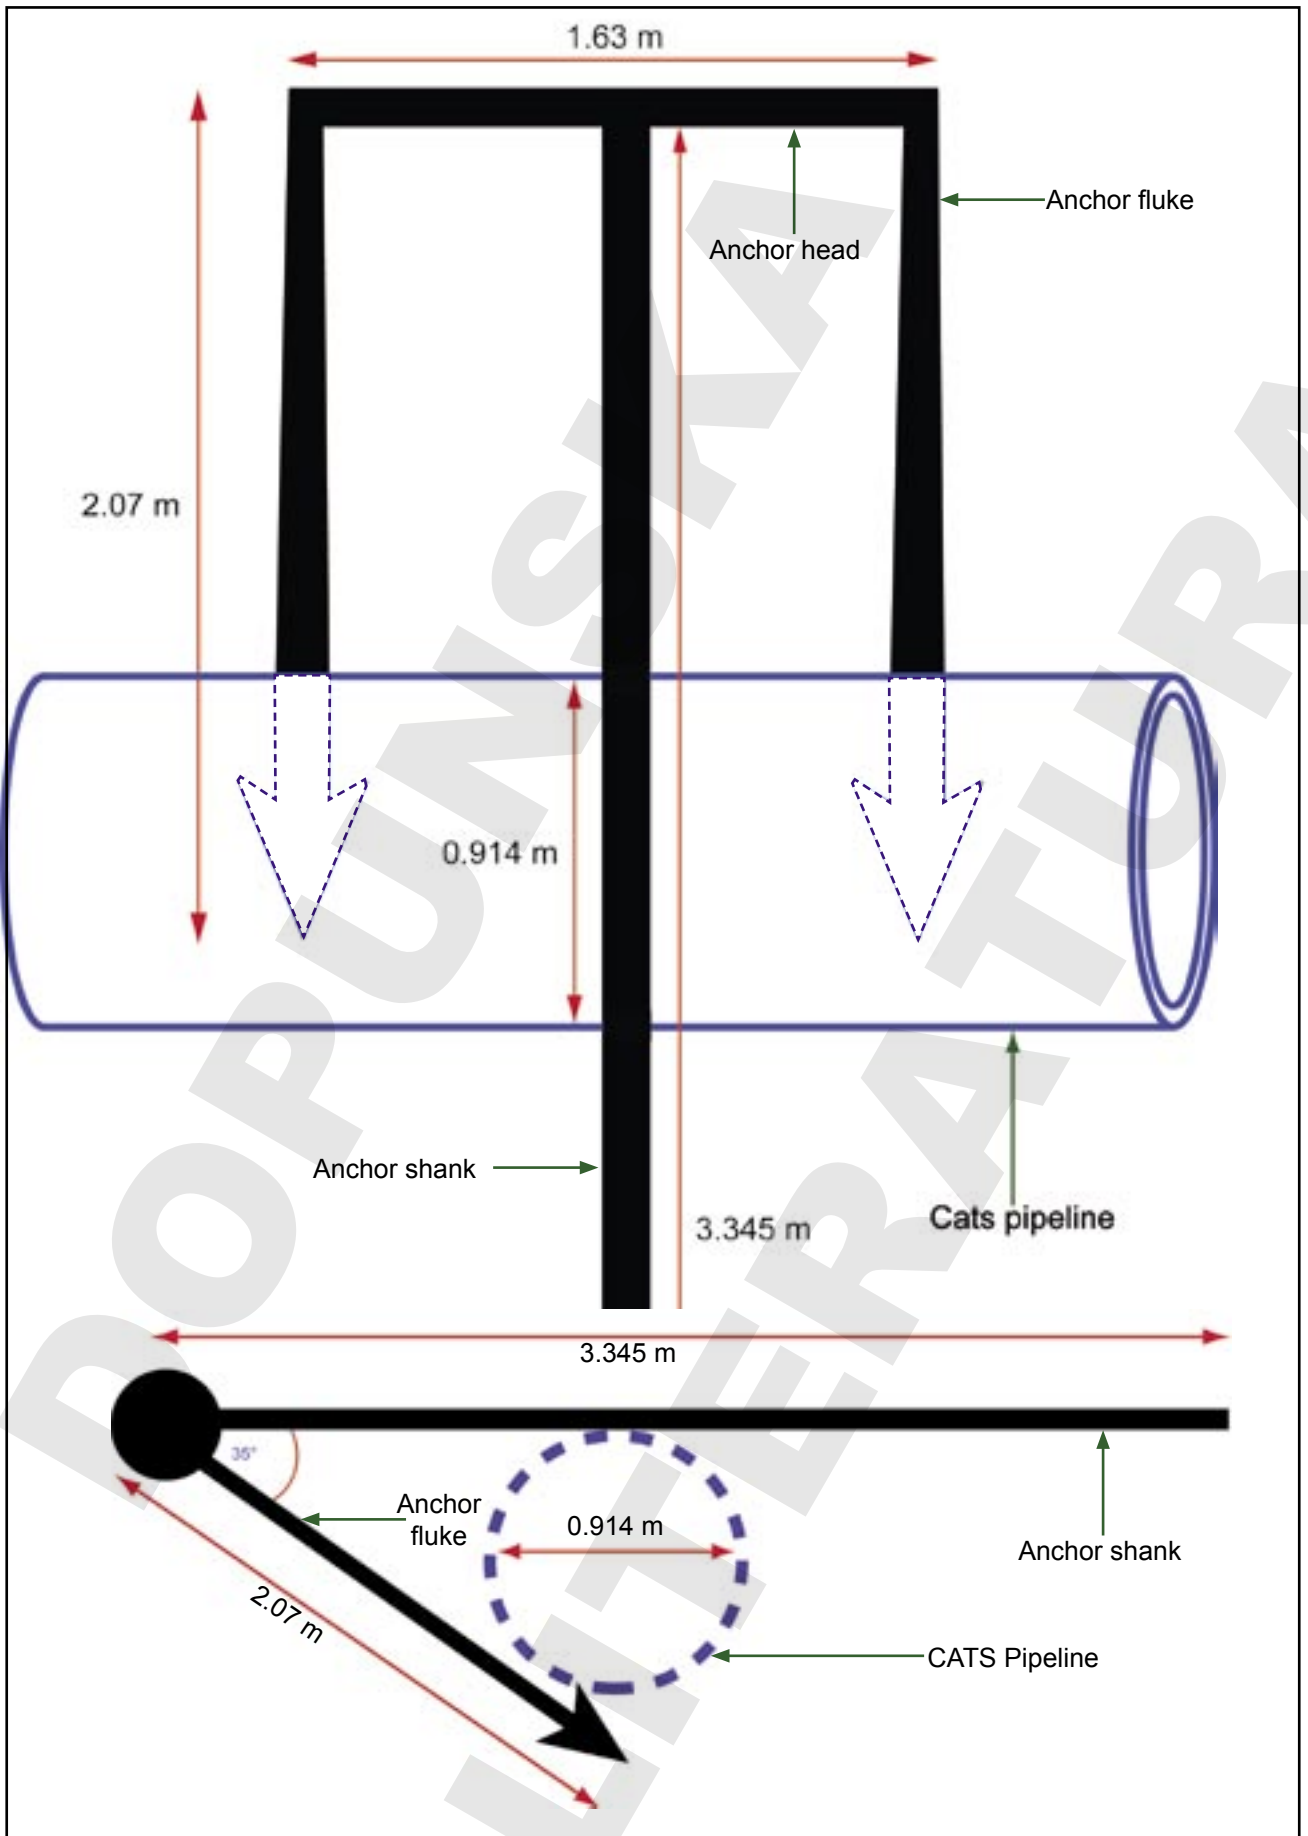
The full damage assessment, conducted by ROV and diver survey, indicated that the pipeline had been lifted 1.5m, moved laterally at the point of contact by 6m in a south-easterly direction, and had been partially exposed over a length of about 170m. The concrete protection had been removed at the point of contact, and impact damage was identified on the steel pipe.

Plan view and elevation diagrams representing *Young Lady's* anchor snagging the CATS pipeline

By the end of July 2007, BP had completed the repair assessment. Primary damage was to the concrete coating, but there was sufficient concern about the damage to the pipeline itself to require the installation of a repair sleeve, which was carried out in August. The pipeline was covered and protected where it lay, and production was restarted in September 2007.
